**PHASE I ENVIRONMENTAL SITE ASSESSMENT
AND LIMITED ASBESTOS AND LEAD-BASED
PAINT SURVEYS
BOB RUUD COMMUNITY CENTER
150 NORTH HIGHWAY 160
PAHRUMP, NEVADA**

PROJECT NO. 117801.01

June 29, 2011

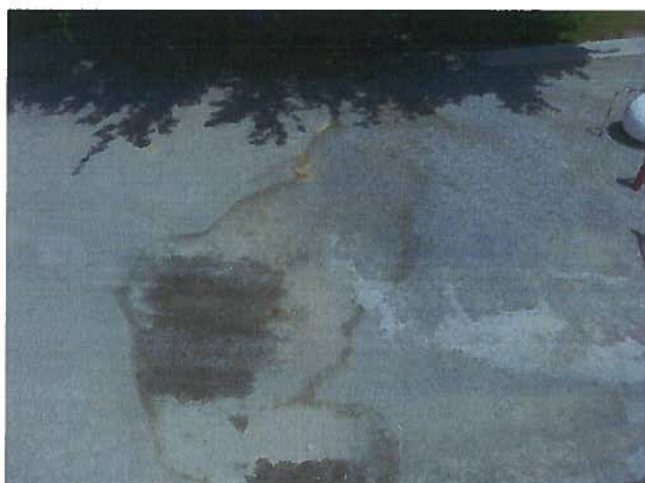
On the exterior, an AST containing propane was observed. Surface staining was on the access road to the park grounds, located between the Subject property and the propane AST. This staining appears to be in the area where one of the two septic tanks was reported to be located.

Stained surface – in area of reported septic tank
(near propane tank)

- Poor best management practices were observed in the supply storage closet. Spilled floor seal/resin type material was observed. Kleinfelder recommends that spills be cleaned and leaking containers be appropriately disposed.
- Surface stained soil was observed in the area where one of the two septic/leach fields areas is reportedly located. The Town of Pahrump should verify whether the surface staining is above the septic/leach field and if so, evaluate if the septic/leach field is functional.

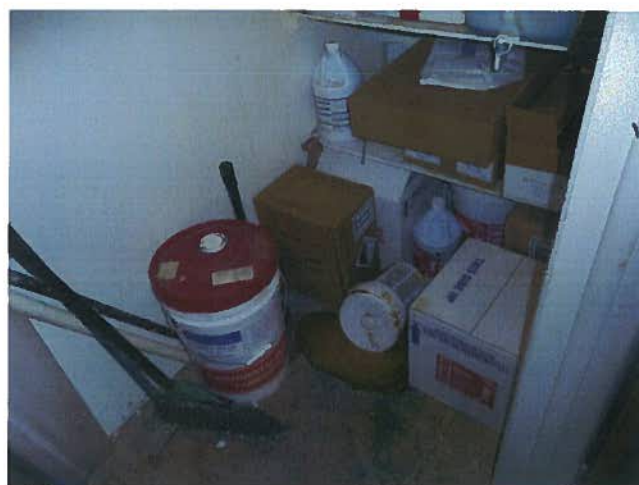
At the time of our site reconnaissance, we observed 5-gallon size containers of corrosive liquids, floor stripping, cleaning and sealant products and some smaller containers of cleaning supplies, within a supply closet. One of the containers, containing an unidentified resin type material, had leaked.

Storage/supply closet

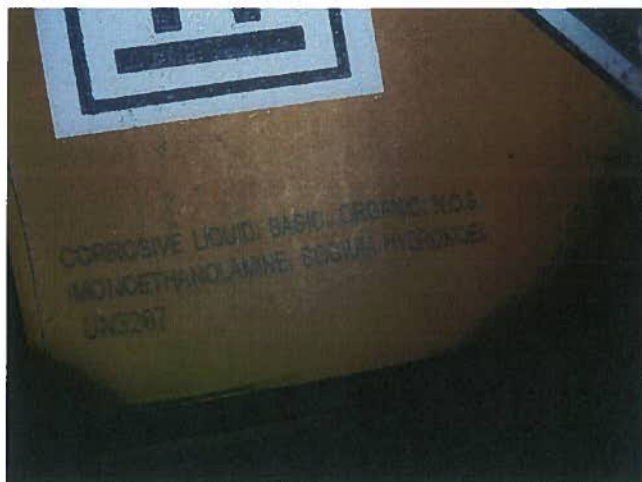
Corrosive liquid in storage /supply closet

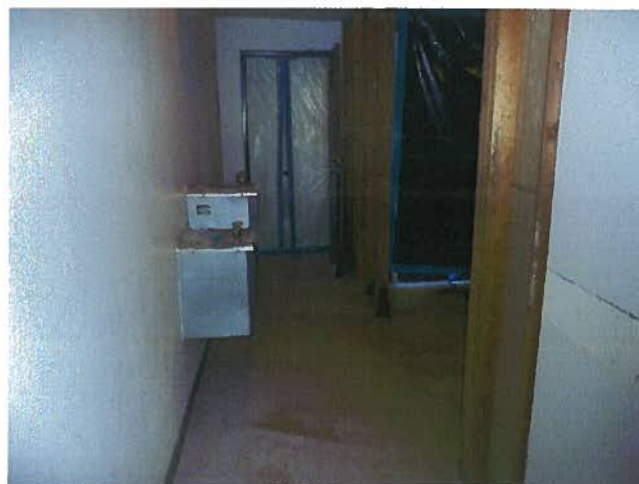
Portion of building with containment (mold remediation) *Original in Color*
