HAZARDOUS BUILDING MATERIALS SURVEY

Asbestos and Lead-Based Paint

**Brewery Arts Center Performance Hall
(APN 003-206-01)
501 West King Street
Carson City, Nevada**

March 6, 2019

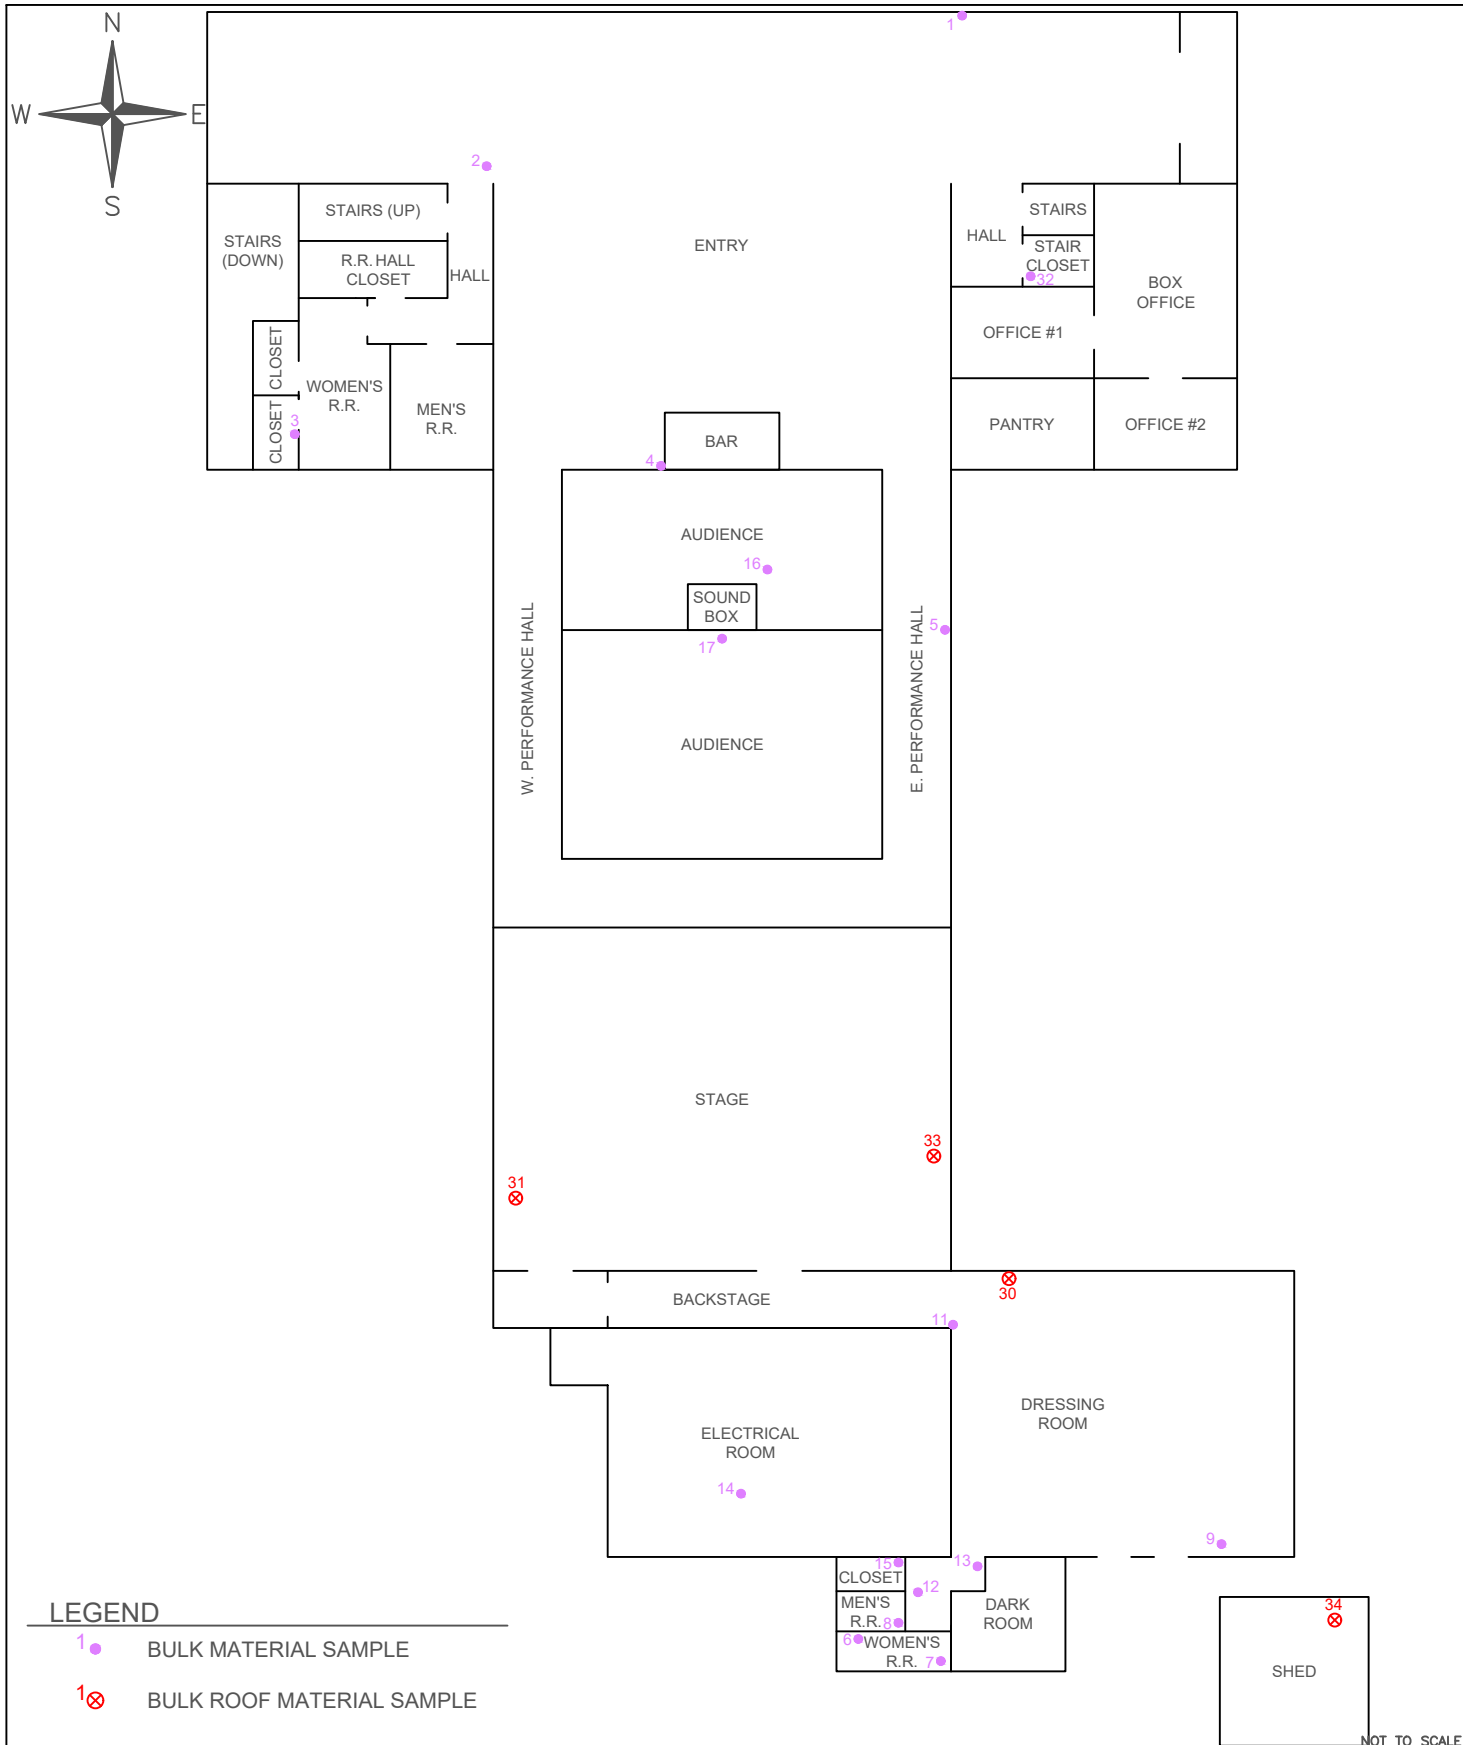
FIGURE 2
SAMPLE LOCATION MAP
BREWERY ARTS CENTER
PERFORMANCE HALL
501 W. KING ST.
CARSON CITY, NEVADA

A copy of the analytical results reported by EMLab is included in Appendix C. Sample locations are presented in Figure 2. Based on the analytical results of bulk samples collected during this survey, the following building materials had an asbestos content in excess of 1%. NESHAP and OSHA classifications are provided below for each building material containing an asbestos content greater than 1%. According to the analytical report, no samples containing <1% (trace) asbestos content were identified. Therefore, no samples were analyzed using 400-point counting by PLM. A summary of reported samples with asbestos content in excess of 1% is provided in Table 1. The following describes the general location and approximate quantities of ACM at each general location:
