ASBESTOS AND LEAD ASSESSMENT

**Former Eagle Gas
1395 US Hwy 395 North
Gardnerville, Nevada 89410
Nevada Brownfields Program
Task MA-02-14**

April 4, 2014

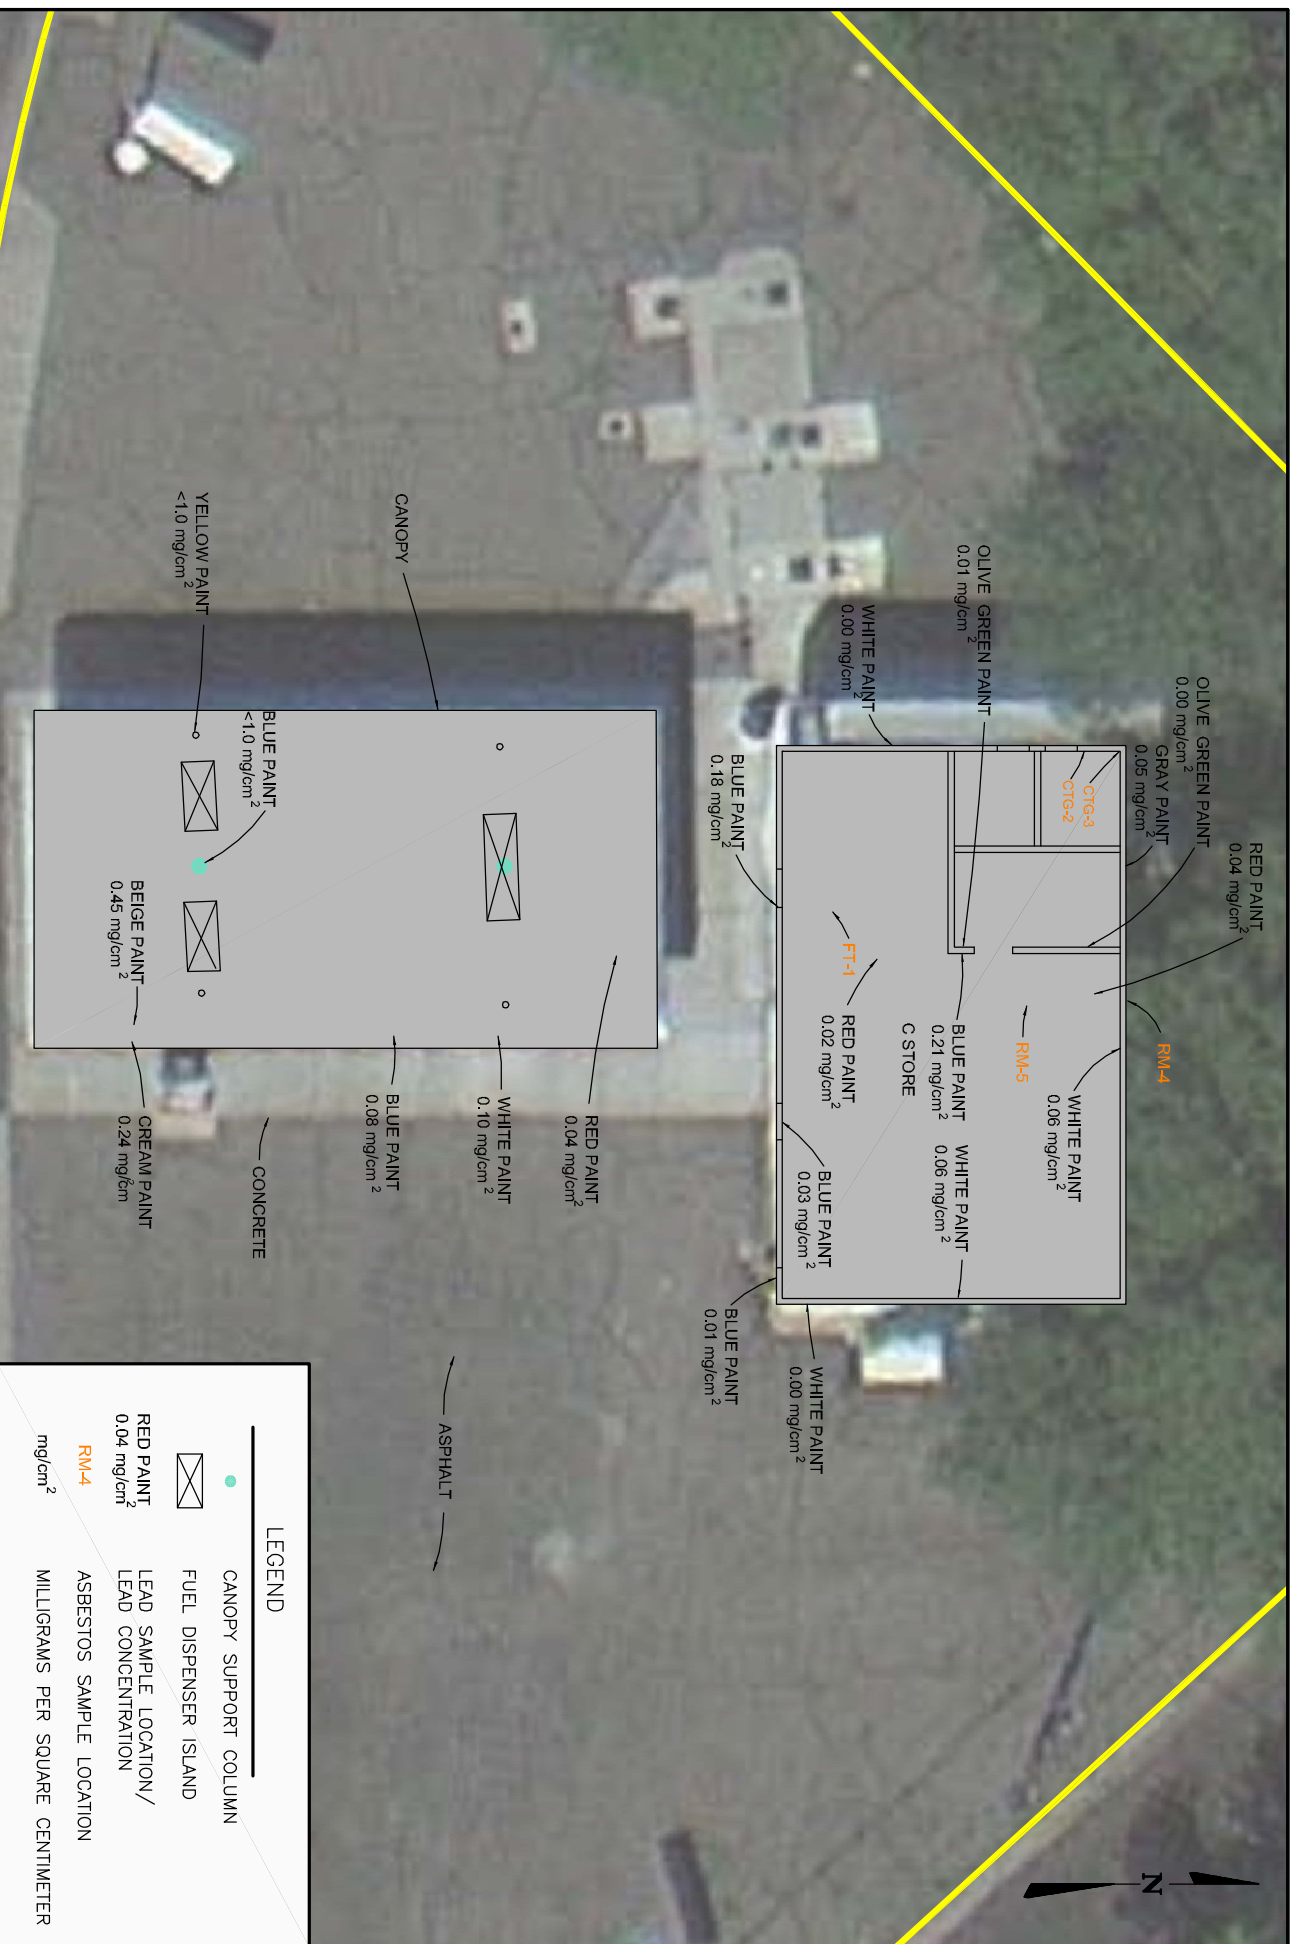
FIGURE 2

Analytical results indicated that one of the five bulk samples that were collected during this inspection was positive for containing asbestos in excess of one percent. Sample #RM-5 (roof penetration mastic) contained 5-10% Chrysotile asbestos. All other materials sampled during this investigation were “None Detected” for containing asbestos. Analytical results and the laboratory chain-of-custody are provided in Appendix A and B respectively.

Readings from the XRF analyzer indicated that painted surface coatings located on the gas pump bollards, and on the canopy structural poles contained 1.0 mg/cm² of lead or greater. All other painted surface coatings located on the canopy and gas station building contained less than 1.0 mg/cm² of lead. Field notes providing XRF data from the assessment are provided in Appendix C.

LEAD AND ASBESTOS SAMPLE LOCATIONS
