June 30, 2015
MGA Final Report
Via electronic mail

**RE: ABATEMENT OVERSIGHT AND MONITORING ACTIVITIES REPORT,
MCGILL LIBRARY, 4 NORTH FOURTH STREET, MCGILL, WHITE PINE
COUNTY, NEVADA**

Project Monitoring and Final Clearance Report

Asbestos and Lead Based Paint Abatement

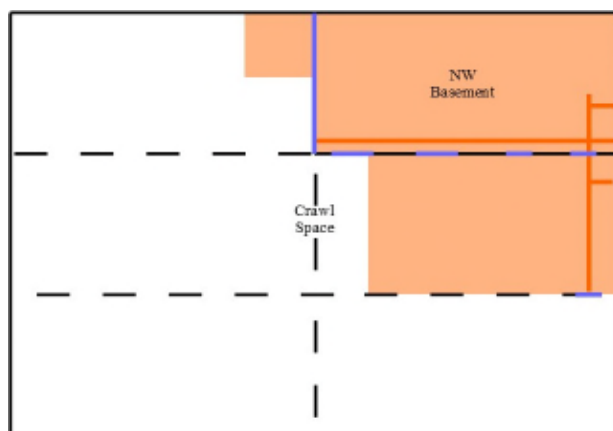
- Orange lines indicate the approximate locations of the TSI on pipes.
- Orange shaded area represents the area that has TSI debris.
- Purple lines indicate the approximate locations of the black wall mastic material.

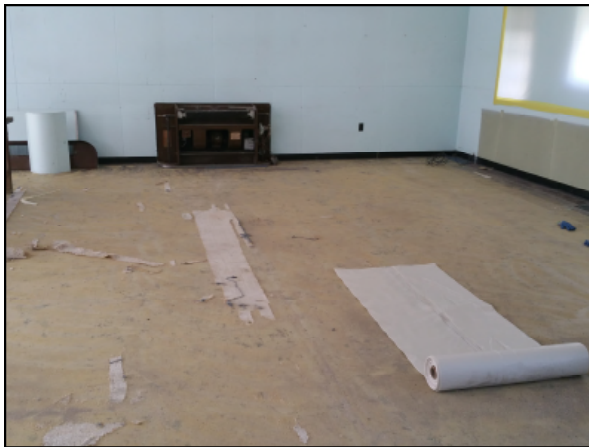
Picture 1—Interior of the building following carpet removal, prior to commencing VCT and base cove abatement.

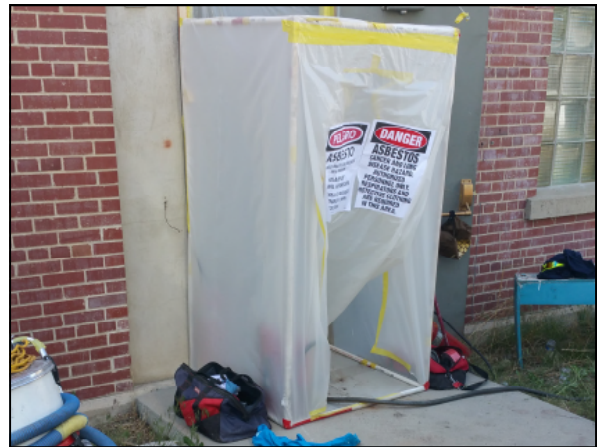
Picture 2—Outer, “clean room” stage of the decontamination chamber to the interior abatement.

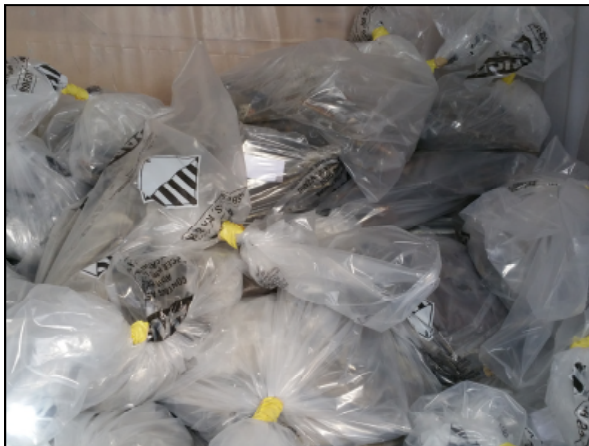
Picture 3—Bags of VCT and base cove debris.

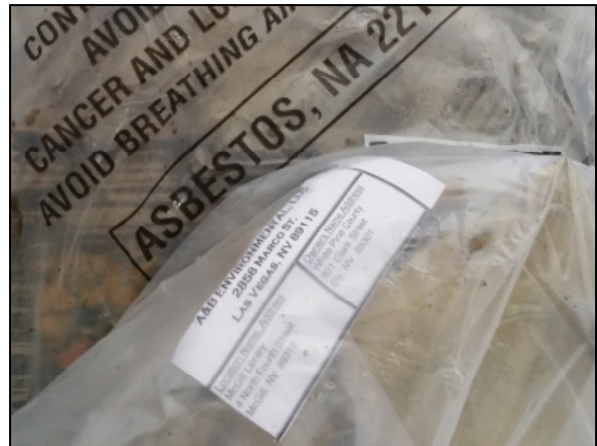
Picture 4—Labeled bags.

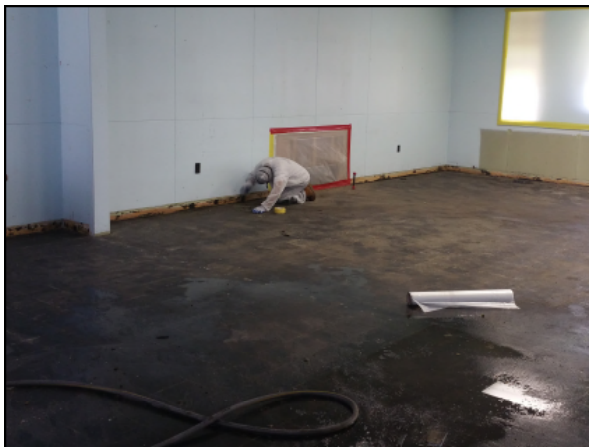
Picture 5—Worker conducting detail cleaning of the floor and lower walls in the interior of the building.

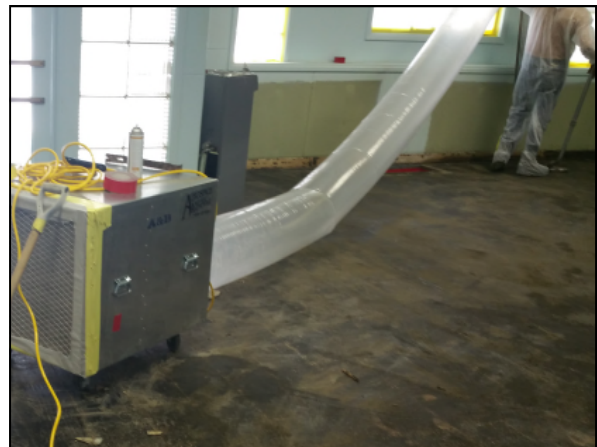
Picture 6—Interior of the containment, during VCT and base cove abatement. Negative air machine and worker using HEPA vacuum.

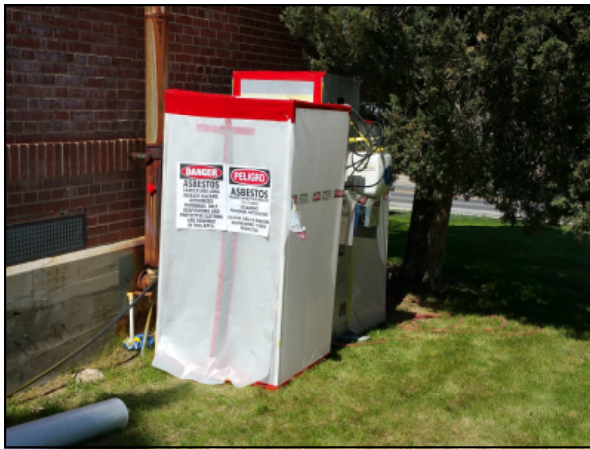
Picture 7—3-Stage decontamination chamber with shower, outside of the entrance to the basement.

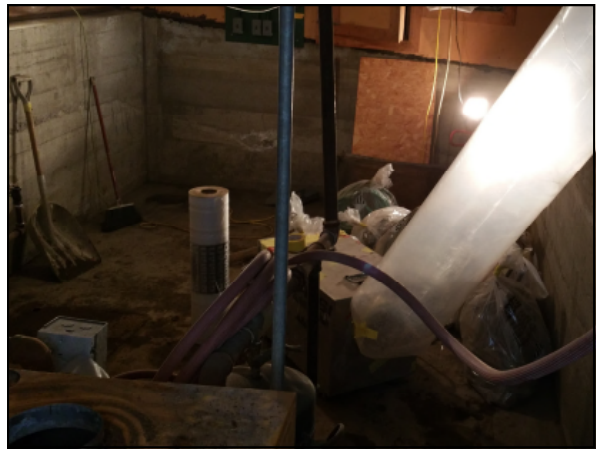
Picture 8—Basement following clean-up and bagging of contaminated contents.

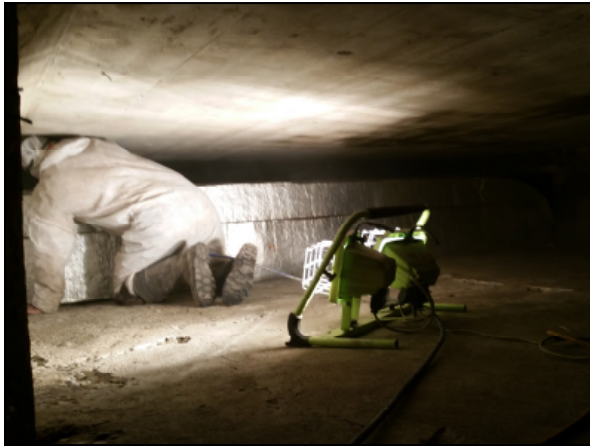
Picture 9—Worker cleaning the North-Center crawl space.

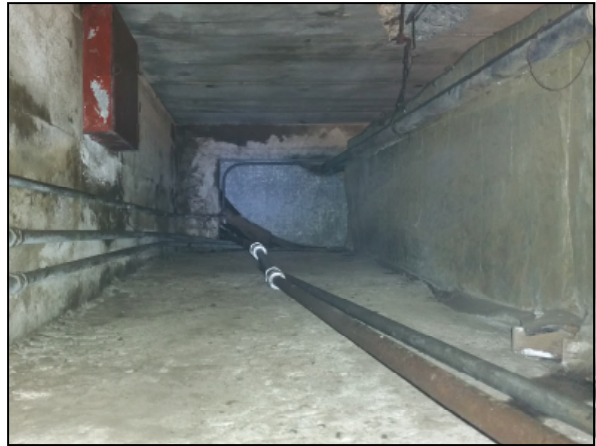
Picture 10—TSI and black mastic removed and cleaned in the north end of the North-Center crawl space.

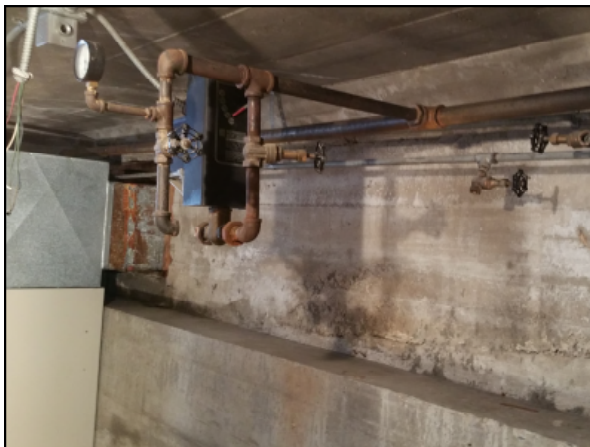
Picture 11—TSI removed and debris cleaned up in the basement.

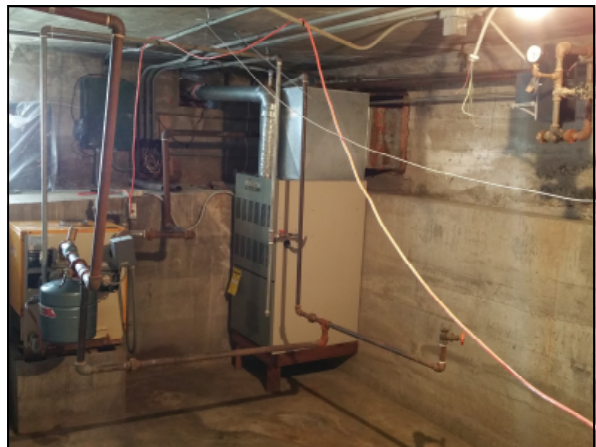
Picture 12—Cleaned basement following all abatement and cleaning activities.

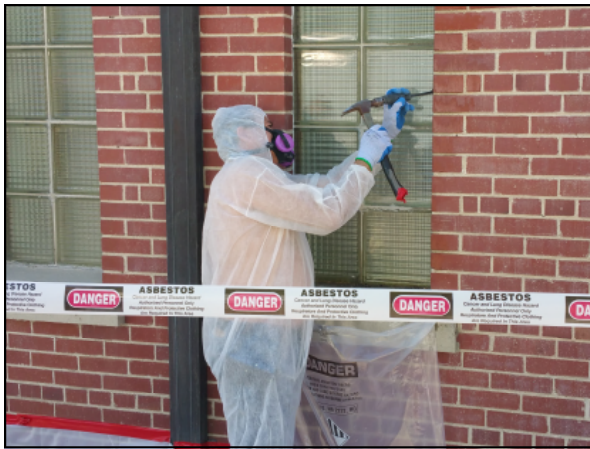
Picture 13—Worker removing window putty on the east side of the building.

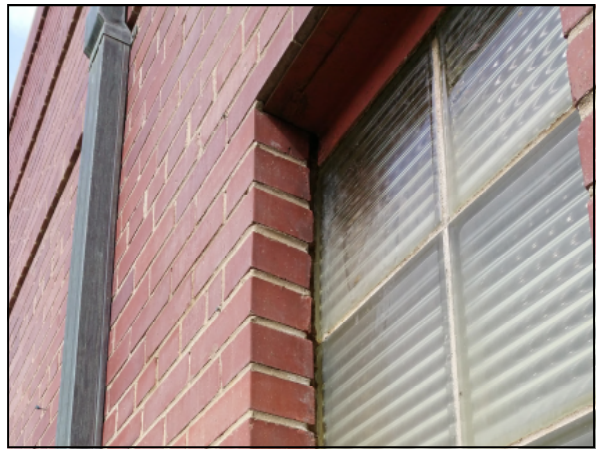
Picture 14—Window on the east side of the building following visual clearance.

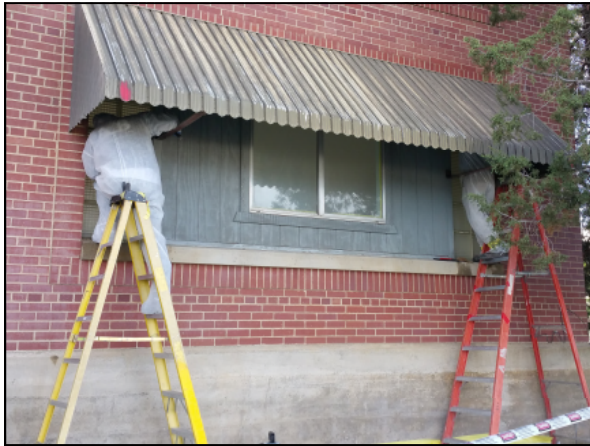
Picture 15—Workers removing window putty from the windows on the west side of the building.

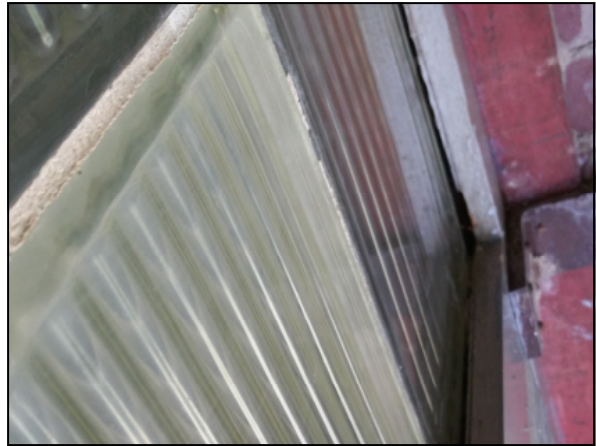
Picture 16—Window on the west side of the building following visual clearance.

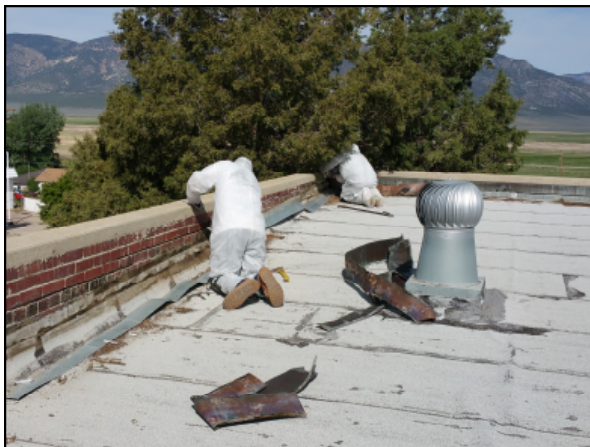
Picture 17—Workers removing the metal flashing that contains roof mastic and lead solder. Note: The black material remaining on the brick wall is non-asbestos containing tar.

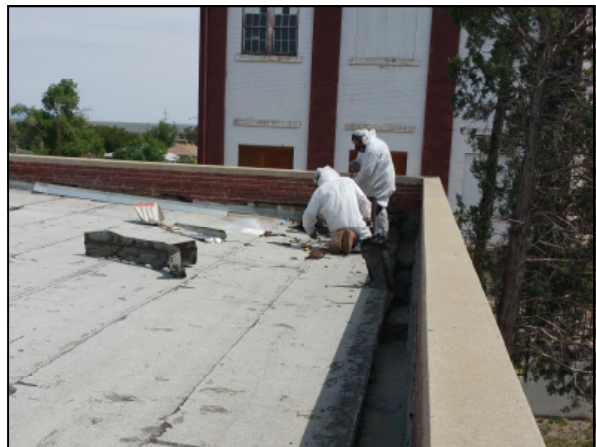
Picture 18—Workers removing the metal flashing that contains roof mastic and lead solder.

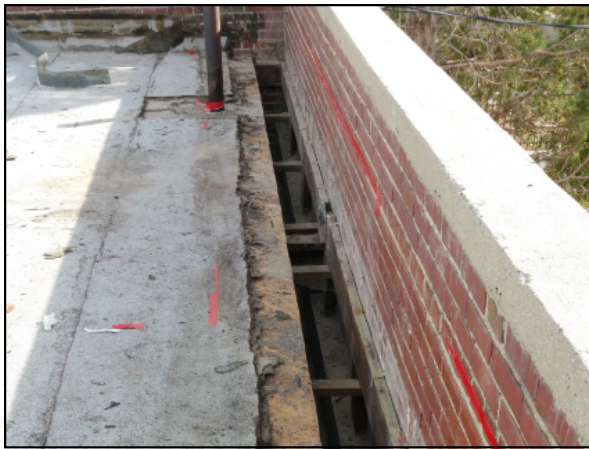
Picture 19—East side of the roof following the removal of the gutter. Note that there was no plywood or other barrier beneath the gutter.

| Time | Notes |
|---|---|
| 7:30 | Workers are removing the gutter. There is no support frame or wood sheathing beneath the gutter. Once removed, there is a 1 foot gap between the roof and the brick wall. Macrotec. shall inform Bill Carpenterwood of the issue so that they can prepare their roster for the situation. |

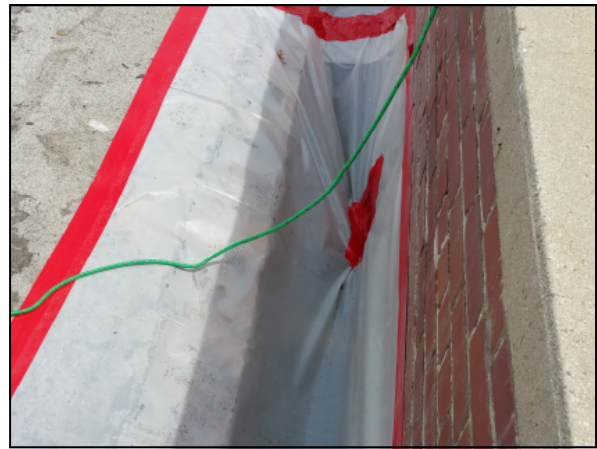
Picture 20—A&B constructed a temporary water barrier where the gutter had been, draining toward the downspout.

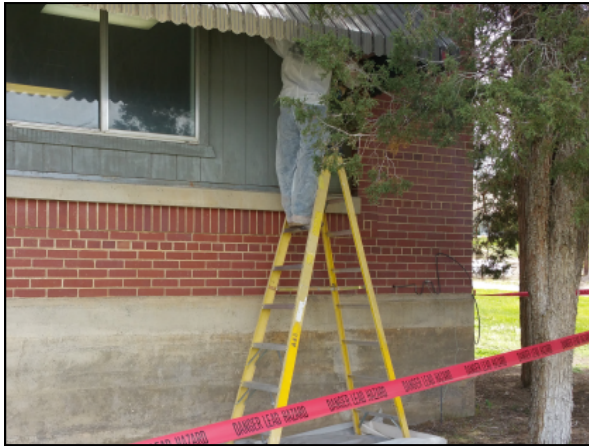
Picture 21—Worker scraping loose and flaking paint on the window trim on the west side of the building.

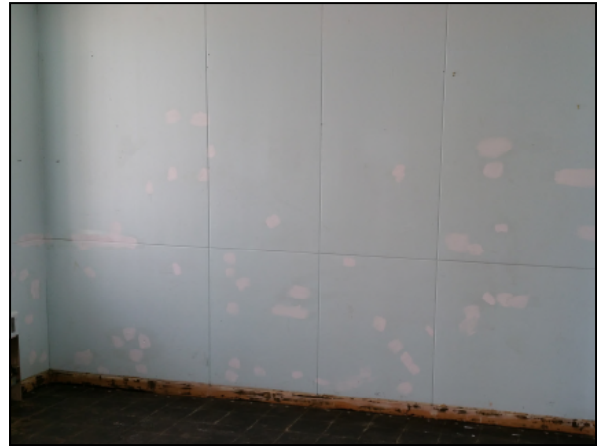
Picture 22—Wall inside the main room following prep of the fiber-board walls including application of two stage lock down and primer.

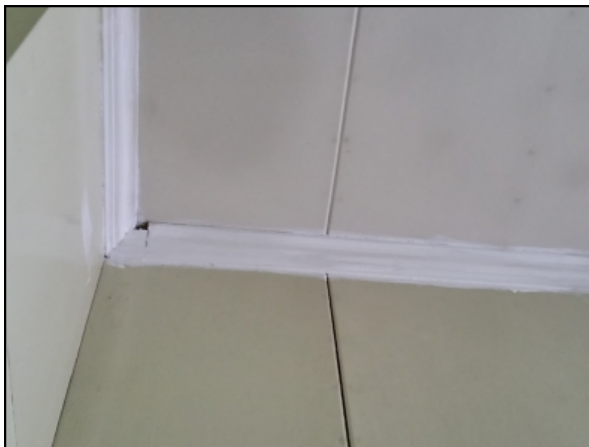
Picture 23—Crown molding in the men's room following prep ,including application of two stage lock down and primer.

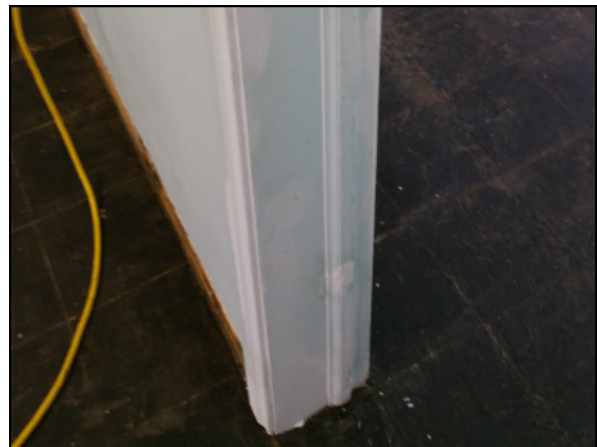
Picture 24—Door frame and casing between the kitchen and living room following prep ,including application of two stage lock down and primer.

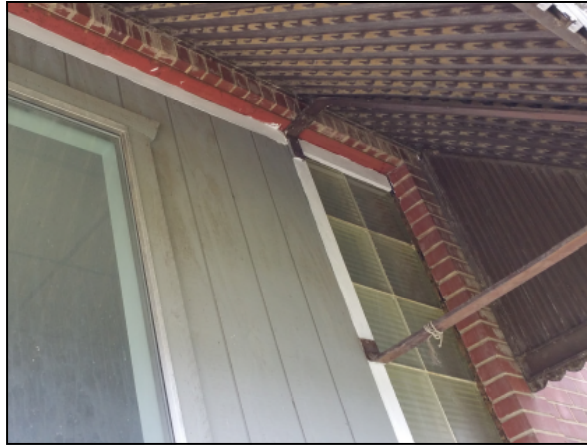
Picture 25—Window trim on the west side of the building following prep ,including application of two stage lock down and primer.

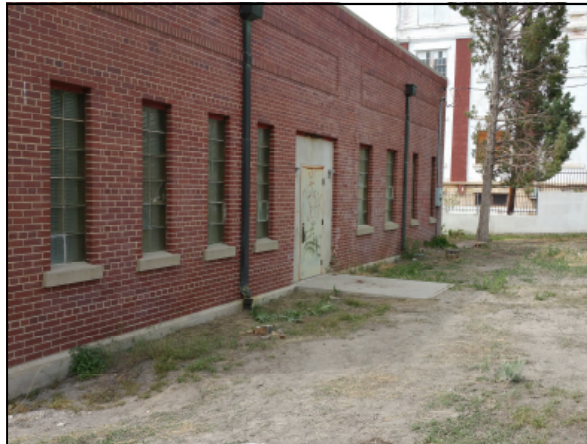
Picture 26—Project completed. East side of the building prior to leaving the site.

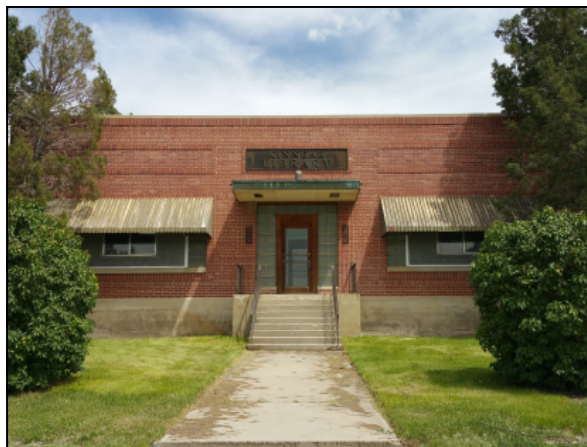
Picture 27—Project completed. West (front) side of the building prior to leaving the site.
