3. Preliminary Field Study Results

3.1 *Methods and Data*

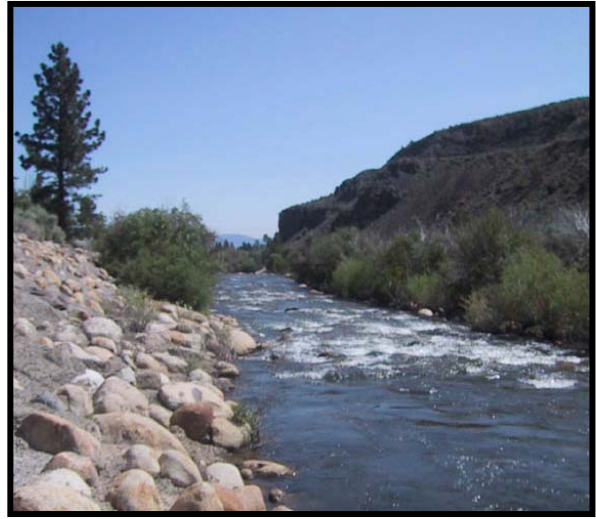
A paved rural road constricts the channel in a few locations. Some areas of bank erosion appear to have occurred during the 1997 flood. Bank protection, consisting of placed and grouted rock, has been constructed in these areas. Some undercutting of the bank protection has occurred, and the grout limits riparian regeneration.

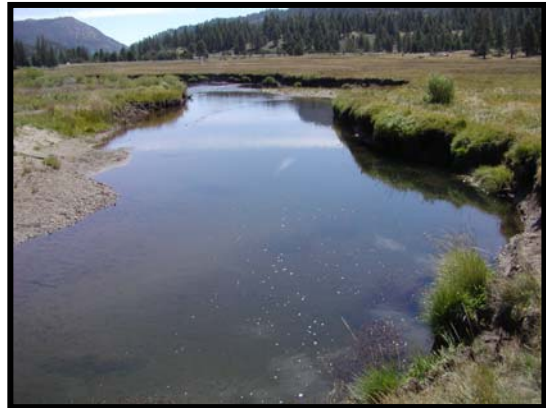
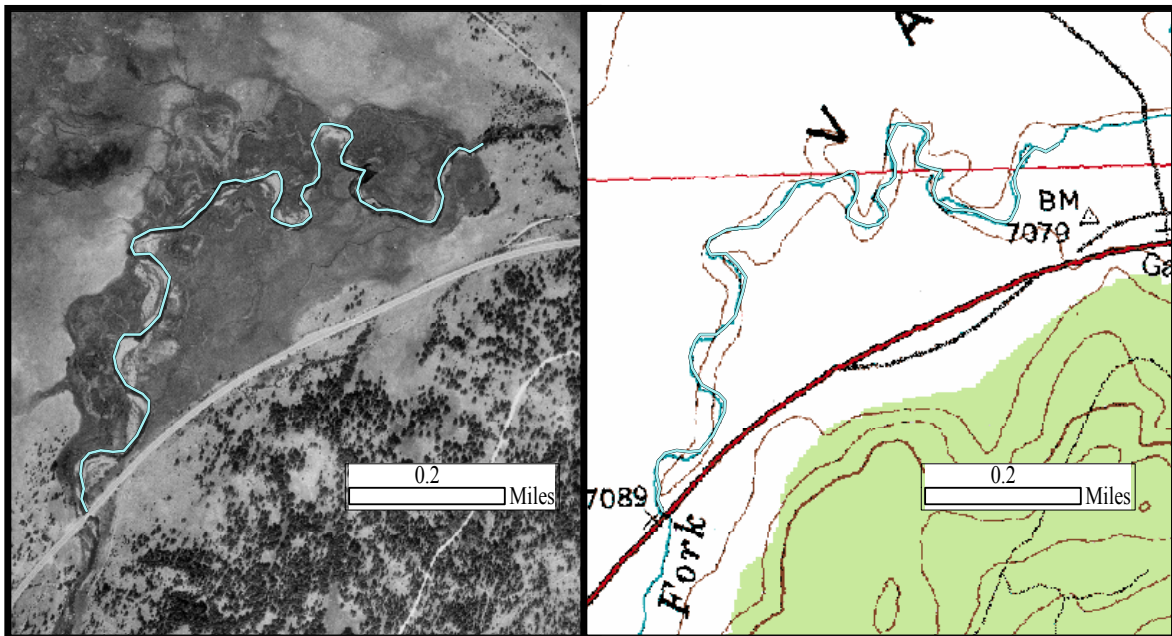
West Fork 8

Although the stream exhibits geomorphic characteristics expected of such an area, stream banks in reaches WF8 and WF10 are relatively high and unstable. Furthermore, an arrested head cut is present at the upstream end of Reach WF10, blocked from further movement upstream by a terminal moraine. This suggests that incision or down cutting may have occurred throughout both meadow reaches. As a result, the floodplain, which would be flooded frequently in such a meadow environment, is inundated only during large flood events. Incision is a typical response to many land-use impacts including channel straightening, constriction by bridges, or intense grazing.

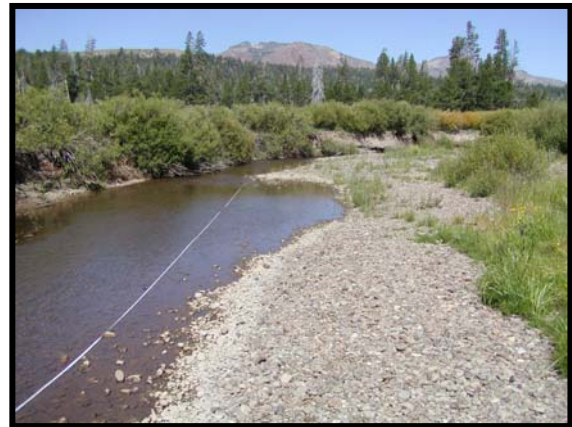
The meadow system was split into two reaches based on field observations and aerial photo analysis. These data suggest significant differences in channel conditions downstream (WF14) of a large tributary entering from the East, as compared to upstream (WF15). The tributary appears to be delivering a large amount of coarse bed load, resulting in unstable stream banks in the downstream reach. During the 1997 flood, the culvert carrying the tributary under the Blue Lakes road apparently clogged and portions of the road may have washed out.

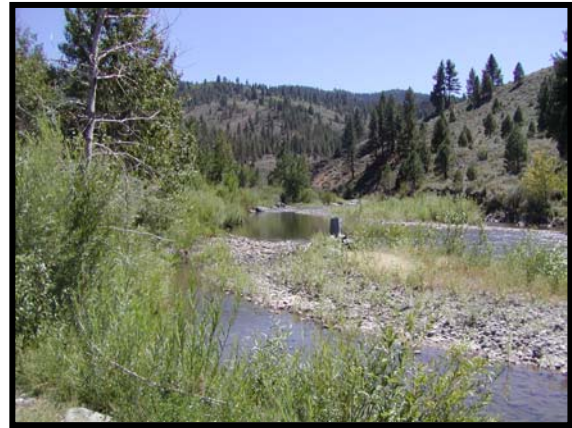
These reaches were split out from Reaches EF6, EF8, and EF10 based on the influence of the adjacent highway, which has a substantial impact on channel form and function. In Reaches EF5, EF7, and EF9, the highway is present within the floodplain. Some natural meanders were cut off during highway construction. Throughout these reaches, substantial portions of the historic floodplain have been taken over by the highway, reducing floodplain area (especially during larger floods), eliminating riparian vegetation, and requiring levees, groins, and revetments to protect the road from undercutting or over wash. Additionally, along Reach EF5, recreational facilities (camping, some structures) have been built in the historic floodplain.

The intermittent, fairly open riparian canopy in reaches EF5, EF7 and EF9 is provided by willow species including coyote willow (*Salix exigua*). Fremont cottonwood (*Populus fremontii*) are found where a connection to the floodplain occurs along bank slopes. Infrequent young age class willows are present on depositional surfaces, while only older cottonwoods are evident as a result of disconnection from the floodplain.

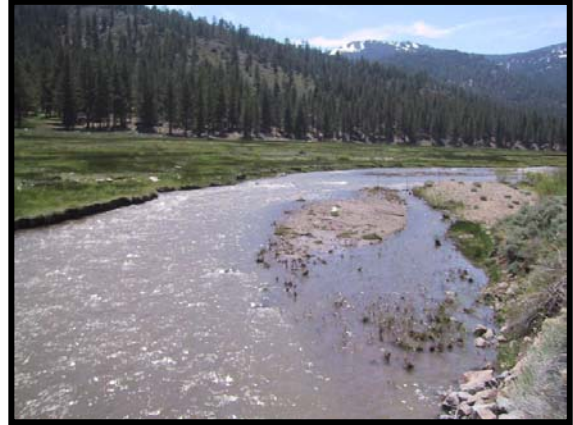
Reach WC2 encompasses the entire privately owned portion of the Wolf Creek meadow. The assessment team viewed the reach from publicly accessible points at the upstream and downstream ends of the meadow. The meadow is structural in nature, formed by a large terminal moraine at the downstream end. Throughout much of the reach, the stream channel is unconfined and meandering with relatively low gradient and a gravel bed (Rosgen C-type). However, stream banks may be more unstable and higher than would normally be expected. Similar to Hope Valley, the stream may have incised within the meadow, as aerial photo analysis of older meander scars throughout the meadow suggest that the meanders have increased in size, and the channel has widened and straightened.

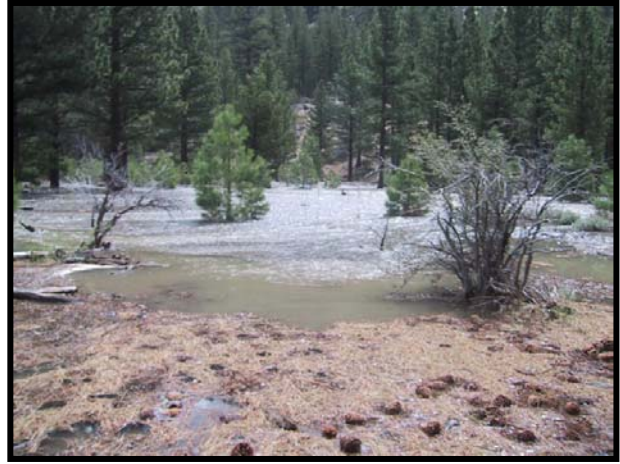
Reach WC3 starts at the upstream end of the Wolf Creek meadow and continues up to the wilderness boundary. The lower portion of the reach consists of an active alluvial fan. This fan is built up of bed load transported out of the narrow upstream canyon and deposited at the head of the meadow. The channel is braided, with extensive bars. The assessment team's visit coincided with peak annual snowmelt conditions. Under these conditions the water spreads out across the valley with no clear channel present for several thousand feet. It is likely that much of the evident bed load deposition occurred during the 1997 flood, which probably changed the channel from single-thread to braided plan form.
