4.2.4 Reach WF15

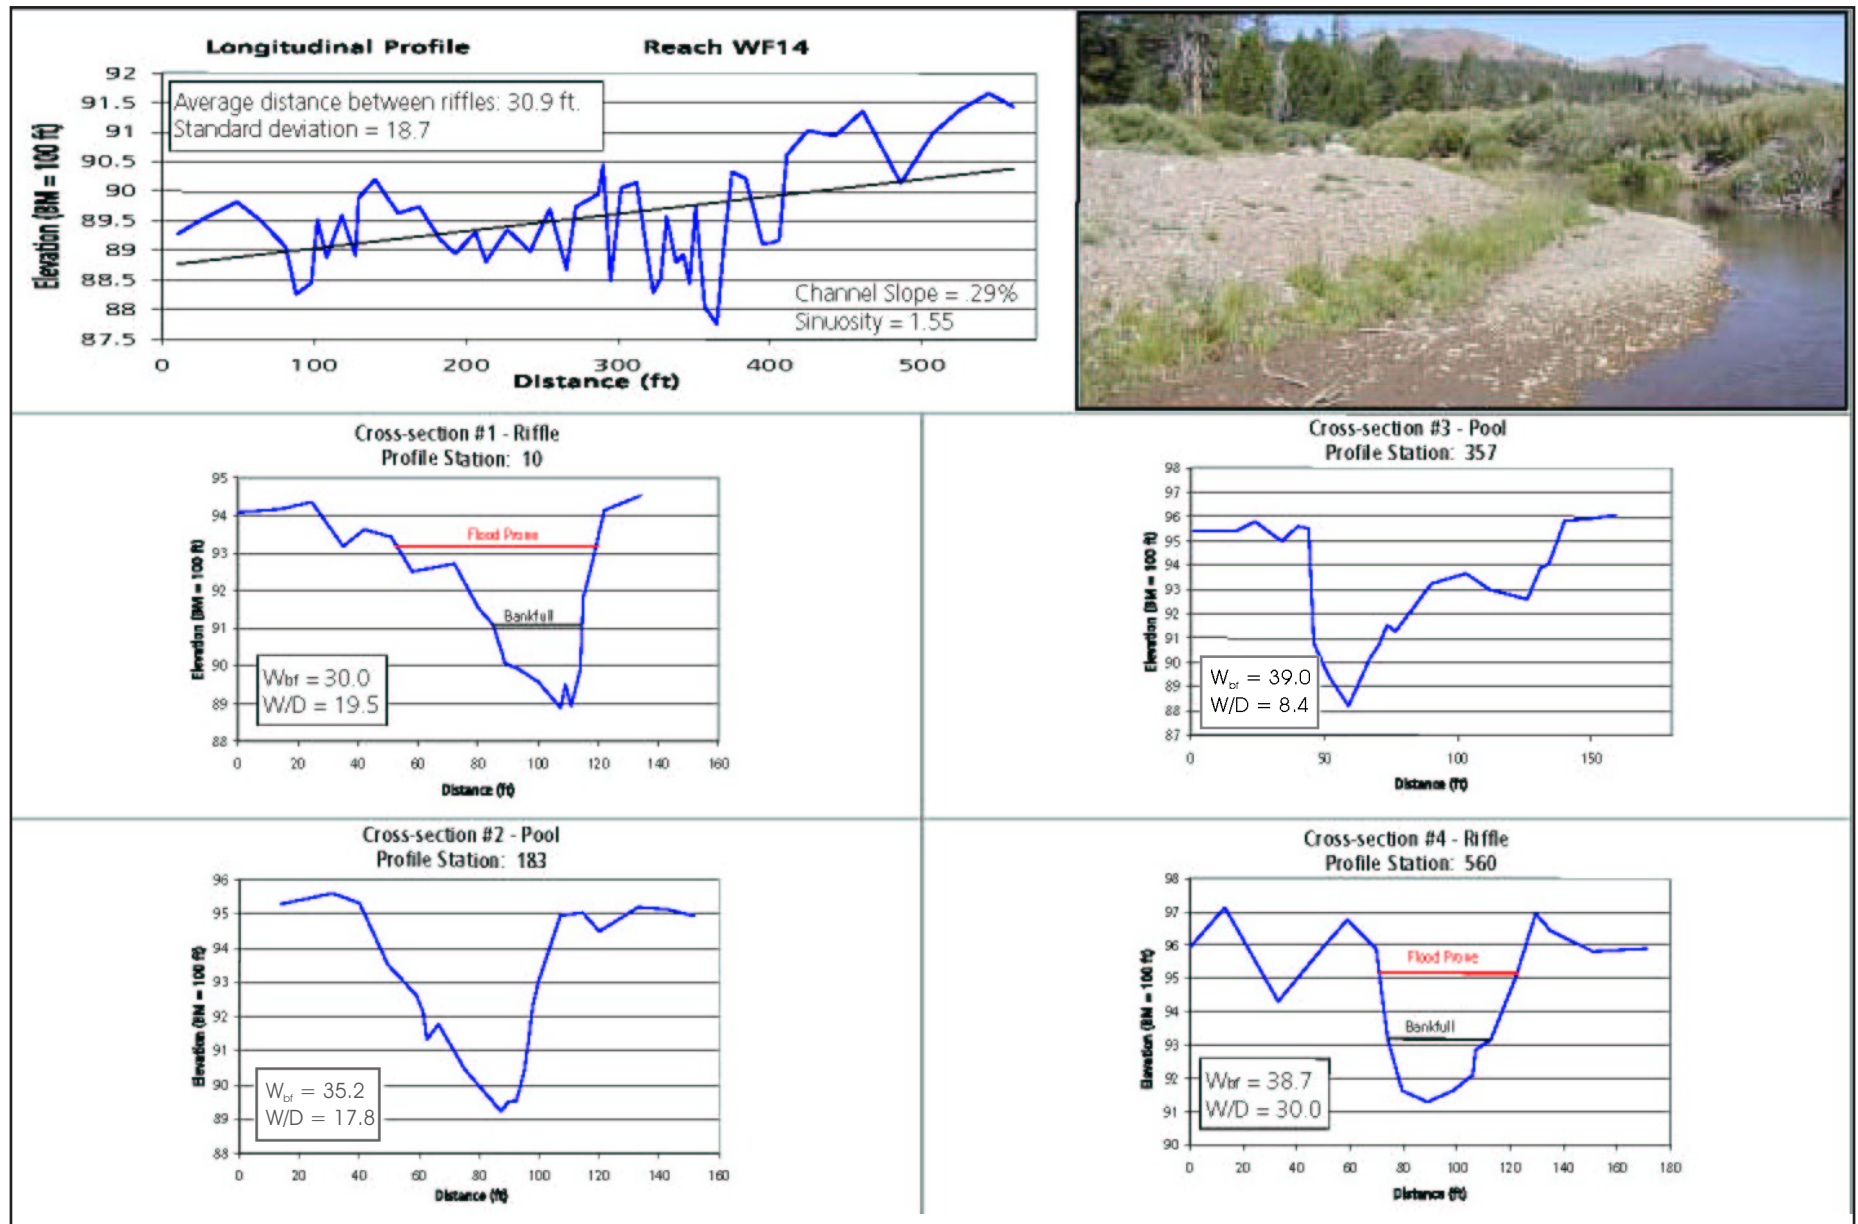
Figure 4.5. Longitudinal profile and cross-section geometry for Reach WF14.

Analysis and Summary: Part of the instability of this reach is due to sediment entering the upstream portion of the reach from a tributary to the east. This tributary carried a substantial amount of coarse sediment during the 1997 floods, when it plugged a culvert on the Blue Lakes road. Extensive deposits of coarse material from this flood are found on the meadow downstream of the road crossing. Much of this material also entered the West Fork, and likely contributed to channel dynamics. Sediment produced in the watershed of this tributary appears to be derived primarily from natural sources, as the upper portions of the watershed have extremely steep hill slopes in volcanic rock types.

Though the tributary is influencing the morphology of this reach to some extent, analysis of historical aerial photographs suggests that modifications of the West Fork may be primarily responsible. Sometime between 1963 and 1993, a new channel formed in the lower portion of this reach (see section 5.3.1.4 for a discussion of the aerial photo analysis). The new channel formed is much straighter than the old channel, and may have induced incision upstream, resulting in streambank instability and the production of large quantities of sediment. This incision has resulted in a meander cutoff in the lower portion of Reach WF15. The headcut appears to have advanced to the middle of Reach WF15, where it has been checked by a large beaver dam (see Reach WF15). Large gravel bars are apparent throughout Reach WF14 following the formation of this new channel, though these bars are not apparent in the 1963 photograph prior to channel formation. Straight channels are very uncommon in natural settings, suggesting that the new channel formed after 1963 may have previously been a man-made structure such as an irrigation ditch or road.

Restoration and management objectives in this reach should be to increase streambank stability and reverse the effects of channel incision. There are several potential restoration options to meet these objectives. One option, which would likely be controversial, would be to introduce additional beavers with the objective of increasing the number of dams constructed. If beavers remained in the area to maintain the dams, sediment would be stored behind the dams, streambanks would be stabilized, and the streambed would eventually be raised. The introduction of beaver has been successful in meeting similar objectives in other locations (Muller-Schwarze and Sun 2003; Naiman et al. 1988). Although there appears to be ample forage to support beavers in Faith Valley, there is some uncertainty as to whether viable long-term populations can be sustained. If beavers were to abandon the area, it is likely that any dams constructed would eventually fail, resulting in additional erosion. This options therefore has a degree of uncertainty and risk, although the cost would be low.

Another option would be to restore the historic channel in the lower part of the meadow. Our preliminary assessment is that this project is feasible, and would meet the objective of raising the channel bed. However, this is a large-scale construction project, and additional analysis of feasibility and costs would be required to accurately assess risk, costs and benefits.

The final option is to stabilize streambanks using similar biotechnical techniques to those recommended for lower reaches on the West Fork. This option would cost relatively little, and probably provides the highest cost-benefit ratio. Implementation of this alternative should be associated with photo monitoring to evaluate trends in channel condition and the success of revegetation and streambank stabilization.

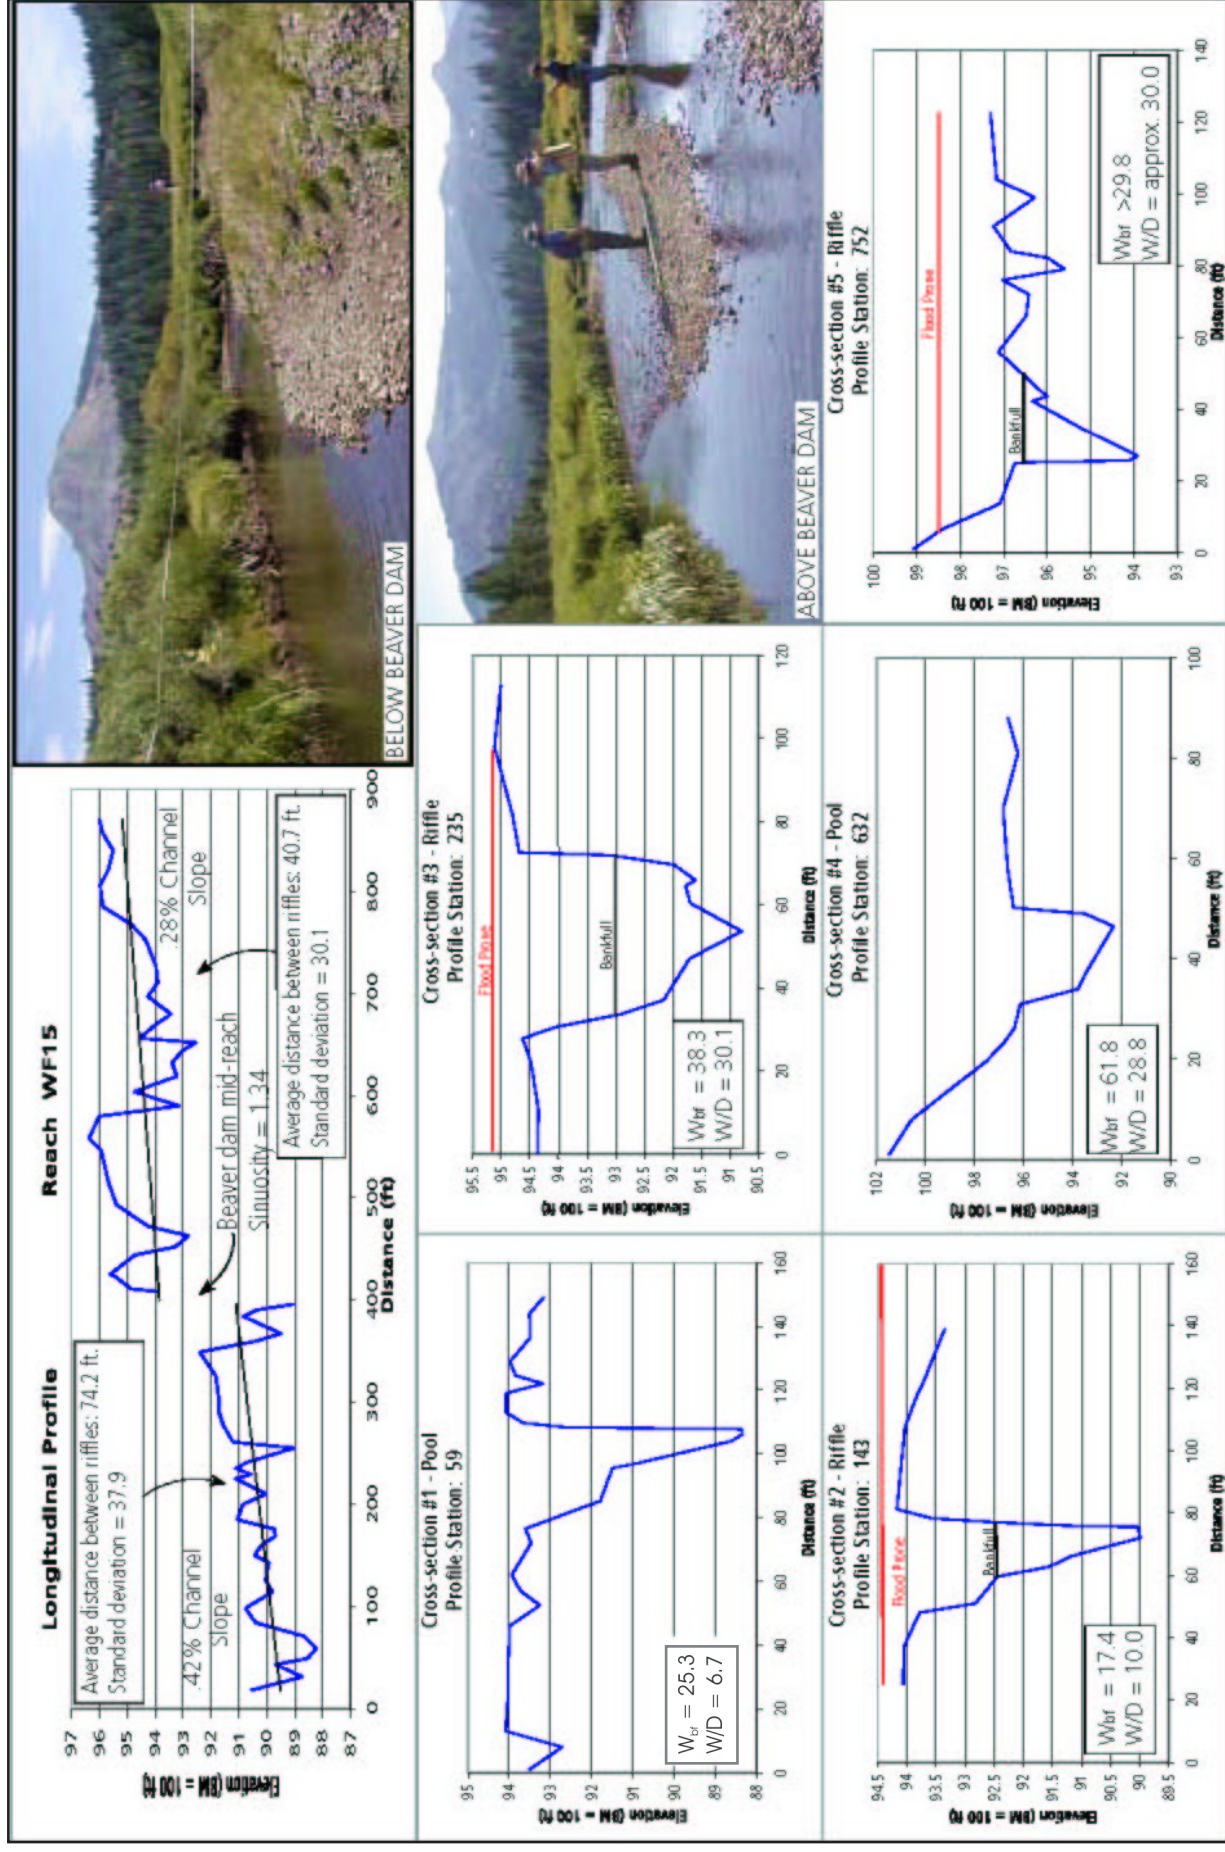
Figure 4.7. Longitudinal profile and cross-section geometry for Reach WF15.

Geomorphic Characteristics: Reach WF15 of the West Fork of the Carson River flows through the middle and upper parts of Faith Valley, a broad flat meadow (see Figure 2.2 and maps contained in Section 3.2.1.13 of this report). A longitudinal profile and cross sections of the reach are provided in Figure 4.7, while discharge and shear data are presented in Figure 4.8. The prominent feature in this reach is the large, stable beaver dam approximately half way through the detailed survey segment. The beaver dam provides grade control upstream and significantly influences the morphology of the channel and its interactions with the floodplain (Figures 4.7 and 4.8). The streambed is composed primarily of gravel-sized particles both above and below the beaver dam. However, the stream is far more entrenched downstream of the beaver dam (flows seldom access the surrounding valley flat), and has a Rosgen classification of F. Upstream of the beaver dam, the Rosgen classification is C, and even smaller floods can reach the surrounding valley flat.

Channel stability is significantly higher above the beaver dam. Both extensive bank erosion and bar formation are evident downstream of the dam. Upstream of the dam, streambanks are lower and tend to be highly stable. Gravel bars are moderate in size. As in Reach WF14, riparian shrubs are found extensively through this reach, and help to stabilize streambanks. More of the streambed is mobile at relatively low flows than in the lower portions of the West Fork, suggesting that more bedload is in transport in this reach. This is probably due to the proximity of this reach to the upper watershed, where coarse sediment is available from steep hillslopes.

Restoration opportunities for this reach are the same as described for Reach WF14. The restoration of the historic channel in the lower portion of the valley would have benefits in the lower portion of this reach as well, by raising the channel bed. No matter which of these options is chosen, the beaver dam in this reach should be stabilized. This dam is currently holding back a great deal of sediment, and is raising groundwater levels in the adjacent meadow. Failure of the dam is likely to cause erosion in the stream channel and drying of the surrounding meadow. Stabilization may require some grade control (perhaps rock structures in the stream), and should also incorporate biotechnical methods of streambank stabilization.
