4.2.6 Reach EF6 (Reference)

4.2.7 Reach EF7

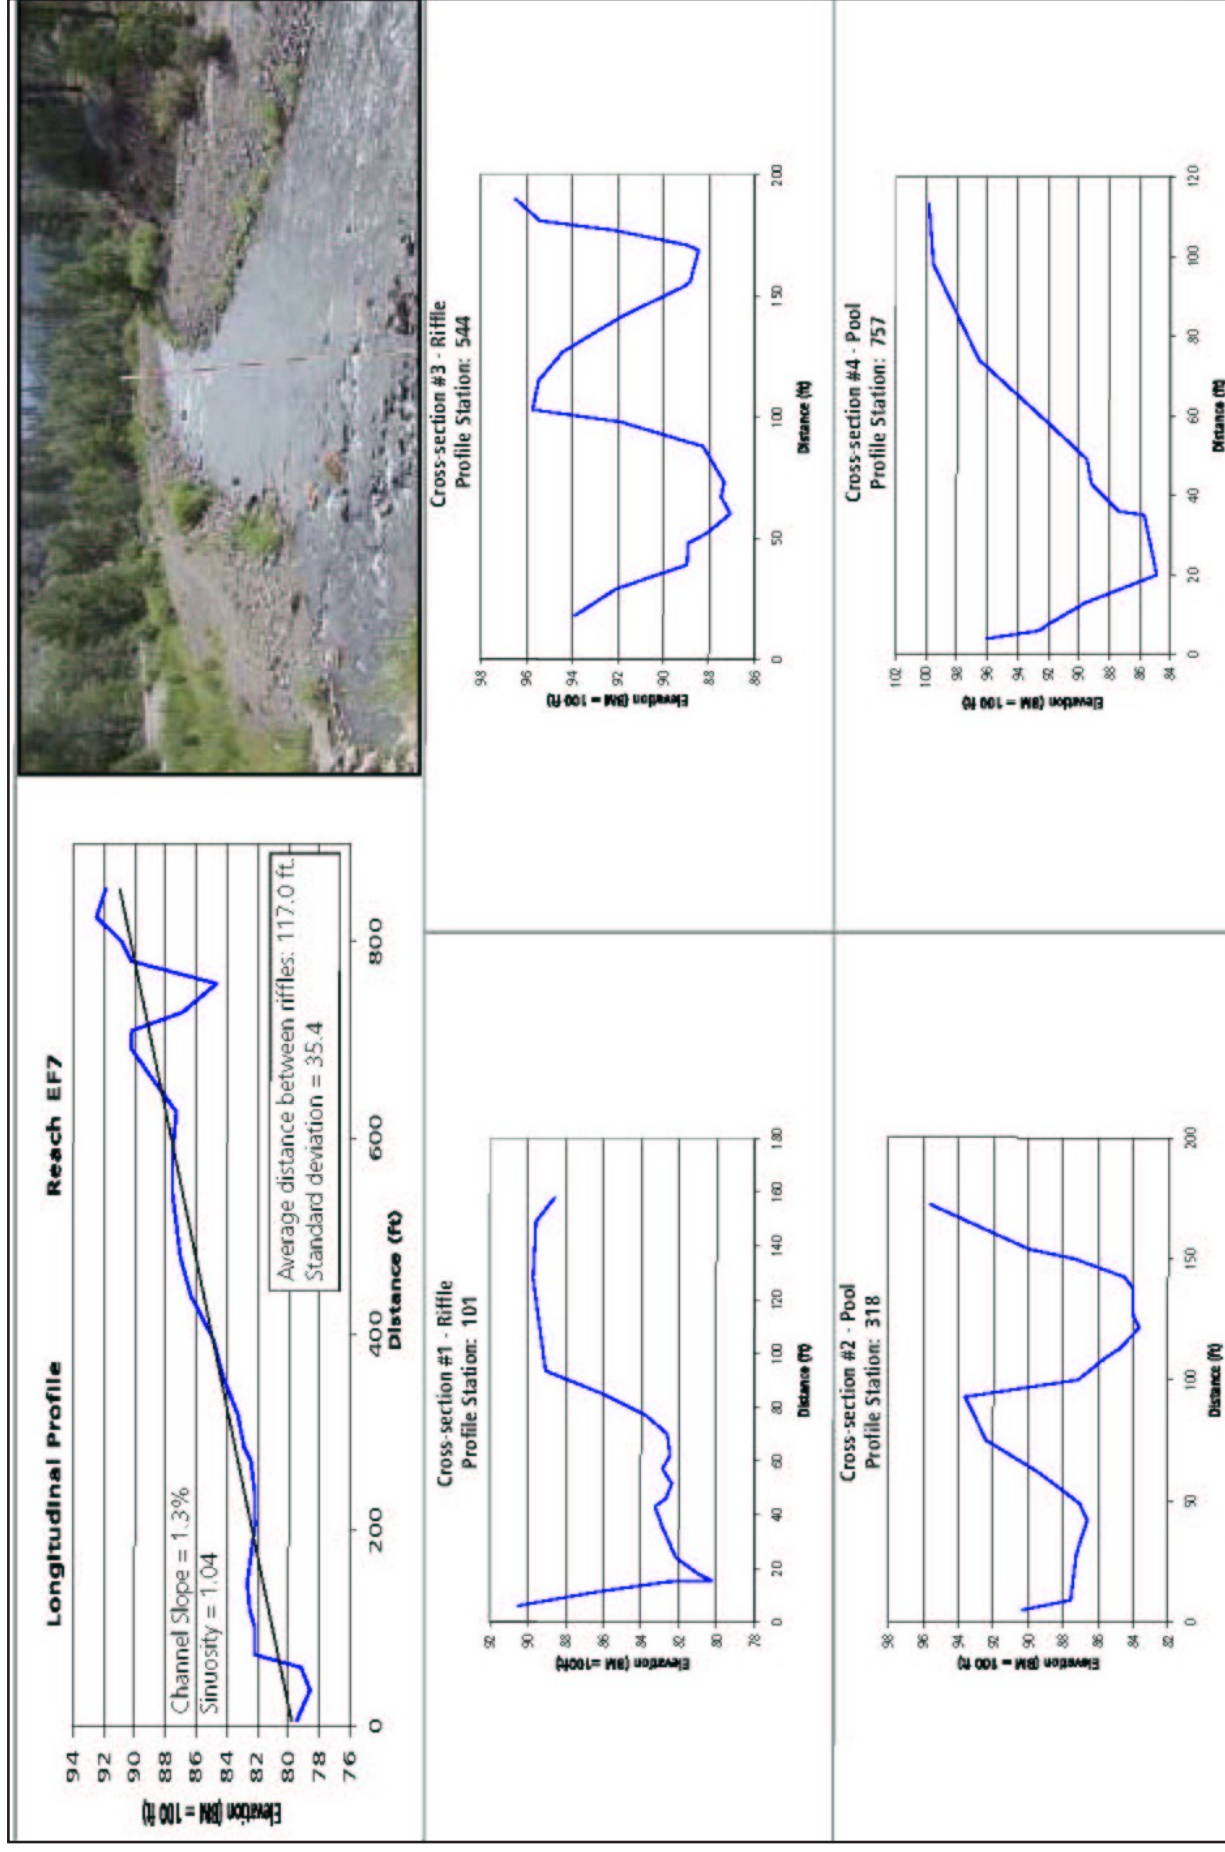
Figure 4.13. Longitudinal profile and cross-section geometry for Reach EF7.

Within the detailed survey reach, a large levee was constructed to cut the main channel off from the overflow channel following the flood of 1997. The cut off channel is on the outer edge of a large bend in the river, suggesting that the cutoff channel may have become the active channel during the 1997 rain on snow event. The impact of cutting off the overflow channel is evident in the longitudinal, cross section and grain size data collected at the site. The slope of the active channel is steeper than what was observed in the reference reach (Reach EF6), reflecting the reduced channel length. It wasn't possible to lengthen the profile due to the constricting influence of the levee. The substrate is also much larger in Reach EF7, which is likely due to increases in shear (the depth-slope product).

The presence of the levee also produces homogeneity in the longitudinal profile with little to no pool and riffle development. The levee occurs through cross sections 2 and 3 of the study reach. Pools are only present at the upstream and downstream end of the study reach, outside the influence of the levee. It is interesting to note that some aggradation, evidenced by a high point in the cross section, occurs just downstream of where the levee ends and the cross section widens.

Restoration Objective: Remove in-channel levees and protect road toe, replace road out of floodplain
