4.2.8 Reach MC2

4.2.9 Reach MC4

4.3 Hydraulic Analyses

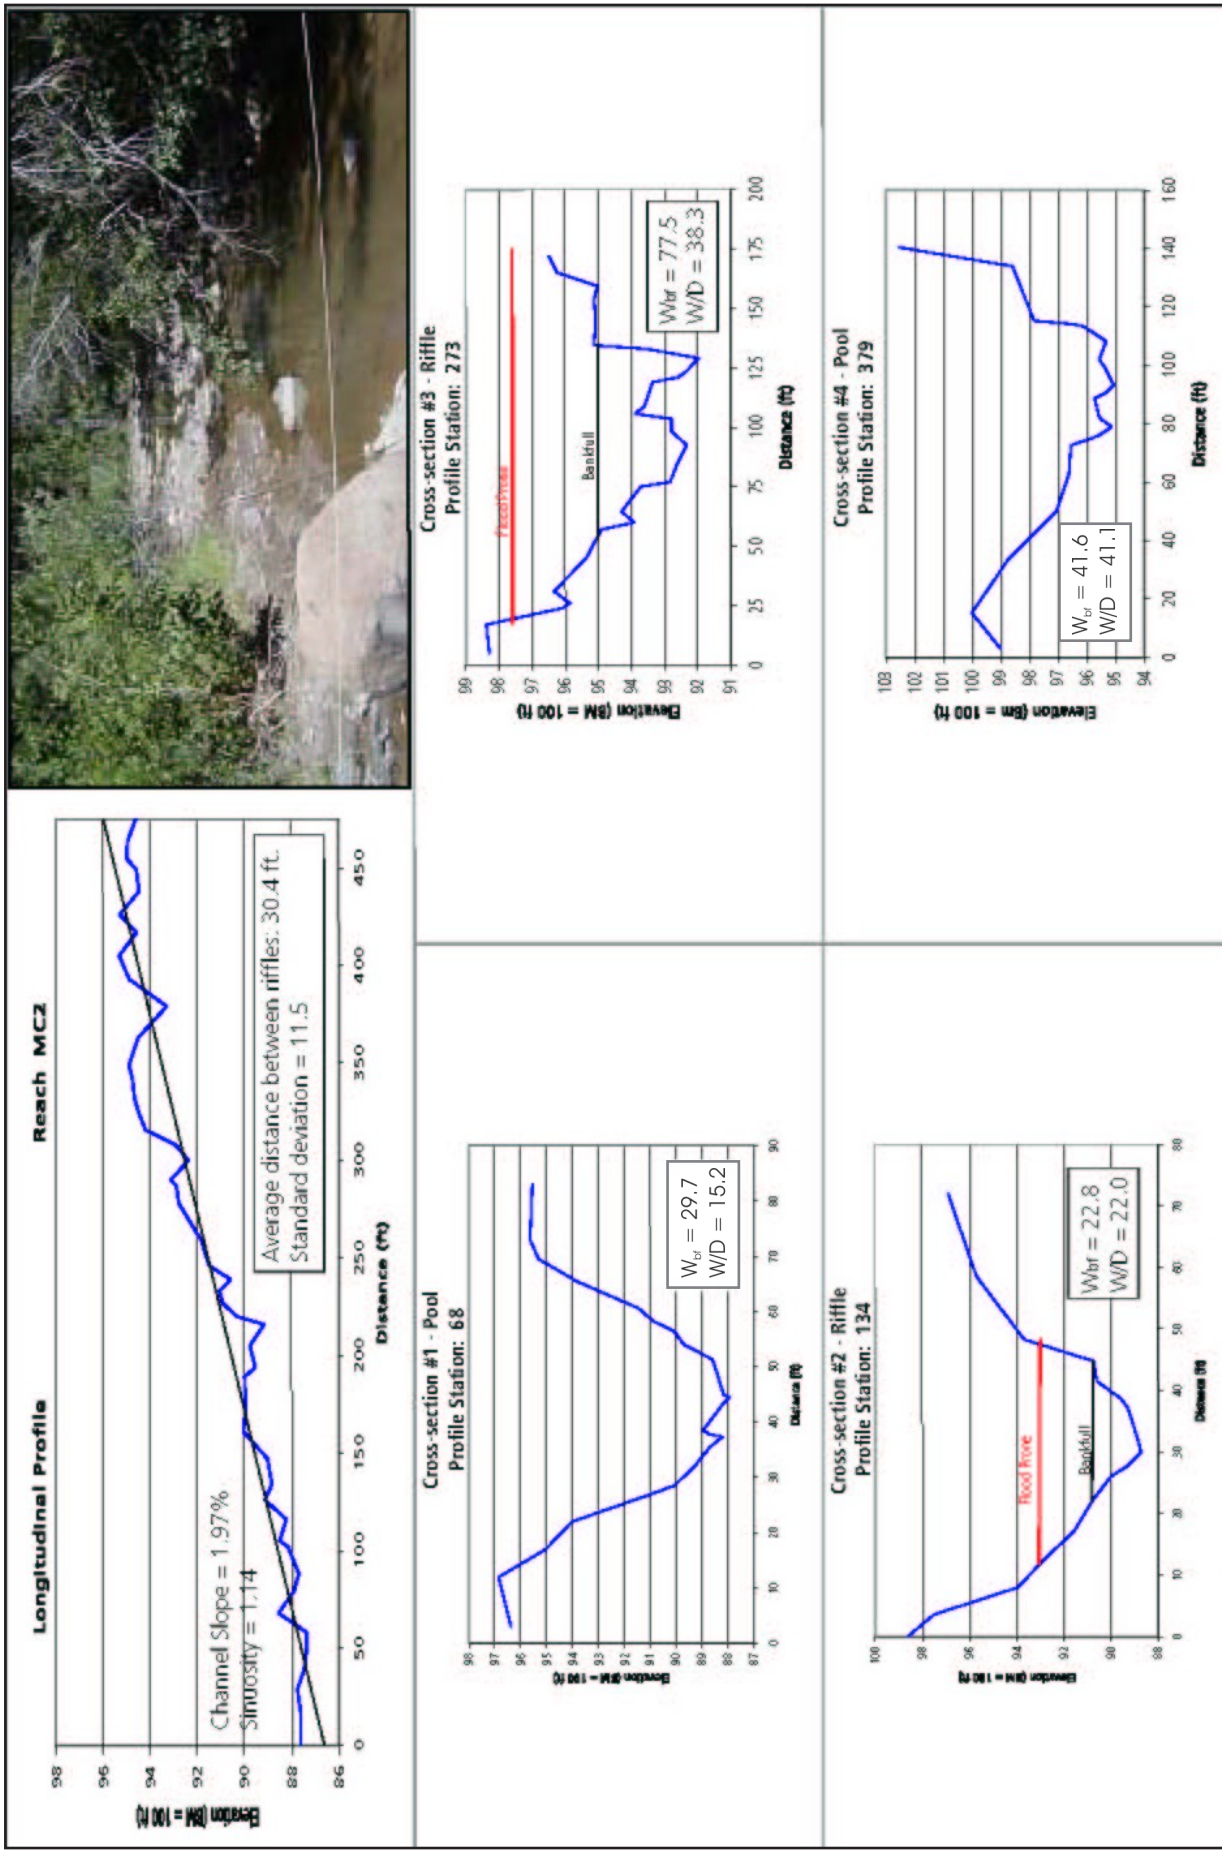
Figure 4.15. Longitudinal profile and cross-section geometry for Reach MC2.

Geomorphic Characteristics: Reach MC2 of Markleeville Creek is characterized by a morphology that alternates between depositional areas where the valley is flat and wide and transport areas where the valley is narrow and steep.. In the depositional areas, a series of low terraces occur that record past sedimentation events. In the narrow valley areas, bedrock is exposed on the bed of the channel and along the banks.

This reach is likely to experience episodic aggradation following a fire or other sediment generating event. Following the aggradation event, a new channel is reincised into the deposited sediment, leaving a terrace surface that is periodically inundated and reworked during high magnitude discharge events. Bank erosion is also likely to occur throughout this reach in the years following an aggradation event or a high magnitude discharge event. Aggradation would occur as the stream reworks unconsolidated, unsorted bank deposits that lack a dense vegetation cover.

In the short-term, geomorphic, aquatic habitat, and water quality goals can be met by restoring the role of large woody material through Reach MC2. Large woody plays an important role in building physical habitat storing sediment behind log jams, reducing velocities by increasing overall channel roughness, and sorting sediment by created heterogeneity in shear and velocity across the channel. Much of this function has been lost due to low recruitment of new wood associated with historic logging and streamside development. Past management practices have also resulted in direct removal of debris jams and large woody material from the stream due to the potential impact to bridges and other infrastructure.

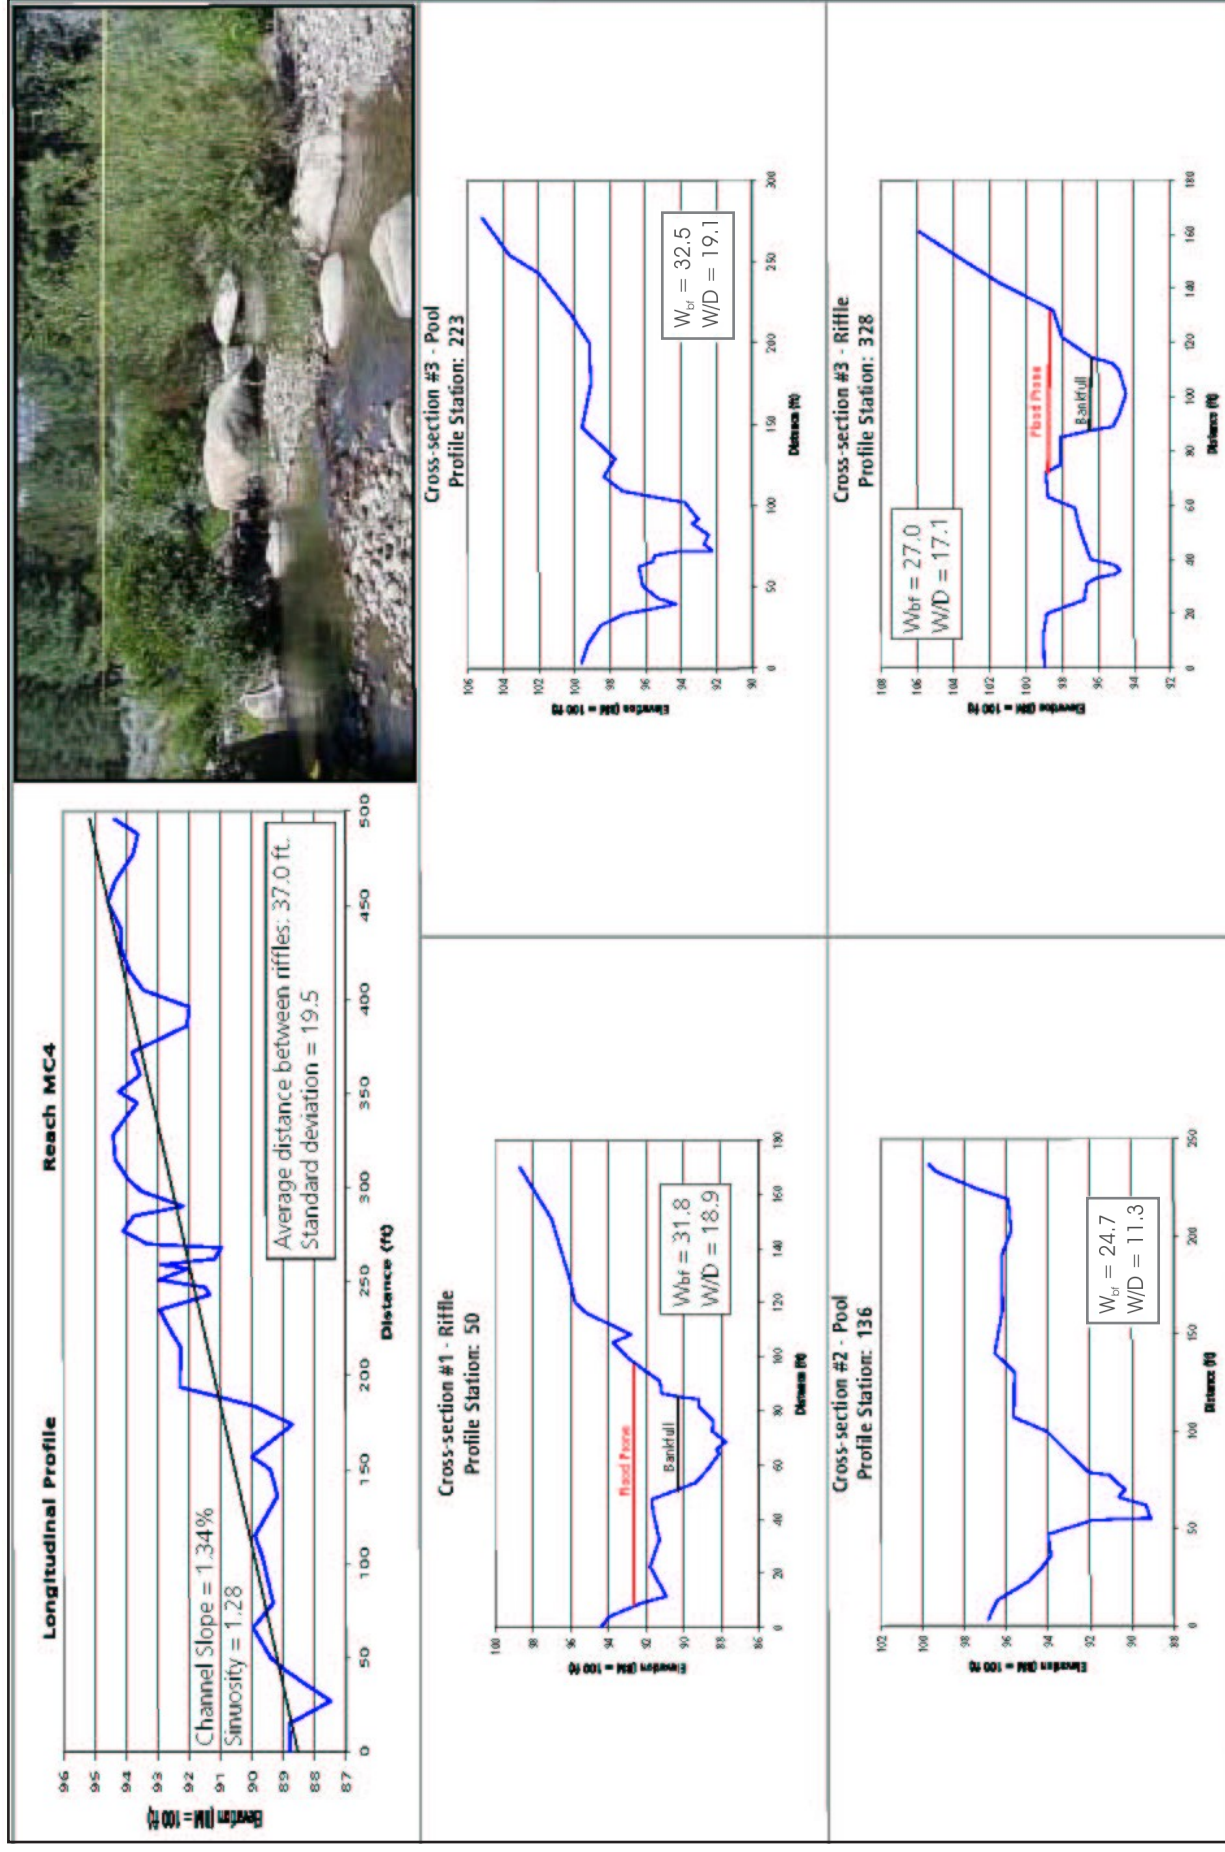
Figure 4.17. Longitudinal profile and cross-section geometry for Reach MC4.

Geomorphic Characteristics: This reach of Markleeville / Hot Springs Creek occurs at a location that is transitional between a confined canyon upstream and a wider meadow downstream. Though a meadow exists here, there is some invasion of conifers, especially on the right bank suggesting that they meadow may be sustained by high ground water and slightly saline soils associated with the springs and geothermal activity at the Grover Hot Springs site. The originally wide meadow morphology may have been formed during the Pleistocene from a combination of glacial outwash deposits and downstream constrictions associated with terminal moraines.

Subsequent to formation of an at-grade meadow, the channel appears to have incised, as evidenced by the presence of cut banks and abandoned channels on several terraces that are currently inaccessible to the active channel. Such a process may be a result of less sediment delivery in the following the glacial period and not necessarily the result of land use impacts. Regardless of the mechanism that has produced an incised channel within the large meadow, the current channel appears to have reached a new equilibrium state in several areas where new overflow channels, bars, and floodplain have formed. In other areas it still appears to be entrenched and significant bank erosion is occurring.

Channel and habitat complexity in Reach MC2 is provided by the presence of some large woody material and boulders but it is likely that historic densities were much higher given the likelihood of debris flow events in the upstream narrow canyon that delivered wood to this transitional reach. Restoration opportunities should focus on improving habitat conditions through riparian vegetation planting efforts and the introduction of channel complexity, such as large woody material.

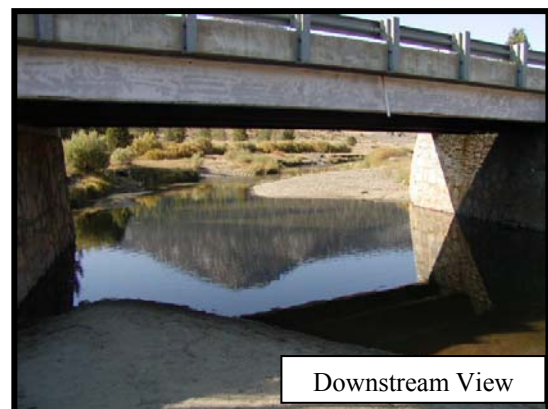
The Hope Valley Bridge is located along Highway 88 where it crosses the West Fork of the Carson River. The bridge carries two lanes of traffic, and is perpendicular (0 degree skew) to the river streamlines. Field observations indicate that the streambed consists primarily of fines up to rounded gravel material, mostly smaller than a few inches in diameter. This reach has a slope of approximately 0.2%.

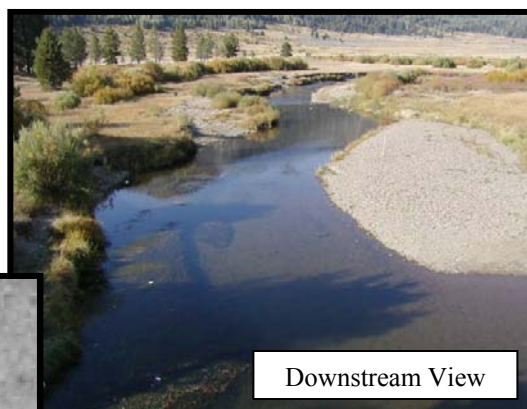
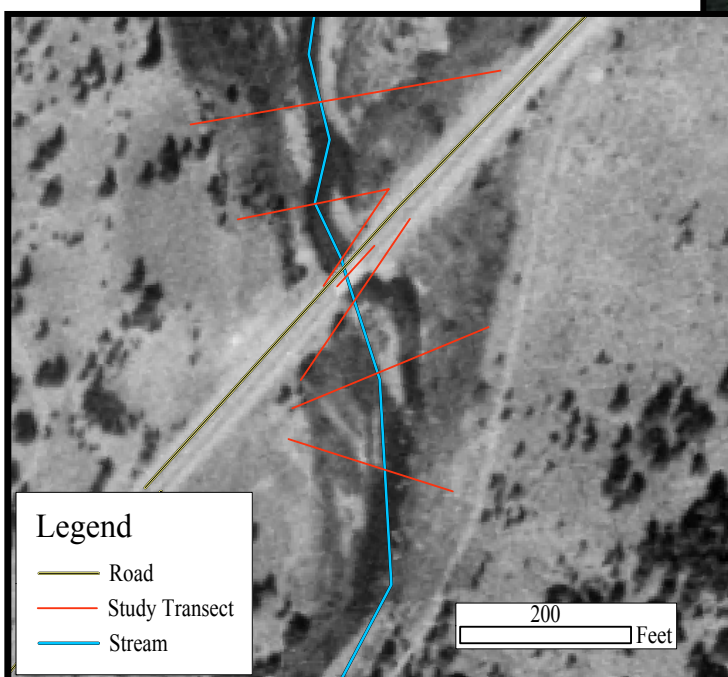
The Hope Valley Bridge significantly narrows the flow path for the stream. Figure H1 (Model data) is a graph showing the top width of flow for the recurrence intervals versus the main channel distance. The highest value on the x-axis represents the upstream end of the evaluated channel section. As shown in Figure H1, the channel constriction begins at main channel distance 227 feet, which is the upstream end of the bridge. It is evident that flows generally resume their previous widths downstream of the bridge (main channel distance 200 feet). Additionally, the stream power (velocity multiplied by shear) significantly increases at the bridge for flows equal to and exceeding the 25-year recurrence interval (see photo above), due in part to the

narrower flow path through the bridge. The bridge-related constriction and increased stream power are most likely responsible for channel incision. As can be seen in Figure H3 (Model data), the elevation of the channel bottom drops significantly at the bridge.

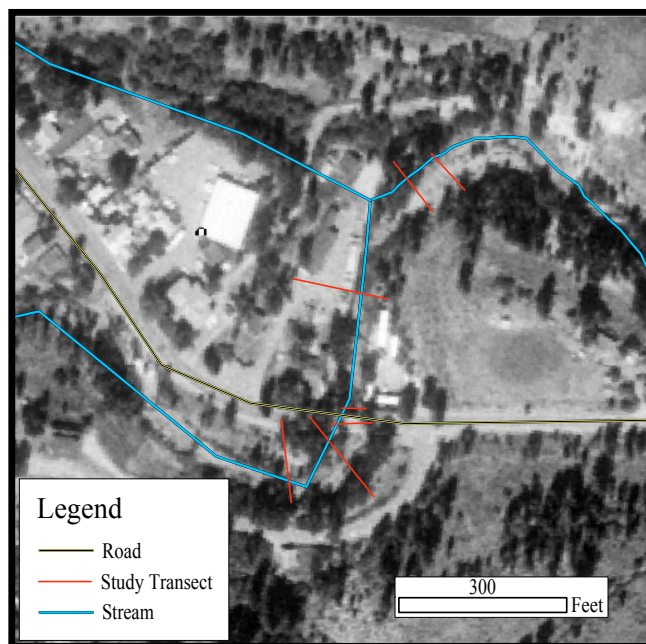
Although the Markleeville Bridge appears to have adequate capacity to convey the 100-year event without overtopping the roadway, the preliminary analysis indicates that the bottom of the bridge may seal during the 100-year event. This means that a pressure flow situation could occur. Additionally, the Forest Service Guard Station and other nearby

buildings are impacted by 50- and 100-year events when flows overtop the rockery wall that separates the main channel from the Guard Station. The footbridge downstream of the Markleeville Bridge will also be impacted by these storm events.

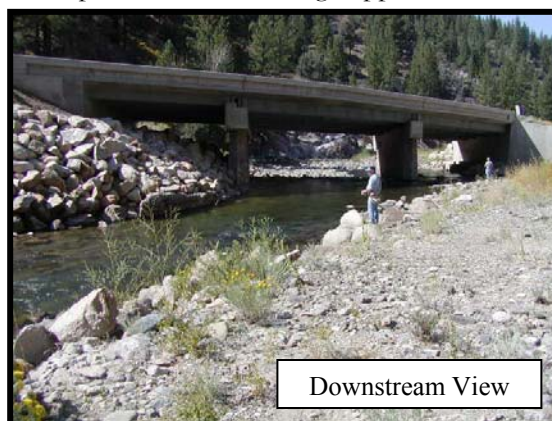
The Centerville Flat Bridge crosses the East Fork of the Carson River along Highway 4. The bridge carries two lanes of traffic, and is at an approximate 20 degree skew to the river streamlines, however, the abutments and piers are only at about a 5 degree skew. Field observations indicate that streambed material consists primarily of angular and rounded boulders

approximately between 6 and 18 inches in diameter, with several boulders outside of this range as well. Larger, and mostly angular, boulders can be found around the bridge abutments. This reach has a slope of approximately 1.5 percent.
