PAINT REMOVAL WORK ACTION PLAN

Brewery Arts Center 449 W. King Street Carson City, Nevada 89703

> Contract DEP22-001 Task Number MA27-23

June 13, 2023

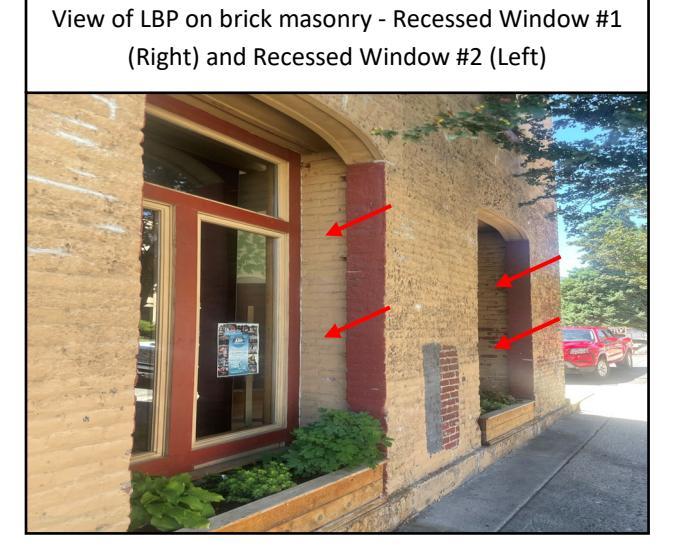
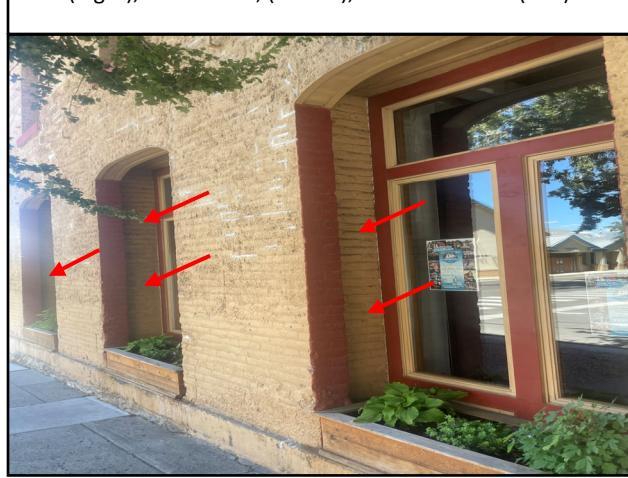
Paint-Chip Sample Number	Sample Location	Sample Description	Total Lead Result	Paint-Chip Result
BRN085-L-006	North Wall – 1st Floor Ext. Recessed Window #1 Wall	Tan paint on brick masonry in poor condition	140,000 ppm	Positive

Paint-Chip	Sample Location Sample Description		Total Lead	Paint-Chip
Sample Number			Result	Result
BRN085-L-007	North Wall – 1st Floor Ext. Recessed Window #2 Wall	Tan paint on brick masonry in poor condition	220,000 ppm	Positive

View of LBP on brick masonry - Recessed Window #1 (Right) and Recessed Window #2 (Left)

- Paint associated with those areas determined to be lead-based paint (north wall recessed windows) will be removed first so that solids and wastewater from those areas can be separated out.

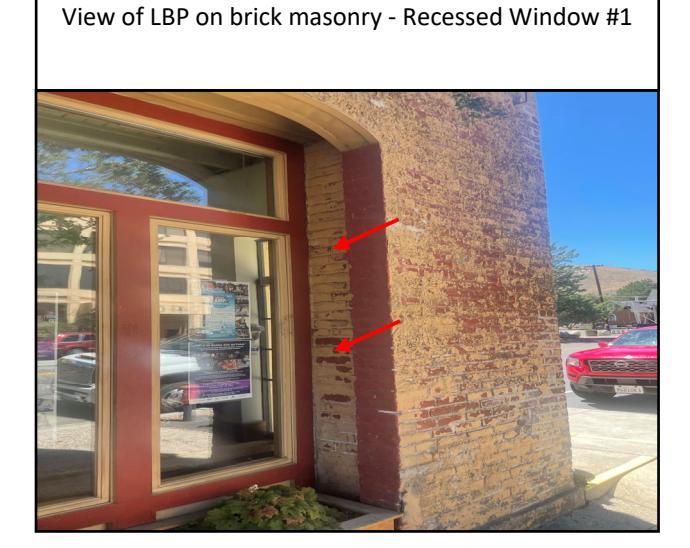
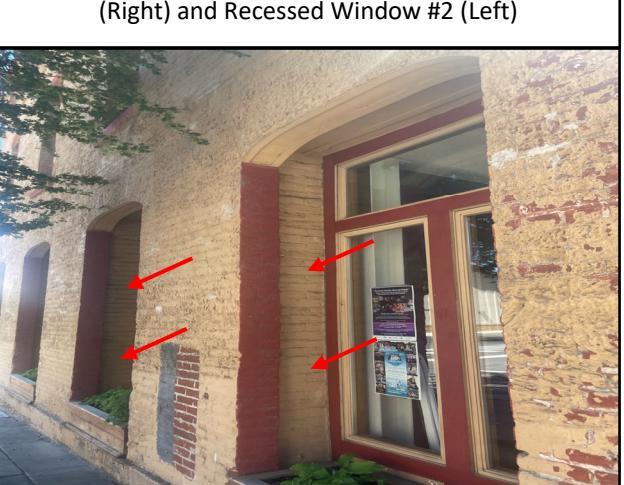
View of LBP on brick masonry - Recessed Window #2 (Right), Window #3, (Center), and Window #4 (Left)
