LIMITED PRE-RESTORATION LEAD-BASED PAINT SURVEY

Brewery Arts Center 449 West King Street Carson City, Nevada 89703

Contract: DEP22-001 Task Number: MA16-22

June 16, 2022

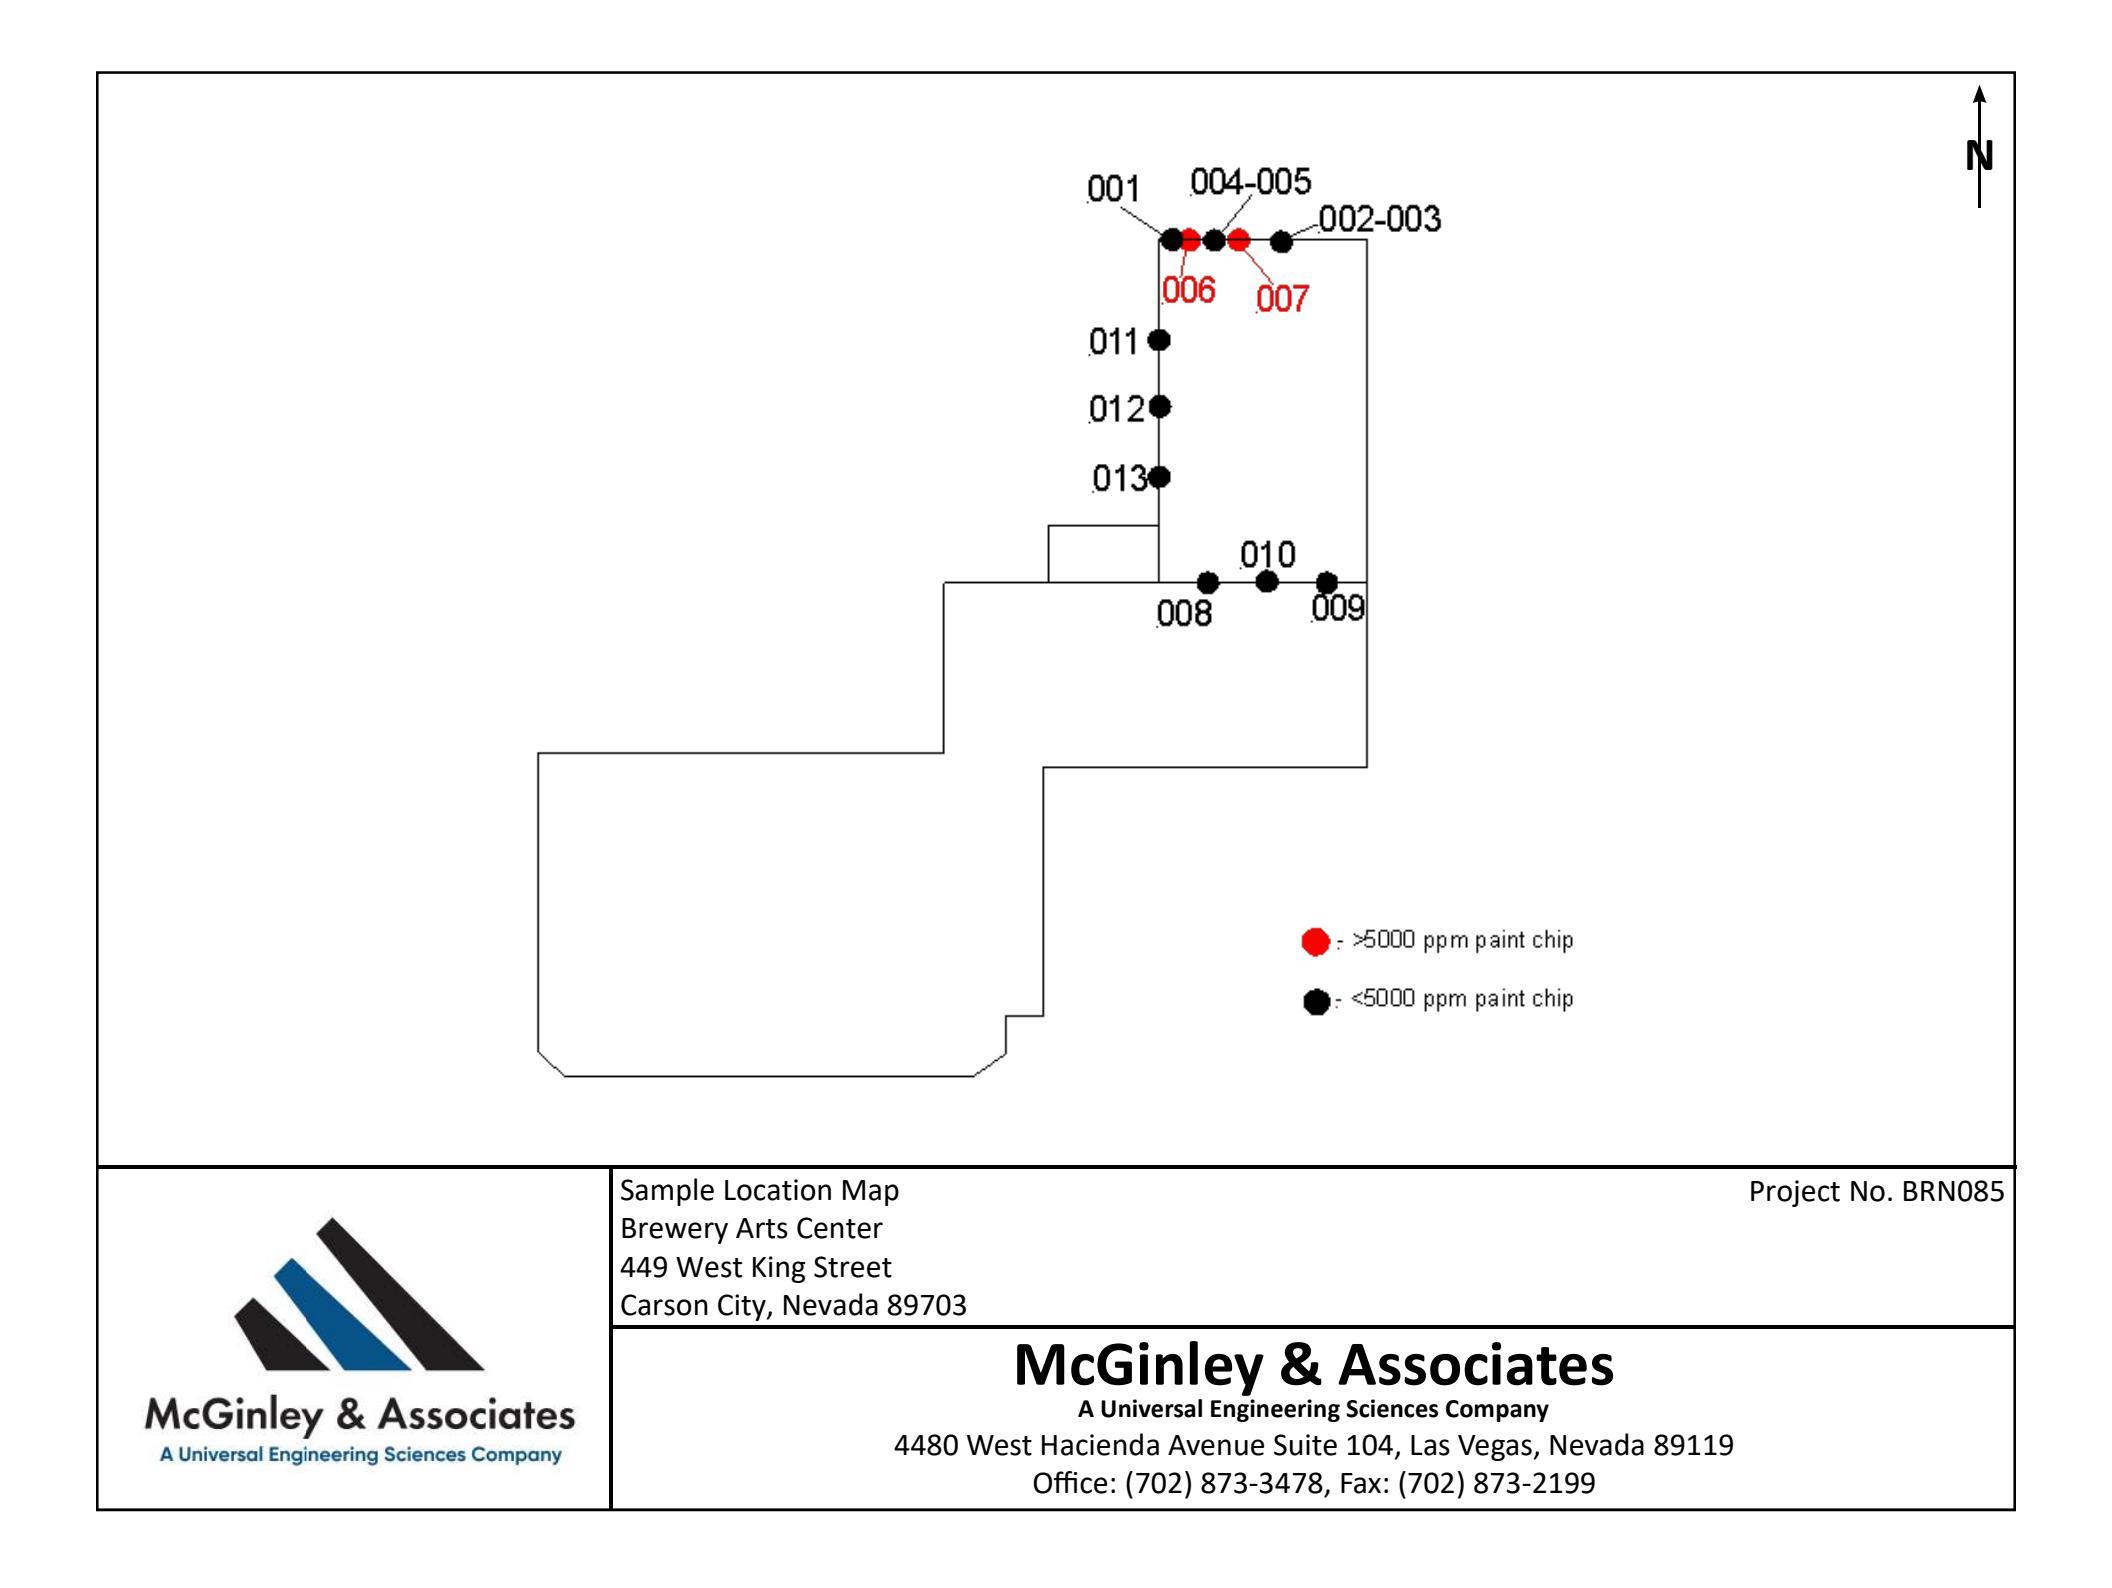
results obtained during the assessment. For this assessment, 13 bulk confirmation paint chip samples were collected from the Subject Property. Each of the bulk paint chip samples collected were placed and sealed in a sample bag and assigned a unique sample identification number (*BRN085-L-001 through BRN085-L-013*). Proper decontamination techniques were utilized after each sample was collected. The bulk confirmation lead samples were submitted using chain-of-custody procedures to Eurofins EMLab P&K, located in Las Vegas, Nevada. The confirmatory paint chip samples were analyzed for lead using flame atomic absorption spectrometry in accordance with the EPA's Method 7000B modified and NIOSH 7082. A full list of paint chip sample locations and results is presented in Table 2. Sample locations are presented in Figures 2.
