Asbestos and Lead-Based Paint Survey Report

FORMER STATELINE HOTEL 617 MAIN STREET CARLIN, NEVADA

CONVERSE Project No. 08-73103-01-05 November 15, 2013

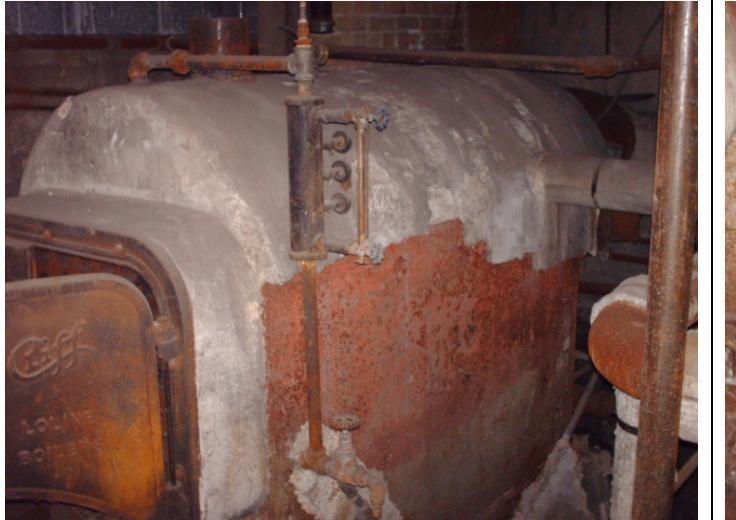
ACM Insulation on Boiler - Basement

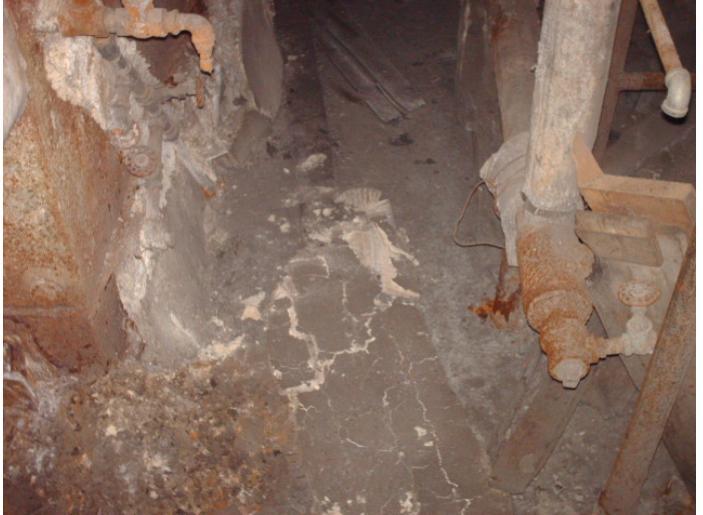
ACM Insulation Debris at Boiler - Basement

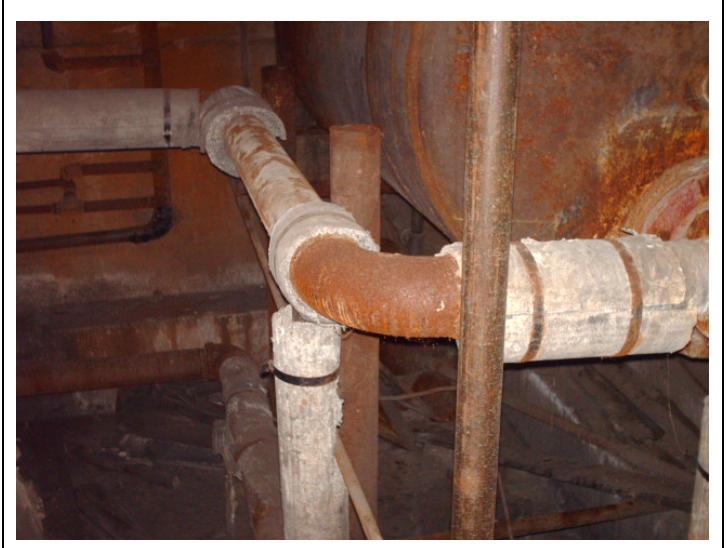
ACM Insulation on Piping at Boiler - Basement

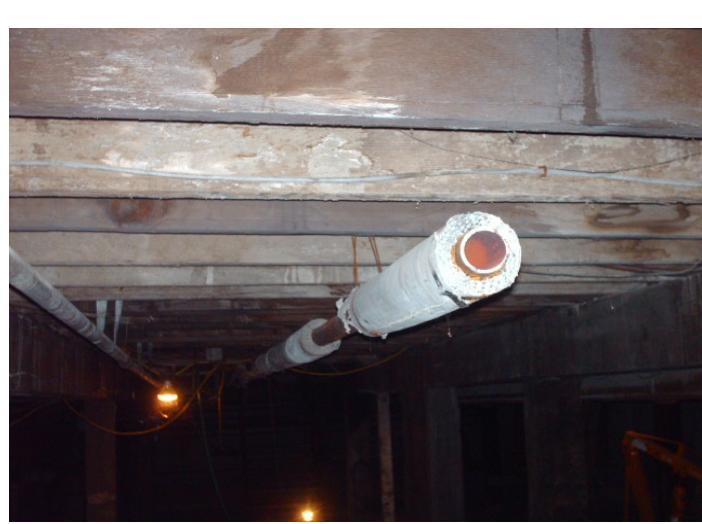
ACM Insulation on Piping - Basement

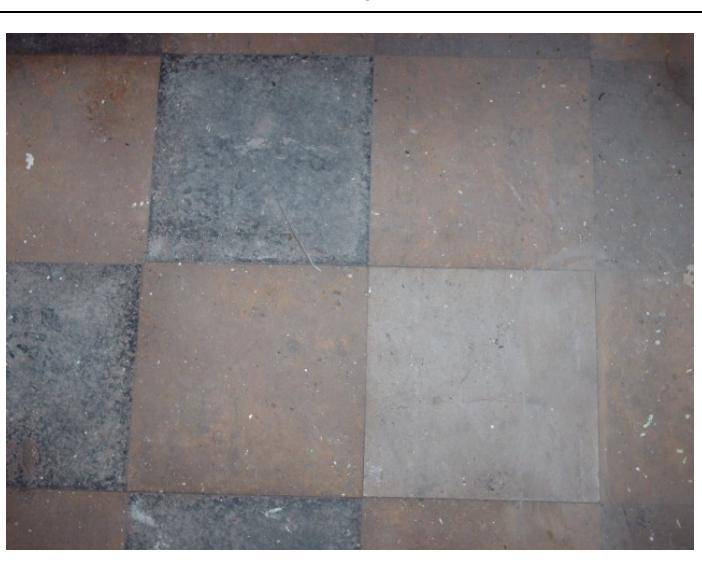
ACM Floor Tile –  $1^{st}$  Floor

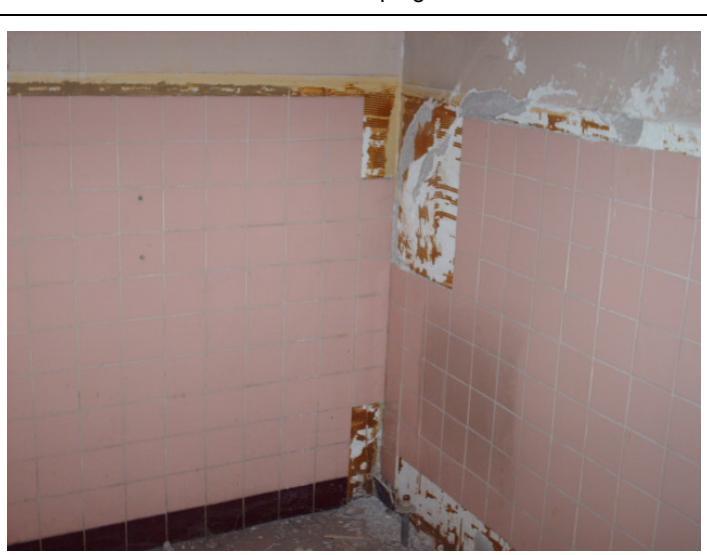
ACM Mortar at Ceramic Tile - Area #9
