4. Detailed Field Study Results

4.2 Reach Summaries

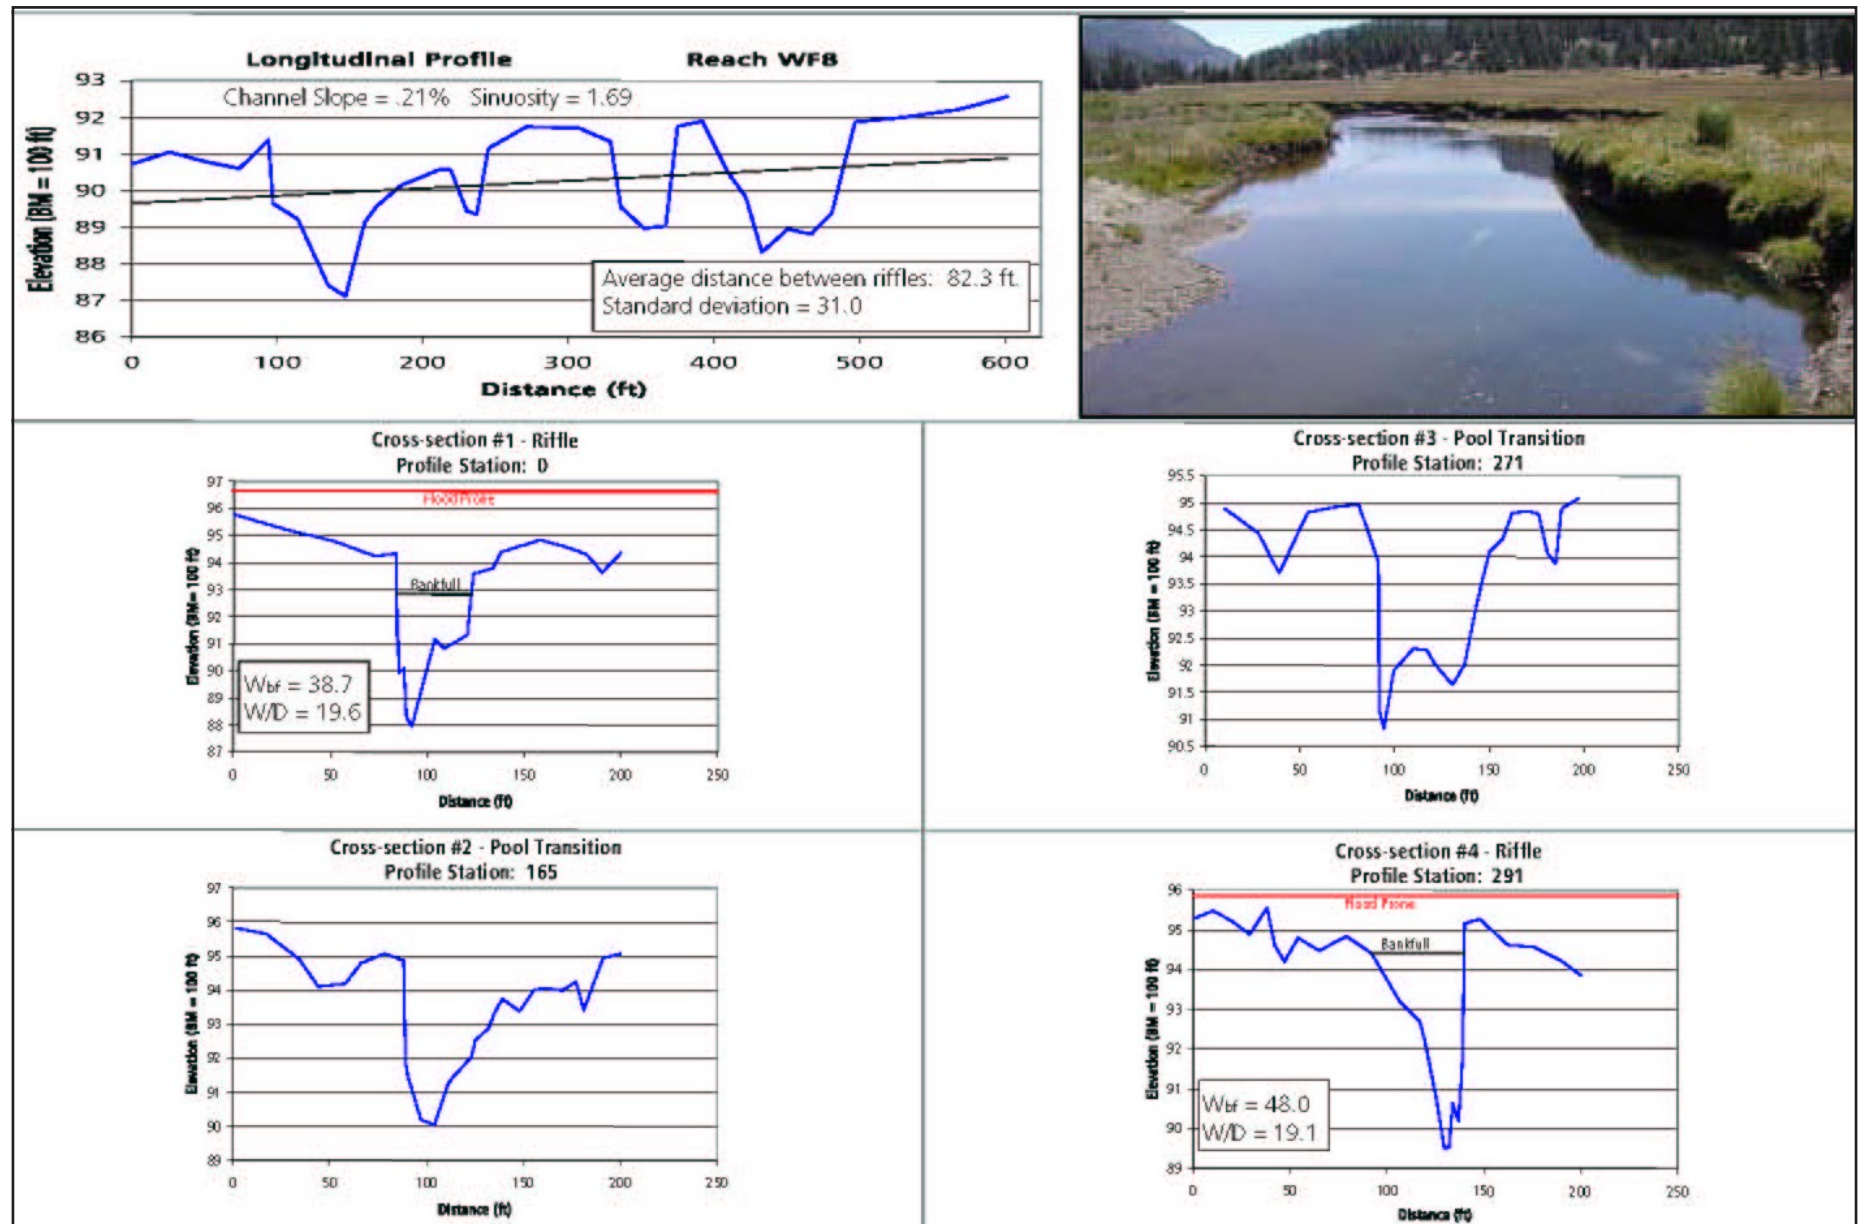
Figure 4.1. Longitudinal profile and cross-section geometry for Reach WF8.

Bankfull indicators are found at an elevation below the surrounding valley flat. The discharge at the bankfull stage, 200 cfs, has a recurrence interval of between 1.5 and 2.0-years as is typical of most streams. The top of the banks is generally at a higher elevation, the stage of the five to 10-year flood. This suggests that the stream may be somewhat incised with respect to the valley flat, although the incision is not great enough to substantially affect channel classification by decreasing the entrenchment ratio.

Channel stability is moderate. Streambanks are generally stable, although many outside bends are eroding to some degree. Much of the bed is relatively immobile at bankfull and top of bank flows, suggesting that bedload transport of sediment is less pronounced in this reach than in reaches further upstream (see Table 4.3). As a result, the channel is less dynamic, and changes less during floods than upstream reaches.

Based on survey results, the best approach to restoring the Reach WF8 stream channel would be to implement management and projects that improve streambank stability and encourage a reduction in the width to depth ratio. This would increase the frequency of pools, increase habitat complexity, and reduce the amount of fine sediment entering the channel. Improved streambank stability would also reduce the negative impact of larger floods, and allow slow restoration of the channel-floodplain relationship.

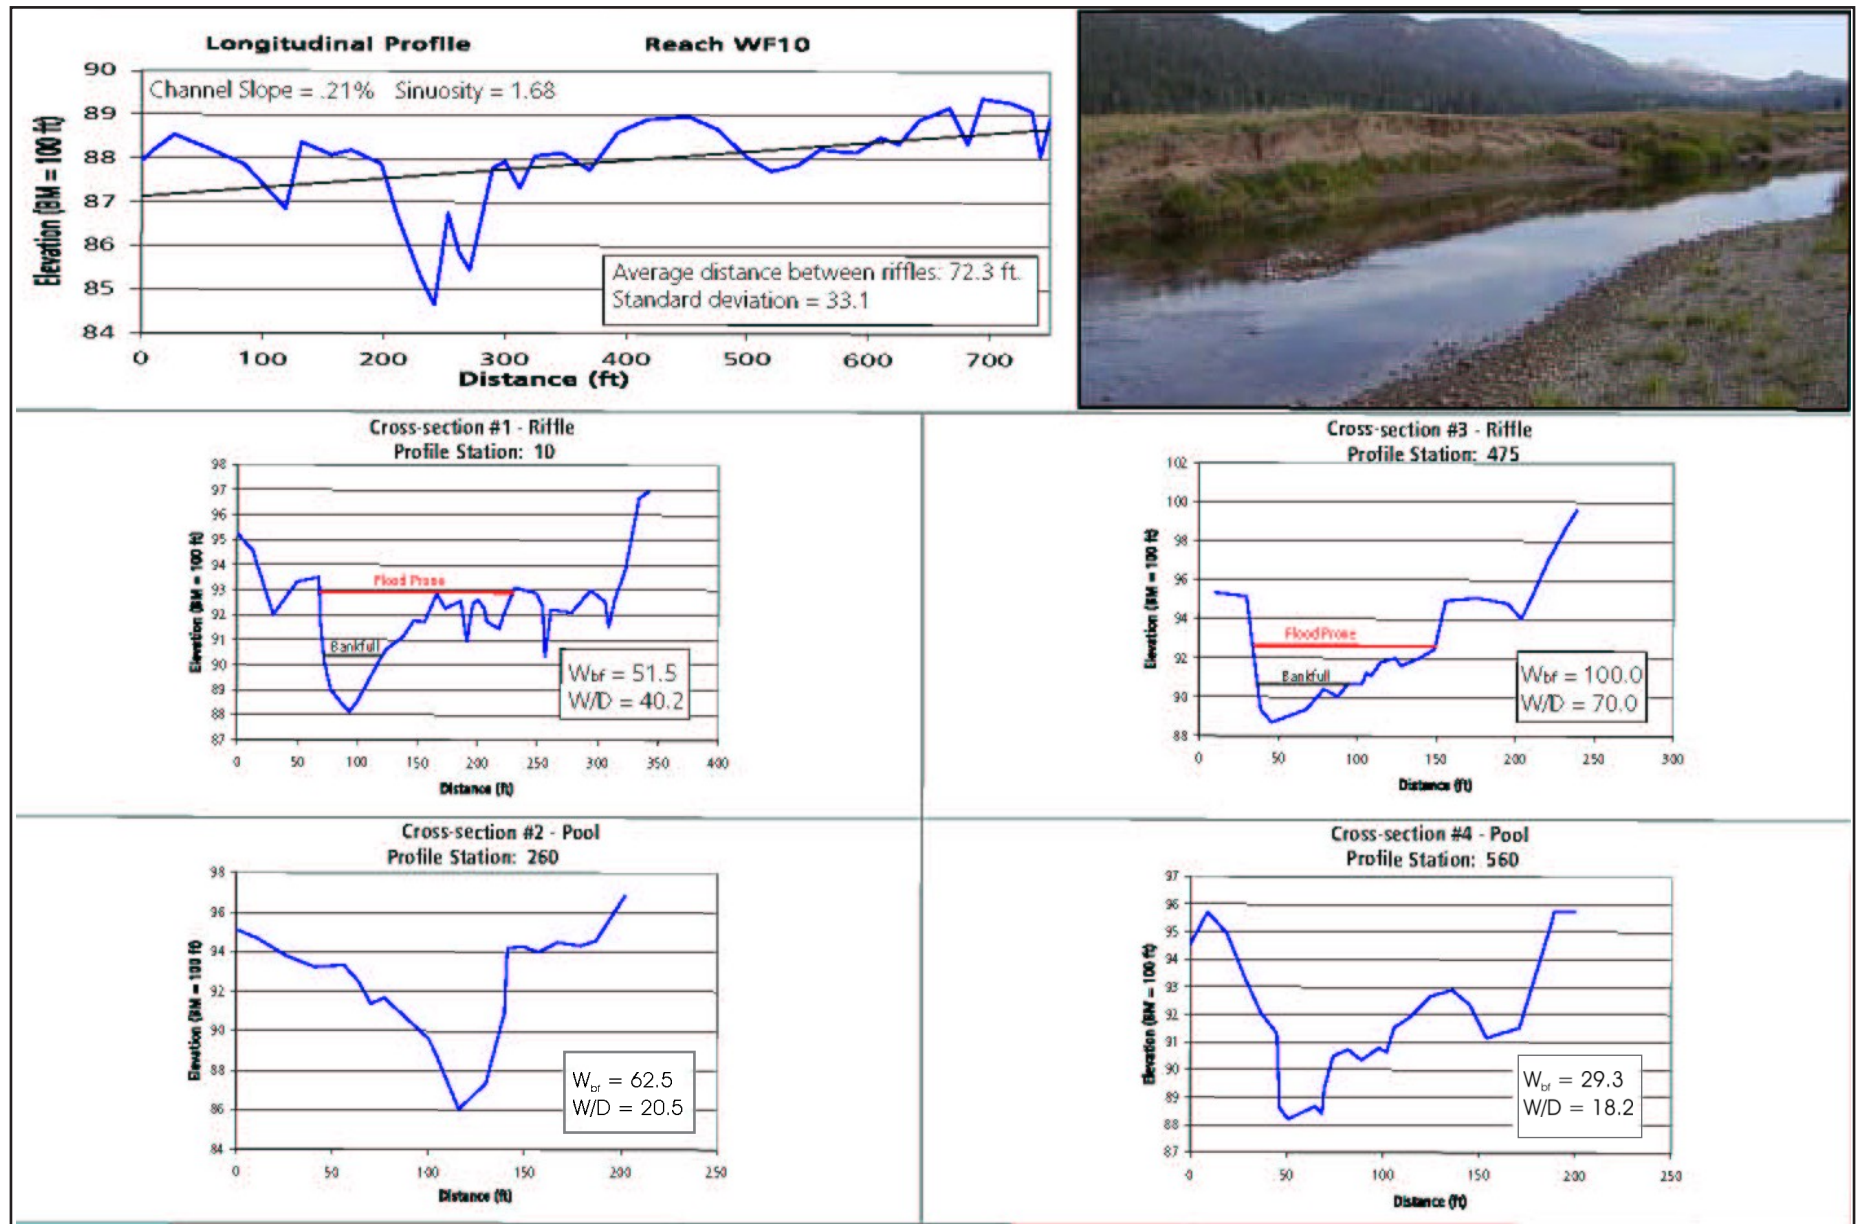
Figure 4.3. Longitudinal profile and cross-section geometry for Reach WF10.

The current channel appears inset within a larger channel and floodplain surface. Higher terrace surfaces are seldom accessed by floods, but show evidence of relatively recent channels and abandoned meander bends. Large bar deposits adjacent to the existing channel likely formed during rain-on-snow events such as those that occurred in 1963 and 1997. Sediment within these bar deposits may be derived from local bank and bed material as the channel widened and eroded adjacent banks to form floodplain. Additional evidence suggests that channel equilibrium has been altered and the channel is adjusting. Localized aggradation (raising of the streambed), which is relatively uncommon in stable, equilibrium channels, is common in this reach. Aggradation is evidenced by low development of the pool-riffle sequence, a significant amount of fine-grained material in the channel, and widened cross-sections with reduced shear and very little bed mobility, even during high magnitude discharge events.

Analysis and Summary: This survey suggests that Reach WF10 is not in equilibrium with the current sediment supply. Throughout our survey reach, the channel is regularly aggrading and degrading in localized areas, adjusting hydraulic characteristics to a constantly changing supply of local sediment. There is also evidence that the stream has incised relatively recently in relation to the surrounding floodplain. This evidence includes numerous abandoned channels and riparian shrub communities on what is now a terrace next to the active floodplain. Although similar features are seen in some locations in Reach WF8, they are much more pronounced in WF10.
