**PHASE II PHYSICAL
CHARACTERISTICS ASSESSMENT
FORMER HAWTHORNE LANDFILL
HAWTHORNE, NEVADA**

**US Army Corps
of Engineers ®**

Sacramento District
Environmental Design Section

OCTOBER 2001

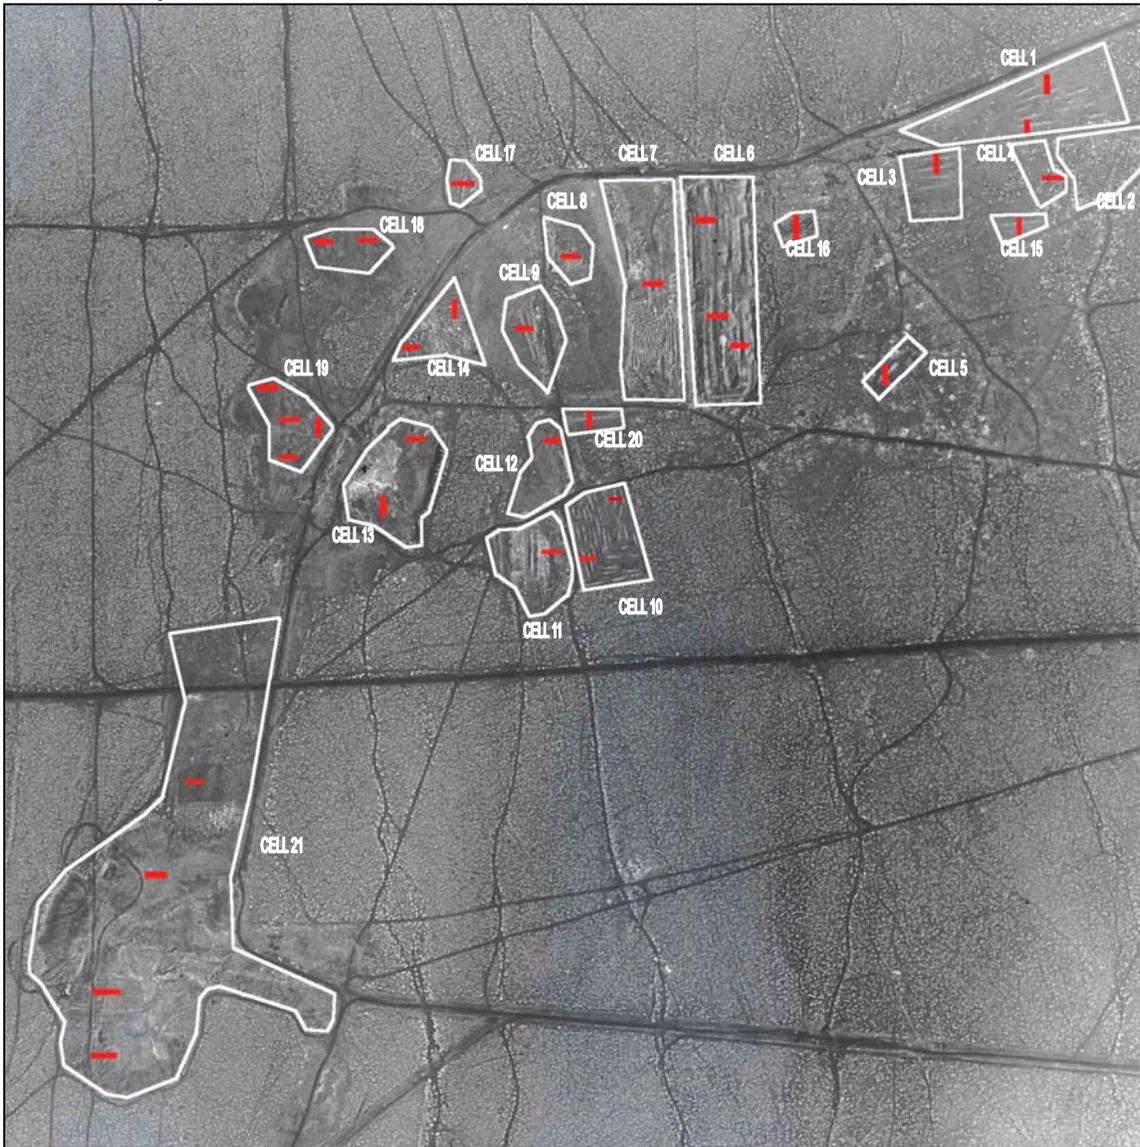
Figure 2. General location of landfill cells (No. 1-21) and the trenches within each cell.

According to Luster National's TBA report, 14 areas of interest or cells were identified based on surface features of trench depressions or soil piles. Using an aerial photo received from Scott Smale, Department of Environmental Protection, and noticeable surface features, 7 additional areas of concern or cells were identified. The locations of individual cells and trenching locations are shown on Figure 2.

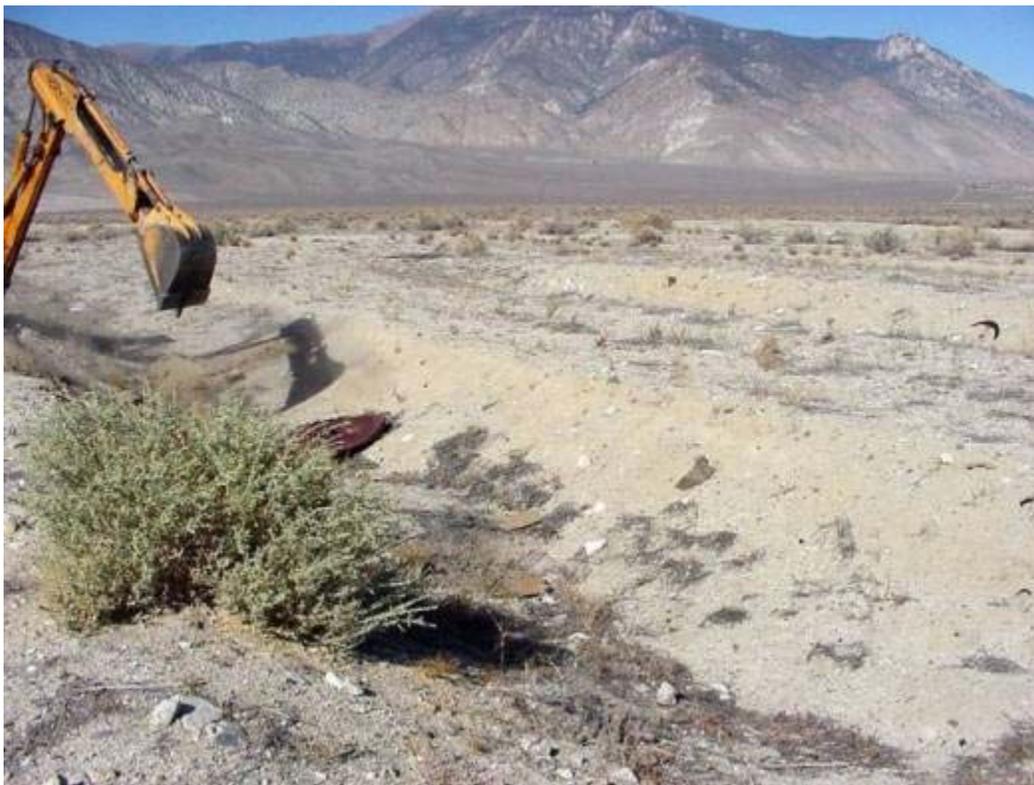
This cell was located in the northern corner of the site. There were approximately twelve trench depressions located in this cell. The average surface dimensions of the trenches were approximately 12 ft. wide by 100 ft. long. Because of the size of this cell, two potholes were done here. Generally, the trench depressions were somewhat deeper on the south side of the cell with less fill cover on the trench. Cover soil was only about 1-½ ft. on the south end, to about 3 ½ ft. on the north end. Both trenches were excavated to approximately 14 ft. before encountering native soil. Mostly late 1960s municipal waste was encountered.

Cell No. 1, southwest corner, looking west.

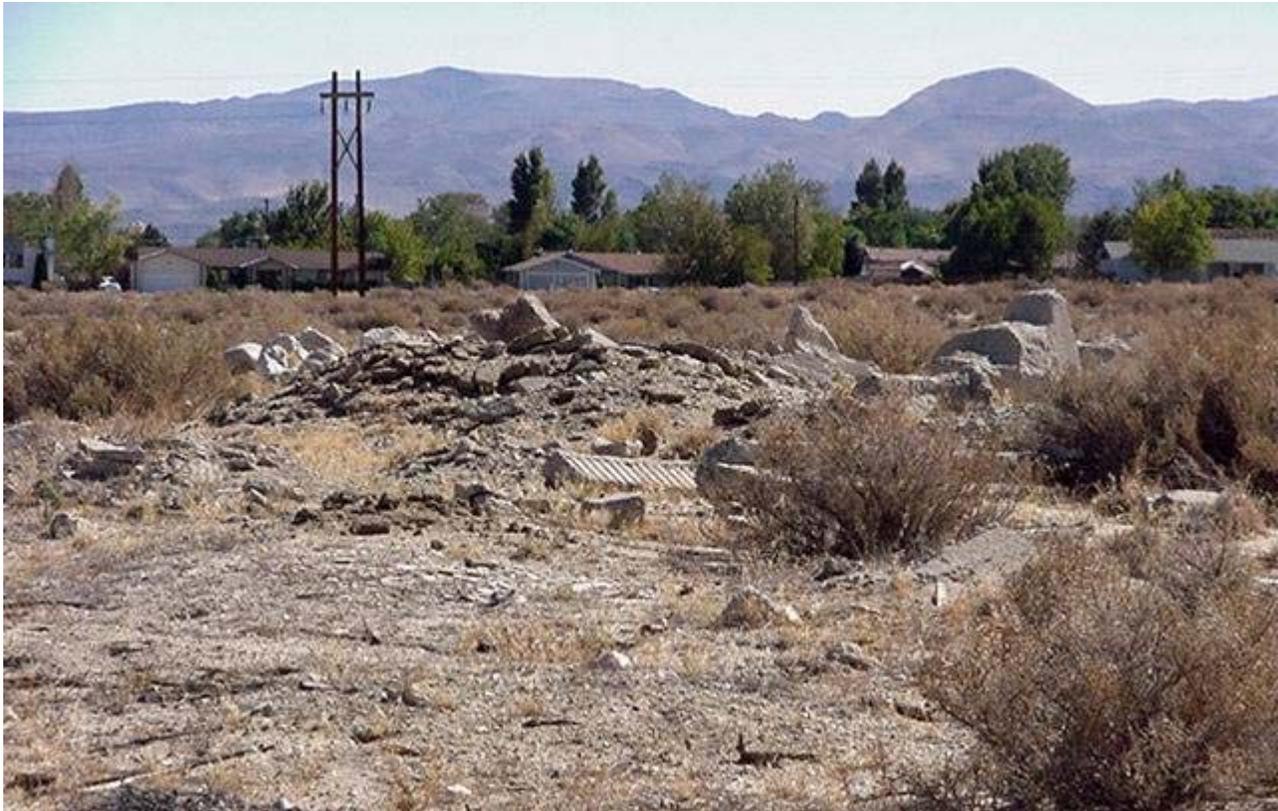
No potholing was conducted at Cell No. 2. The Luster report observed piles of construction debris (concrete and asphalt) predominantly covering the area. This observation was confirmed during this investigation.

Cell No. 2 looking east, just piles dumped on the surface

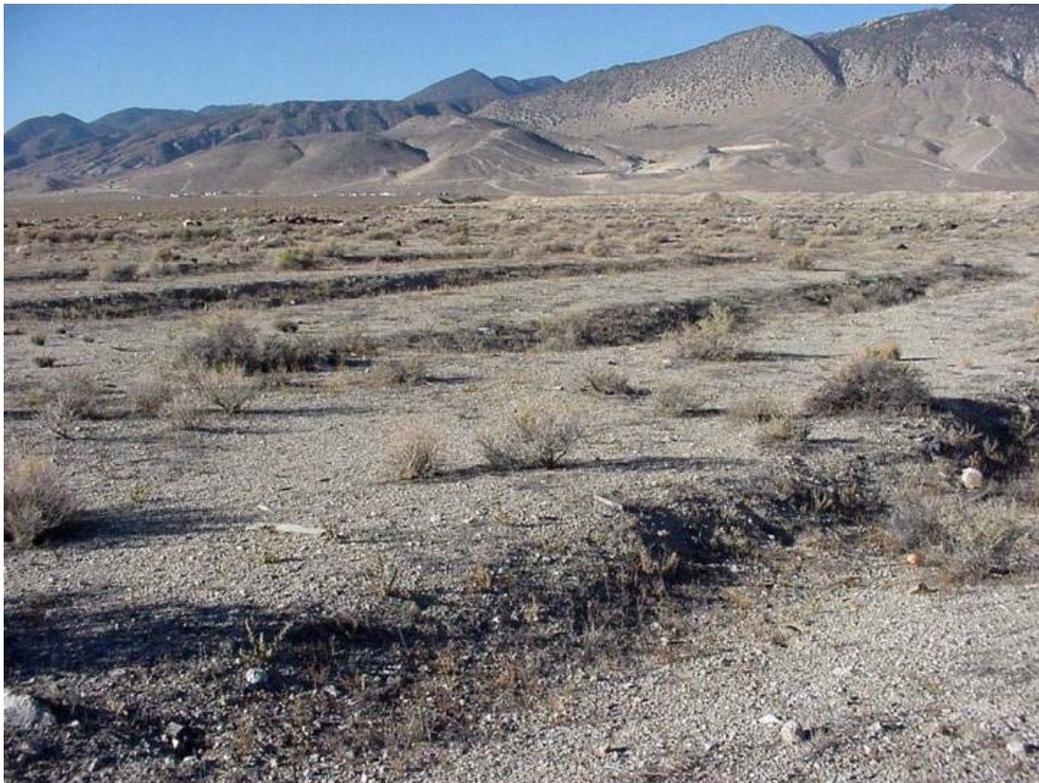
A set of five 2-ft. deep trench depressions approximately 12 ft. wide and 100 ft. long were observed at Cell No. 3. One foot of soil covered the trenches before encountering waste. Mostly burned municipal waste covered with soil was encountered. The layer of waste was approximately 11 ft. before encountering native material.

North end of Cell No. 3, looking west.

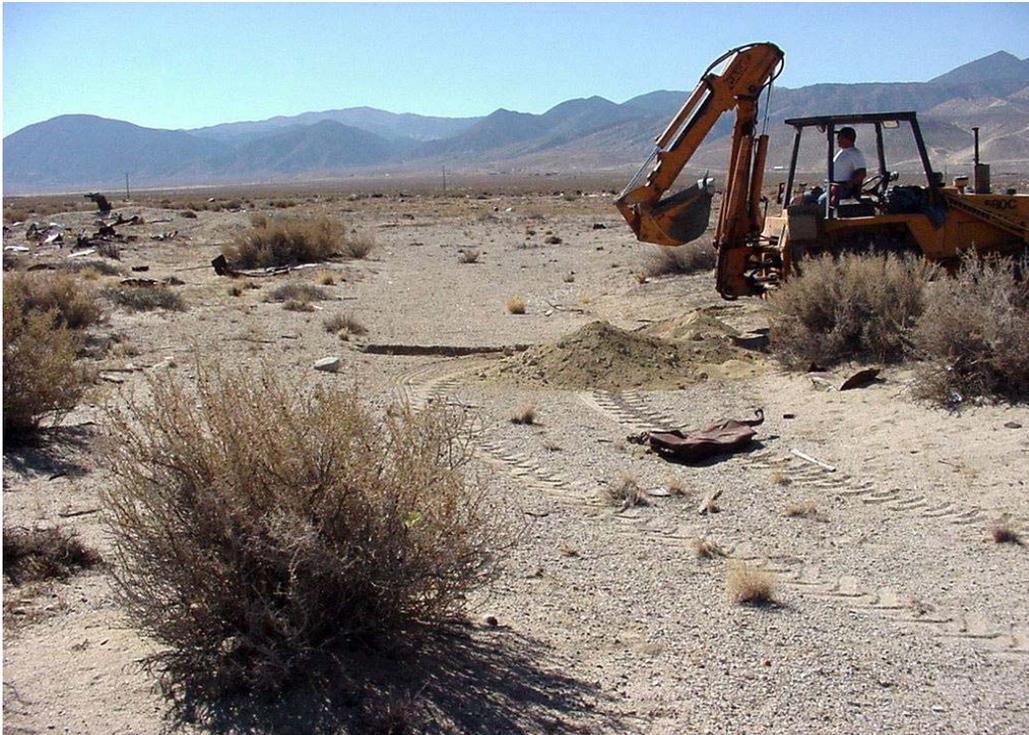
Several soil piles that appeared to have been dumped on the surface were observed in this area just south of the road. According to the Luster report, an area west of the soil piles appeared to have been disturbed. Potholing was conducted here, but only native material was encountered. This area may have been used as a borrow source for fill material used to cover the trenches.

Cell No. 4, looking southwest.

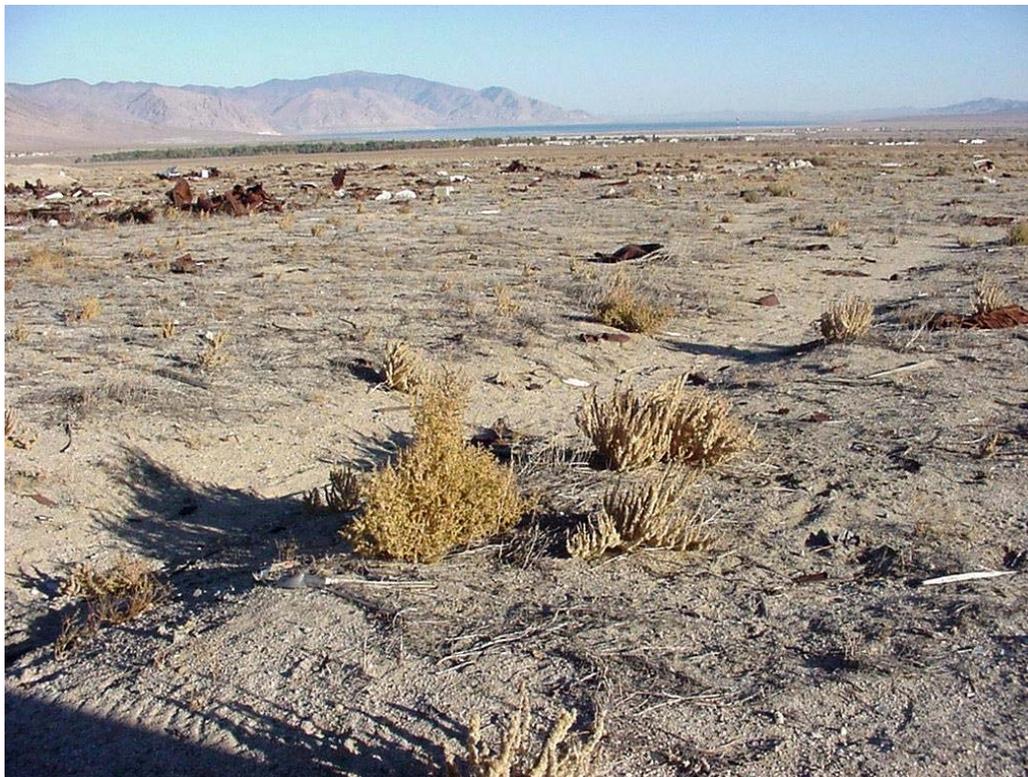
This area contained a lot of large metal debris on the surface, but little indication of soil disturbance. Two potholes were excavated in Cell No. 5. The first area where potholing was conducted appeared to be a trench depression of 8 ft. wide by 80 ft. long. The excavation continued to 5 ft. bgs and waste was not encountered. All soil from this area appeared to be native material. This area could be a natural drainage canal or run-off ditch.

Possible drainage ditch in Cell No. 5.

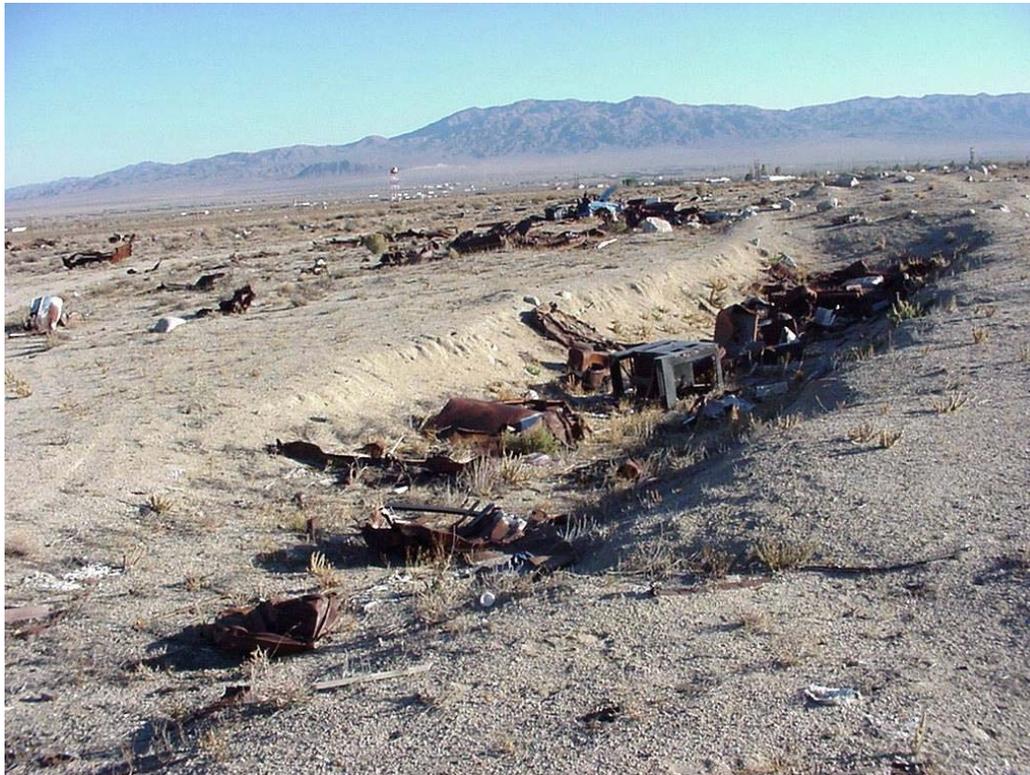
The second disturbed area in Cell No. 5 was an open trench, which contained a large amount of auto gas tanks along with car bodies, several crushed drums, and other metal debris. Only native material was encountered during potholing. Based on the surface debris and contents of the open ditch, it appeared that metal was separated and disposed of here. It also appeared as though gas tanks were removed from automobiles and placed in the ditch for safety.

Open ditch with gas tanks and auto bodies in Cell No. 5.

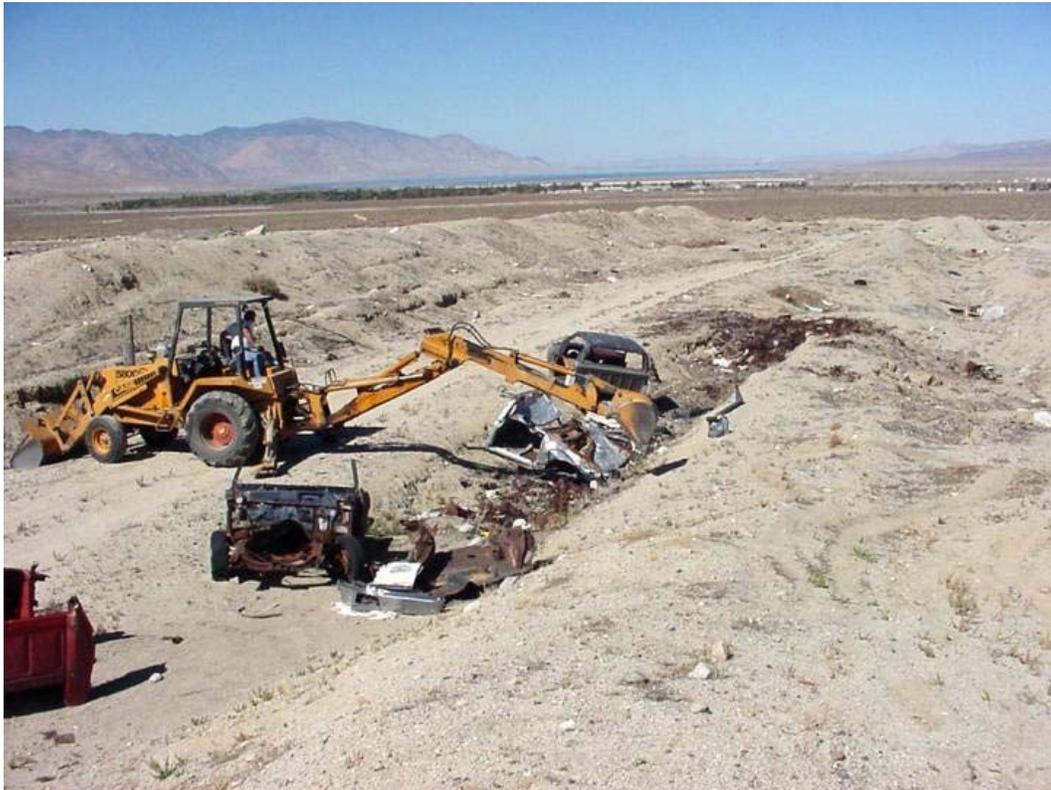
This cell was one of the largest cells in the landfill with several north-south trenches approximately 1,000 ft. long by 8 ft. wide. Trenches in Cell No. 6 were surrounded by soil ridges that opened on the north end. Three potholes were excavated here to gather adequate information. Surface debris was found mostly in the southern portion of the cell (i.e., car bodies, large metal debris).

Southern end of Cell No. 6. Soil cover was approximately 1 ft. thick. Subsurface waste was 4 ft. deep here. All buried waste was municipal waste that was burned.

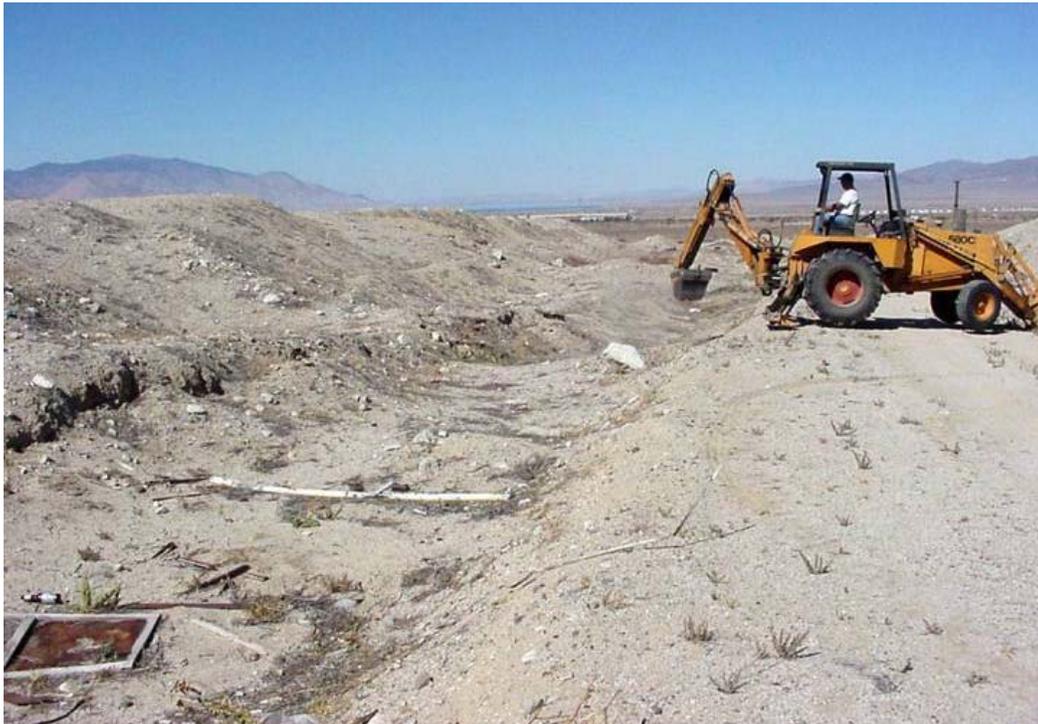
Middle of Cell No. 6. Trench depression here was approximately 3 ft. deep and 12 ft. wide. There was 2 ft. of soil cover prior to encountering waste. Mostly burned municipal waste covered by soil was encountered. Excavated to 18 ft. without reaching the trench bottom, before the sides of the trench caved-in.

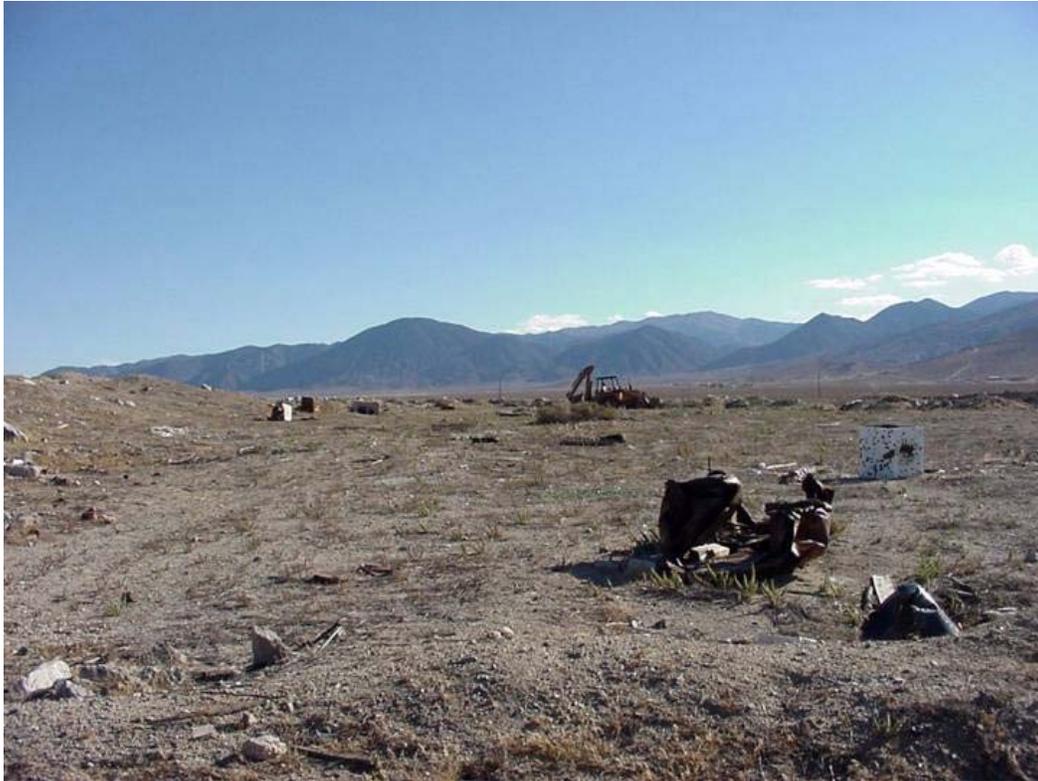
Cell No. 7 covered as large of an area as Cell No. 6. The southern end of the cell was covered with soil and debris piles that appeared to have been dumped. Excavation was conducted within one trench located in the middle of the cell. Approximately 3 ft. of soil covered waste in this area. The excavation continued to 14 ft. before caving in. It appeared that 14 ft. was the bottom of the trench. The trench contained mostly burned municipal waste covered with soil.

Cell No. 7 at the north end looking south.

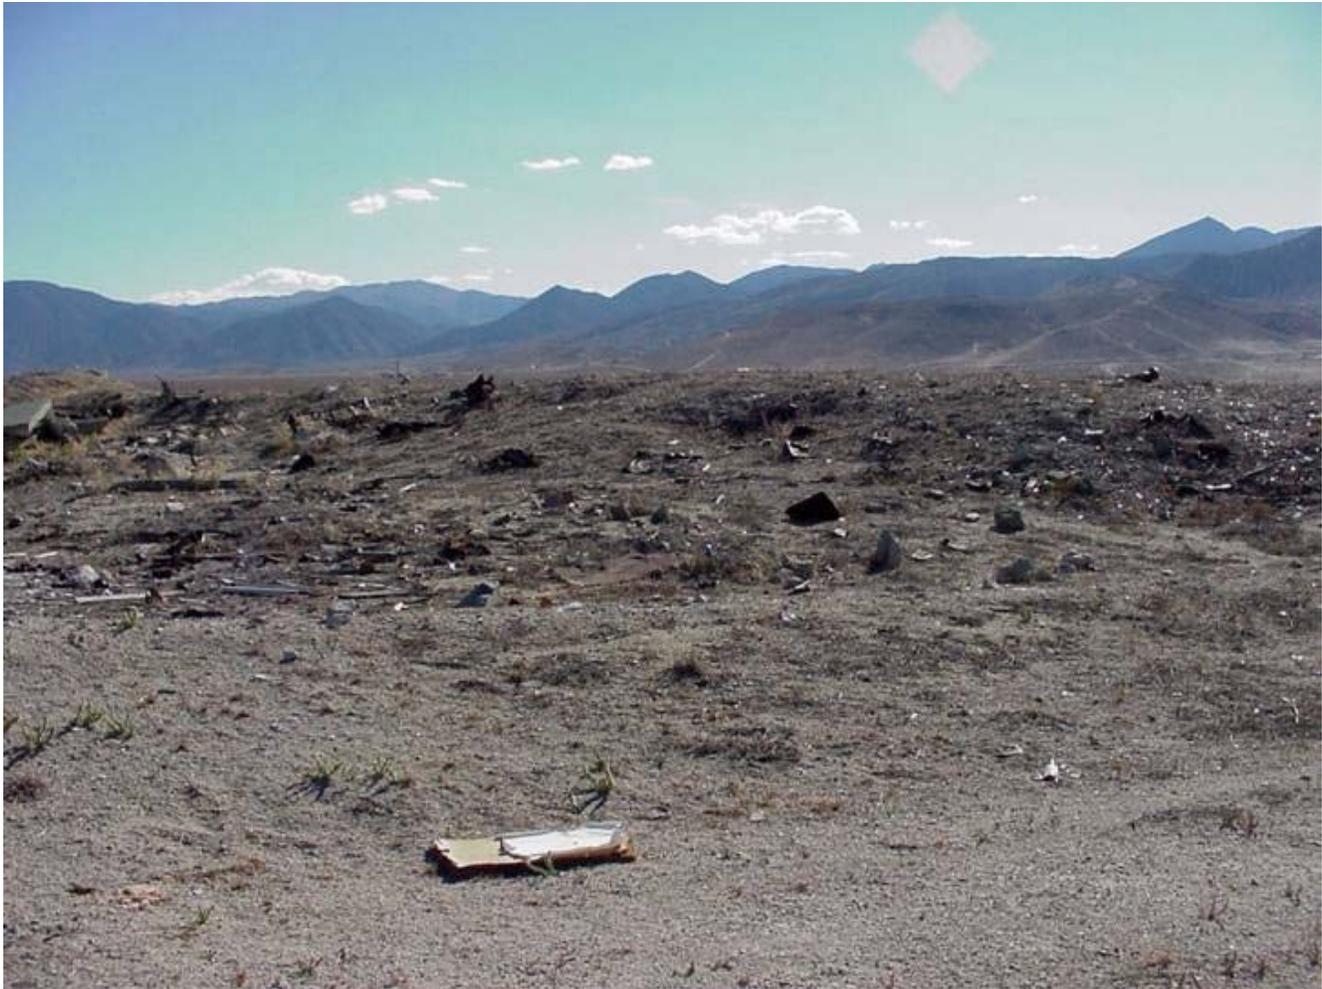
A large soil berm was encountered in Cell No. 8. Separate piles of concrete and asphalt were located around the soil berm. The berm was approximately 6 ft. high. Waste was encountered approximately 2 ft. below the surface. Waste continued for approximately 6 ft. bgs until native material was encountered. The cell contained mostly burned municipal waste covered with soil. Significantly more ash was encountered within this cell.

Soil berm in Cell No. 8 looking west.

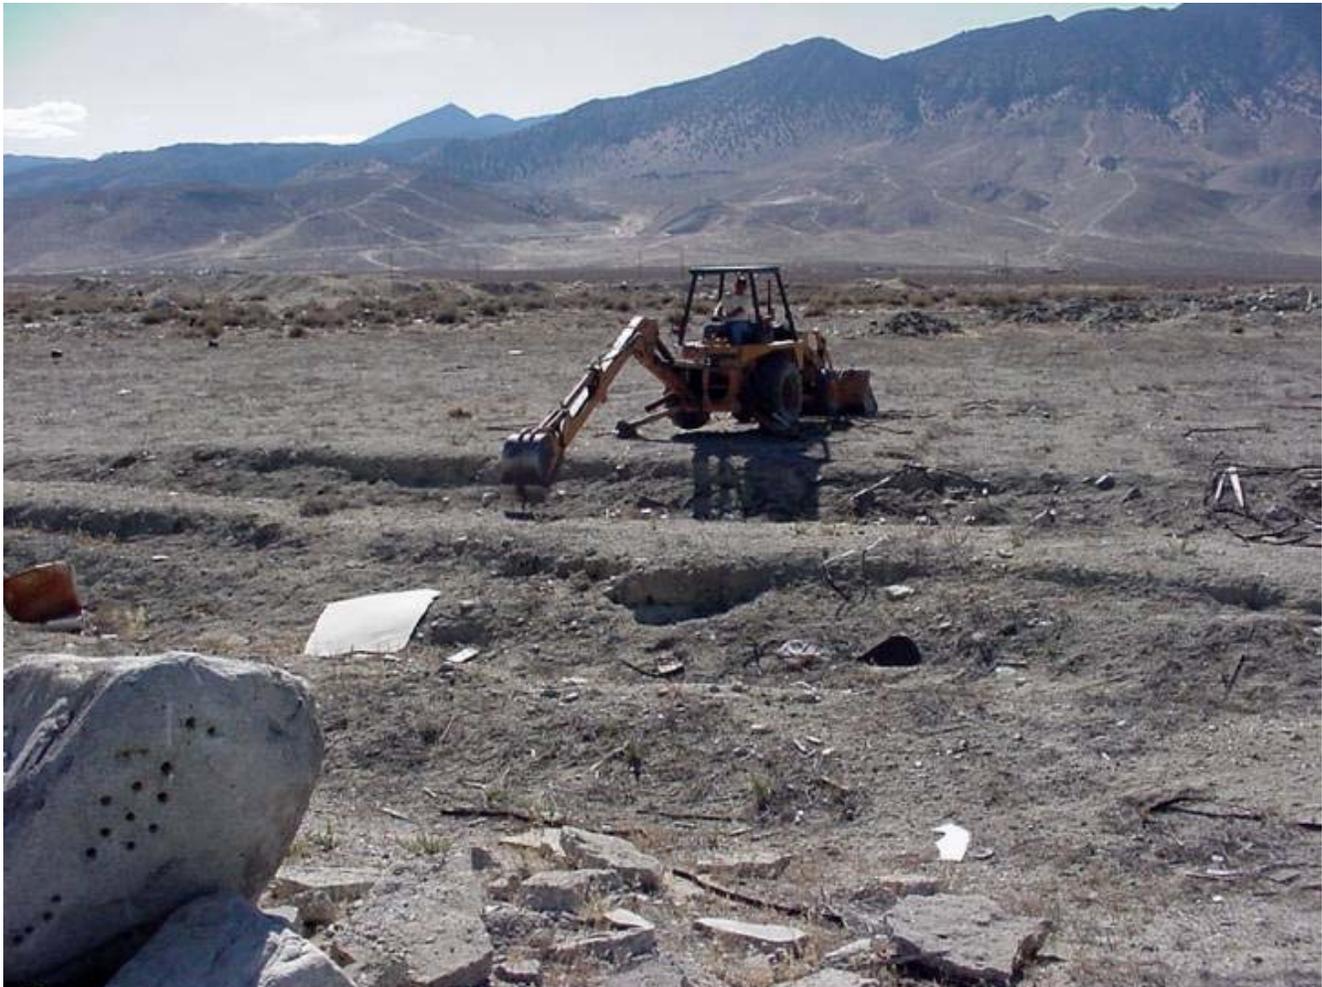
Cell No. 9 contained a series of north-south trench depressions. Scattered concrete rubble was encountered east of the trench depressions. The trenches measured 12 ft. wide by 150 ft. long, with a 3 ft. depression. Approximately 2 ft. of fill material covered the waste. The excavation continued to 13 ft. before caving in. The base of the waste was not encountered. The trench contained mostly burned municipal waste covered with soil.

Cell No. 9 looking west.

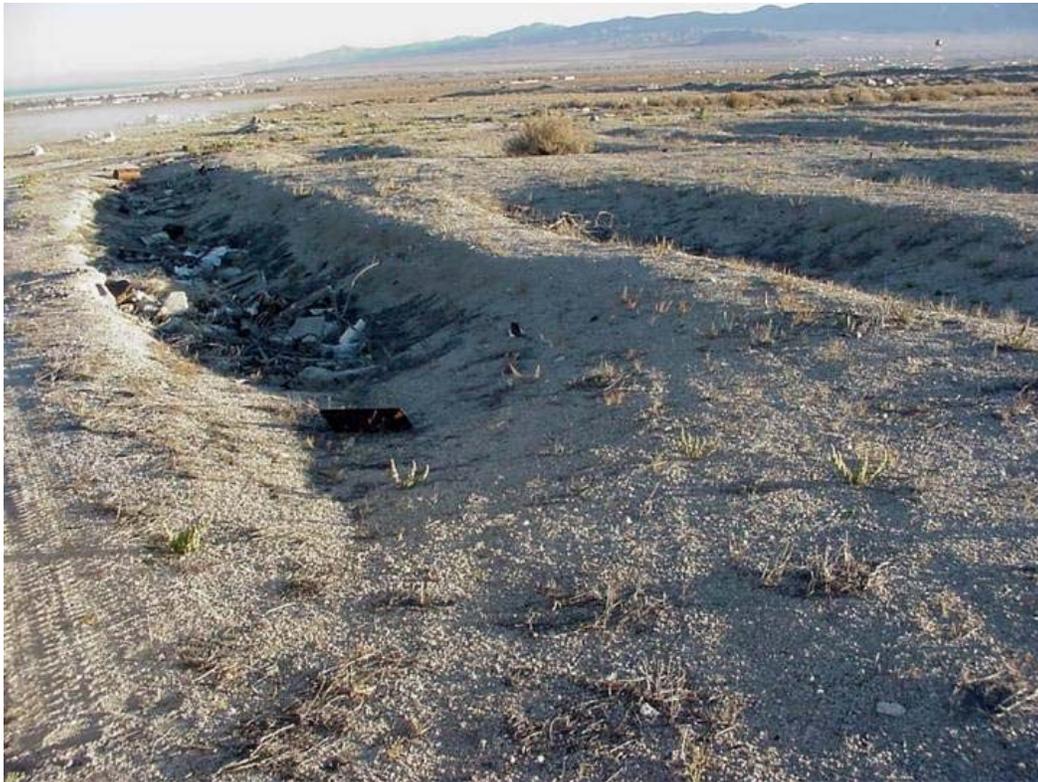
Cell No. 10 contained a series of trench depressions 2-3 ft. deep. Two potholes were excavated, one in the northwest corner and one in the southeast corner. Approximately 4 ft. of fill material covered the waste. The excavation continued to 10 ft. before caving in. The trenches contained mostly burned municipal waste covered with soil. There were several piles of soil and concrete in this area.

Cell No. 10. From the southwest corner looking north. This trench was never covered and the exposed waste can be observed.

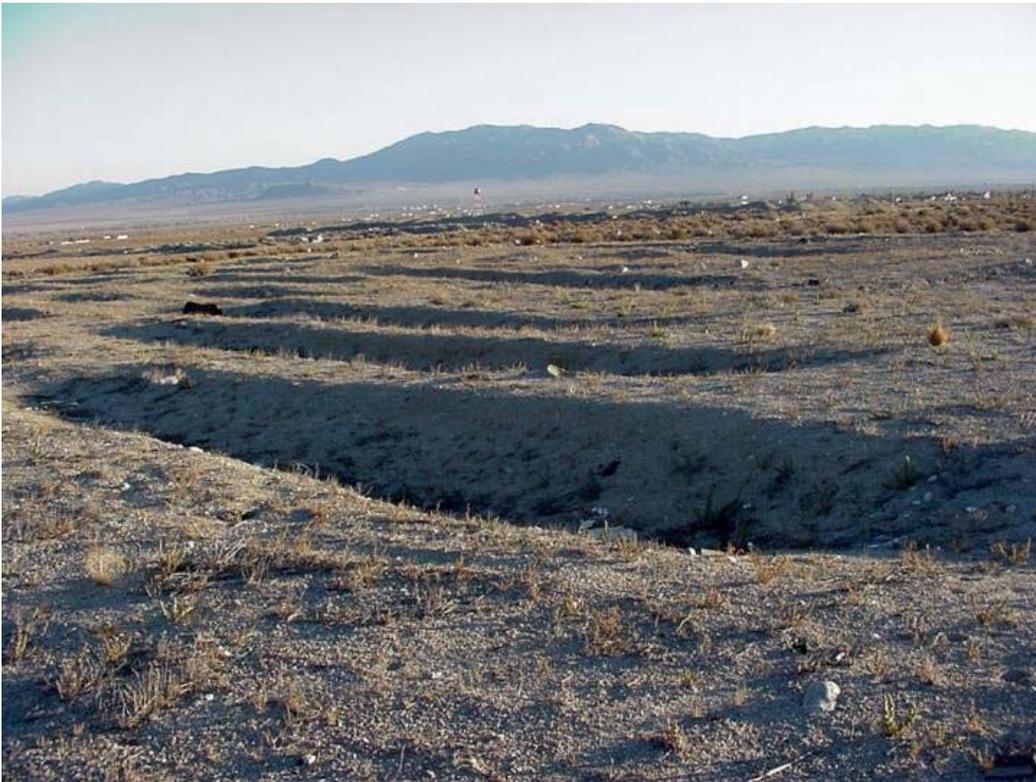
Cell No. 11 contained larger debris on the surface (car parts, appliances, metal debris). A series of trench depressions were observed just west of Cell No. 10. The trenches were approximately 100 ft. long by 6 ft. wide, with 3-ft. depressions. Approximately 2 ft. of fill material covered the waste. The trench contained mostly burned municipal waste covered with soil. The depth of waste was approximately 8 ft. in most trenches.

Cell No. 11 looking south.

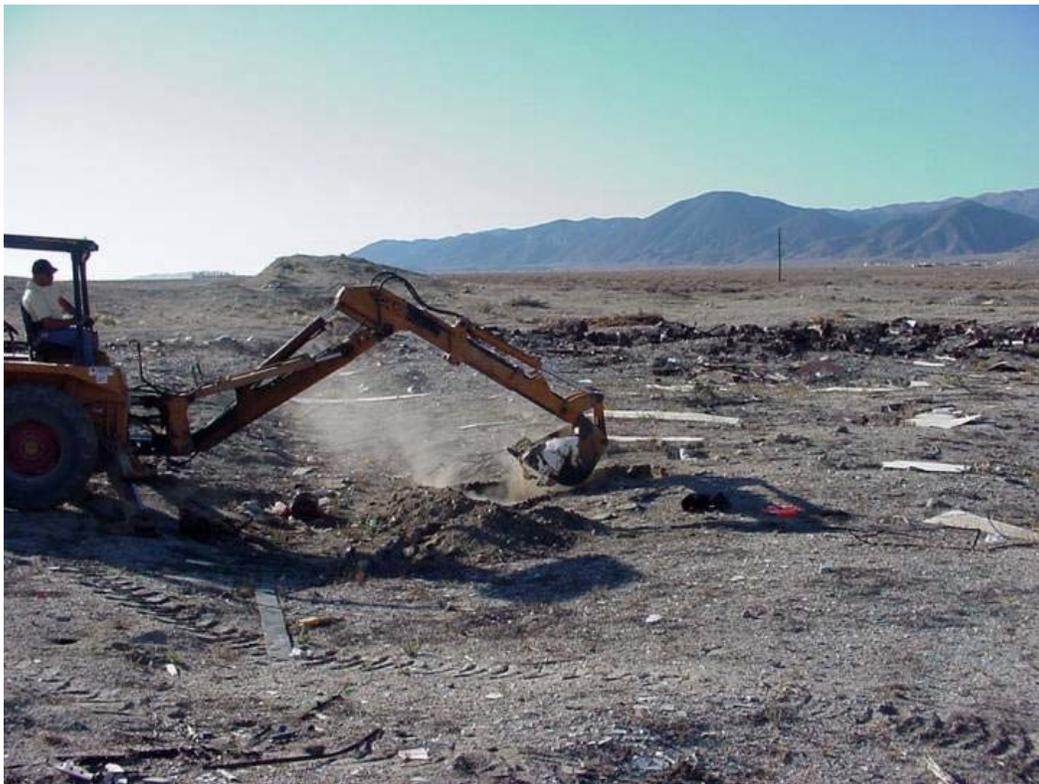
Cell No. 3 contained a large open pit on the east side of the cell. The pit was approximately 75 square feet and contained metal debris. Soil mounds and trench depressions were observed on the west side of the cell. The soil mounds appeared to have come from the pit or the trenches. The trenches were approximately 150 ft. long by 12 ft., with a 2 ft. depression. The trenches were composed of 12 ft. of waste and 2 ft. of cover, and contained mostly burned municipal waste covered with soil.

Cell No. 13 trench looking south.

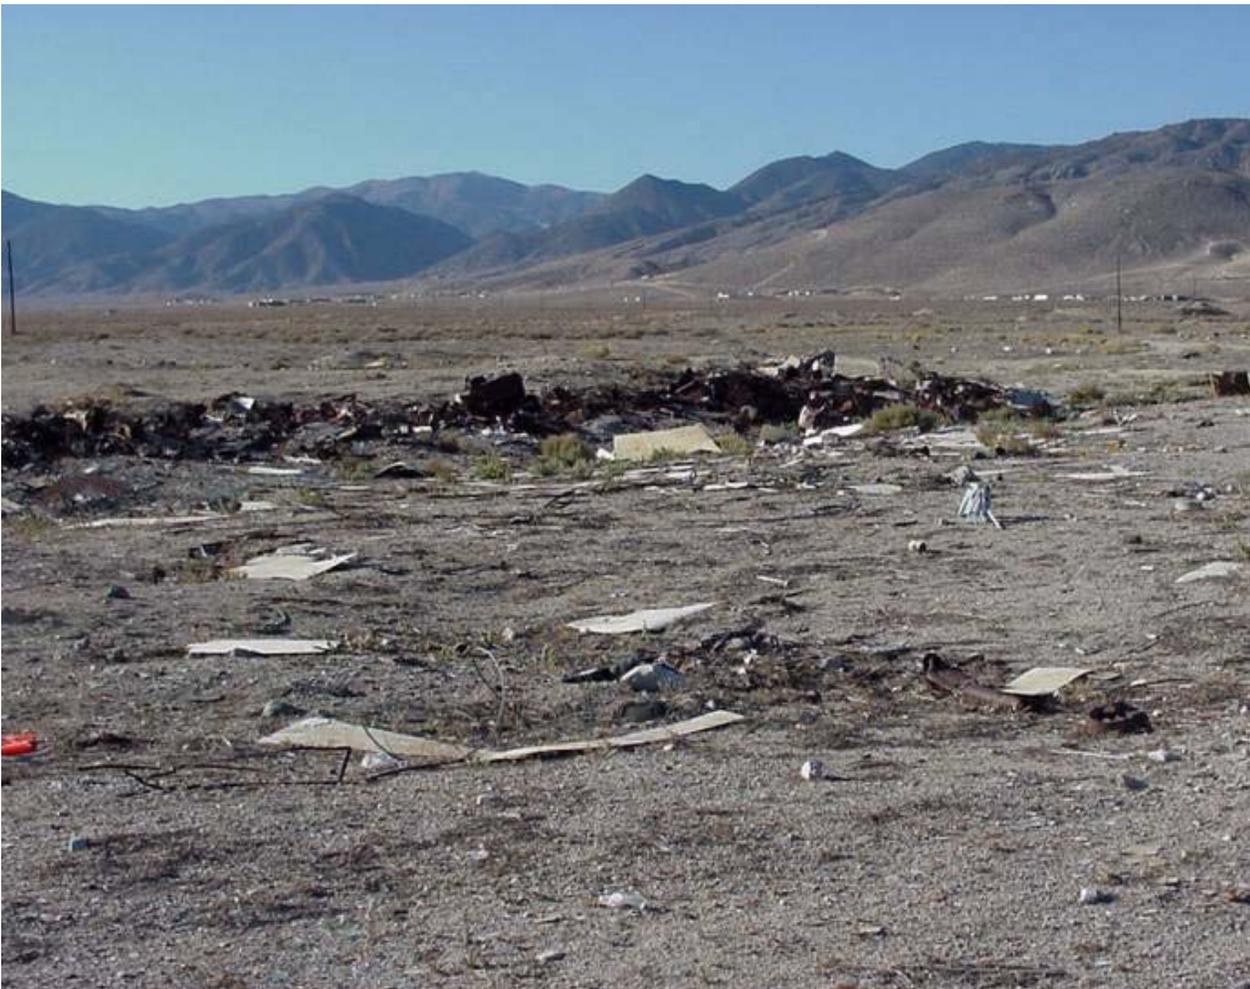
Metal debris pit on the south side of Cell No. 13 looking south.

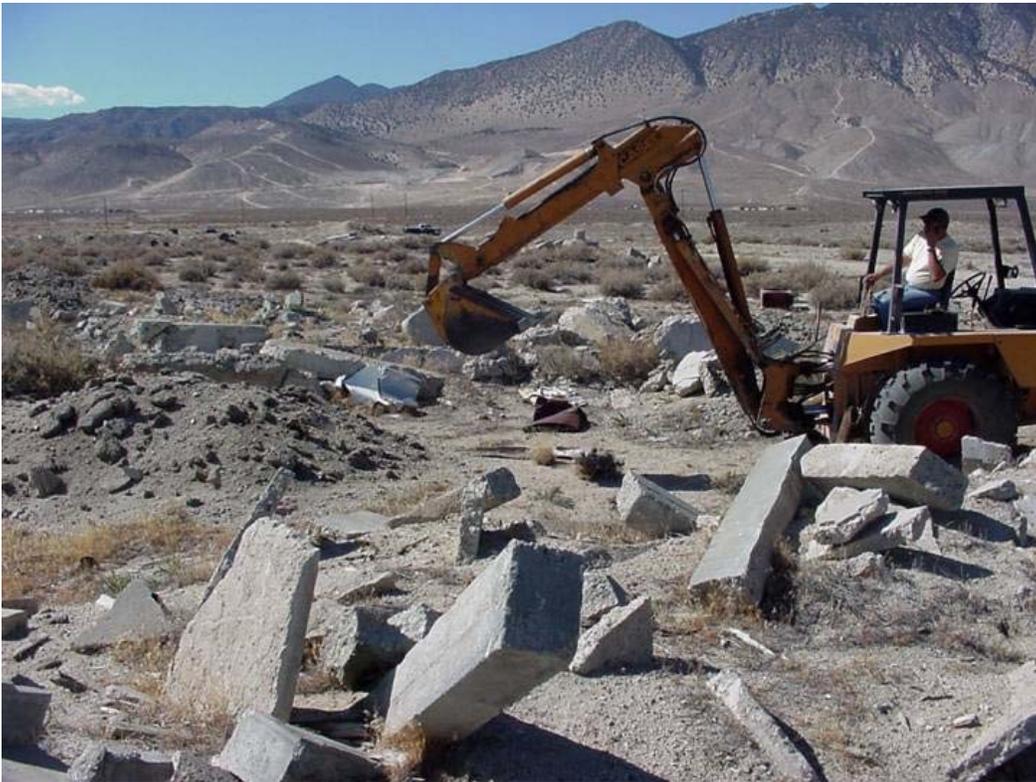
This cell contained a large pile of building material, concrete, asphalt, and soil piles. A pothole was attempted, but only native soil was encountered. A trench depression was located west of the debris pile, approximately 100 ft. away. The depression was approximately 6 ft. wide by 50 ft. long. Potholing revealed the trench was composed of 6 ft. of waste and 2 ft. of cover. The trench contained mostly burned municipal waste covered with soil.

Debris pile in Cell No. 14 looking west.

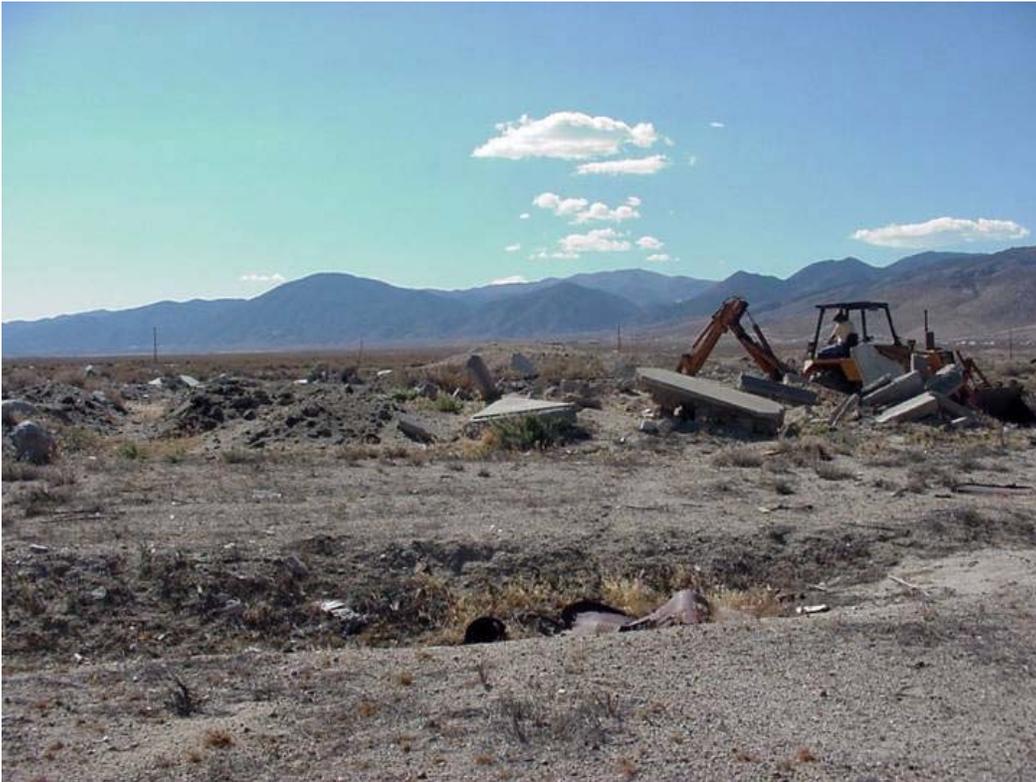
Cell No. 14, looking south. The debris pile is in the background and trench depression in the foreground.

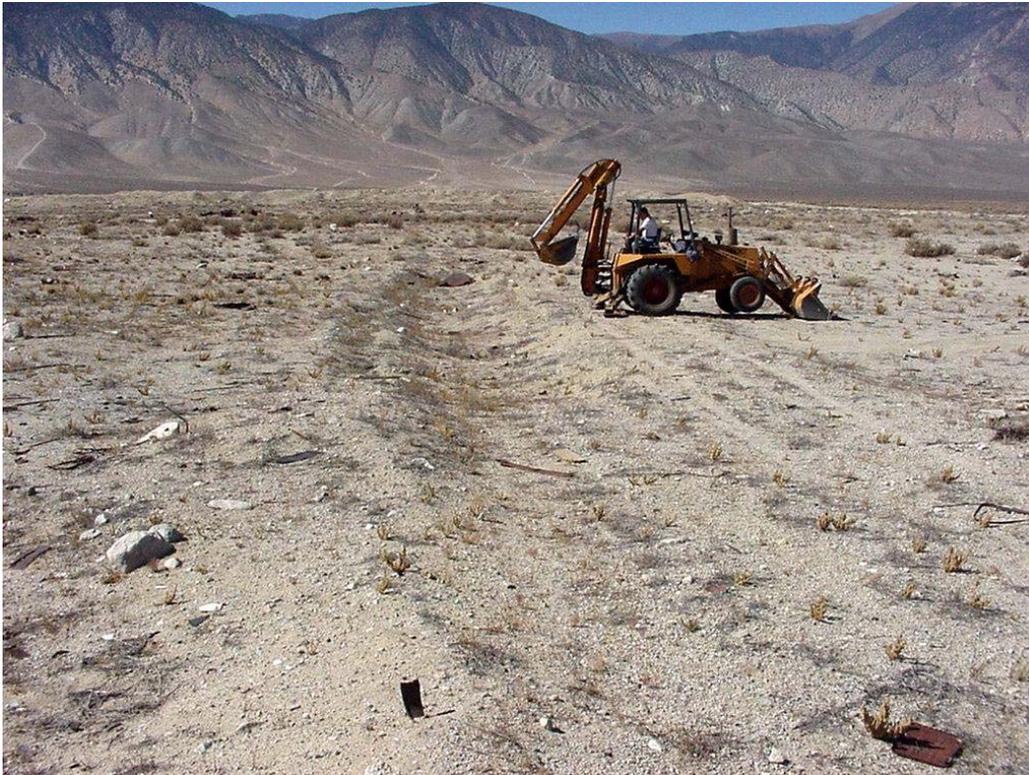
Cell No. 15 was located approximately 200 ft. west of Cell No. 4. Only one trench depression was visible here with dimensions of 8 ft. wide by 100 ft. long, with a 2 ft. depression. The trench was composed of 10 ft. of waste and 3 ft. of cover, and contained mostly burned municipal waste covered with soil. Some metal debris (mostly car parts) were included with the municipal waste.

Site of east-west ditch in Cell No. 15 looking west.

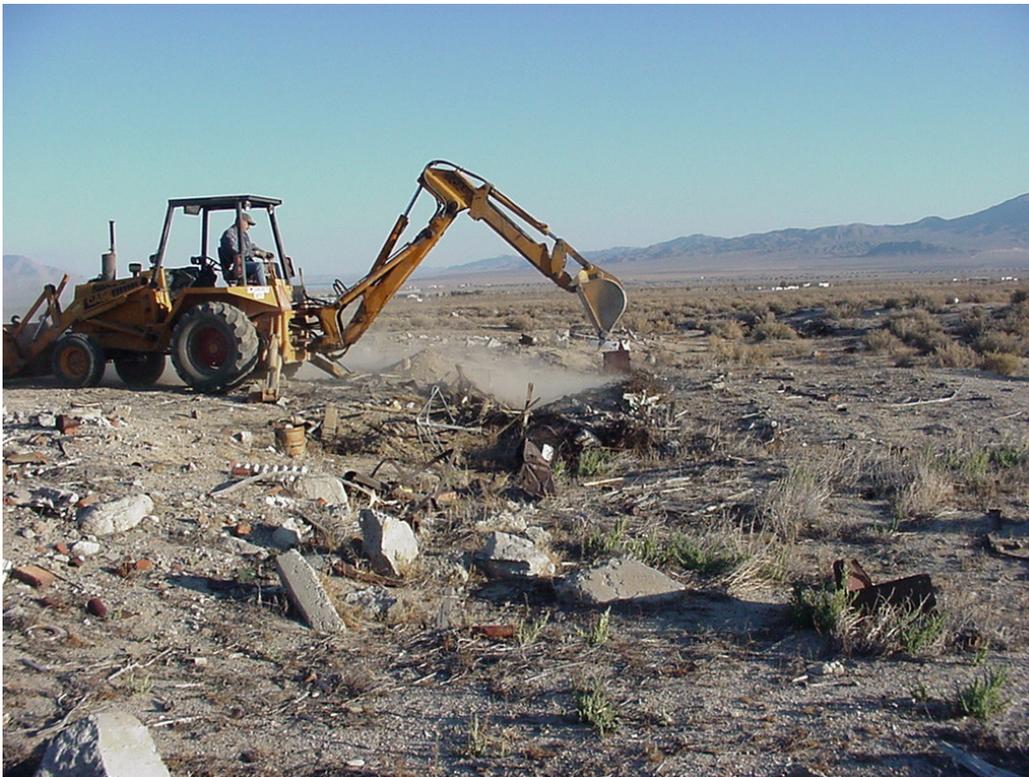
Cell No. 17 contained two east-west trenches with surface waste. The trenches were depressed approximately 1-½ ft. There was little to no soil cover and waste was approximately 2 ft. deep. Waste consisted of mostly landscape materials and brush with some concrete on the surface. This area appeared to have had an old wash run through it that was filled in.

Trench in Cell No. 17 looking south.

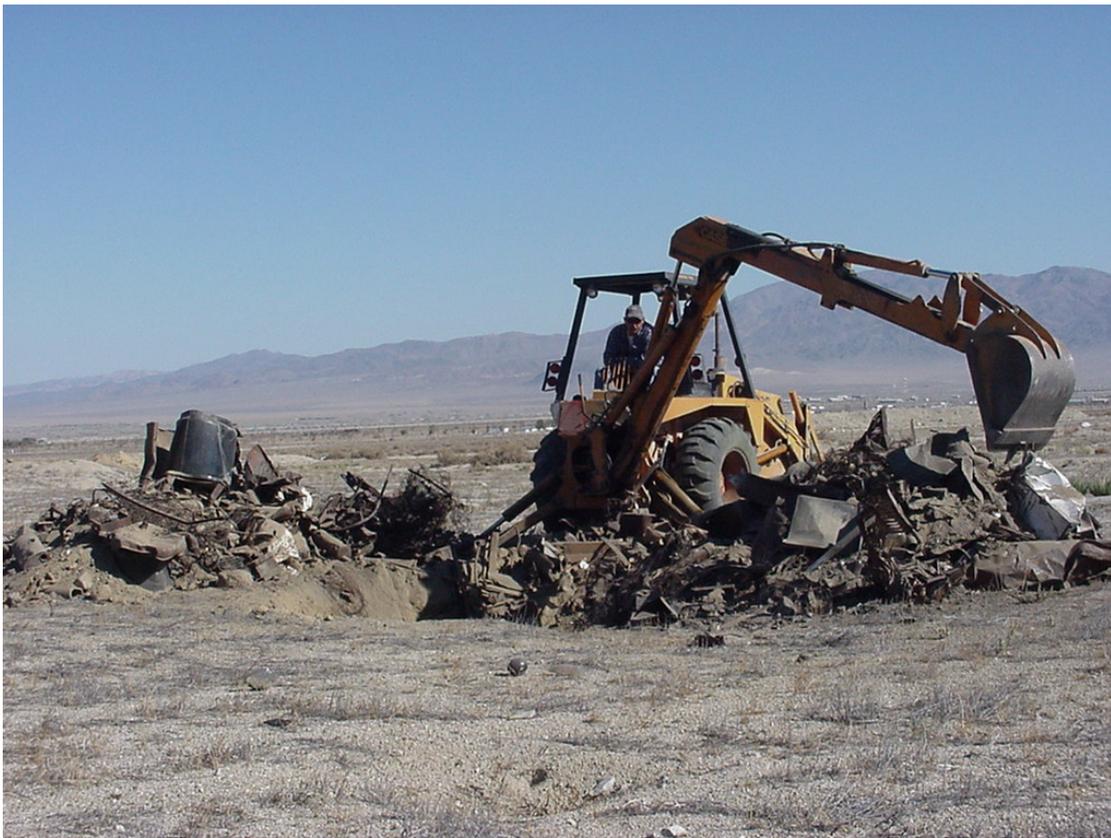
This area was fairly flat with several unnatural ground swells. Potholing began in the lowest area of the cell where a large metal debris pit was found. The pit had 3 ft. of soil cover and contained car parts, appliances, bedsprings, and construction waste. Unlike other areas, this waste did not appear to be burned. The excavation continued to a depth of 18 ft. without encountering native material. Three other areas were potholed around the perimeter of the pit within 150 ft., and no waste was encountered.

Cell No. 19, looking east.

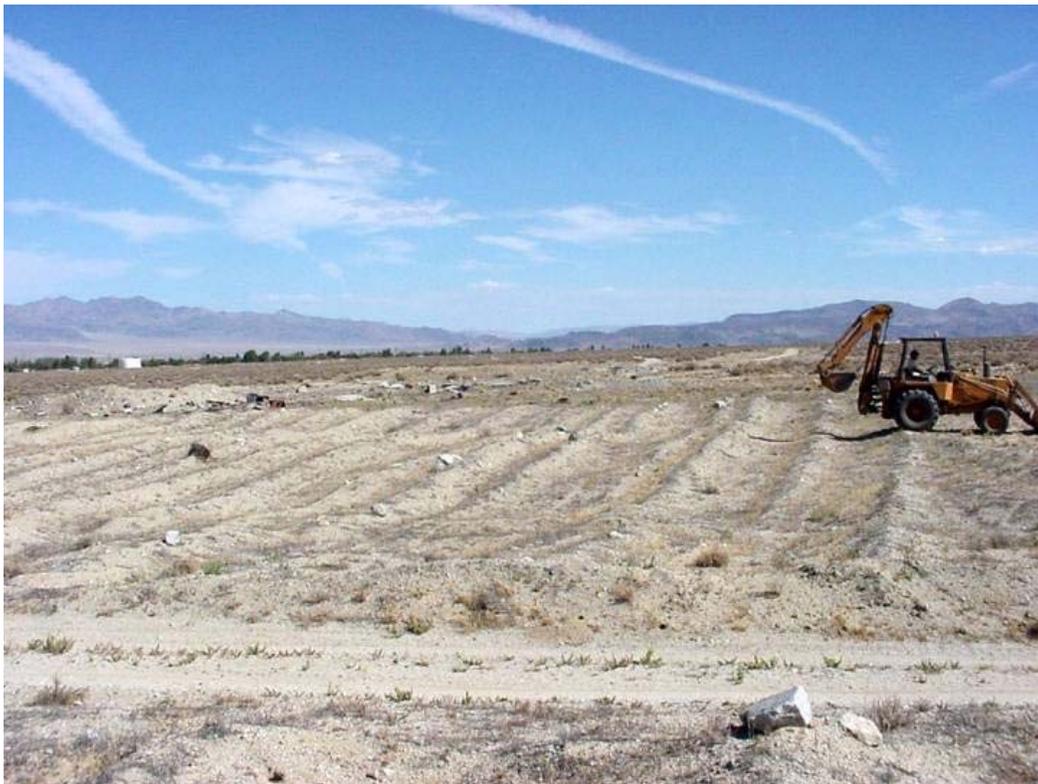
Cell No. 21 was the largest cell within the landfill, and was located the furthest south. Four potholes were excavated here. The northern-most trench area appeared flat and slightly lower than the surrounding area, however, potholing in this area resulted in no waste. This area may have been a borrow source for fill material. The other three potholes all revealed waste at depths of 10 to 14 ft. Waste in this area appeared to have been from the 1970s (aluminum cans, pull tabs, 12 oz. bottles) and may have been the last area within the landfill to be used for disposal of municipal waste.

Cell No. 21, southern end looking west.
