Existing Tank 10A

Completed Tank 10B next to existing Tank 10A

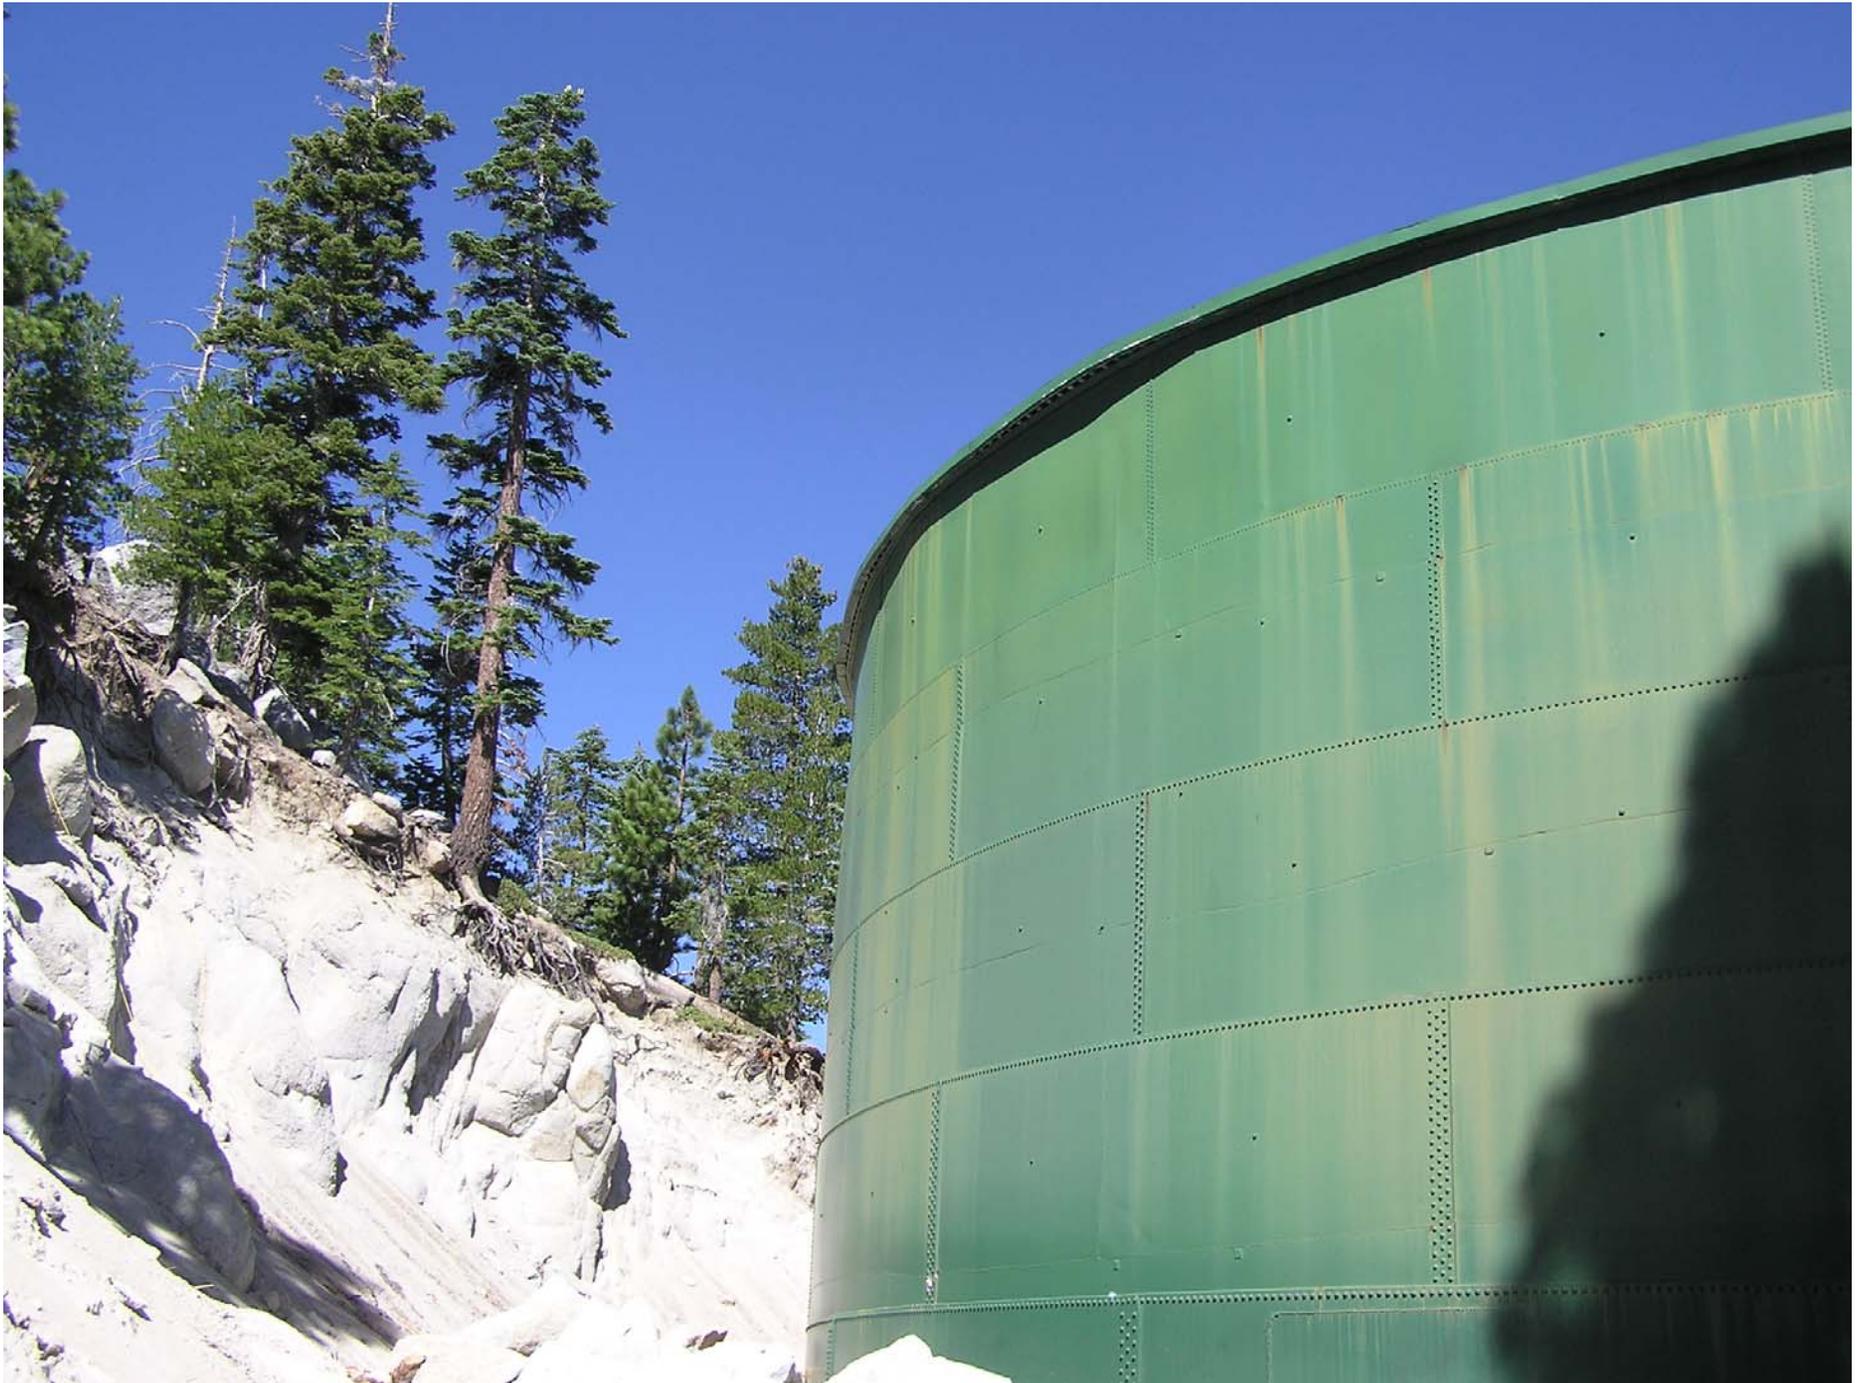
Existing Tank 10A - roof is detached in places allowing foreign material to get into tank

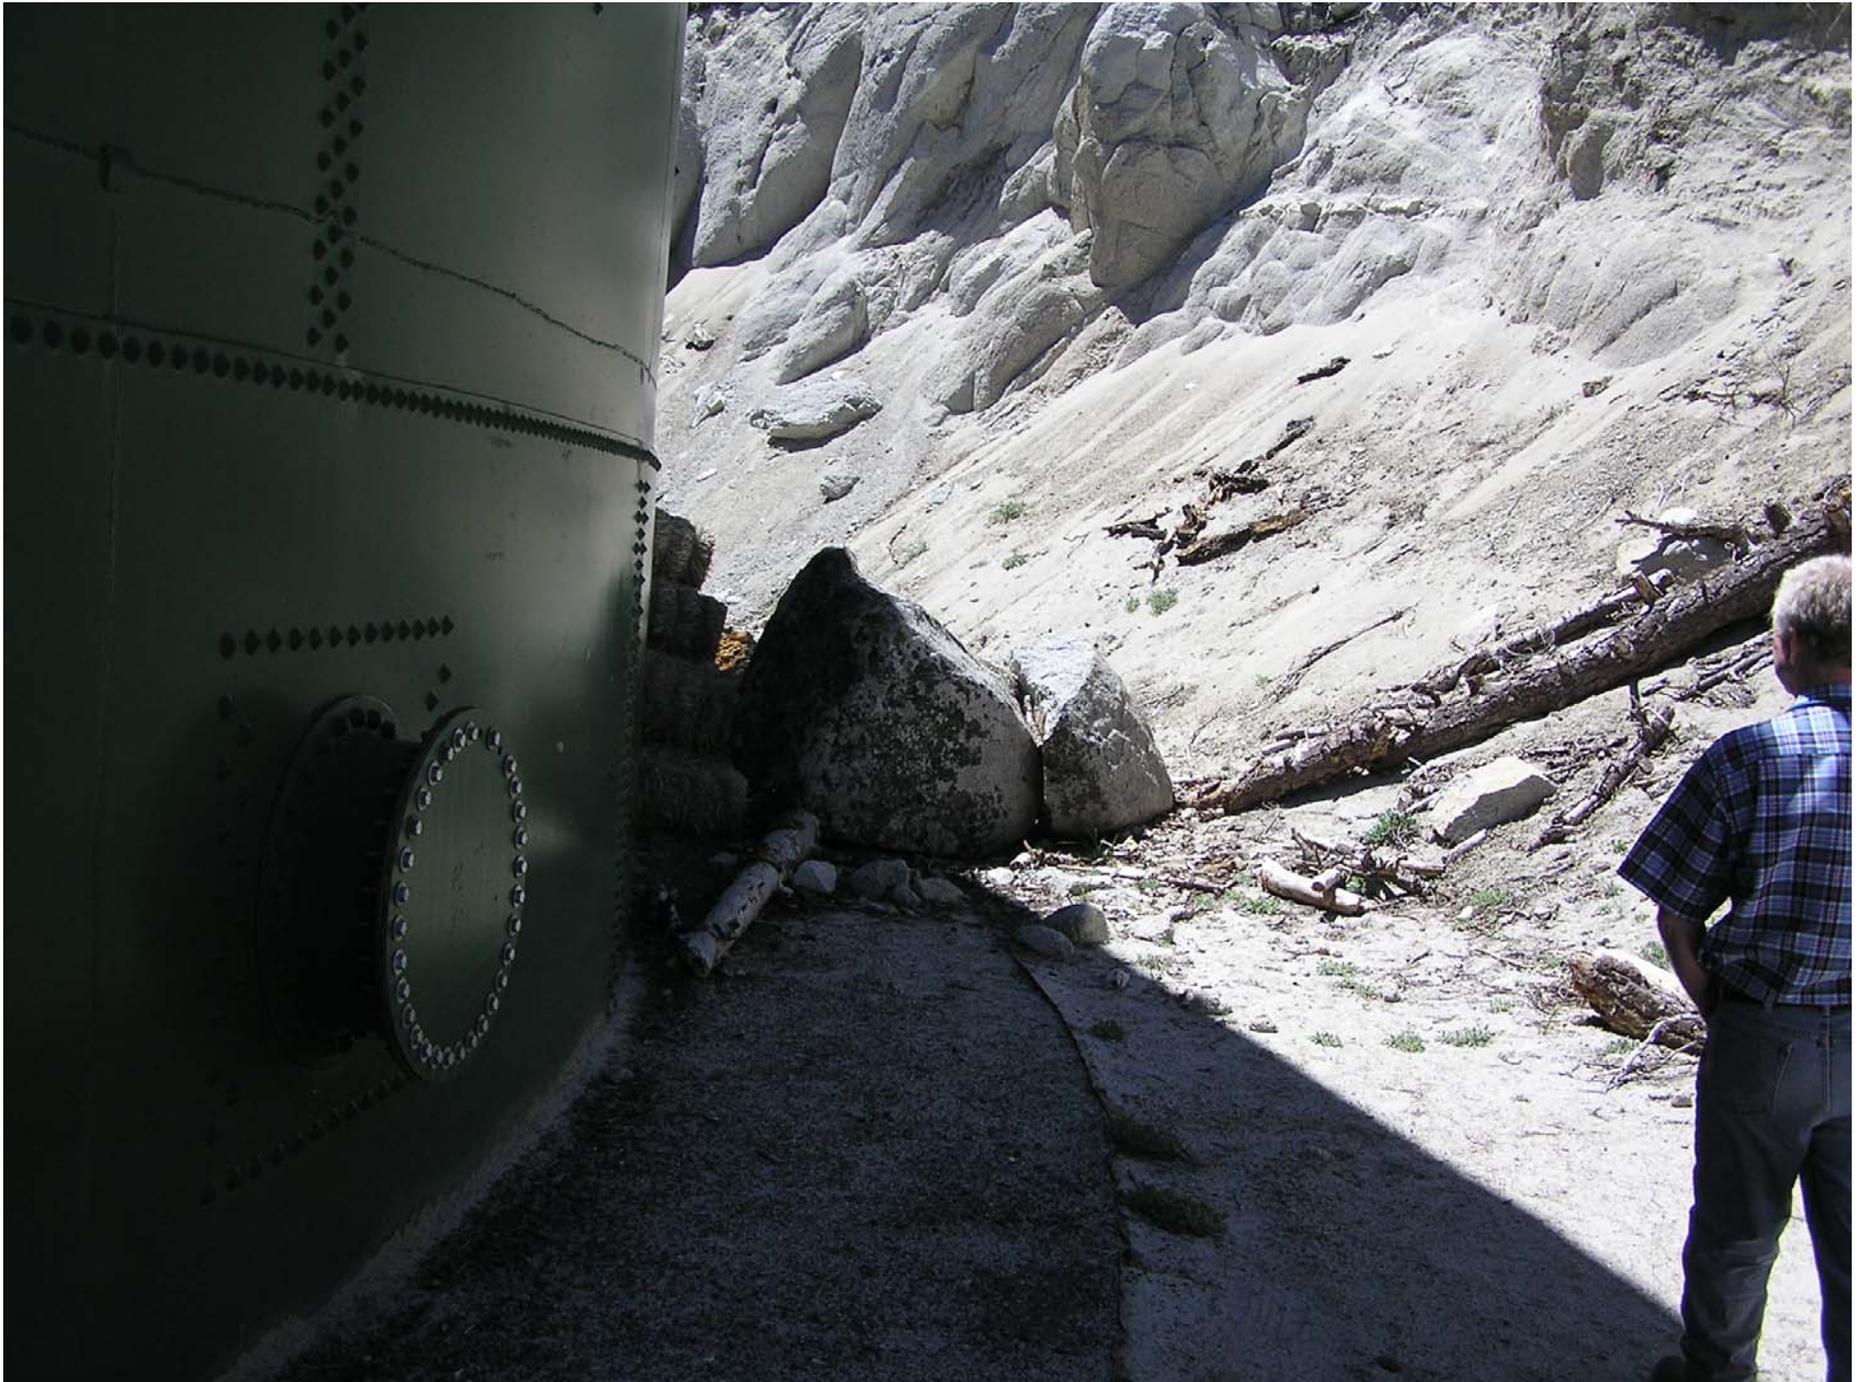
Existing Tank 10A - boulders have fallen from the outcrop above & cause a risk to the integrity of the tank

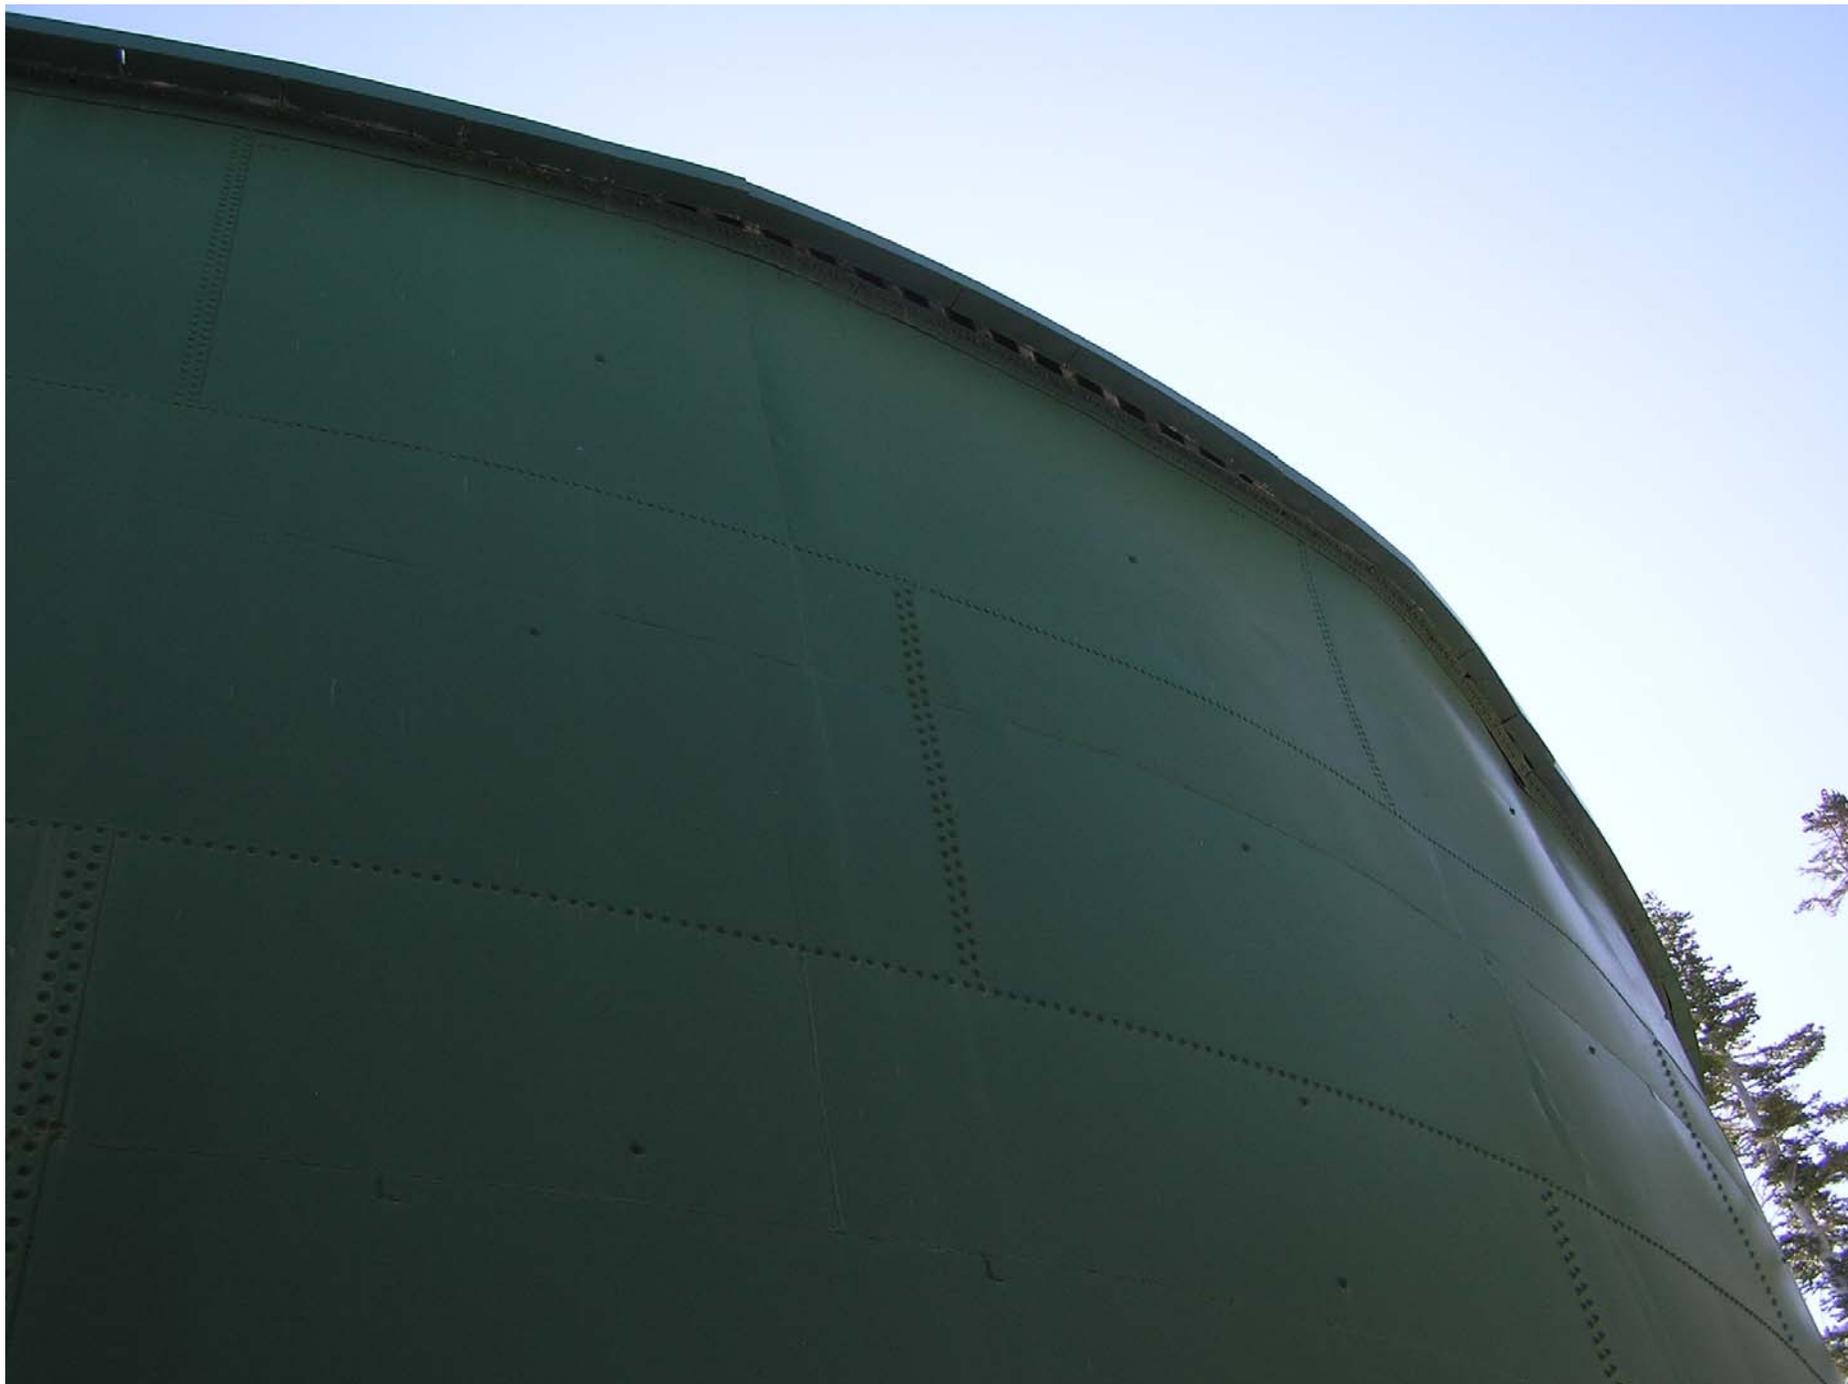
Existing Tank 10A - roof is detached in places allowing foreign material to get into tank

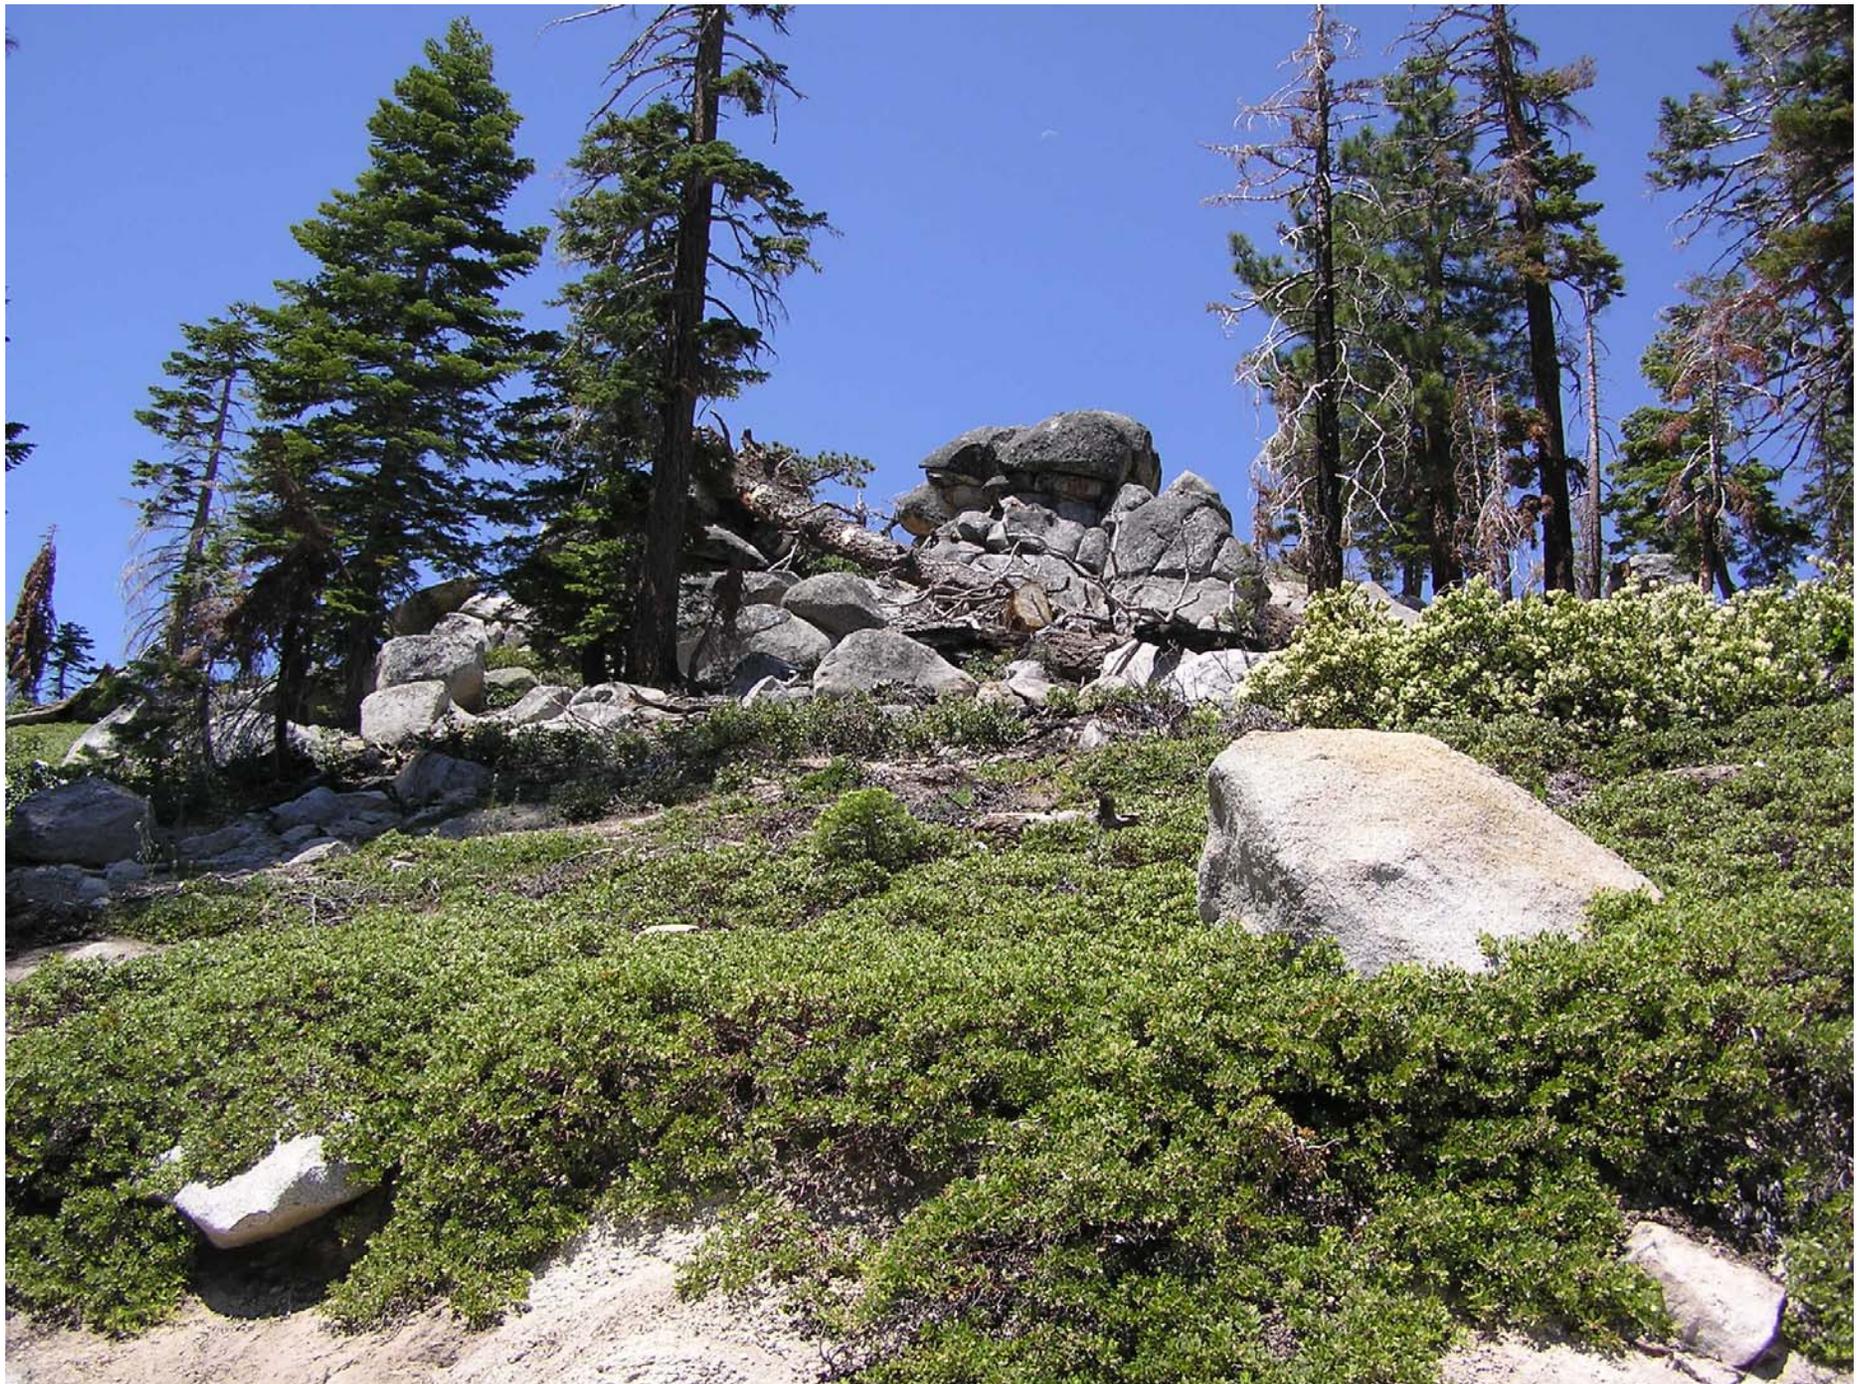
Outcrop above existing Tank 10A

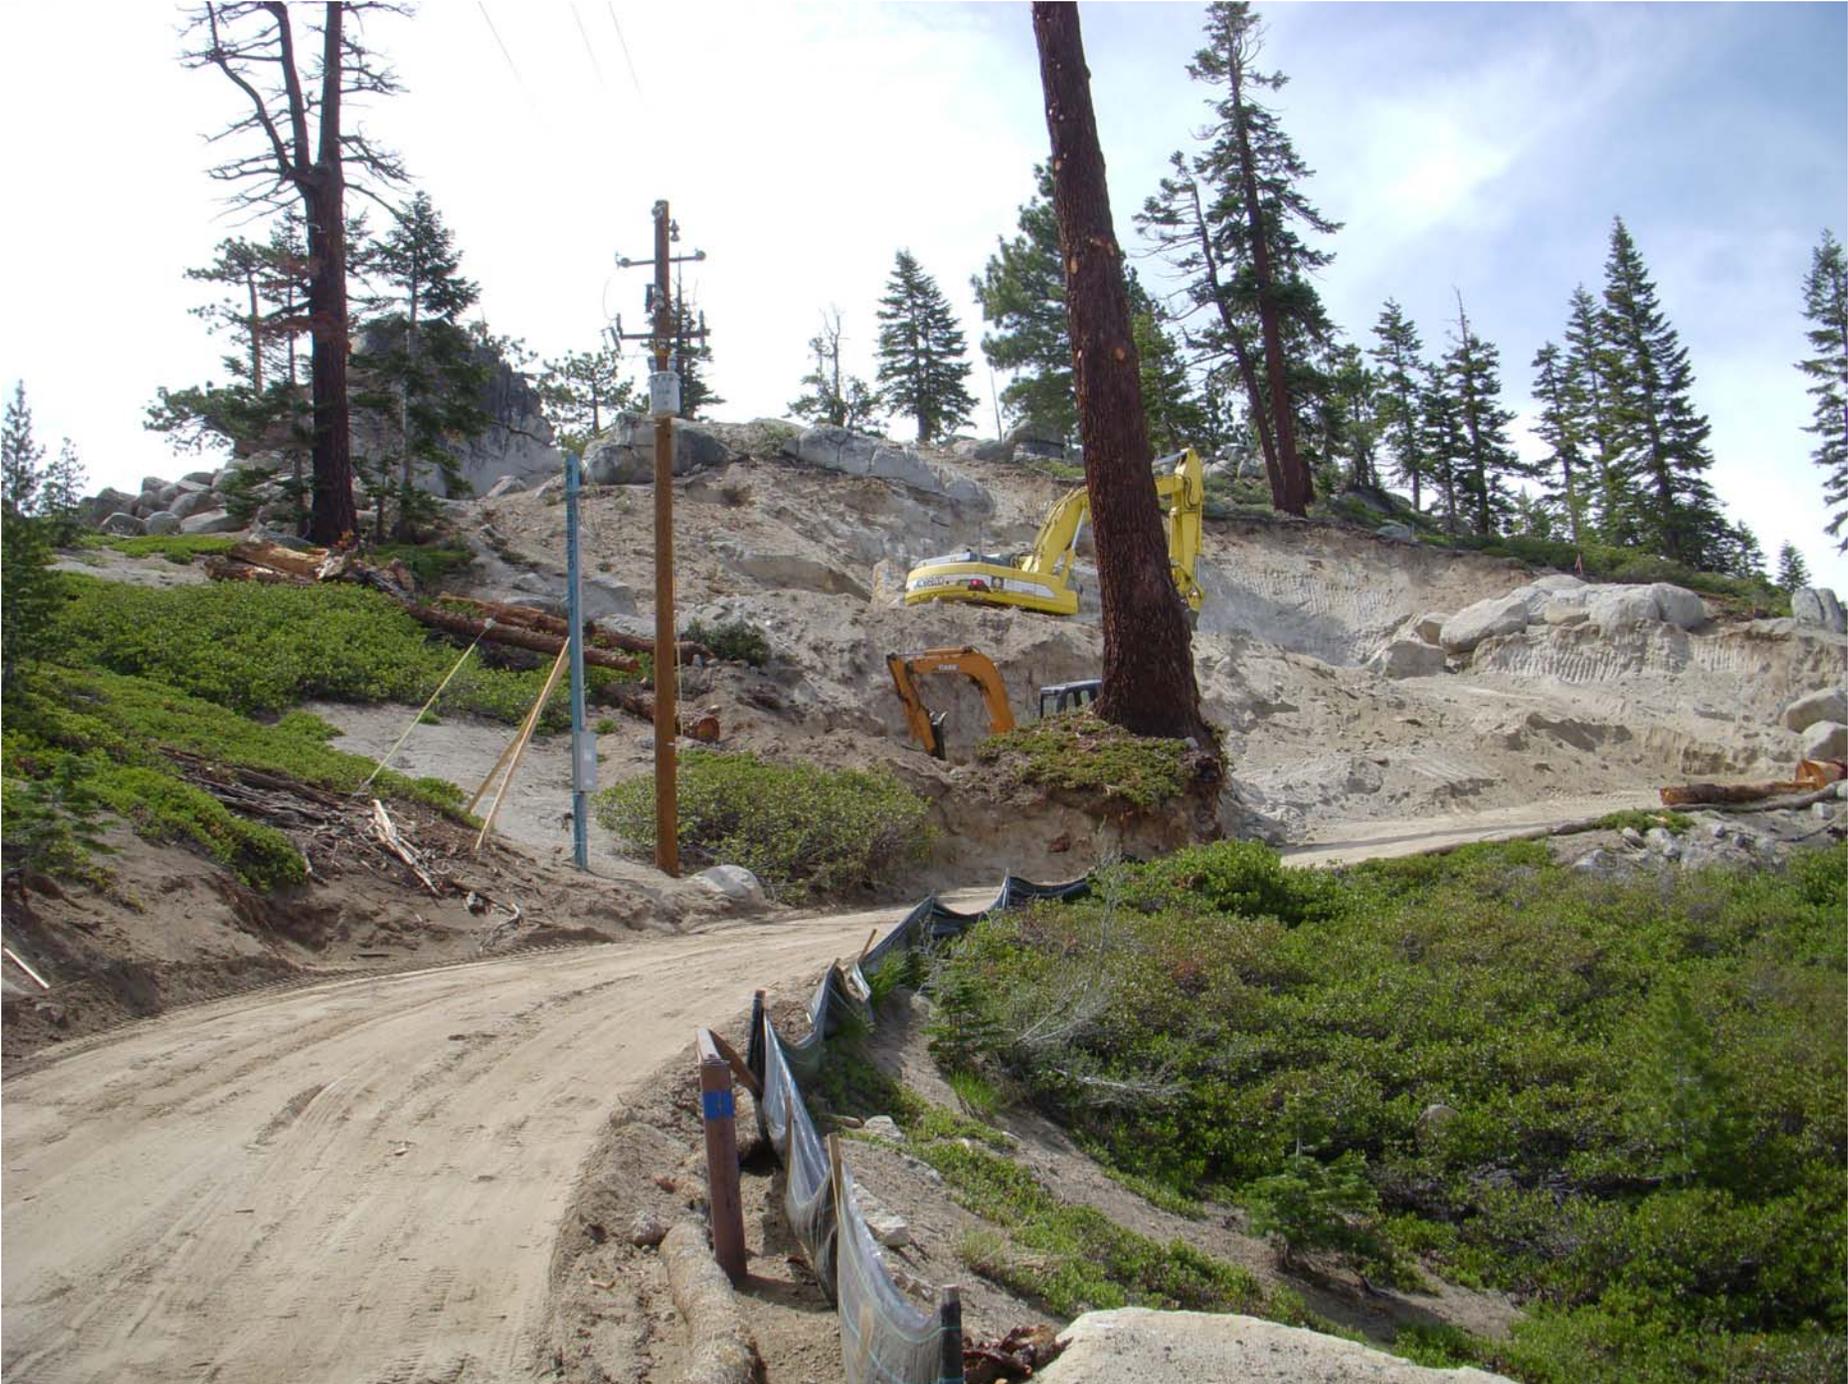
General contractor - Aspen - excavating the site for Tank 10B next to existing Tank 10A

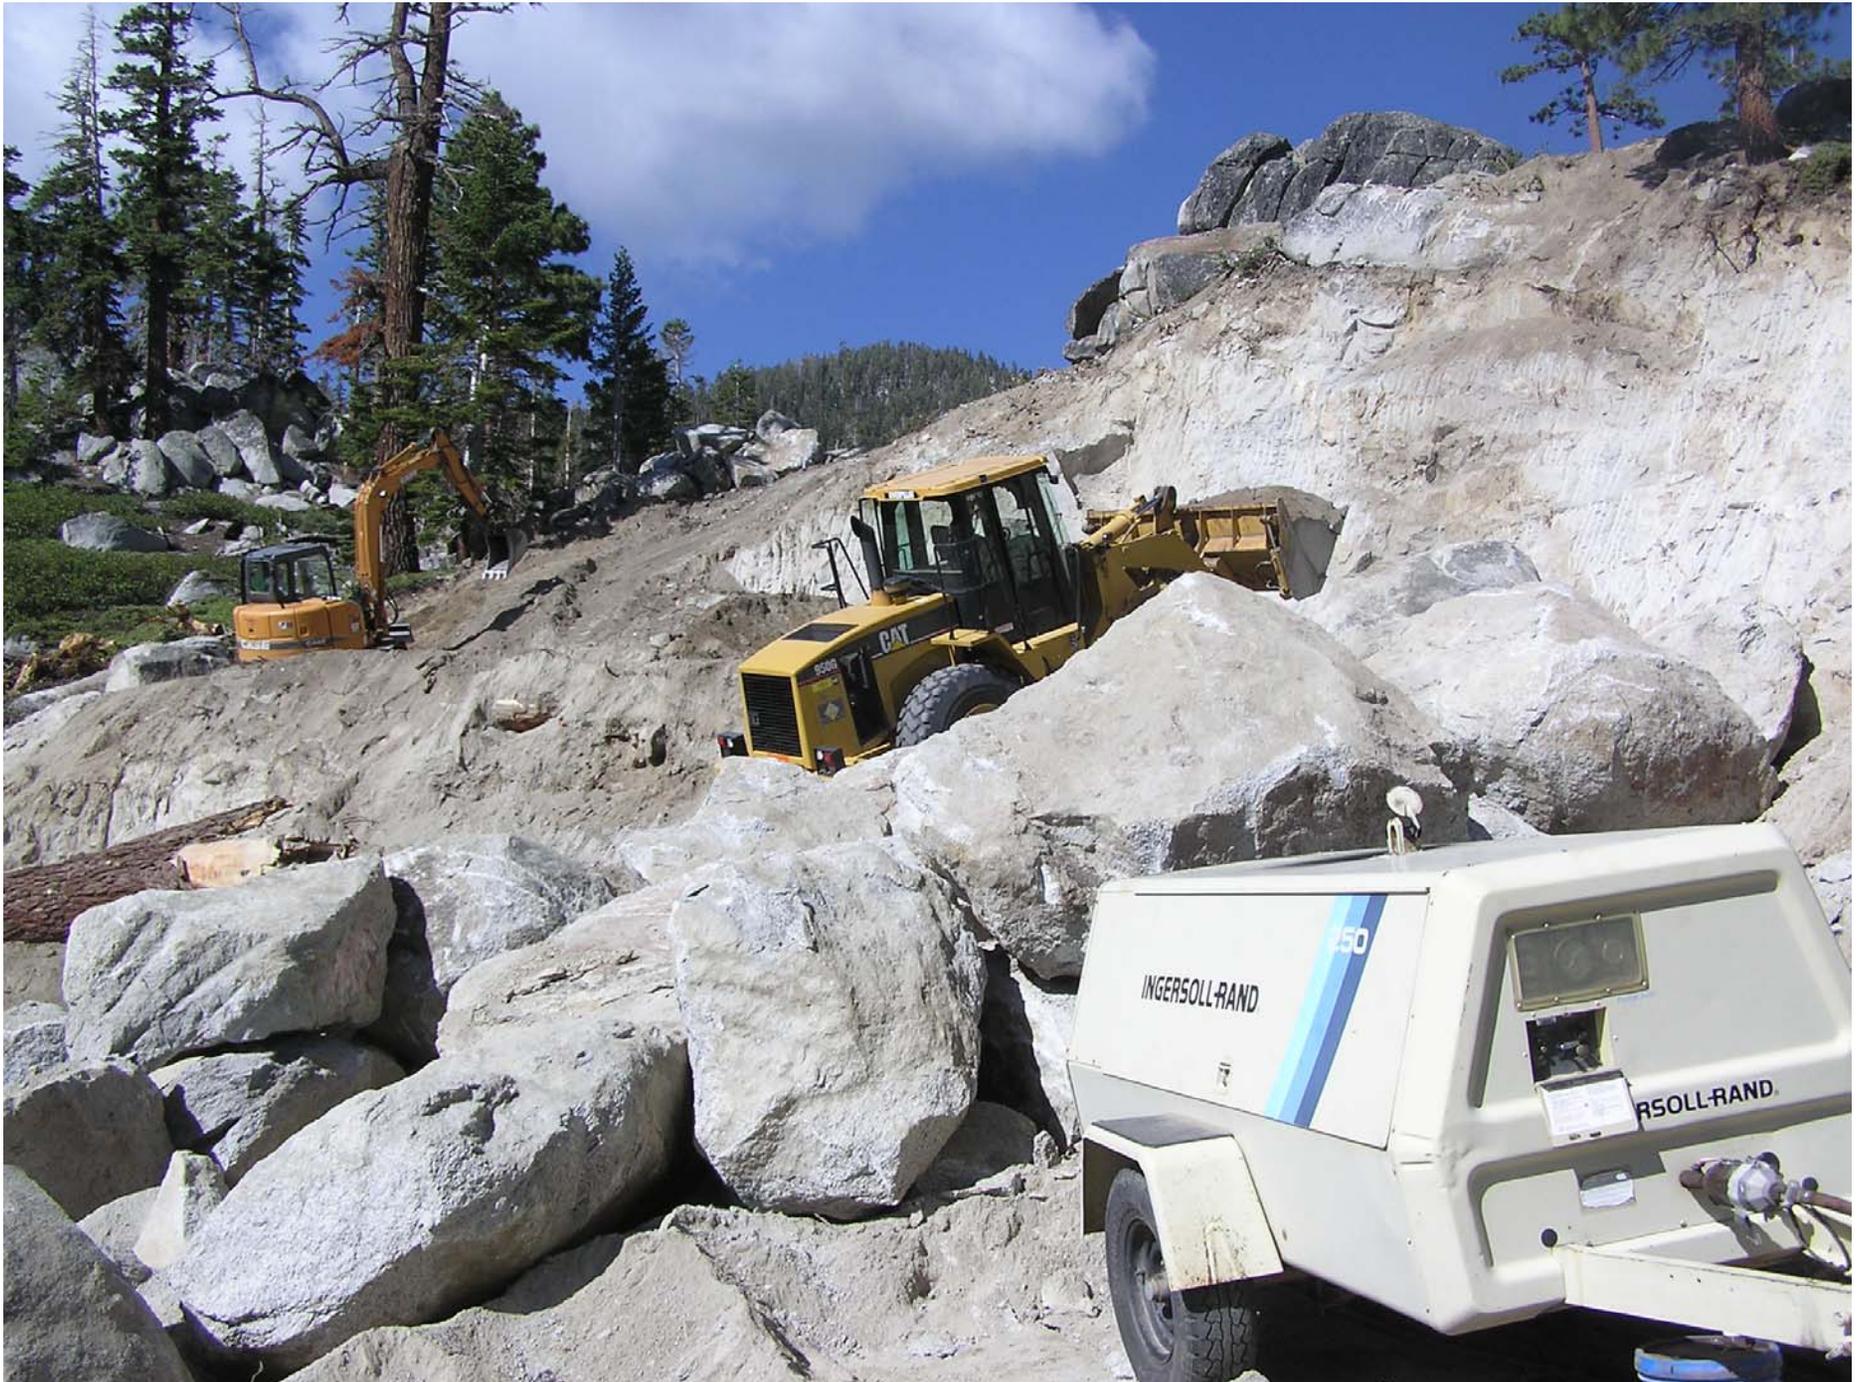
General contractor - Aspen - excavating the site for Tank 10B - a considerable amount of granite was removed from the hillside

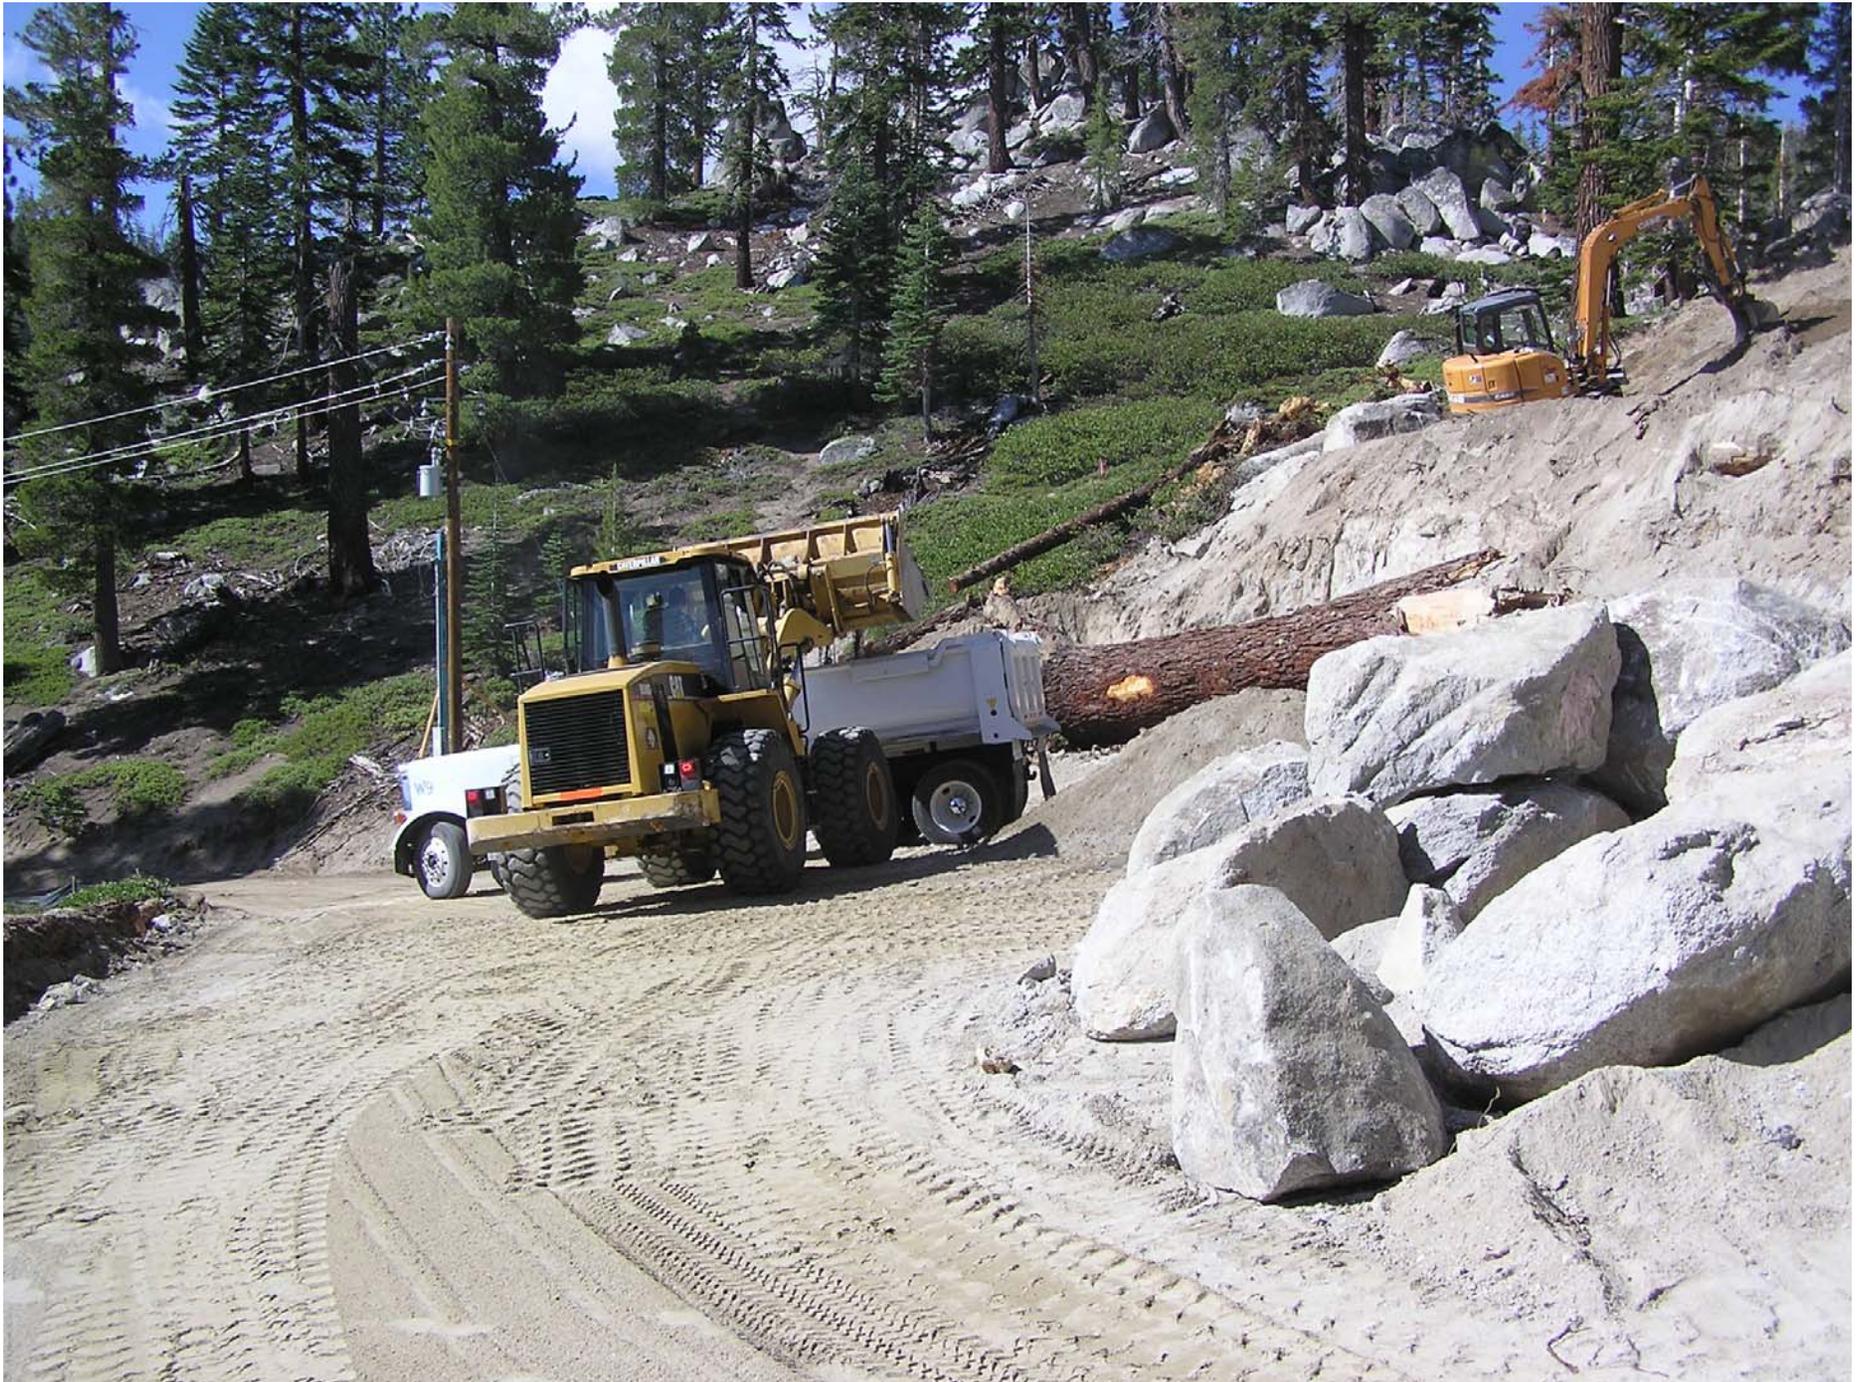
General contractor - Aspen - excavating the site for Tank 10B - several trees were also removed

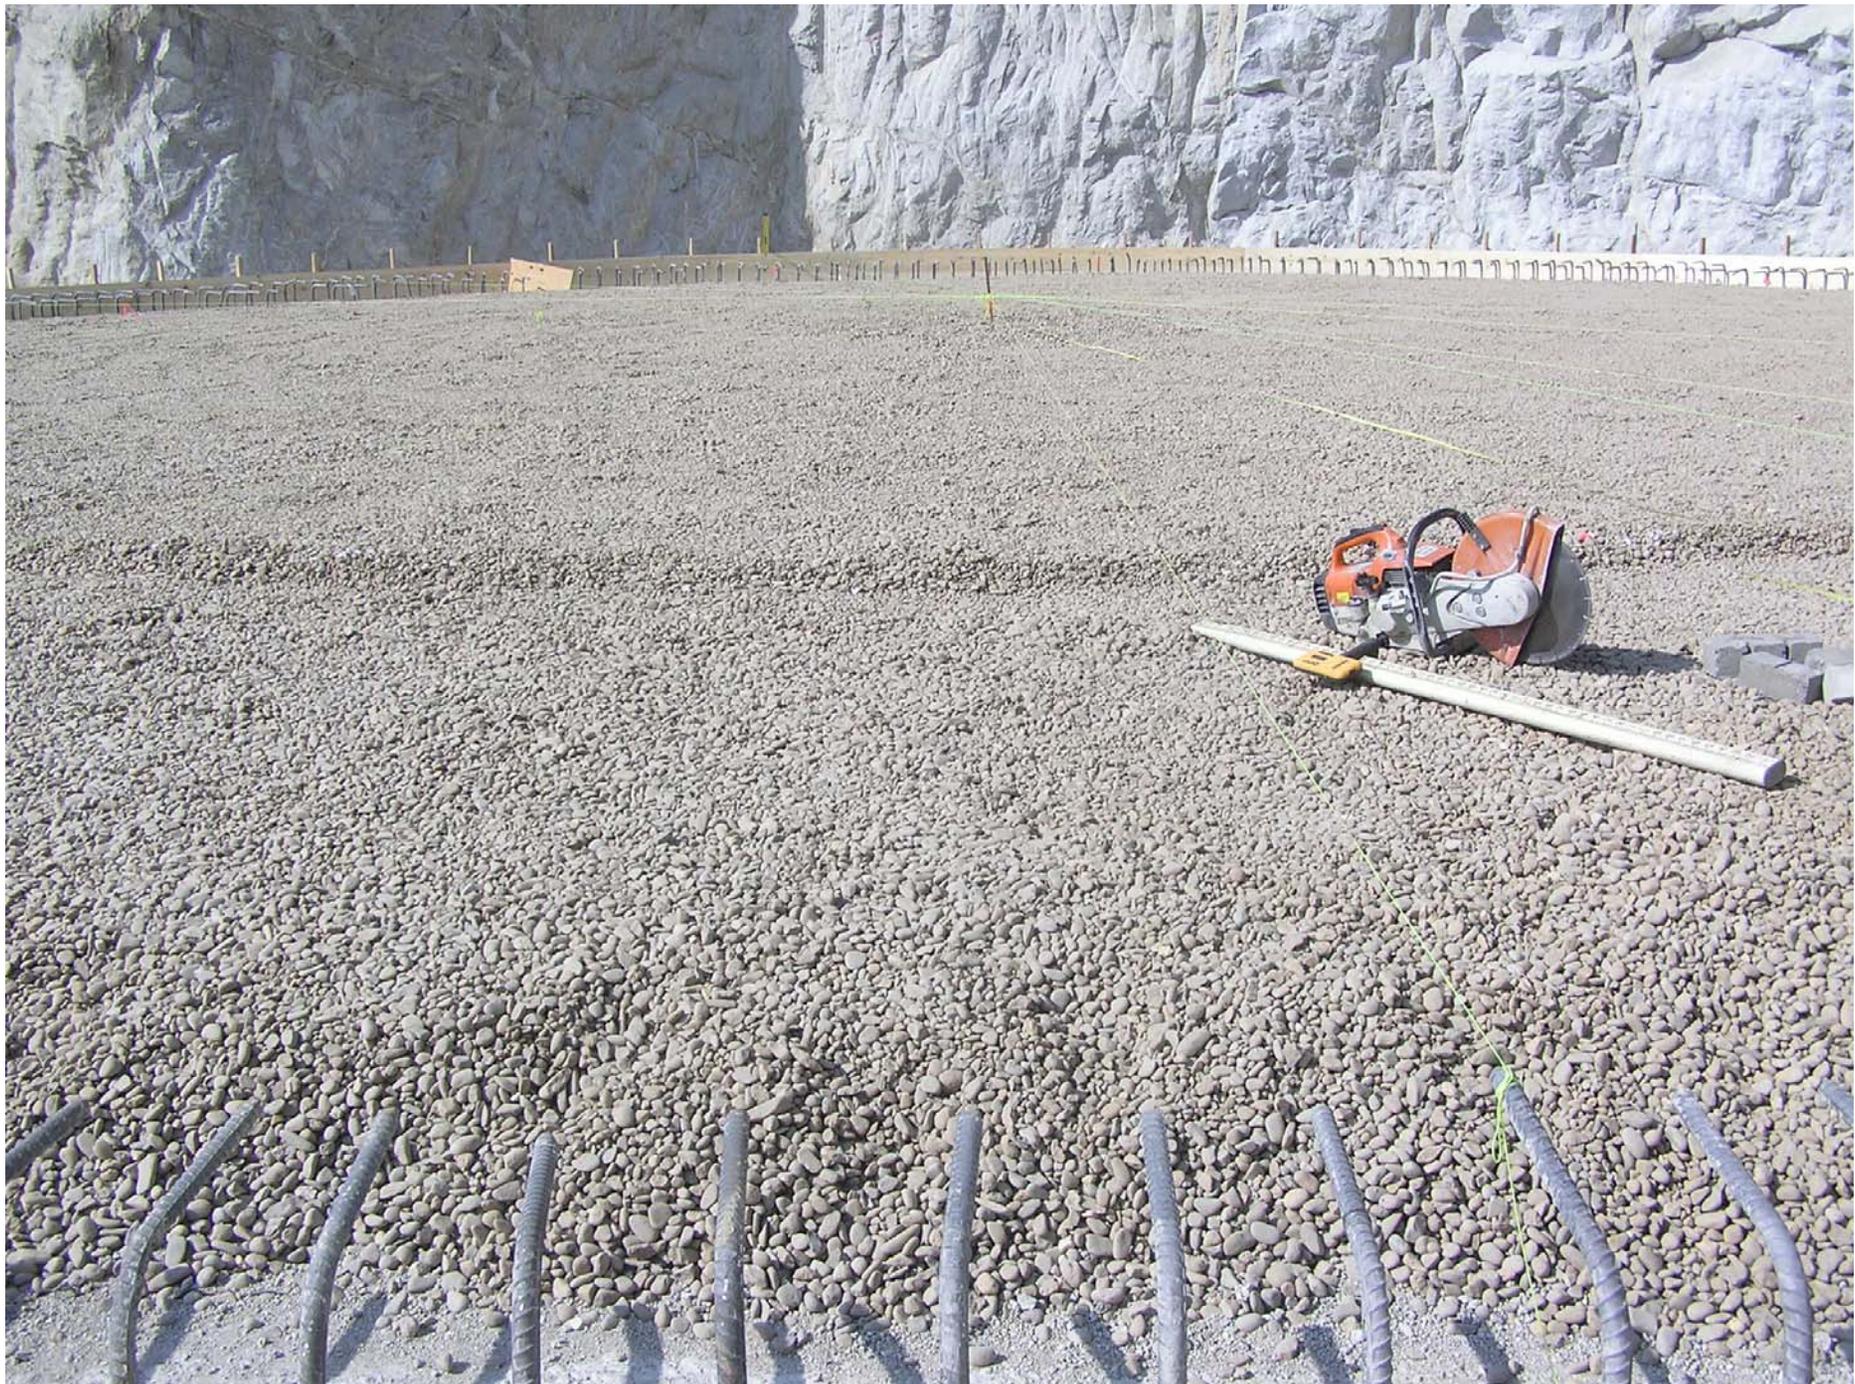
Subcontractor - Natgun - concrete footer ring poured & foundation prepared

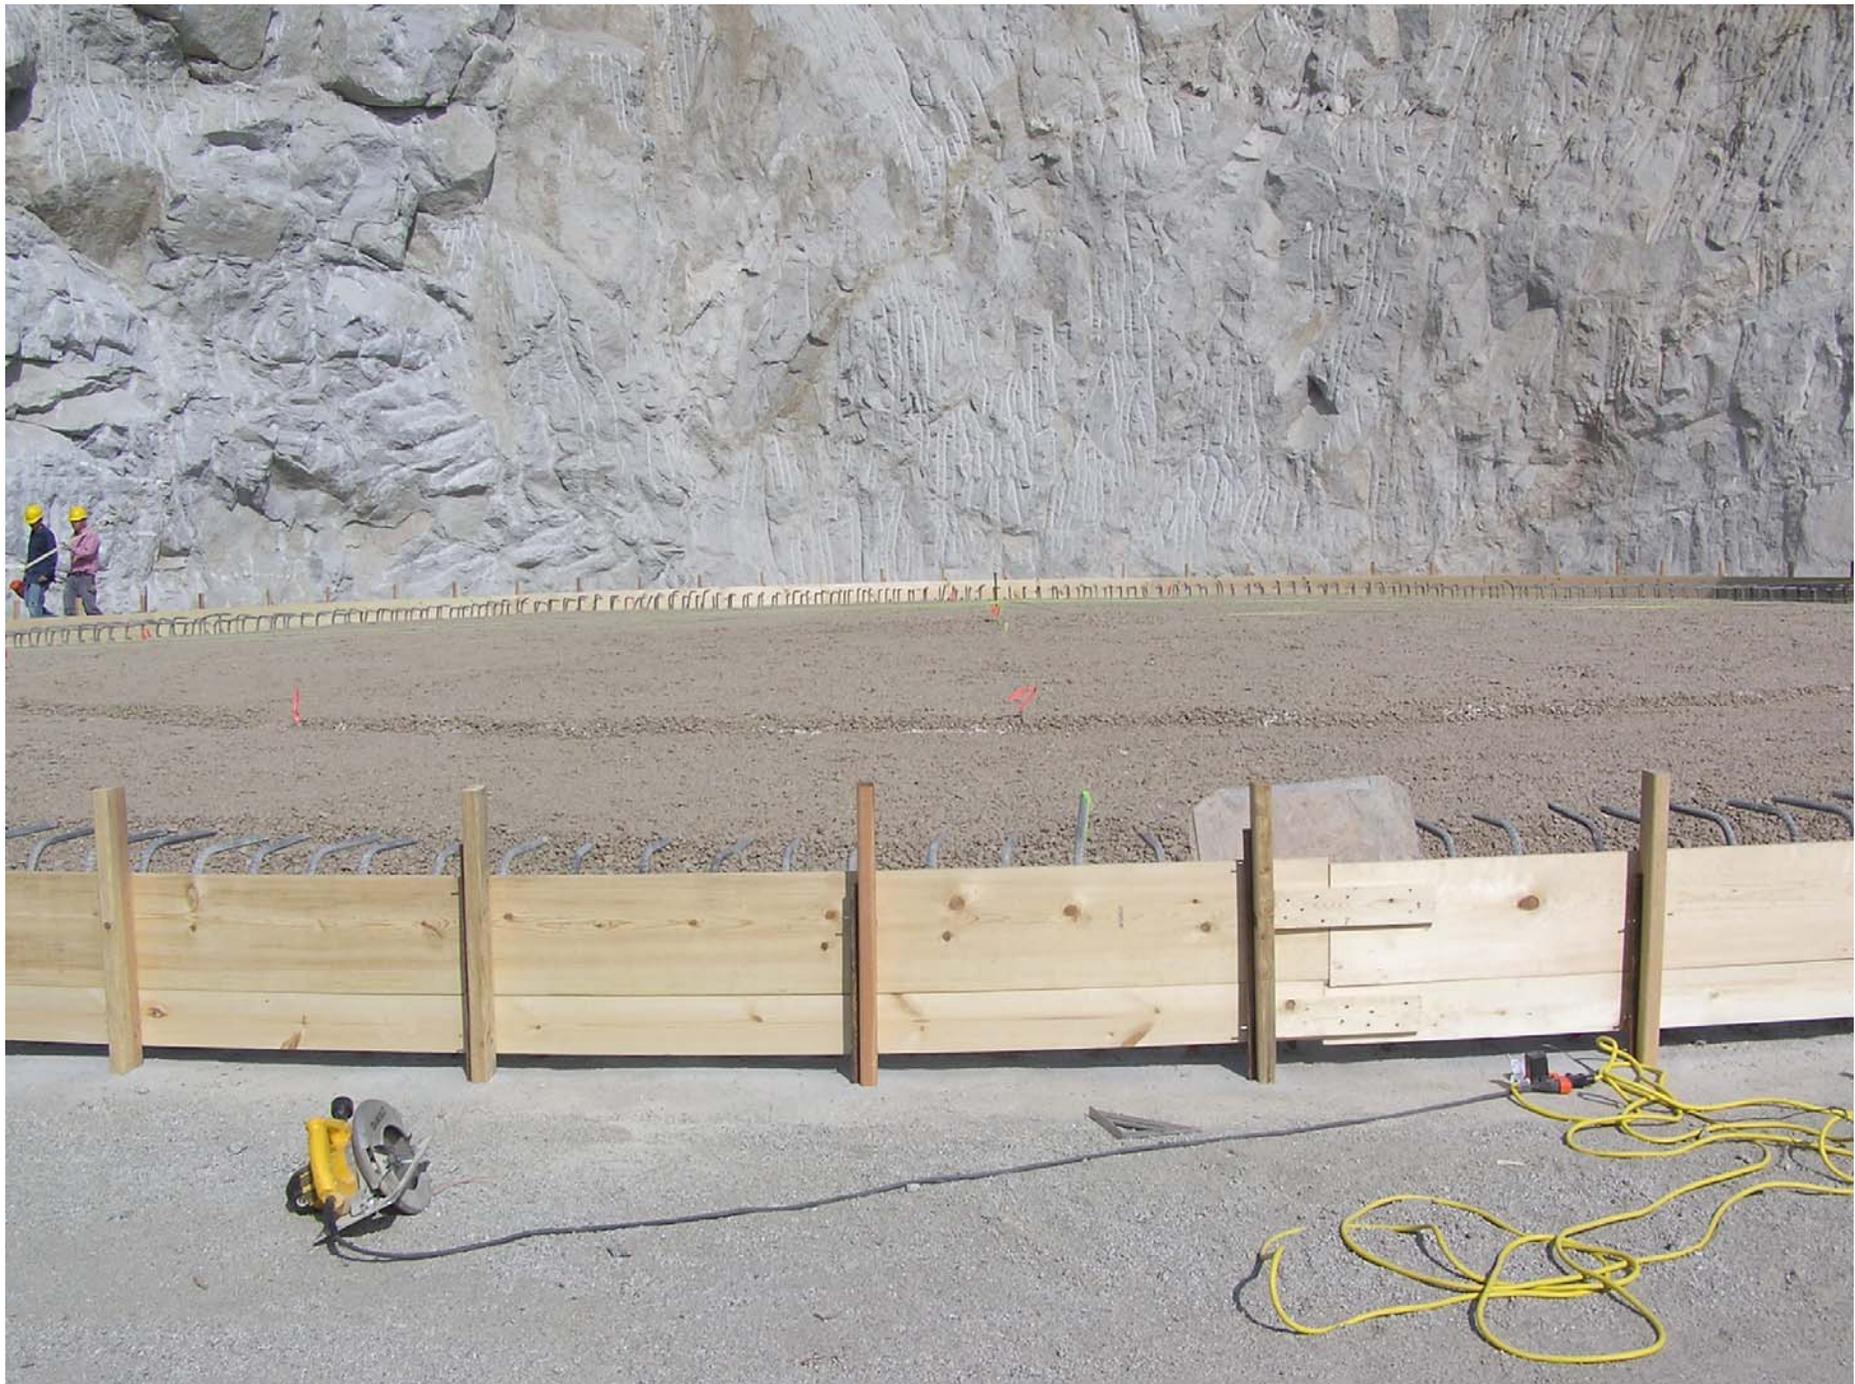
Subcontractor - Natgun - foundation prep
