Existing Tank 10A

Completed Tank 10B next to existing Tank 10A

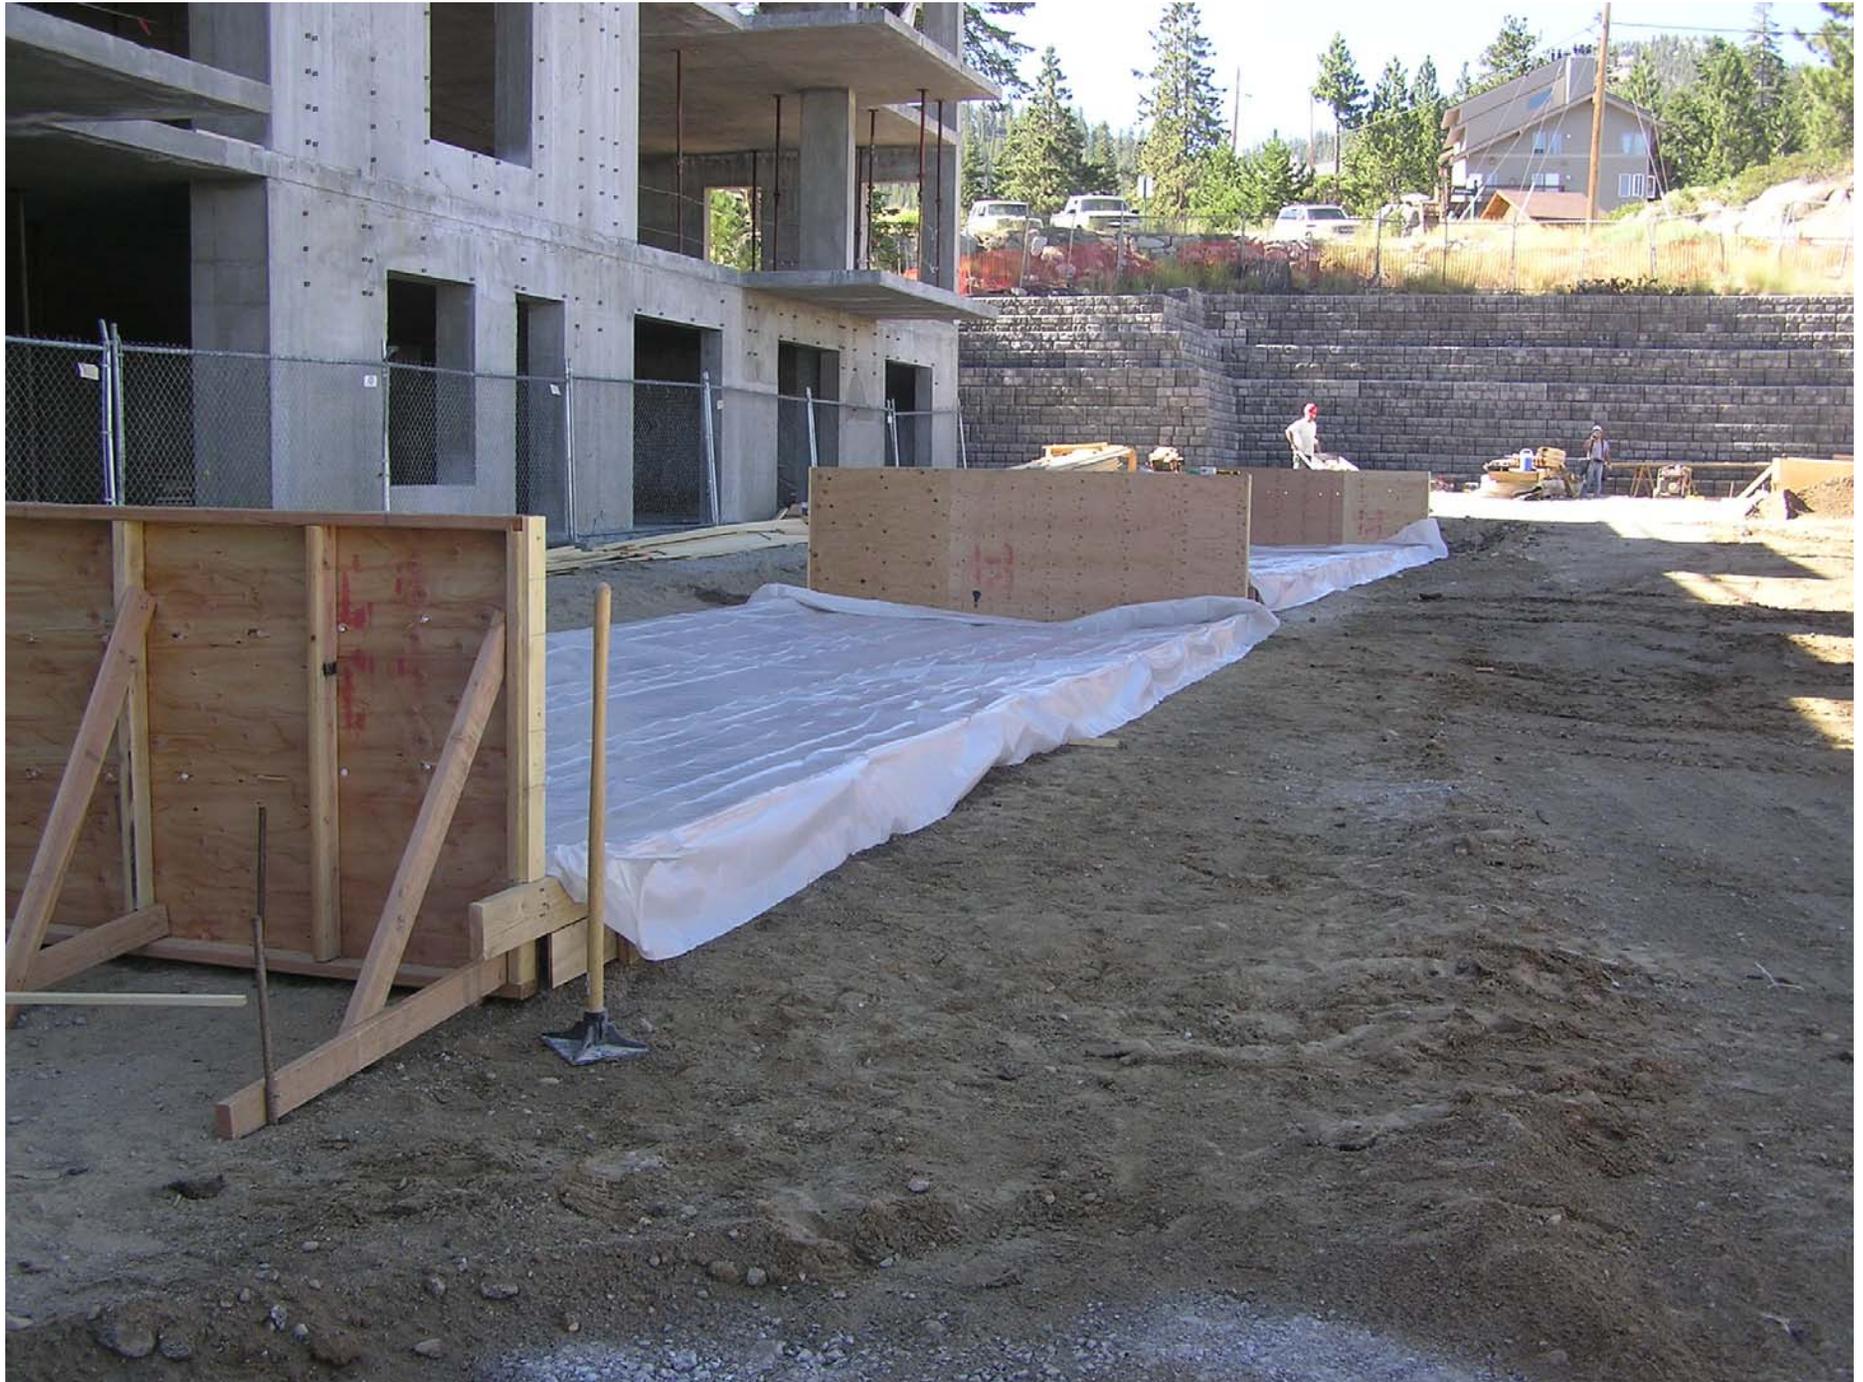
Subcontractor - Natgun - concurrently poured wall and dome panels at a nearby site in custom-built "stack" casting beds

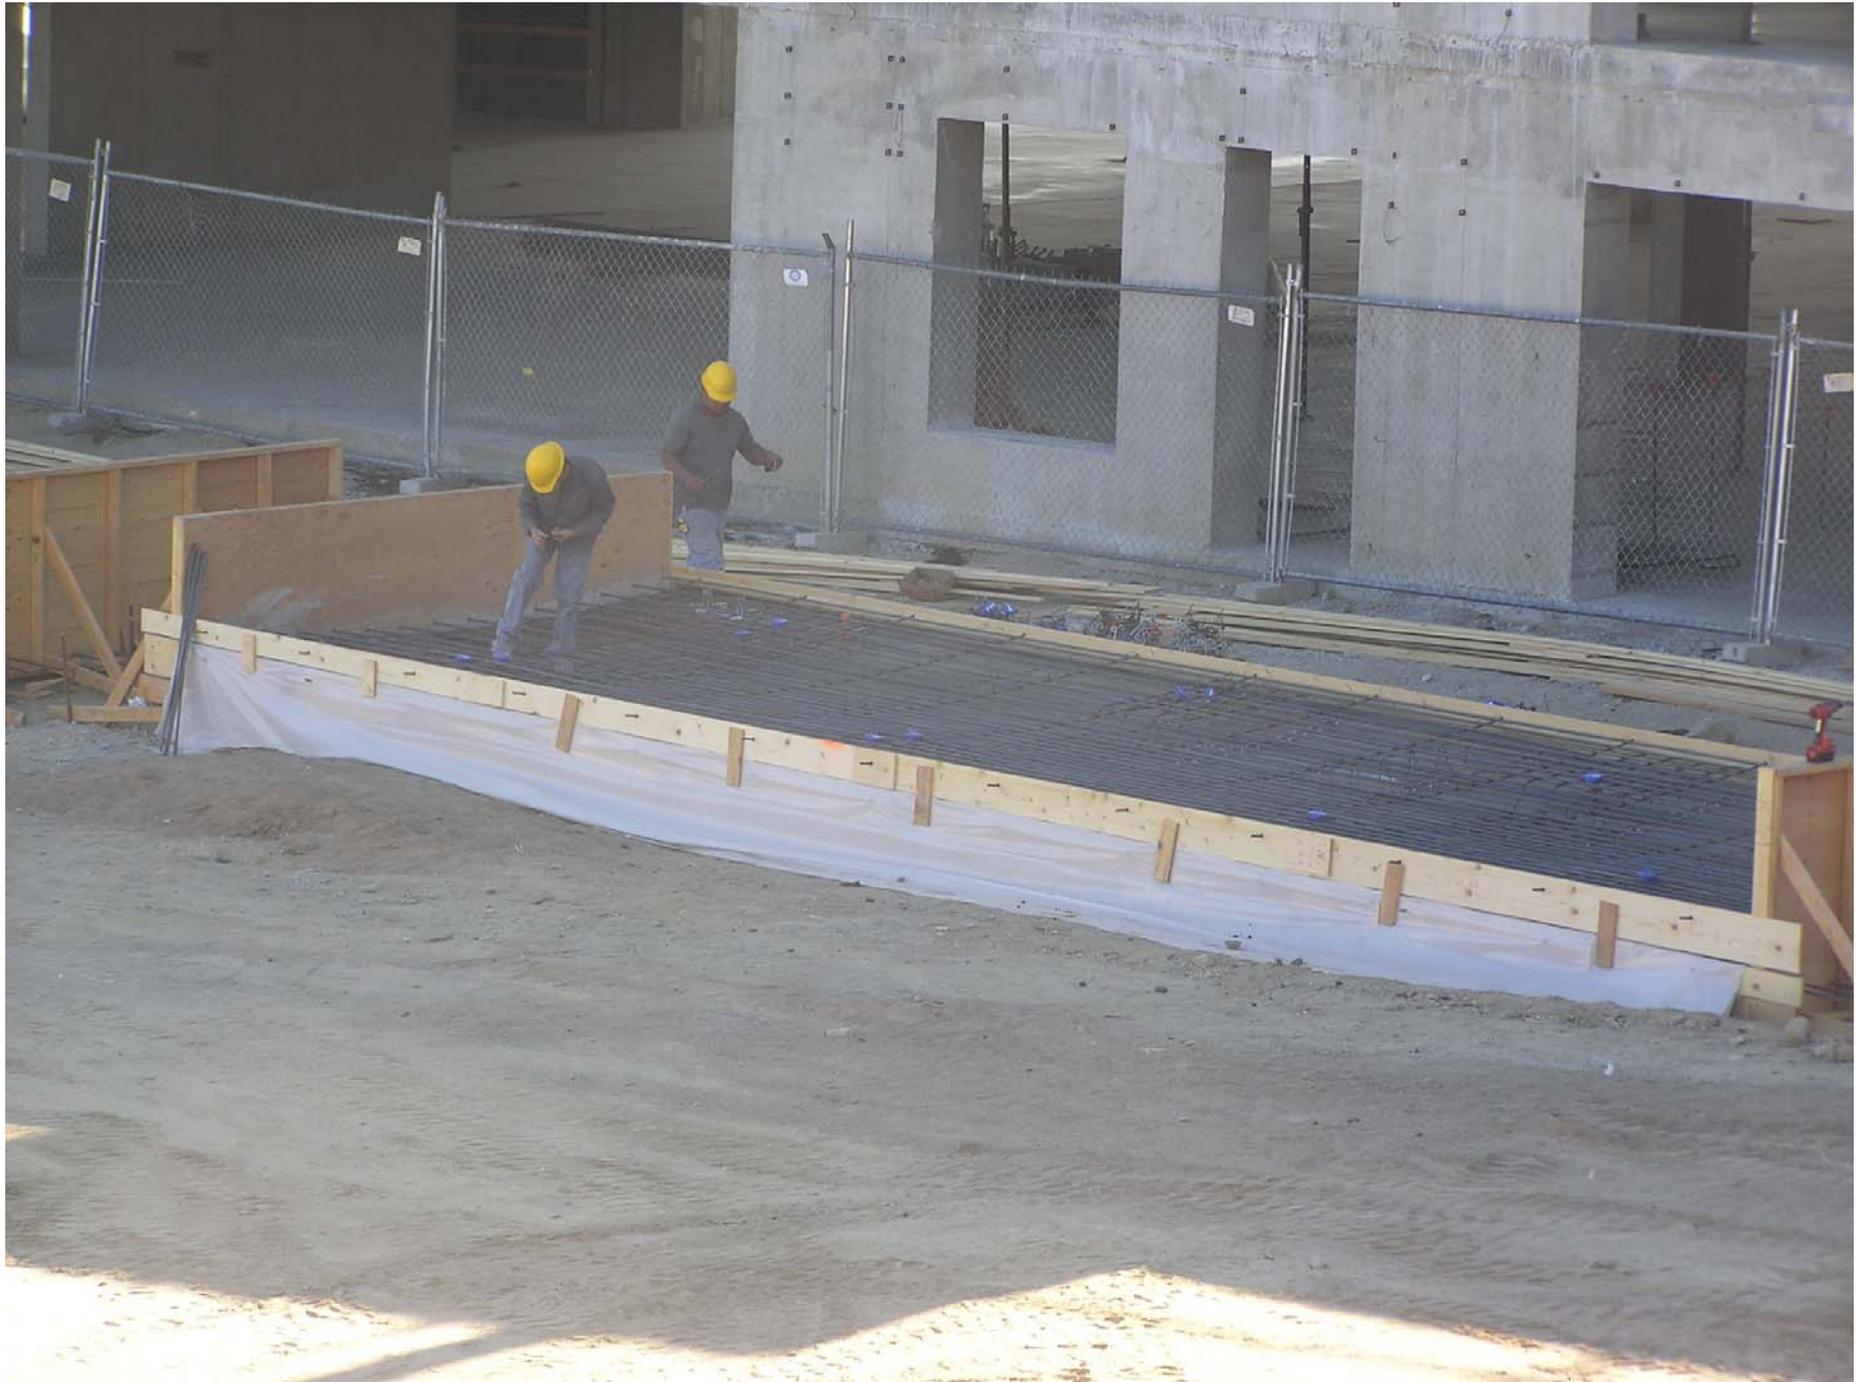
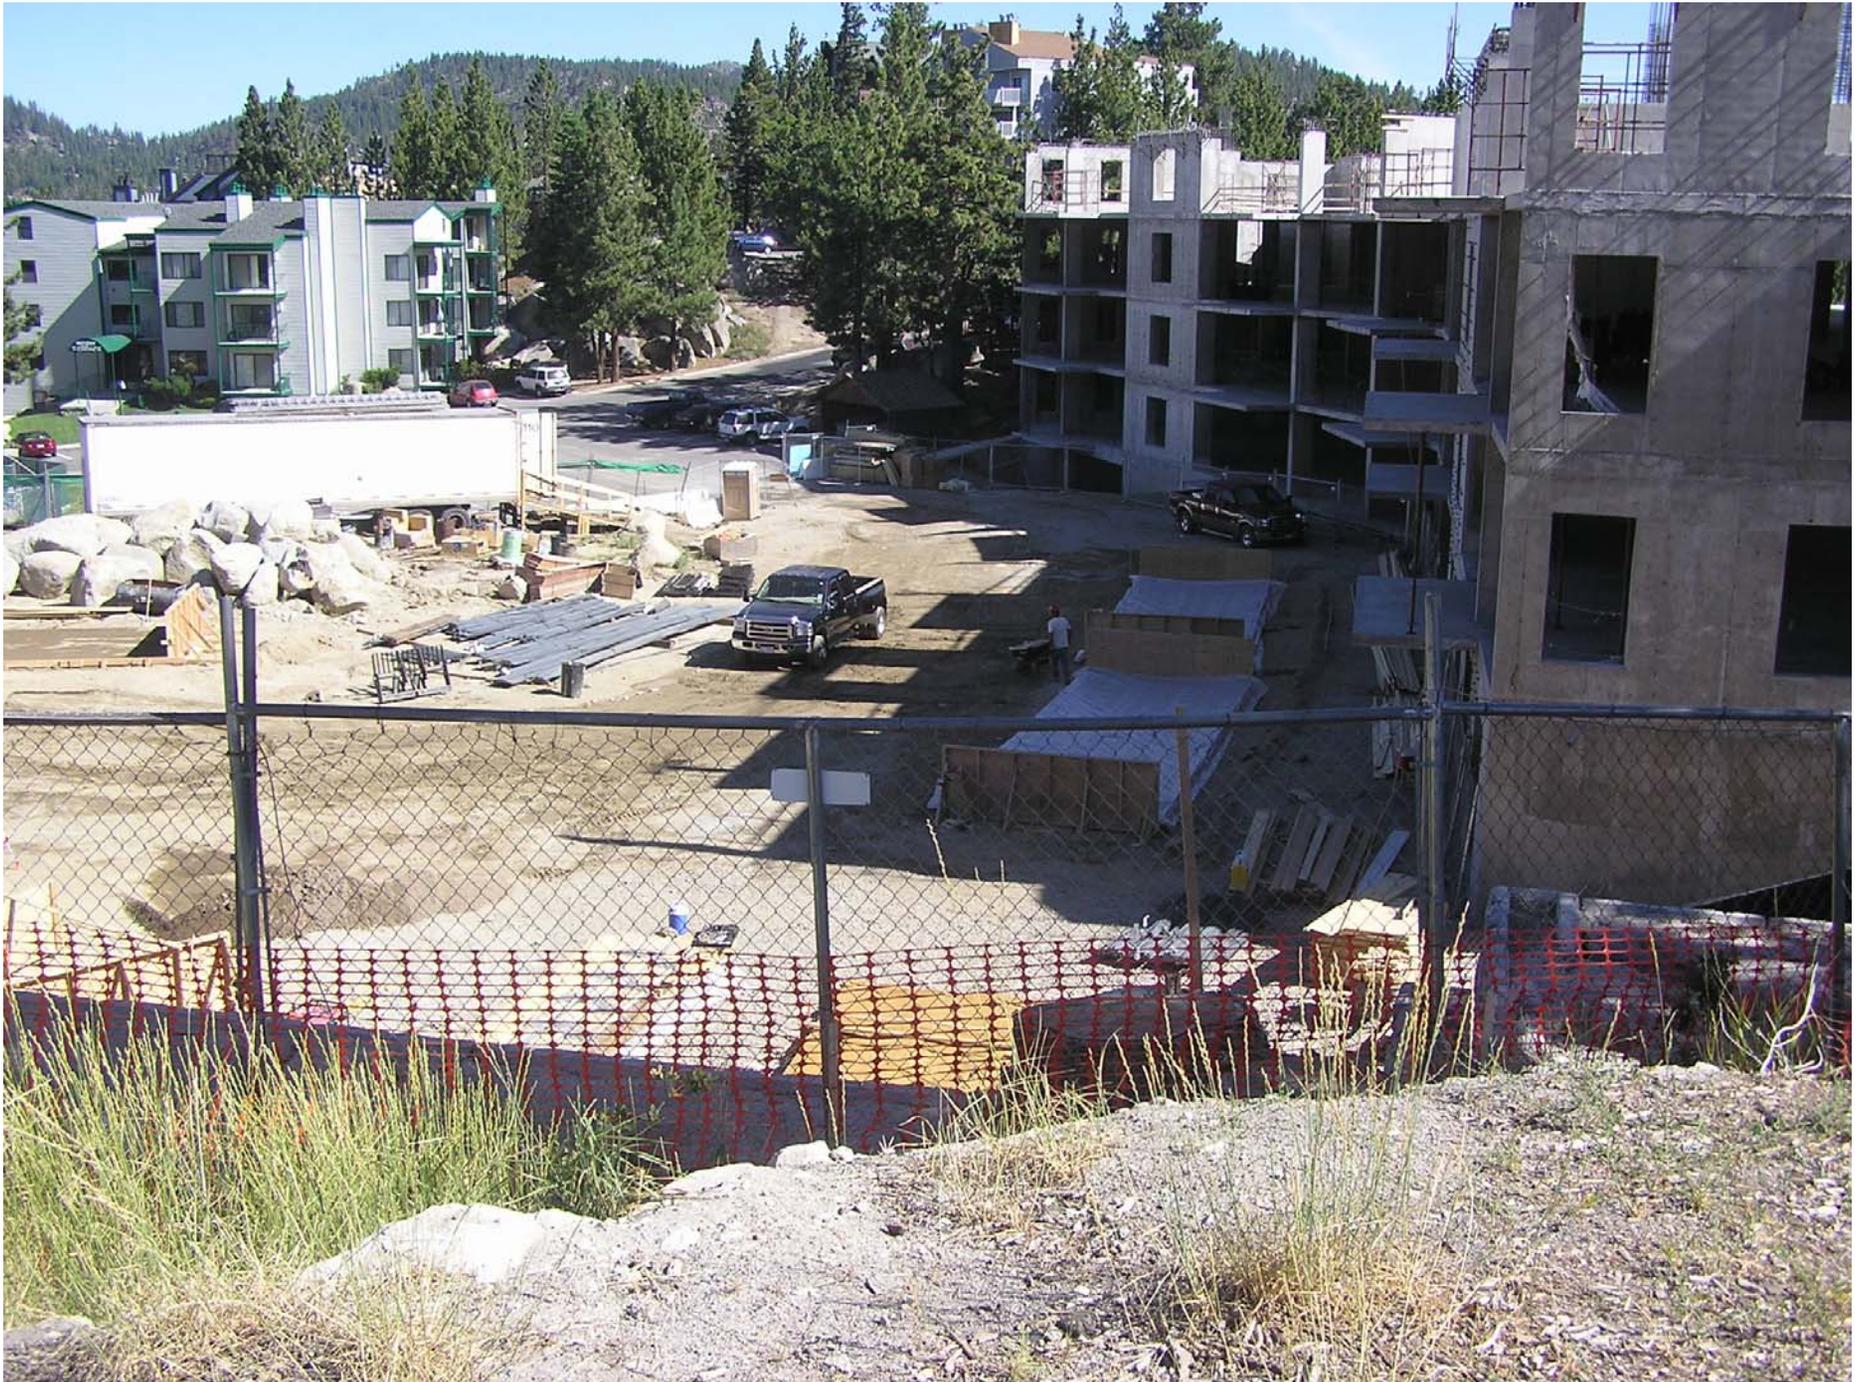
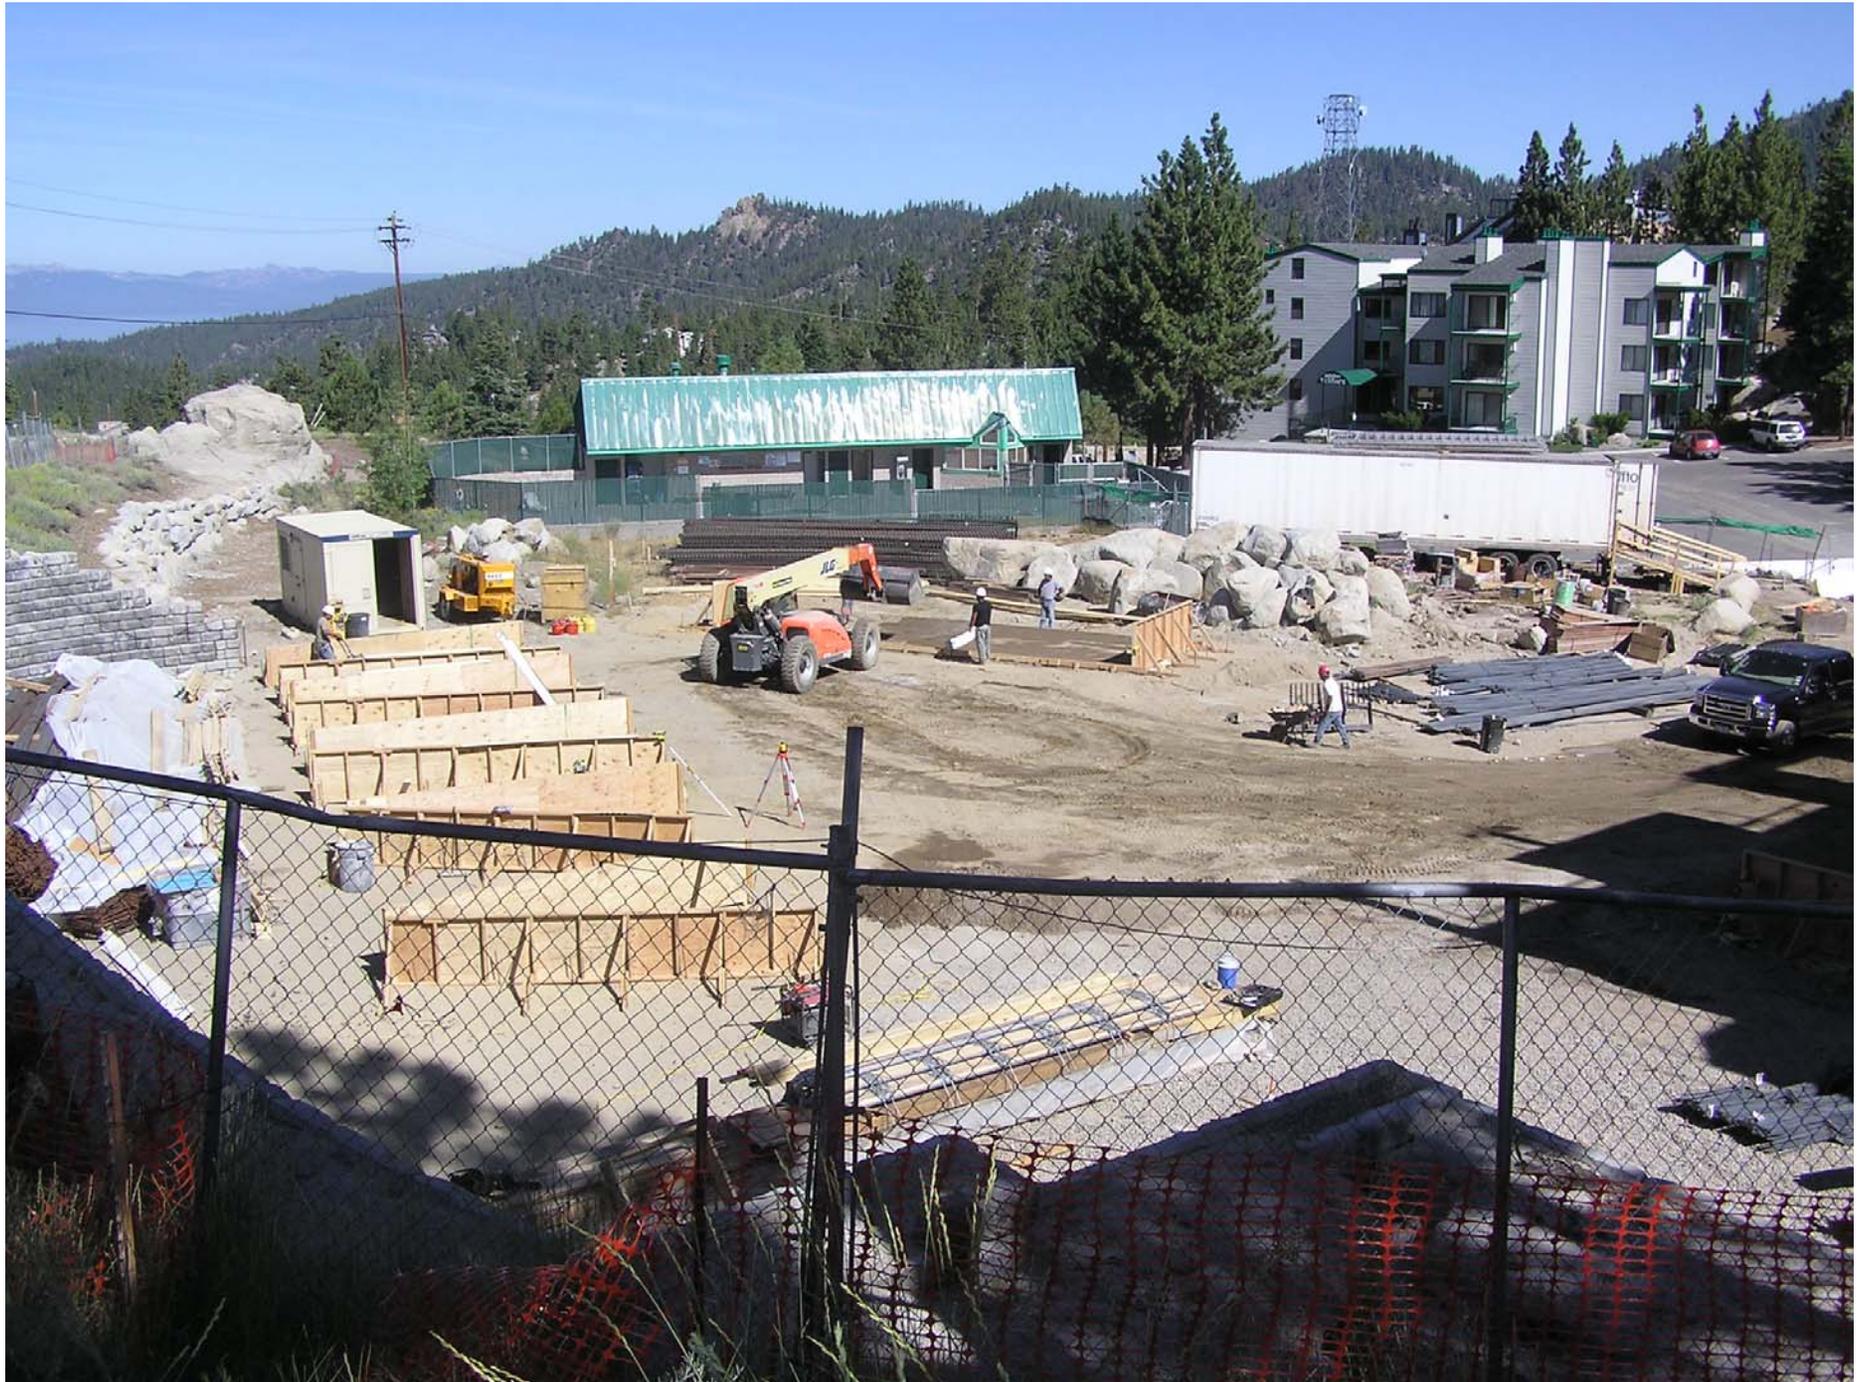
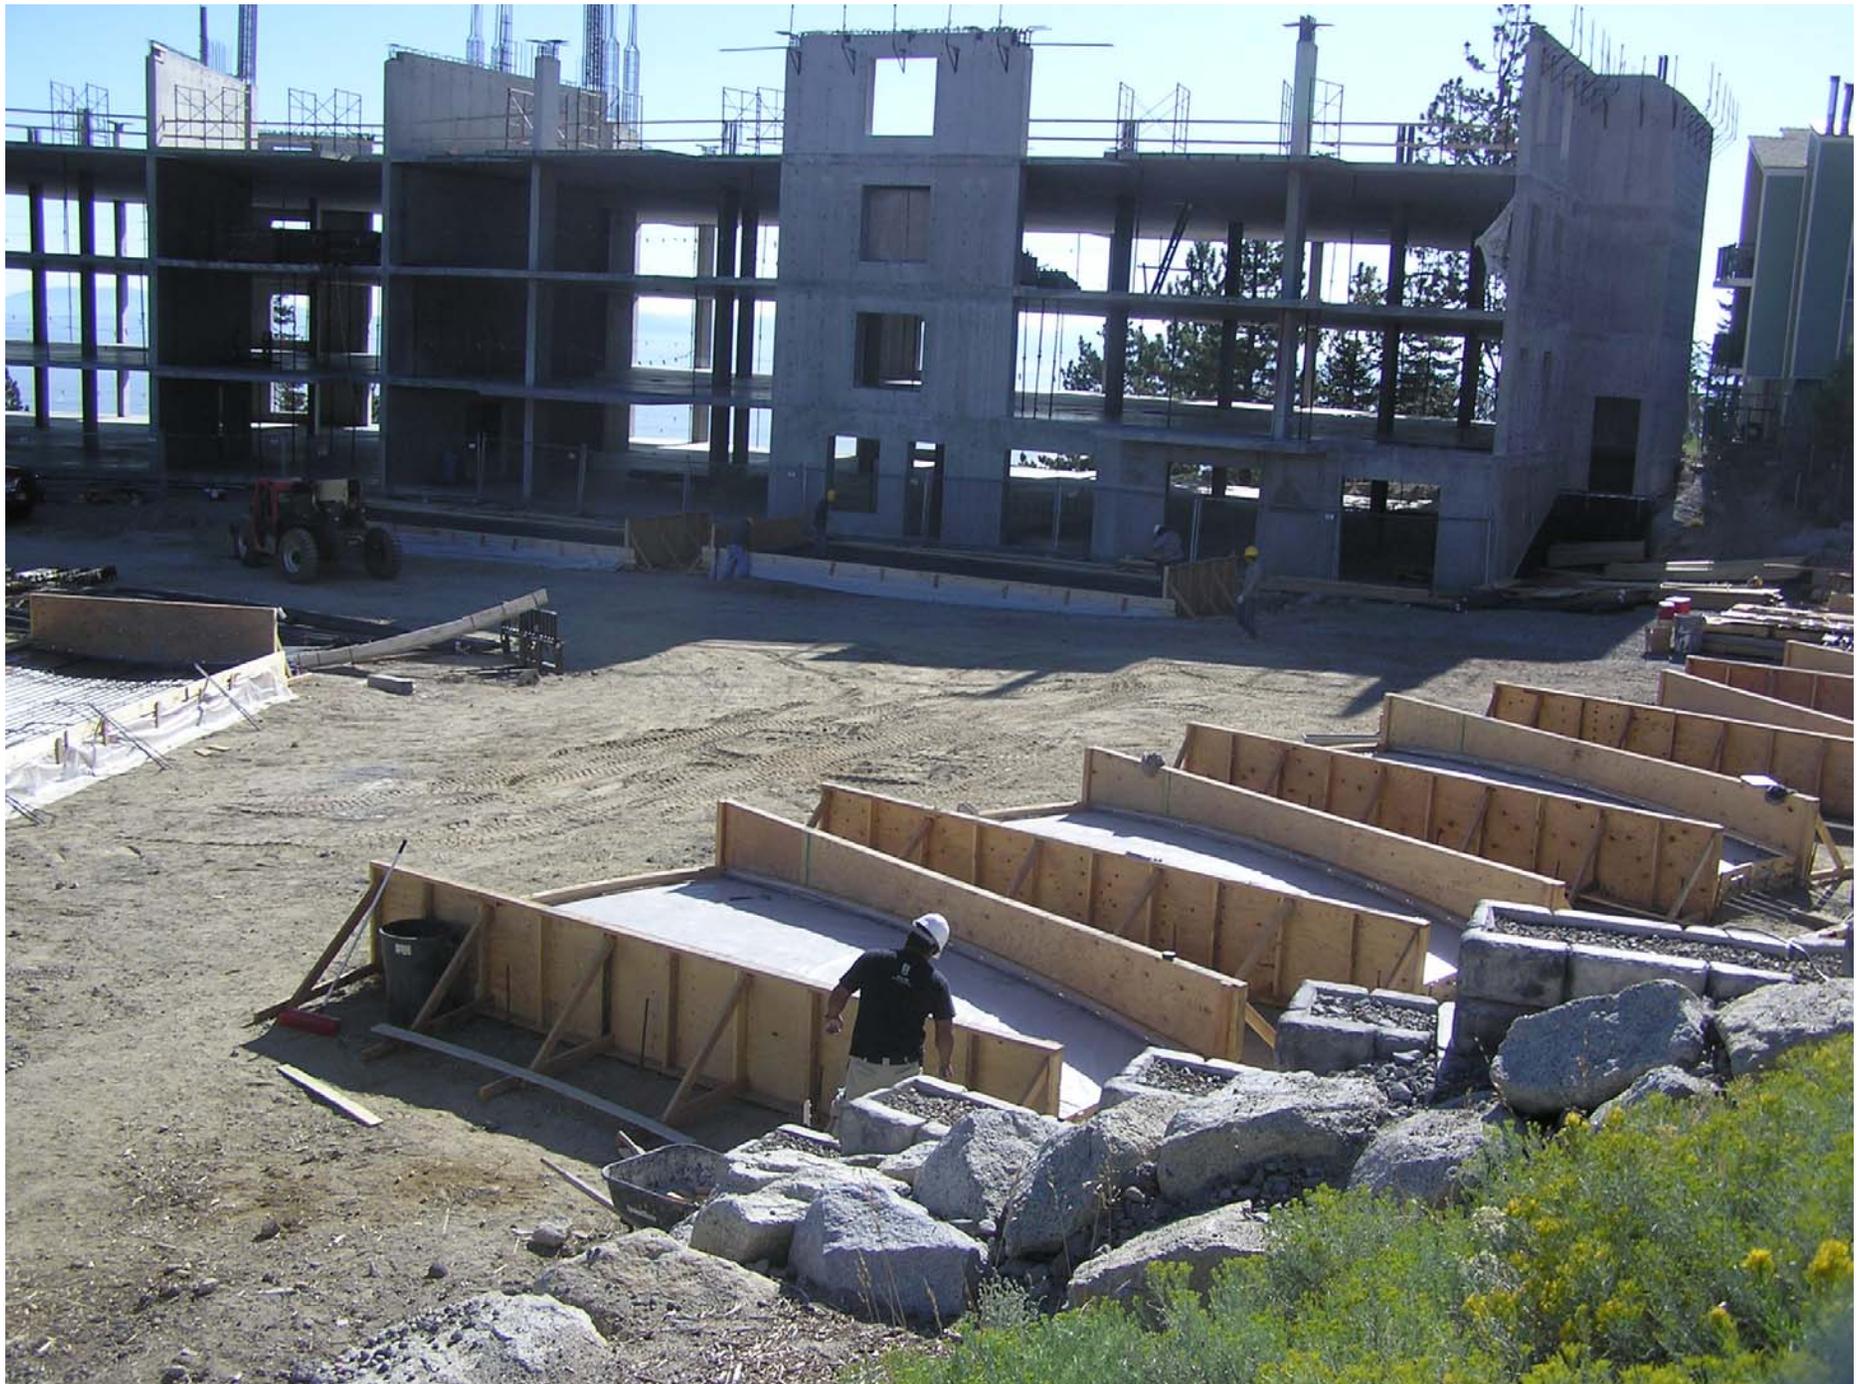
Subcontractor - Natgun - concurrently poured walls and dome panels at a nearby site

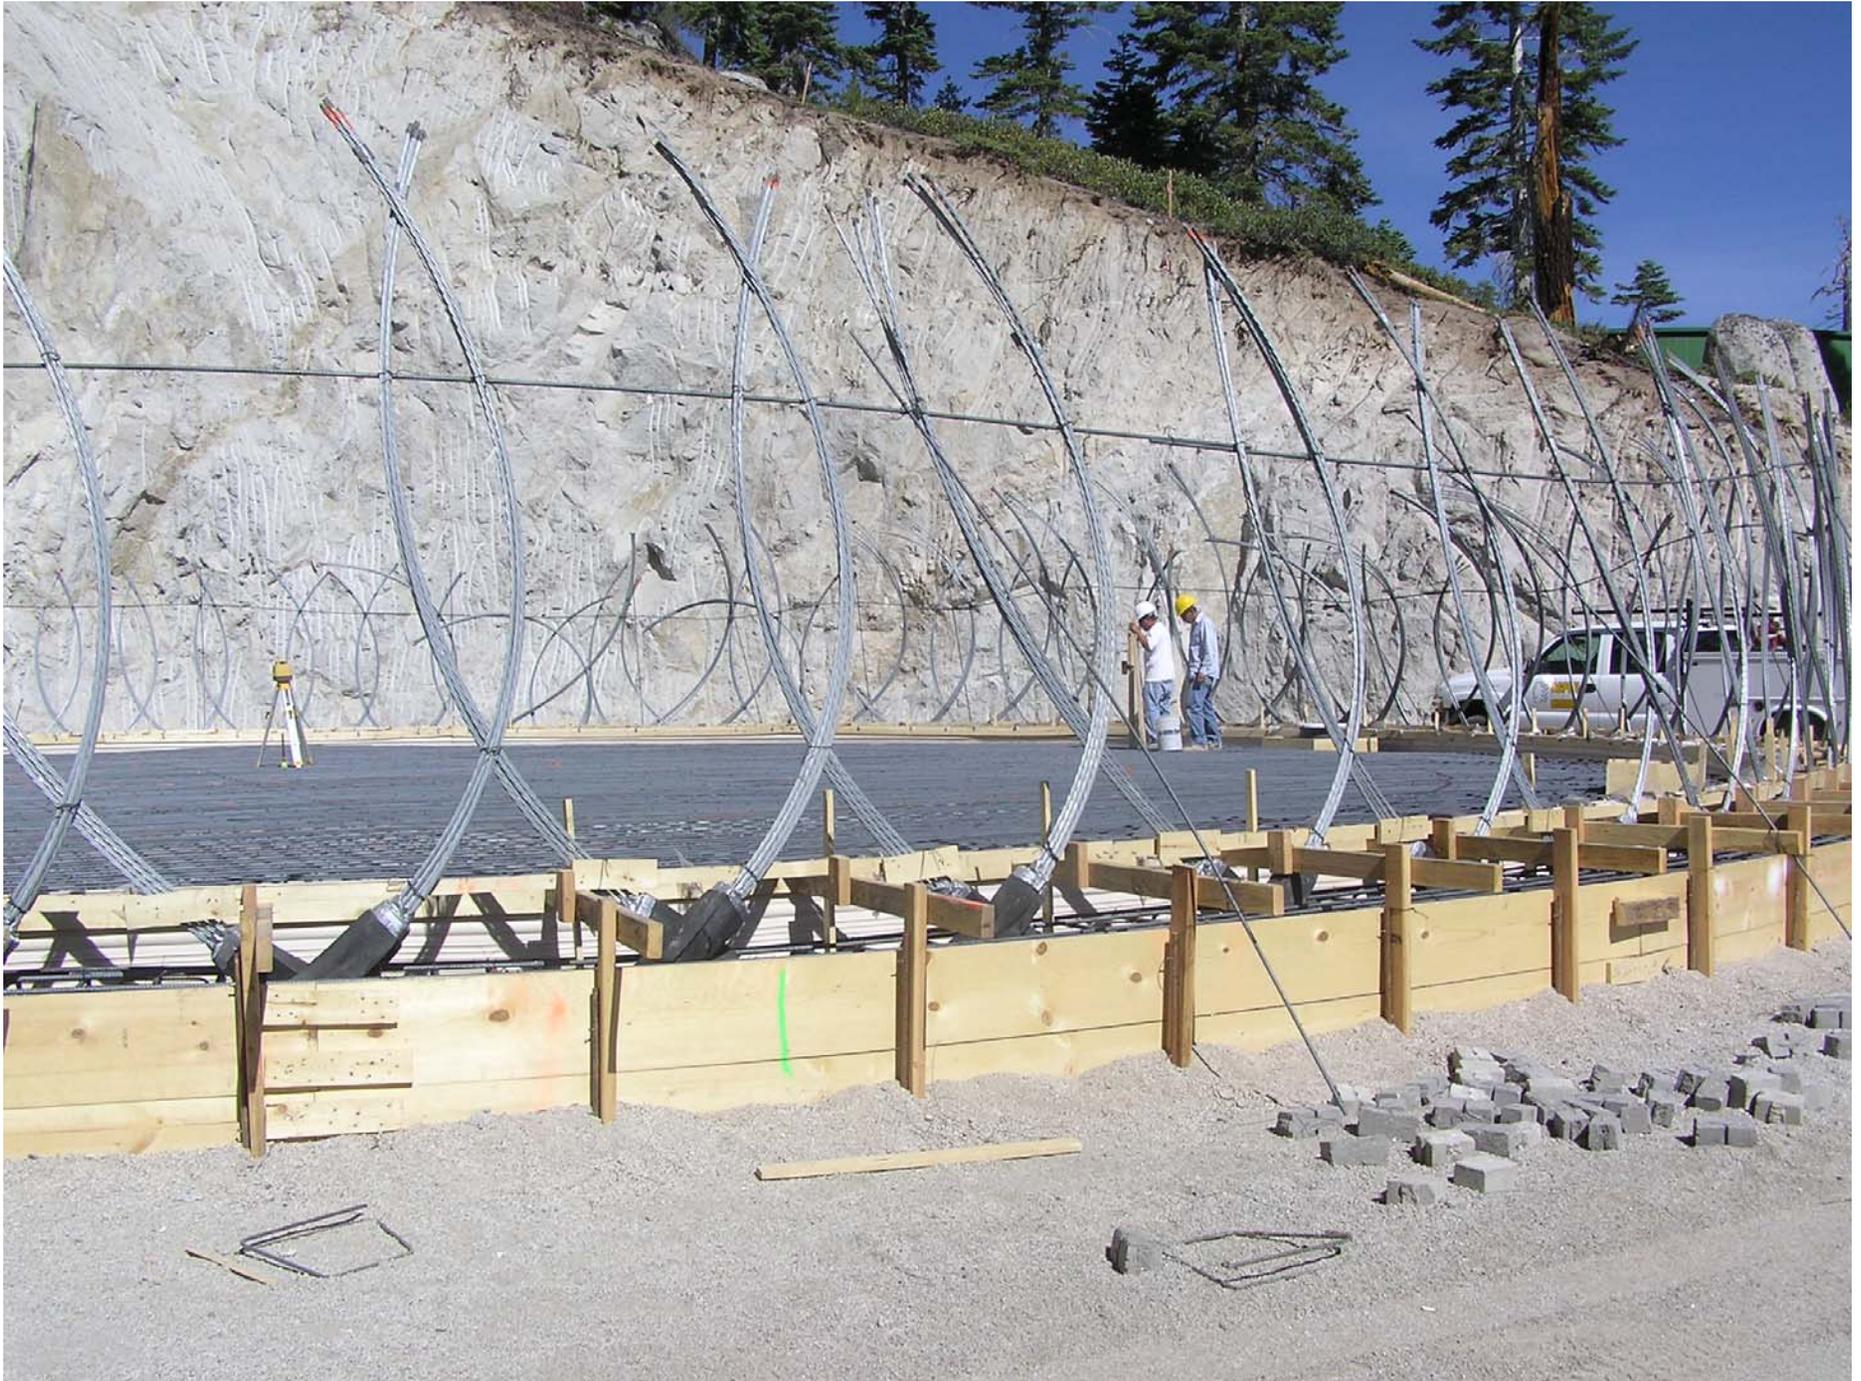
Subcontractor - Natgun - installation of rebar & earthquake straps

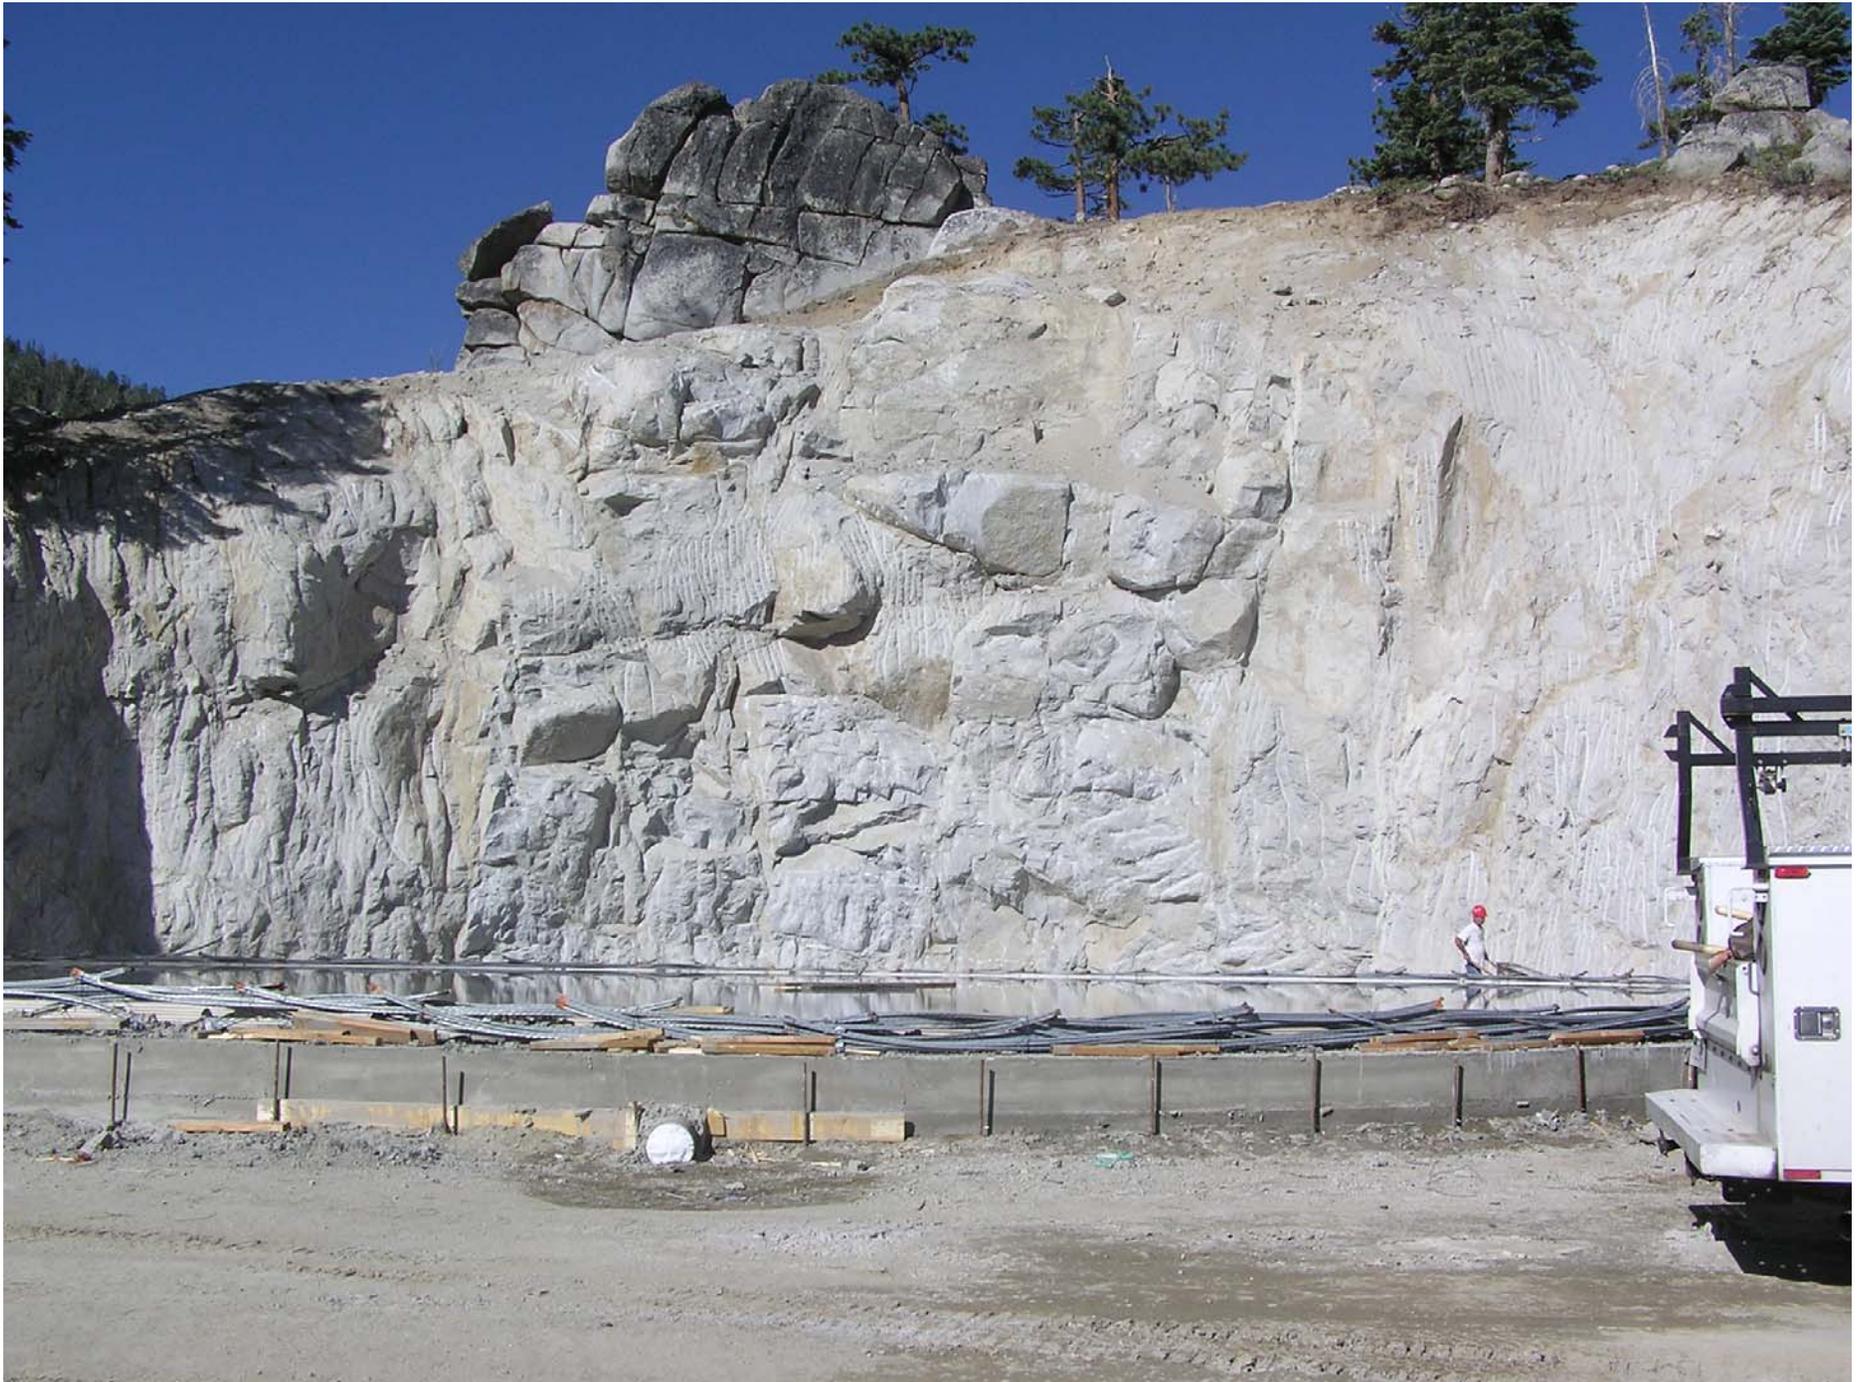
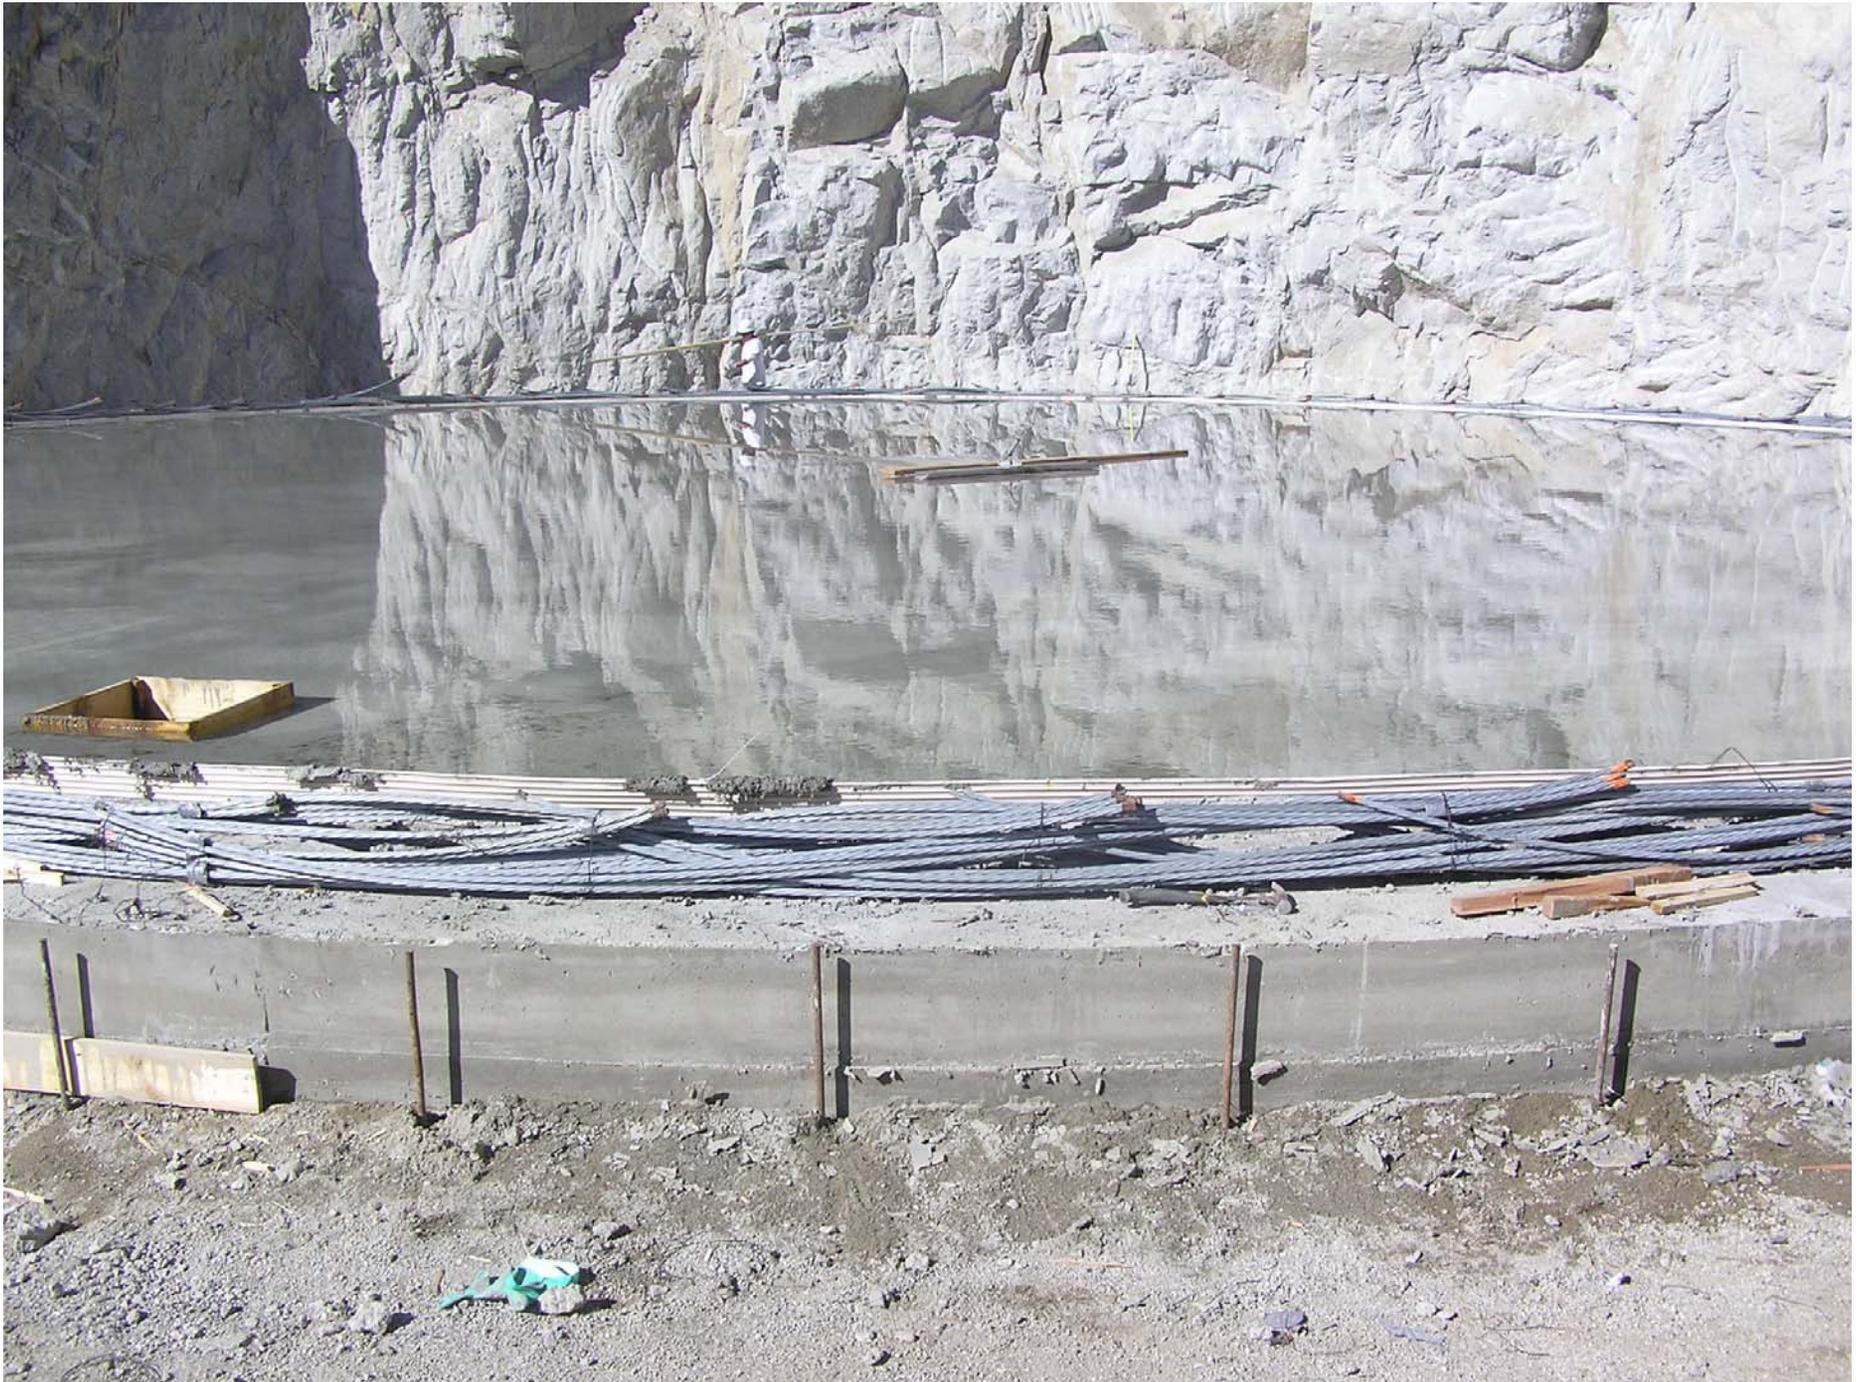
Subcontractor - Natgun - concrete floor of tank poured

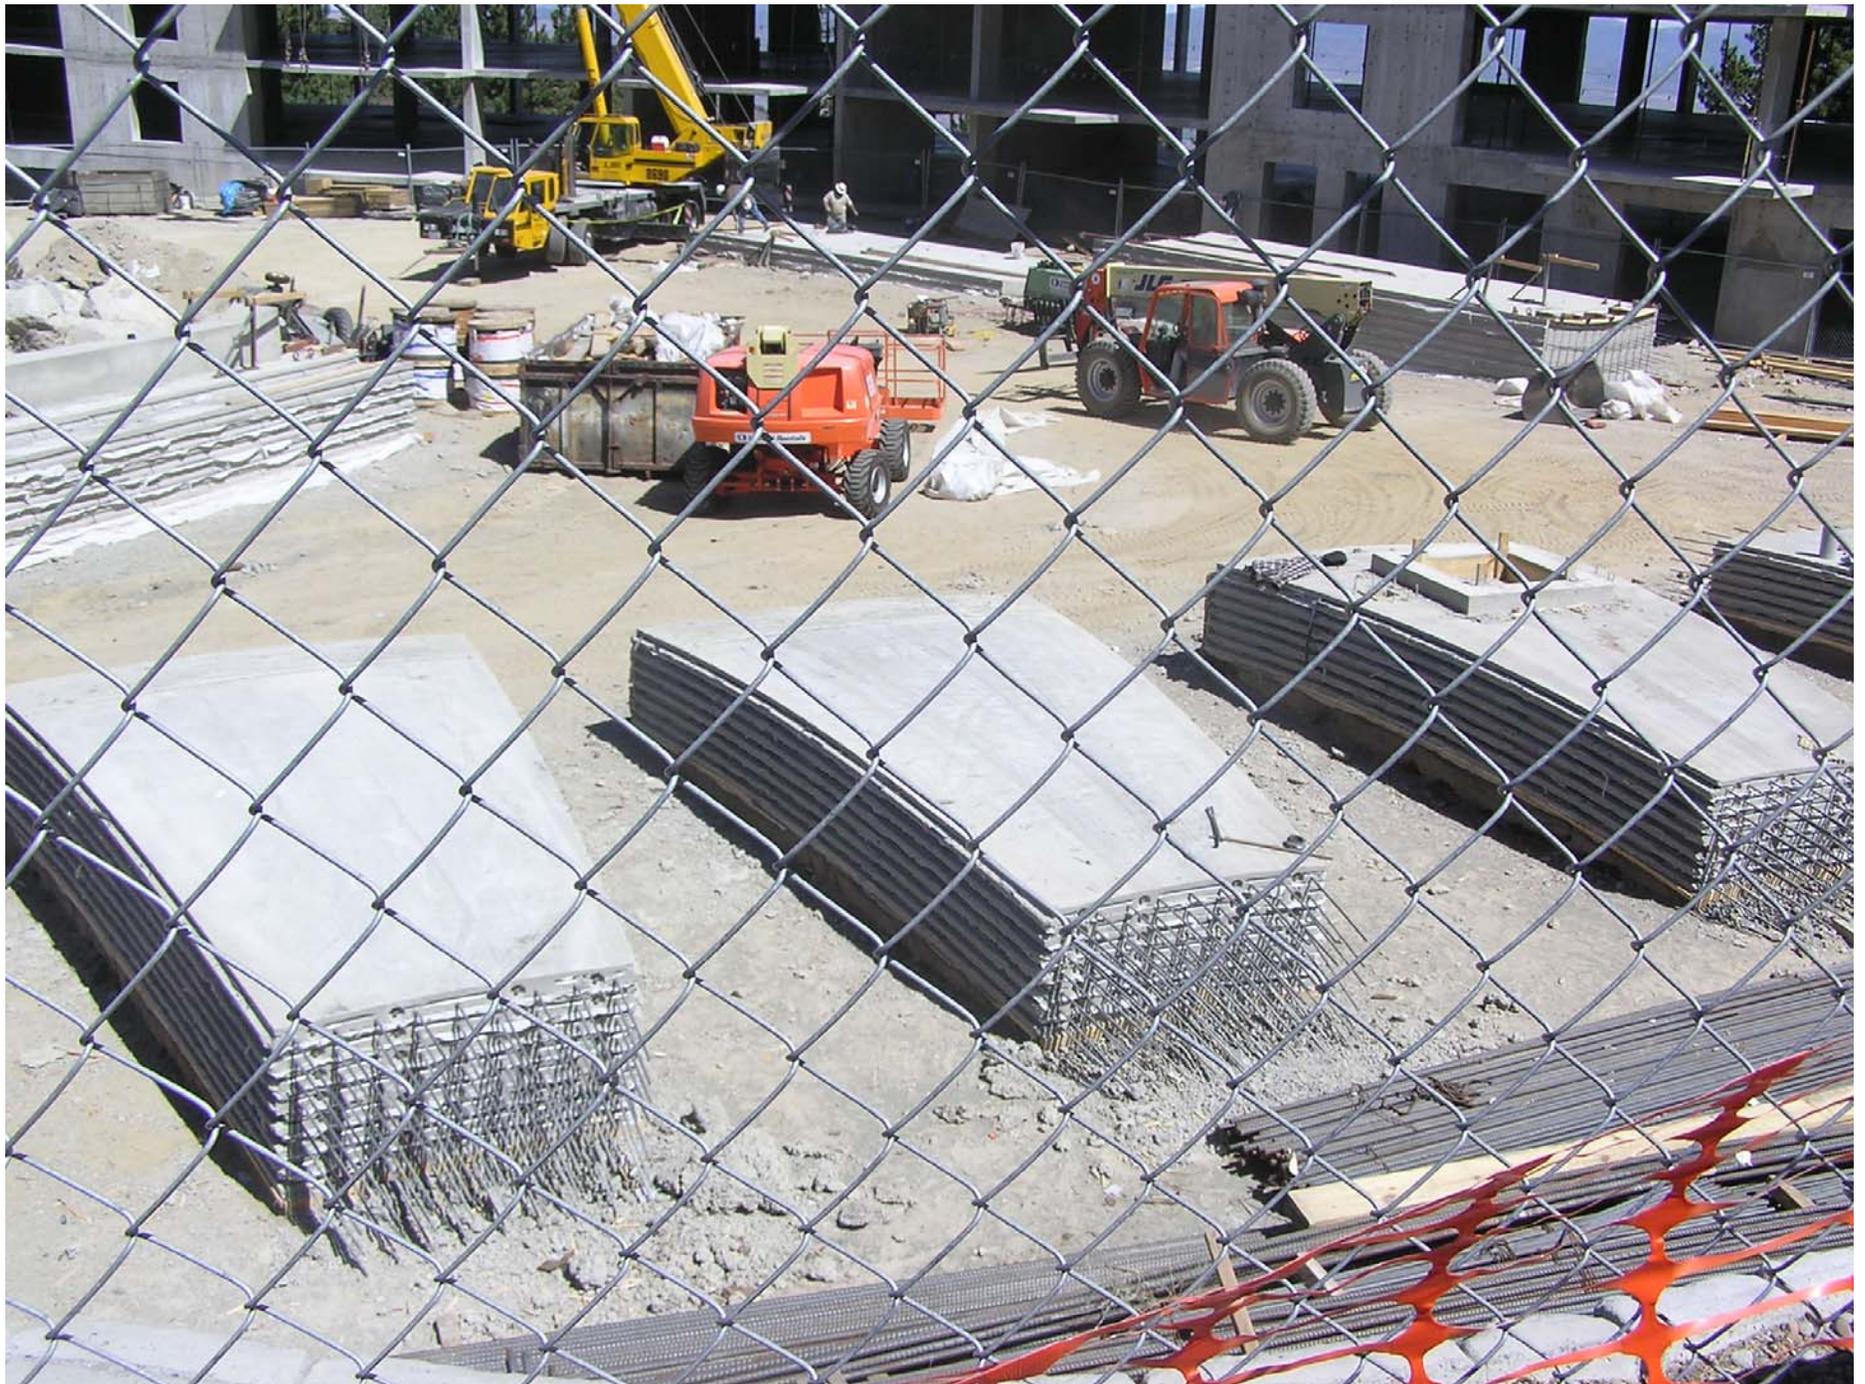
Subcontractor - Natgun - preparing to transport walls & dome sections up to tank site
