Existing Tank 10A

Completed Tank 10B next to existing Tank 10A

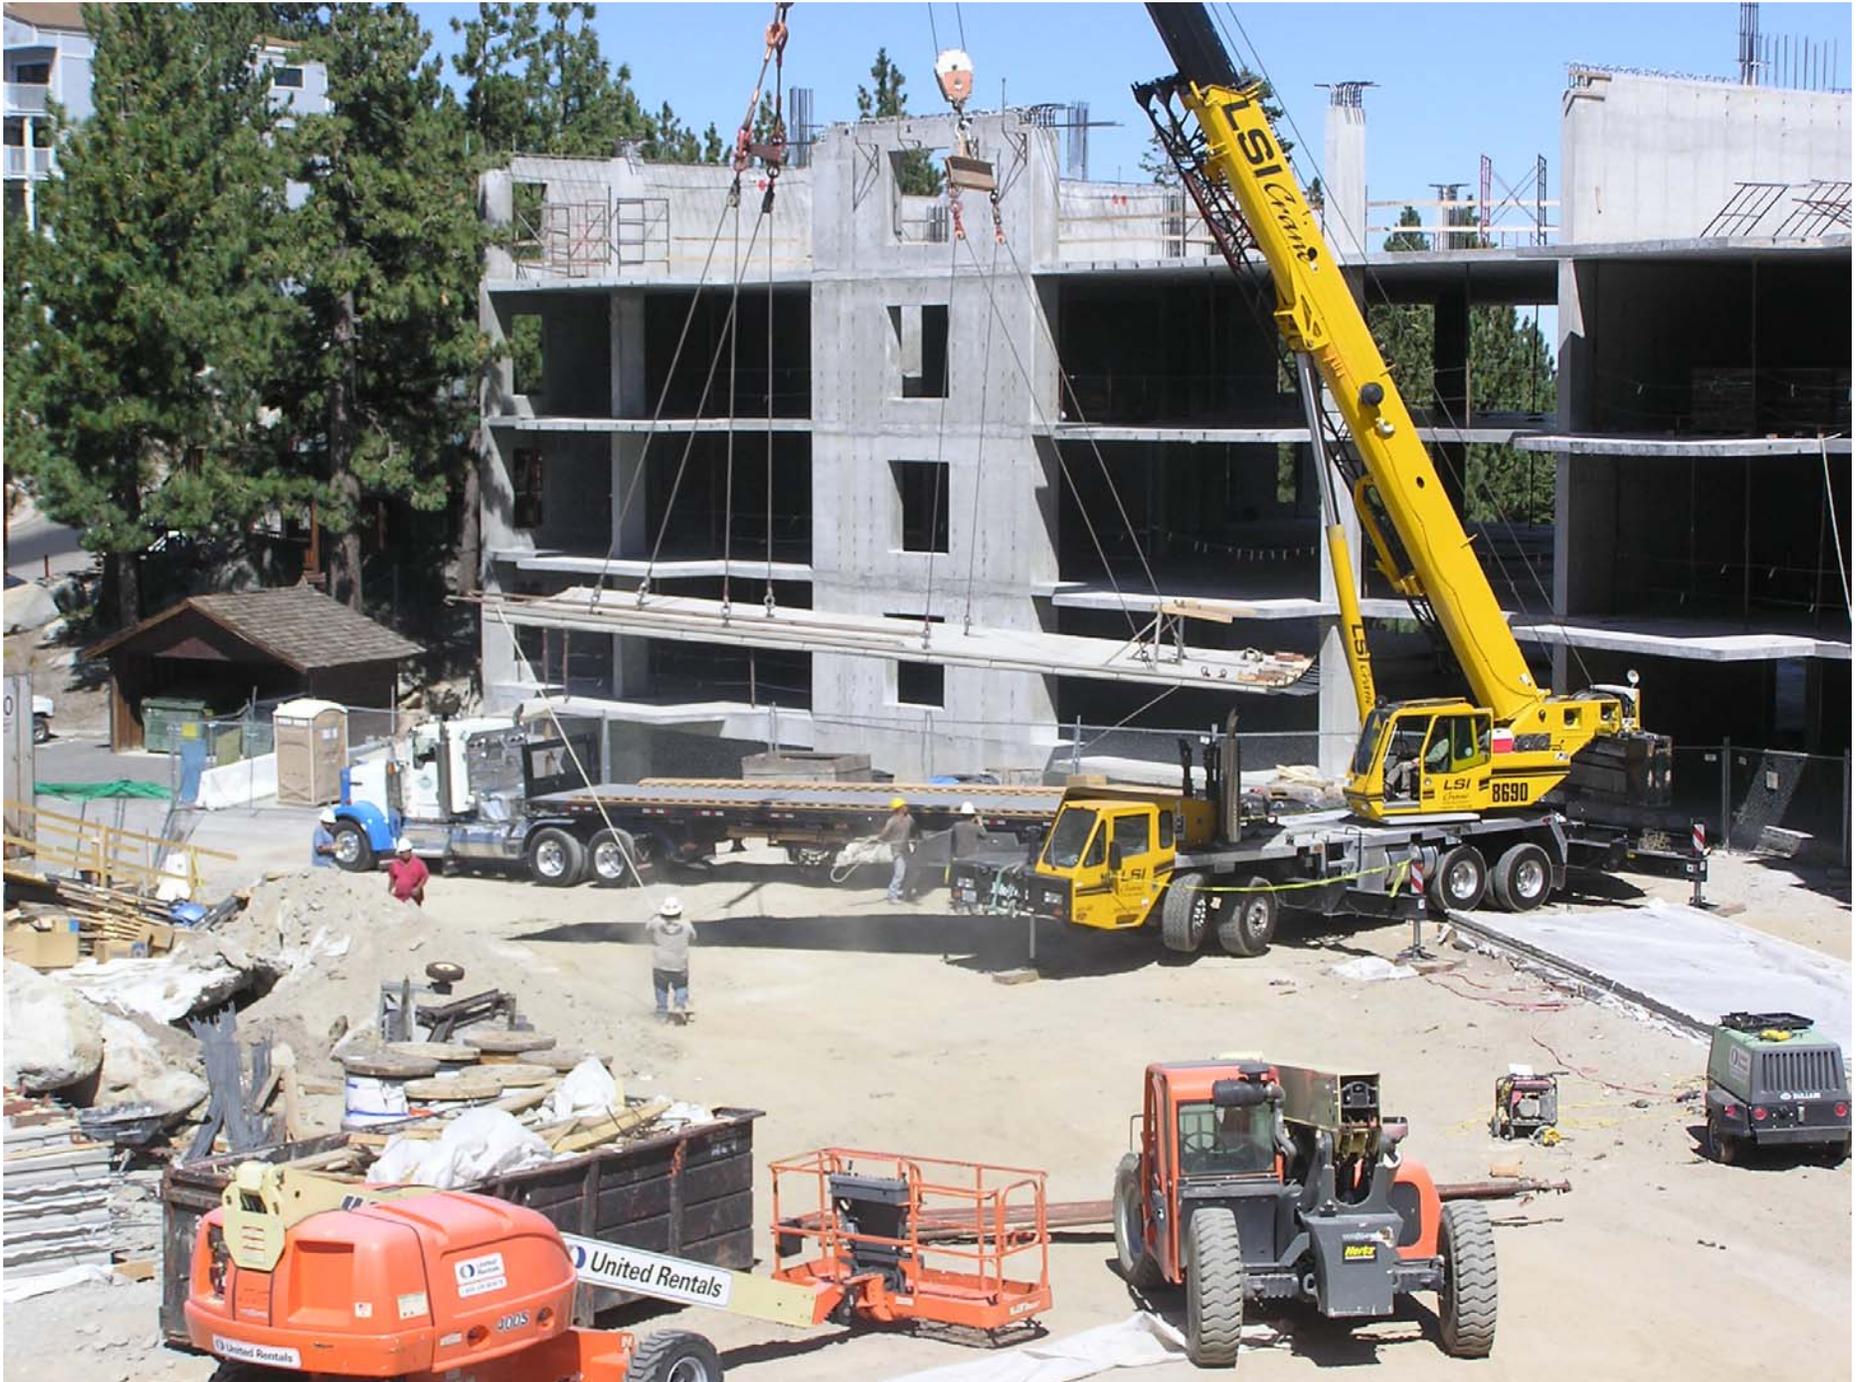
Subcontractor - Natgun - loading wall panel on truck

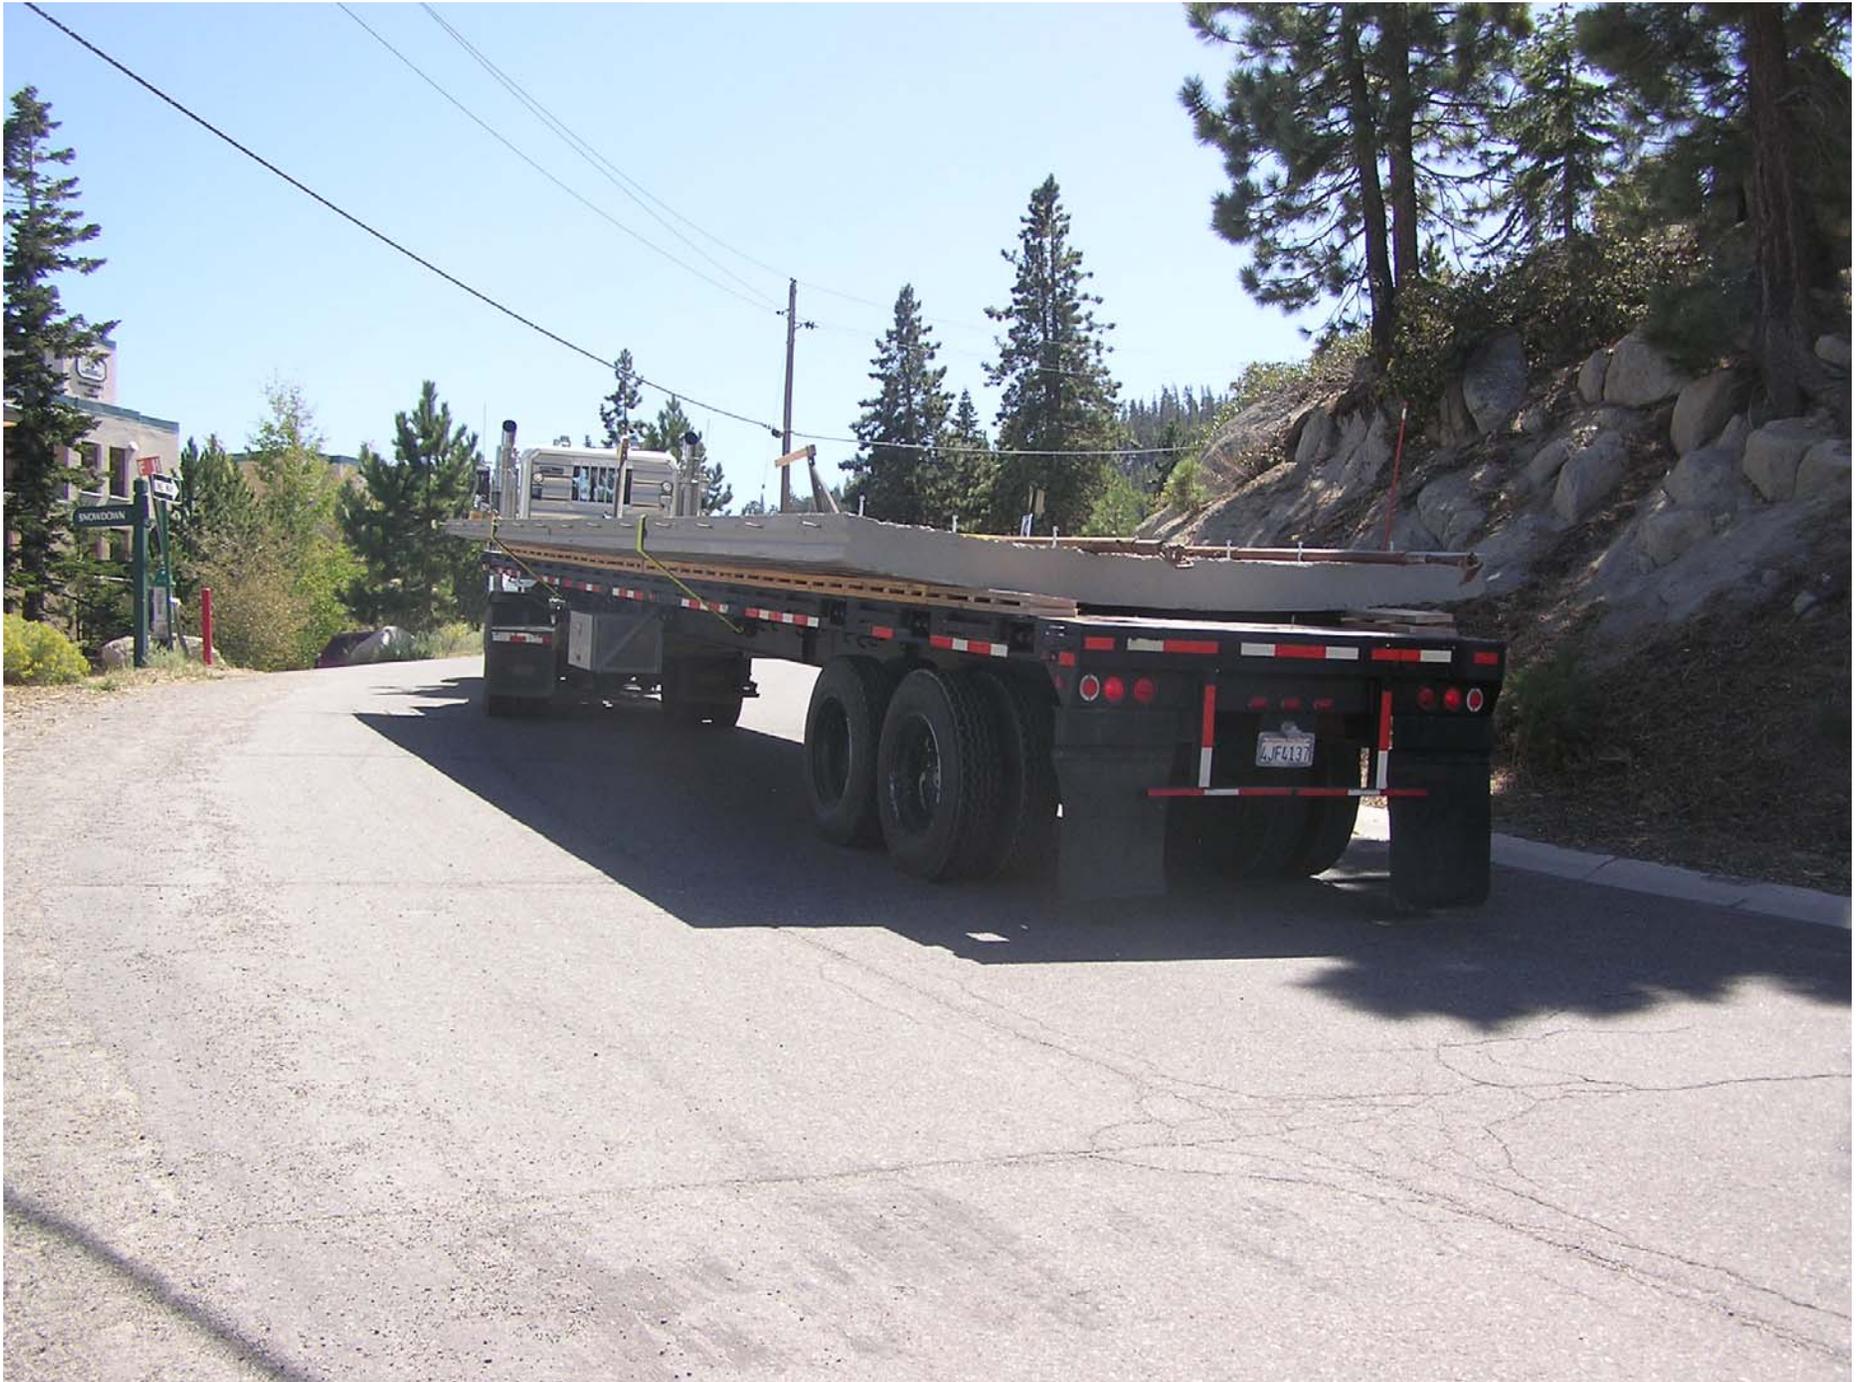
Subcontractor - Natgun - wall panel on truck on its way to tank site

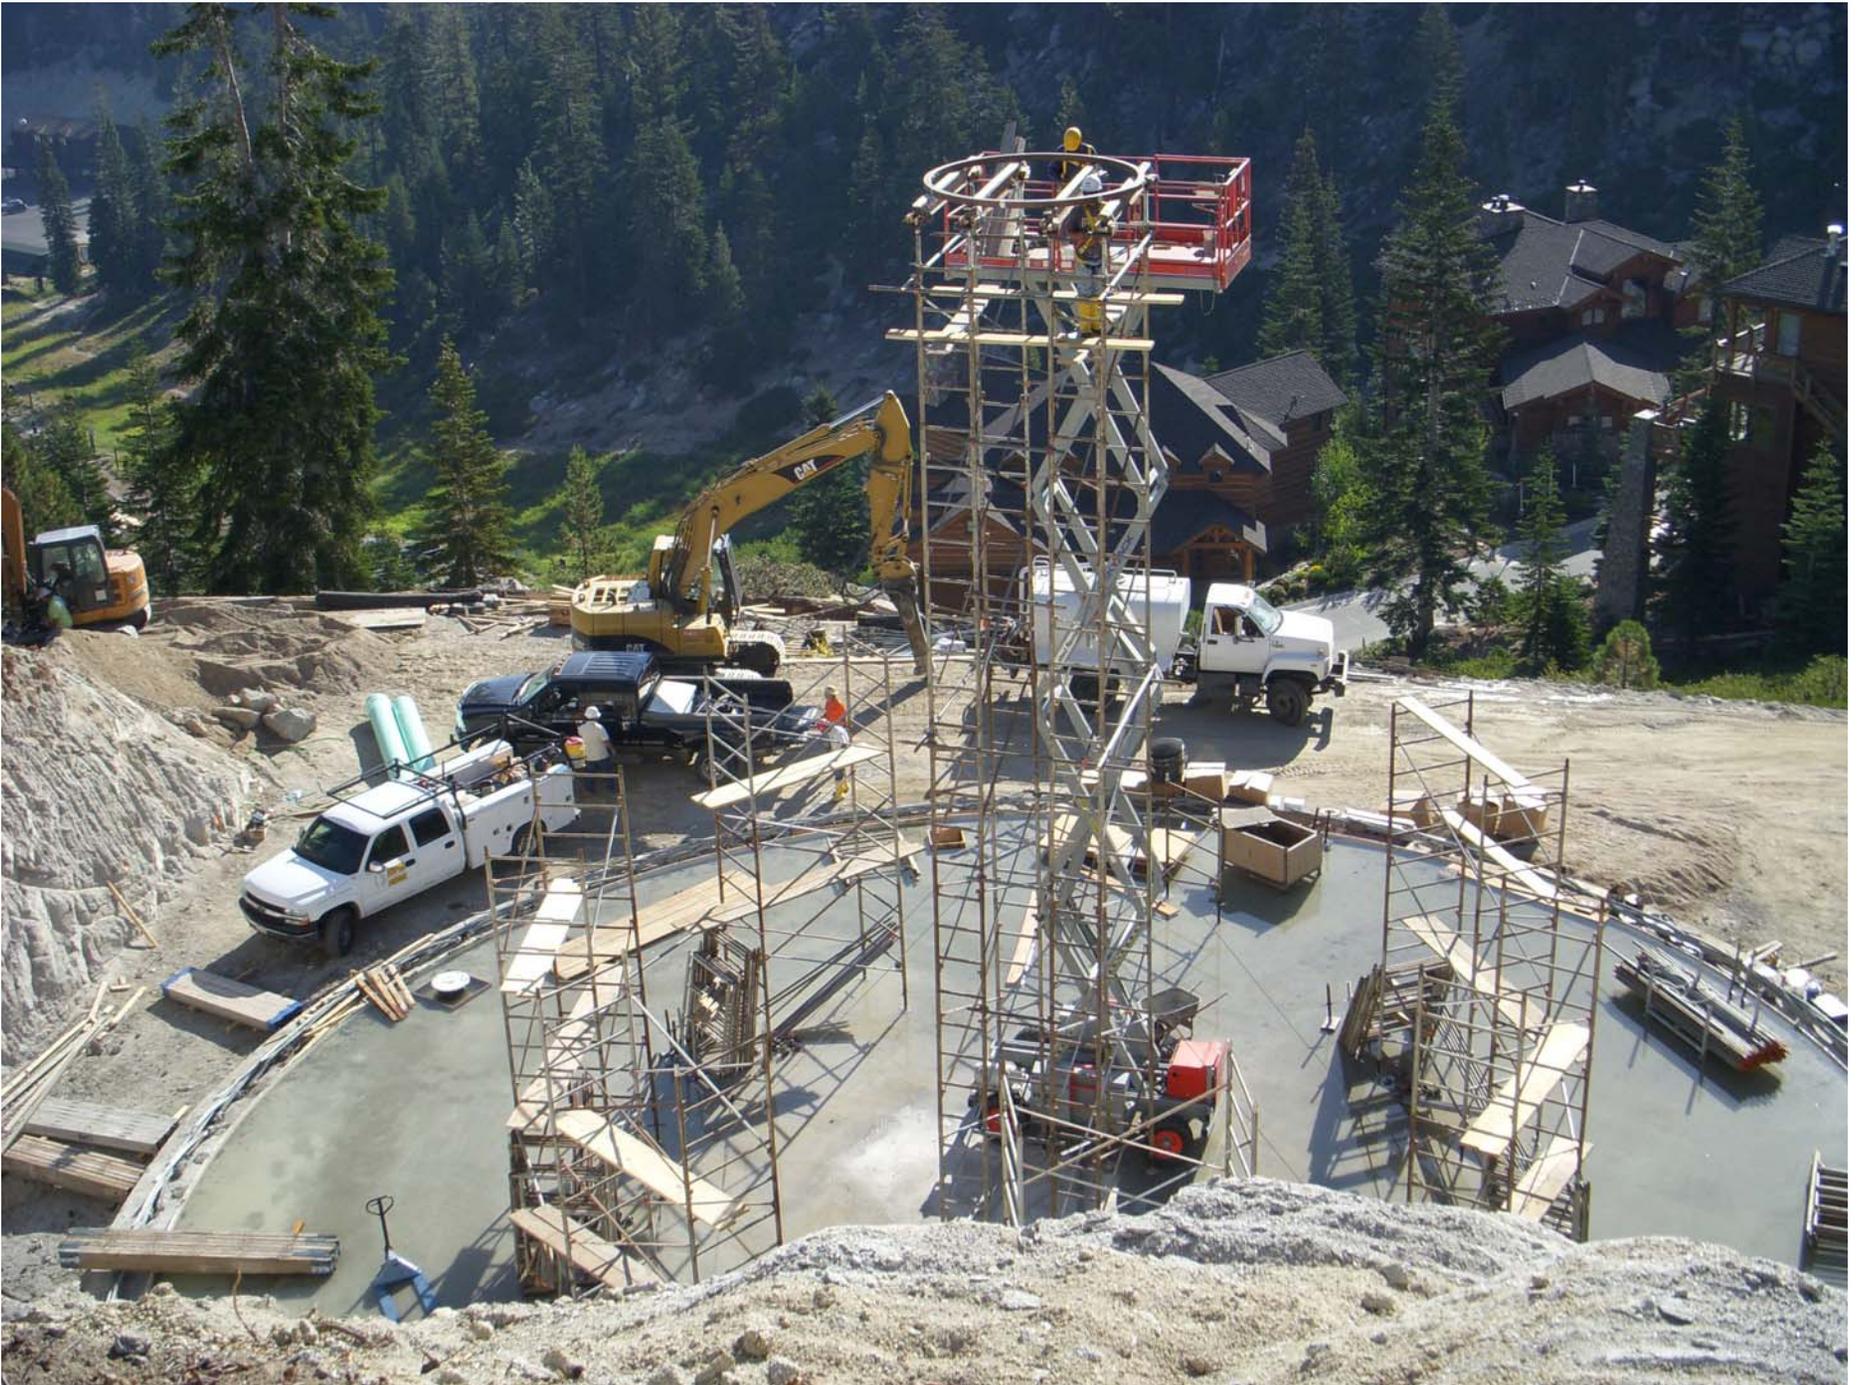
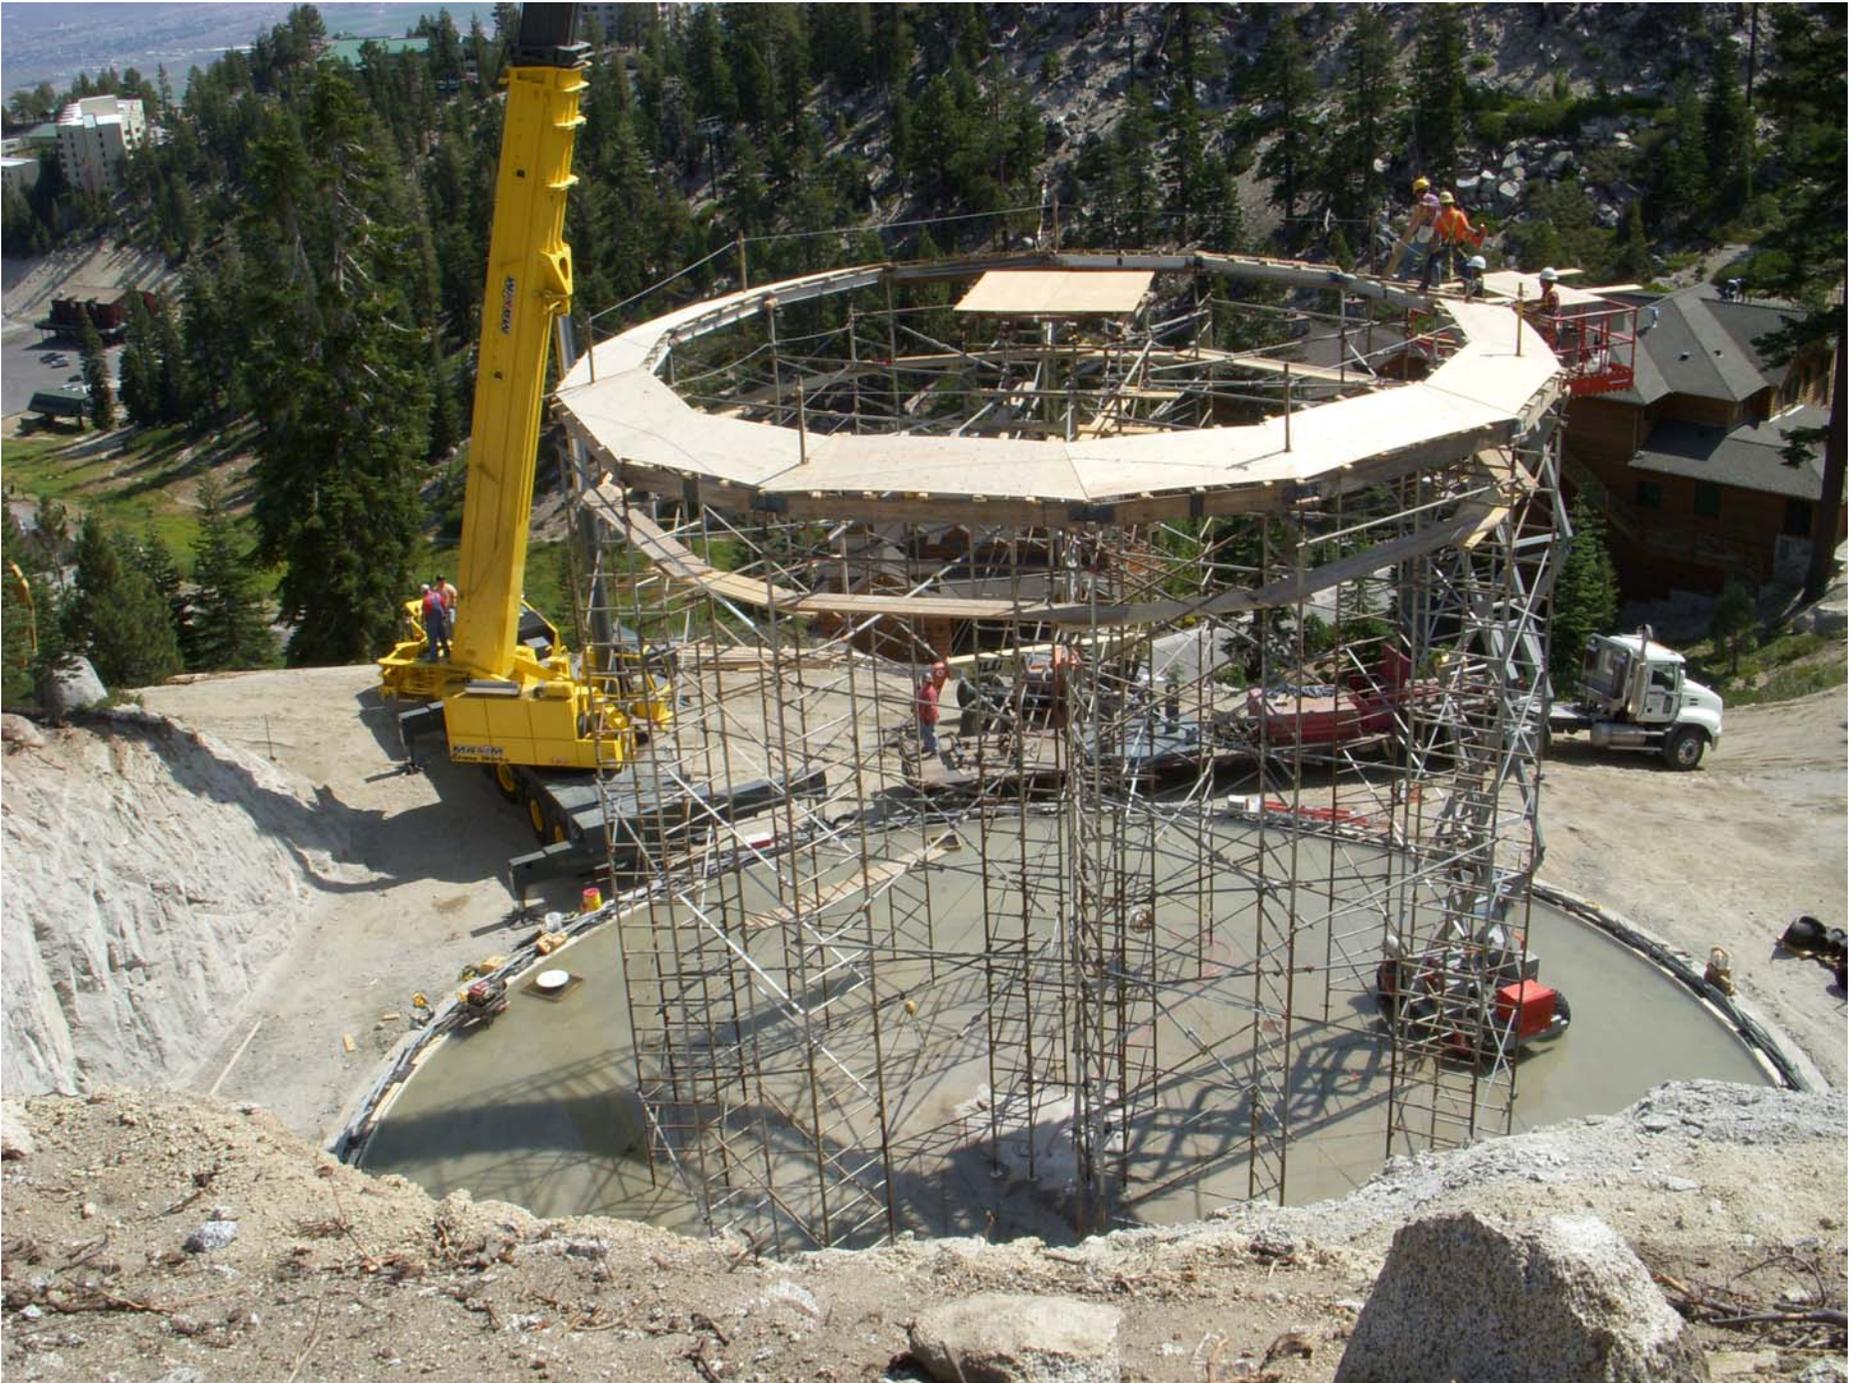
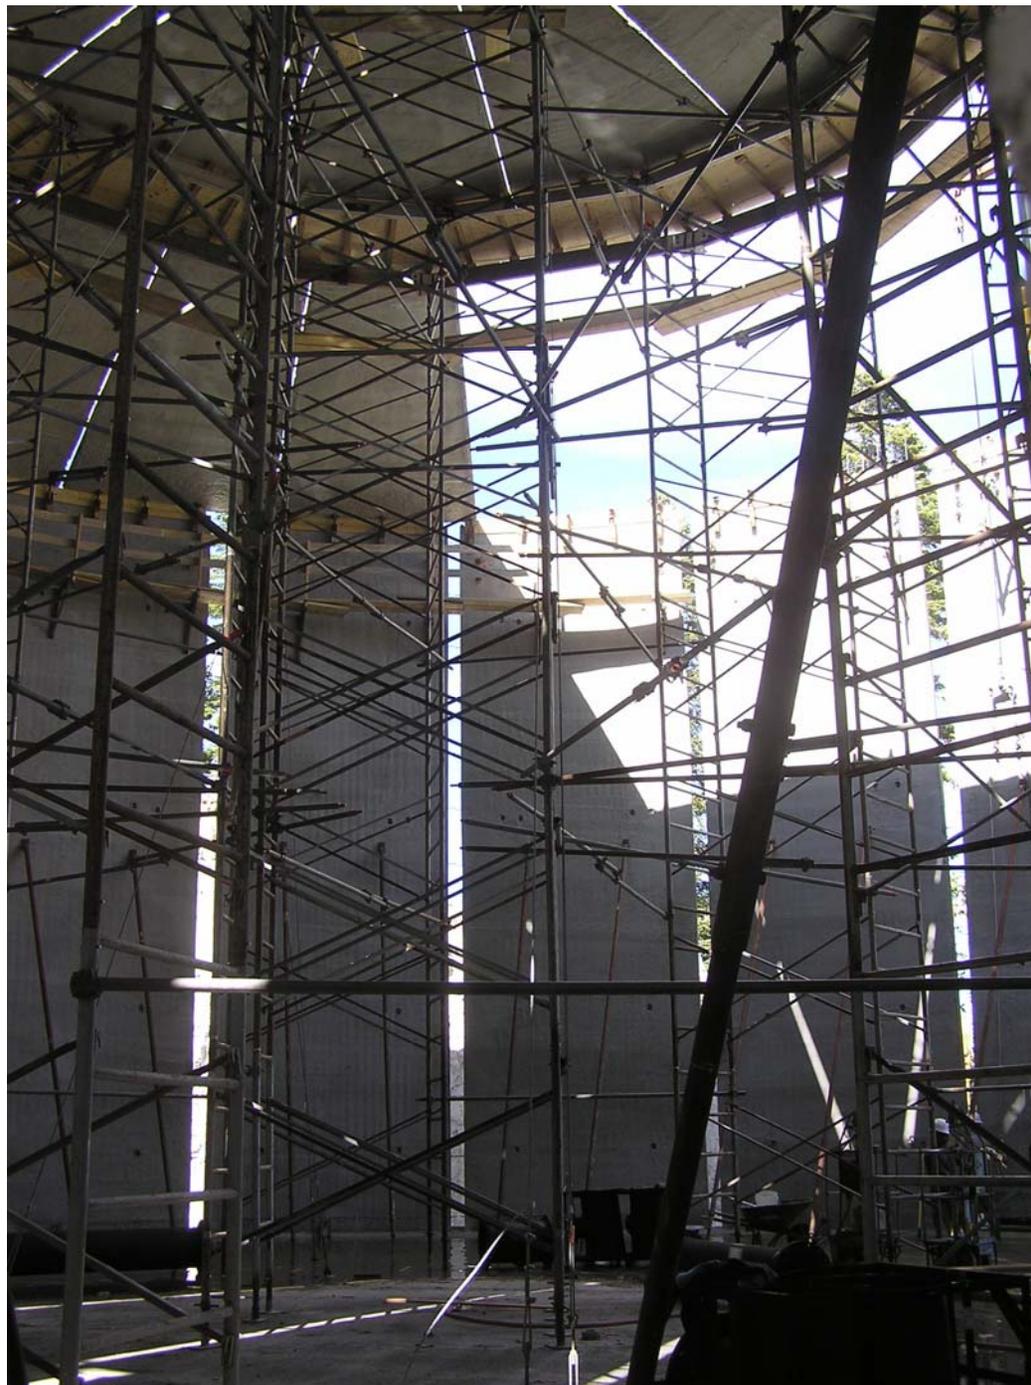
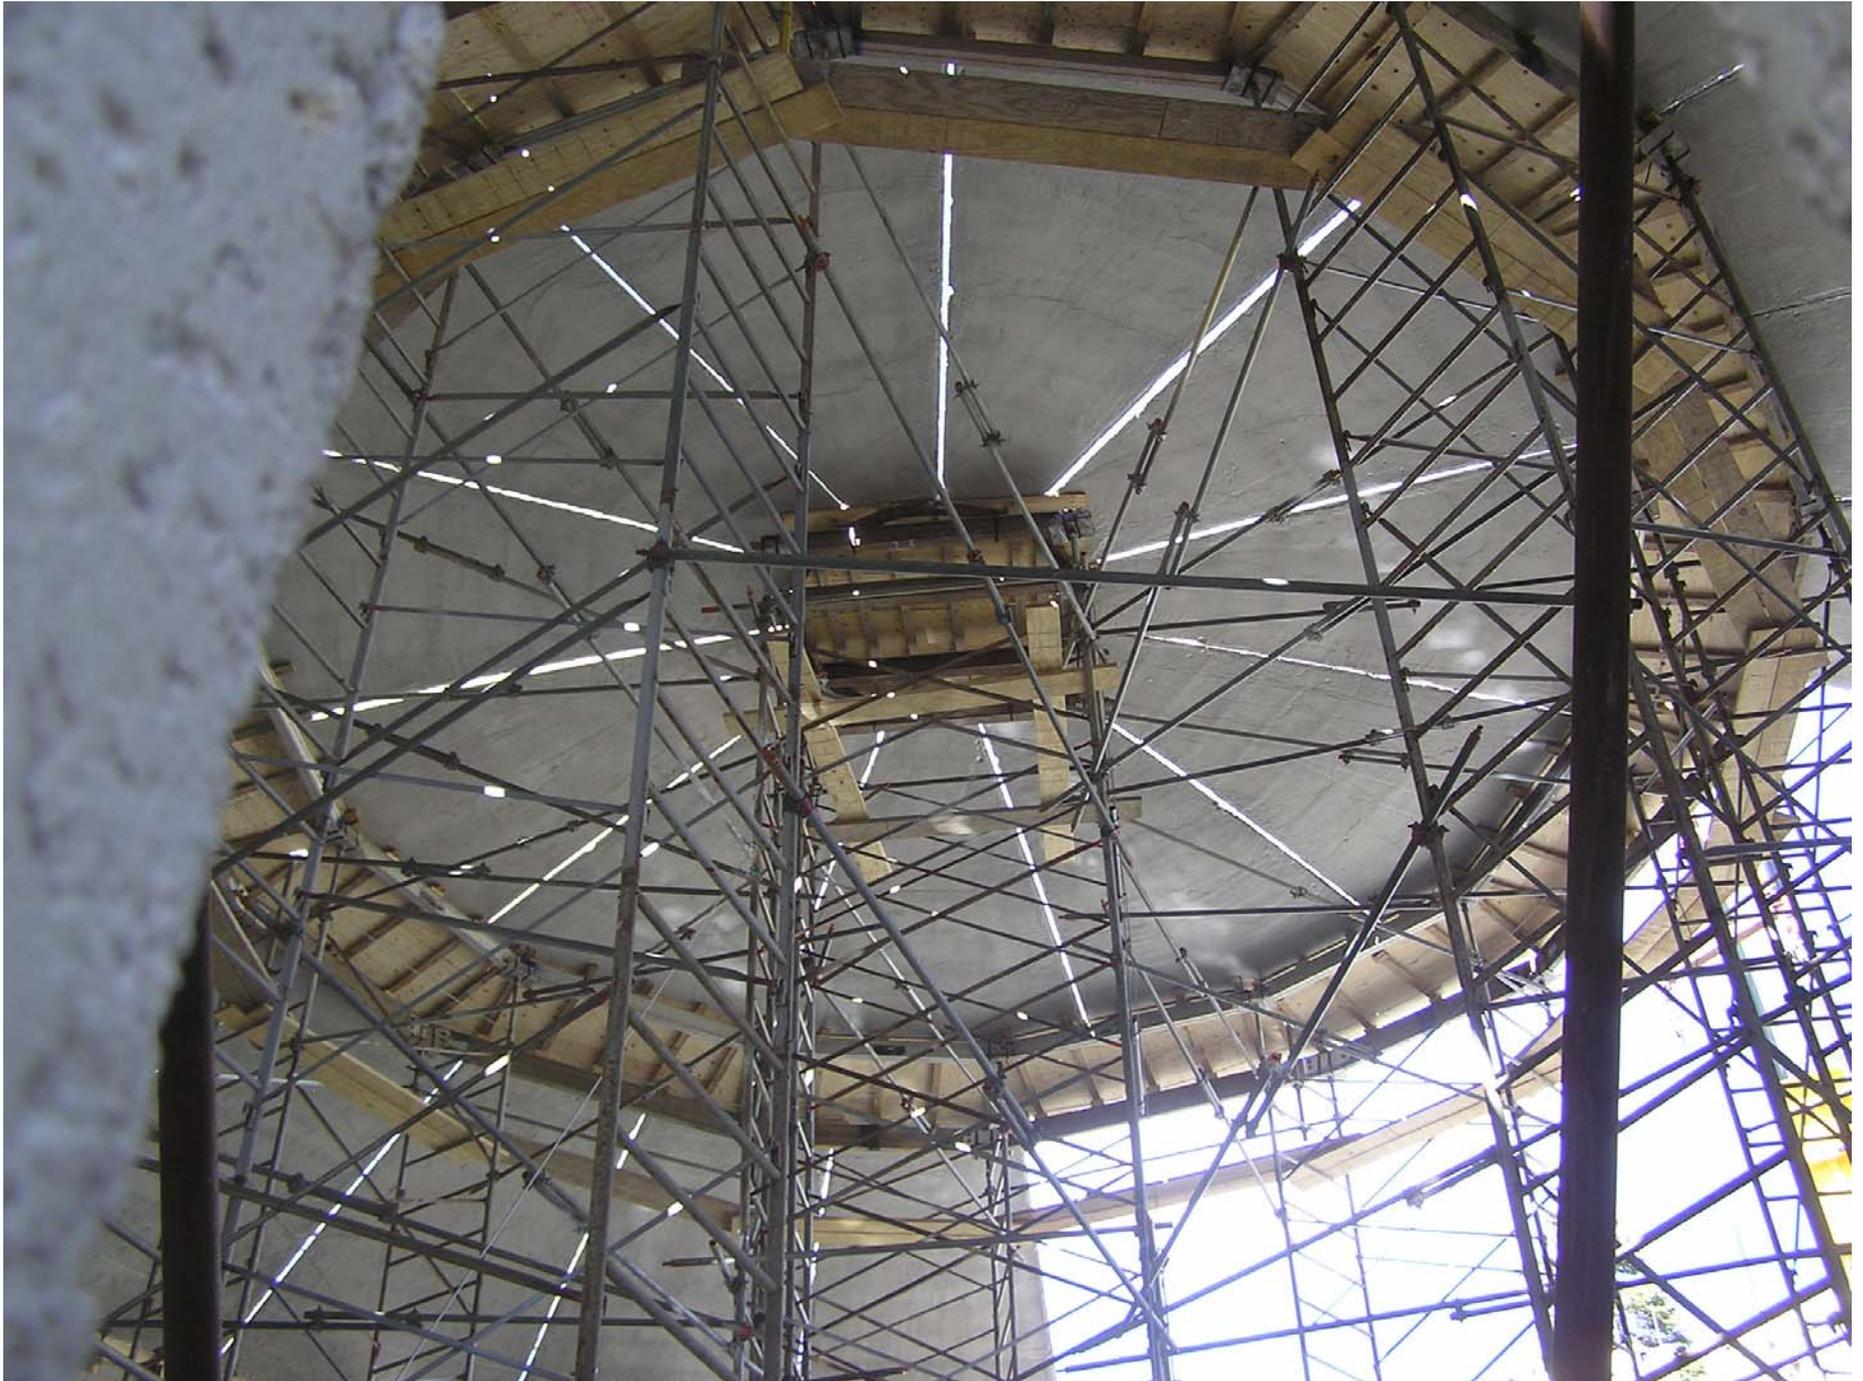
Subcontractor - Natgun - scaffolding inside tank area used during erection of walls & dome

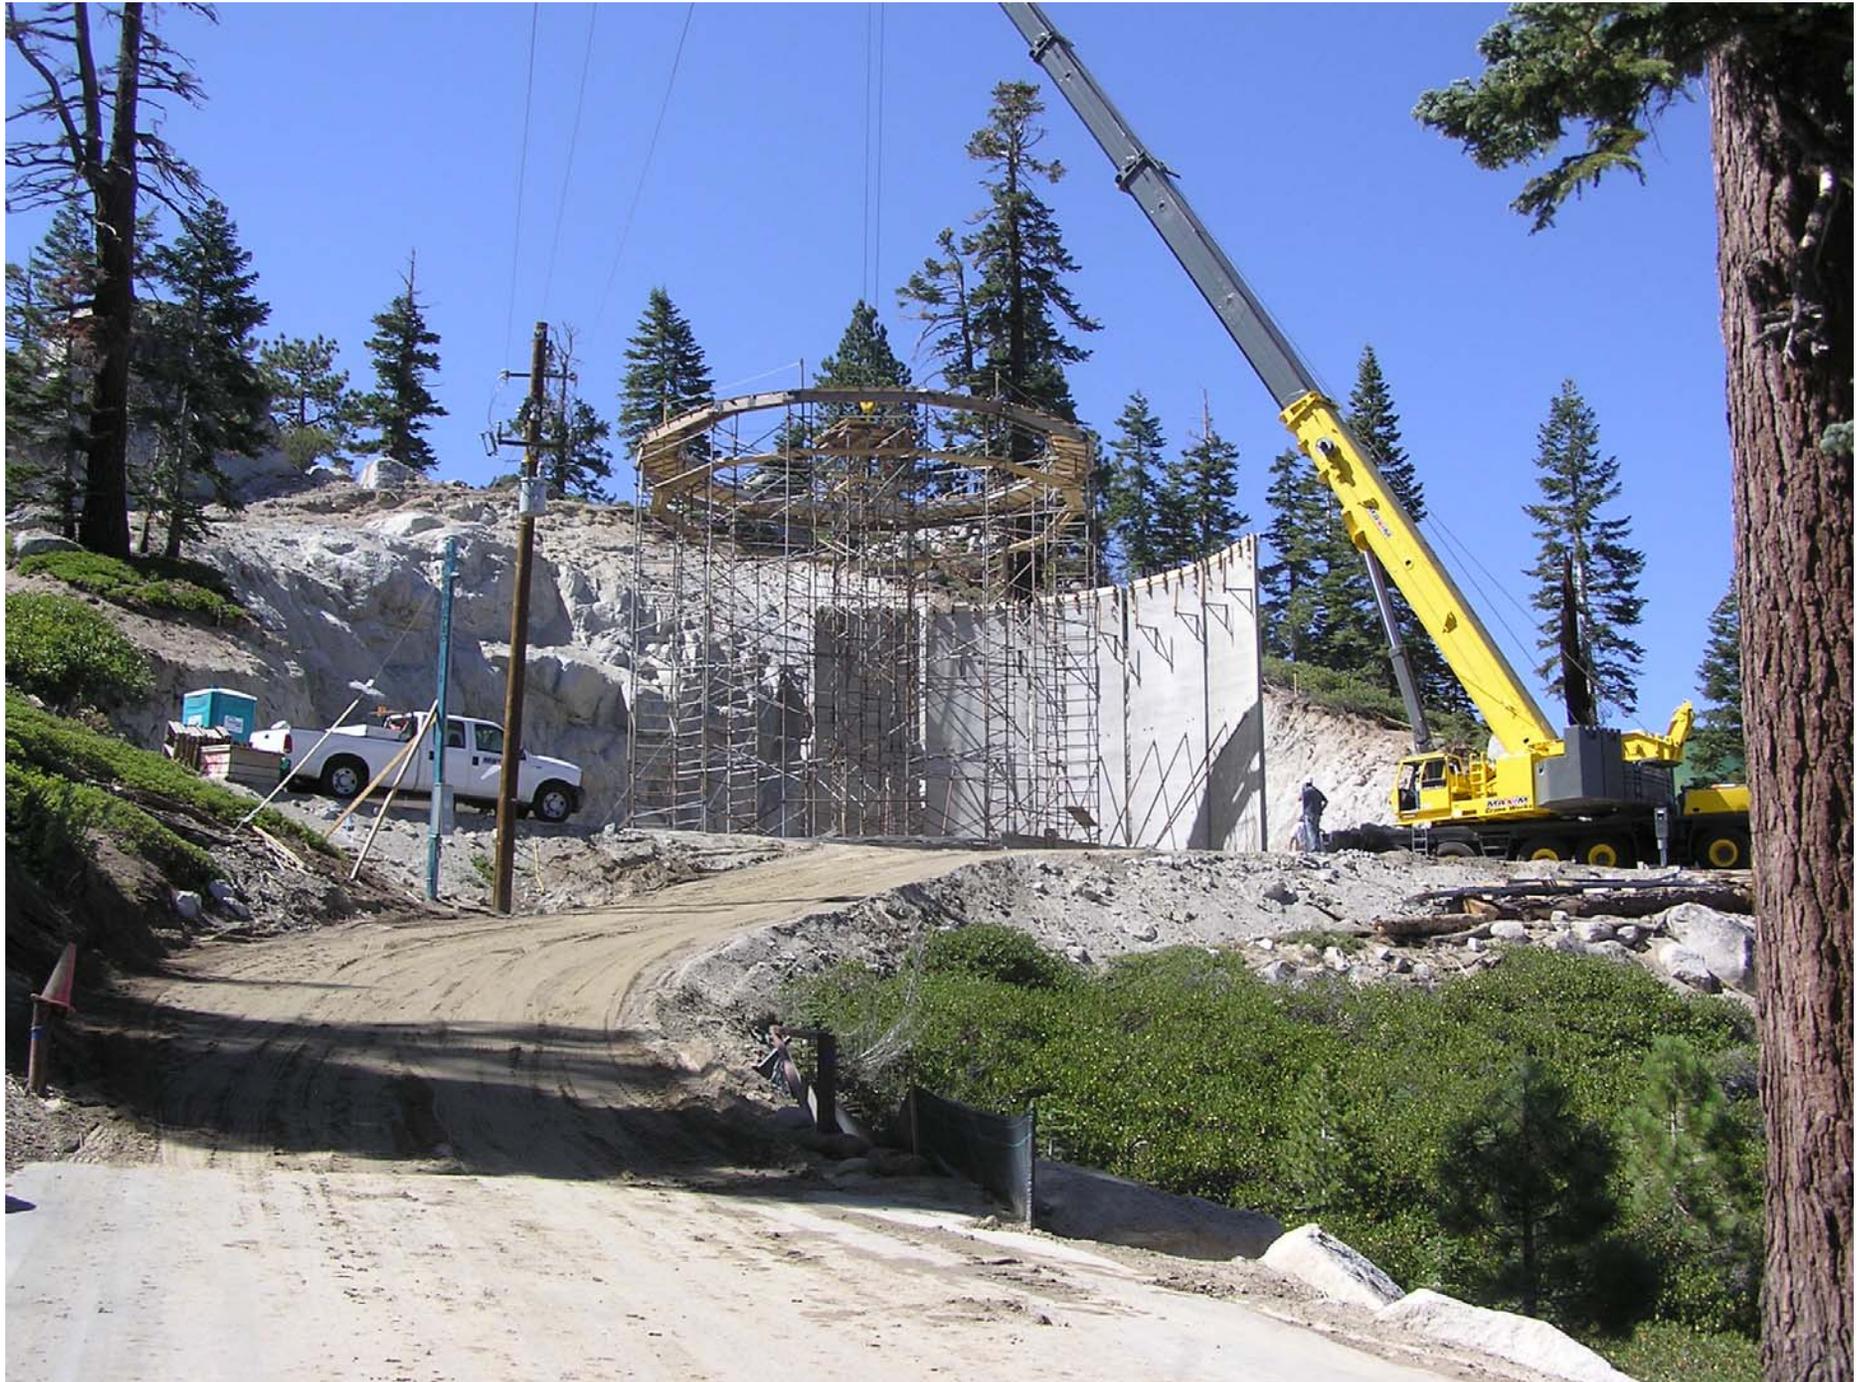
Subcontractor - Natgun - scaffolding inside tank area with wall panels being stood & secured

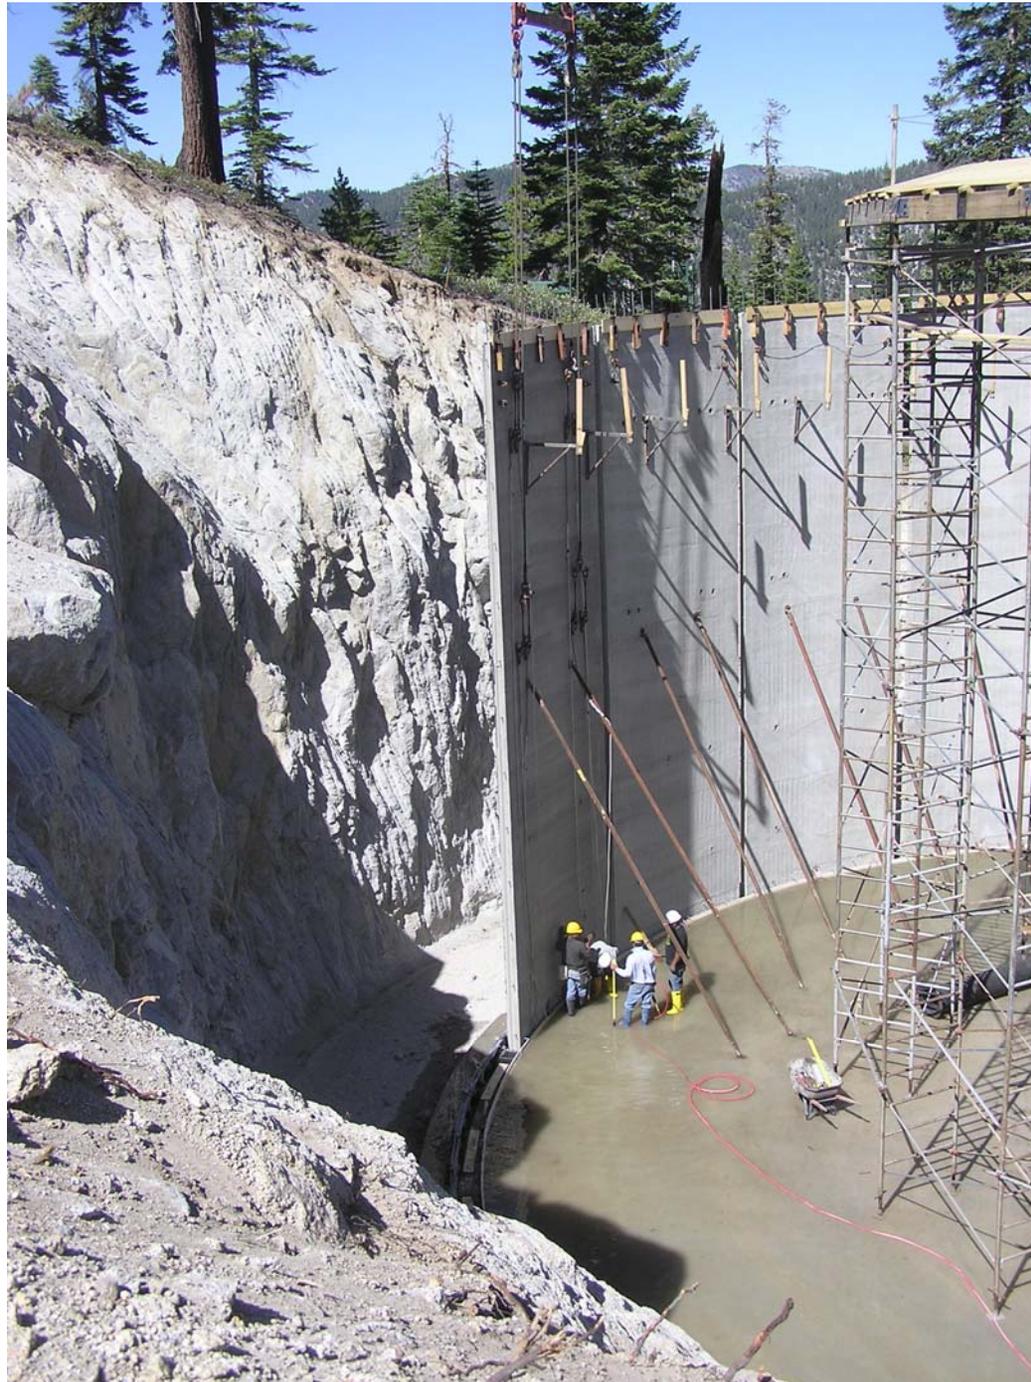
Subcontractor - Natgun - scaffolding inside tank area with wall panels being stood & secured with temporary bracing

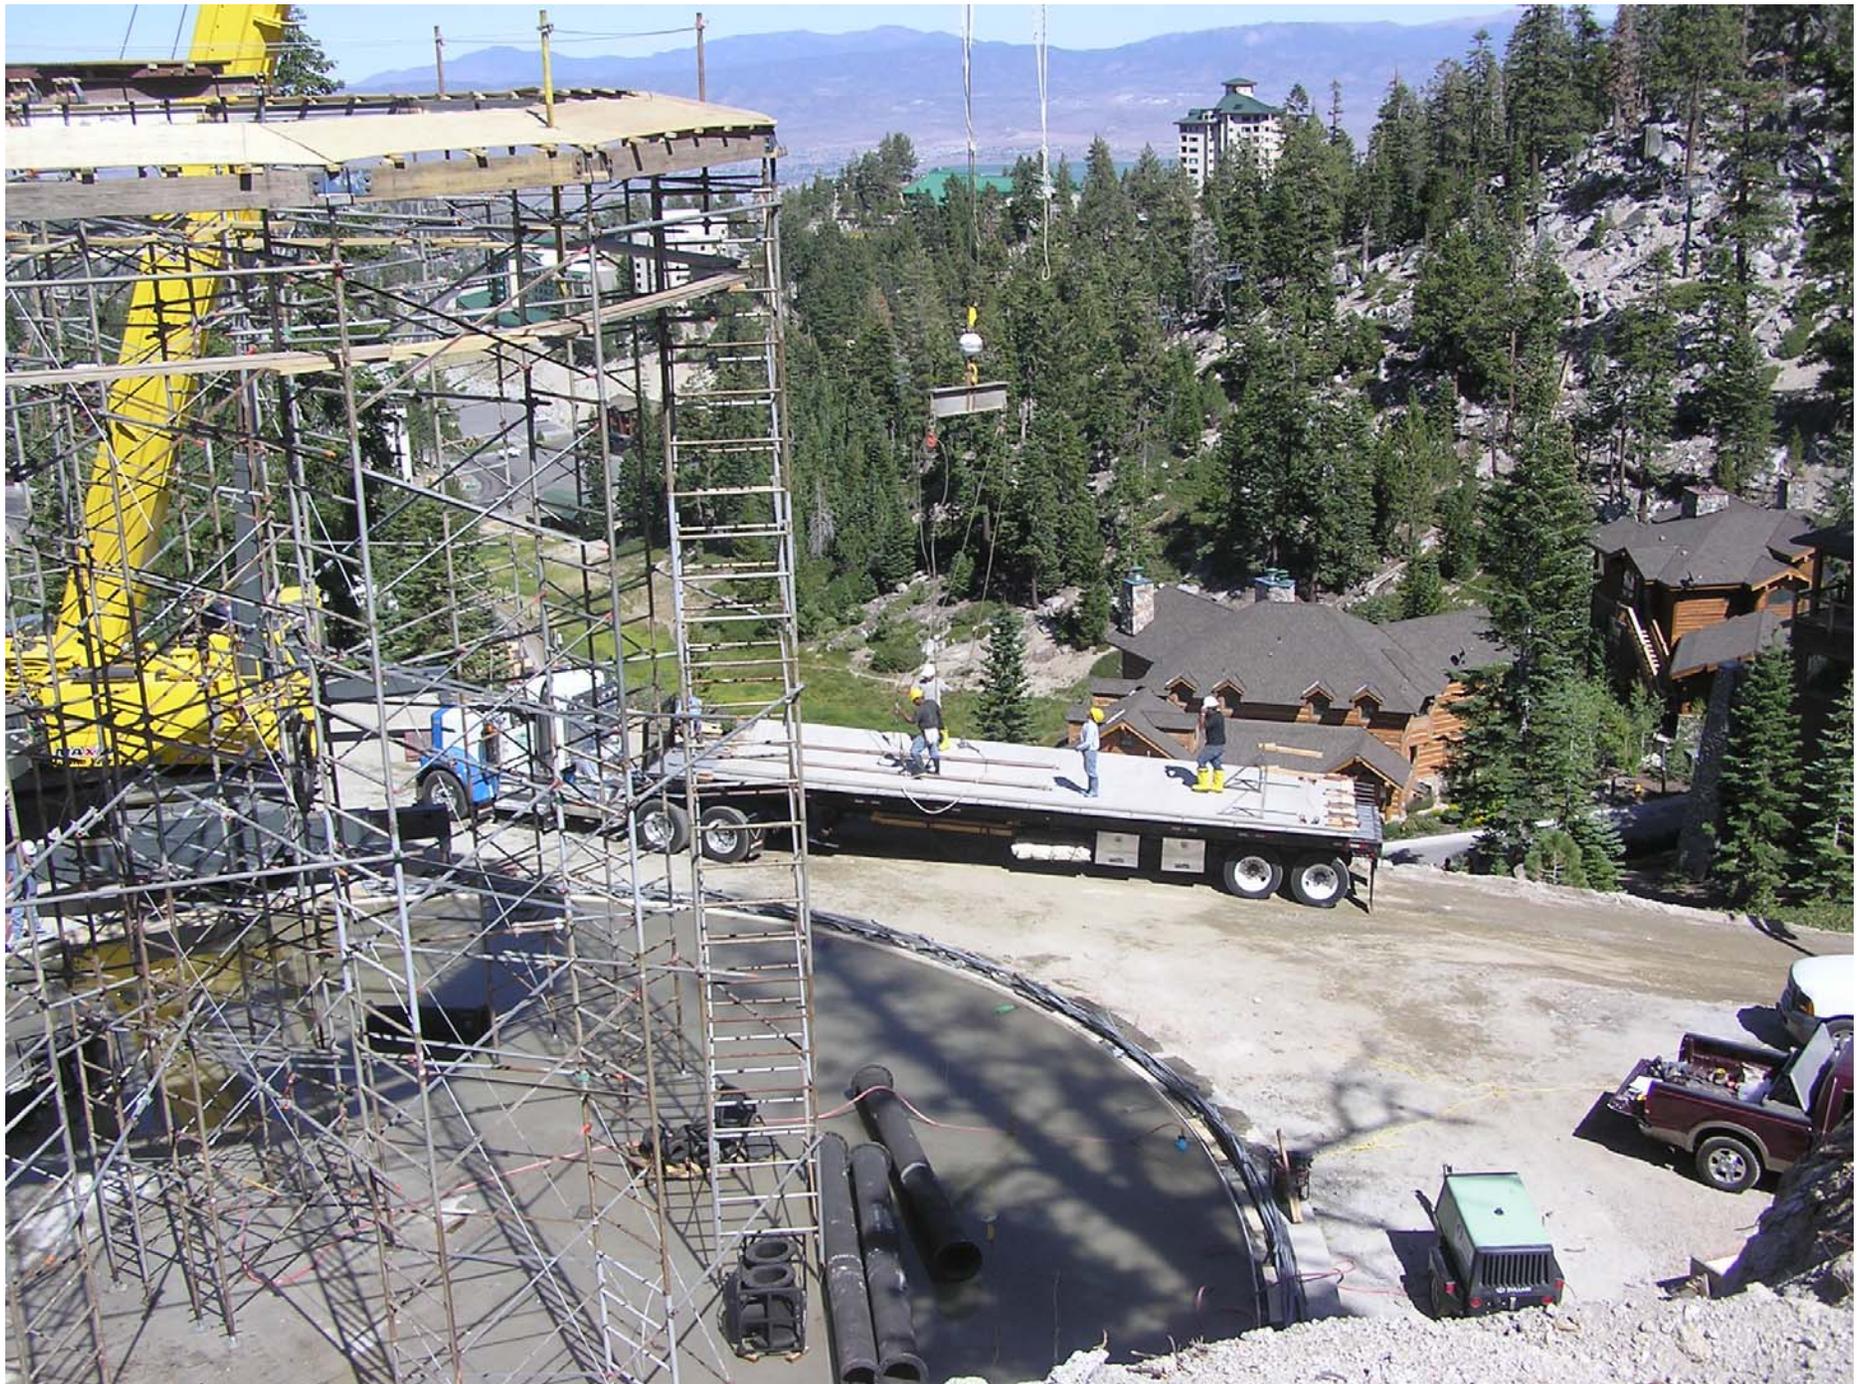
Subcontractor - Natgun - scaffolding inside tank area with next wall panel delivered
