Existing Tank 10A

Completed Tank 10B next to existing Tank 10A

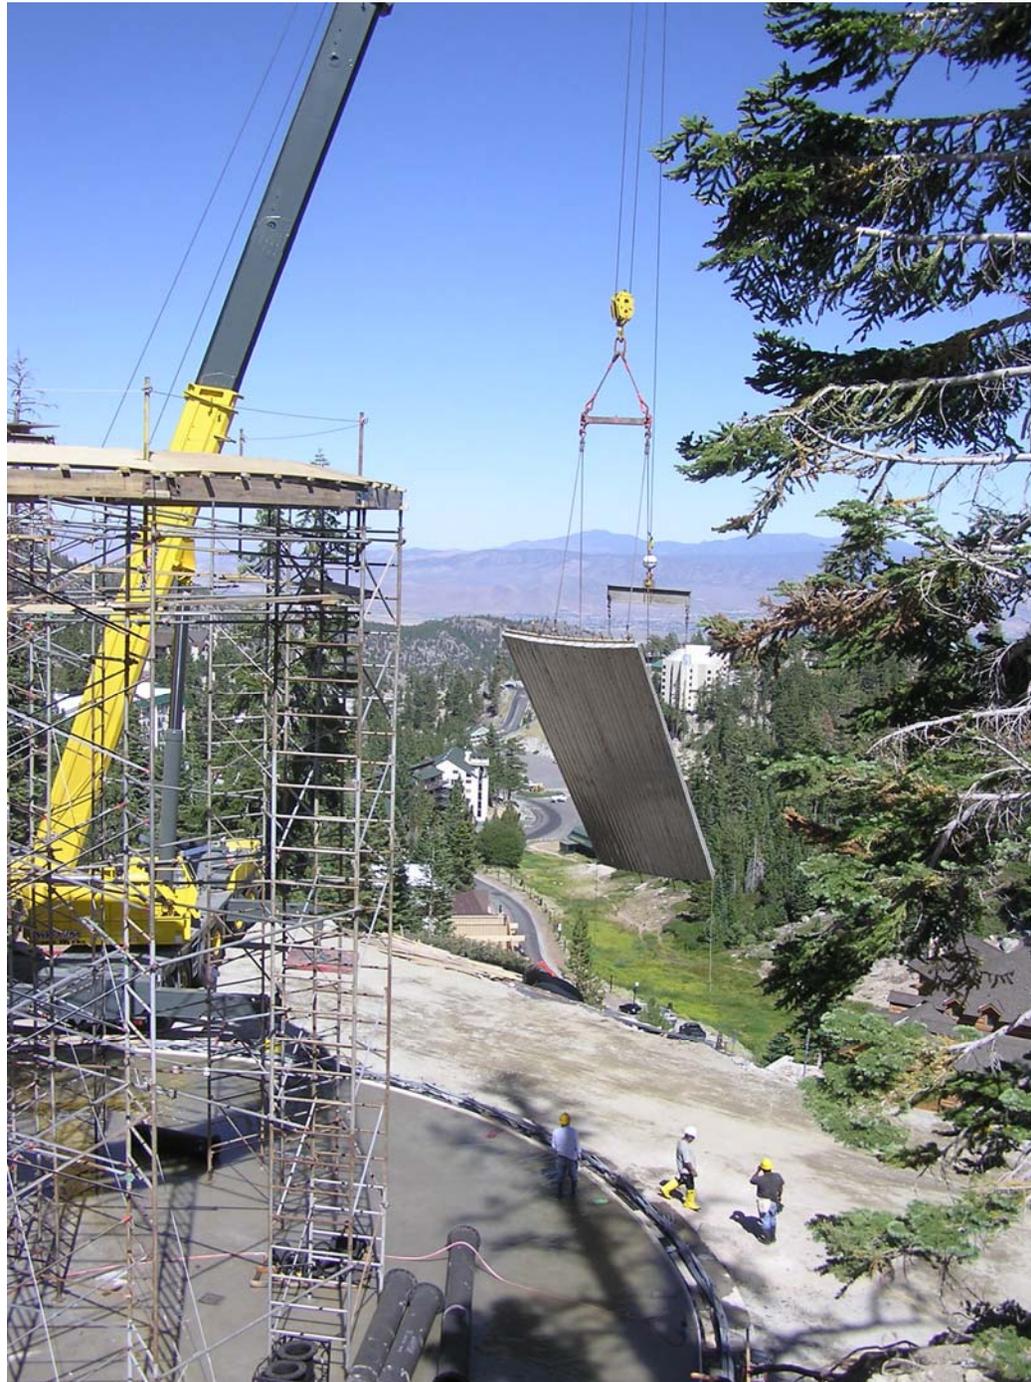
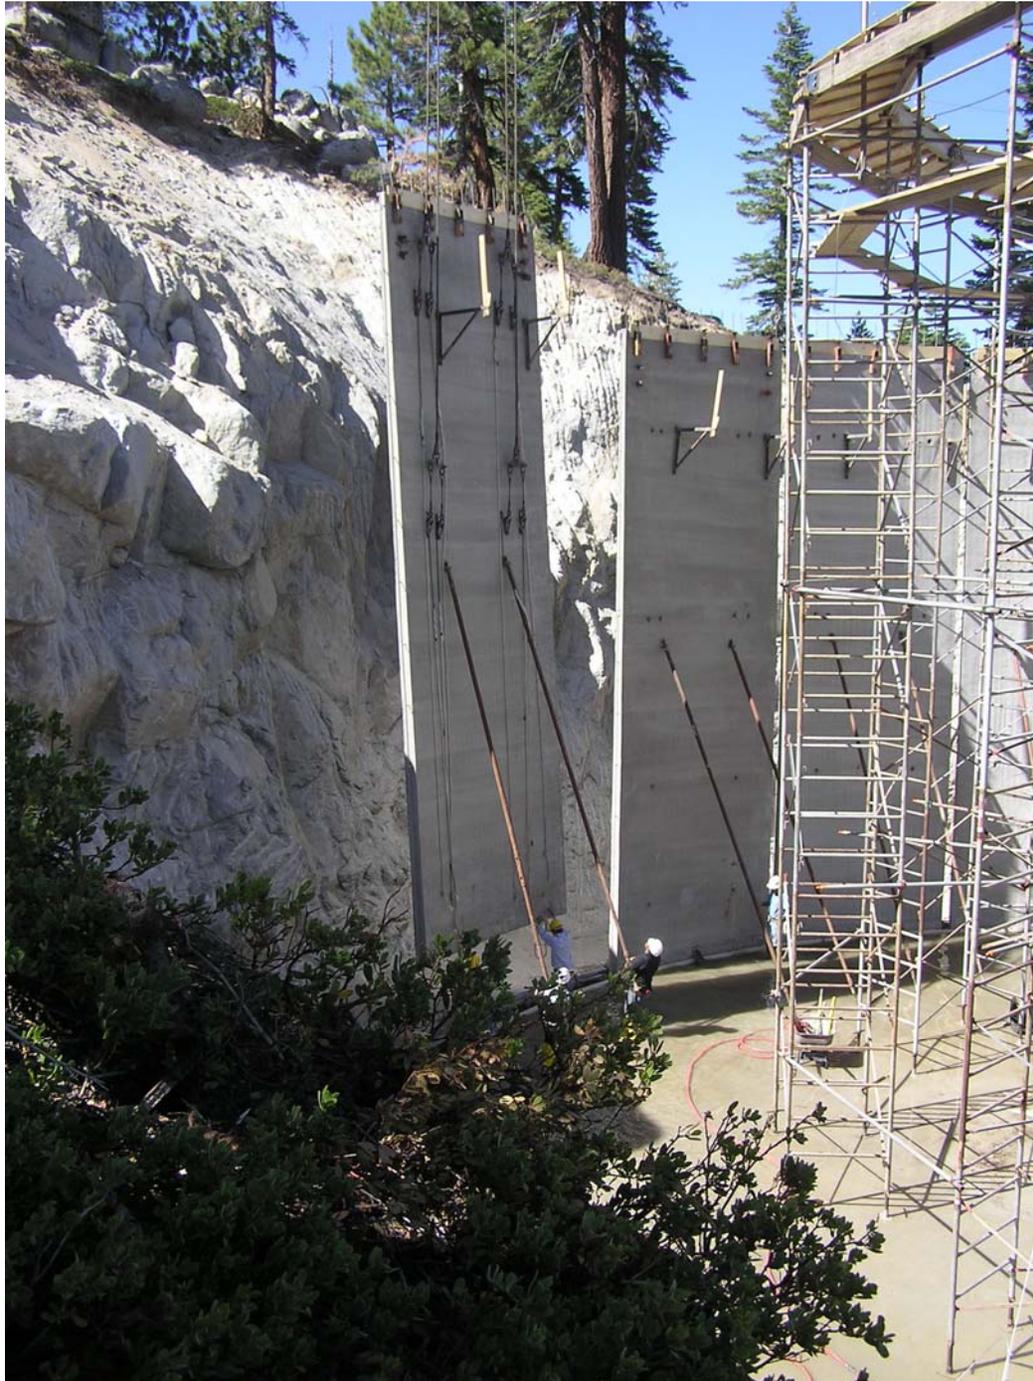
Subcontractor - Natgun - next wall panel being placed

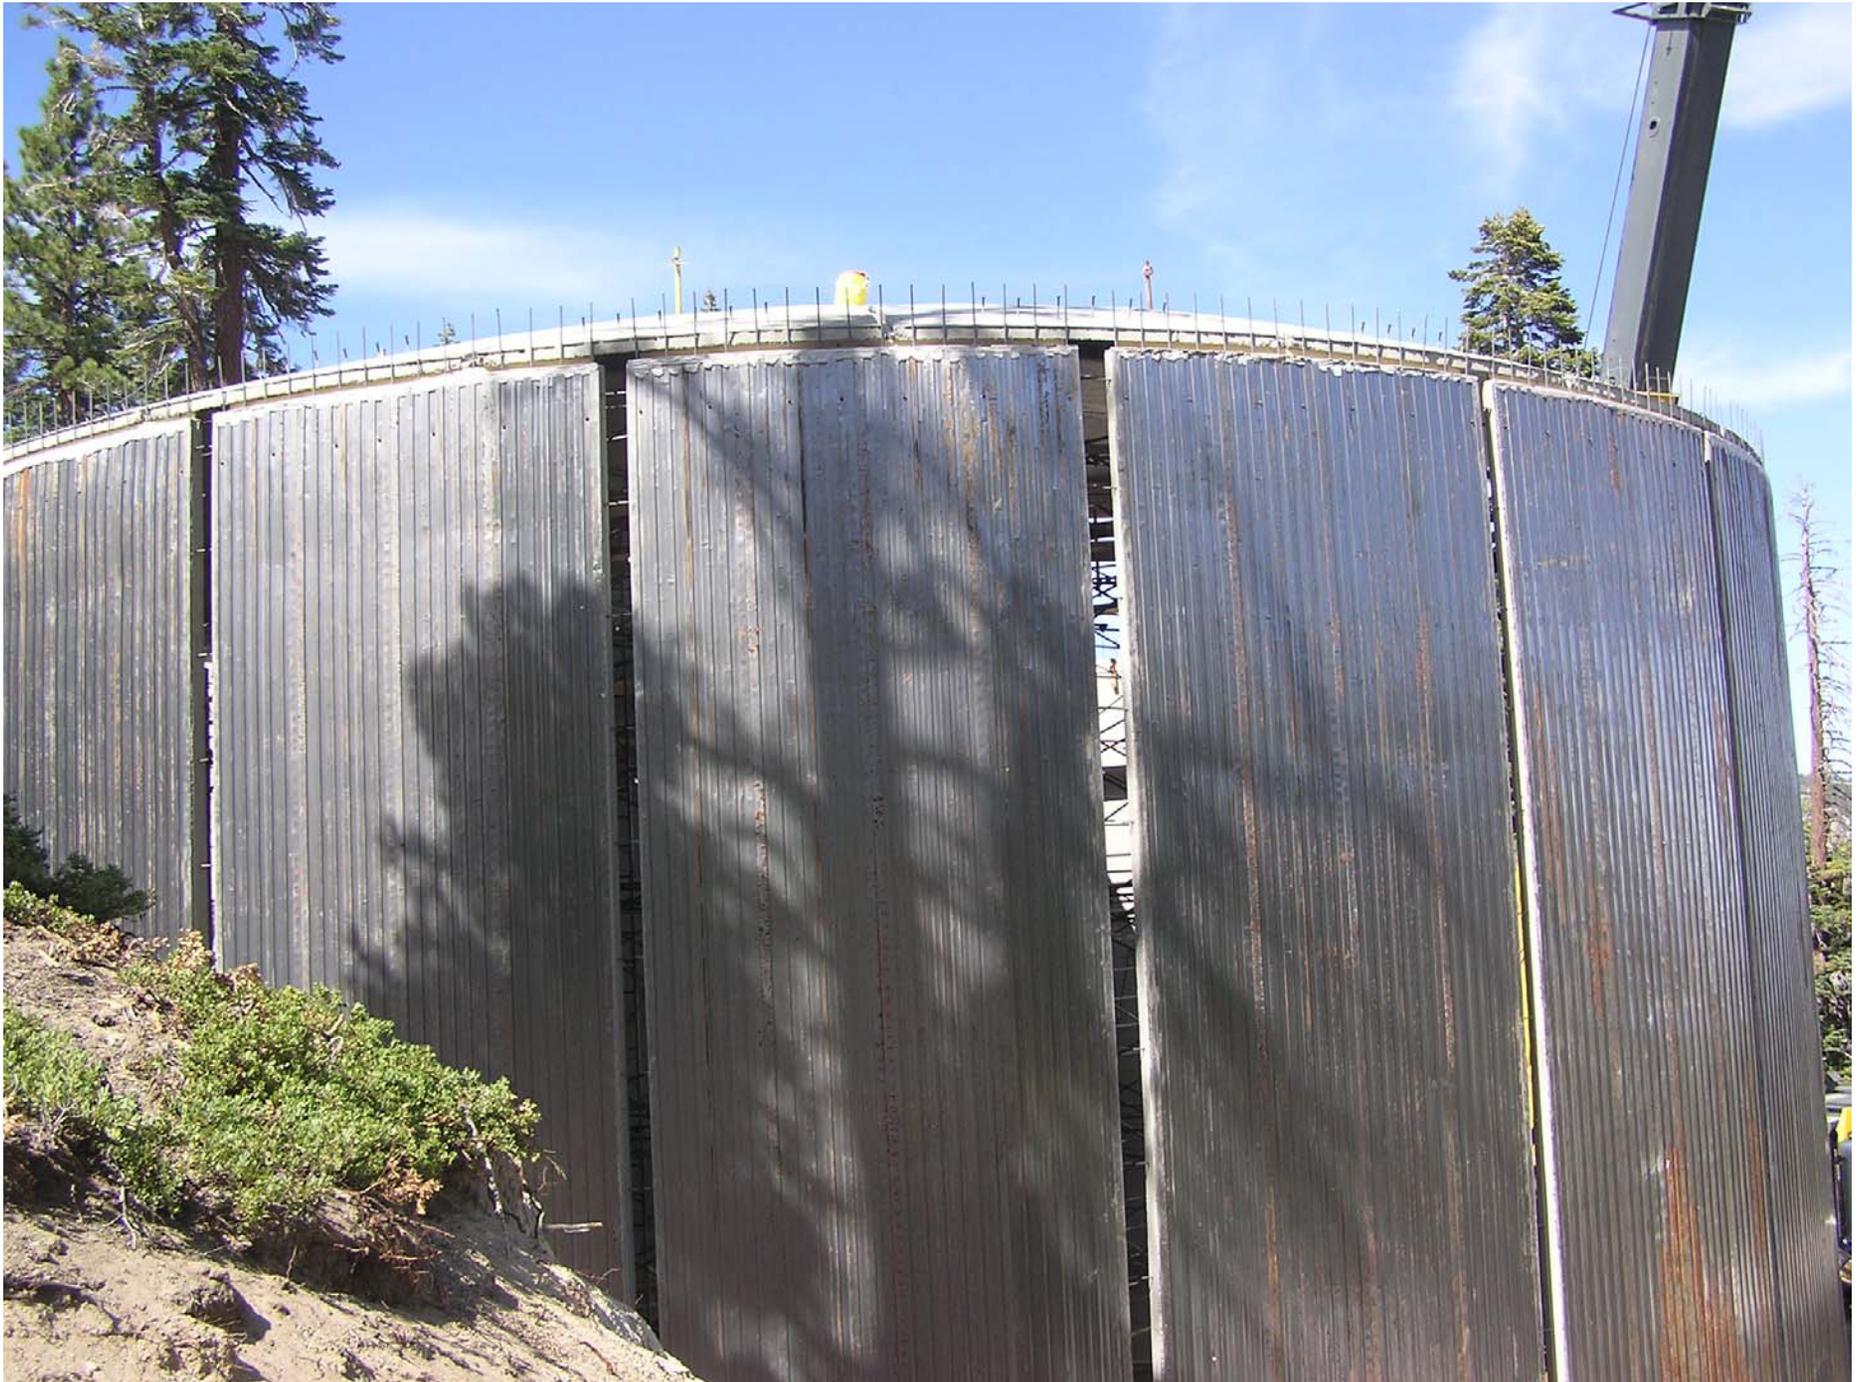
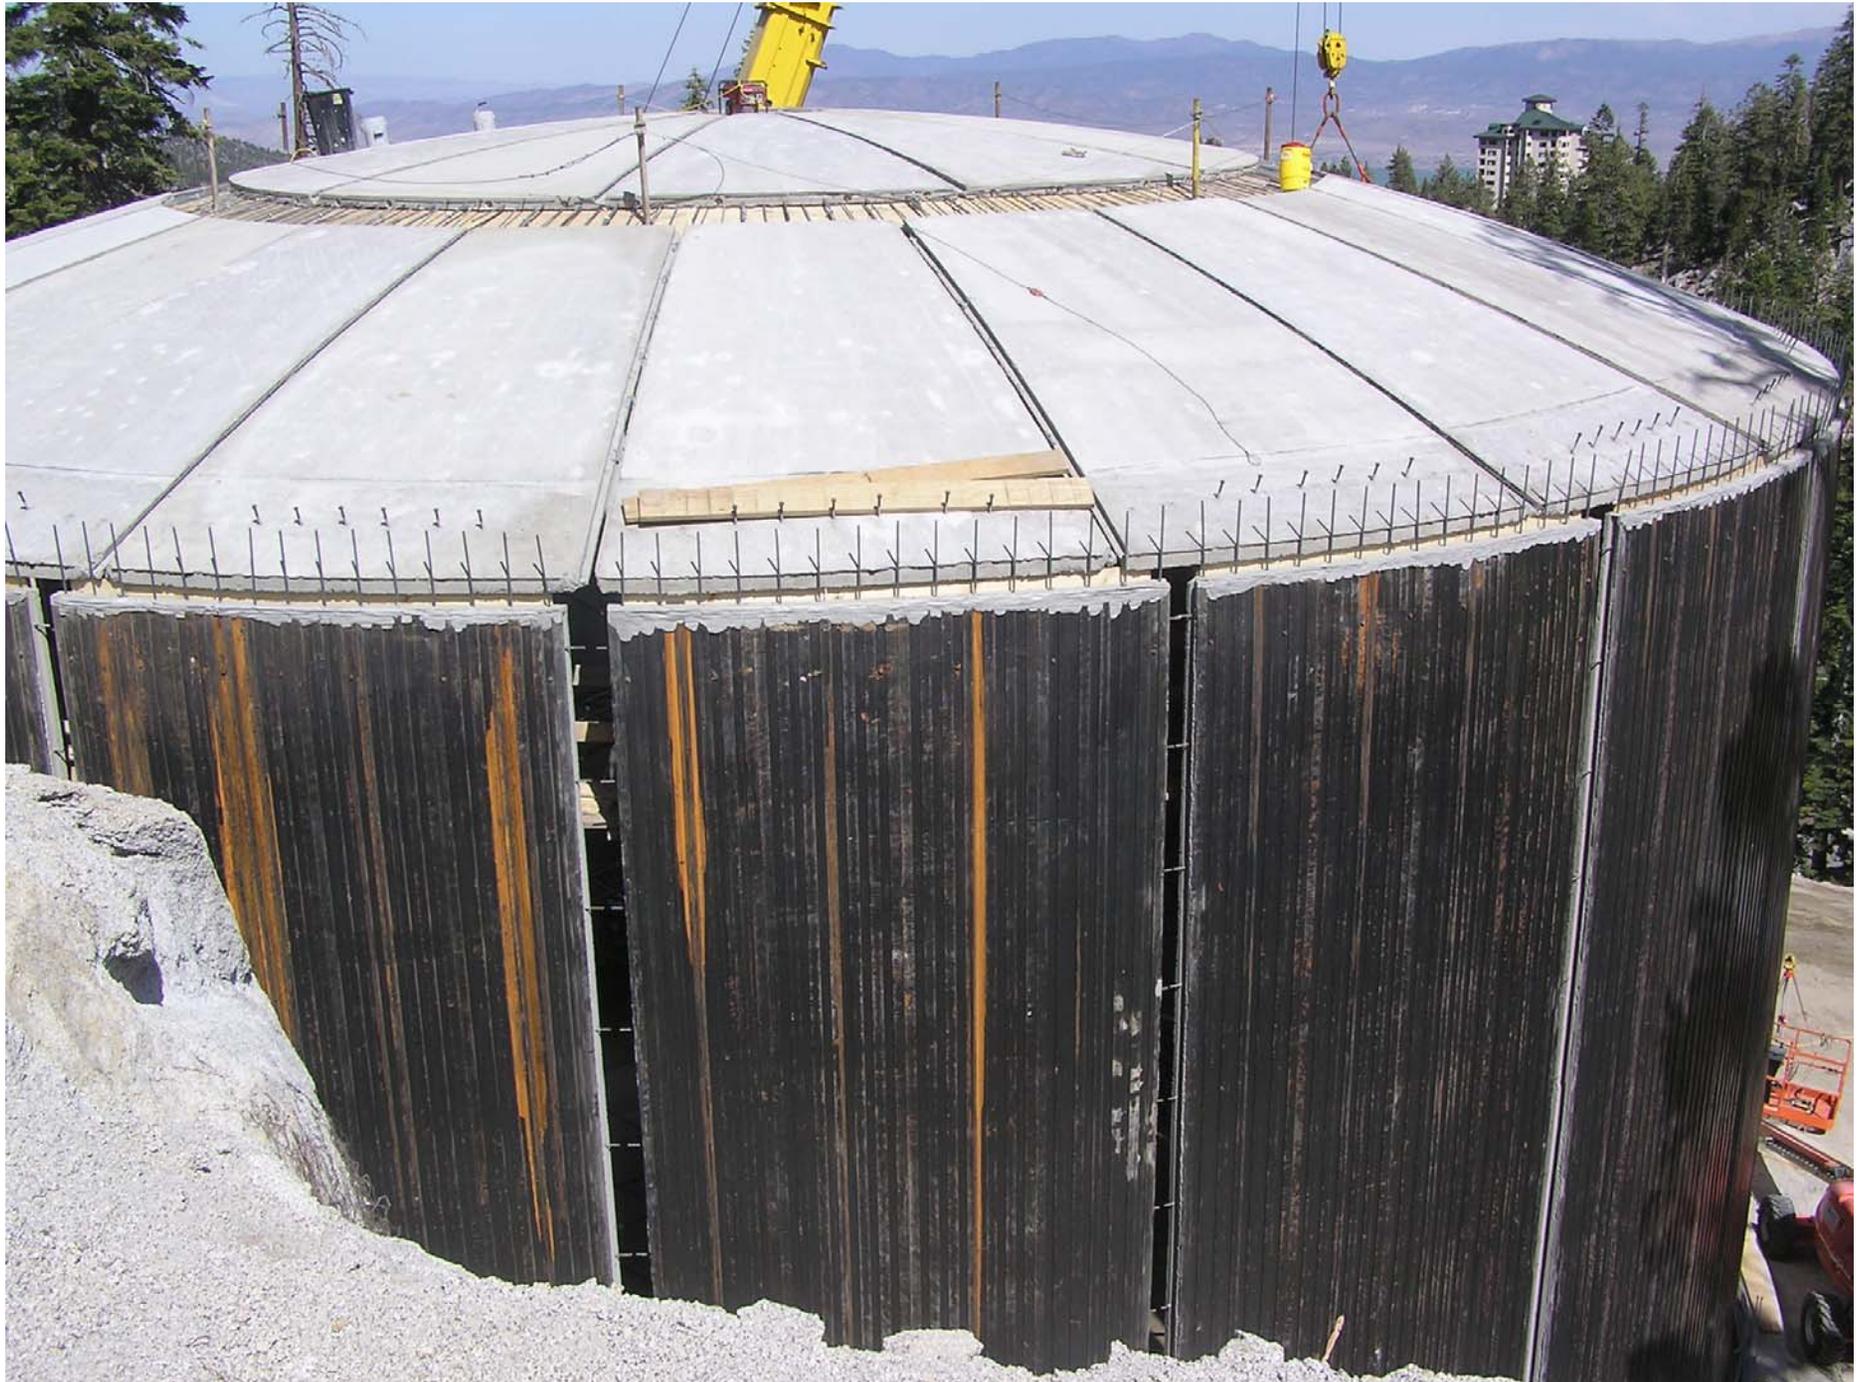
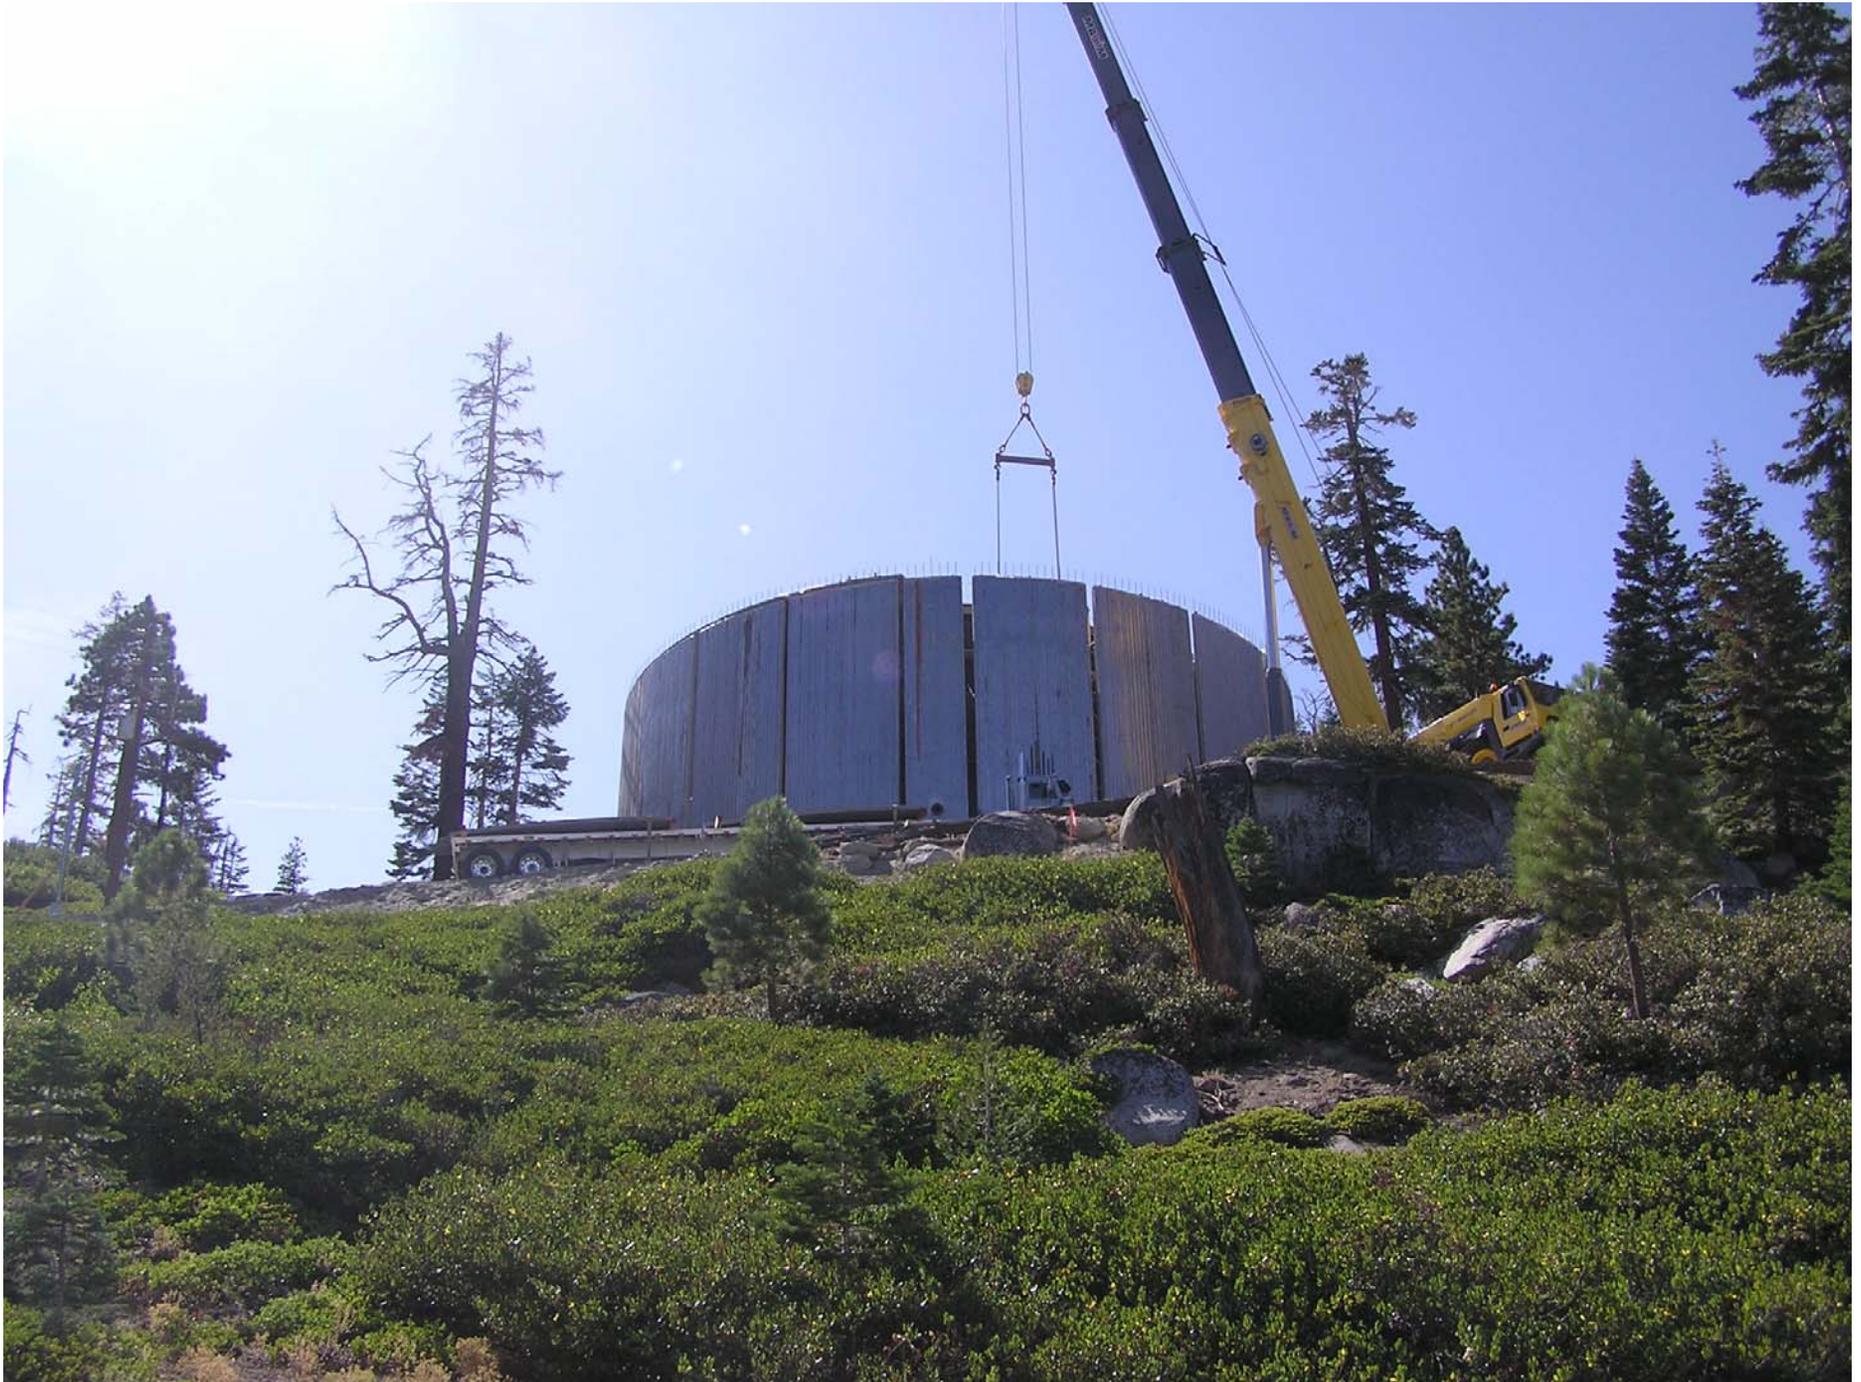
Subcontractor - Natgun - final wall & dome panels lifted into place

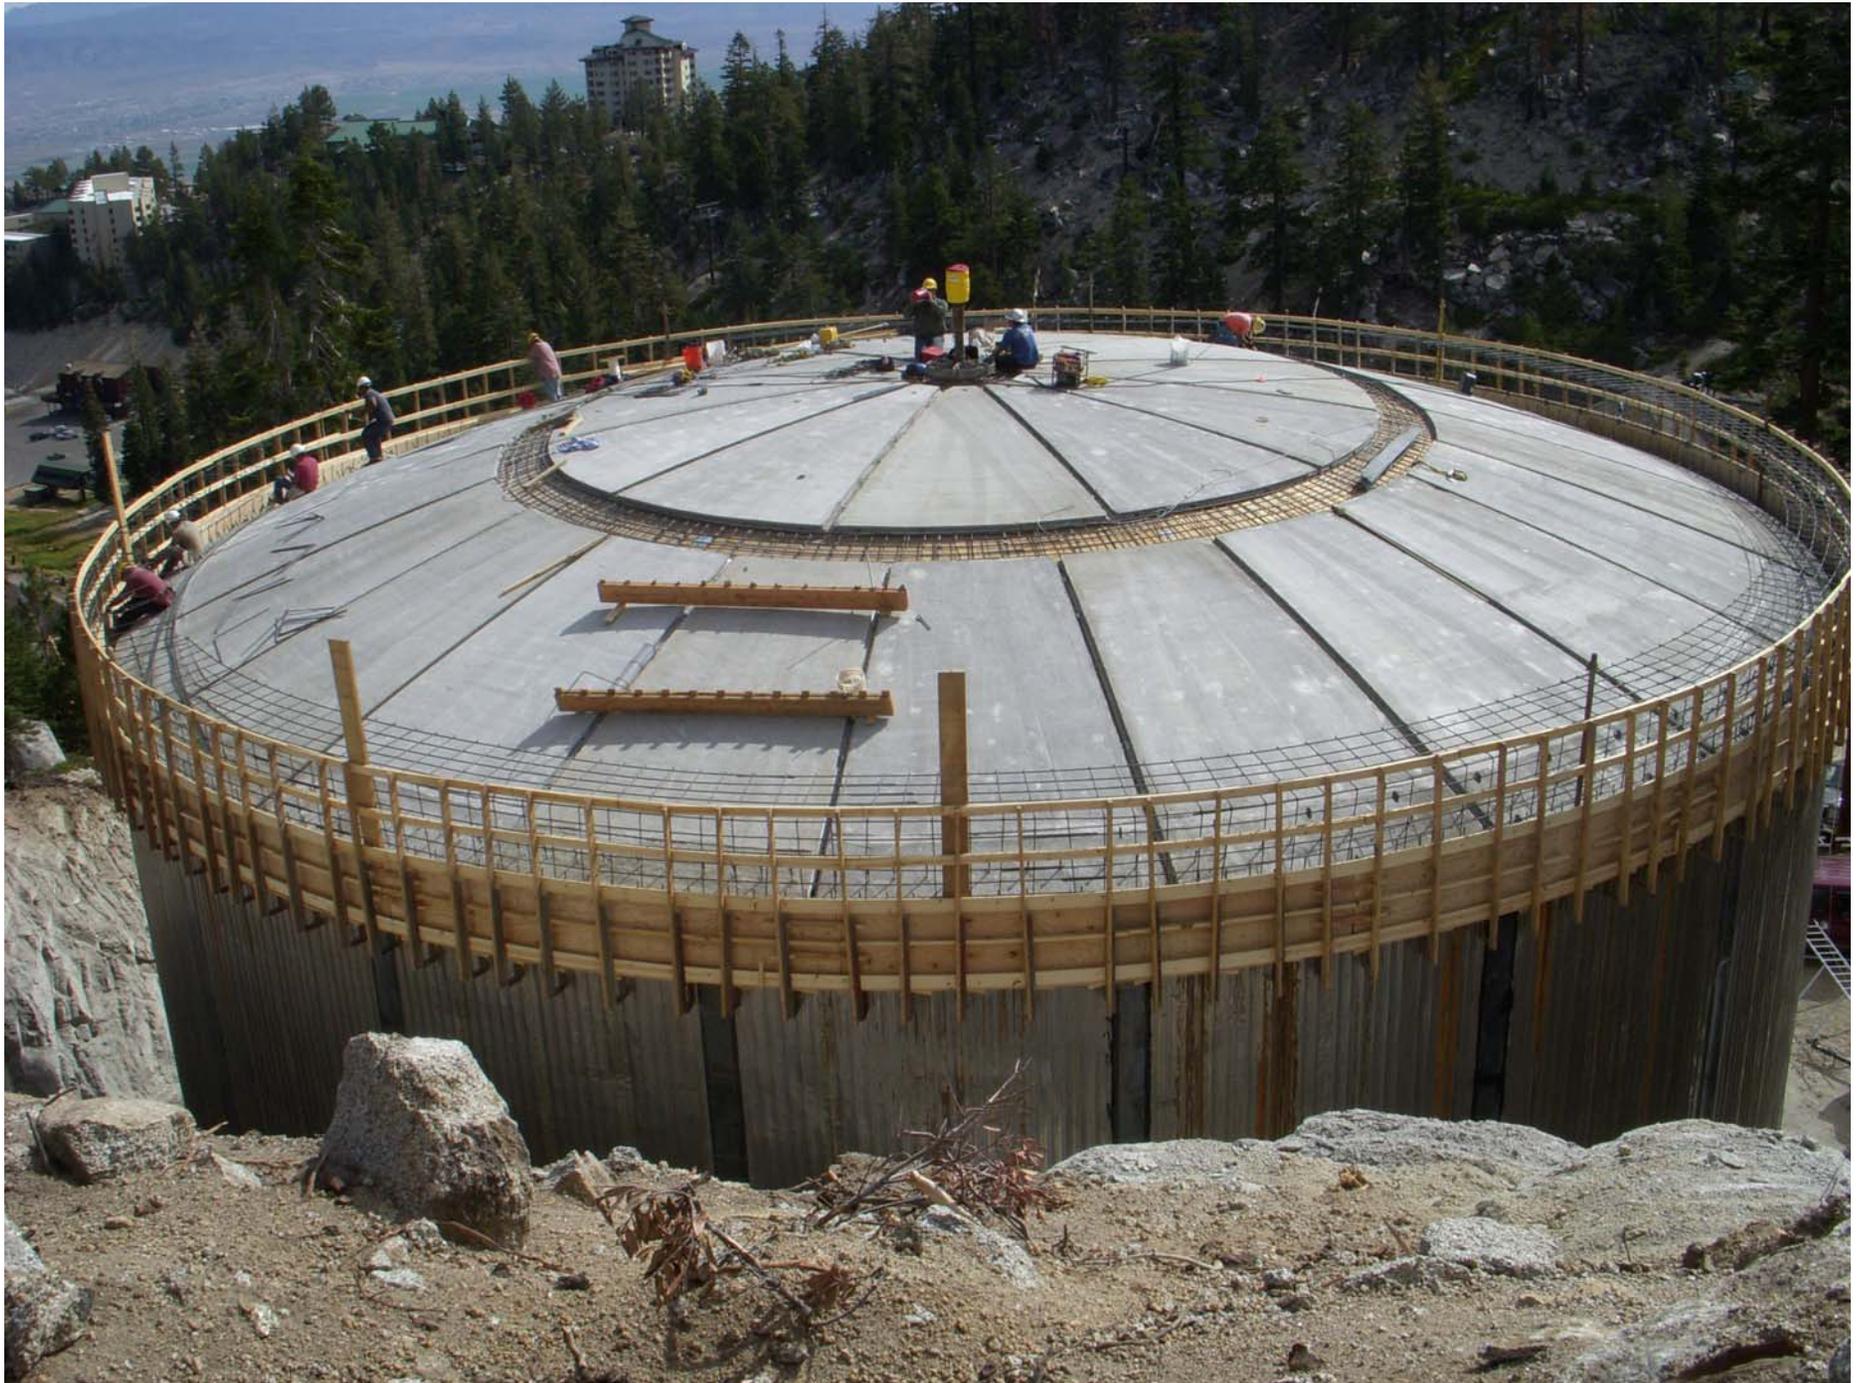
Subcontractor - Natgun - preparations for final concrete pours between panels

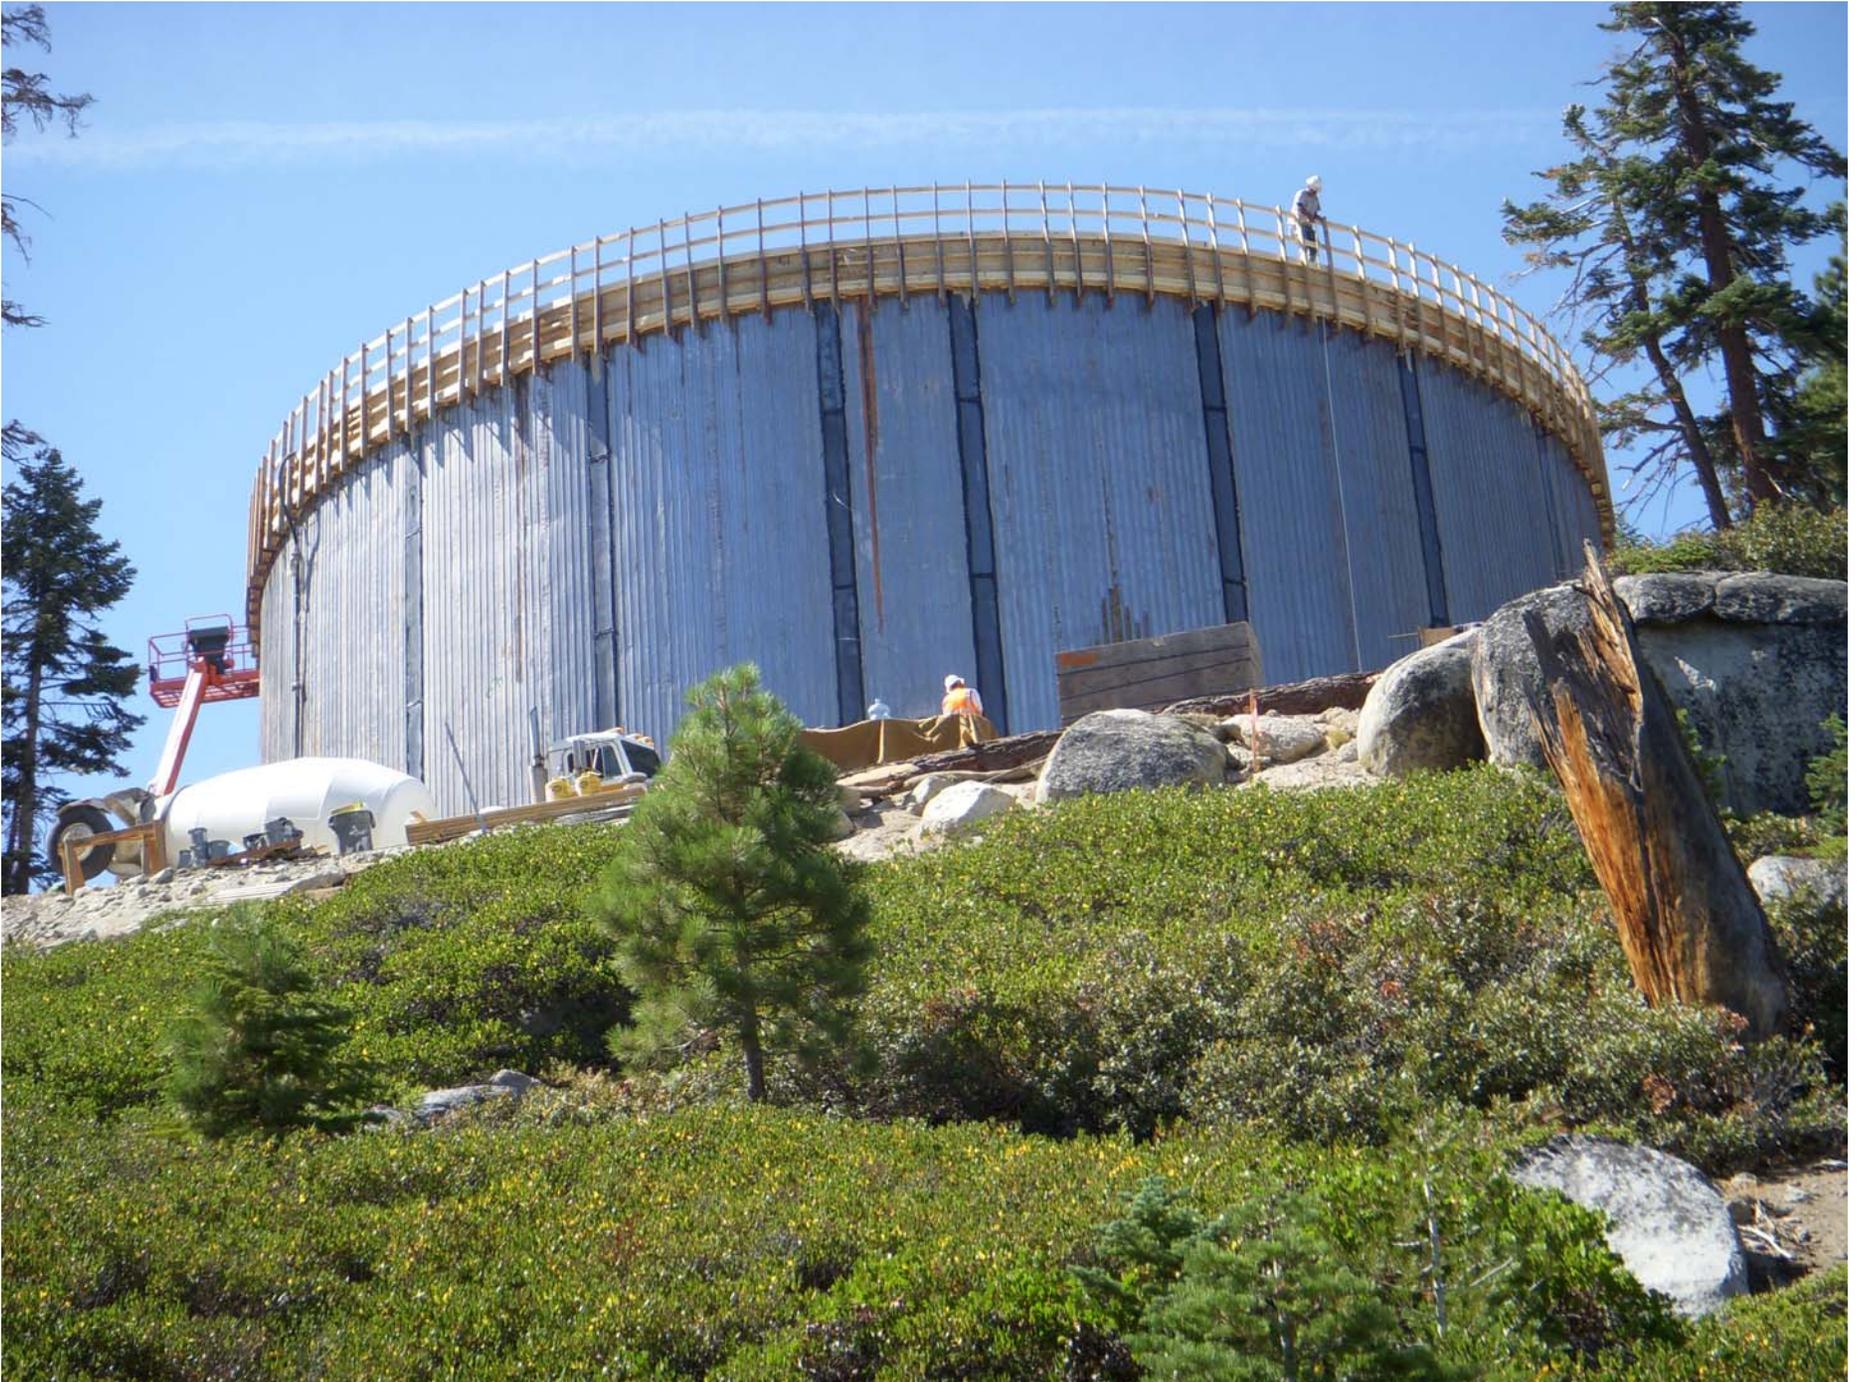
Subcontractor - Natgun - final concrete pours between panels

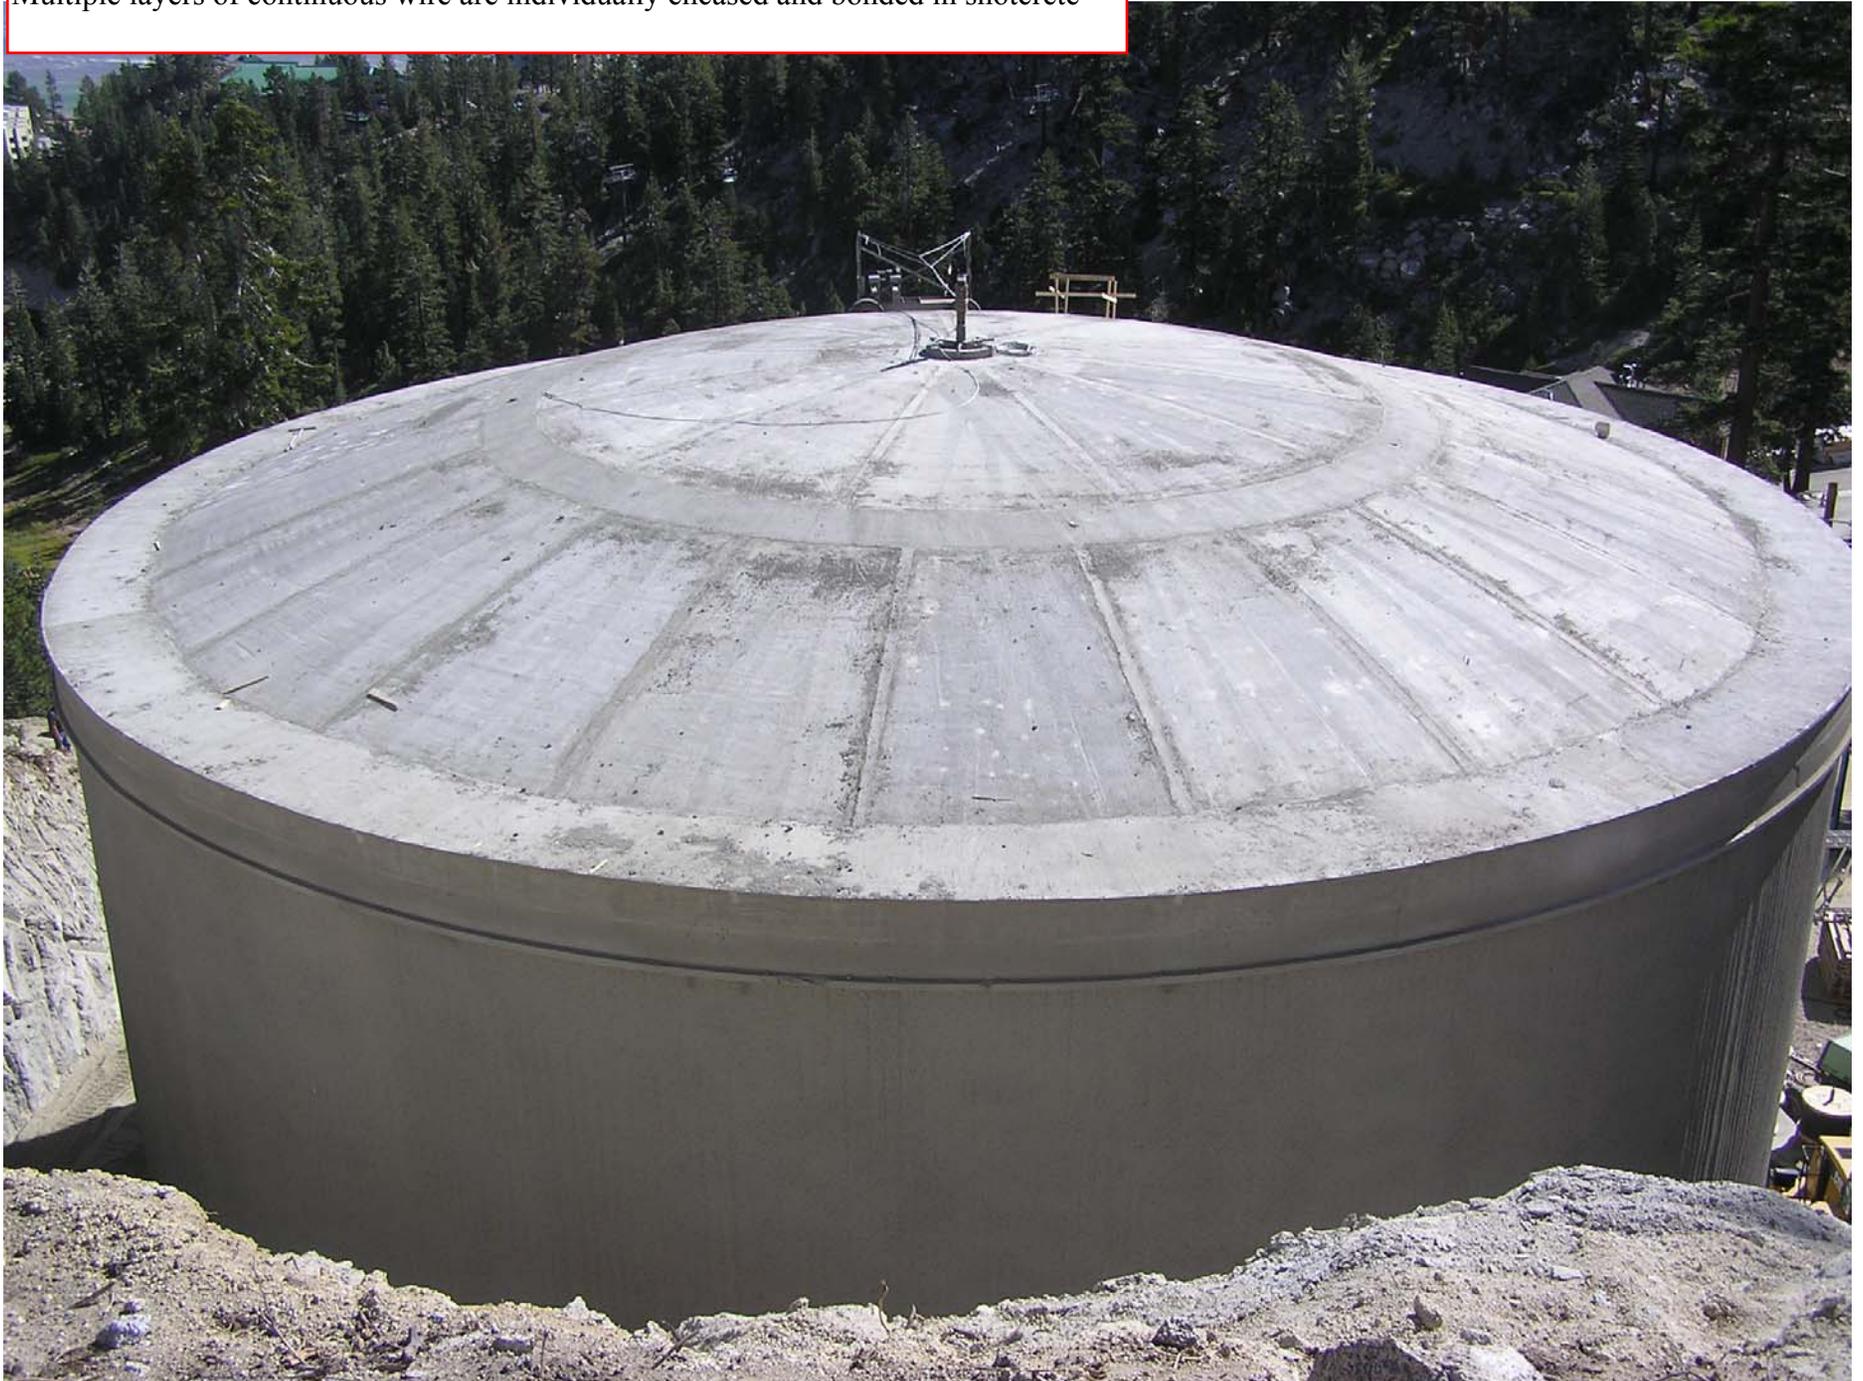
Subcontractor - Natgun - dome has been wire wound & shotcrete applied
Multiple layers of continuous wire are individually encased and bonded in shotcrete
