Existing Tank 10A

Completed Tank 10B next to existing Tank 10A

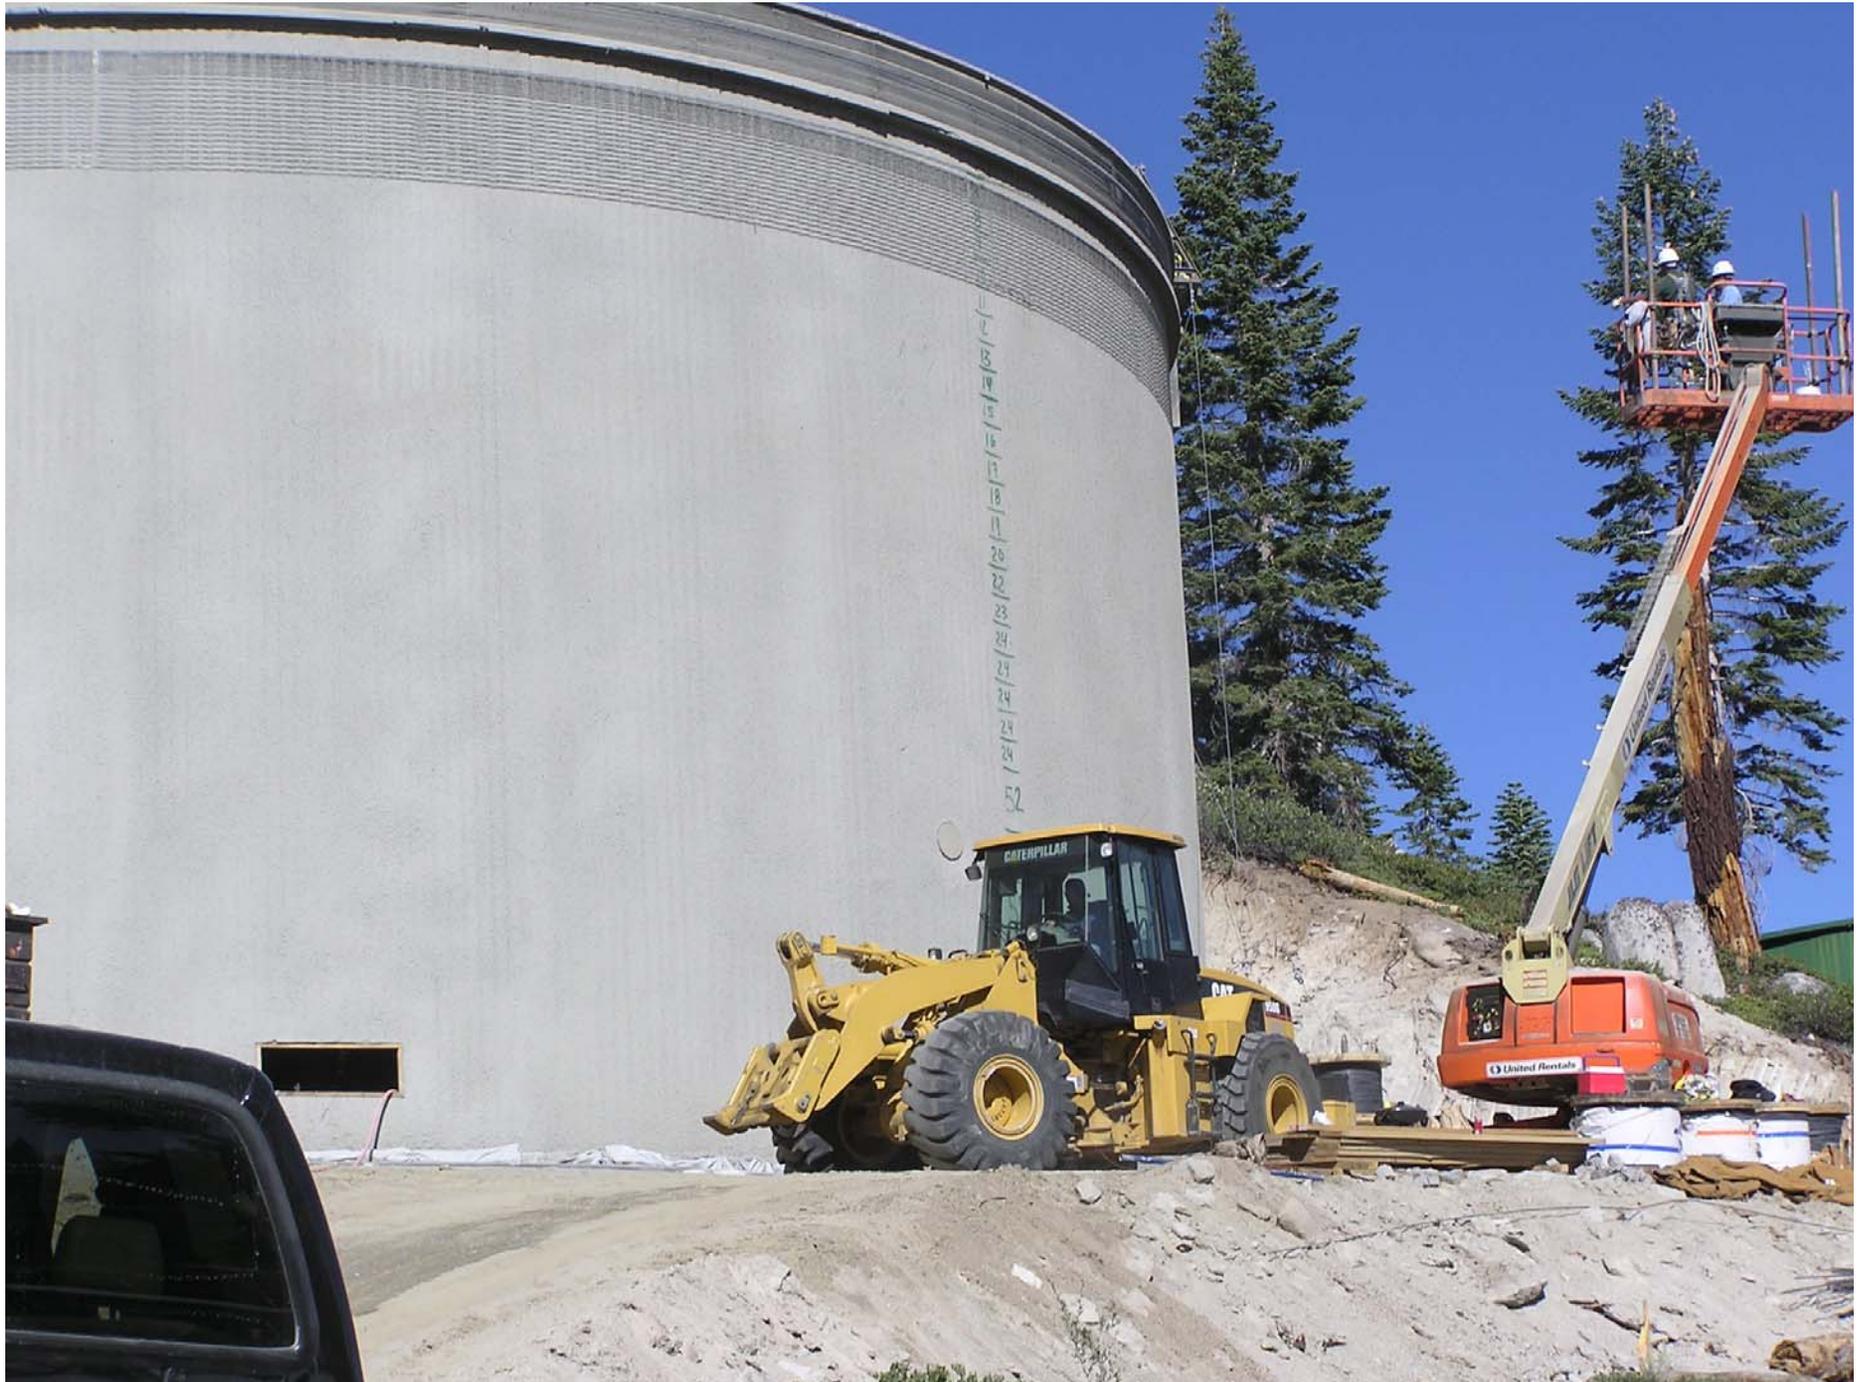
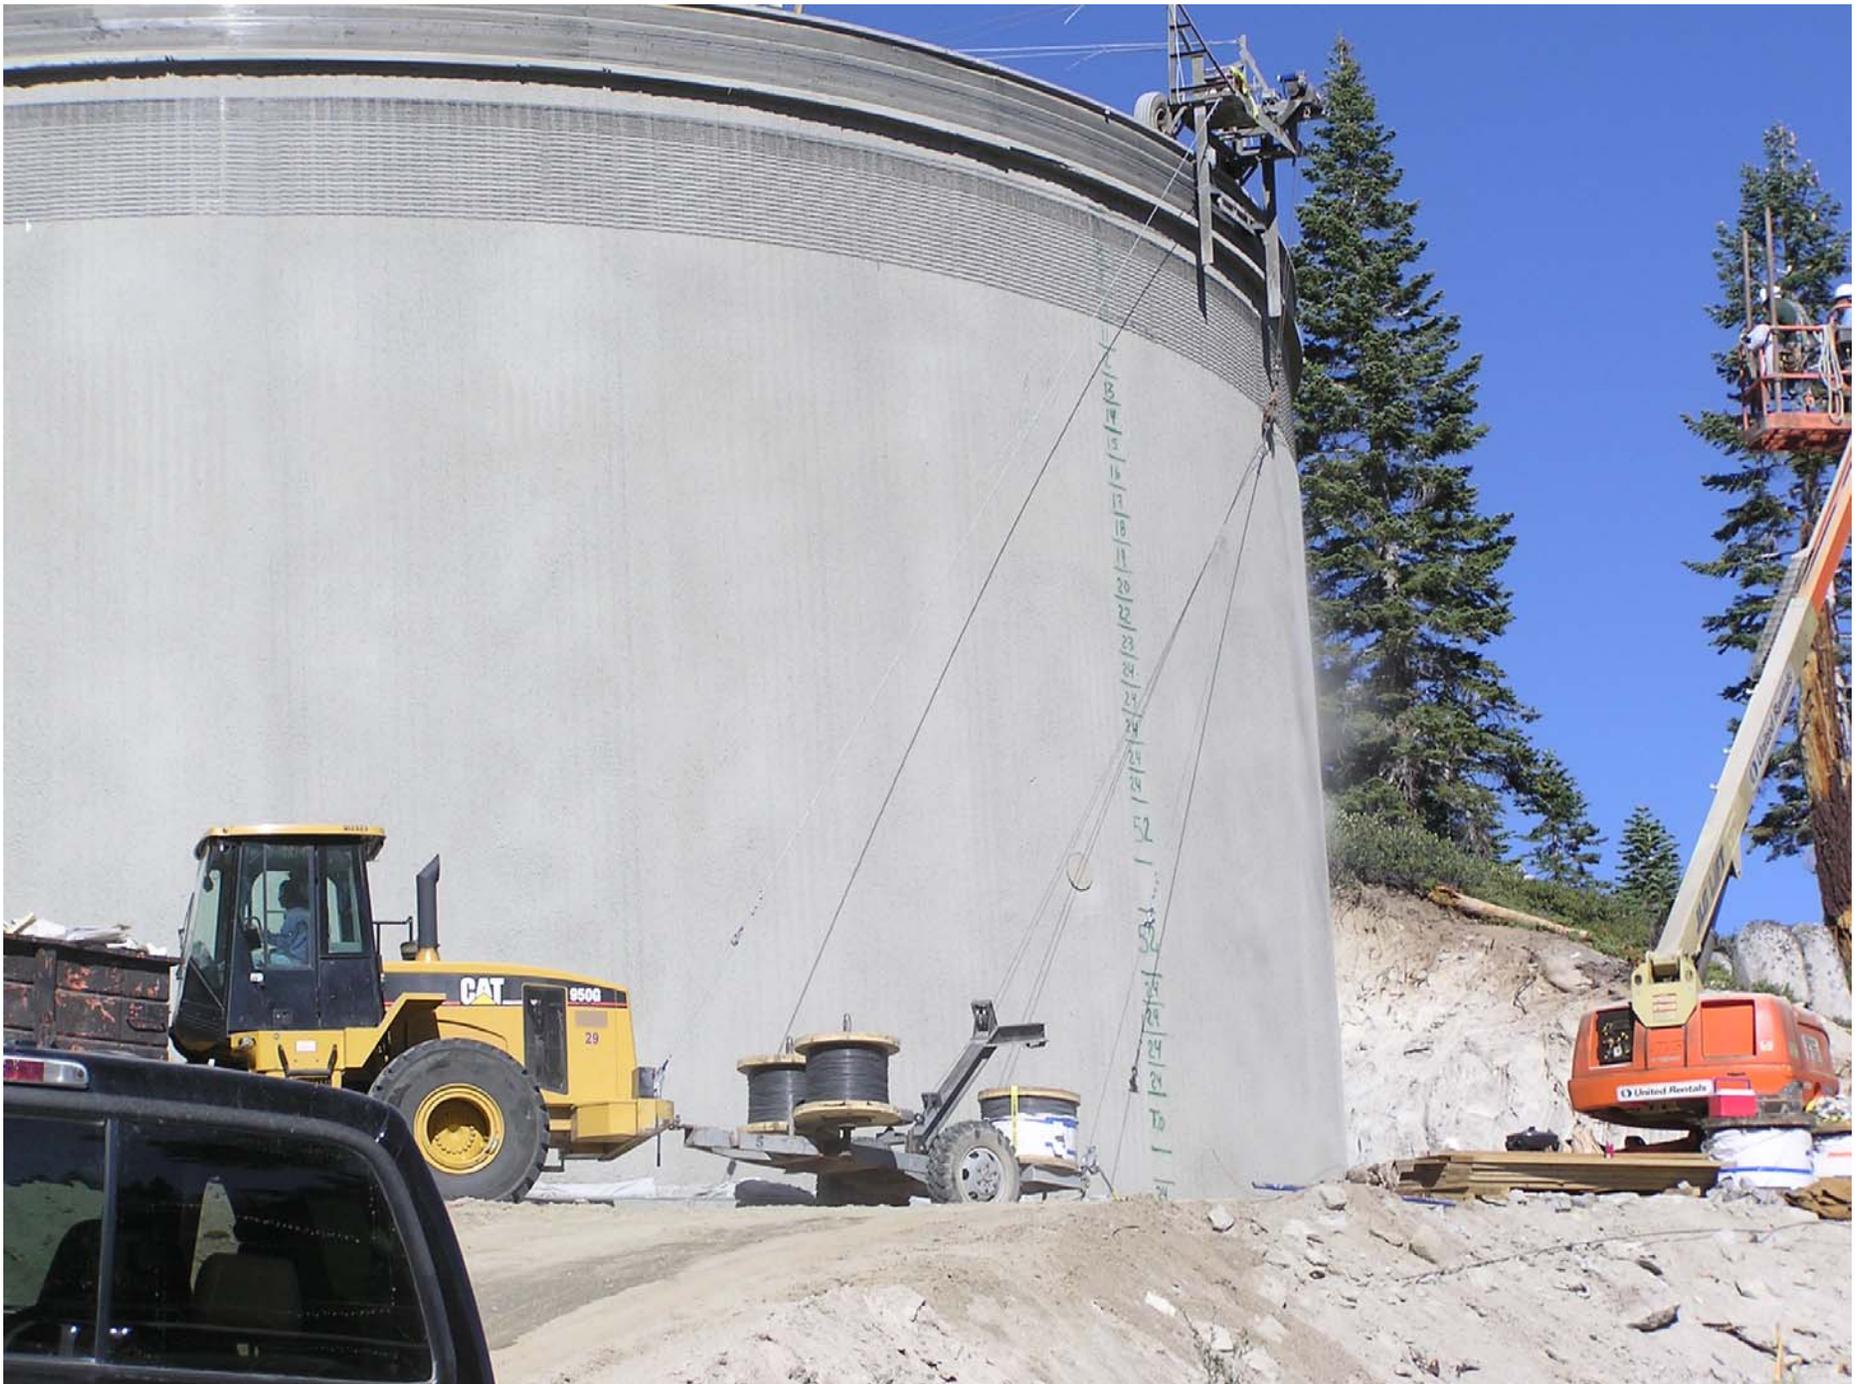
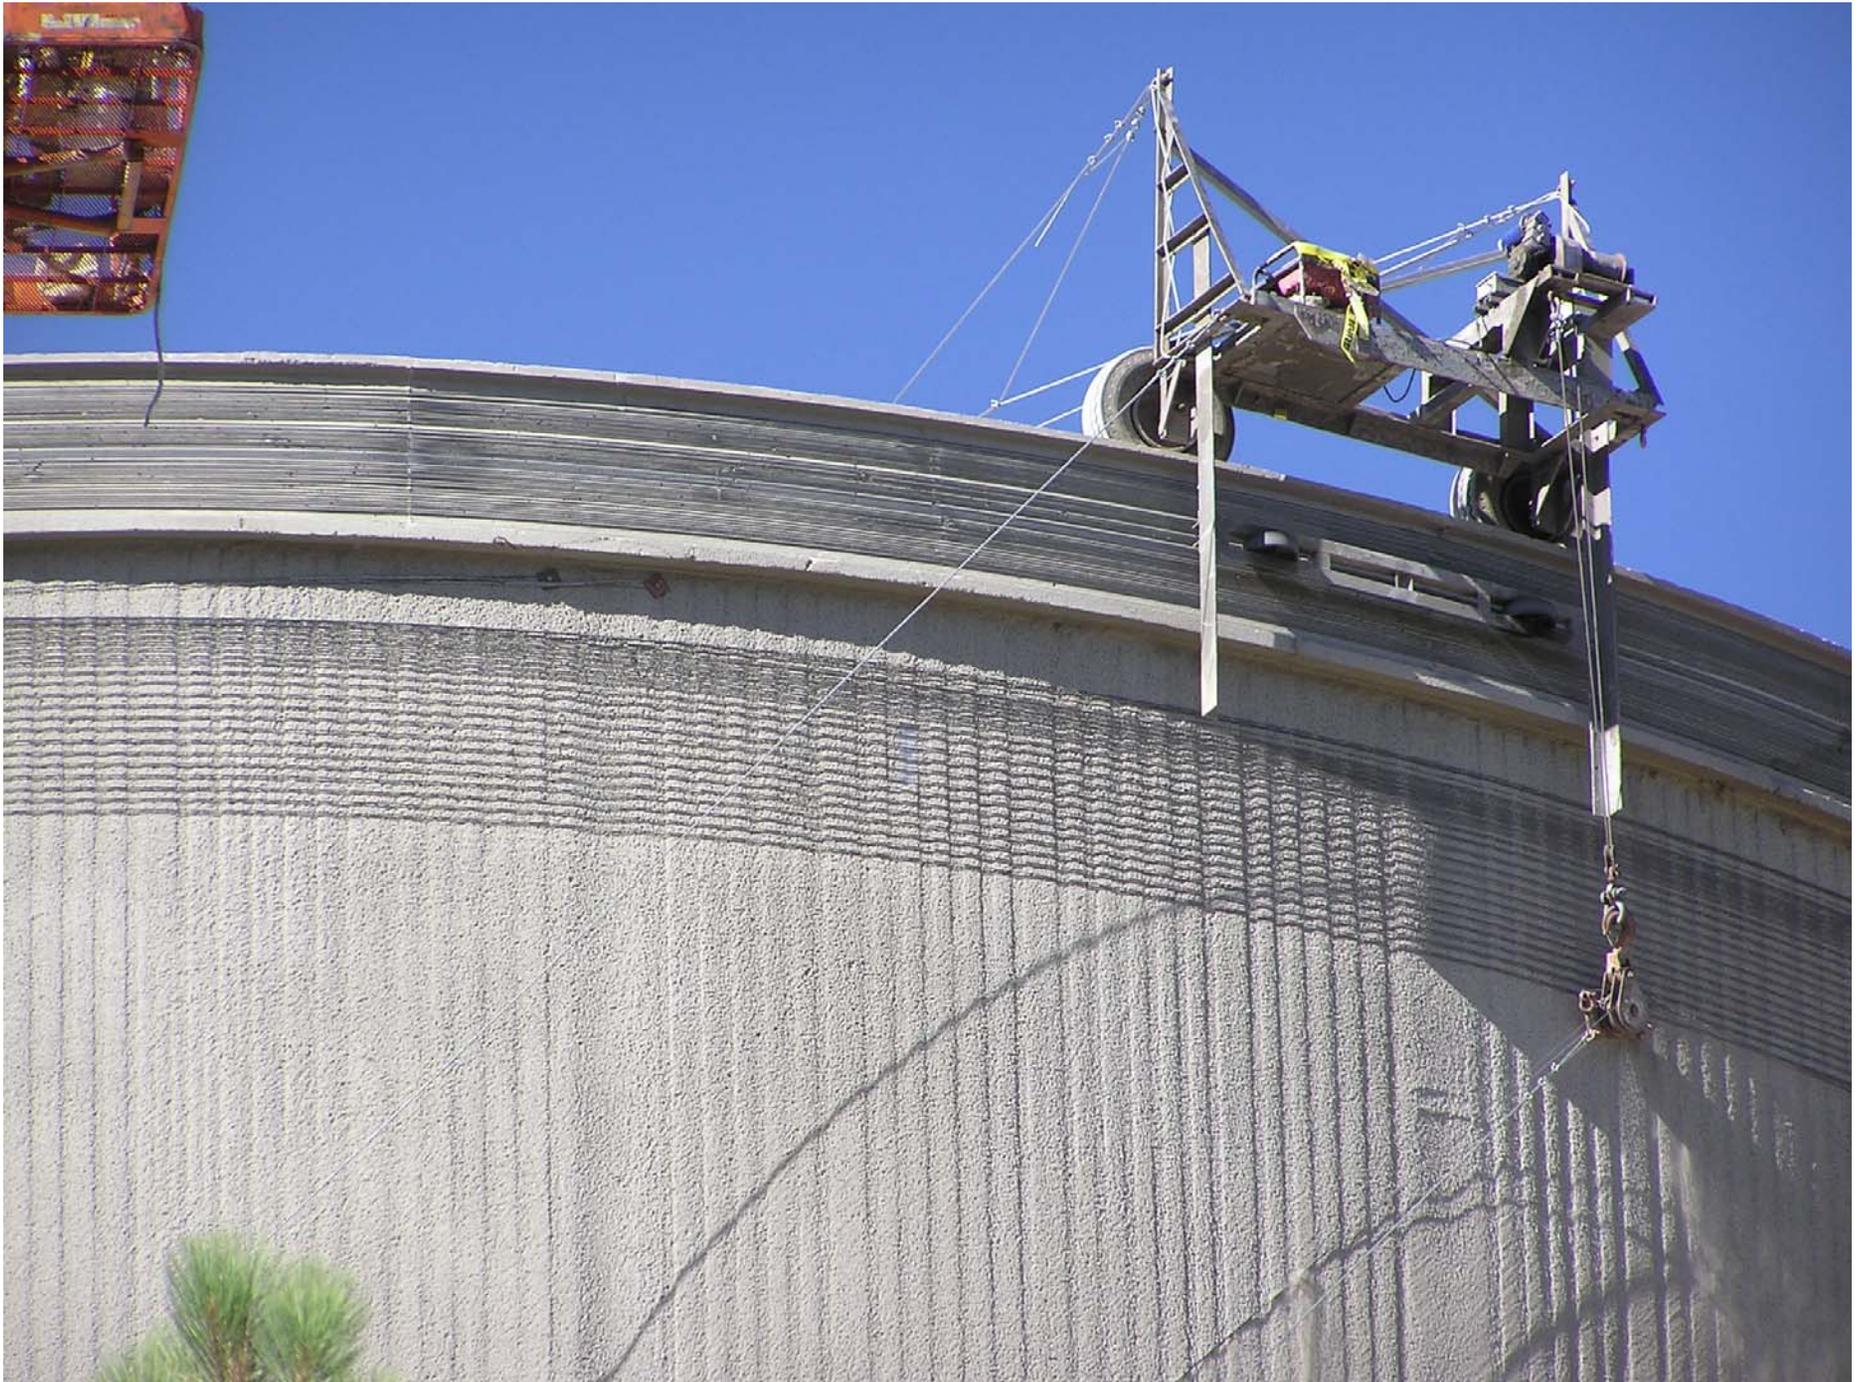
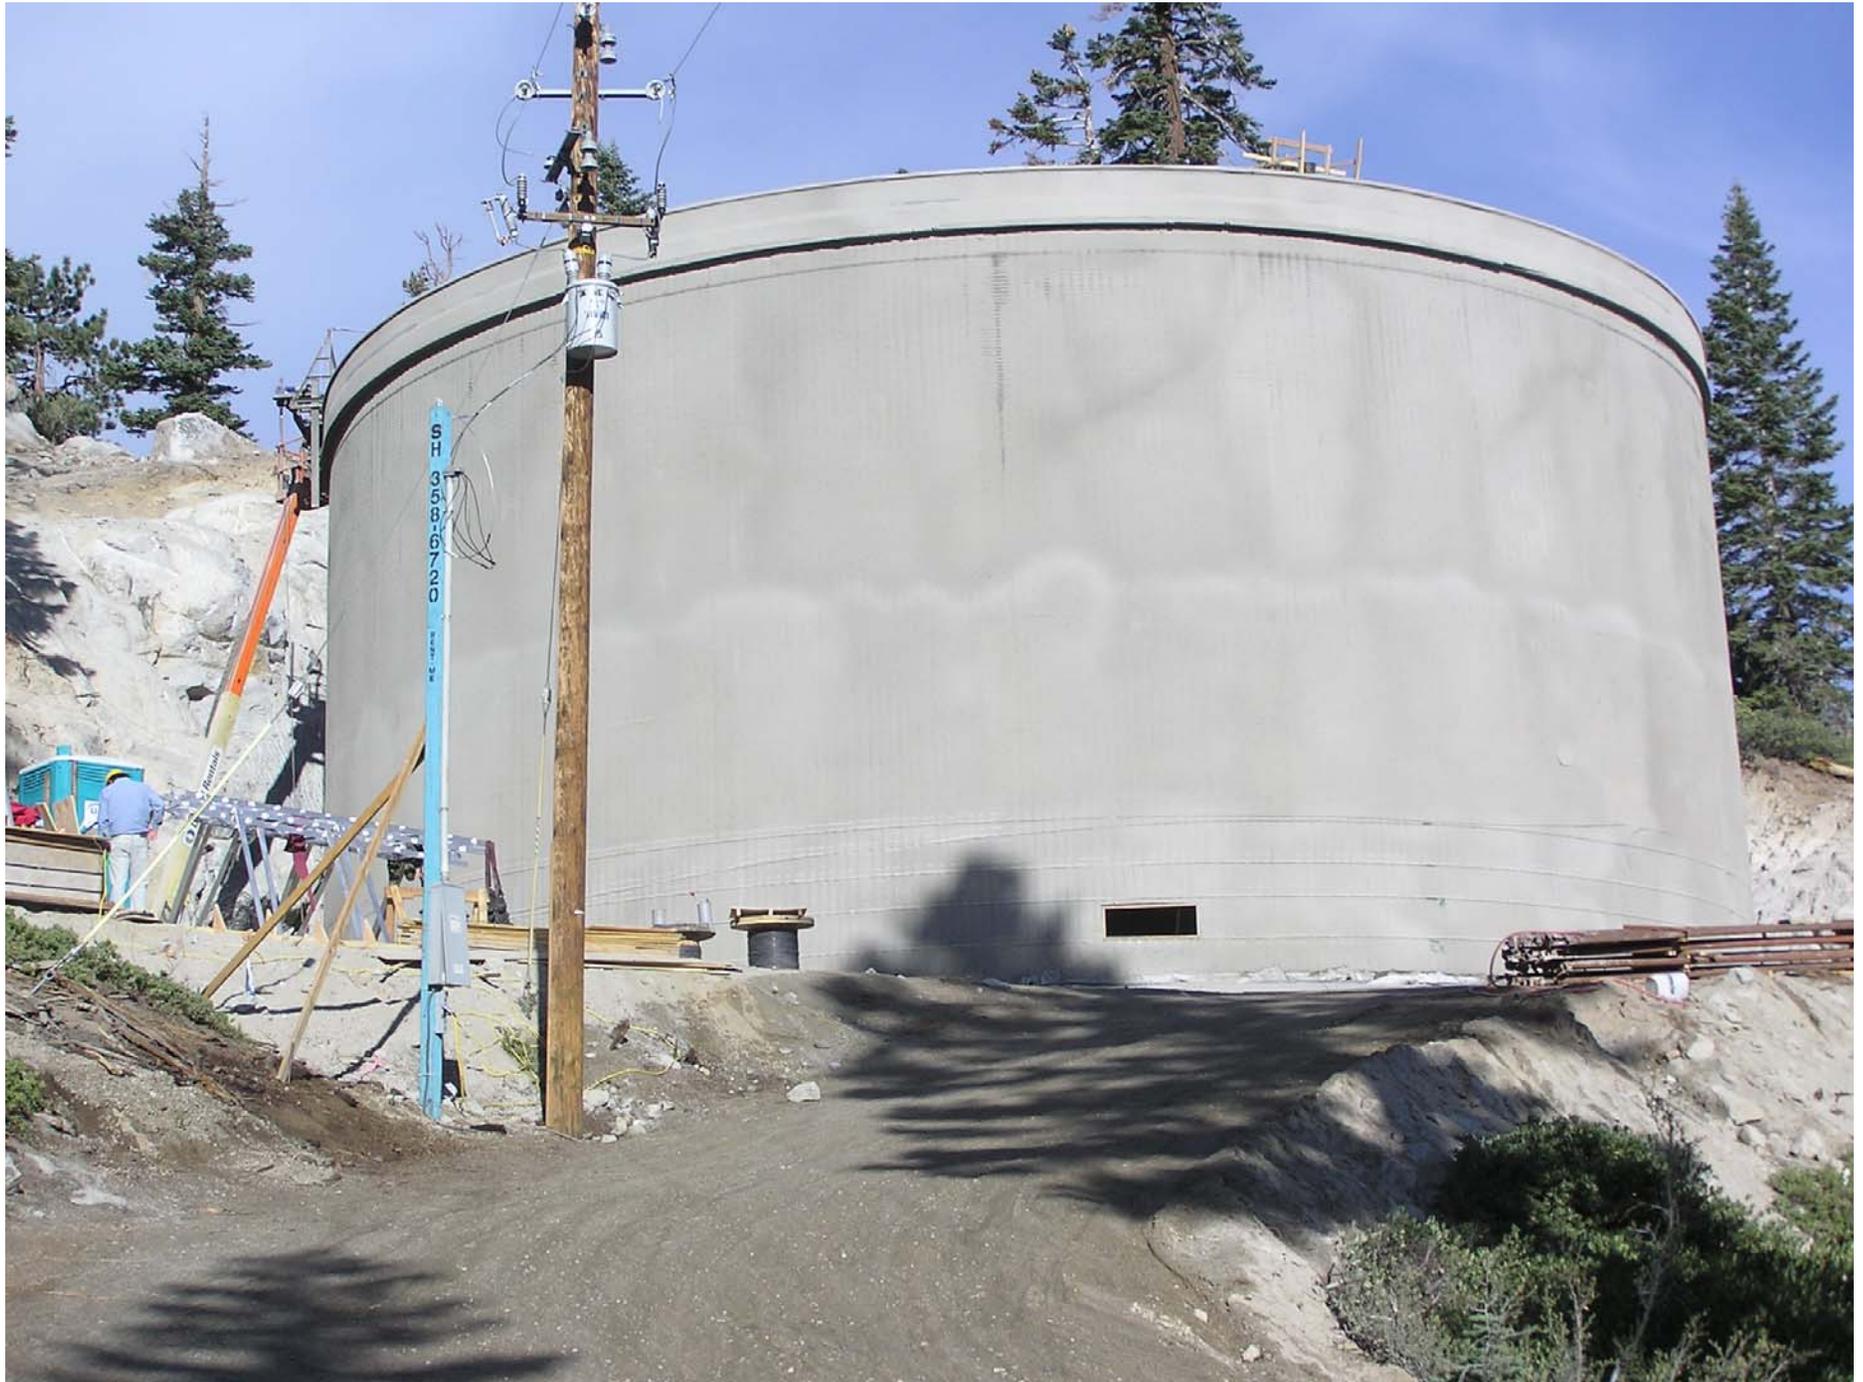
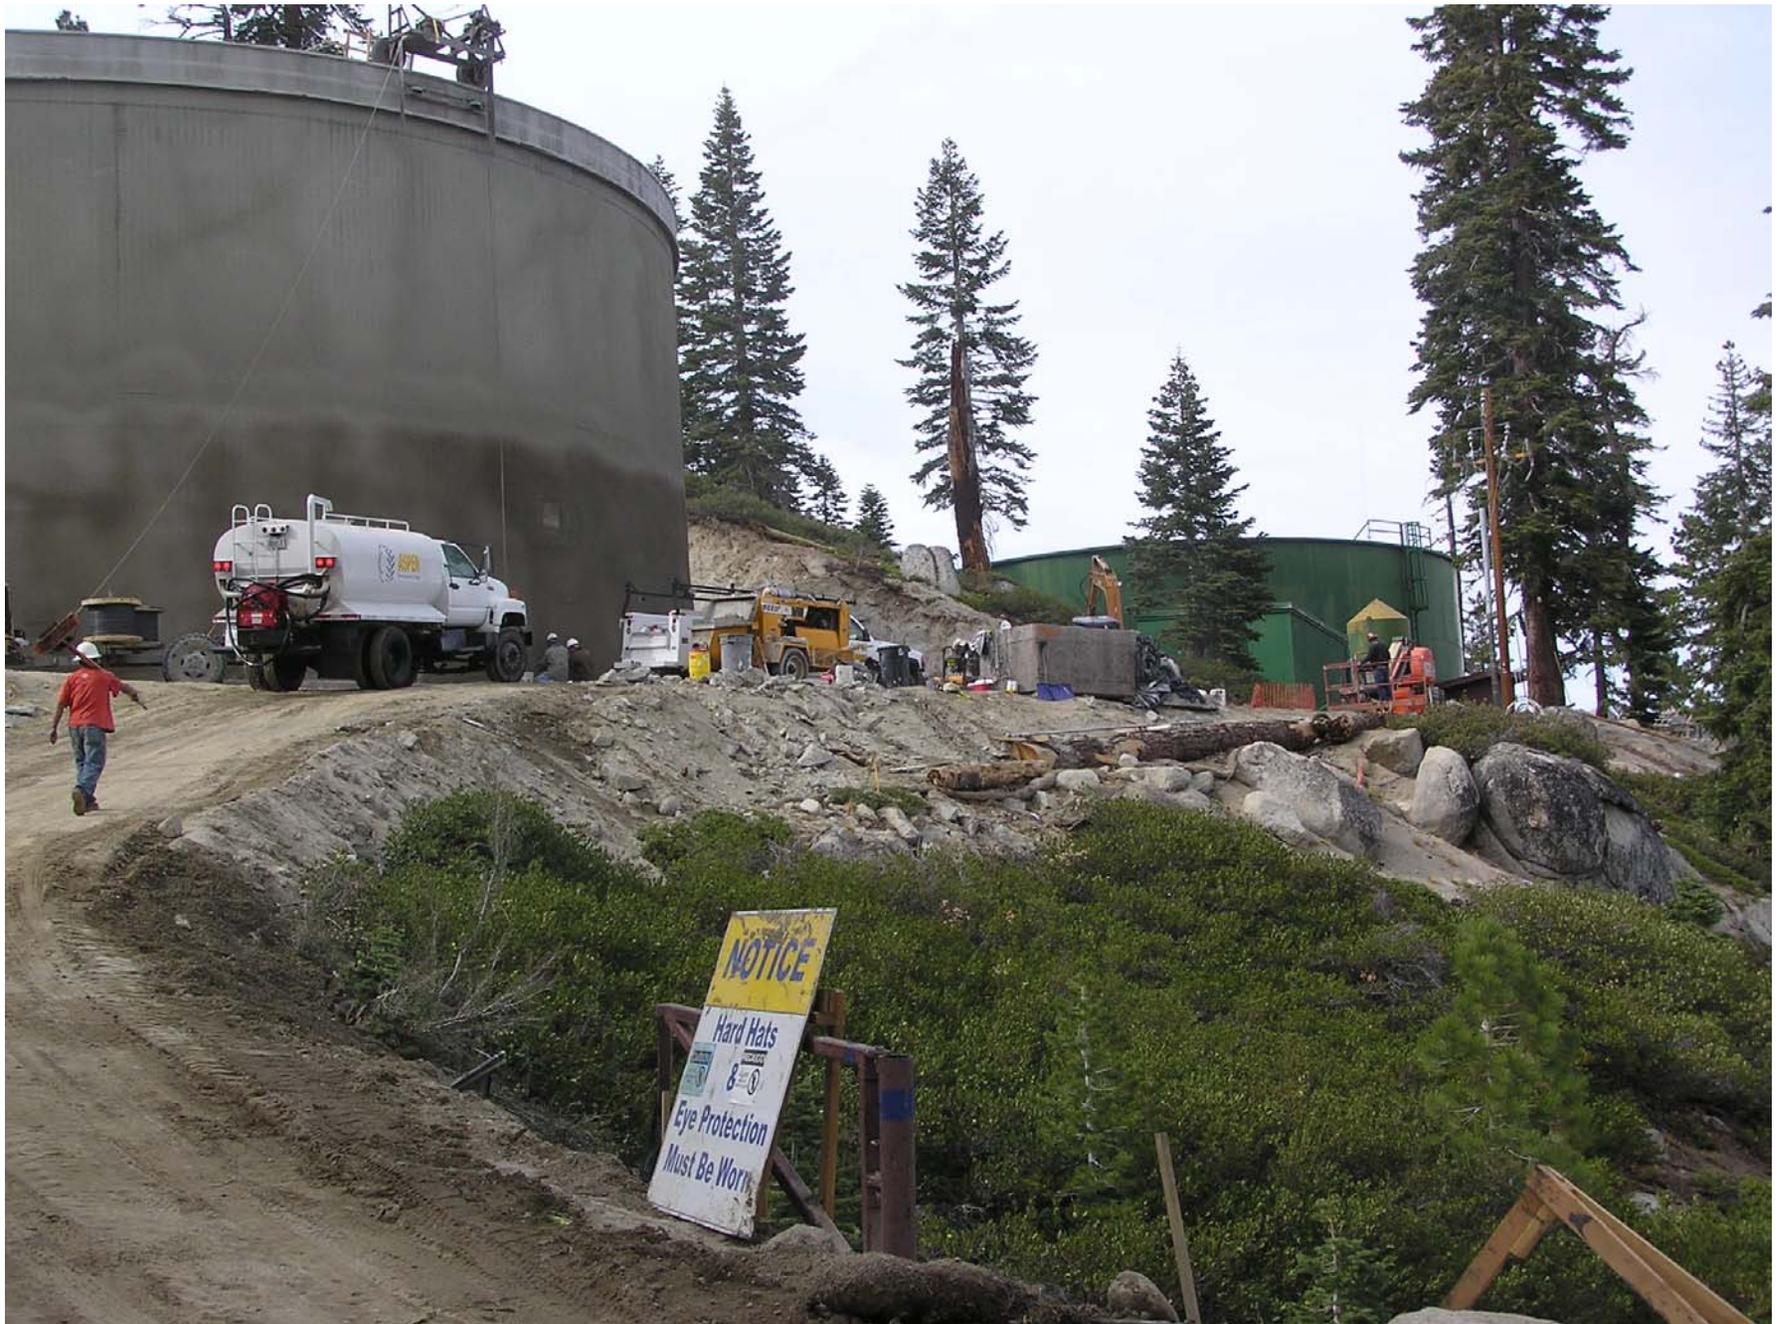
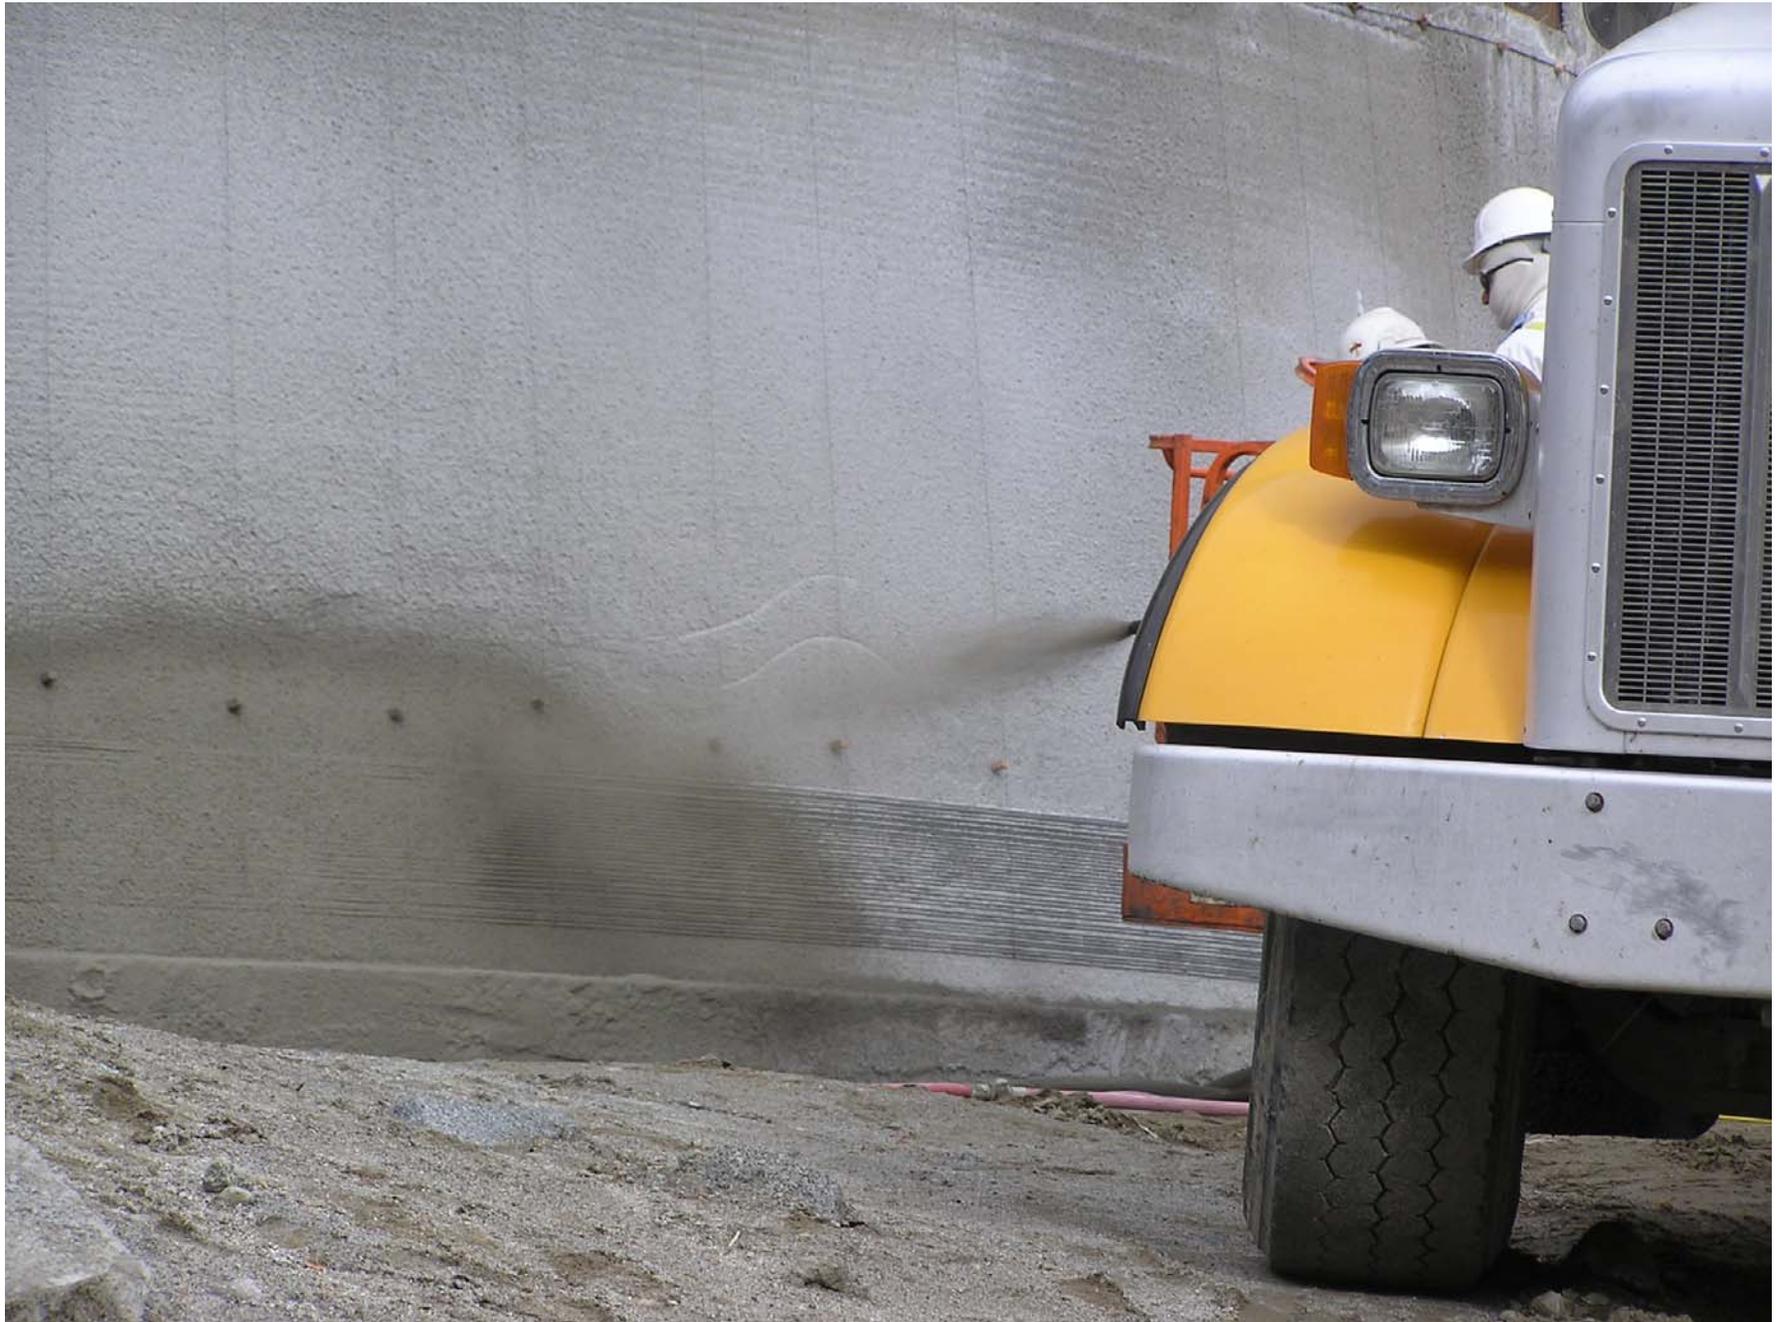
Subcontractor - Natgun - multiple layers of continuous wire applied to the tank then individually encased and bonded in shotcrete

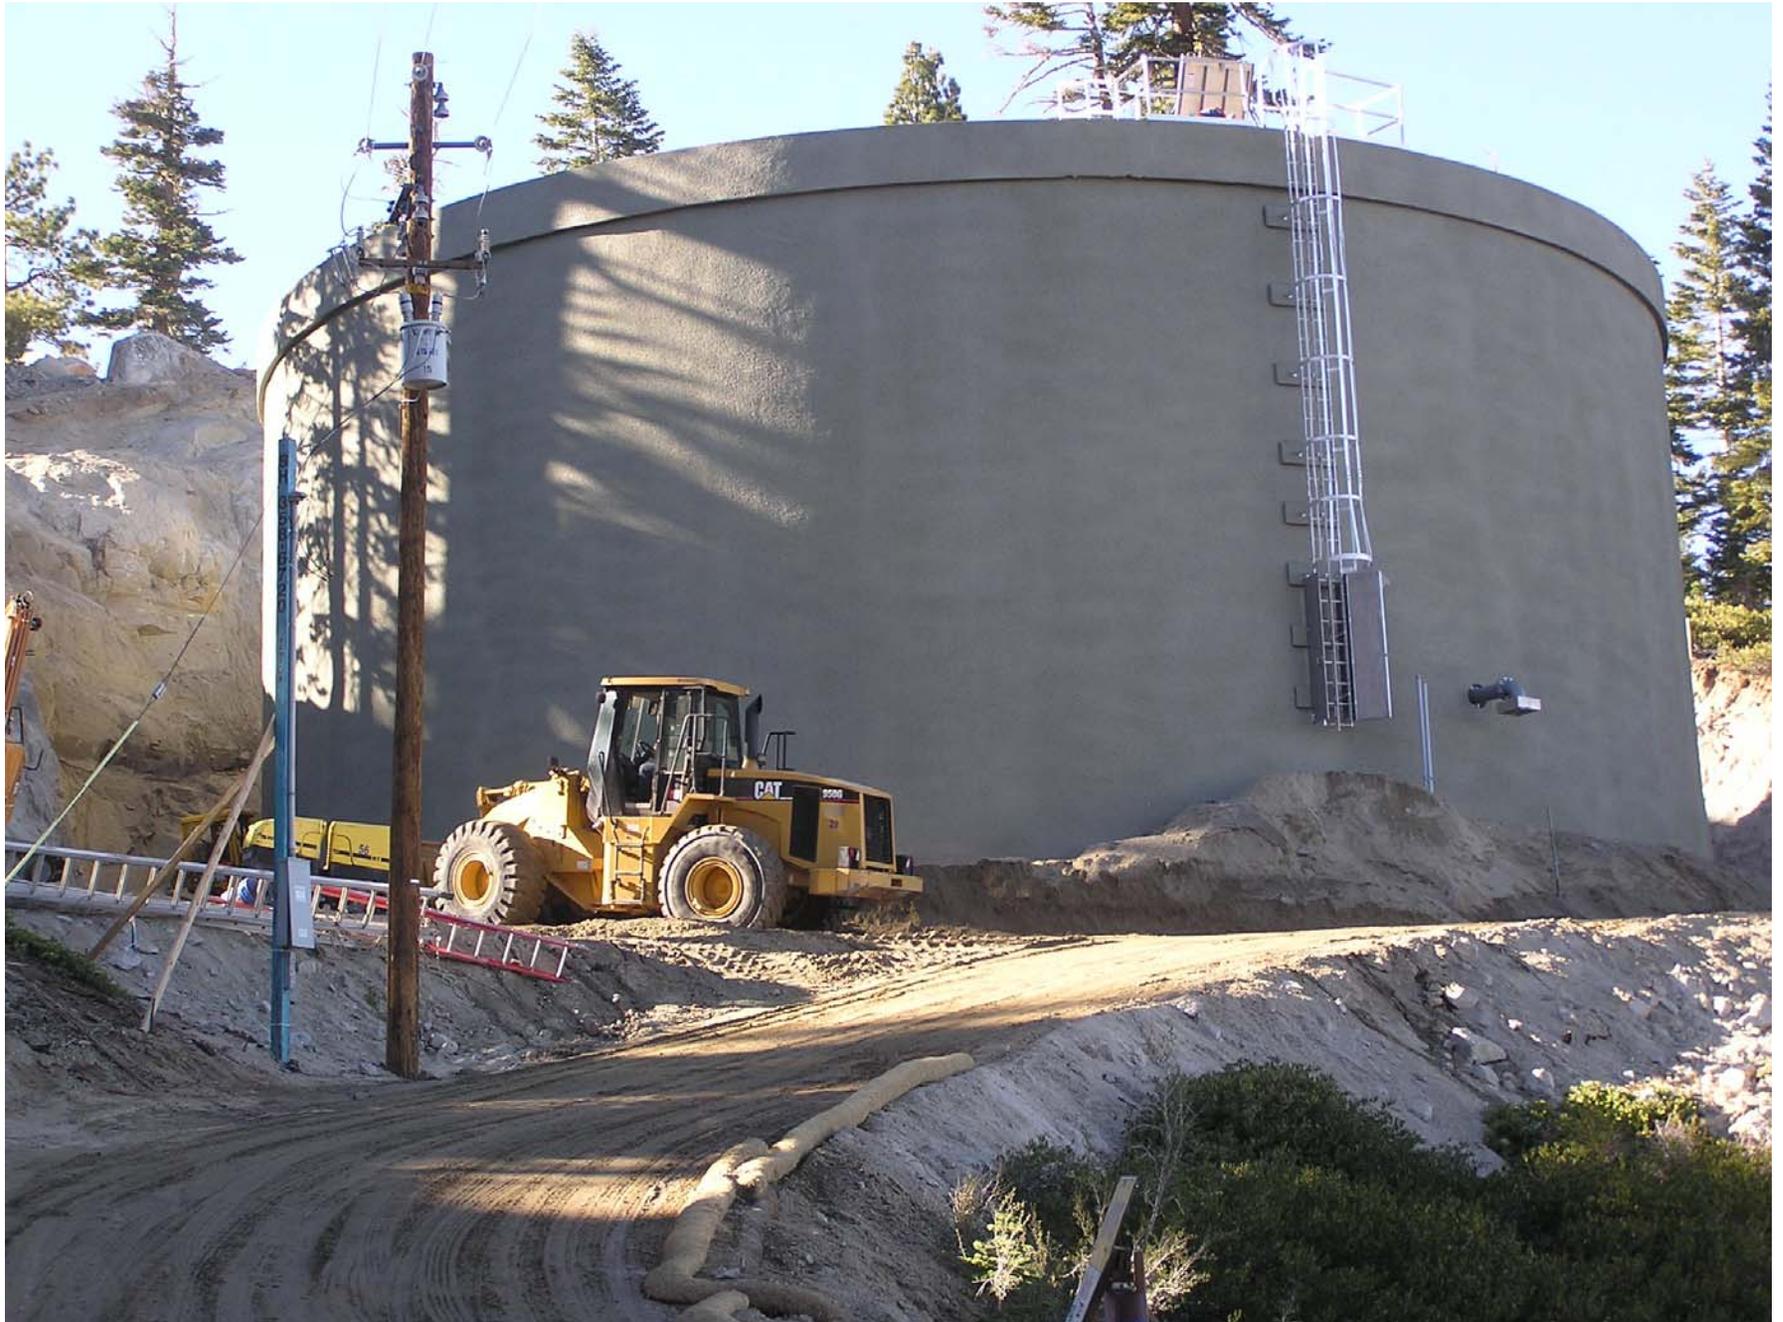
Completed tank in the process of being backfilled
