# **A Review of Nutrient Conditions and Associated Water Quality Standards for the Carson River**

*A supporting document for the Carson River Report Card*

**November 2007**

Prepared by:  
Randy Pahl  
Nevada Division of Environmental Protection  
Bureau of Water Quality Planning

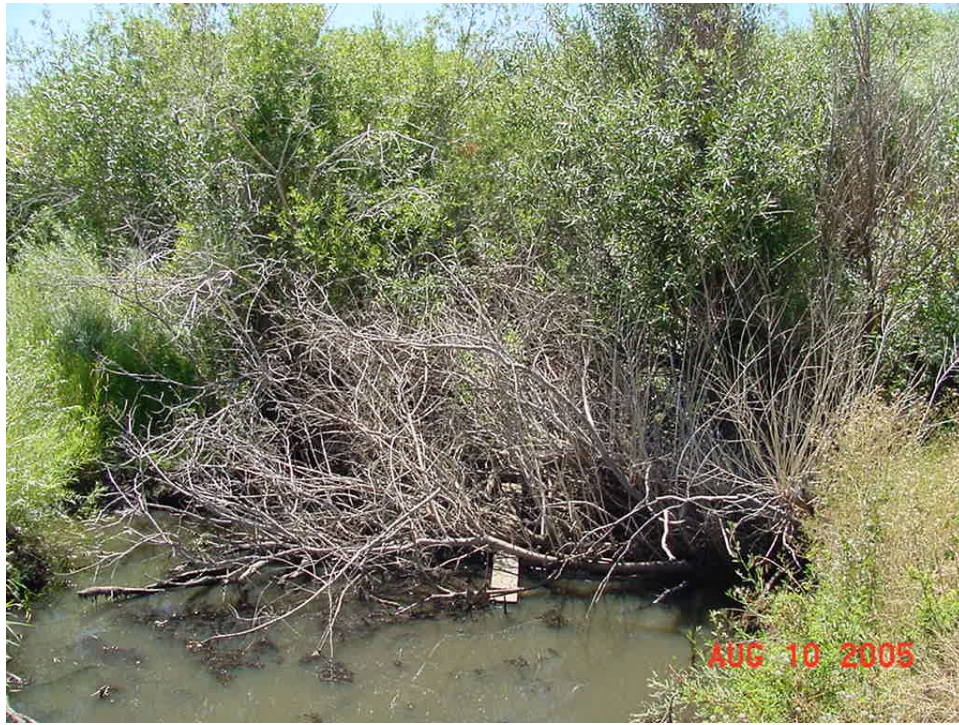
**West Fork Carson River between Highway 88 and Centerville Lane:** NDEP (Pahl, 2006) measured low DO levels in this reach of the West Fork Carson River with the lowest levels at Centerville Lane (as low as 1.4 mg/l). Figure 2 shows the stagnant flow conditions that typically exist at Centerville Lane. As discussed earlier, the West Fork is largely redirected to Brockliss Slough leaving little flow in the West Fork at this location.

**Figure 2. West Fork Carson River at Centerville Lane, 2005**

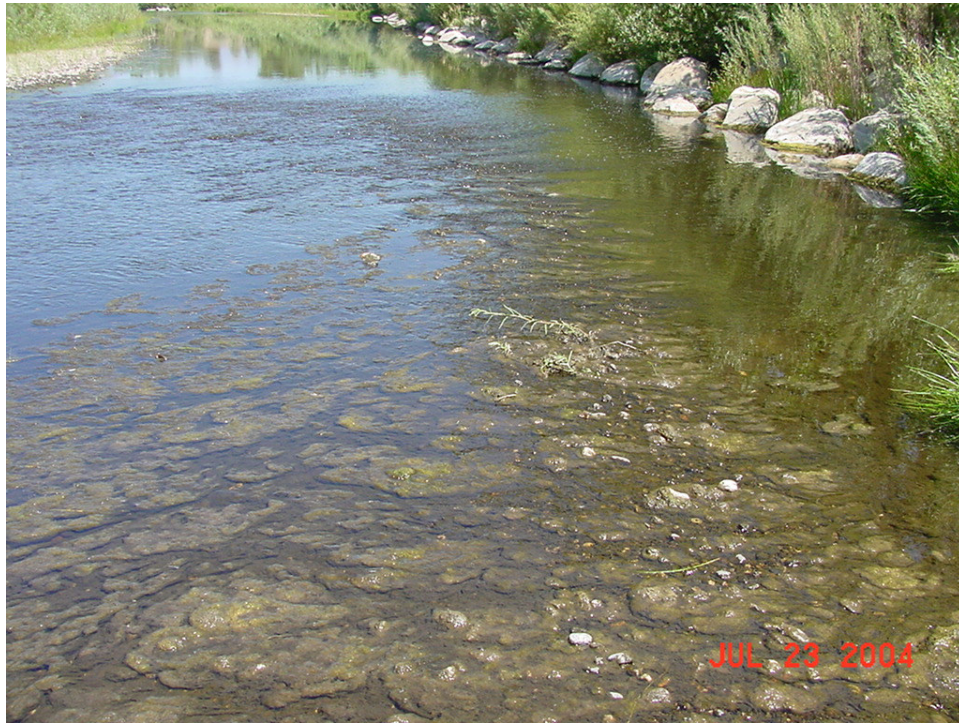
**East Fork Carson River between Highway 88 and Muller Lane:** NDEP (Pahl, 2002; Pahl 2006) measured low DO levels in the East Fork Carson River at Muller lane in 2001 (as low as 1 mg/l) and in 2006 (around 4 mg/l). During 2001, a thick algae mat developed in this reach and has been observed in subsequent years (Figure 4). In 2006, higher flows were experienced and thick algae mat still developed. This stretch of the river has very little shading providing much light for algal use.

**Figure 4. Algae Mat in East Fork Carson River between Highway 88 and Muller Lane, 2004**

- EF Carson River at Muller Lane experienced DO levels down to 3.7 mg/l, consistent with earlier findings during the 2001 NDEP special study (Pahl, 2002). The likely cause of the low DO levels were thick algae mats found in the river between Highway 88 and Muller Lane.

2. Very excessive algae have been observed every year on the East Fork Carson between Highway 88 and Muller. Additional work should be done to understand the source of this problem.

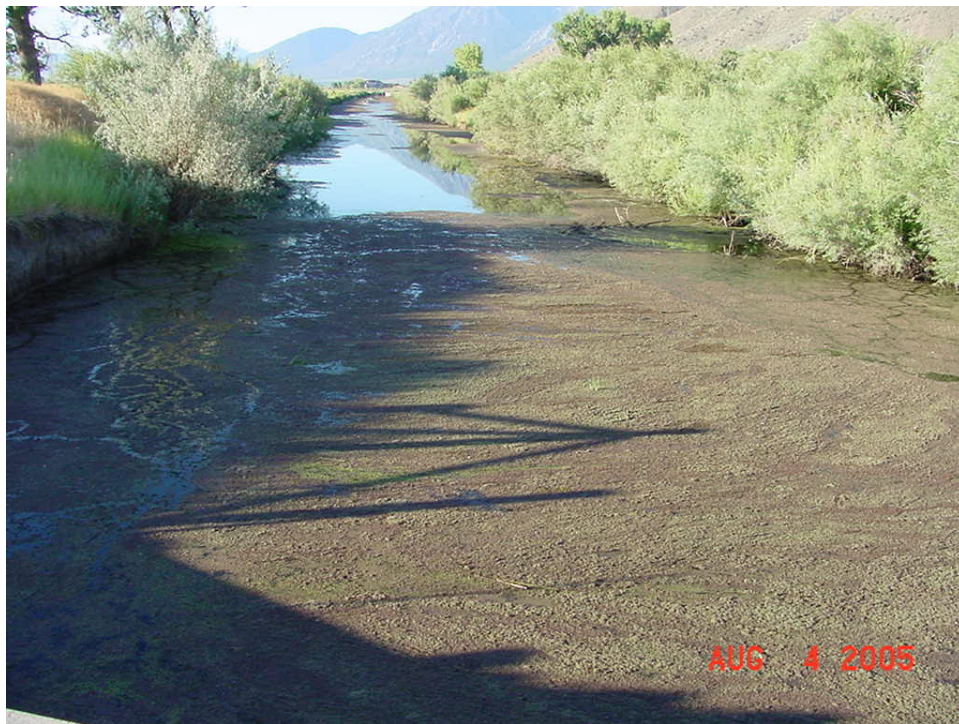
**Brockliss Slough:** At several locations throughout the Brockliss Slough, NDEP (Pahl, 2006) measured DO levels frequently less than the 5 mg/l water quality standard. The worst conditions were in the West Branch Brockliss Slough at Genoa Lane with minimum DO levels below 2 mg/l. Figure 5 shows the stagnant conditions typical for this location. A downstream diversion dam for the Genoa Lake Golf Course has caused flow to backup at Genoa Lane on both branches of the Brockliss Slough. However, minimum DO conditions on the East Branch Brockliss Slough appear to be somewhat better (ranging from 3.4 to 5 mg/l).

**Figure 5. West Branch Brockliss Slough at Genoa Lane, 2005**

- DO readings at many of the Brockliss Slough locations were typically in the 4 to 5 mg/l range. The most severe conditions were found at the West Branch Brockliss Slough at Genoa Lane with morning DO levels consistently around 1 mg/l. Though little flow movement was visible for both Brockliss branches at Genoa Lane, the East Branch experienced higher DO levels (3.4 to 4.9 mg/l).

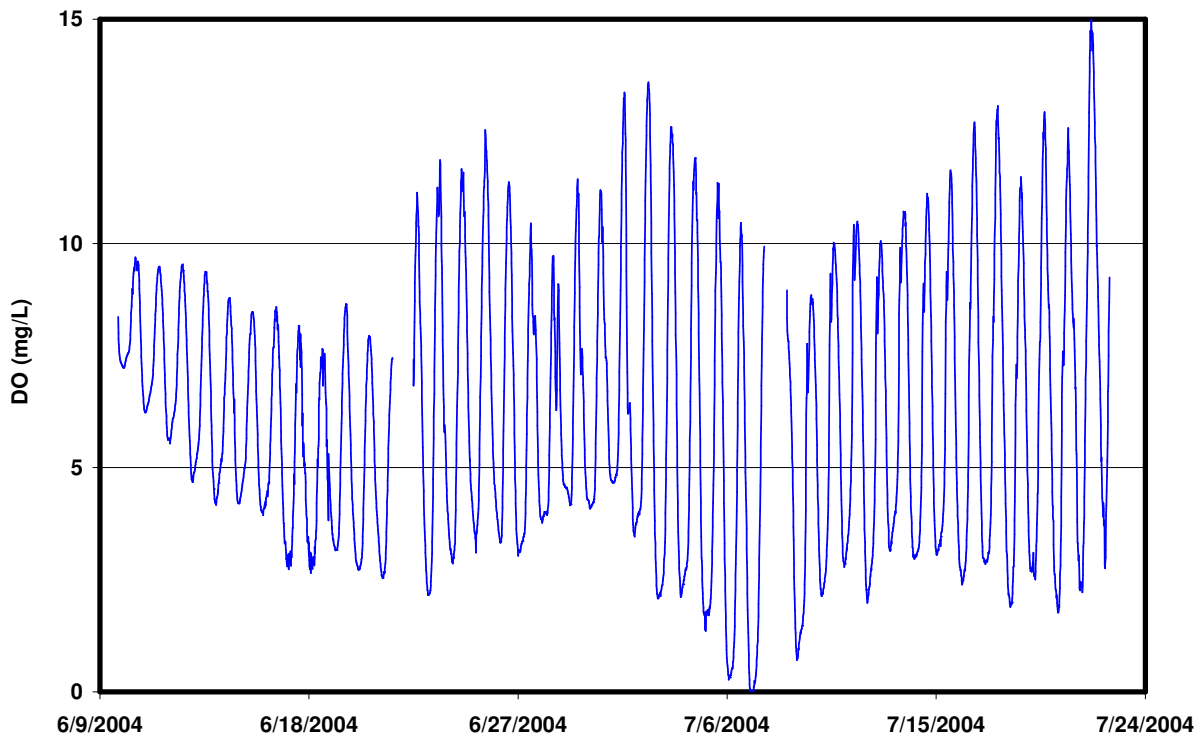
**Carson River at Riverview Park:** DRI (Latham, 2005; Fritsen et al., 2006) measured extremely low dissolved oxygen levels (Figure 6) in the Carson River at Riverview Park during the summer of 2004, with below average flows. Thick algal mats were also observed in the area (Figure 7). As noted by Latham (2005) and Fritsen et al. (2006), excessive algae and depressed DO problems were not observed in 2003 at Riverview Park, which experienced near average flows. In subsequent visits to the site by NDEP staff, excessive algae levels have not been observed during the summers of 2005 and 2006 which experienced higher flows than 2004. Even in 2007, when flows were lower than 2004 flows, no excessive algae were observed. Flow may not be a good indicator of when eutrophication problems are expected to occur at this site.

**Figure 6. Dissolved Oxygen at Riverview Park - 2004**

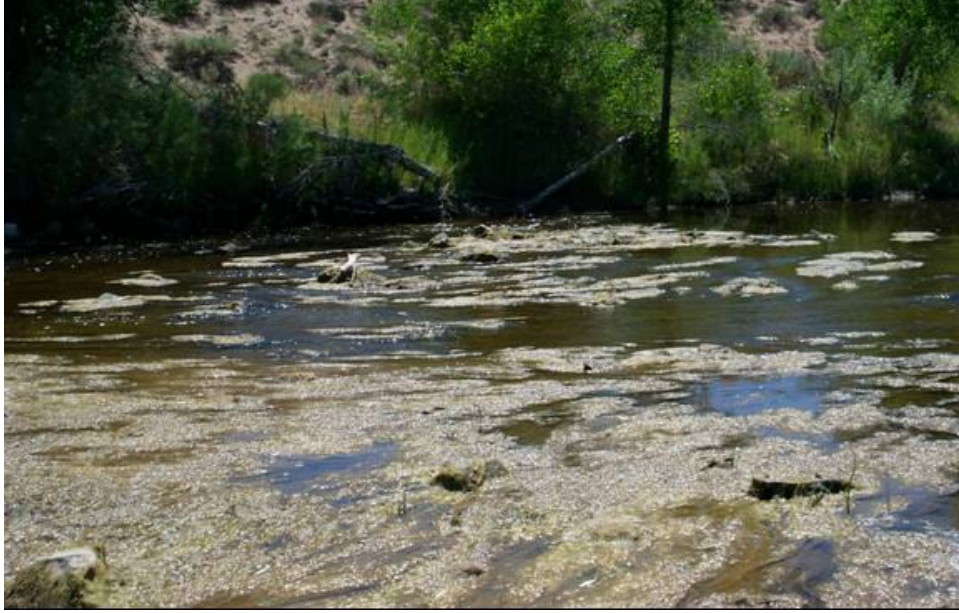
**Figure 7. Algae Mats in Carson River near Riverview Park, 2004**

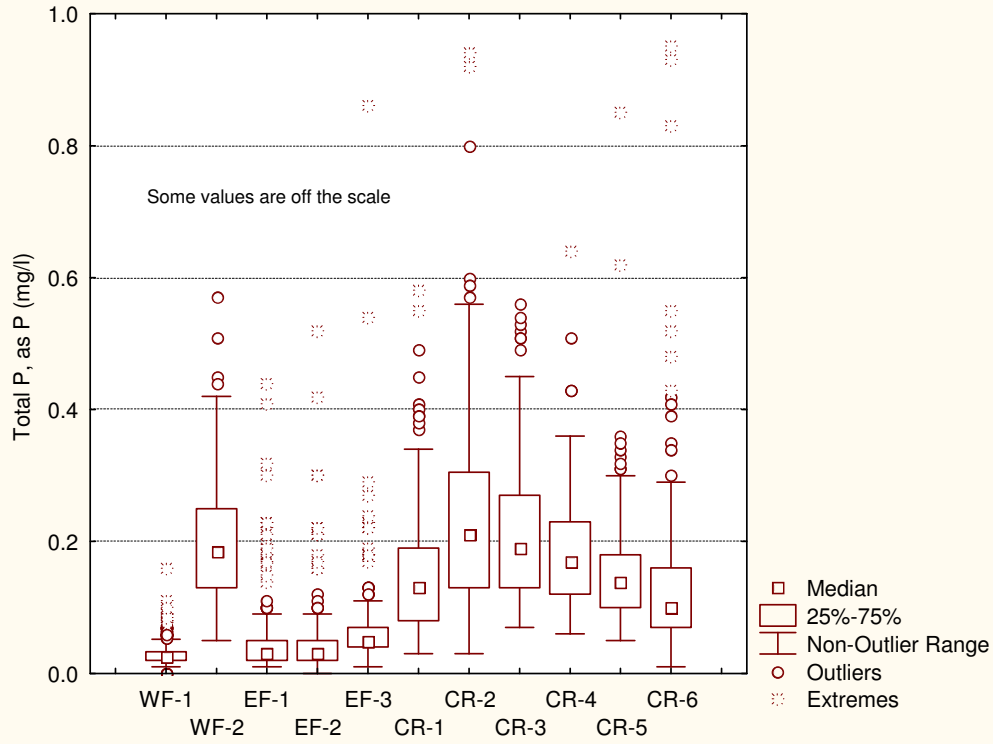
Figure 9. Total Phosphorus (1988-2006)

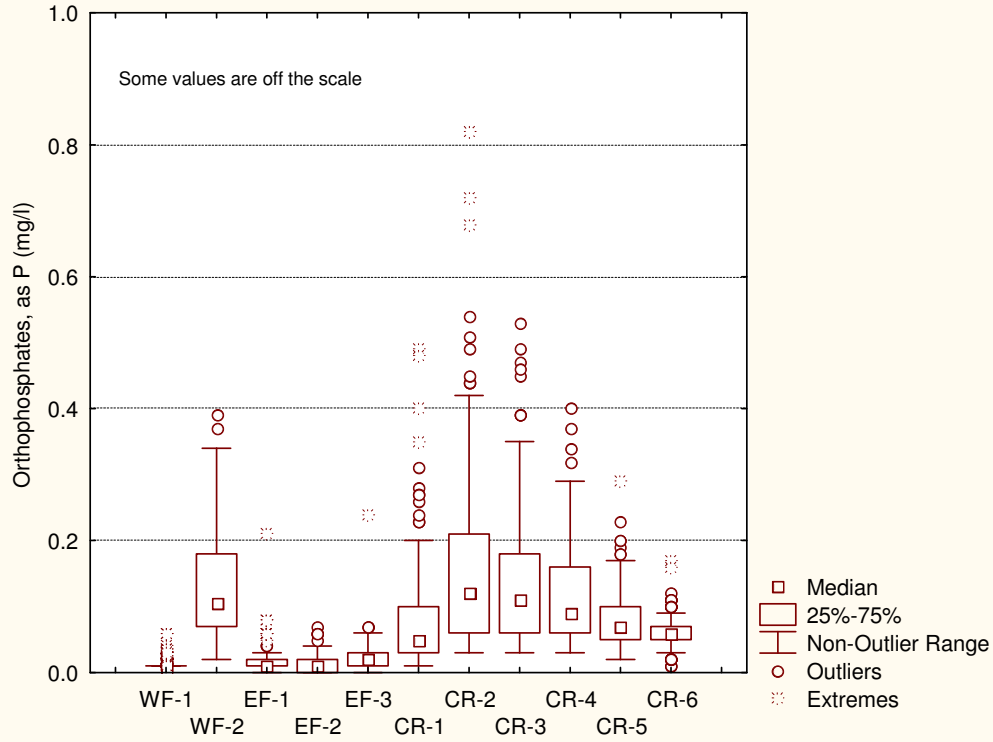
Figure 10. Orthophosphates (1988-2006)

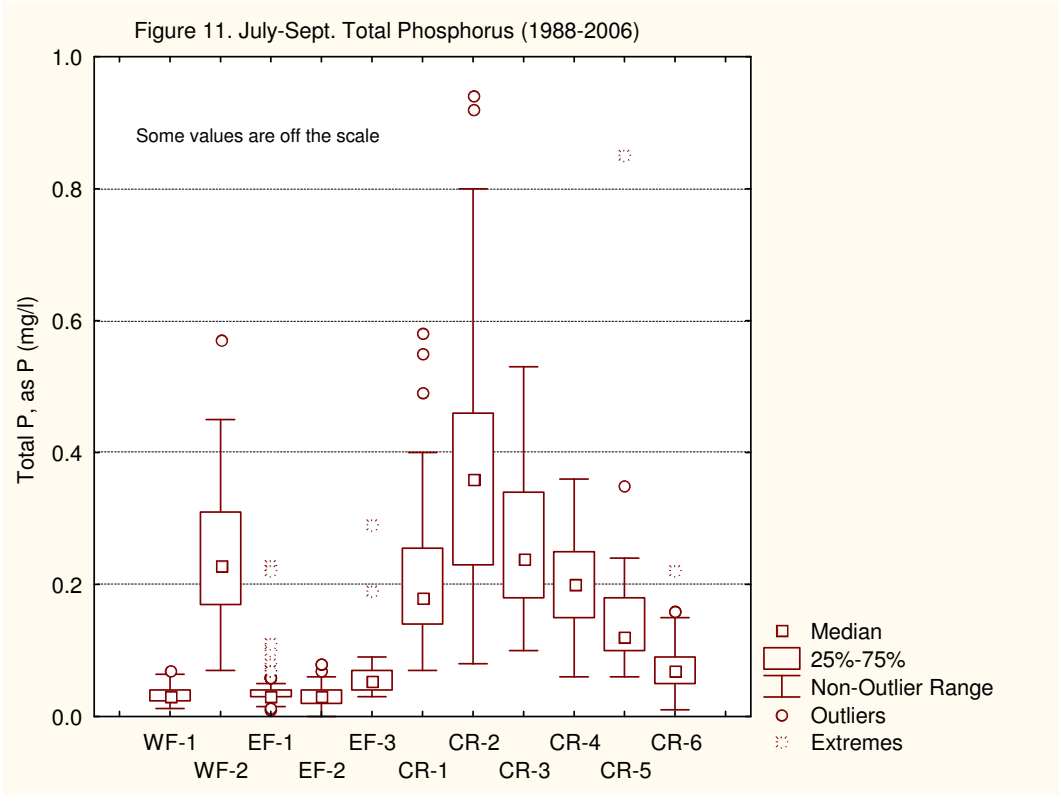
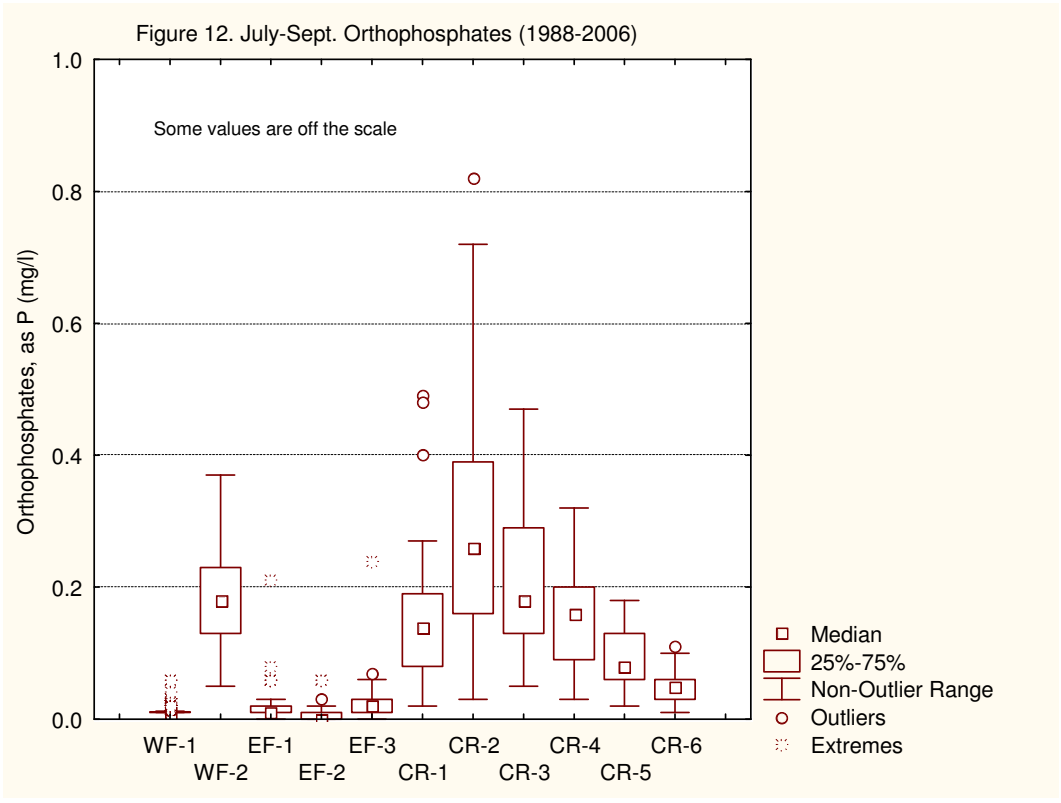
Figures 11 and 12 present boxplots of TP and OP levels for July through September for the period 1988-2006. The July-September period was chosen in an attempt to capture nutrient conditions during the peak growing season for algae. Again, the highest median values are identified at Carson River at Cradlebaugh Bridge. Compared to the year-round data, the summer TP and OP medians are generally higher.

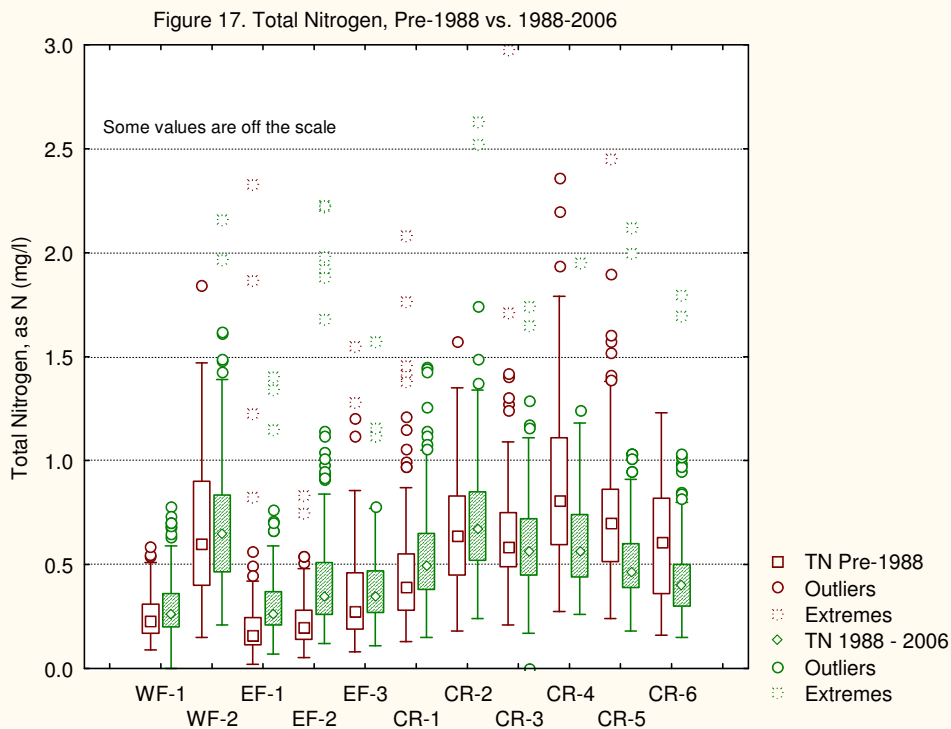
Figure 17 presents boxplots of total nitrogen levels for the Pre-1988 Period versus 1988-2006. The median values at the upper sites (above CR-3: Carson River at Mexican Gage) show an increase for the 1988-2006 period. However, the cause of these increases is unknown. The largest decreases in median TN values occurred at CR-4: Carson River at Deer Run Road and below. Figure 18 shows that median nitrate+nitrite values have decreased at sites in the Genoa area and lower. Much like TN, some of the largest decreases in median nitrate+nitrite values occurred at CR-4: Carson River at Deer Run Road and below. These decreases are likely due to changes in upstream wastewater effluent management.

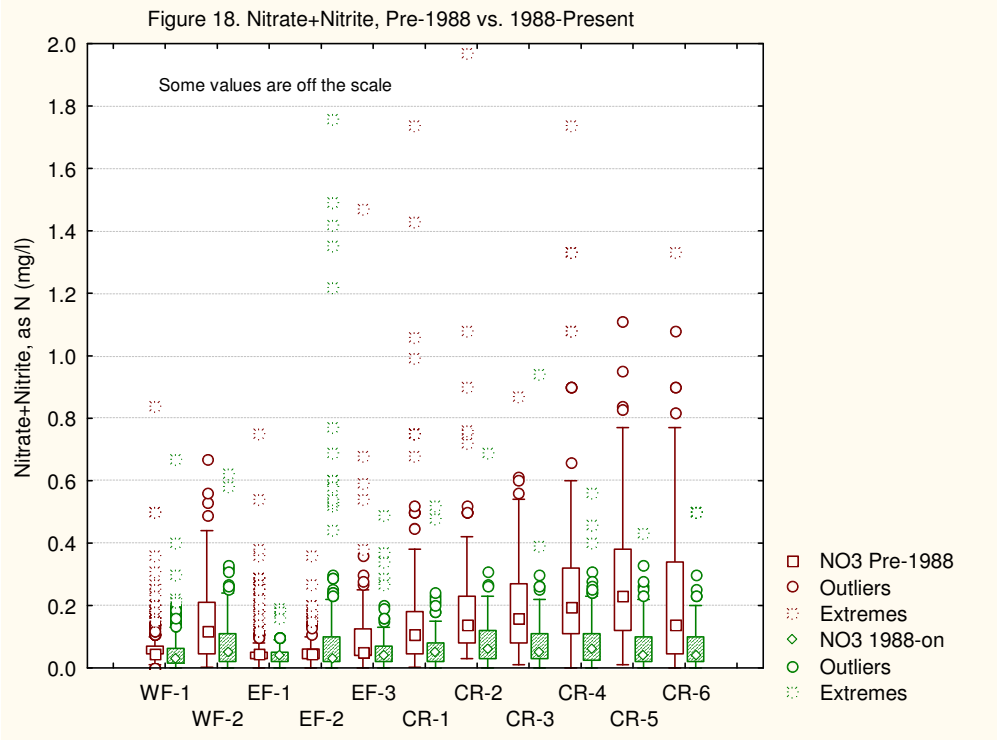
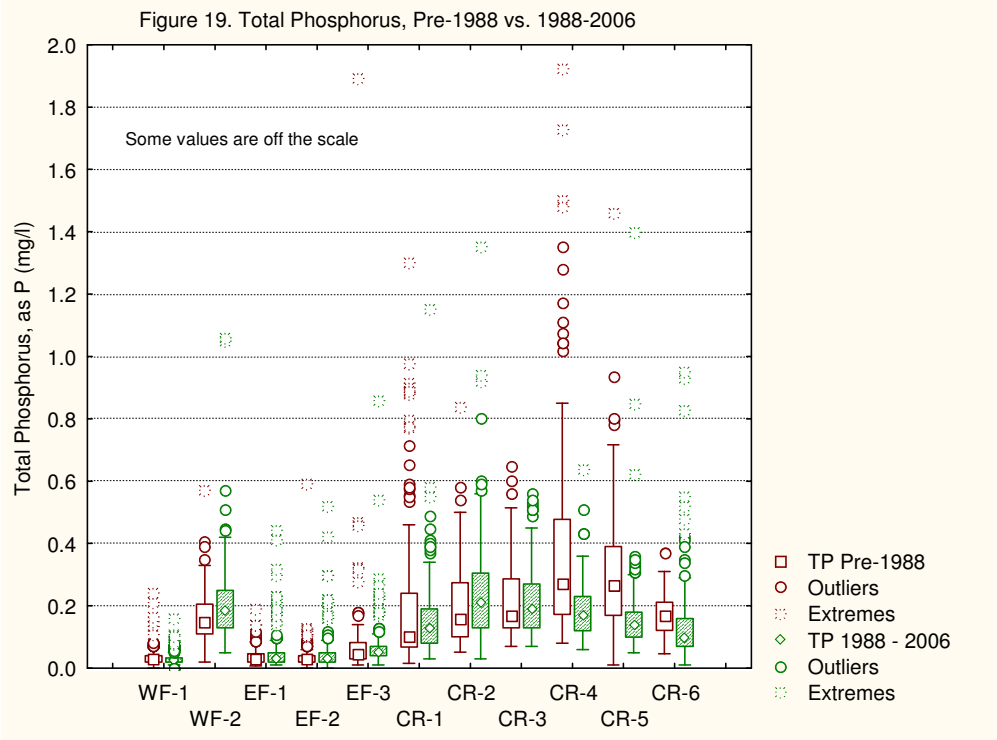
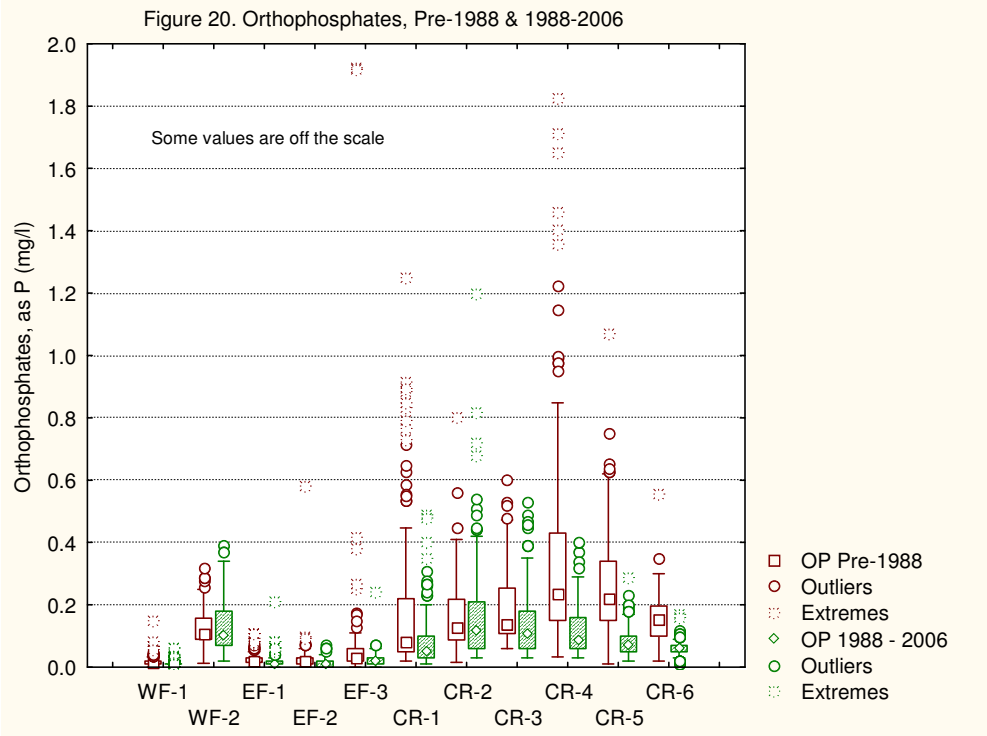
Figure 19 shows little change in total phosphorus median values at many of the sites. Median values decreased at CR-4: Carson River at Deer Run Road and below. Changes in Carson City’s wastewater effluent management are likely the major cause of these decreases. Figure 20 also shows little change in orthophosphates in the upper sites<sup>3</sup>. However, the large median values decreased occurred at CR-4: Carson River at Deer Run Road and below, again due to Carson City’s effluent management changes.

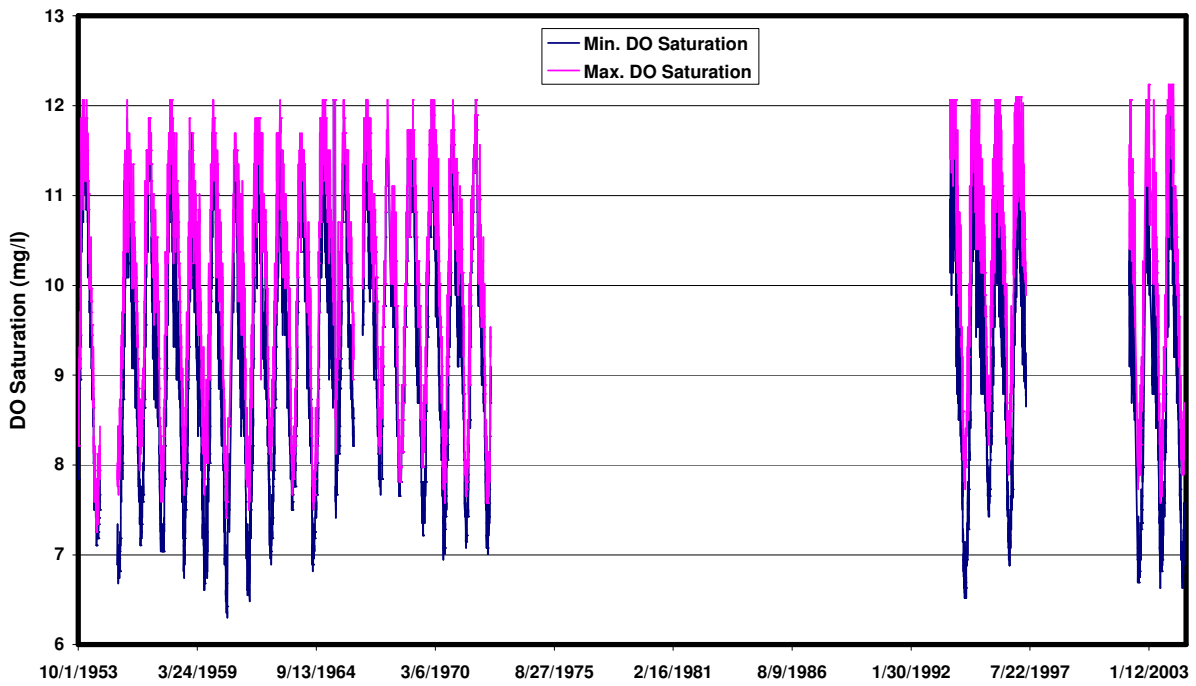
<sup>4</sup> DO saturation levels decrease with increases in temperature and increases in elevation.

**Figure 22. Minimum and Maximum DO Saturation Levels  
- USGS Sta. 10309000 - EF Carson River nr. Gardnerville**
