Carson River Special Monitoring Project - 2001

August 2002

**Randy Pahl
Bureau of Water Quality Planning
Nevada Division of Environmental Protection
Department of Conservation and Natural Resource**

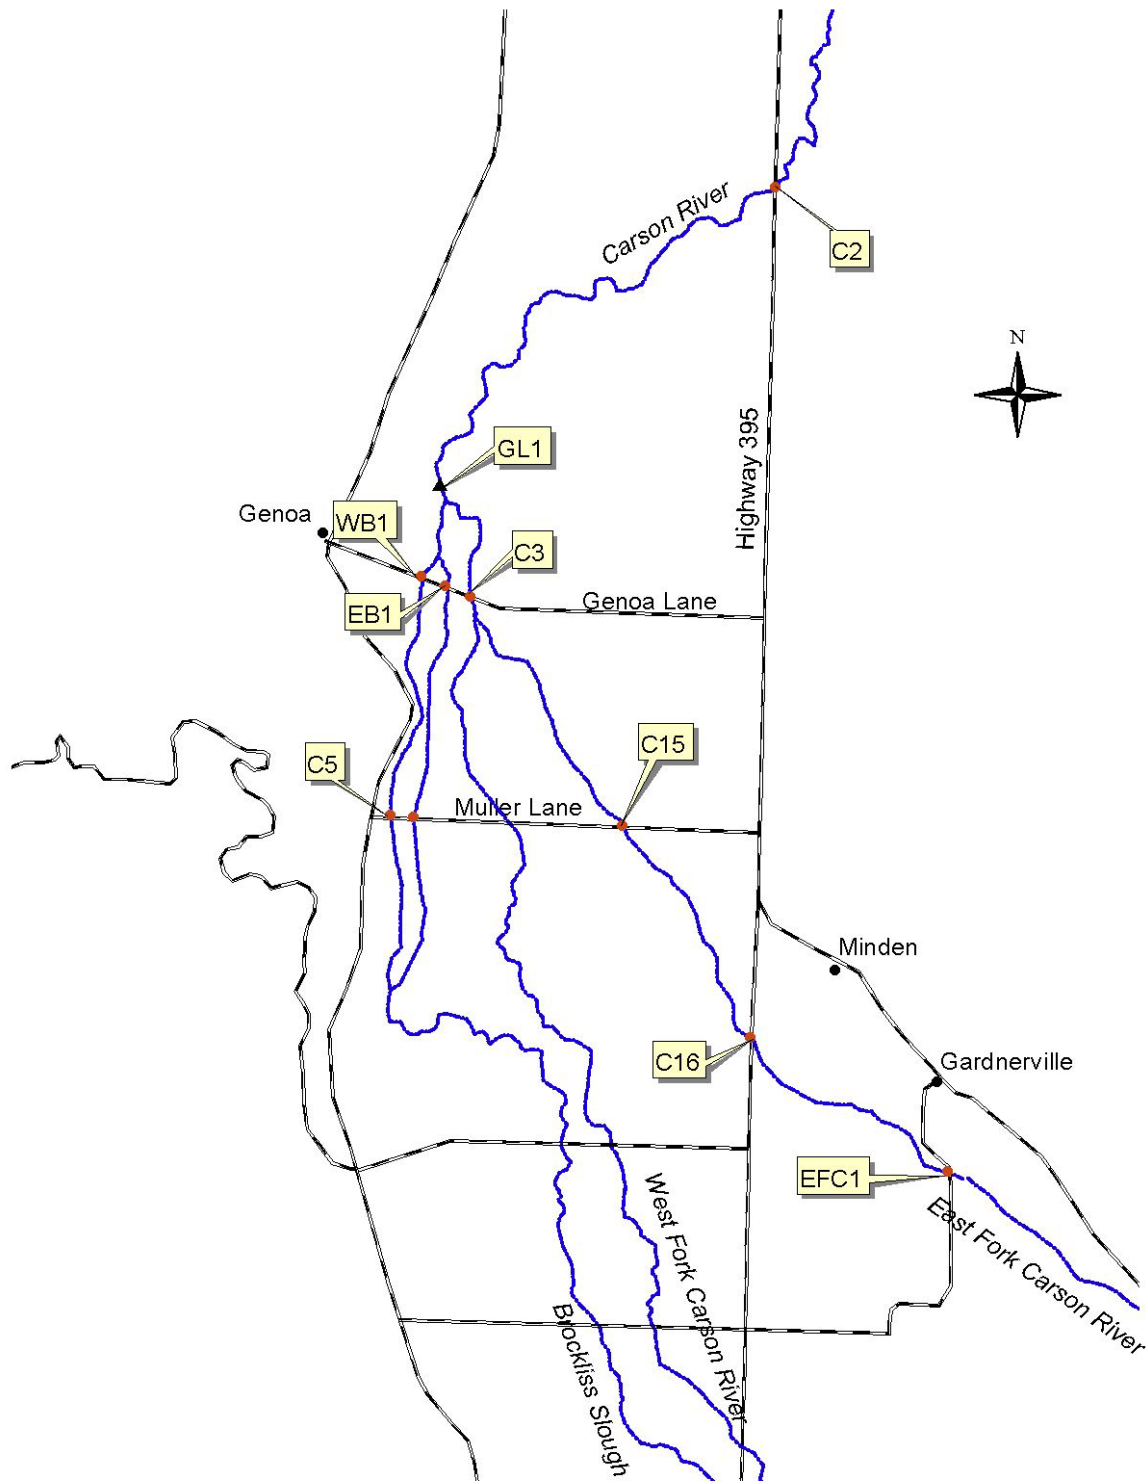
Figure 1. Water Quality Monitoring Sites

During the period July 6, 2001 through September 24, 2001, the BWQP performed intensive monitoring for a portion of the Carson River system in Carson Valley. Figure 1 and Table 1 present the main monitoring sites used during this project. On July 6, 2001, BWQP installed a Hydrolab DataSonde in the Carson River at the Genoa Lake Golf Course. The Hydrolab was used to collect hourly DO, temperature and pH values over the course of the study. Each week, data were retrieved from the Hydrolab and the unit was recalibrated. At that time, a water grab sample was taken and sent to the laboratory for analysis. Also, streamflows at the site were estimated by staff.

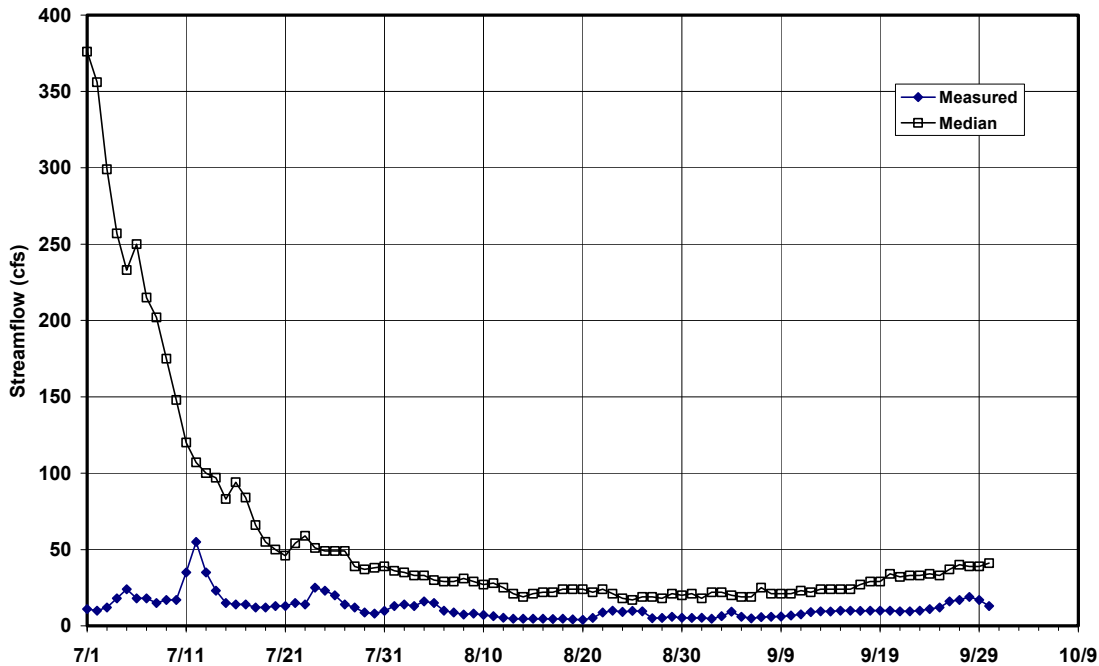
Figure 2. 10311000 - Carson River at Carson City, NV - Measured and Median Flows

Conditions during this project were extreme in terms of streamflow and weather. The 2001 Water Year was the driest and hottest on record. During the study period, streamflows at Carson River at Carson City were significantly lower than the historic median flows at this station, especially during the early part of the monitoring (Figure 2). Flows were approximately at the

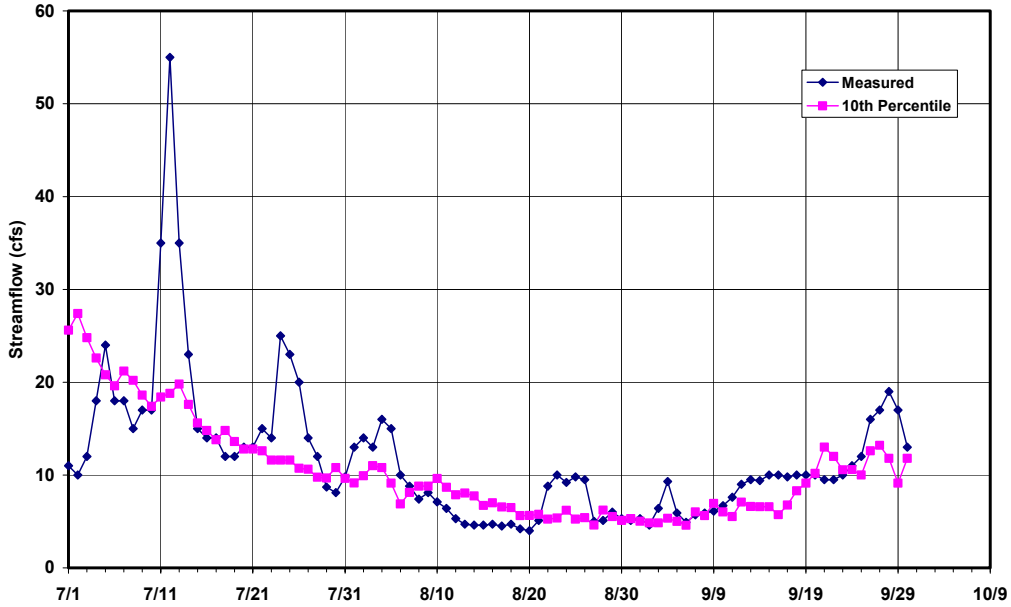
Figure 3. 10311000 - Carson River at Carson City, NV - Measured and 10th Percentile Flows

historic 10th percentile level (Figure 3). In other words, historic flows have been at these levels (or lower) for these days about 1 out of 10 years. Further exacerbating the low flow conditions, air temperatures were frequently hotter than normal (Figure 4).

Though Water Year 2001 was the driest on record, flows during the monitoring period were not the lowest on record. As shown on Figure 3, flows at Carson City have been lower than the July 7, 2001 through September 24, 2001 flows about 10 percent of the time. These lower flows have occurred during previous drought years such as 1977 and 1988. Based upon this information, it would appear that the data collected as part of this study are close to the 7Q10_{low} threshold and are borderline for evaluating water quality standards compliance.

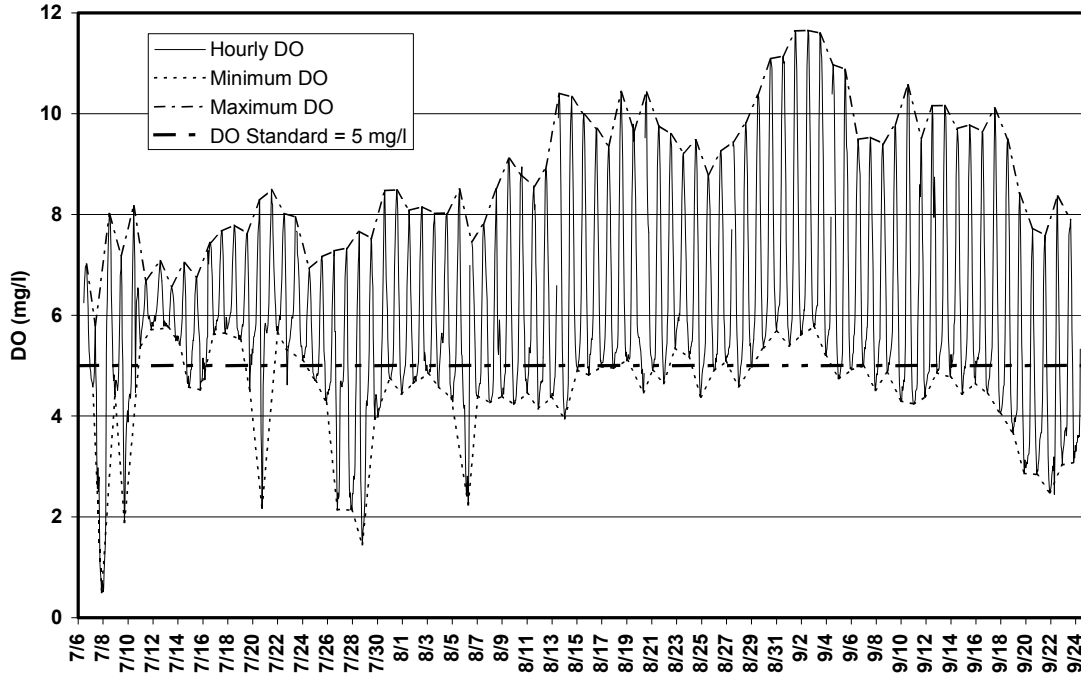
Figure 5. Carson River at Genoa Lakes Golf Course - Dissolved Oxygen

Hourly DO and water temperature data collected at the Carson River at Genoa Lake Golf Course site are summarized in Figures 5 and 6. When the Hydrolab was installed on July 7th,

streamflows at the site were estimated to be approximately 44 cfs. At that time, the Hydrolab had been installed near the left bank. By August 6, flows had decreased to about 10 cfs and the Hydrolab was in a section of the river that was getting little to no flow. As a result, the Hydrolab was moved about 100 feet downstream (near the left bank) to better flow conditions. However, flows continued to drop and the Hydrolab area became somewhat disconnected from the main flow.

As stated earlier, the water quality standard for dissolved oxygen for June through October is 5 mg/l (single value) at this location on the Carson River (See NAC 445A.153). During the 80-day monitoring period, most of the days (75%) experienced DO levels below the 5 mg/l standard for some period during the day (Table 2). However in many instances, the lower DO levels were of limited duration with only 29% of the hourly readings having DO levels below 5 mg/l. Exceedances of the standard were even less (14%) when the data were examined on an average daily basis.

There appears to have been quite a lot of instability in the diurnal DO patterns during the first two weeks of the monitoring. It is believed that some of these erratic fluctuations in the DO and temperature occurred as the result of weather systems passing through the region. As discussed above, the initial Hydrolab site was experiencing limited flow movement in the days prior to August 6. Some of the erratic fluctuations in the data may have been caused by this condition. It may be that the data collected after August 6 are more reliable and indicative of conditions in the main stream. However it must be noted that the Hydrolab was installed near the river bank and the data may not be representative of conditions across the channel cross section.

It is interesting to note that after August 6th most of the minimum DO levels were near the 5 mg/l level. However during the last week of the monitoring, the minimum DO levels dropped to below 3 mg/l. This drop seems to coincide with an increase in total nitrogen, nitrate and phosphorus levels on 9/24/01 (see Table 3).

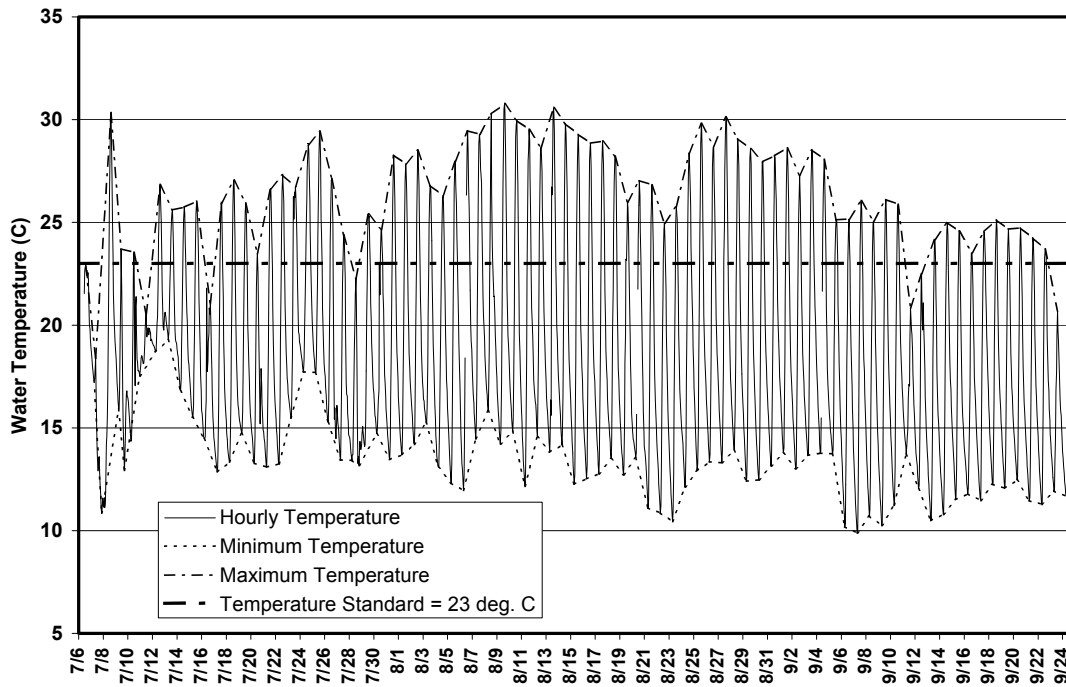
Figure 6. Carson River at Genoa Lakes Golf Course - Water Temperature

The temperature standard for July through October is 23 degrees C for this reach of the Carson River (NAC 445A.153). Over 90% of the monitored days experienced water temperatures higher than the 23 degree C standard. Only 22% of the hourly readings had temperature levels higher than the standard. When the temperature data were averaged for each day, none of the daily average values were over the 23 degree C standard.

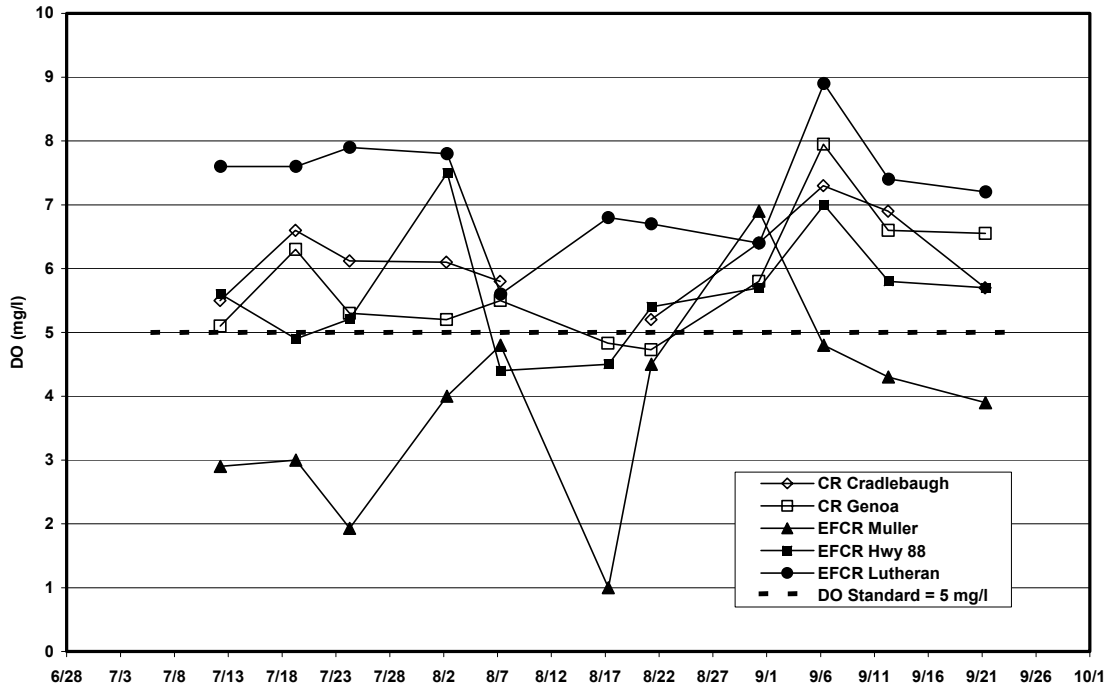
Figure 7. Early Morning DO at Spot Reading Sites - EF Carson and Carson River

As mentioned earlier, BWQP staff monitored early morning and late afternoon DO and temperature at eight other locations upstream and downstream from the Hydrolab site. Of particular interest are the early morning DO (typically the lowest of the day) and the afternoon temperature (typically the highest) readings. Figures 7 and 8 summarize the early morning DO data collected at these sites. In general, more frequent violations of the DO standard occurred at: East Fork Carson River at Muller Lane and at all of the West Brockliss Slough sites.

There are some limitations with this approach. The intent is to monitor at the appropriate time in order to capture the minimum DO levels in the morning and maximum water temperatures in the afternoon, however it can become difficult to time the spot readings to coincide with the DO and temperature extremes. The Hydrolab data collected at Carson River at Genoa Lakes Golf Course indicate that the daily minimum DO levels generally occurred before 6 AM and the maximum temperatures occurred between 2 and 3 PM. Based upon this information, it is probable that the morning DO spot readings taken between 6 to 8 AM are higher than the actual minimums experienced at those locations. However, the afternoon temperature readings taken between 2 and 4 PM are good indicators of the daily maximum temperatures for those locations.

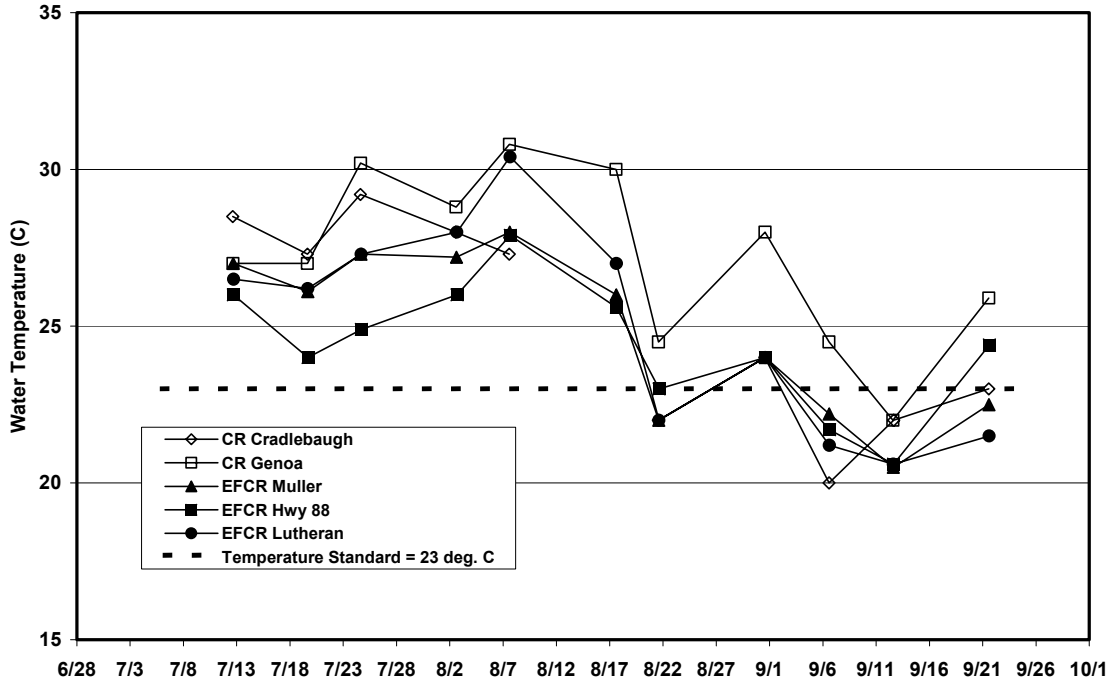
Figure 9. Afternoon Temperature at Spot Reading Sites - EF Carson and Carson River

Figures 9 and 10 present the afternoon temperature data collected at the spot reading sites. The most frequent exceedances of the temperature standard occurred during the first part of the monitoring period at the East Fork Carson and Carson River sites.
