**SUMMARY REPORT  
ENVIRONMENTAL ASSESSMENT AND CLEANUP ACTIVITIES  
FORMER HAWTHORNE LANDFILL  
HAWTHORNE, NEVADA**

June 26, 2009  
File: 99433.01

**SUBJECT: Summary Report  
Environmental Assessment and Cleanup Activities  
Former Hawthorne Landfill  
Hawthorne, Nevada**

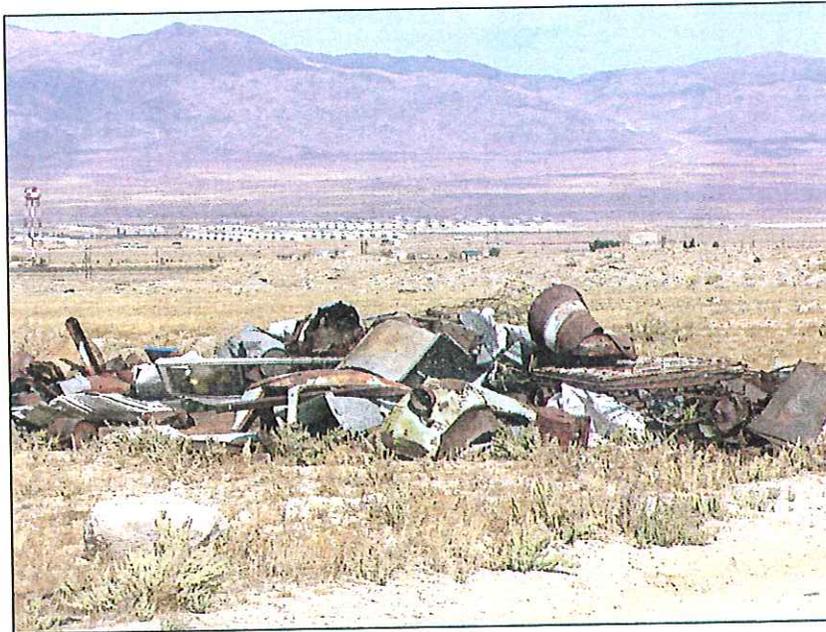
METAL SURFACE DEBRIS AT SITE PRIOR TO CLEAN-UP ACTIVITIES

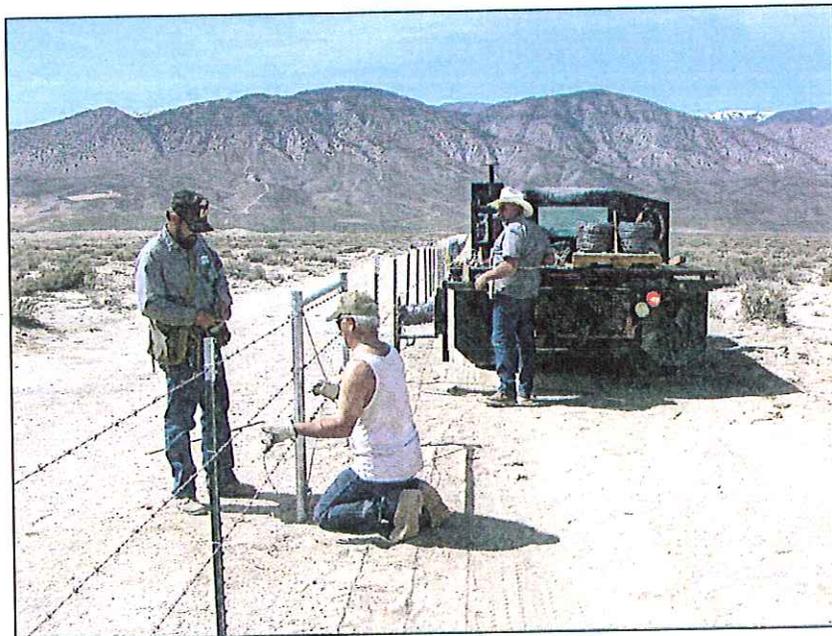
MINERAL COUNTY PERSONNEL INSTALLING SITE PERIMETER FENCE

During February and March 2008, Kleinfelder subcontracted Mineral County to perform fence repairs at locations where vehicles had damaged fence posts. During fence repair, Mineral County collected surface trash that had been recently dumped. Fencing repair was performed on weekends during February, March, April, May, and June 2009.

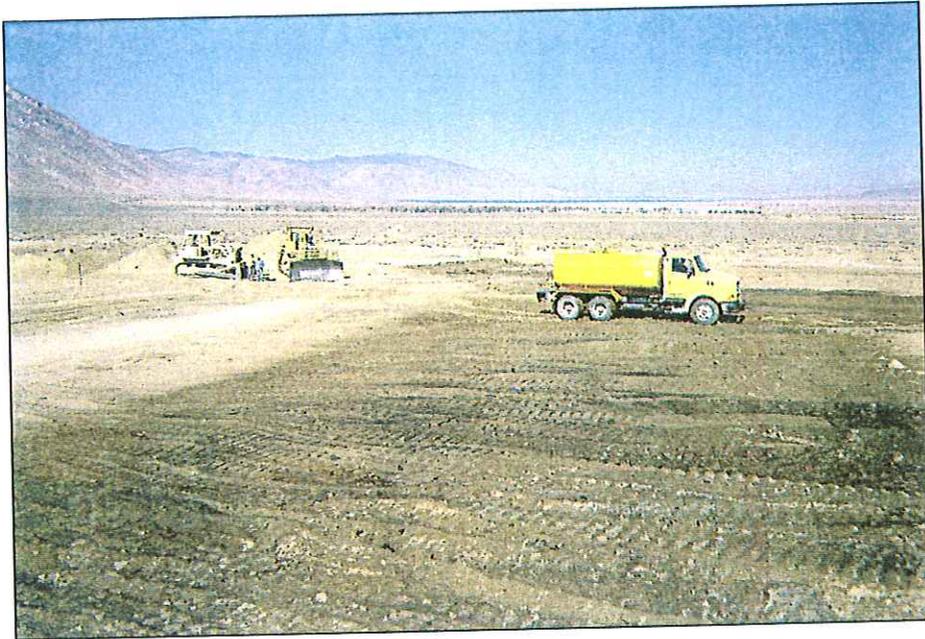
**SURFACE DEBRIS CONSOLIDATION, DISPOSAL  
 AND FINAL GRADING ACTIVITIES**

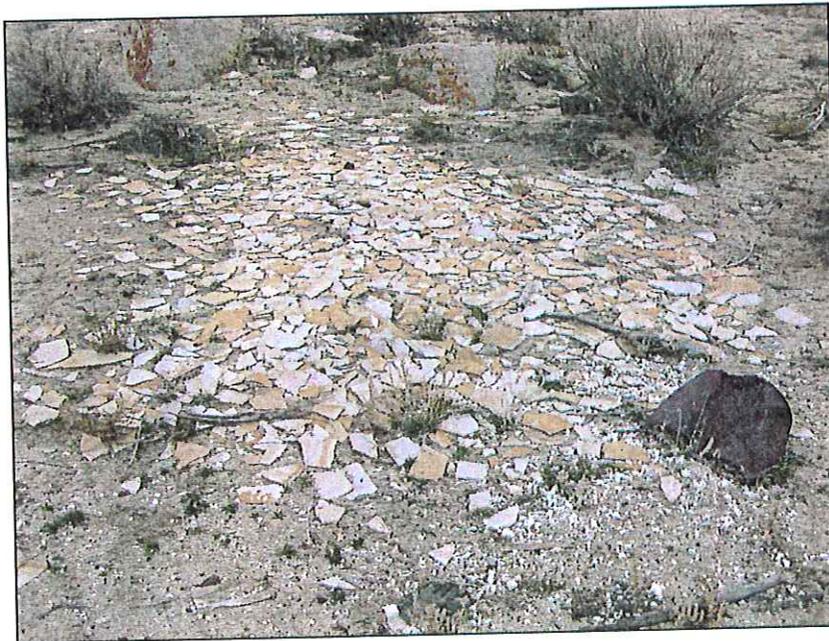
During cleanup activities, suspected Asbestos Containing Material (ACM) was observed on the ground surface of the Site. The suspected ACM was observed as cementitious roofing tiles and friable pipe insulation material; see Photo 6 in Plate 5 and Photo 7 in Plate 6. The NDEP requested Kleinfelder provide ACM abatement services as a part of cleanup activities.

**ASBESTOS CEMENT TILES LOCATED ON-SITE  
 PRIOR TO ABATEMENT**

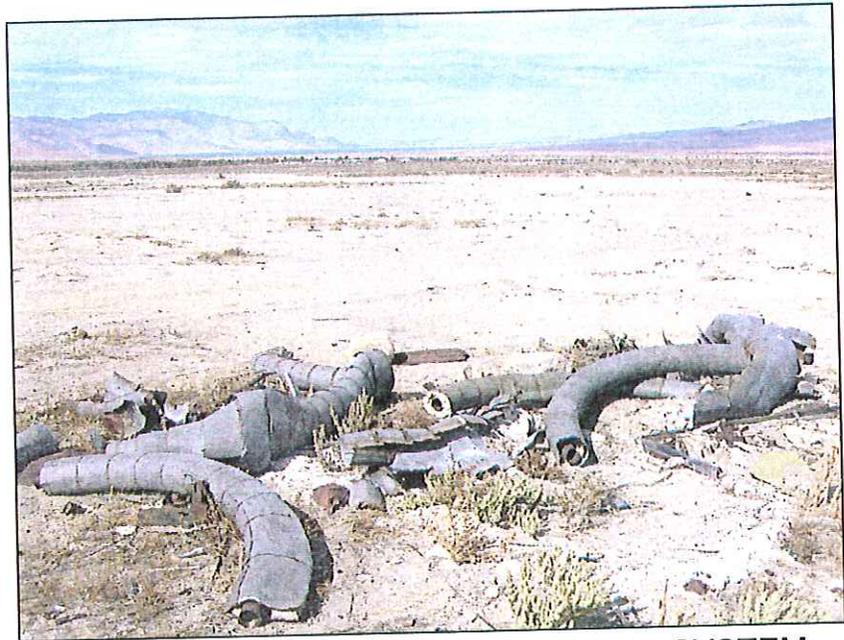
ASBESTOS-CONTAINING THERMAL SYSTEM  
 INSULATION LOCATED ON-SITE  
 PRIOR TO ABATEMENT

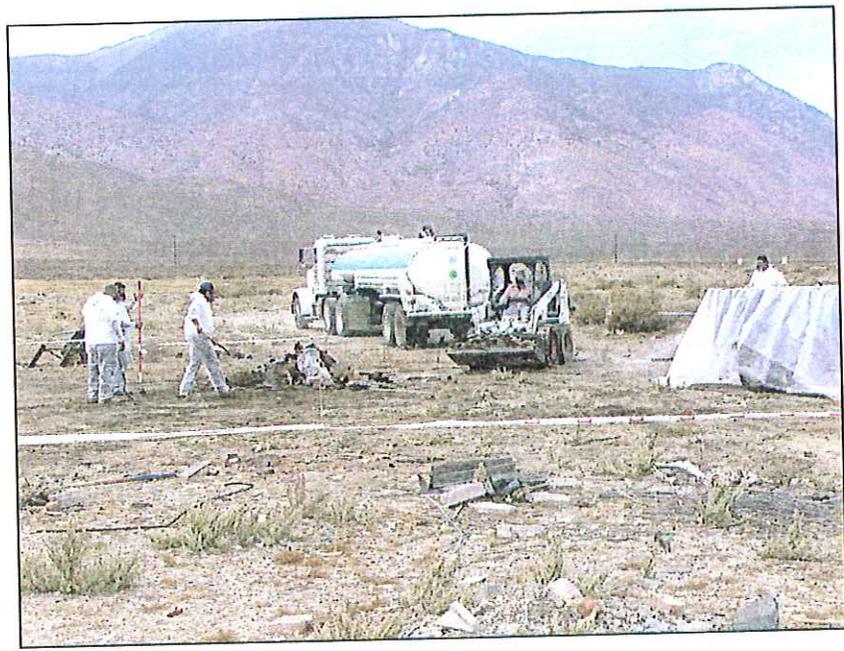
ASBESTOS ABATEMENT ACTIVITIES

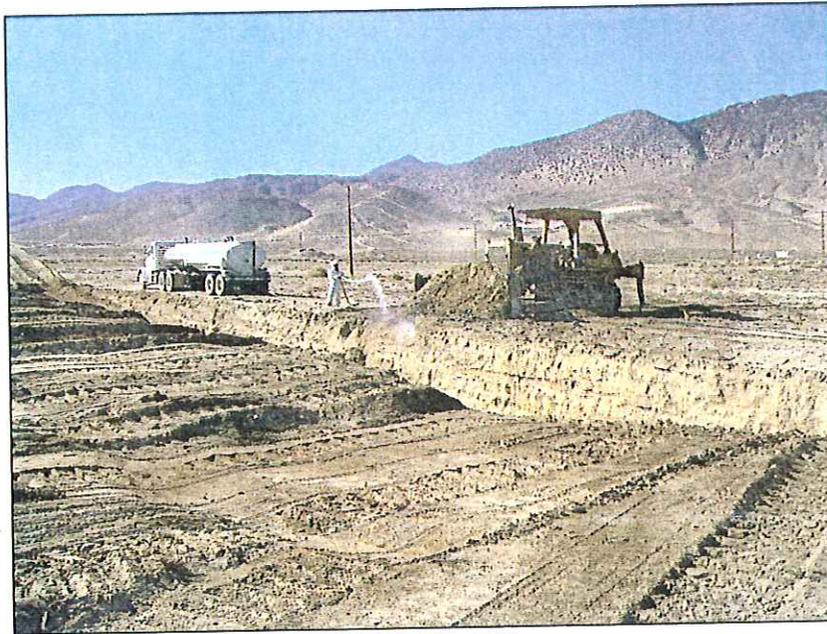
ASBESTOS ABATEMENT ACTIVITIES

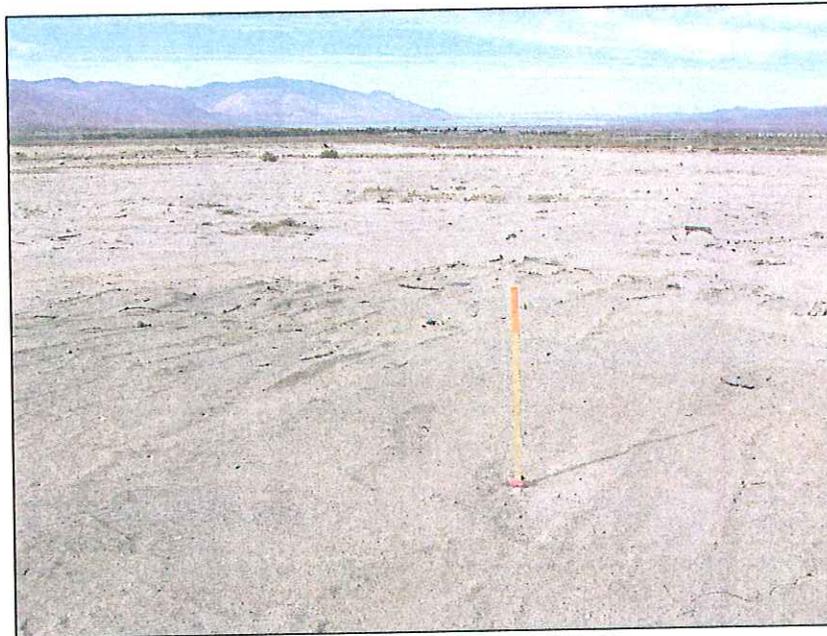
COMPLETED ABATEMENT AT FORMER THERMAL SYSTEM INSULATION LOCATION
