# DRAFT DIXIE AND HANKS CREEKS TEMPERATURE TMDLS

**JUNE 2010**

Prepared by:  
Randy Pahl  
Nevada Division of Environmental Protection  
Bureau of Water Quality Planning

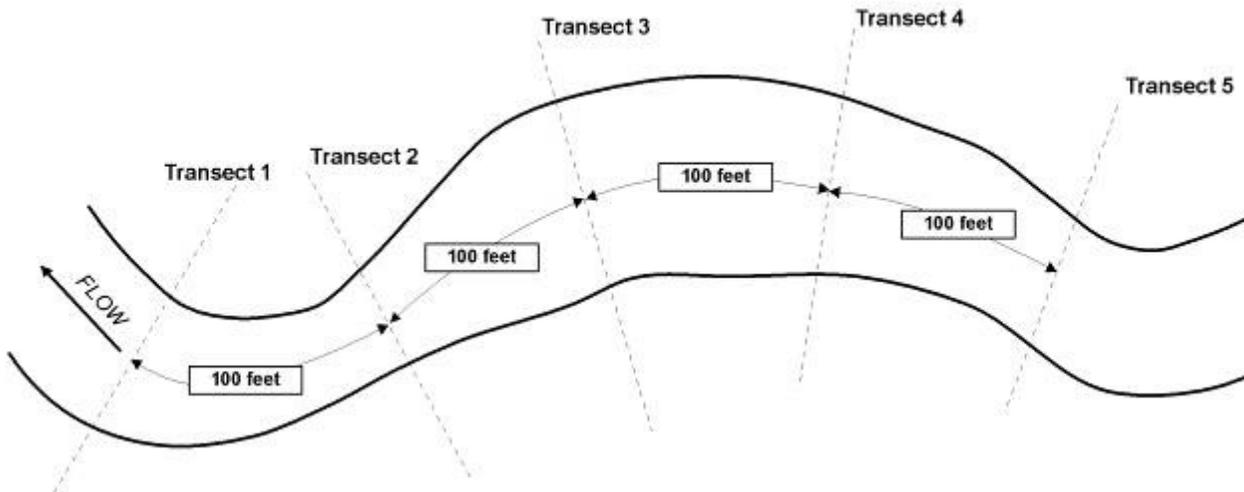
**Figure 2. Transect Layout for BLM Habitat Surveys**

At each survey site, five cross-sectional transects (T1 – T5) are placed 100 feet apart with T1 at the downstream point (Figure 2). At each transect, a bank cover rating and a bank stability rating are estimated for both the left bank and the right bank extending 50 feet above and below the transect. Ratings vary from 0.5 to 2.0 as shown in Tables 1 and 2. The overall bank cover rating for the site is equal to the sum of the 10 subreach cover ratings, and the overall bank stability rating is equal to the sum of the 10 subreach stability ratings. A maximum rating of 20 can be achieved if all subreaches have a rating of 2.0. From the bank cover and bank stability ratings, BLM calculates a riparian condition rating by adding the bank cover and bank stability ratings and dividing by the total number of points. The resulting riparian condition calculation can vary from 25% to 100% of optimum. See Appendix A for example photographs for each rating.

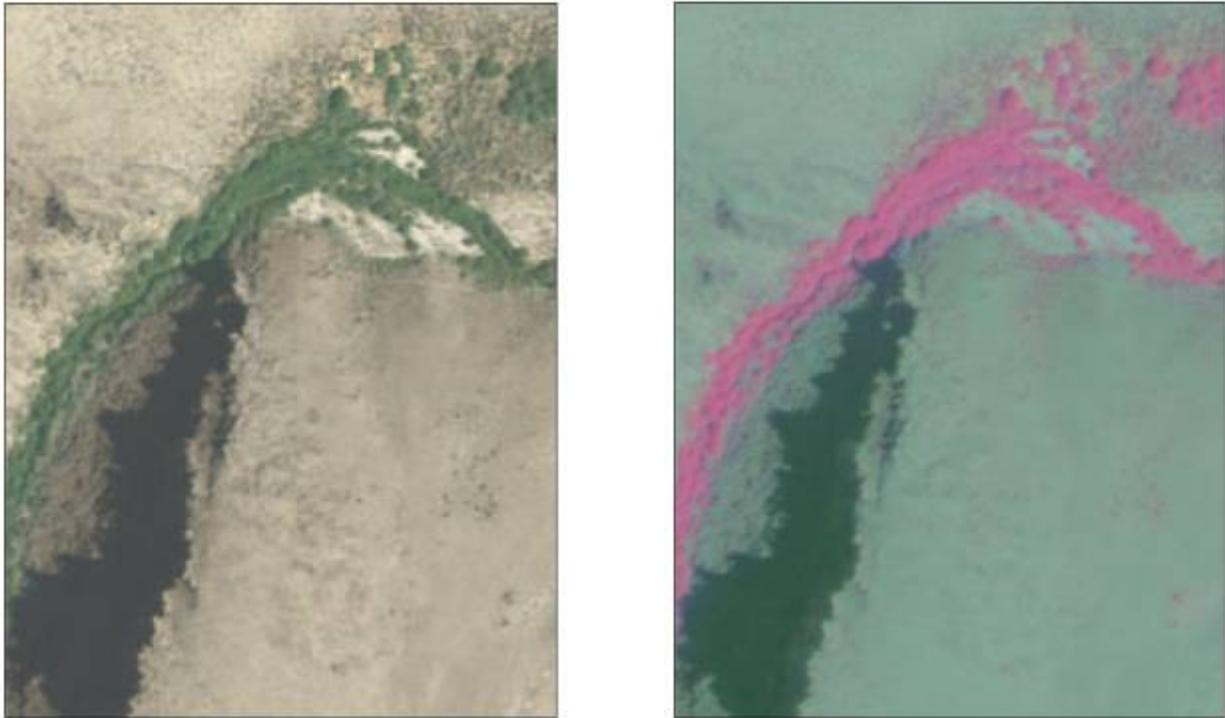
**Figure 3. Sample NAIP Natural Color and Color Infrared Imagery on Hanks Creek**

Fortunately, recent aerial photography was available to test this approach. During the summer of 2006, the U.S. Department of Agriculture produced 1-meter resolution aerial imagery throughout Nevada as part of the NAIP (National Agriculture Imagery Program) efforts. Products consisted of two sets of imagery – natural color and color infrared (Figure 3). While natural color imagery shows those colors visible to the naked eye, the color infrared (CIR) includes an invisible near infrared band. CIR imagery is commonly used in vegetation study, as healthy vegetation is depicted in red and generally stands out from the rest of the land cover.

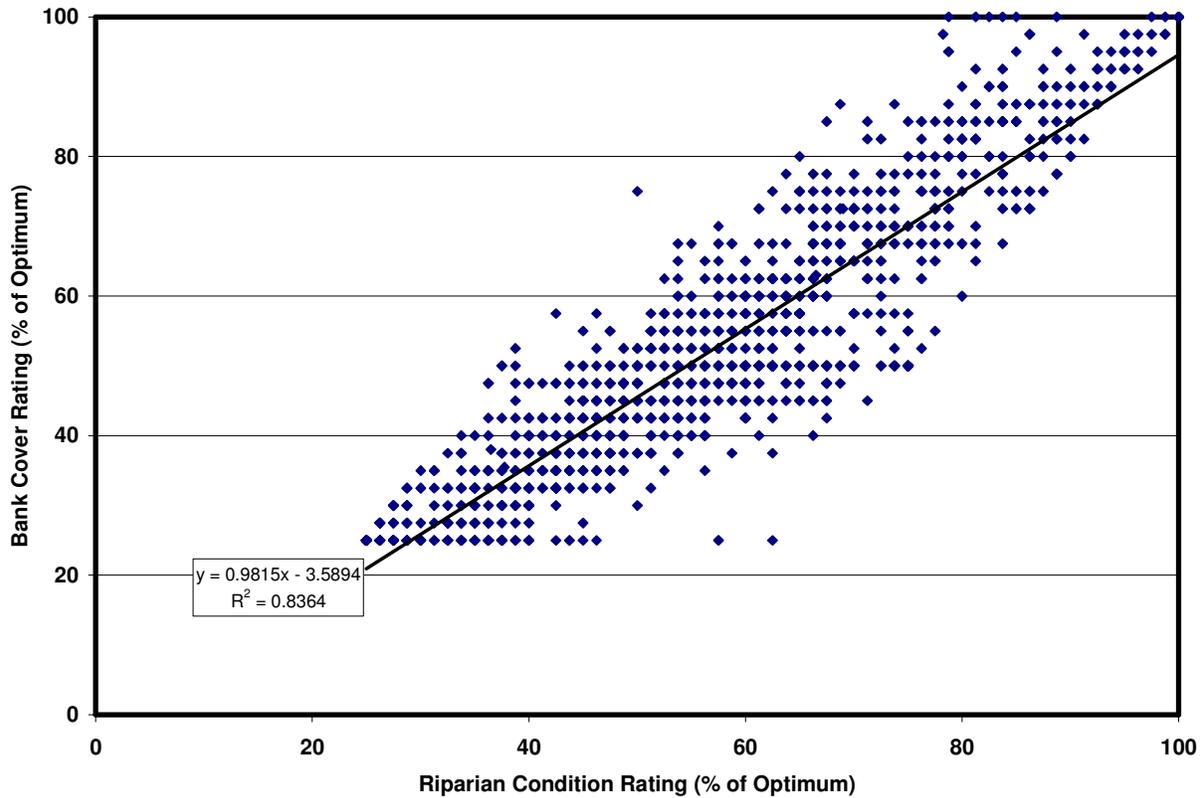
**Figure 4. Bank Cover Rating vs. Riparian Condition Rating**

As discussed earlier, BLM's riparian condition rating incorporates both the bank cover rating and the bank stability rating. However, it was determined that bank stability conditions could not be readily estimated from the NAIP imagery, but bank cover conditions could. Therefore, the bank cover rating has been selected as the surrogate for the riparian condition rating. An evaluation of the nearly 30,000 datapoints in the BLM database indicated a good correlation between riparian condition rating and the bank cover rating (see Figure 4). This is not surprising as the bank cover scores make up ½ of the riparian condition ratings. Also, channel health is needed to facilitate vegetation health so one would expect a reasonable relationship.

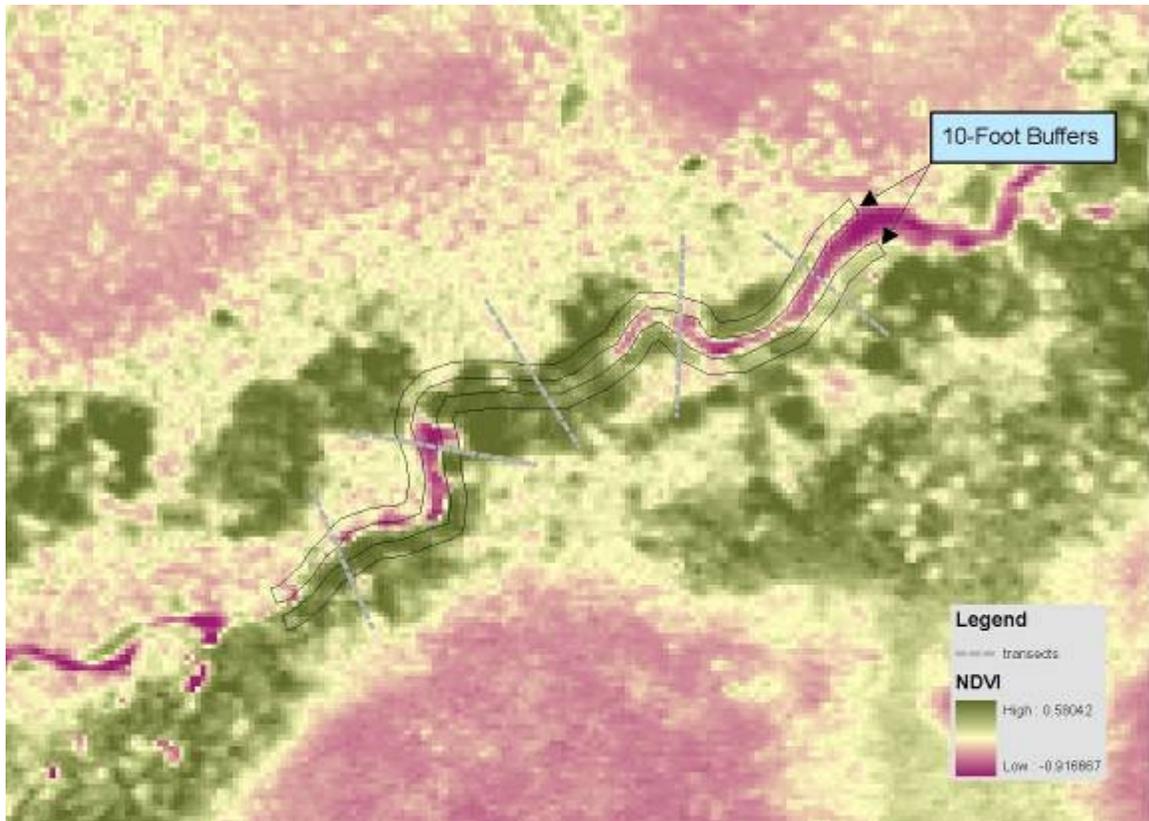
**Figure 5. NDVI Results for Sample BLM Survey Site Area**

Index values can range from -1.0 to 1.0, but vegetation values typically range between 0.05 and 0.7 (BAE Systems, 2004). Higher index values are associated with higher levels of healthy vegetation cover. NDVI values near zero and decreasing negative values indicate non-vegetated features such as barren surfaces (rock and soil) and water, snow, ice, and clouds. Figure 5 shows the NDVI values for a selected BLM habitat survey site along with its 10-foot buffer.

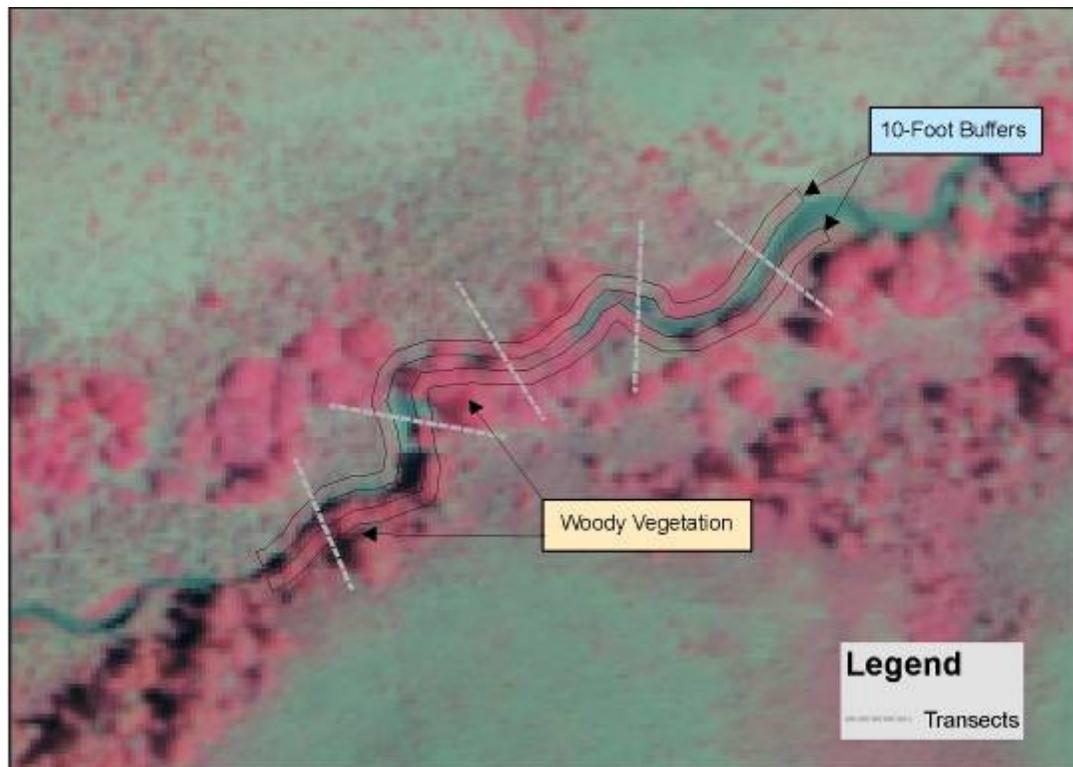
**Figure 7. Woody Vegetation for Sample BLM Survey Site**

**Percent Woody Vegetation:** It was initially hoped that woody (primarily willows on these systems) vegetation could be delineated (digitized) throughout each of the 46 selected survey site buffers, and that the same techniques could be used to delineate woody vegetation on Dixie and Hanks creeks. However with the 1-meter resolution, it was not possible to accurately delineate the extent of woody vegetation for a site. Therefore, each buffer was assigned one of five general categories of woody cover (0%, 25%, 50%, 75%, or 100%) based upon visual estimates from the imagery.

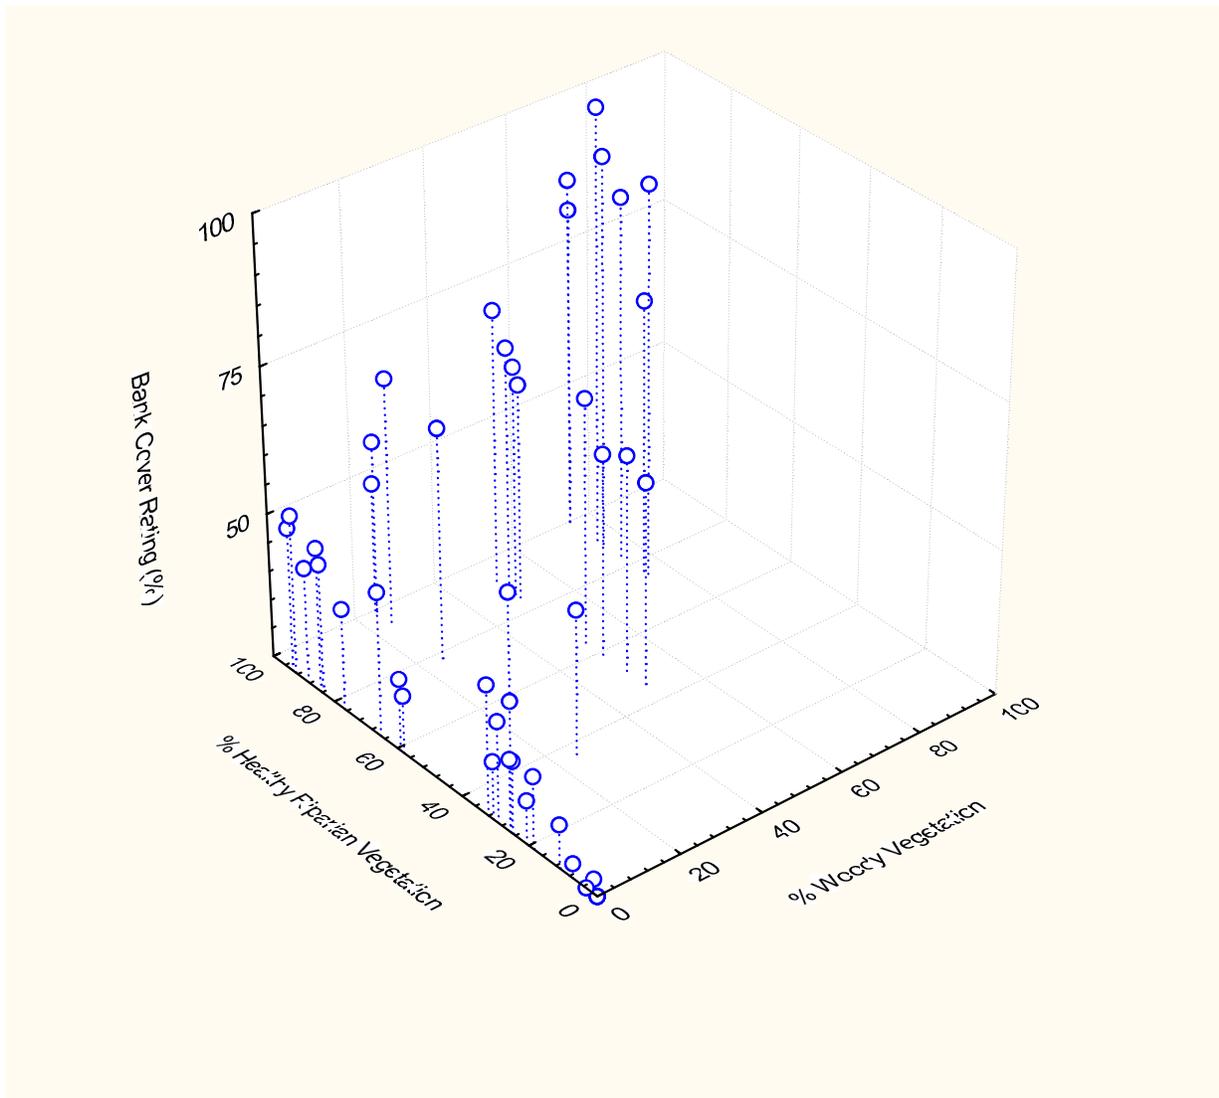
**Figure 8. Plot of Bank Cover Ratings and Buffer Characteristics for Selected BLM Survey Sites**

$$\text{Bank Cover} = (0.478 \times \% \text{ Woody Vegetation in Buffer}) + (0.264 \times \% \text{ Riparian Vegetation in Buffer}) + 25$$

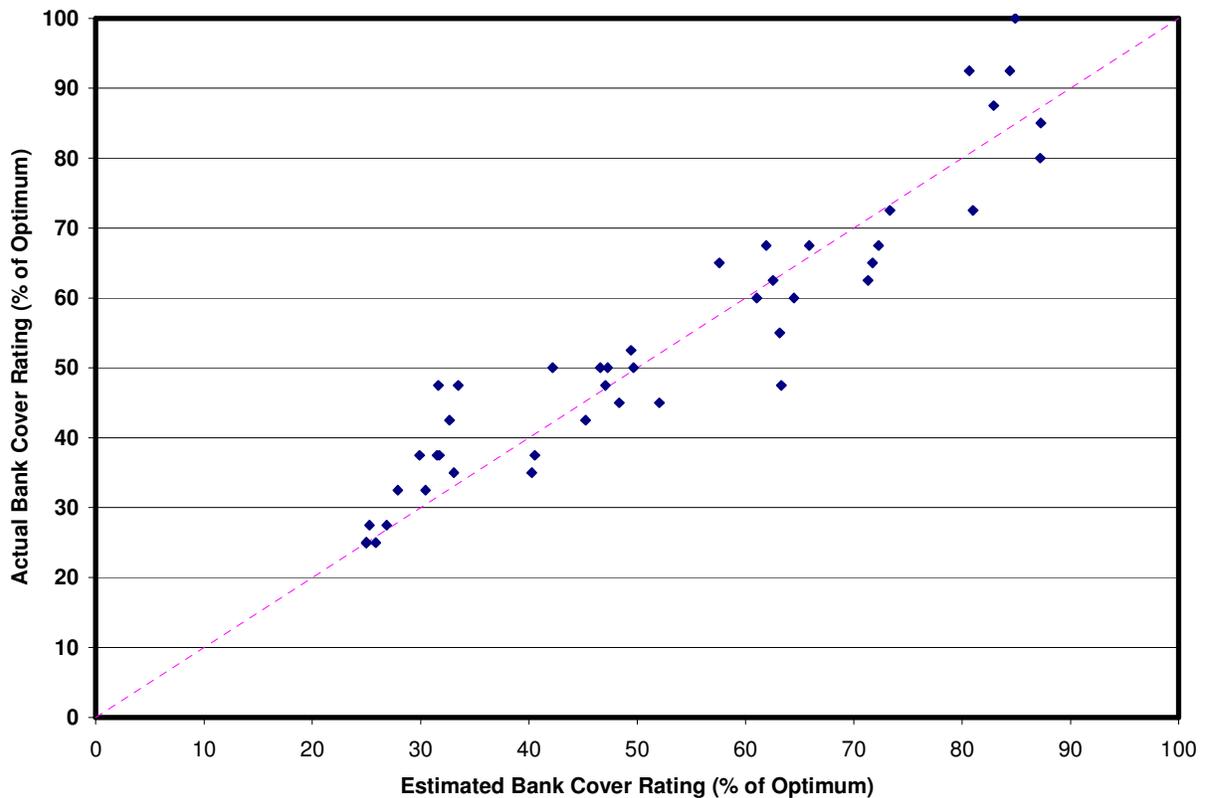
**Figure 9. Predicted Bank Cover Rating vs. Actual Bank Cover Ratings**

When applied to the 46 selected sites, this relationship provided very reasonable estimates of the actual bank cover ratings for those sites (Figure 9). This relationship was deemed to be more than adequate for estimating bank cover conditions throughout Hanks and Dixie creeks.

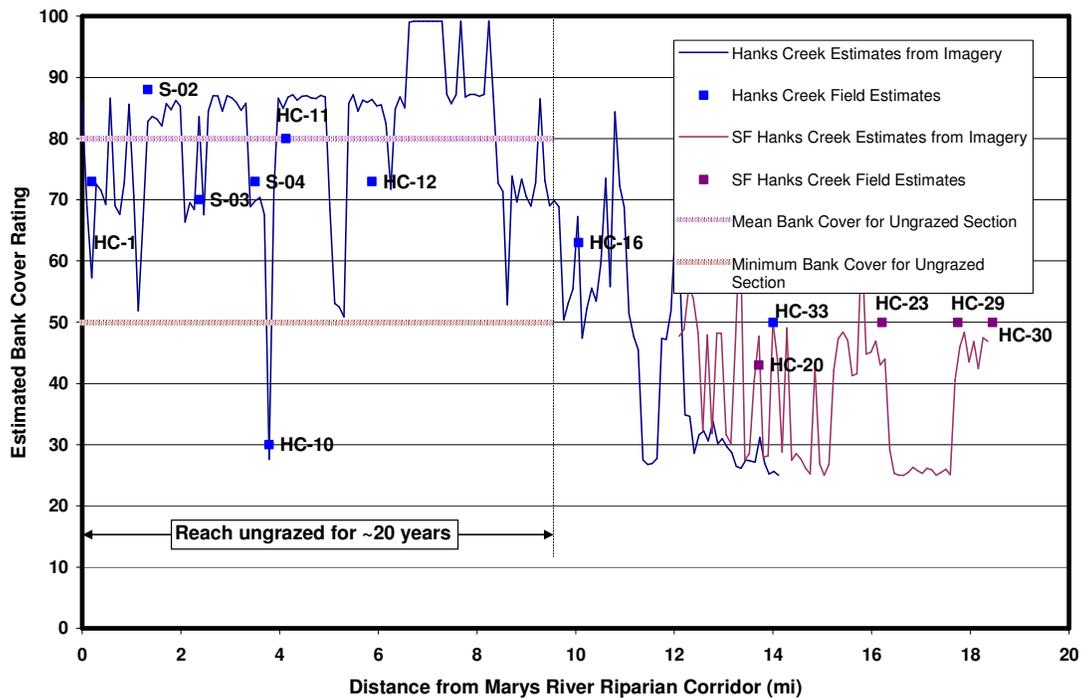
Figure 12. Estimated Bank Cover for the Ungrazed Portion of Hanks Creek

Using Equation 1 and NAIP imagery (collected prior to recent wildfires), bank cover conditions were estimated for Hanks Creek and SF Hanks Creek (Figure 12). Field estimates were also performed during the summer of 2009 at selected sites (Figure 13). For the lower, ungrazed 9.5 miles, bank cover conditions ranged from about 30 to nearly 100. However the low value at HC-10 is due to the existence of a water gap where livestock are allowed access to the stream for drinking water. The other locations with low bank cover values (0.2, 1.1, 5.3 and 8.6 miles) are thought to be part of the natural variability of the system. Excluding the HC-10 location, the bank cover for the ungrazed portion of Hanks Creek has an average value of 80 and a minimum value of 50. These values will be used as the target for these TMDLs.

There is considerable uncertainty associated with the individual bank cover estimates depicted on Figure 12. For any given location along the creek, there is a 95% certainty that the actual bank cover value falls within the range represented by the Prediction Interval lines on Figure 14. If the uncertainty associated with individual predictions using Equation 1 were considered, the actual range of bank cover conditions (excluding the HC10 section) could vary from 37 to 100.

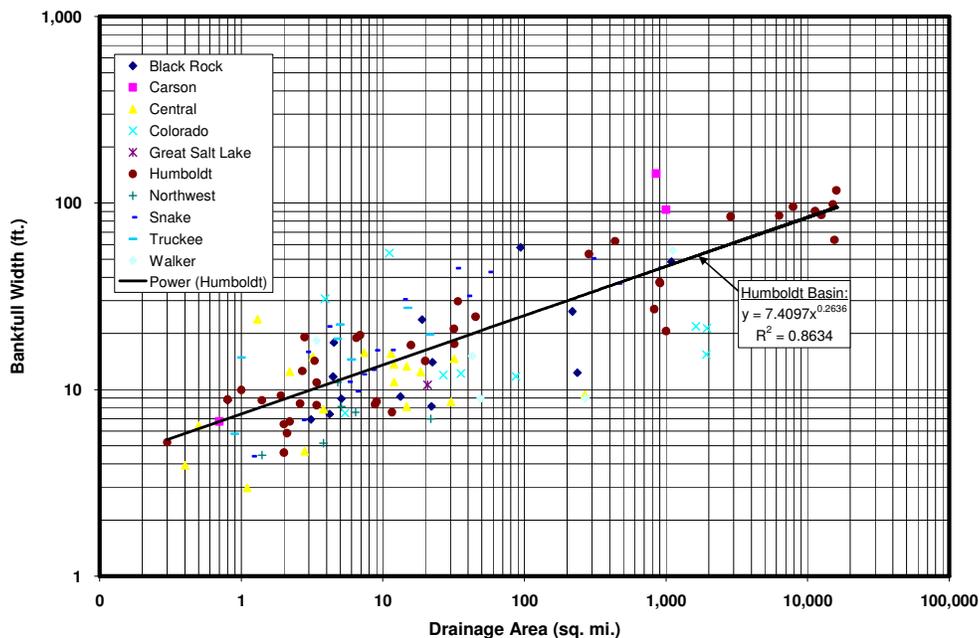
Figure 15. Drainage Area vs. Bankfull Width – All NDEP Biosites

Current bankfull widths may not be representative of desired widths for stream sections with riparian conditions at the set target. Impacted streams are typically wider and shallower than healthier stream, and have vegetation shading covering a lower percentage of the water surface. Regional curves relating bankfull width to drainage area are often used to estimate “expected” widths for a given location. Using NDEP’s data compiled as part of its biological assessment efforts, Figure 15 has been developed. However, this curve has been developed using all types of sites from the healthy to the highly impacted sites. As a result, most (if not all) of the healthy sites on Dixie and Hanks Creek have bankfull widths which fall below this curve. Target widths for the creeks were derived from relationships similar to Figure 15, however using only healthy sites in the regressions.

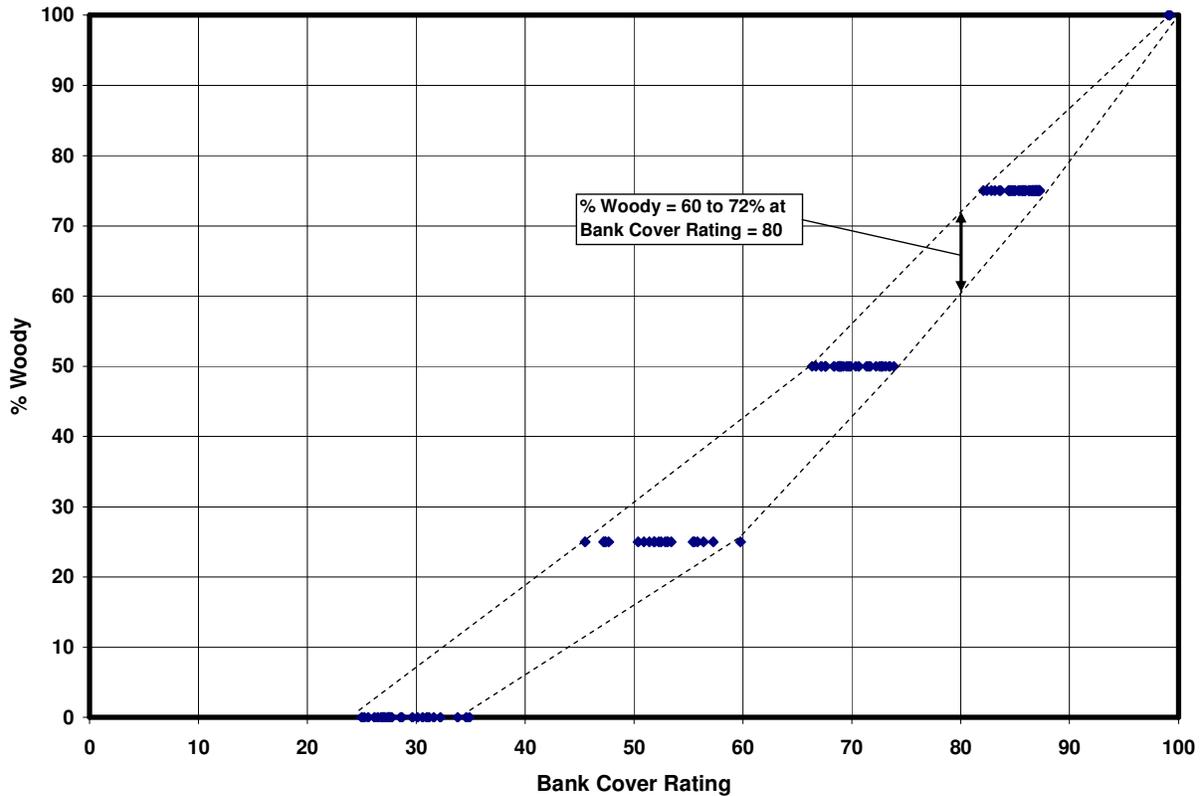
**Figure 16. Bank Cover vs. Percent Woody Vegetation – Hanks Creek**

For those reaches at or exceeding the Bank Cover Average Target of 80, existing woody vegetation densities estimated from the NAIP imagery were used in the shade modeling. For those reaches below the Bank Cover Average Target of 80, woody vegetation densities were set at 72% based upon the findings of Figure 16. This plot (Figure 16) of estimated bank cover ratings versus % woody vegetation for Hanks Creek suggests that one could expect the % woody vegetation to vary from about 60 to 72 percent when bank cover rating conditions are at the target of 80.

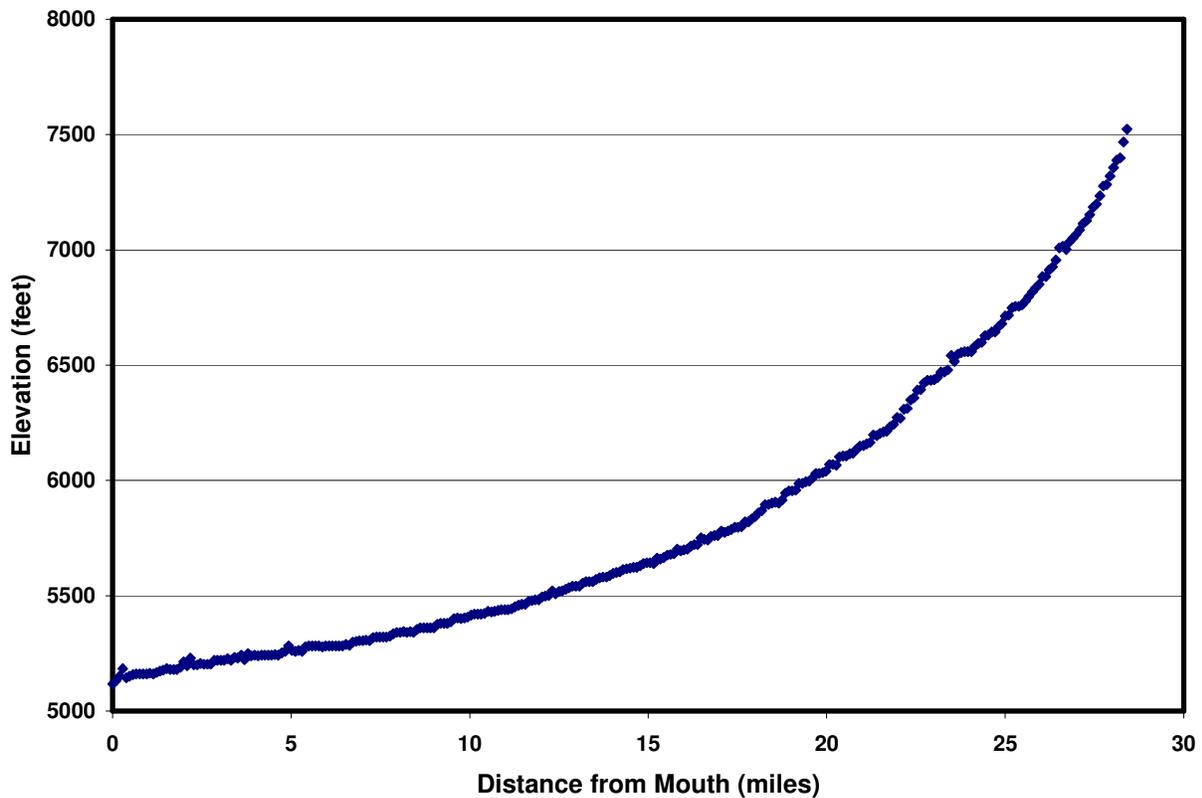
Figure 21. Dixie Creek Stream Profile

Dixie Creek is a small stream with widths typically less than 6 feet (Schroeter, 2001), and a typical parabolic shape to the stream profile (Figure 21). Slopes range from about 5% in the upper reaches to about 0.05% in the lower 10 miles of the creek. Much of lower 21 miles of Dixie Creek is incised to some degree, with depths as high as ~15 feet in some areas (Figure 22). However, new floodplains have been developed in many reaches providing areas for riparian vegetation establishment.

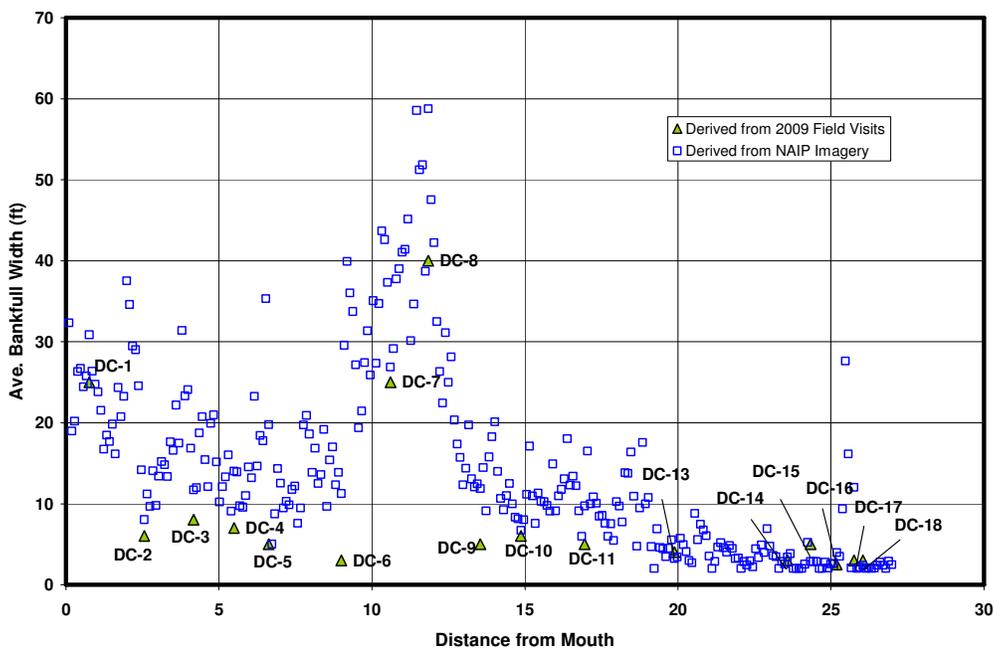
**Figure 23. Dixie Creek Existing Bankfull Widths**

Bankfull widths vary from about 1-2 feet in the headwaters to 40 feet and higher in the mid-section of the stream (Figure 23). The higher widths tend to occur in those areas with limited perennial flow.

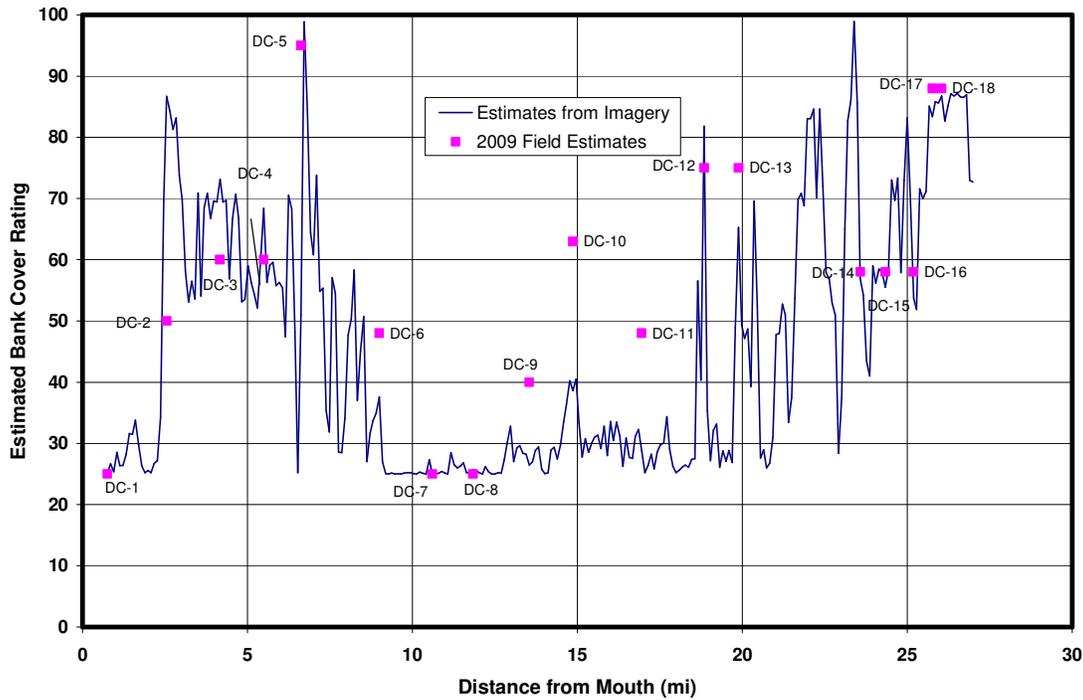
**Figure 29. Dixie Creek – Existing Bank Cover Rating**

Figure 29 shows a good correlation between the bank cover ratings estimated from the NAIP imagery and those from field visits. The low bank cover ratings tend to occur in those locations with little to no flow in the late summer. Between River Mile 13.0 and 18.0, the 2006 NAIP imagery showed poor riparian vegetation conditions with bank cover ratings around 30. Field visits in 2009 indicate that conditions in this reach have improved due to management changes.

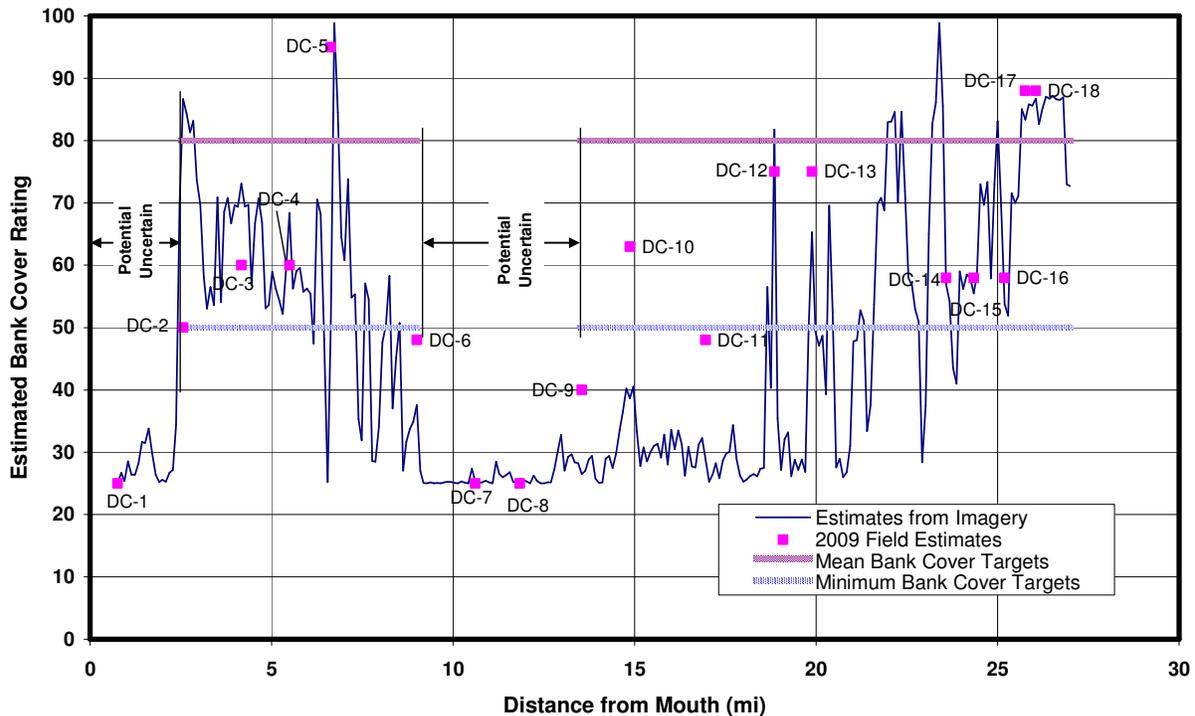
Figure 30. Dixie Creek – Existing and Target Bank Cover Rating

Figure 30 presents bank cover conditions as estimated using the 2006 NAIP imagery and bank cover targets for Dixie Creek. Of the approximately 20 miles with assigned targets, only about 14% of Dixie Creek exceeds the mean bank cover target of 80, with about 54% exceeding the minimum bank cover target of 50. The actual percentages are expected to be some what higher as conditions have improved since the 2006 NAIP imagery was collected.

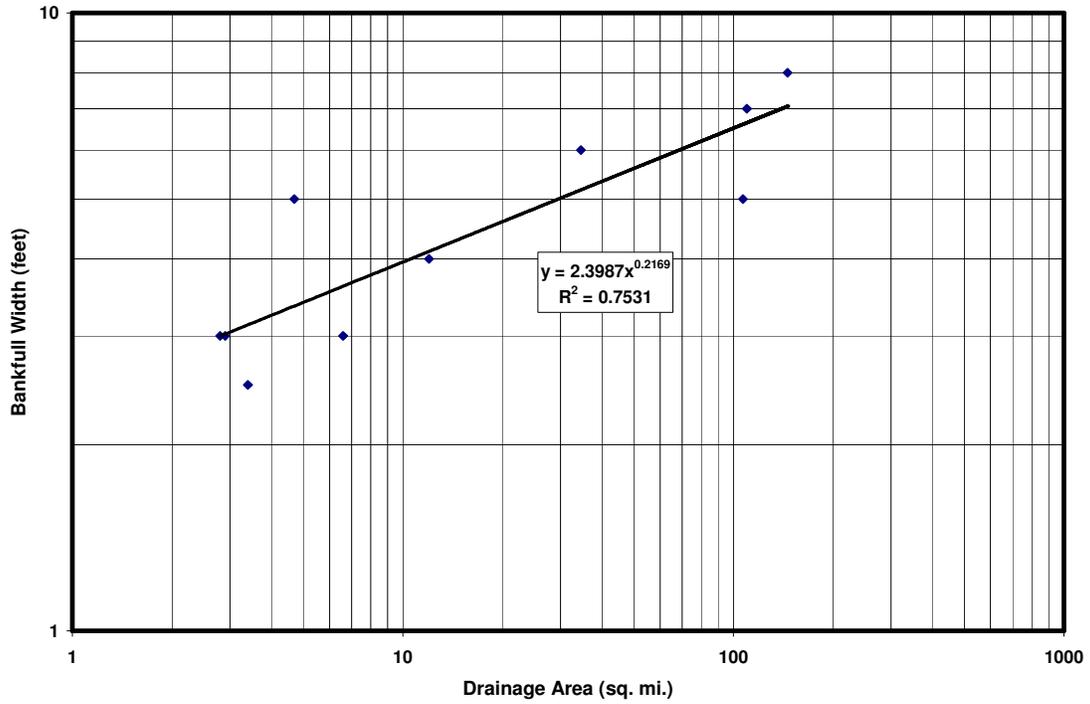
**Figure 31. Drainage Area vs. Bankfull Width – Dixie Creek Stations Near or exceeding Bankfull Targets**

**Target Loads:** Target loads were calculated using the same model inputs as the existing loads, except for stream width and vegetation density. The target bankfull widths were assigned based upon the widths for the healthier locations within Dixie Creek. Using data for selected 2009 field survey sites with bank cover conditions near or above the bank cover targets, a relationship between bankfull widths and drainage area was developed and was used to develop target bankfull widths (Figure 31).

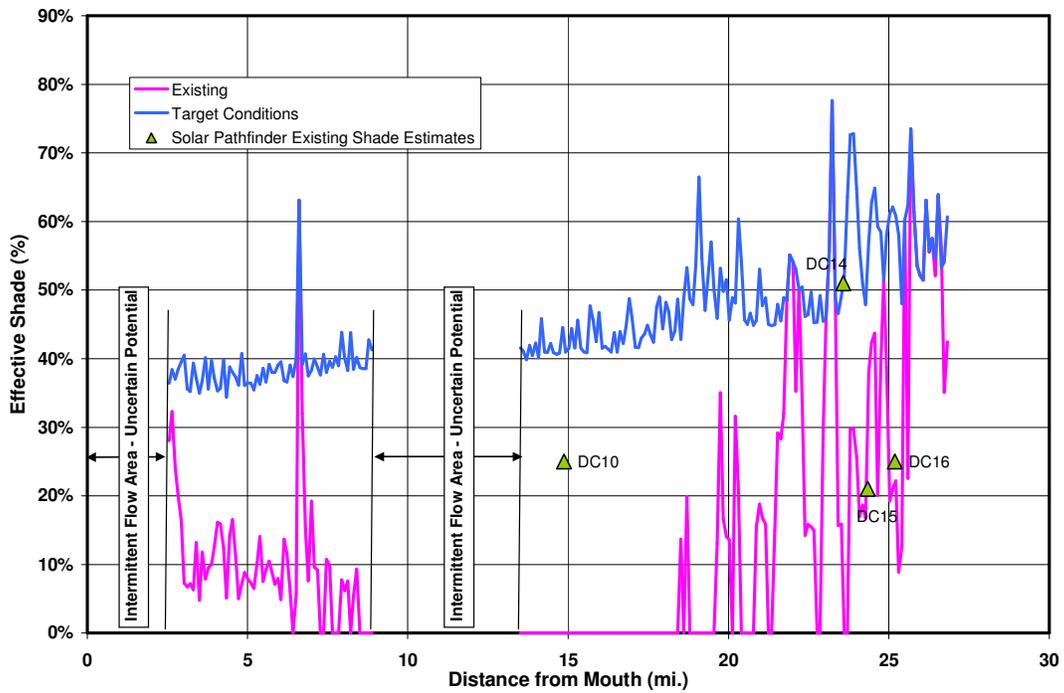
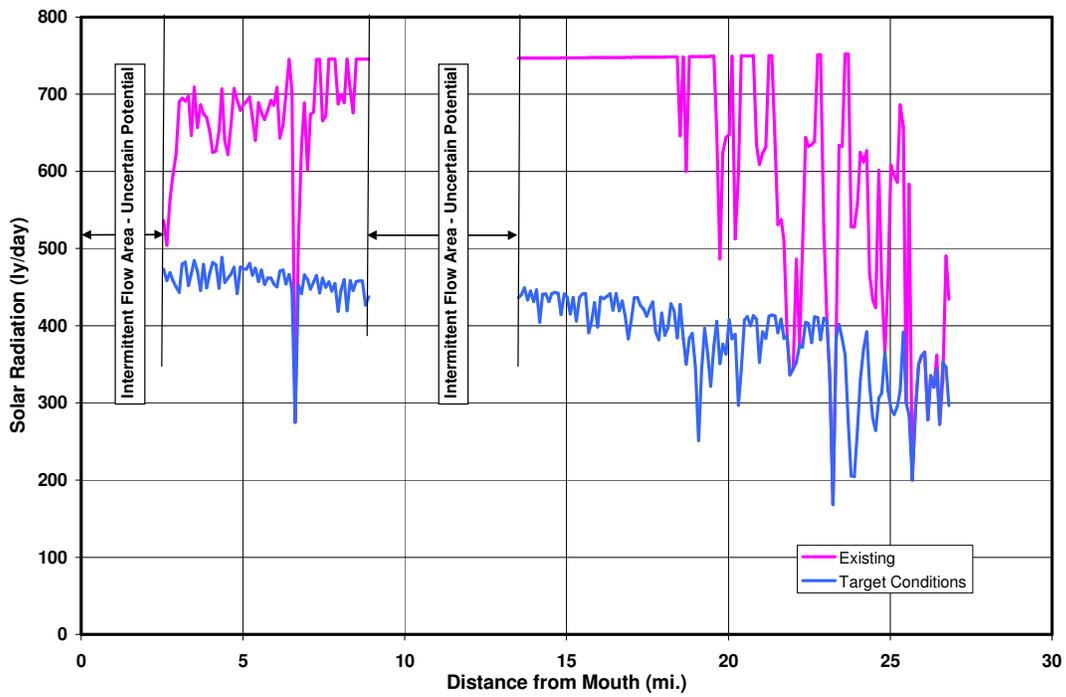
**Allocations and Load Reductions:** The existing and target shade and solar radiation loads as estimated using the Heat Source Model are shown in Figures 32 and 33. Shade estimates from the Solar Pathfinder were close to those estimated using the Heat Source Model, with the exception of DC-10 which has experienced improved riparian conditions since the 2006 NAIP imagery was generated.

Load allocations for Dixie Creek are represented by Figure 33, and are assigned to nonpoint source activities that have or may affect riparian vegetation. Solar radiation reductions associated with the vegetation target conditions and the load allocations are presented in Figure 34. The overall average solar radiation reduction is estimated at about 37% (Table 6). A detailed breakdown for the existing and target conditions for each 500-foot subreach of Dixie Creek is provided in Table 7.

Average Percent Shading	Average Solar Loading (Langleys/day)
Existing	14.1%	643
Target Allocations	46.1%	403
Load Reduction	na	-240
% Change	na	-37%

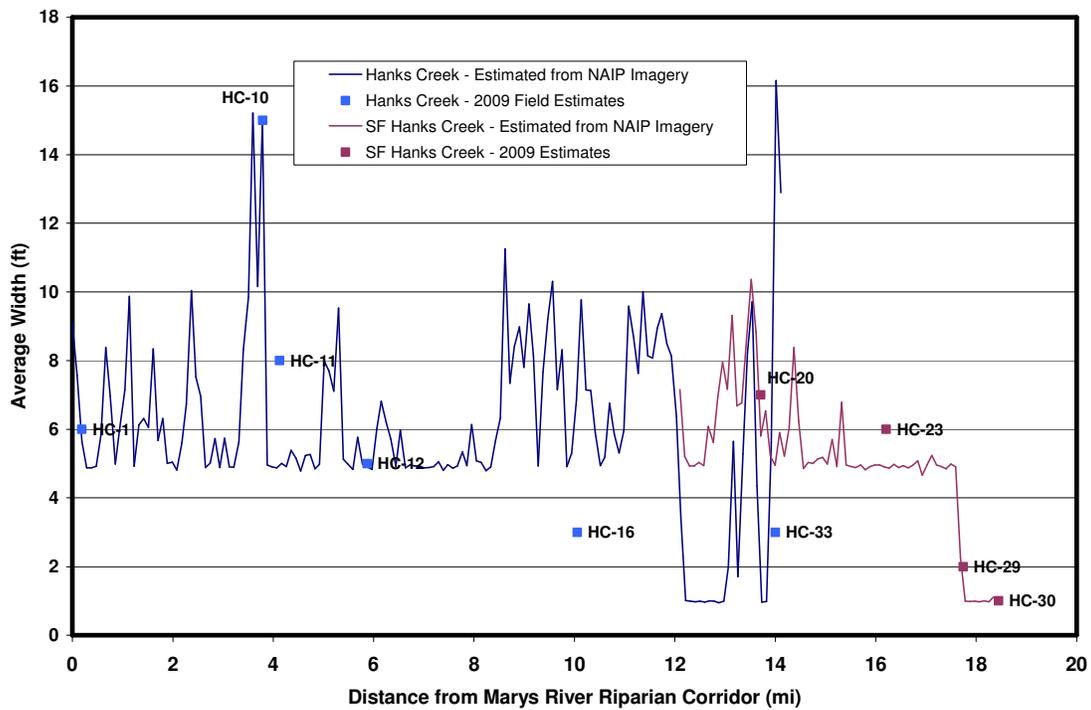
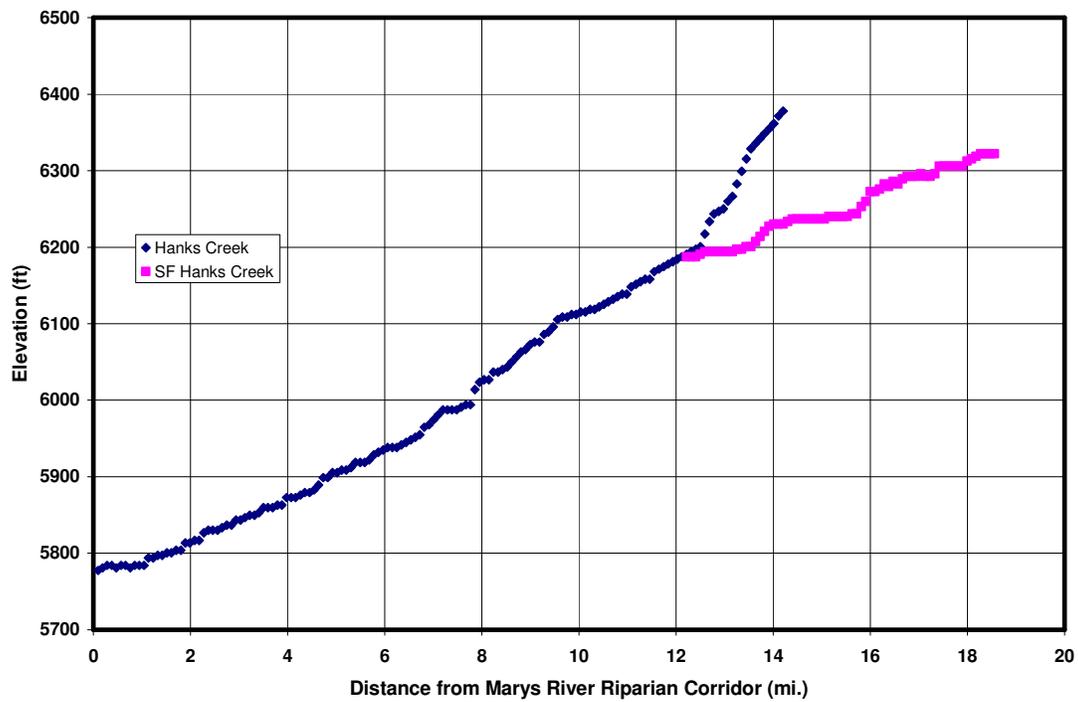
Hanks Creek and its main tributary, SF Hanks Creek, are small streams with widths typically less than 6 to 8 feet as derived from field visits and the 2006 NAIP imagery (Figure 38). Slopes are not as variable as in Dixie Creek, with gradients ranging from about 2% in upper Hanks Creek to 0.5% in lower Hanks Creek (Figure 39).

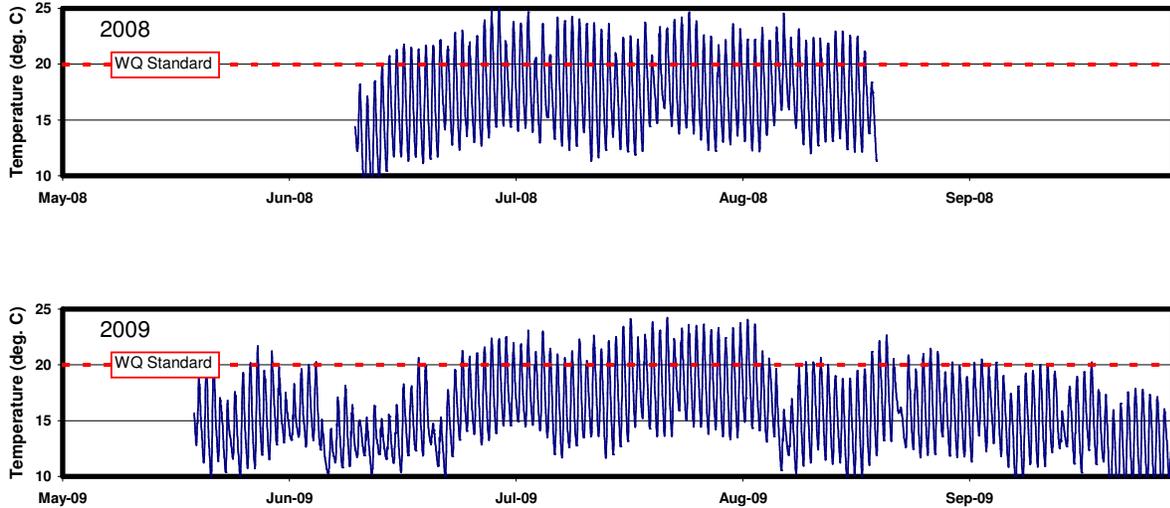
**Figure 40. Temperature Data for Upper Hanks Creek**

Parameter	2002	2003	2004	2005	2006	2008	2009	Total
<b><i>Upper Hanks Creek</i></b>								
No. of Days Sampled	---	---	---	---	---	71	140	211
No. of Standard Exceedances	---	---	---	---	---	66	70	136
% of Sampled Days with Exceedances	---	---	---	---	---	93%	50%	64%
% of Year with Exceedances	---	---	---	---	---	18%	19%	19%
<b><i>Lower Hanks Creek</i></b>								
No. of Days Sampled	145	162	139	66	105	---	140	757
No. of Standard Exceedances	54	74	37	22	35	---	22	244
% of Sampled Days with Exceedances	37%	46%	27%	33%	33%	---	16%	32%
% of Year with Exceedances	15%	20%	10%	6%	10%	---	6%	11%

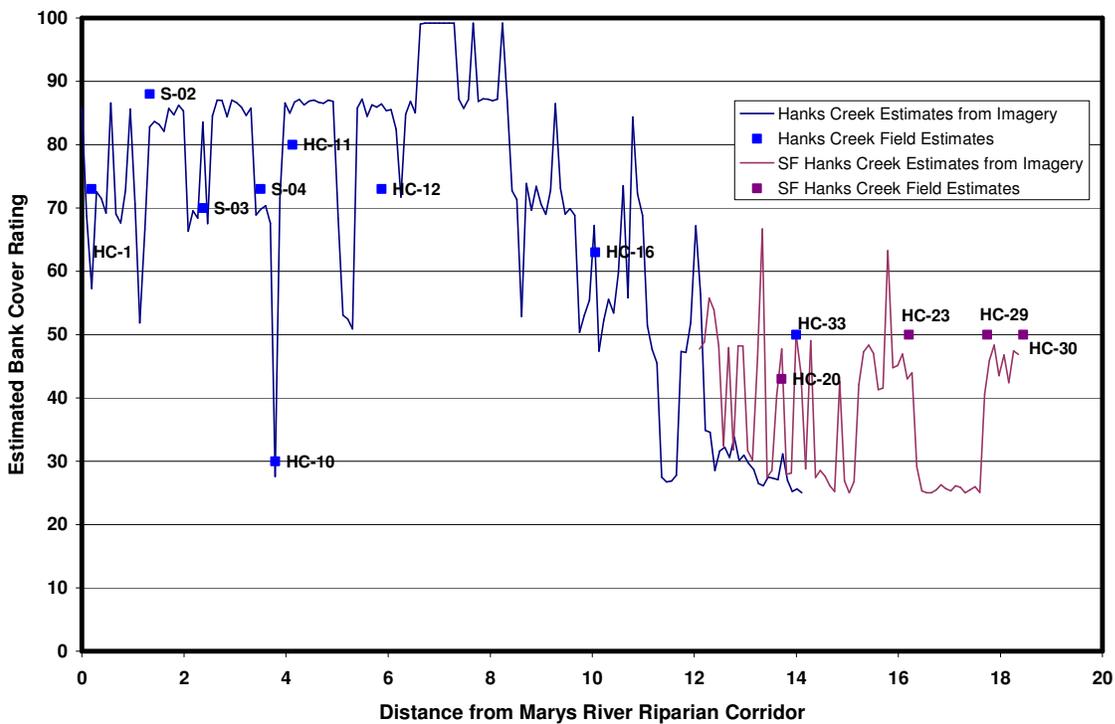
**Figure 44. Hanks Creek and SF Hanks Creek – Existing Bank Cover Rating**

As mentioned earlier, about 50% of riparian community along Hanks Creek experienced moderate to heavy fire intensity during 2006. Three years after the fire, field surveys by NDEP showed bank cover conditions were good for much of lower Hanks.

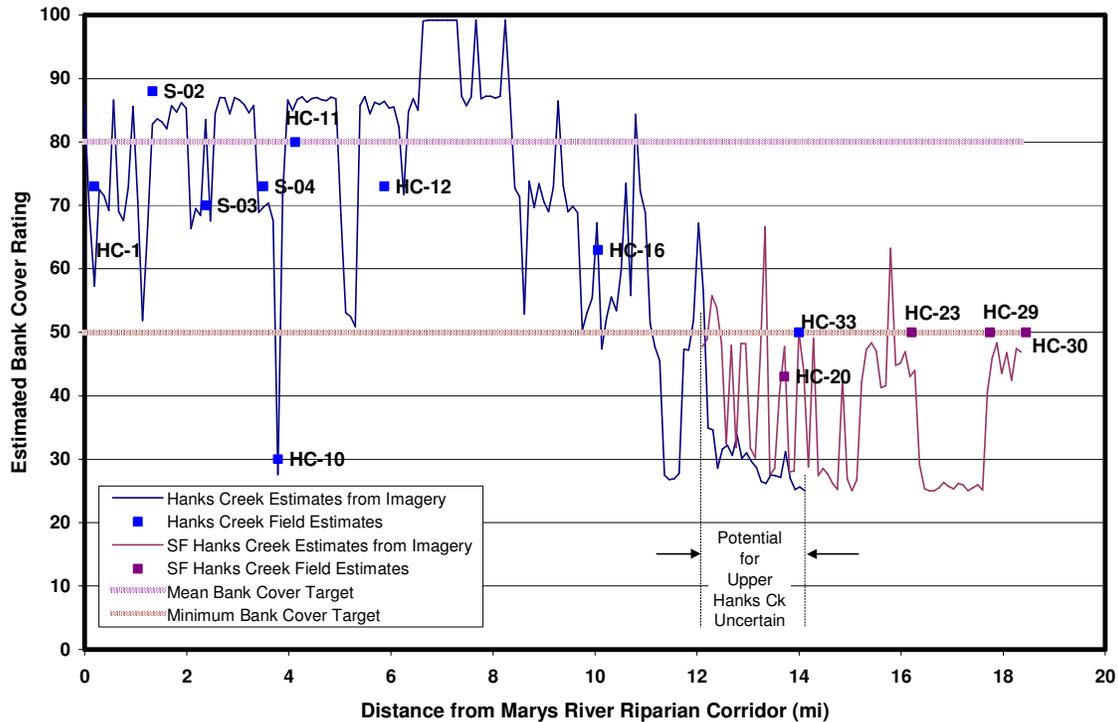
**Figure 45. Hanks Creek and SF Hanks Creek – Existing and Target Bank Cover Ratings**

As previously discussed, the TMDL targets are to be defined in terms of riparian vegetation conditions (using BLM’s riparian condition rating system) rather than stream temperature. Conditions within the lower Hanks Creek have been selected as representative of achievable “natural” conditions for much of the remaining Hanks Creek and SF Hanks Creek. Bank cover targets for these stretches have been set at an average of 80 with a minimum of 50 (Figure 45). However, no targets have been set for the naturally-intermittent stretch of Hanks Creek above the confluence with SF Hanks Creek. The potential to establish health riparian vegetation in this section is uncertain given the dry conditions.
