# DRAFT DIXIE AND HANKS CREEKS TEMPERATURE TMDLS

**JUNE 2010**

Prepared by:  
Randy Pahl  
Nevada Division of Environmental Protection  
Bureau of Water Quality Planning

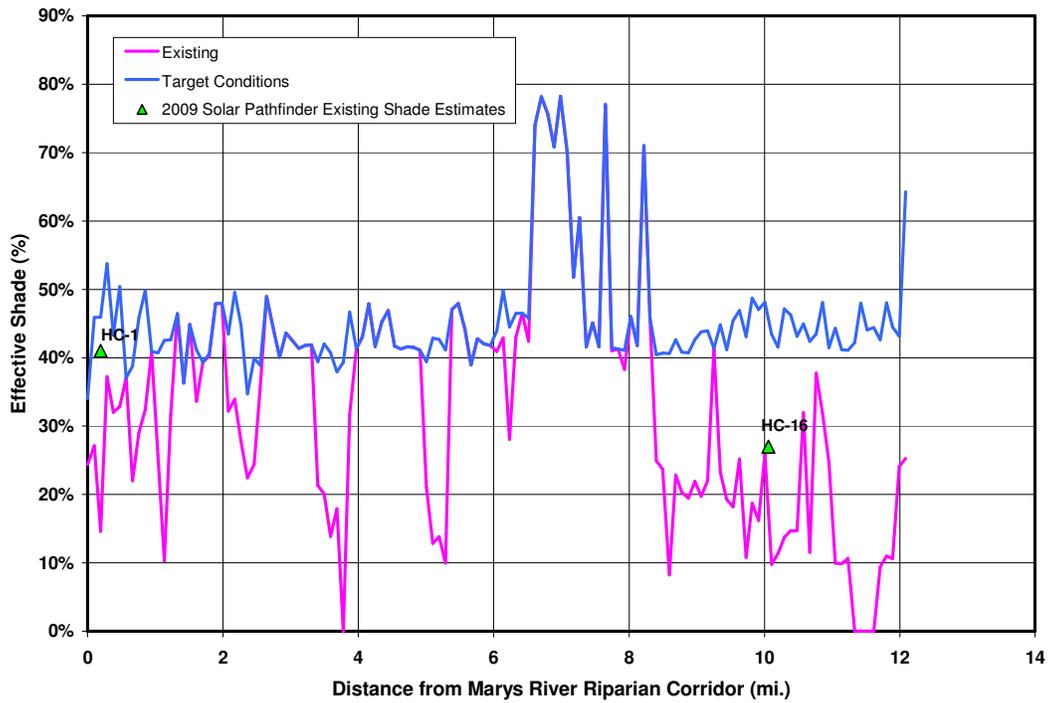
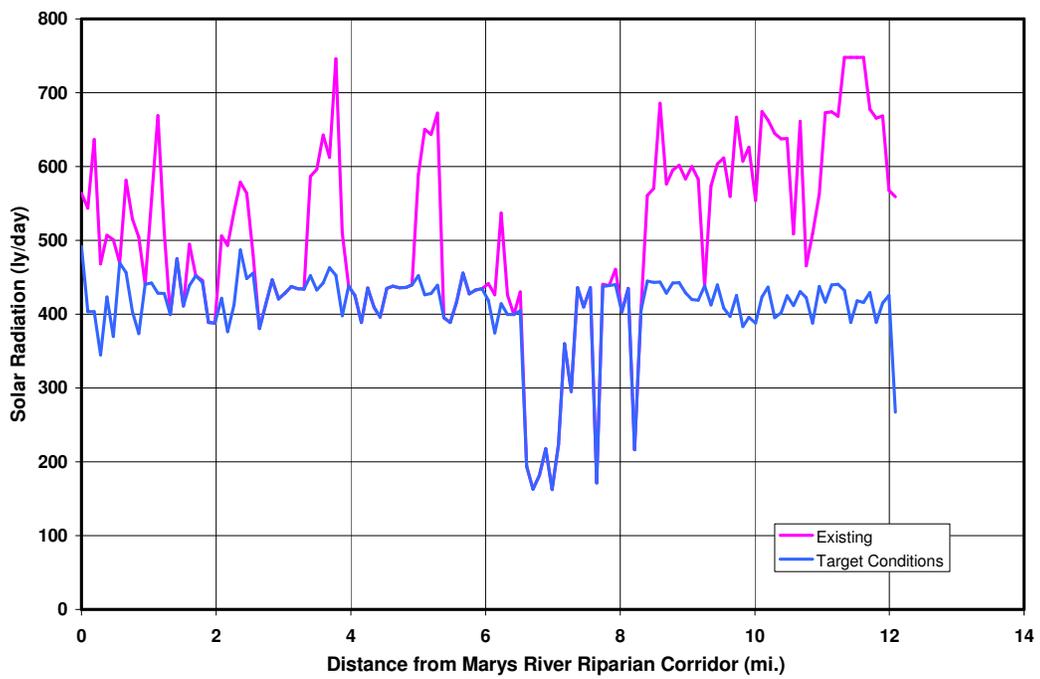
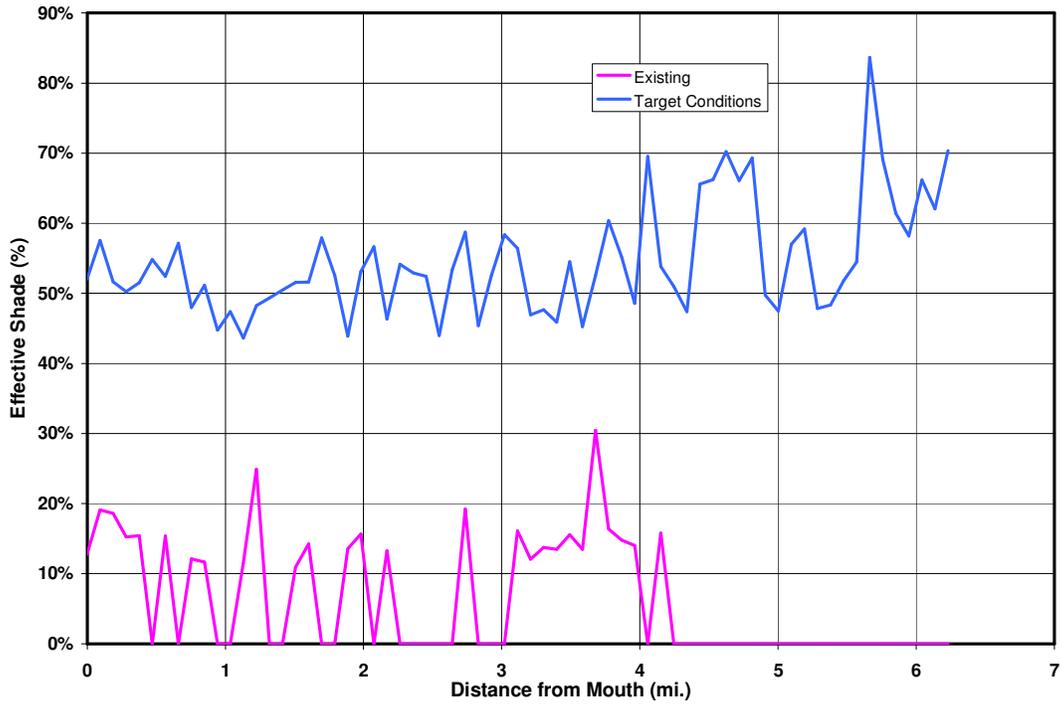
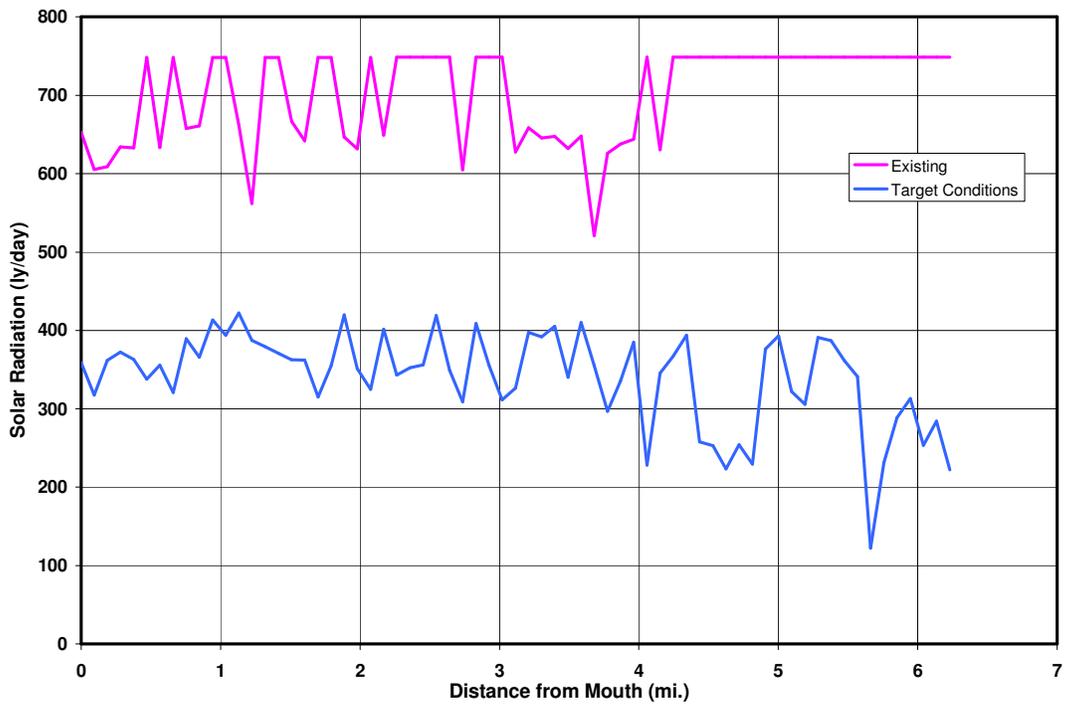
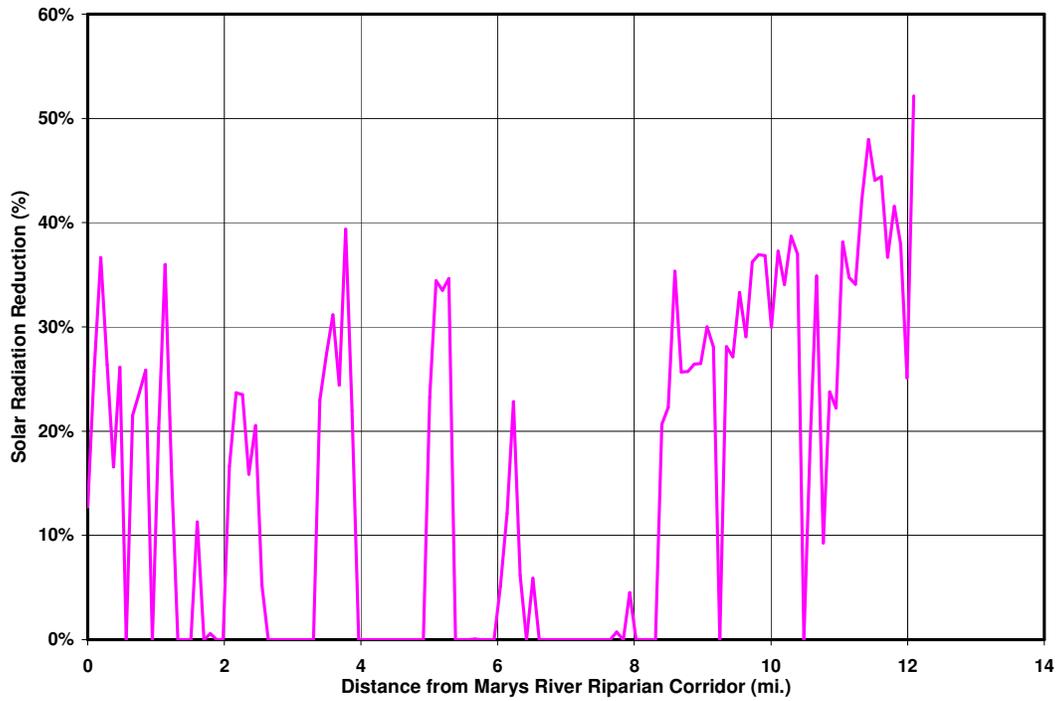
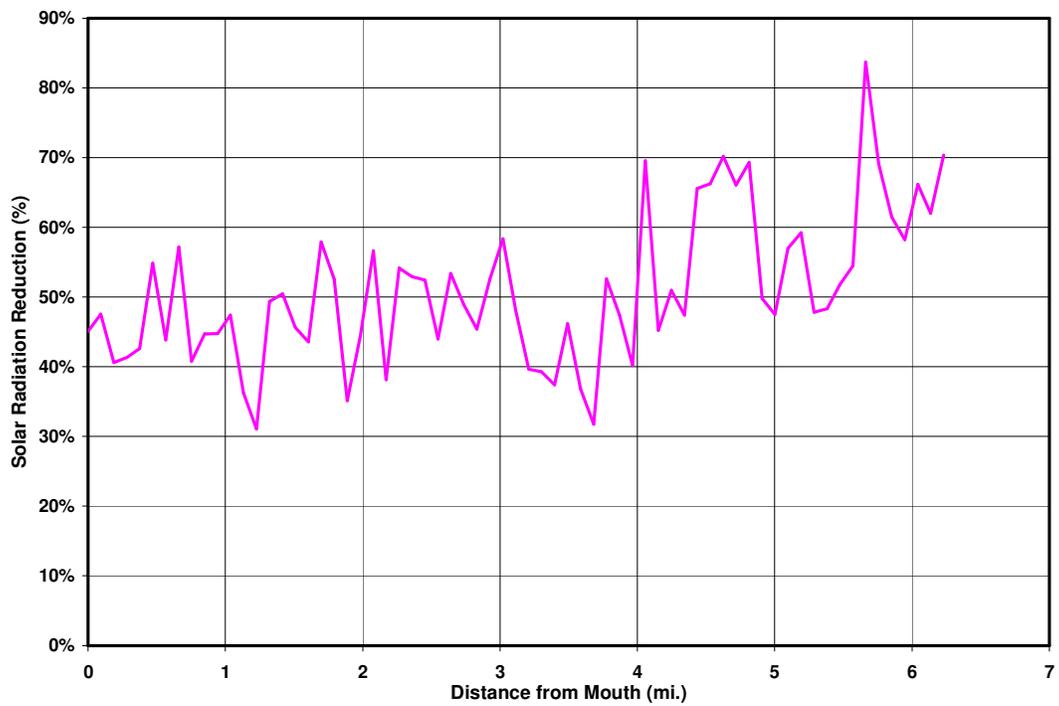
Hanks Creek (Waterbody ID NV04-MR-98_00)		SF Hanks Creek (no Waterbody ID assigned as yet)	
	Average Percent Shading	Average Solar Loading (Langley/day)	Average Percent Shading	Average Solar Loading (Langley/day)
Existing	32.7%	502	6.3%	702
Target Allocations	45.6%	406	54.6%	340
Load Reduction	na	-96	na	-362
% Change	na	-19%	na	-57%

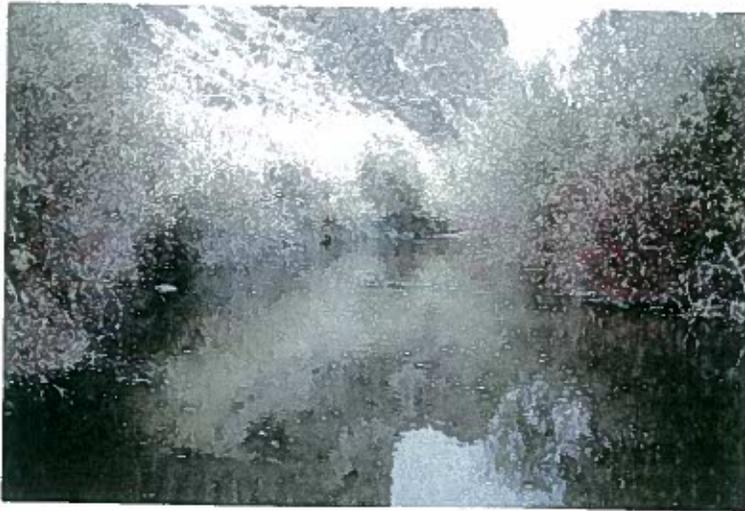
**2.0 Cover**

Height, density and proximity of the willow/dogwood riparian community give this site a rating of 2.0.

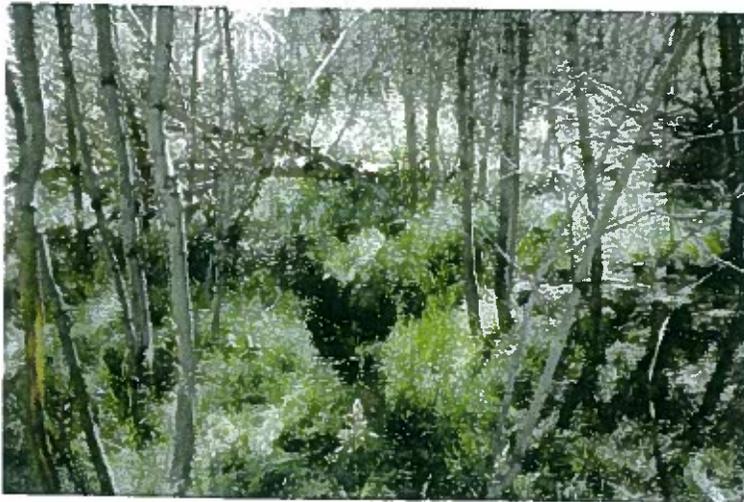
**2.0 Cover**

Height and spacing of aspen saplings form the basis of this 2.0 cover rating. Openings between aspen do not exceed ten feet.

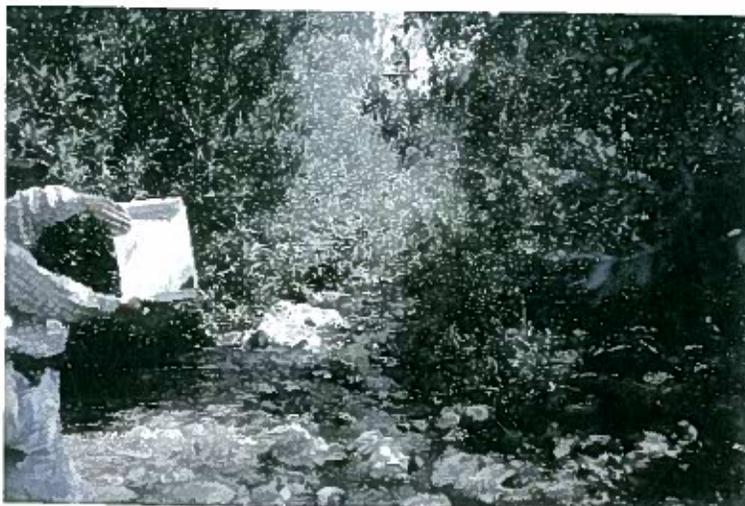
**2.0 Cover**

Although low flow conditions contribute to some exposure of the channel, willow height and proximity of willows to the baseflow stream channel easily allow for a rating of 2.0 for this site.
