Las Vegas Wash Revegetation Program 2000-2012

May 23rd, 2013

Jason R. Eckberg
Las Vegas Wash Coordination Committee
Southern Nevada Water Authority

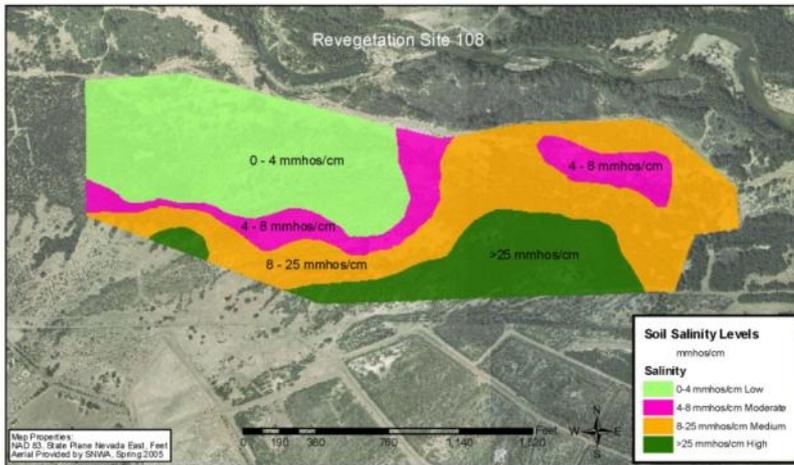
April 1, 2006
Soil Salinity Map

Southern Nevada Water Authority
Las Vegas Wash Revegetation Design

- Soil sampling
 - Salinity
 - Texture
- Depth to Water
- Choose plants that will survive under microclimate conditions

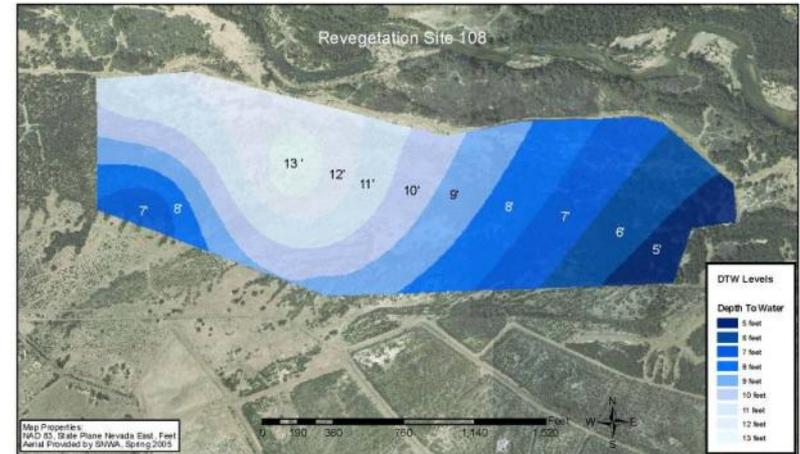
April 1, 2006
Surface To Water
Table Depth Map

Southern Nevada Water Authority
Las Vegas Wash Revegetation Design

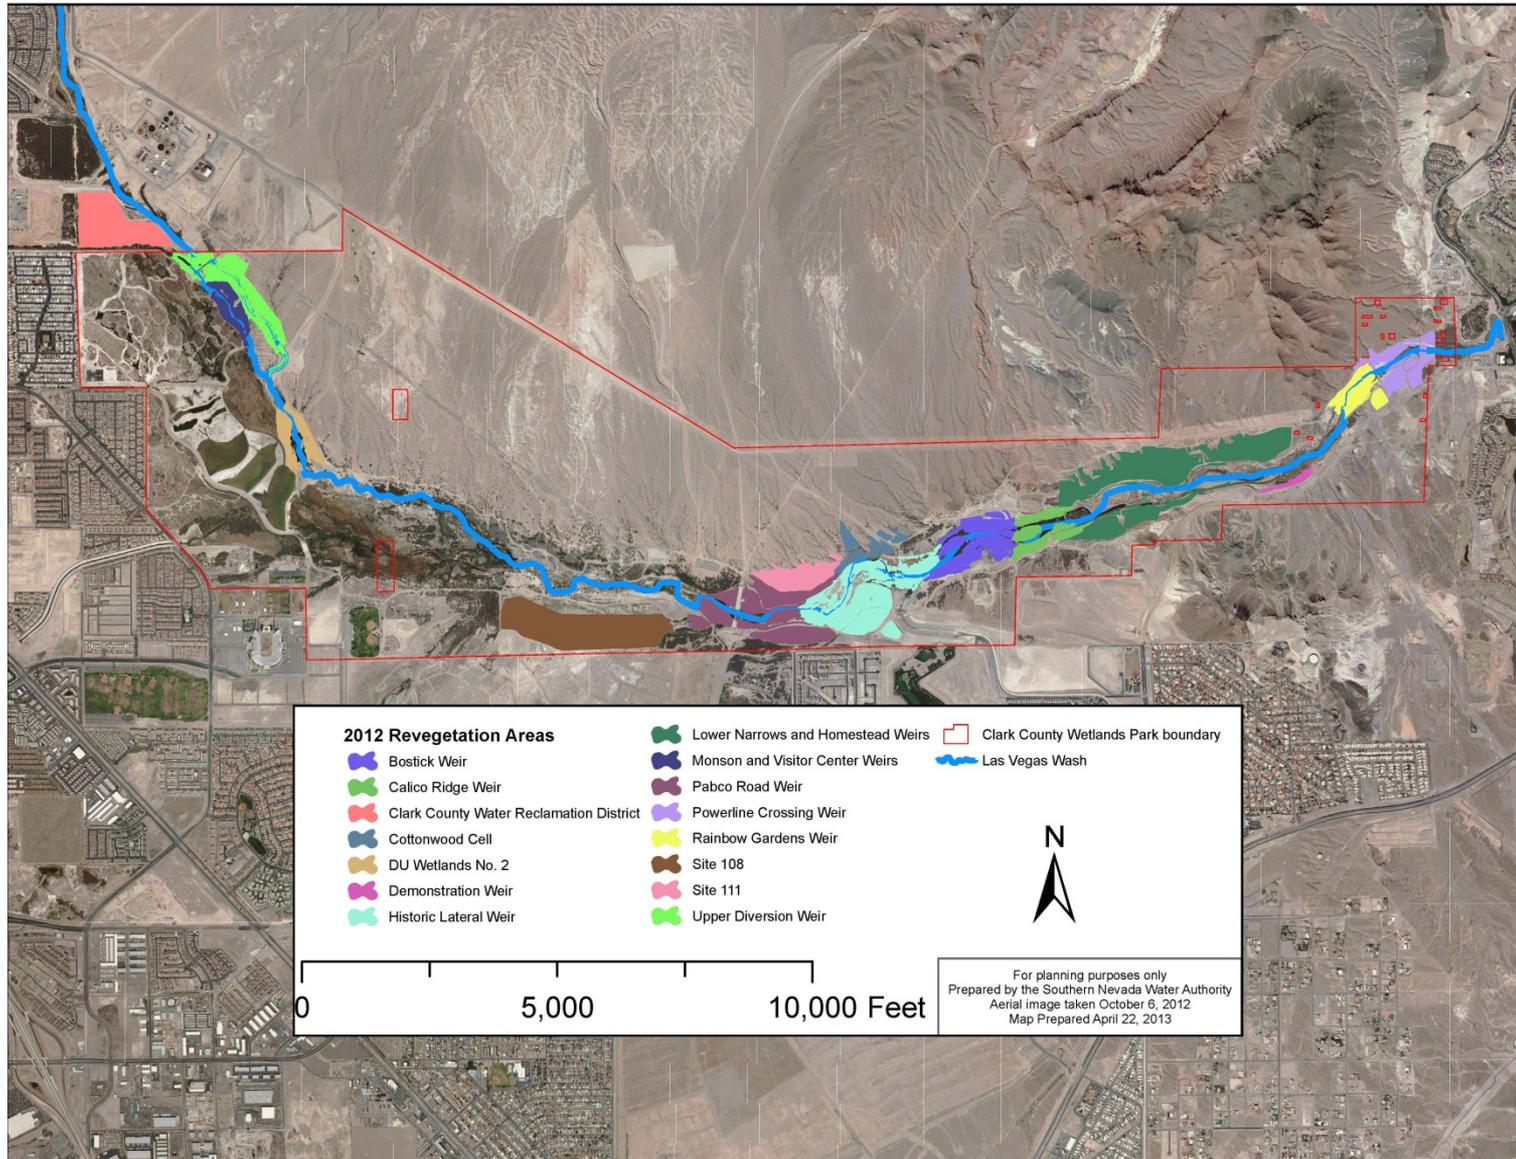
Las Vegas Wash revegetation areas 2001 through 2012 ~ 360 Acres

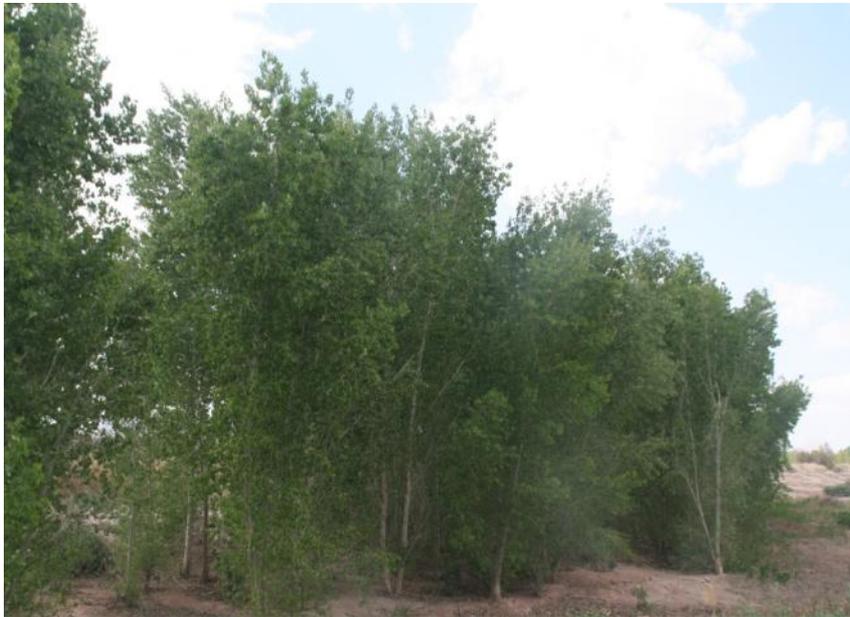
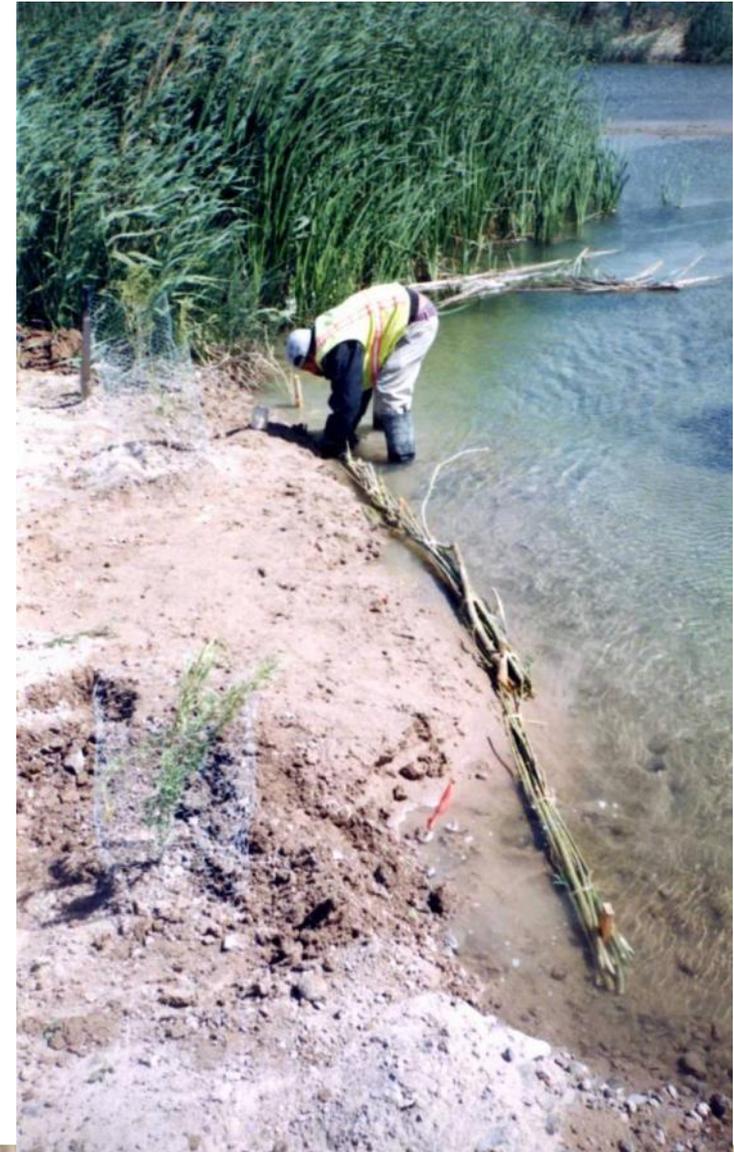
- Pole planting
 - Cottonwoods
 - Willows
 - Arrowweed
 - Seep willow

- Pole Plantings
 - More cost effective and higher success rates than potted plants
- Choosing the right plants is key to the success of the restoration program
 - Wash has many microclimates
 - Various soil types and soil conditions

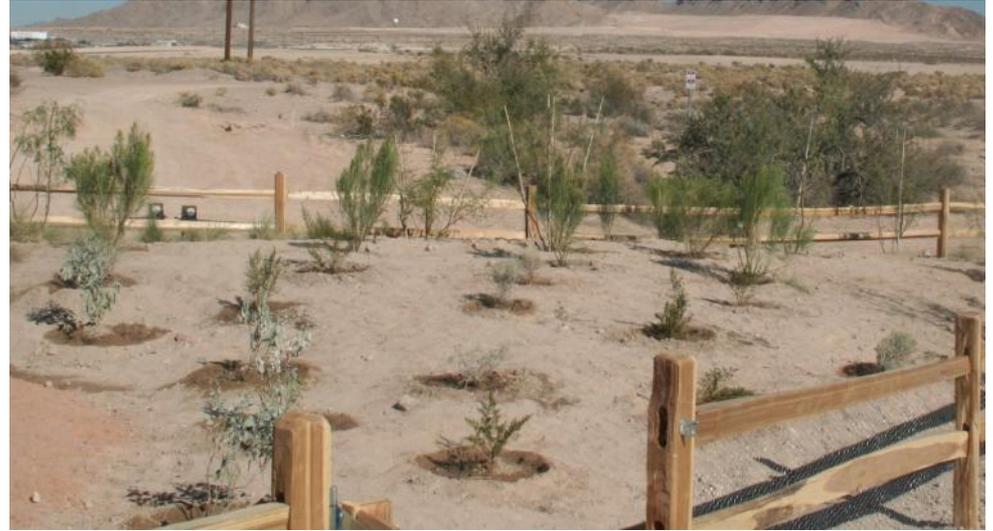
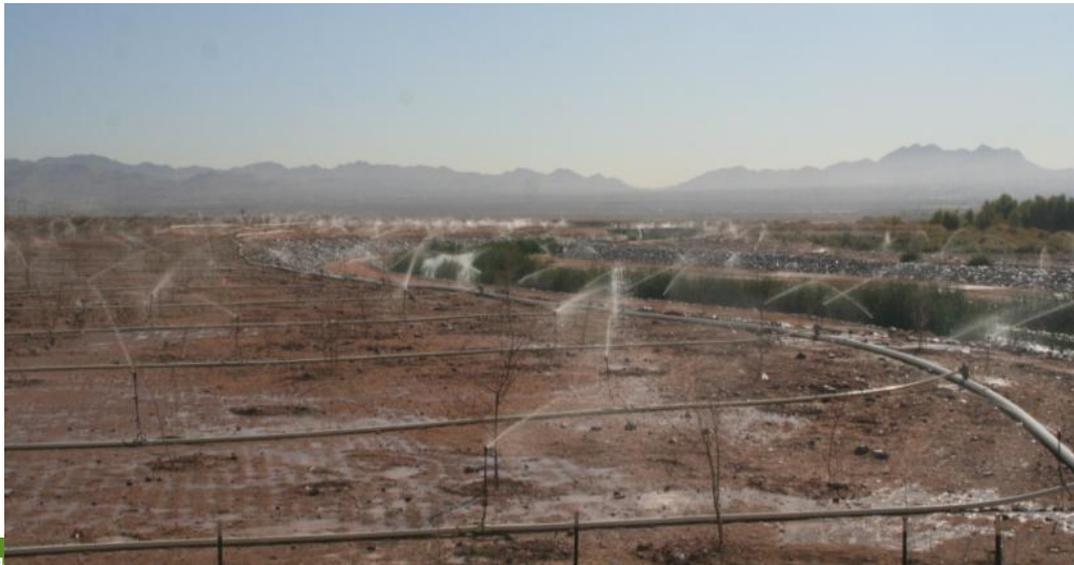
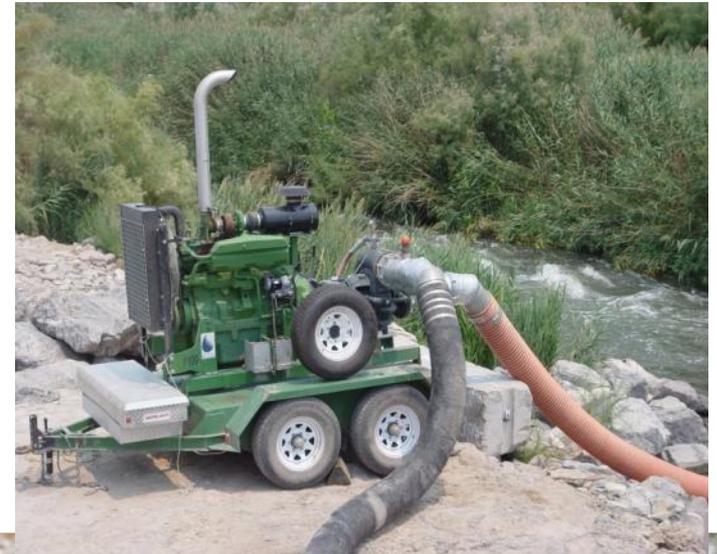
- Irrigation
 - Spray
 - Certa-lok irrigation pipe
 - Mobile pumps
 - Drip

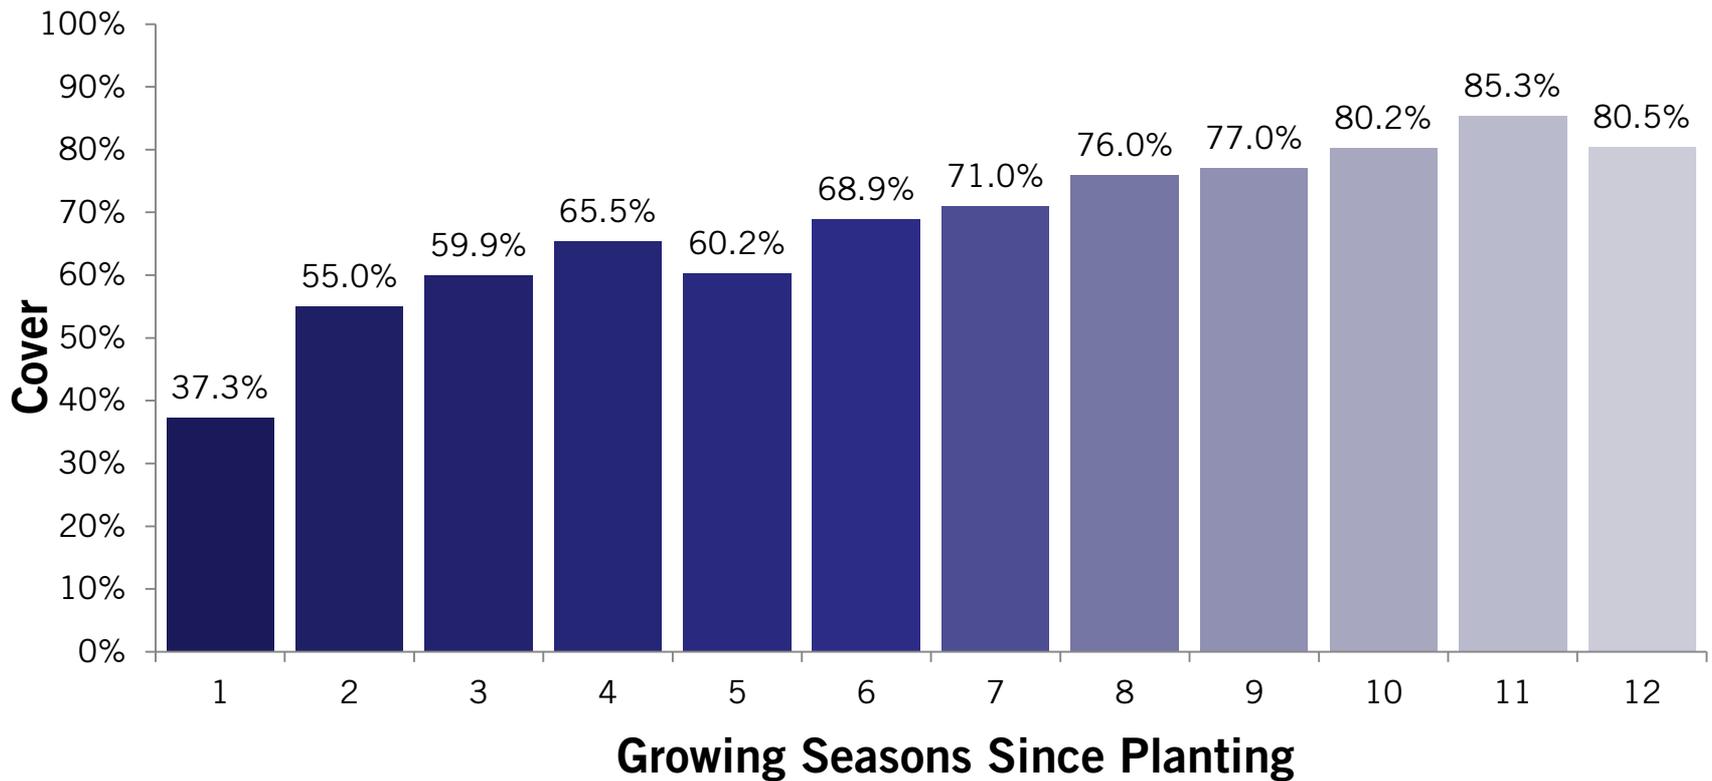
- **Site Cover Trend**

- Average of Weighted Average cover (acreage)

Cover Rank	Value Range	Midpoint
R	<<1%	0.1%
T	<1%	0.5%
1	1-5%	2.5%
2	5-25%	15.0%
3	25-50%	37.5%
4	50-75%	62.5%
5	75-100%	87.5%

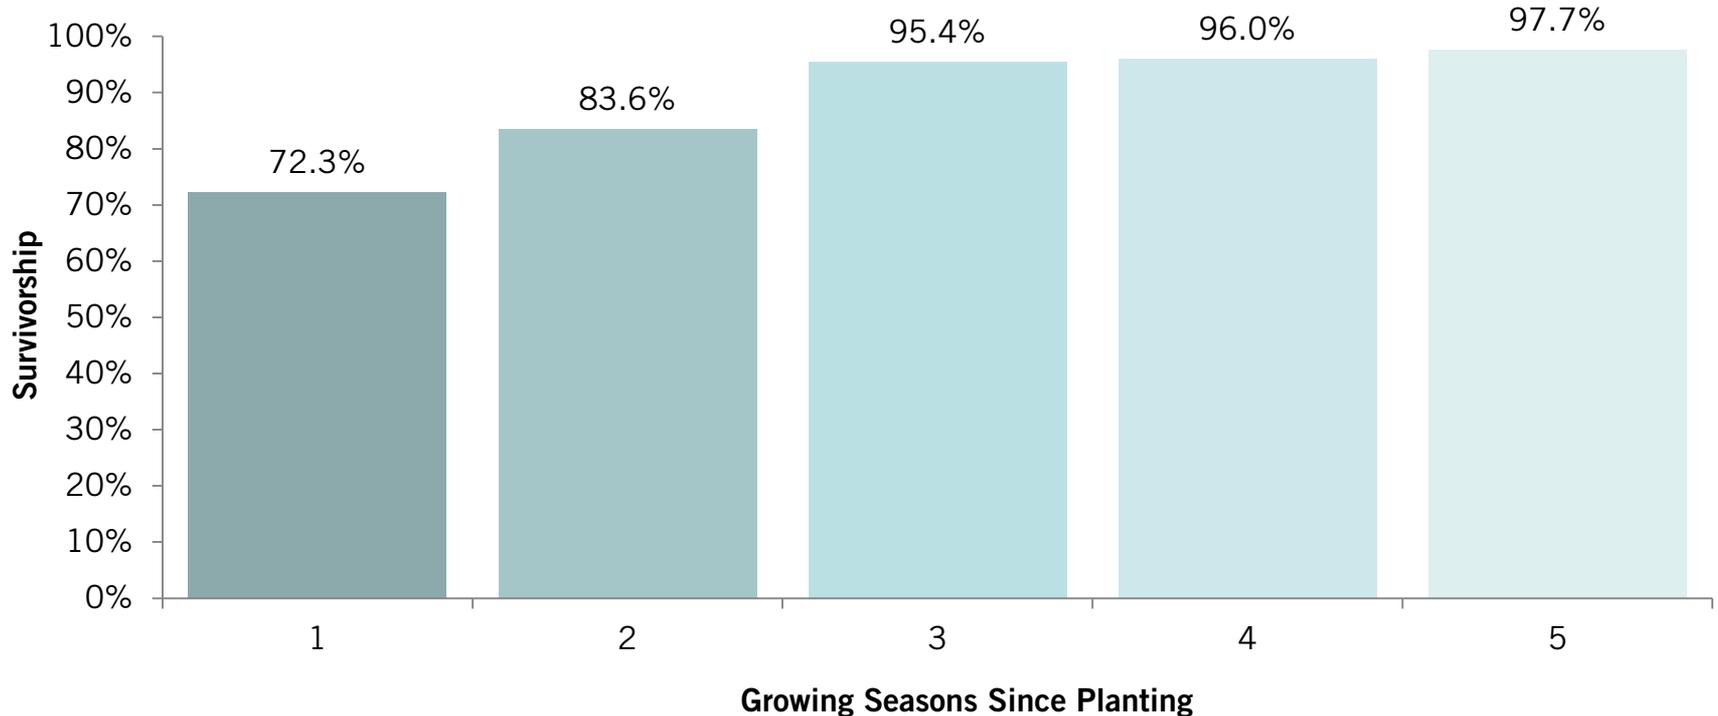
- Average survivorship of planted plants
 - Data skewed in later growing seasons

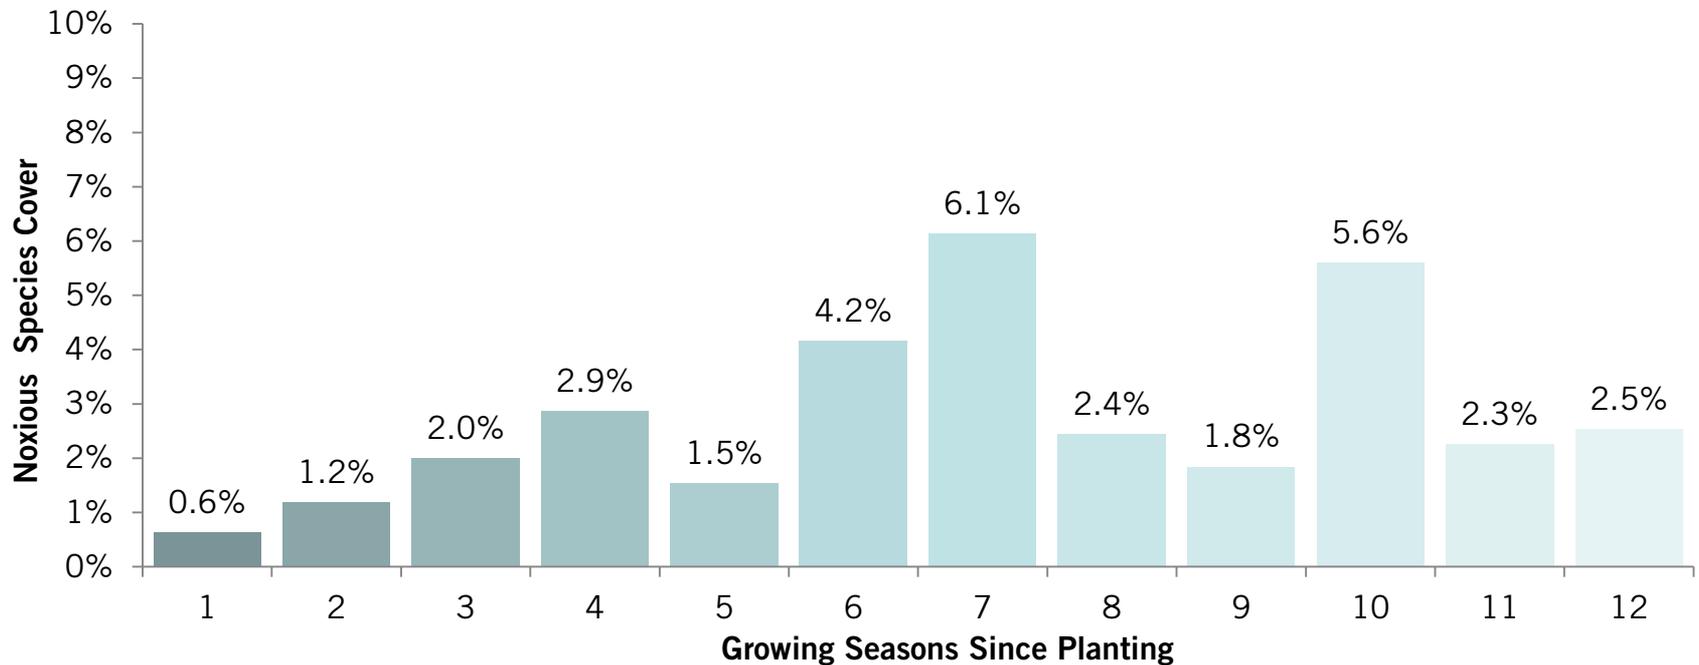
- Average invasive species cover

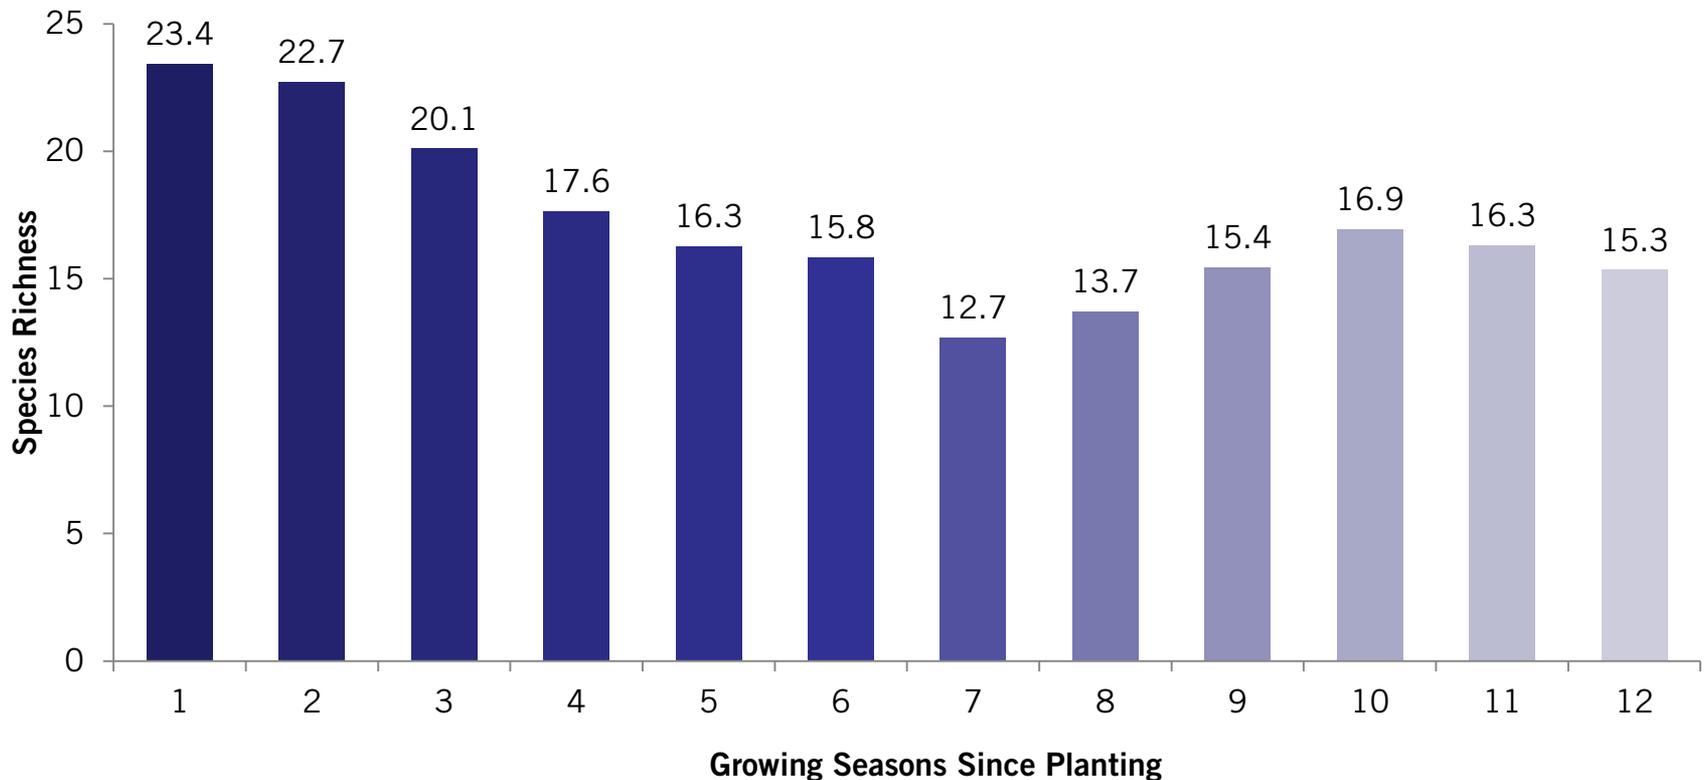
- Average species richness
 - Typical non-wetland sites are irrigated for the first 2 growing seasons

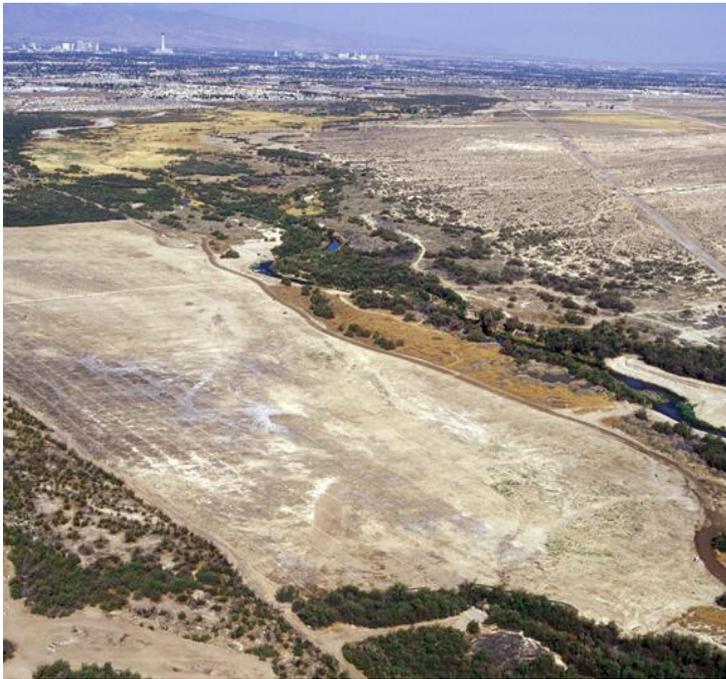
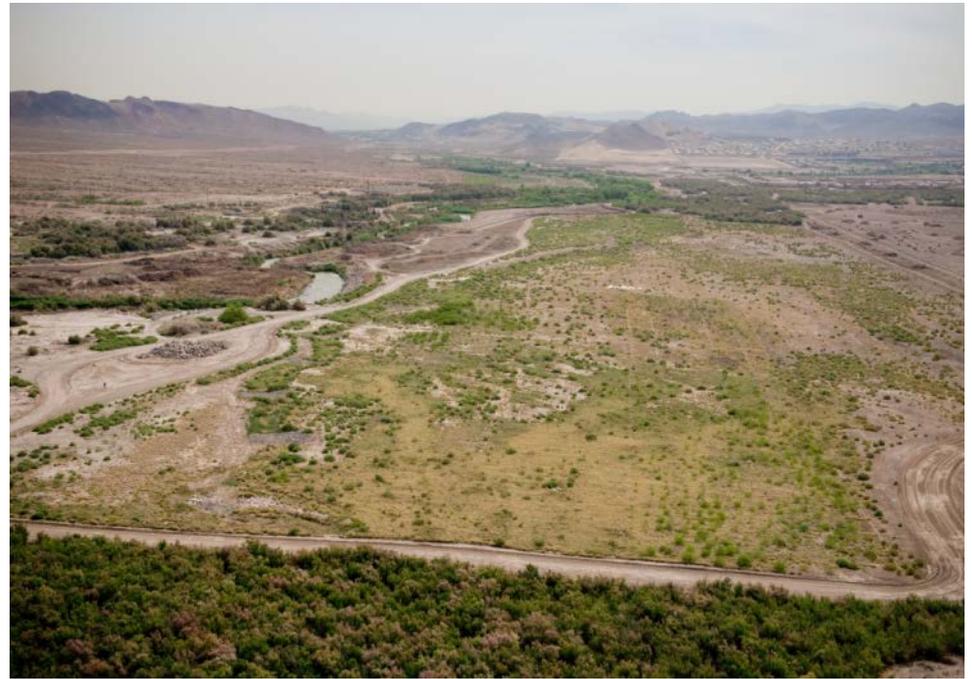
Example – Site 108

- Non-wetland revegetation site
 - Not associated with Weir
 - Provides important buffer to Wash and increases wildlife habitat

April, 2006

April, 2009

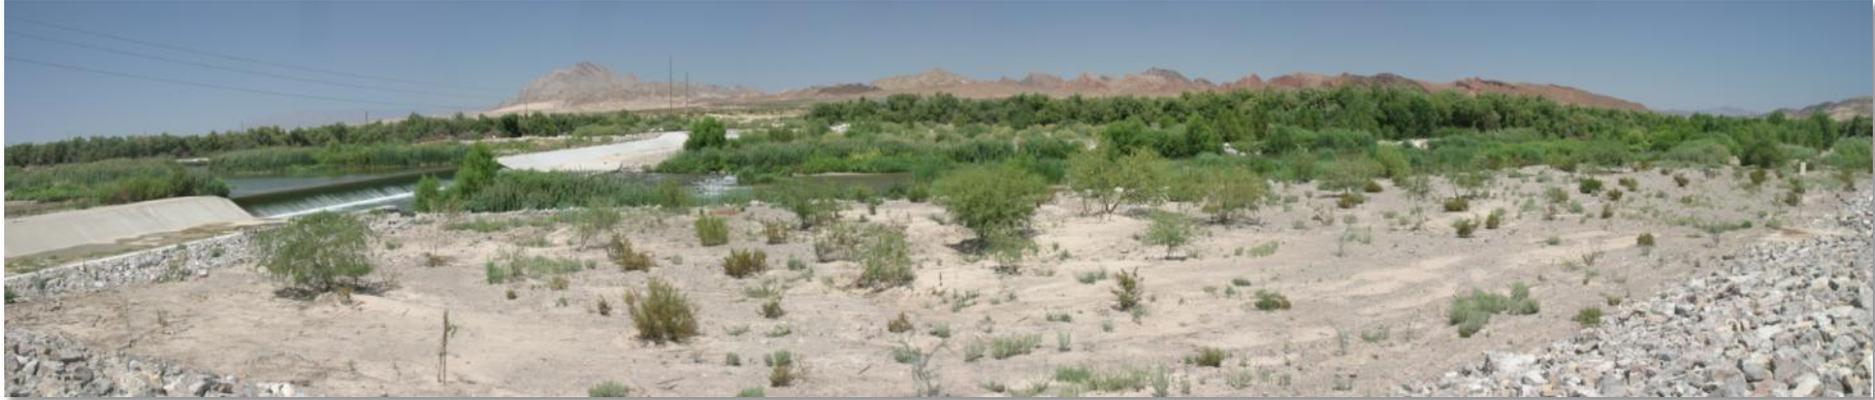
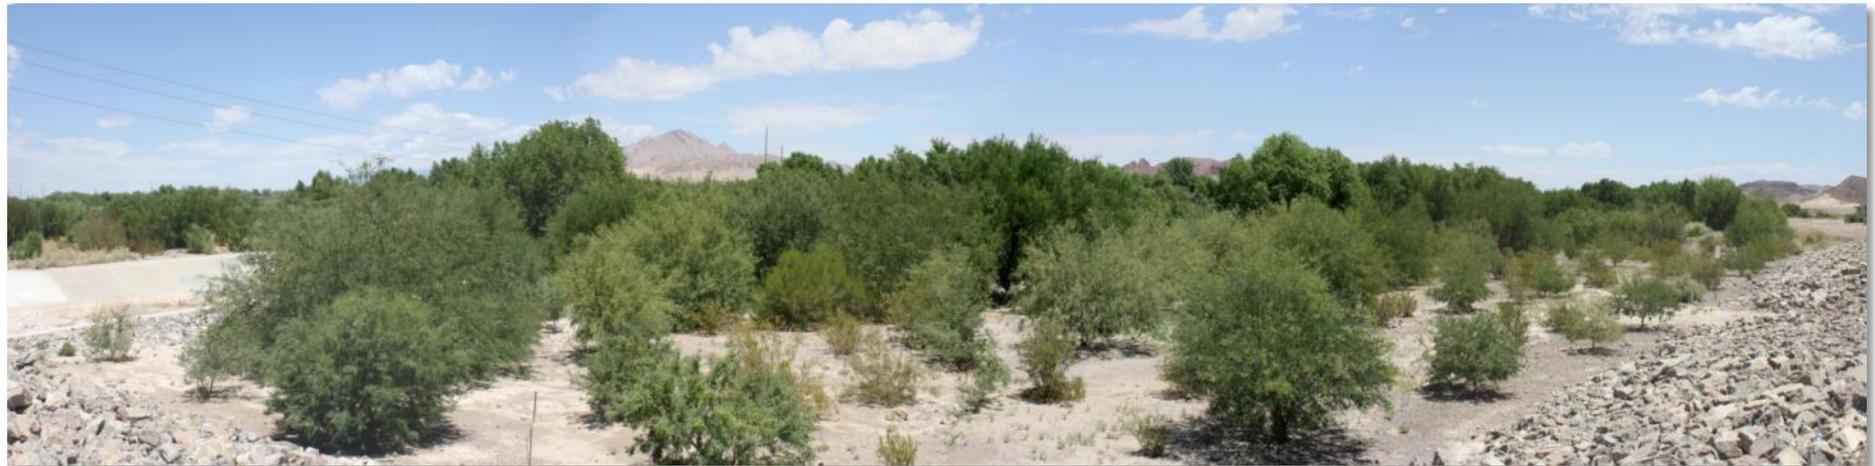
Active Revegetation Site Example – Pabco South

2004

2010

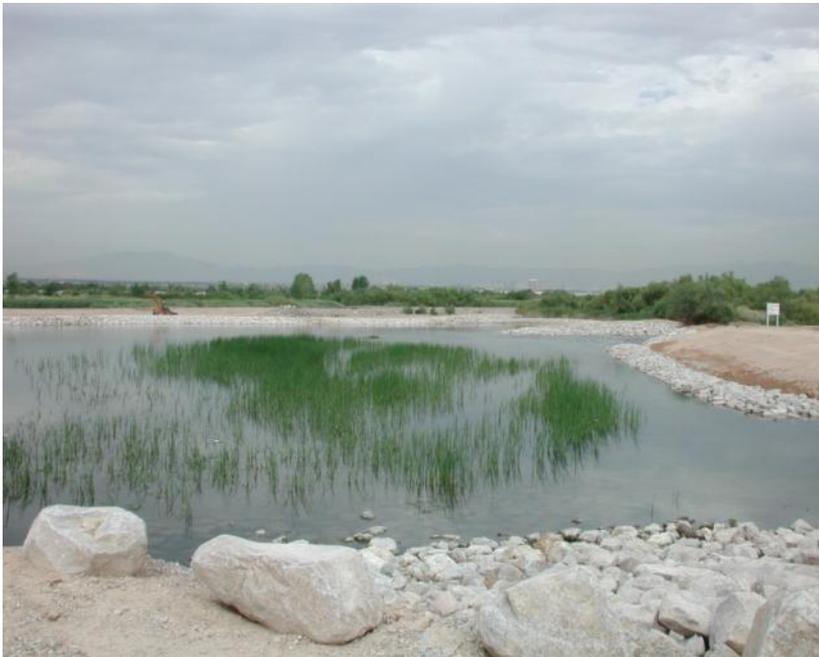
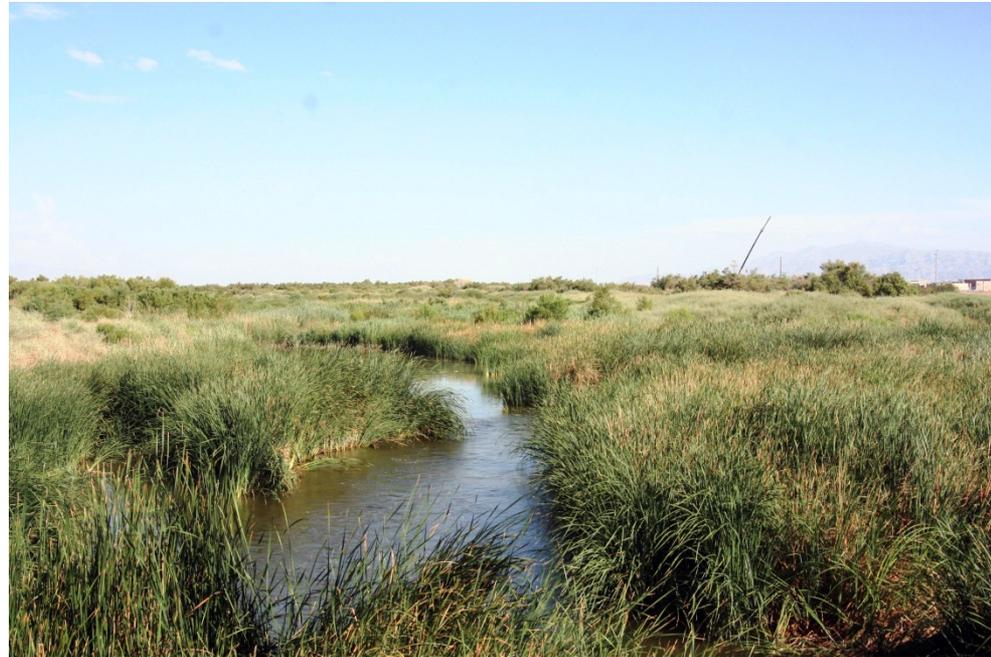
Passive Wetland Example

- **Upper Diversion Weir**
 - Pond located upstream of Weir completed in summer of 2008
 - Passive establishment of large cattail community
 - Provides food and shelter to a wide variety of bird species

July, 2008

July, 2012

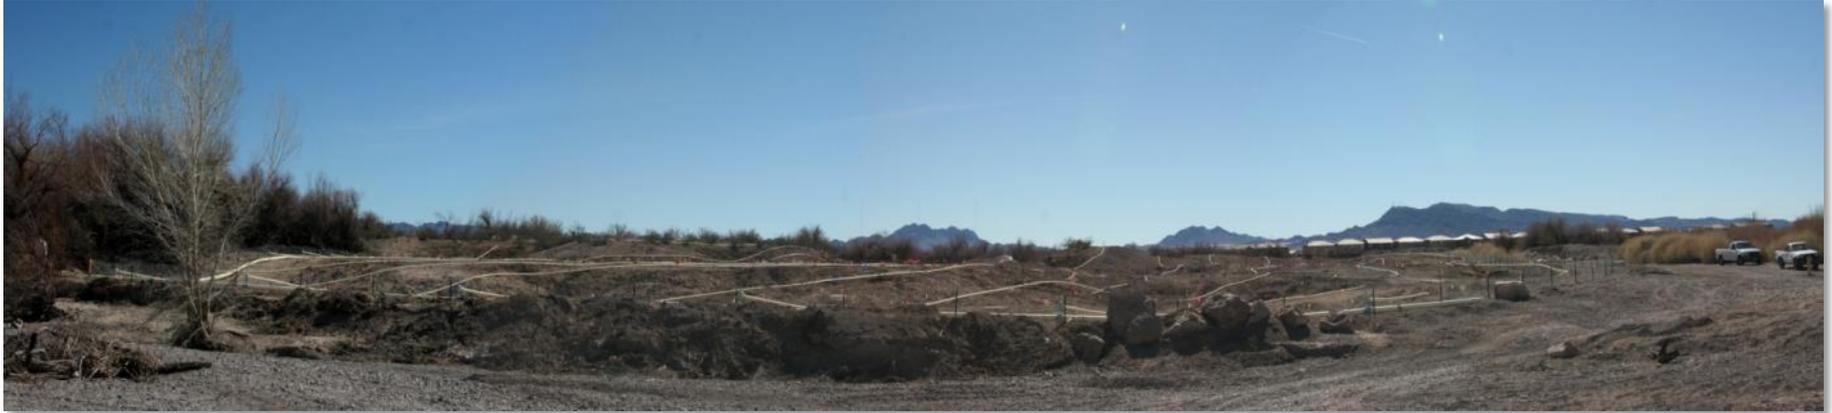
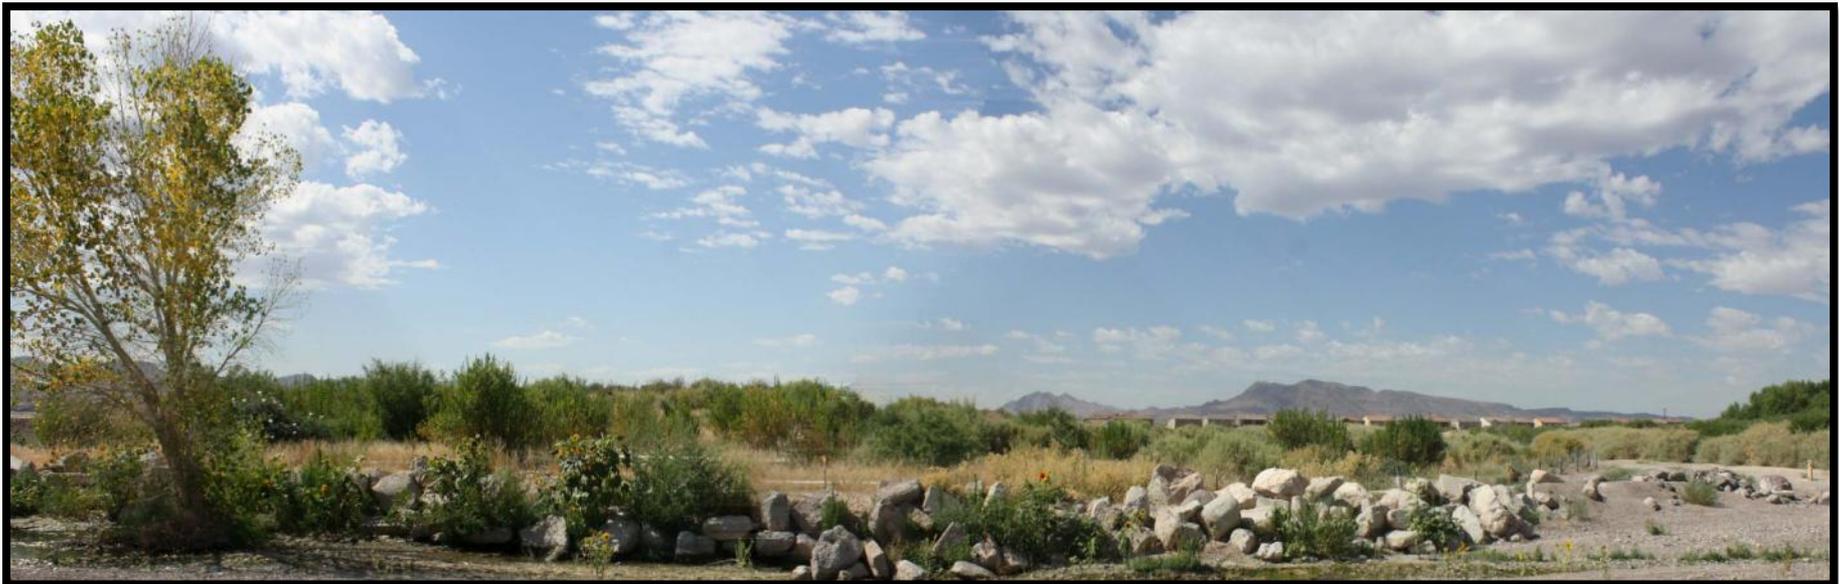
Active Revegetation Site Example – Historic Lateral South

2008

2010
