**FINAL  
CLOSURE DECISION DOCUMENT  
BUILDING 103-16 CATCHMENT PITS  
SWMU B27A**

**HAWTHORNE ARMY DEPOT  
HAWTHORNE, NEVADA**

**June 2012**

**Plexus Scientific Corporation  
4501 Ford Avenue, Suite 1200  
Alexandria, Virginia 22302**

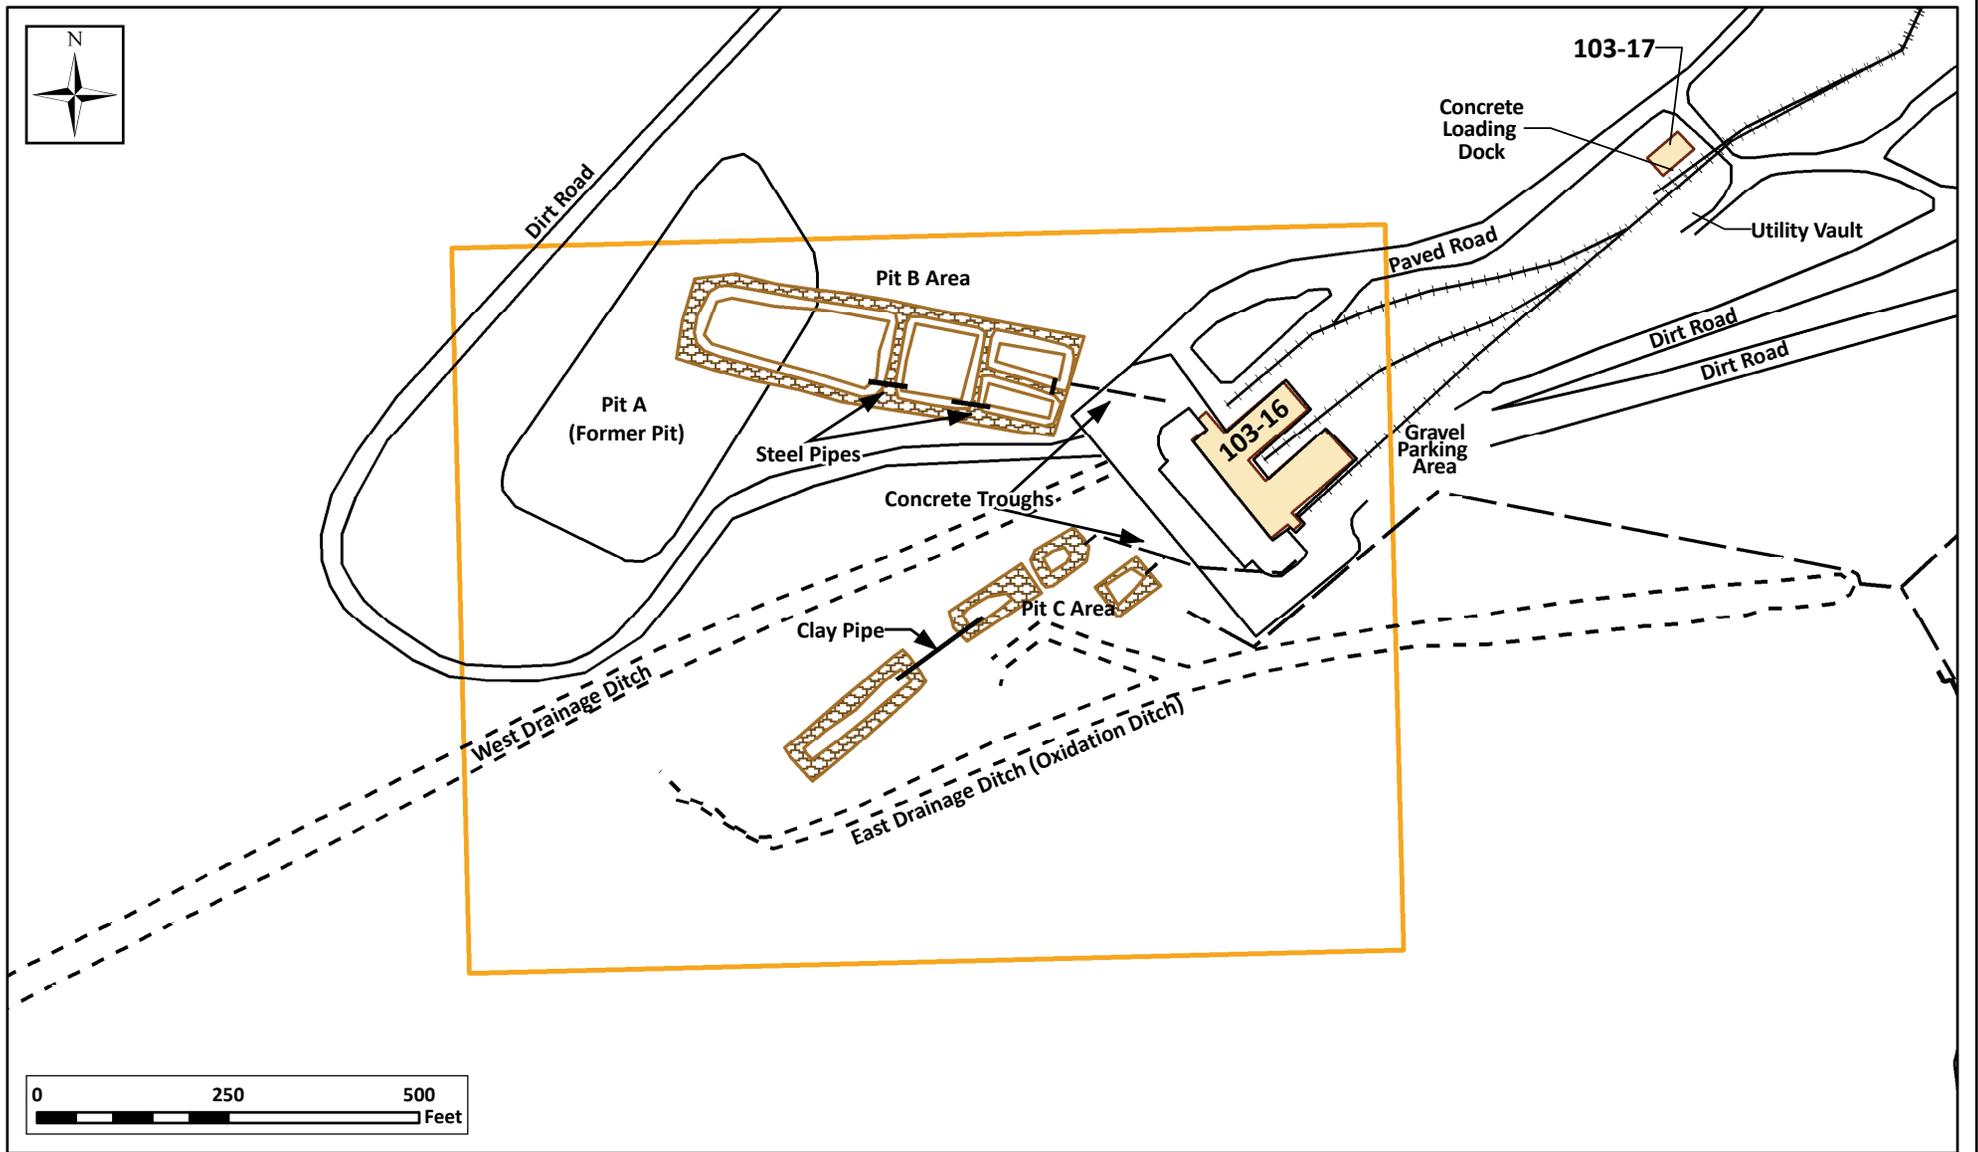
**Figure 2-3**

SWMU B27A is located in the north magazine area of HWAD, adjacent to Building 103-16 (**Figure 2-2**). The SWMU consists of eight inactive unlined catchment pits (**Figure 2-3**):

- Pit Group B (four pits);
- Pit Group C (four pits); and
- One suspected former pit location, Pit A.

The eight catchment pits occupy a total area of approximately 10 acres. The existing catchment pits are between 3 – 8 feet deep, and are interconnected with a series of steel and clay pipes that appear to have been used for transferring liquids between pits. There are two concrete troughs (Concrete Troughs) at SWMU B27A; one trough extends from the north side of Building 103-16 to the east edge of Pit Group B, and the second trough extends from the southwest side of Building 103-16 to the northeastern edge of Pit Group C. Historically there were two drainage ditches at SWMU B27A. One ditch extended southwest of Building 103-16 for approximately 0.5 mile (West Drainage Ditch), and the second ditch was located south of Building 103-16 (East Drainage Ditch). The East Drainage Ditch was investigated and backfilled as part of remediation activities at Building 103-8/10 Oxidation Ditch - SWMU B27B. There is also one drain line (Drain Line) that extends into SWMU B27A from SWMU B27B and ends in Pit Group C.

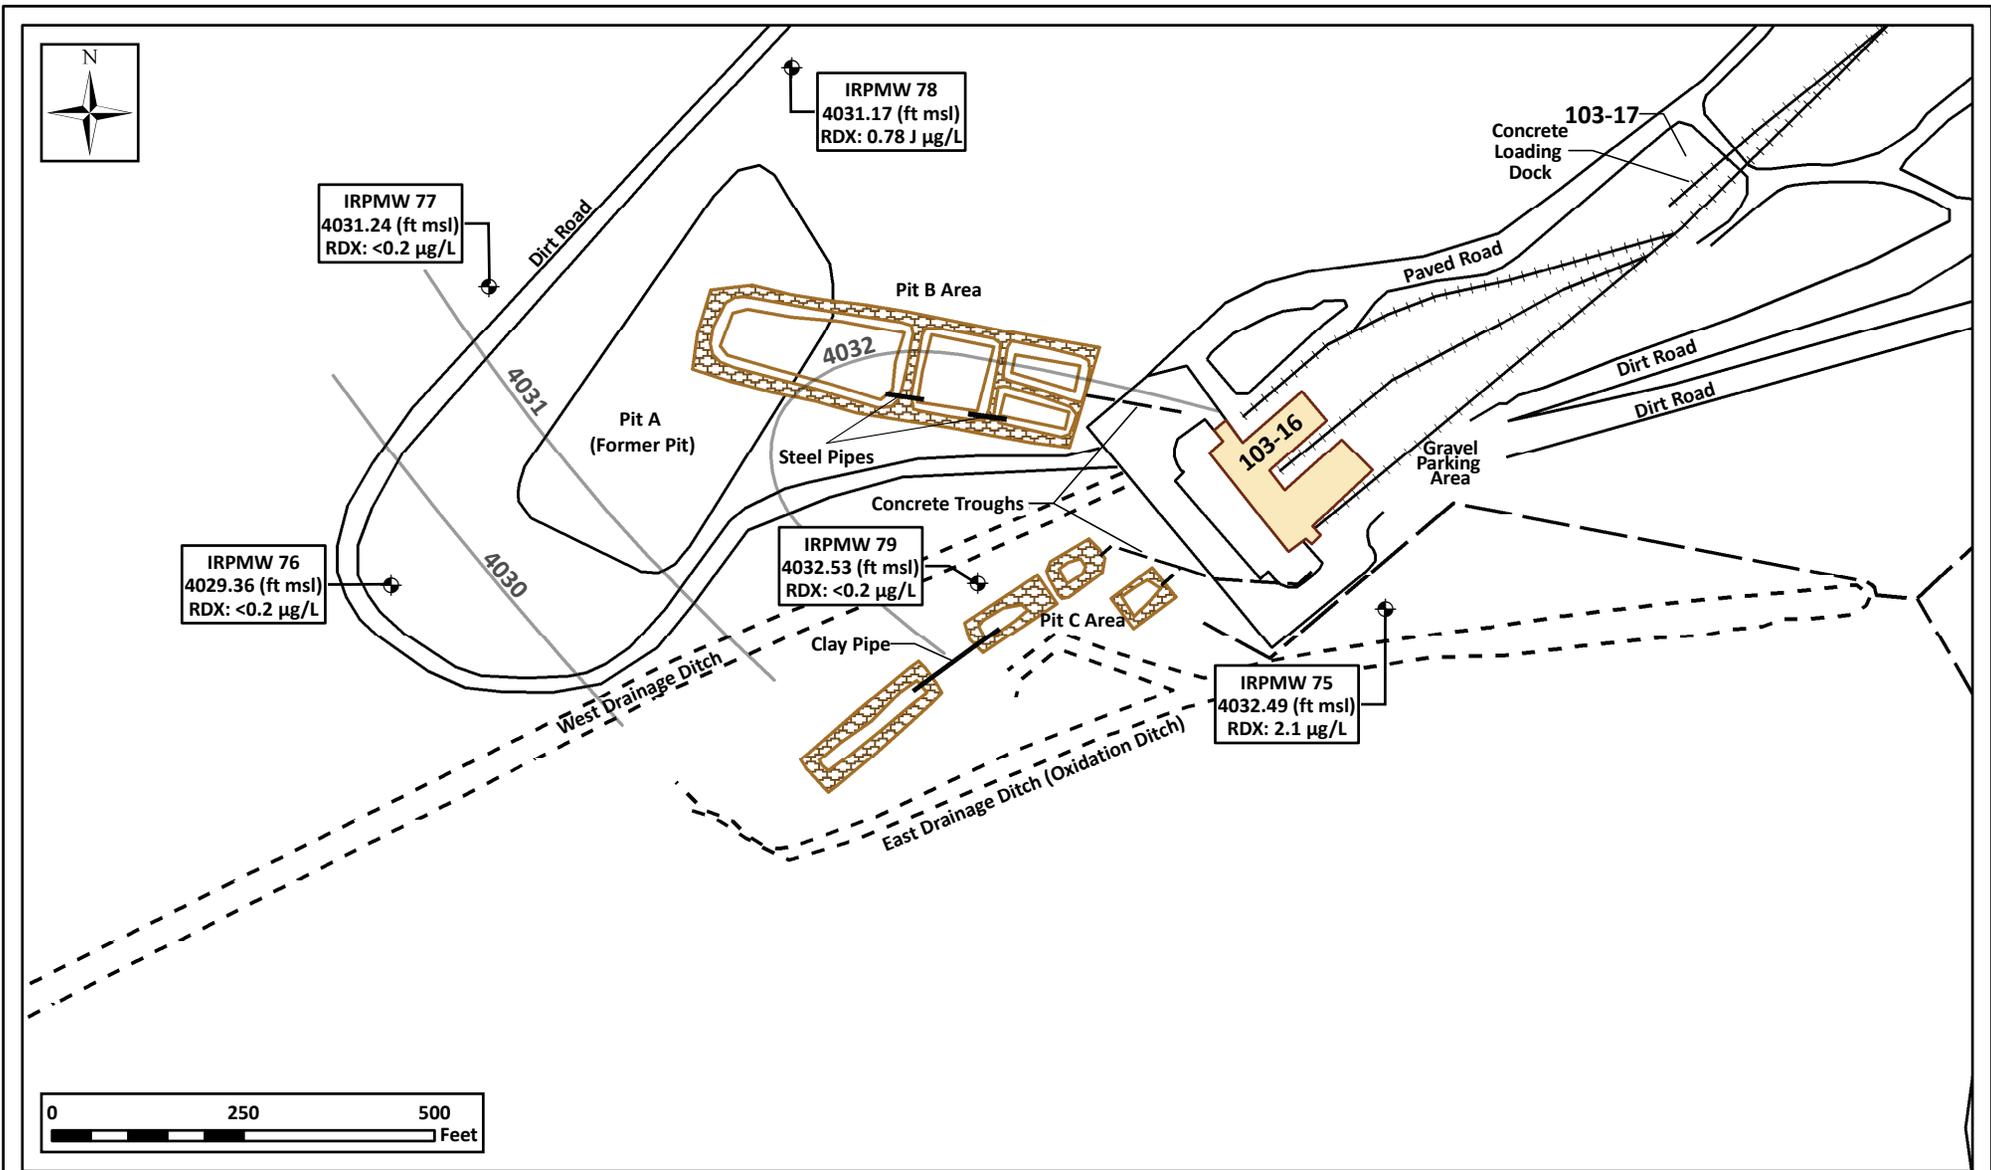
**Figure 3-1**  
**Hawthorne Army Depot**  
**Hawthorne, Nevada**

Plexus installed four monitoring wells (IRPMW75, IRMMW76, IRPMW77, and IRPMW78) at SWMU B27A in December 2010, and the fifth monitoring well (IRPMW79) was installed in January 2011. The four monitoring wells were installed to evaluate potential groundwater impact due to historical activities within B27A. The fifth monitoring well was installed during a second mobilization in January 2011 to determine if ammonium picrate-impacted soil in the Pit C3 area also impacted groundwater in the immediate vicinity of the pit (Plexus, 2011). The location of these five groundwater monitoring wells at SWMU B27A are shown in **Figure 3-1**.

IRPMW75, IRMMW76, IRPMW77, IRPMW78, and IRPMW79. Cyclotrimethylenetrinitramine (RDX) was detected in exceedance of the RSL of 0.61 µg/L in samples collected from IRPMW75 (2.1 µg/L) and IRPMW78 (0.78 J µg/L). The analytical results are located in **Table 3-1**, and results are also shown in **Figure 3-1**.

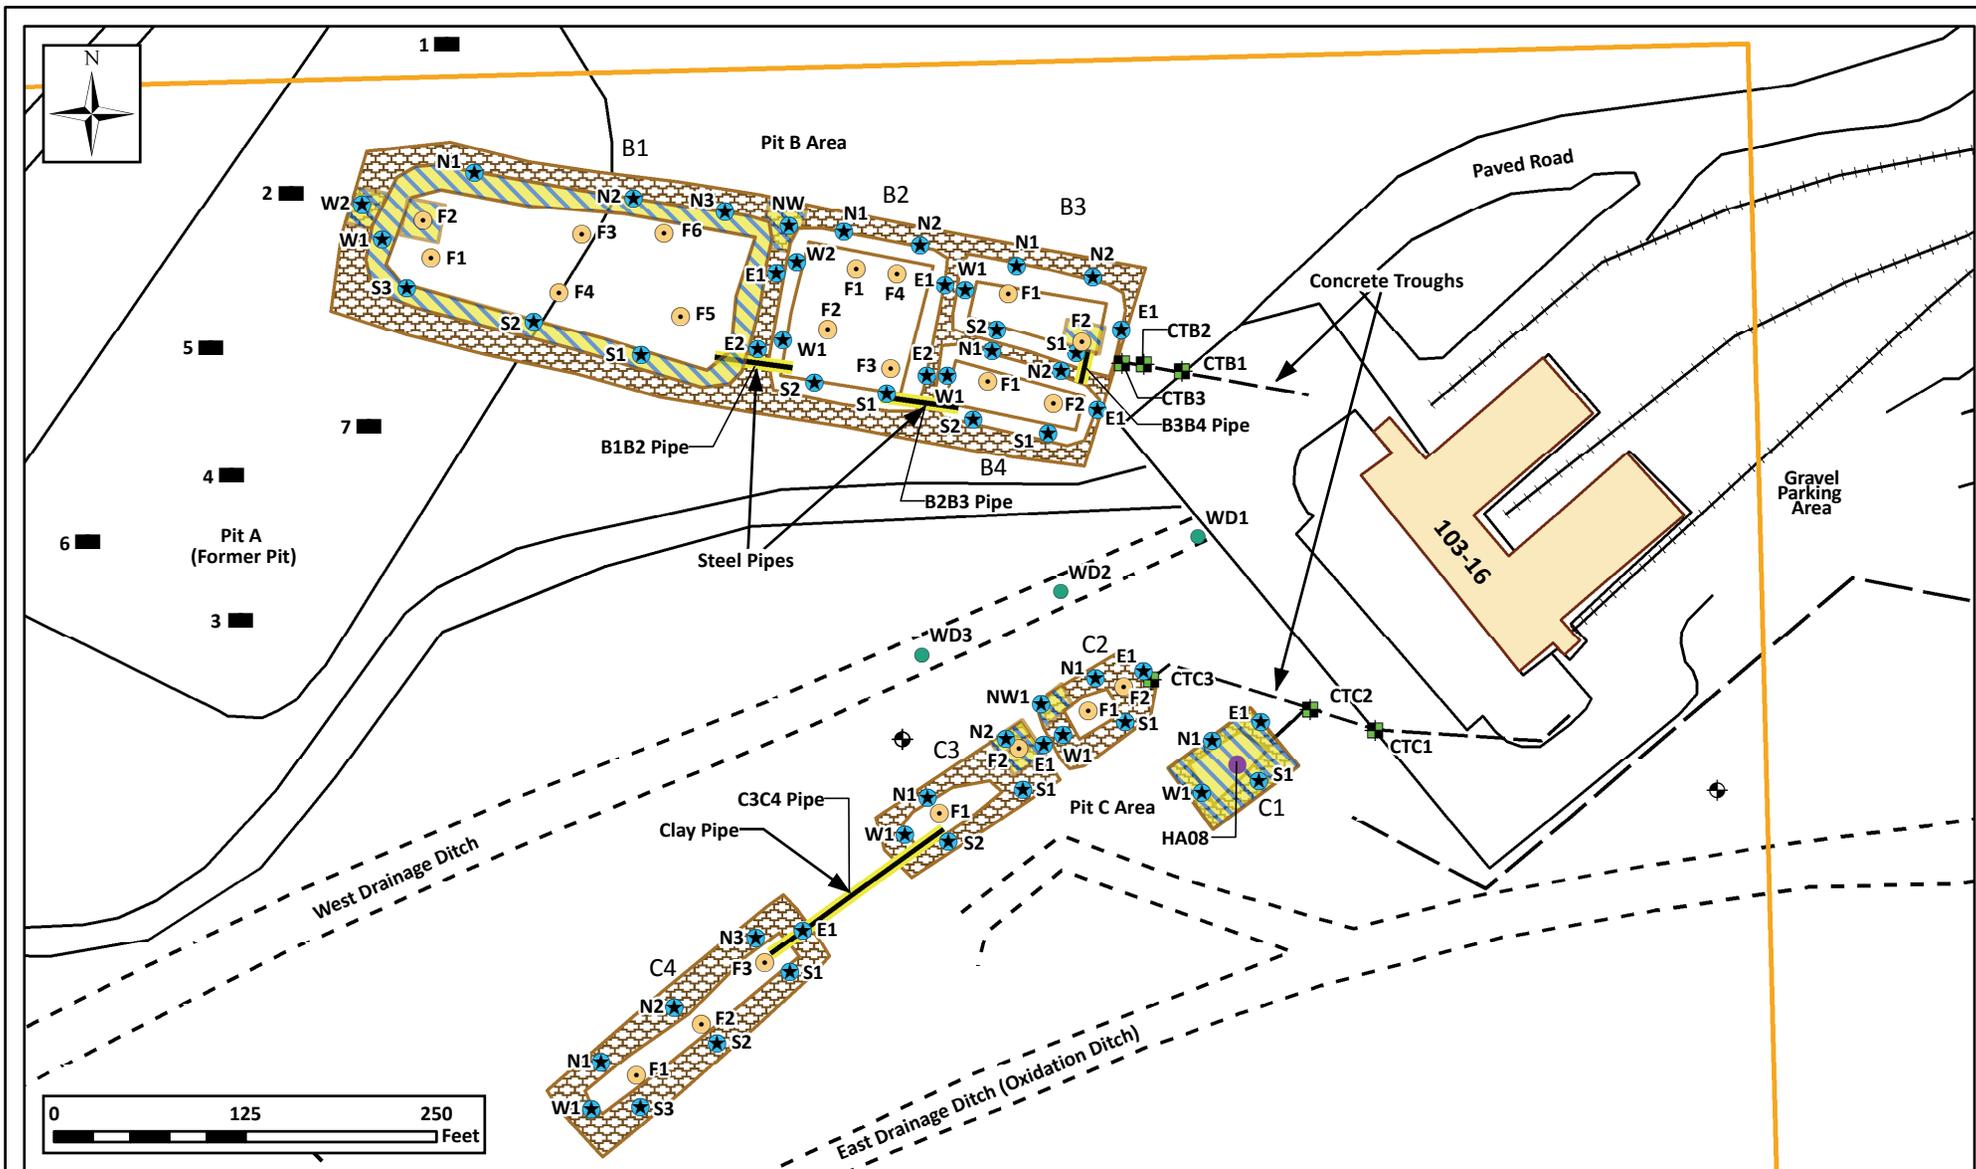
<p><b>PLEXUS</b> scientific</p>	Figure 3-2
	<p><i>Hawthorne Army Depot</i> Hawthorne, Nevada</p>

Visible staining was evident in pit bottoms and surrounding berms. Concentrations of the explosives ammonium picrate (maximum of 17,000 mg/kg in the floor of Pit B1 at 0.5 feet bgs) and TNT (maximum of 1,900 mg/kg in the floor of Pit B3 at 0.5 feet bgs) exceeded RSLs in several Pit B and Pit C soil sample locations. All metals were either not detected or were detected below their established HWAD background concentrations in Pit Group B and Pit Group C (Plexus, 2011). Concentrations of explosives in soil above RSLs were generally limited to the upper 5 feet.

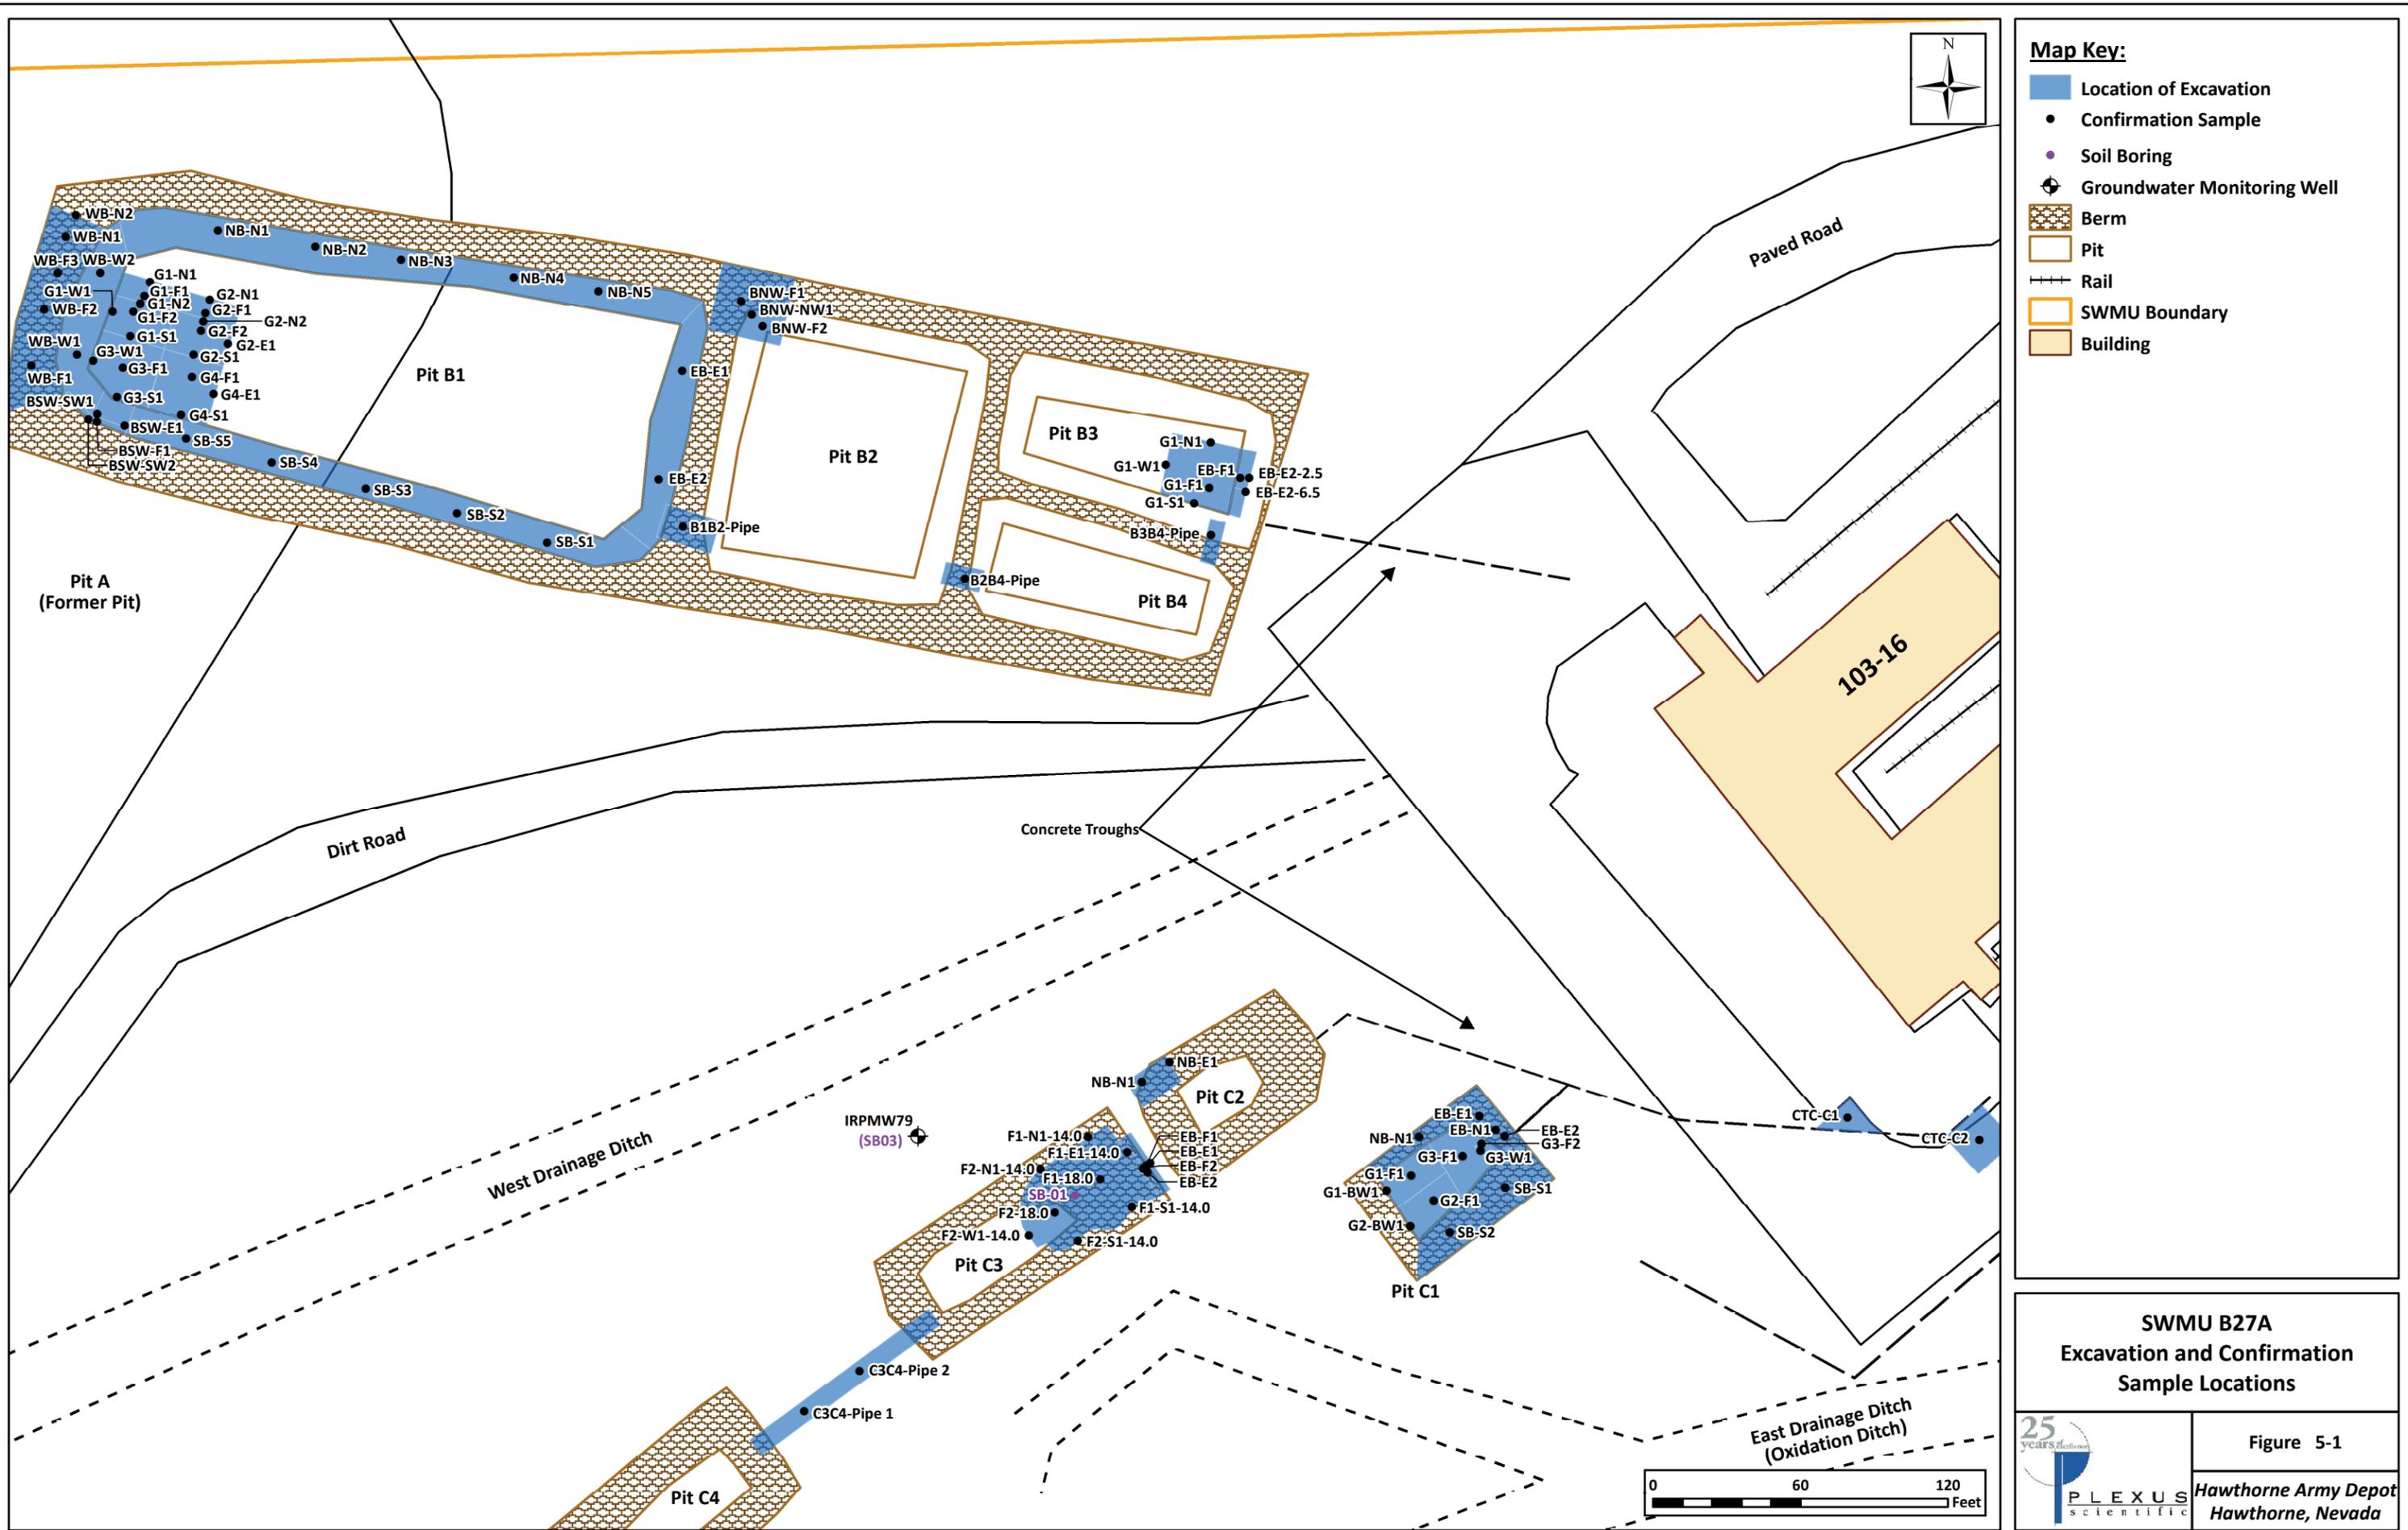
**SWMU B27A**  
Excavation and Confirmation  
Sample Locations

Excavations within the Pit Groups B and C extended to a maximum depth of 7.5 feet below the original pit floors, generally corresponding with the results of the November 2010 soil investigations. An exception was Pit C3. Although exceedances of SSTLs at Pit C3 were detected at a maximum depth of 2.5 feet bgs during the November 2010 investigation, the extent of yellow staining was observed to be more widespread following the initial 0.5-foot vertical removal. Soil excavation eventually extended to a maximum depth of 18 feet below the original pit floor surface (approximately 24 feet below the top of the berm) in one area near the center of Pit C3.

Confirmation samples were collected from each excavation and submitted for laboratory analysis, and all final extent analytical results were below SSTLs. As previously discussed in Sections 3.1.1 and 3.1.2, an additional investigation was conducted at Pit C3 following corrective action activities. Staining was observed within two soil borings at a maximum of 51 feet bgs, and concentrations of target compounds in soil samples collected from these borings were below SSTLs.

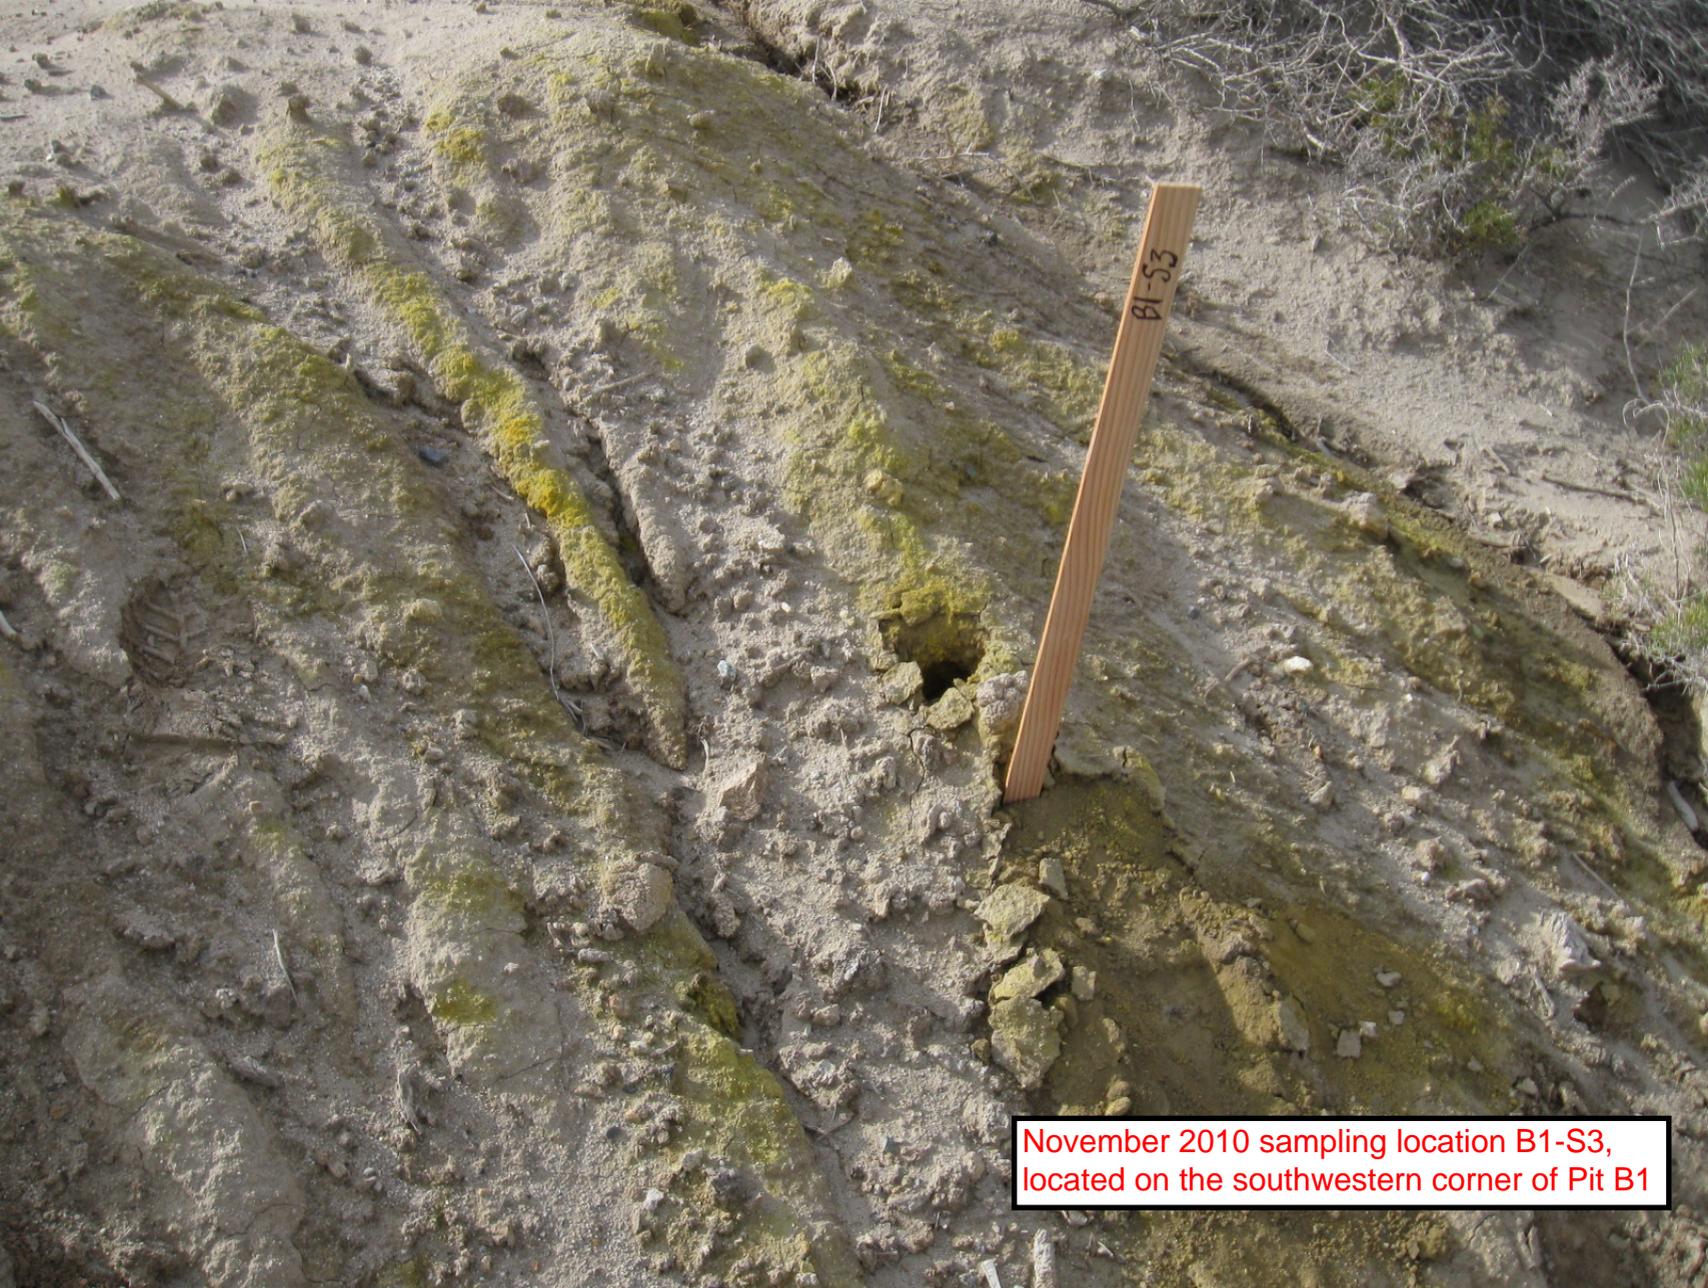
November 2010 sampling location B1-S3, located on the southwestern corner of Pit B1

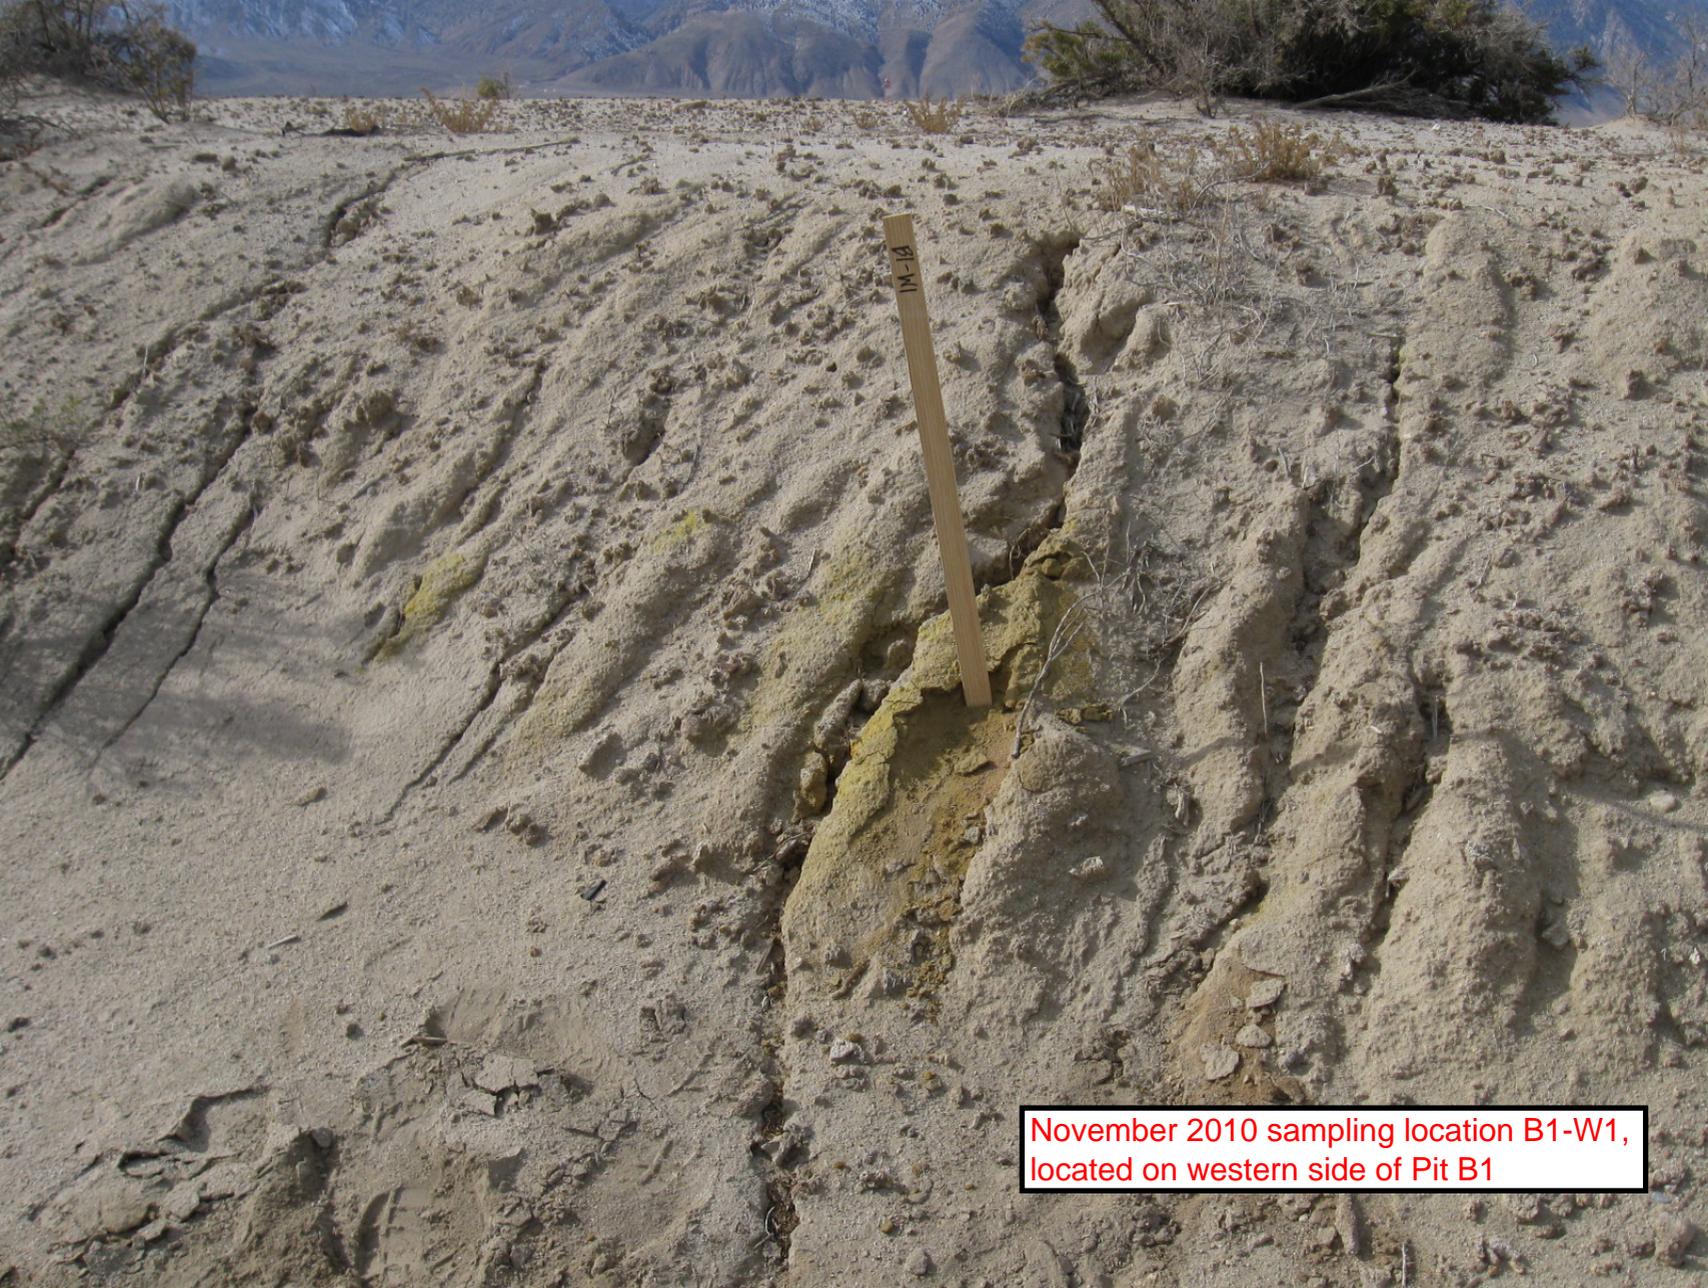
November 2010 sampling location B1-W1,  
located on western side of Pit B1

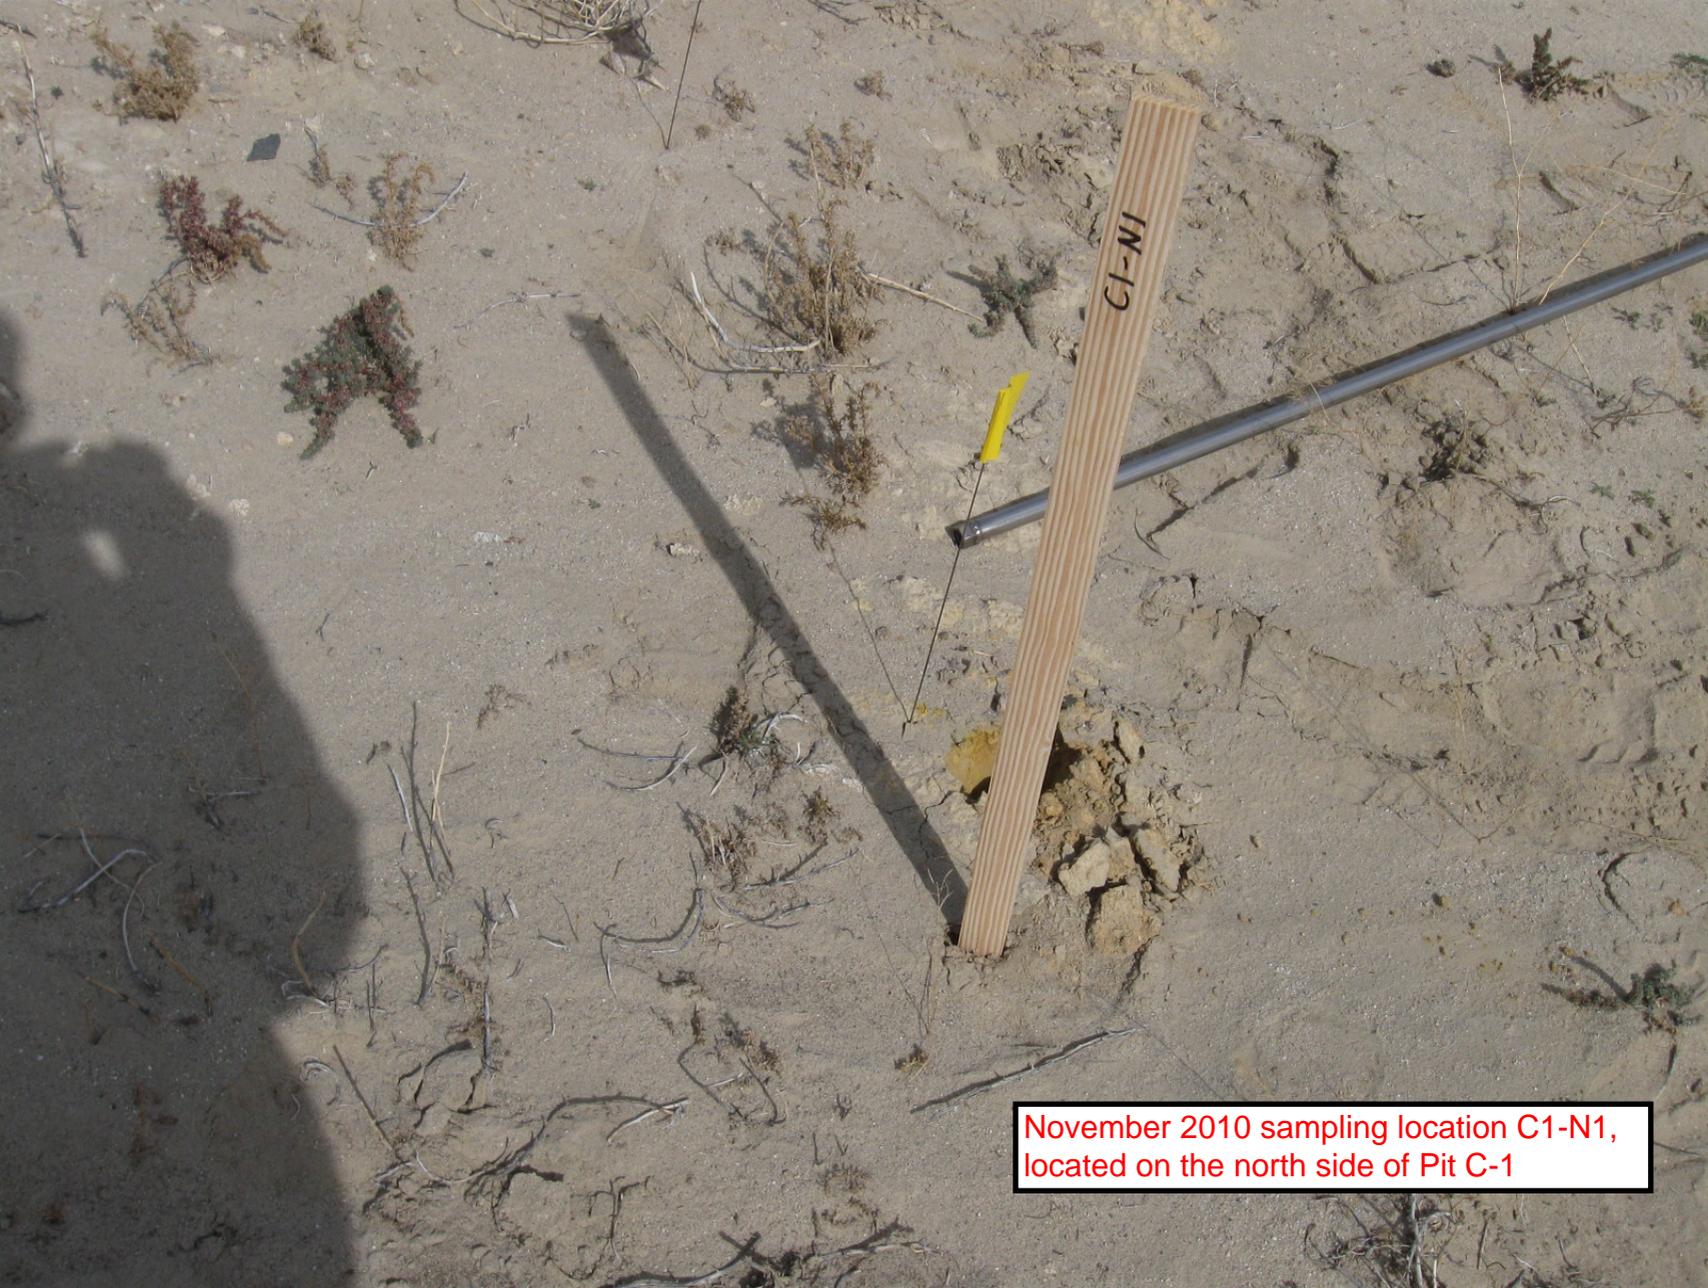
November 2010 sampling location C1-N1,  
located on the north side of Pit C-1

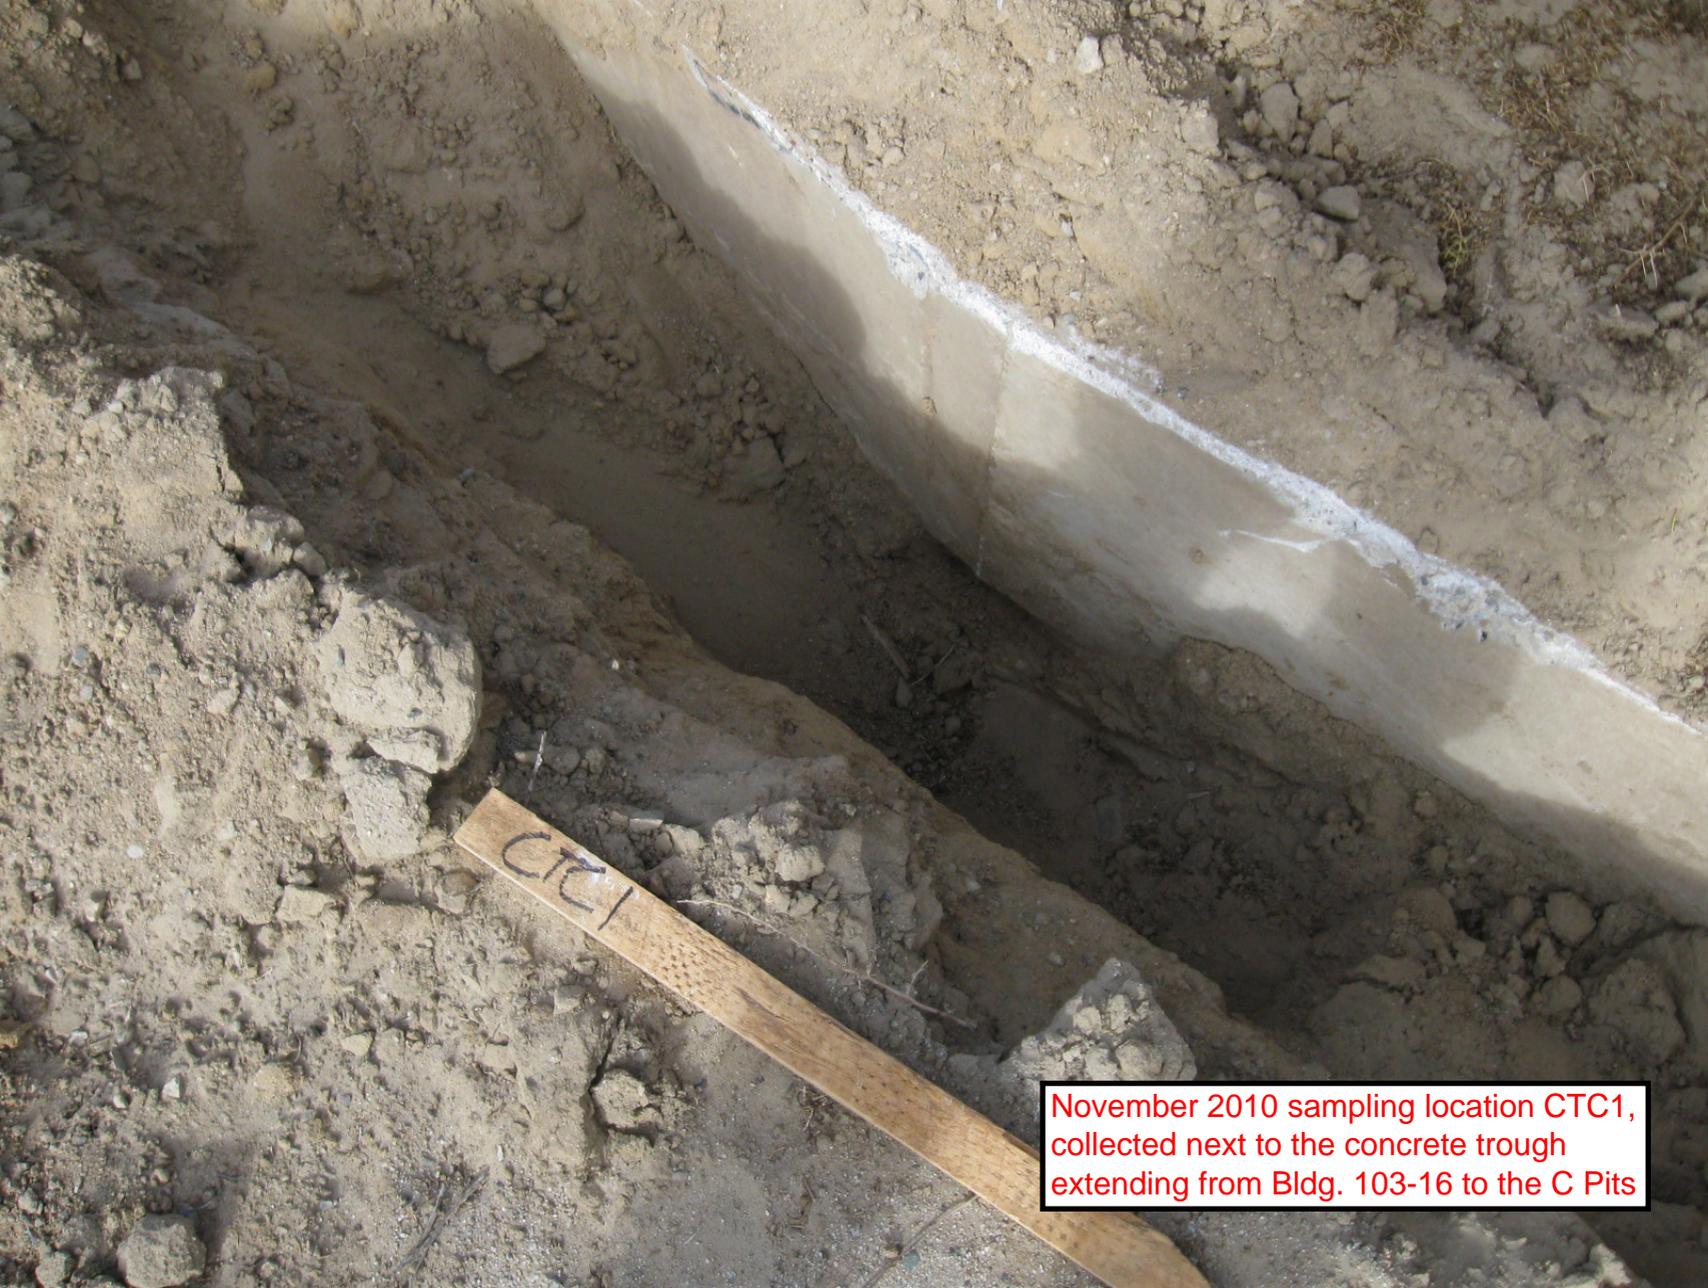
November 2010 sampling location CTC1, collected next to the concrete trough extending from Bldg. 103-16 to the C Pits
