**FINAL  
CLOSURE DECISION DOCUMENT  
BUILDING 103-16 CATCHMENT PITS  
SWMU B27A**

**HAWTHORNE ARMY DEPOT  
HAWTHORNE, NEVADA**

**June 2012**

**Plexus Scientific Corporation  
4501 Ford Avenue, Suite 1200  
Alexandria, Virginia 22302**

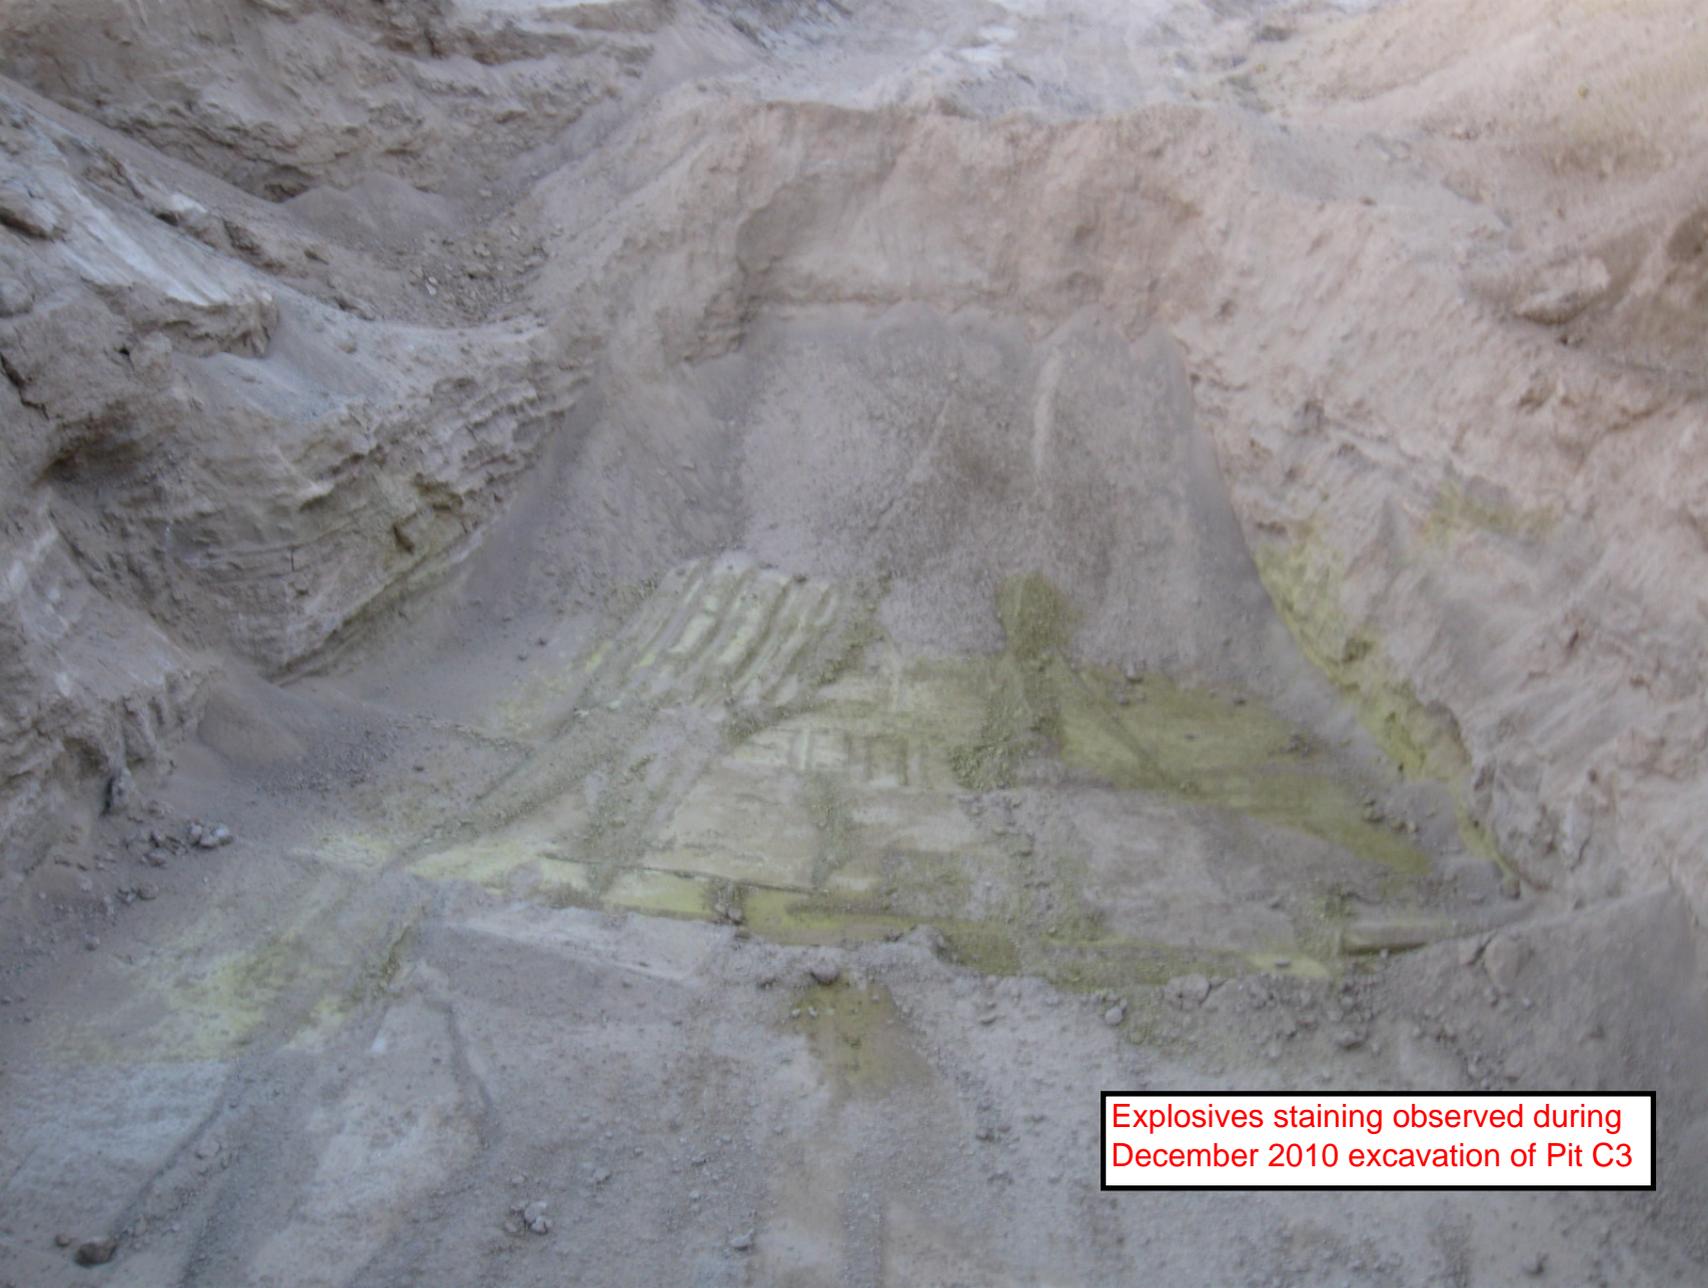
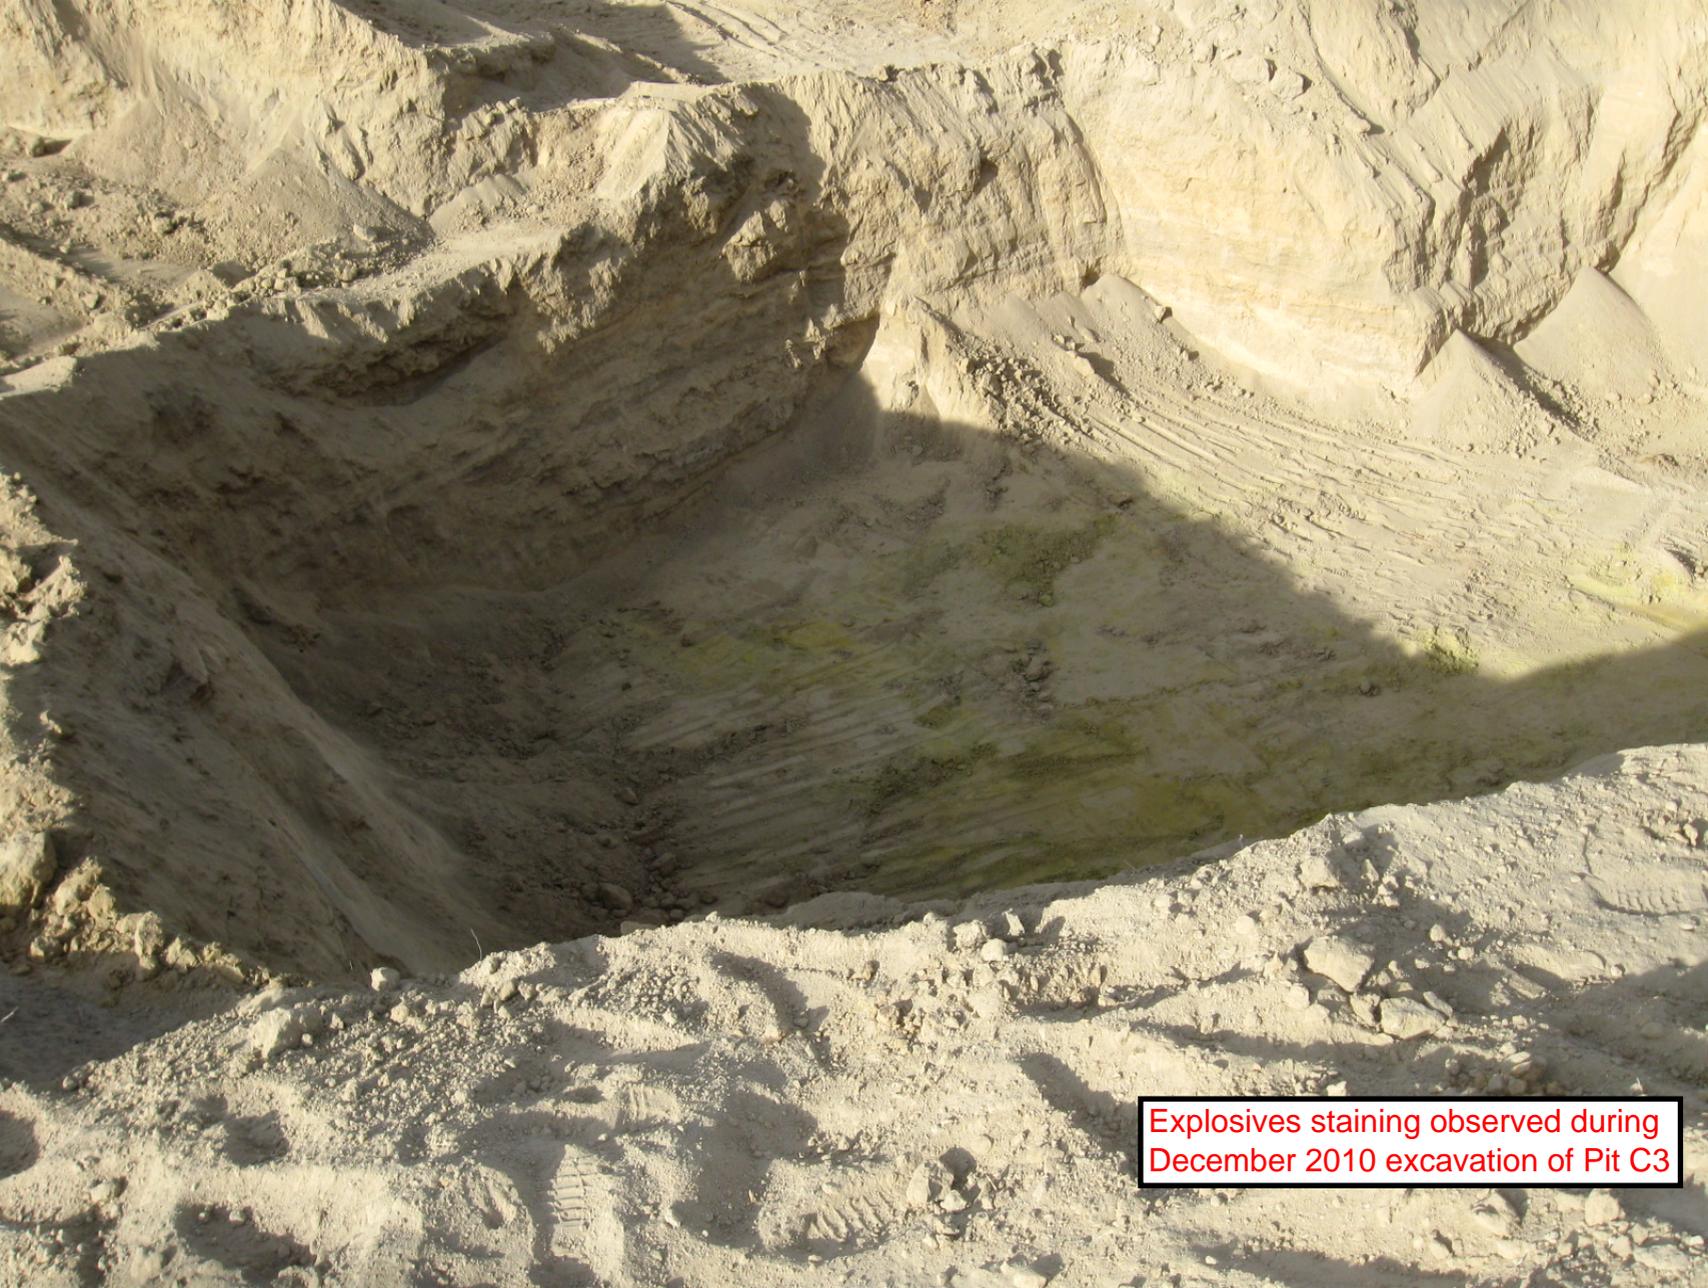
Deeper stained soil was uncovered during remedial activities, which lead to an additional investigation of Pit C3 after soil removal was completed. Two soil borings (SB-01 and SB-03) were installed; one in the center of the pit (SB-01), and one down-gradient from the impacted area (SB-03) to depths of 62 and 109 feet, respectively. Soil staining was observed at a maximum depth of 51 feet bgs in SB-01. SB-03 was completed as a monitoring well (IRPMW79) to determine the impact to groundwater. Two soil samples collected from SB-01 and one collected from SB-03 were submitted for laboratory analysis, and none of the three soil samples exceeded RSLs.

Explosives staining observed during December 2010 excavation of Pit C3

Excavations within the Pit Groups B and C extended to a maximum depth of 7.5 feet below the original pit floors, generally corresponding with the results of the November 2010 soil investigations. An exception was Pit C3. Although exceedances of SSTLs at Pit C3 were detected at a maximum depth of 2.5 feet bgs during the November 2010 investigation, the extent of yellow staining was observed to be more widespread following the initial 0.5-foot vertical removal. Soil excavation eventually extended to a maximum depth of 18 feet below the original pit floor surface (approximately 24 feet below the top of the berm) in one area near the center of Pit C3.

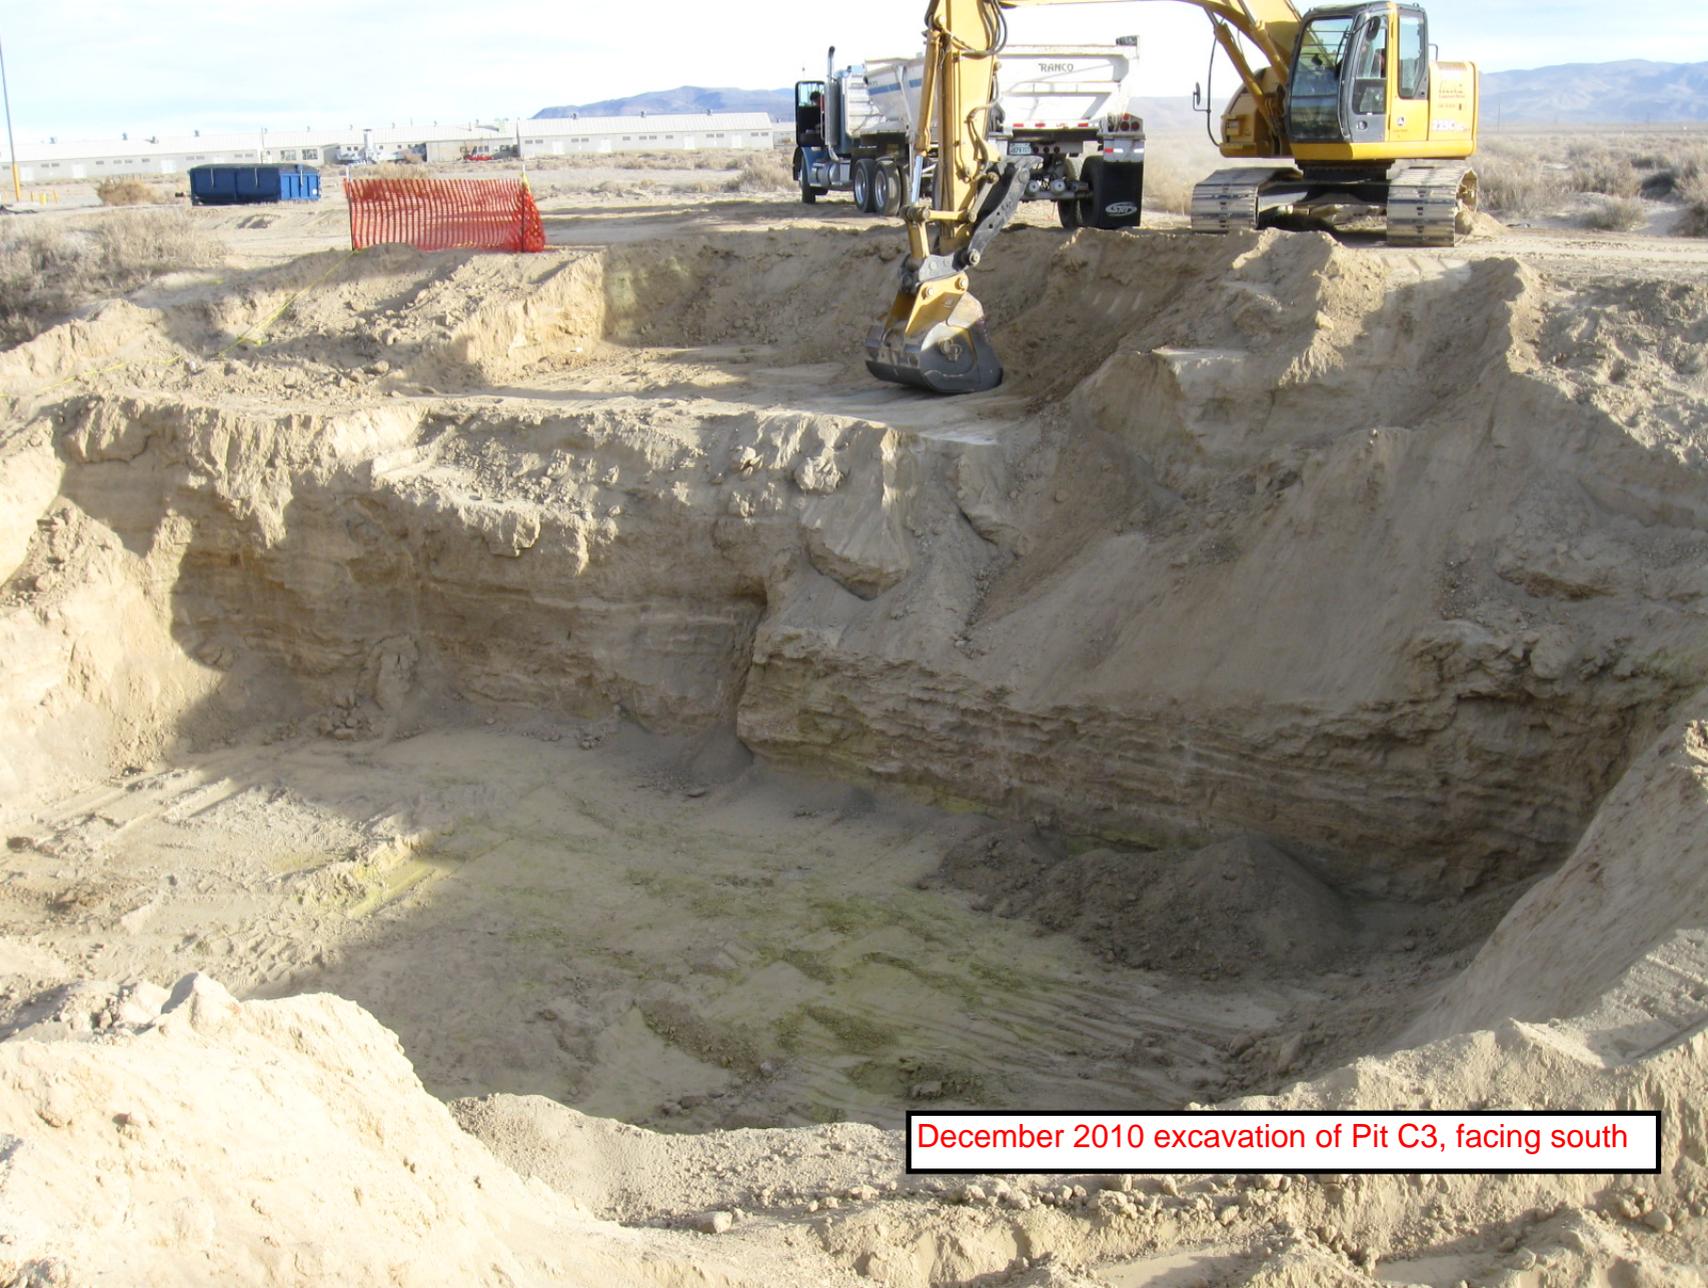
December 2010 excavation of Pit C3, facing south

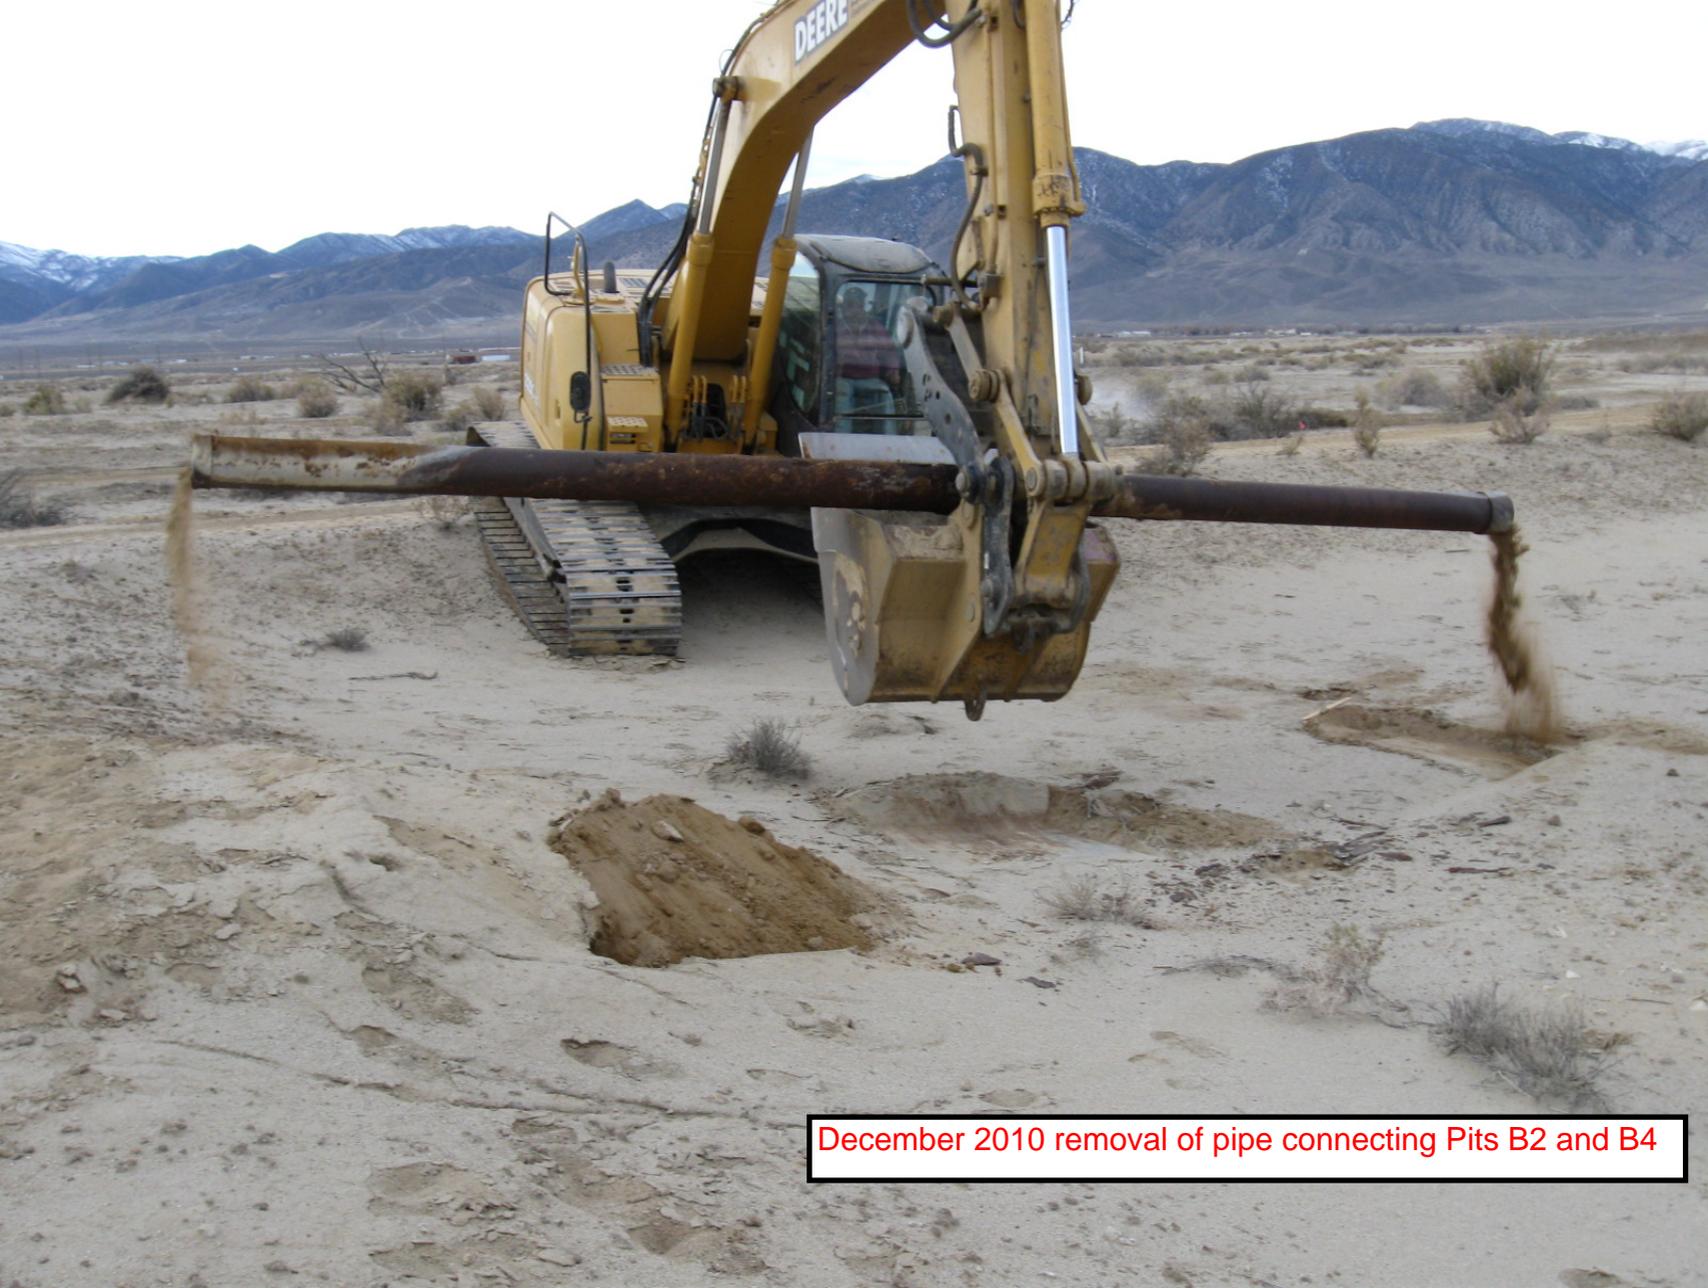
December 2010 removal of pipe connecting Pits B2 and B4

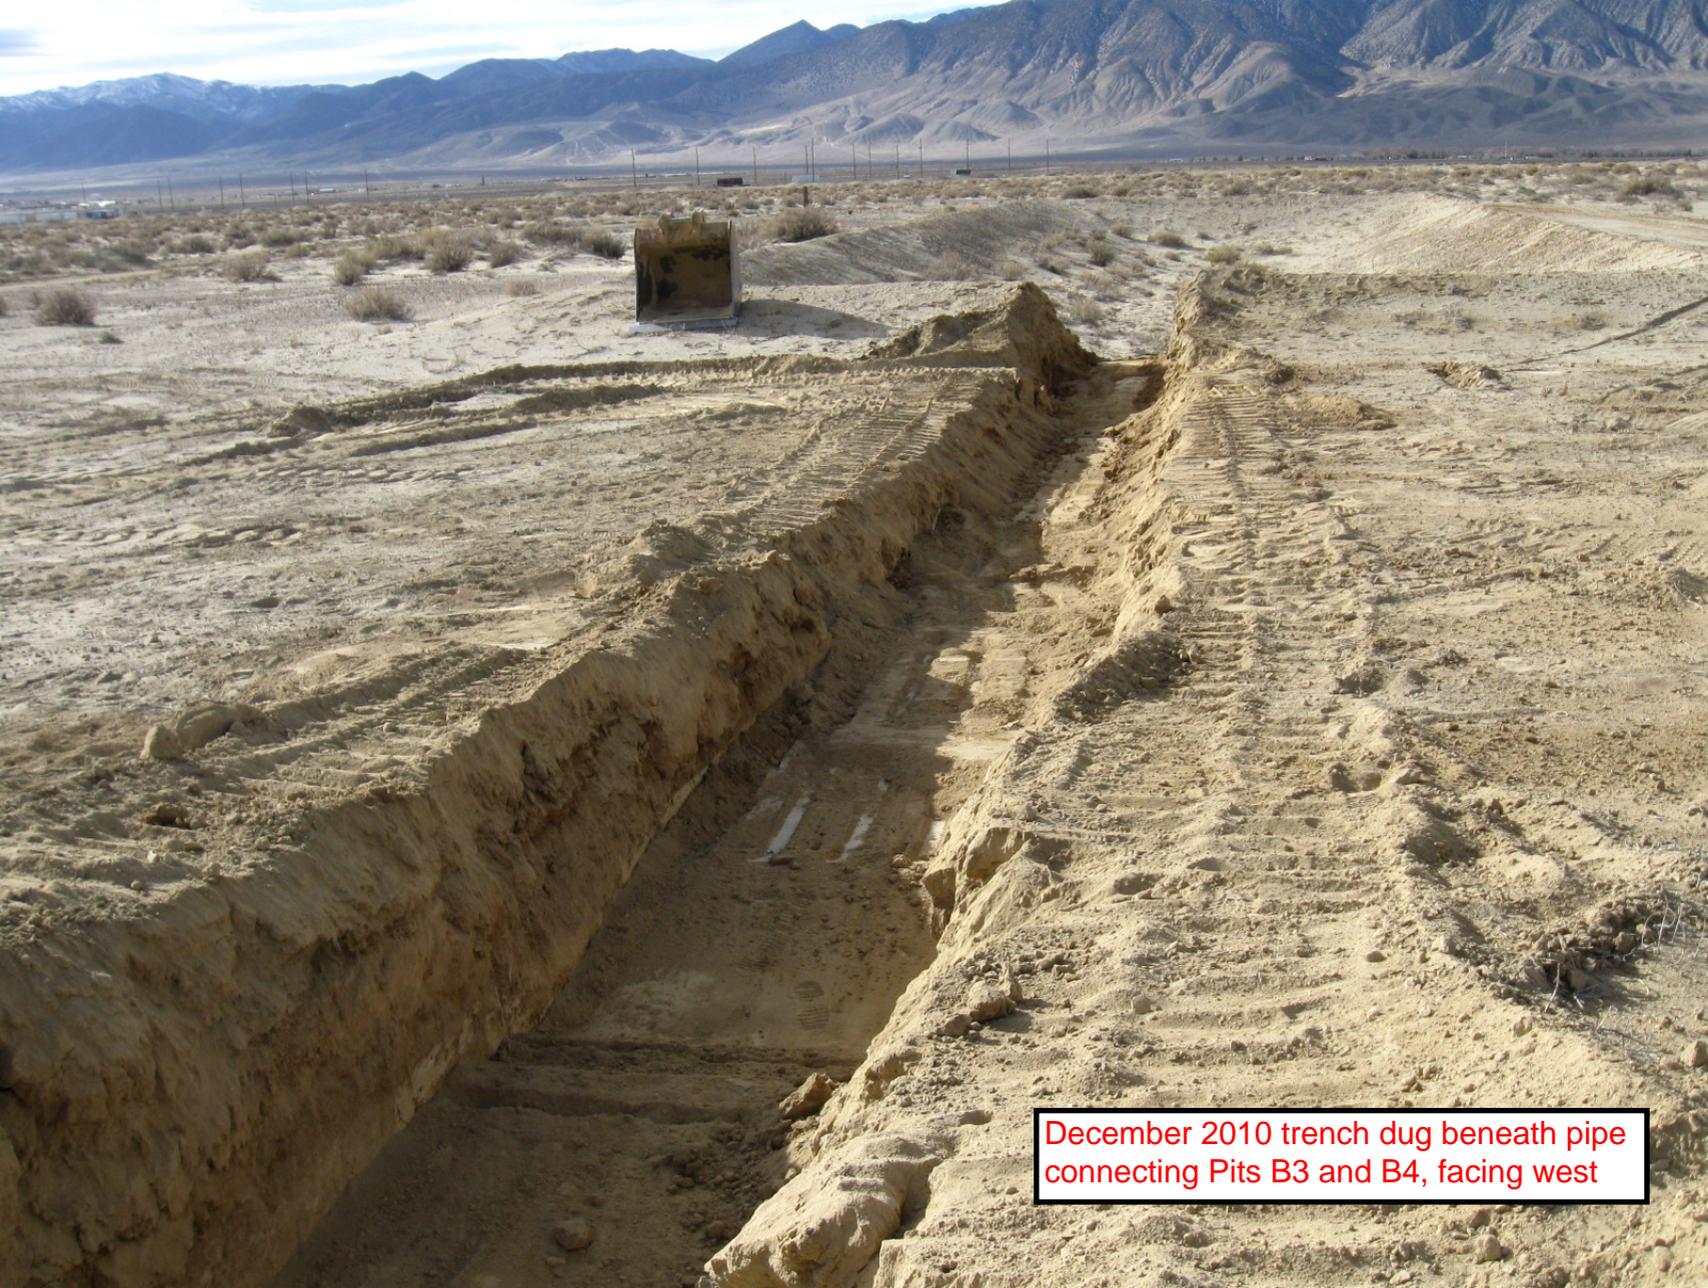
December 2010 trench dug beneath pipe connecting Pits B3 and B4, facing west

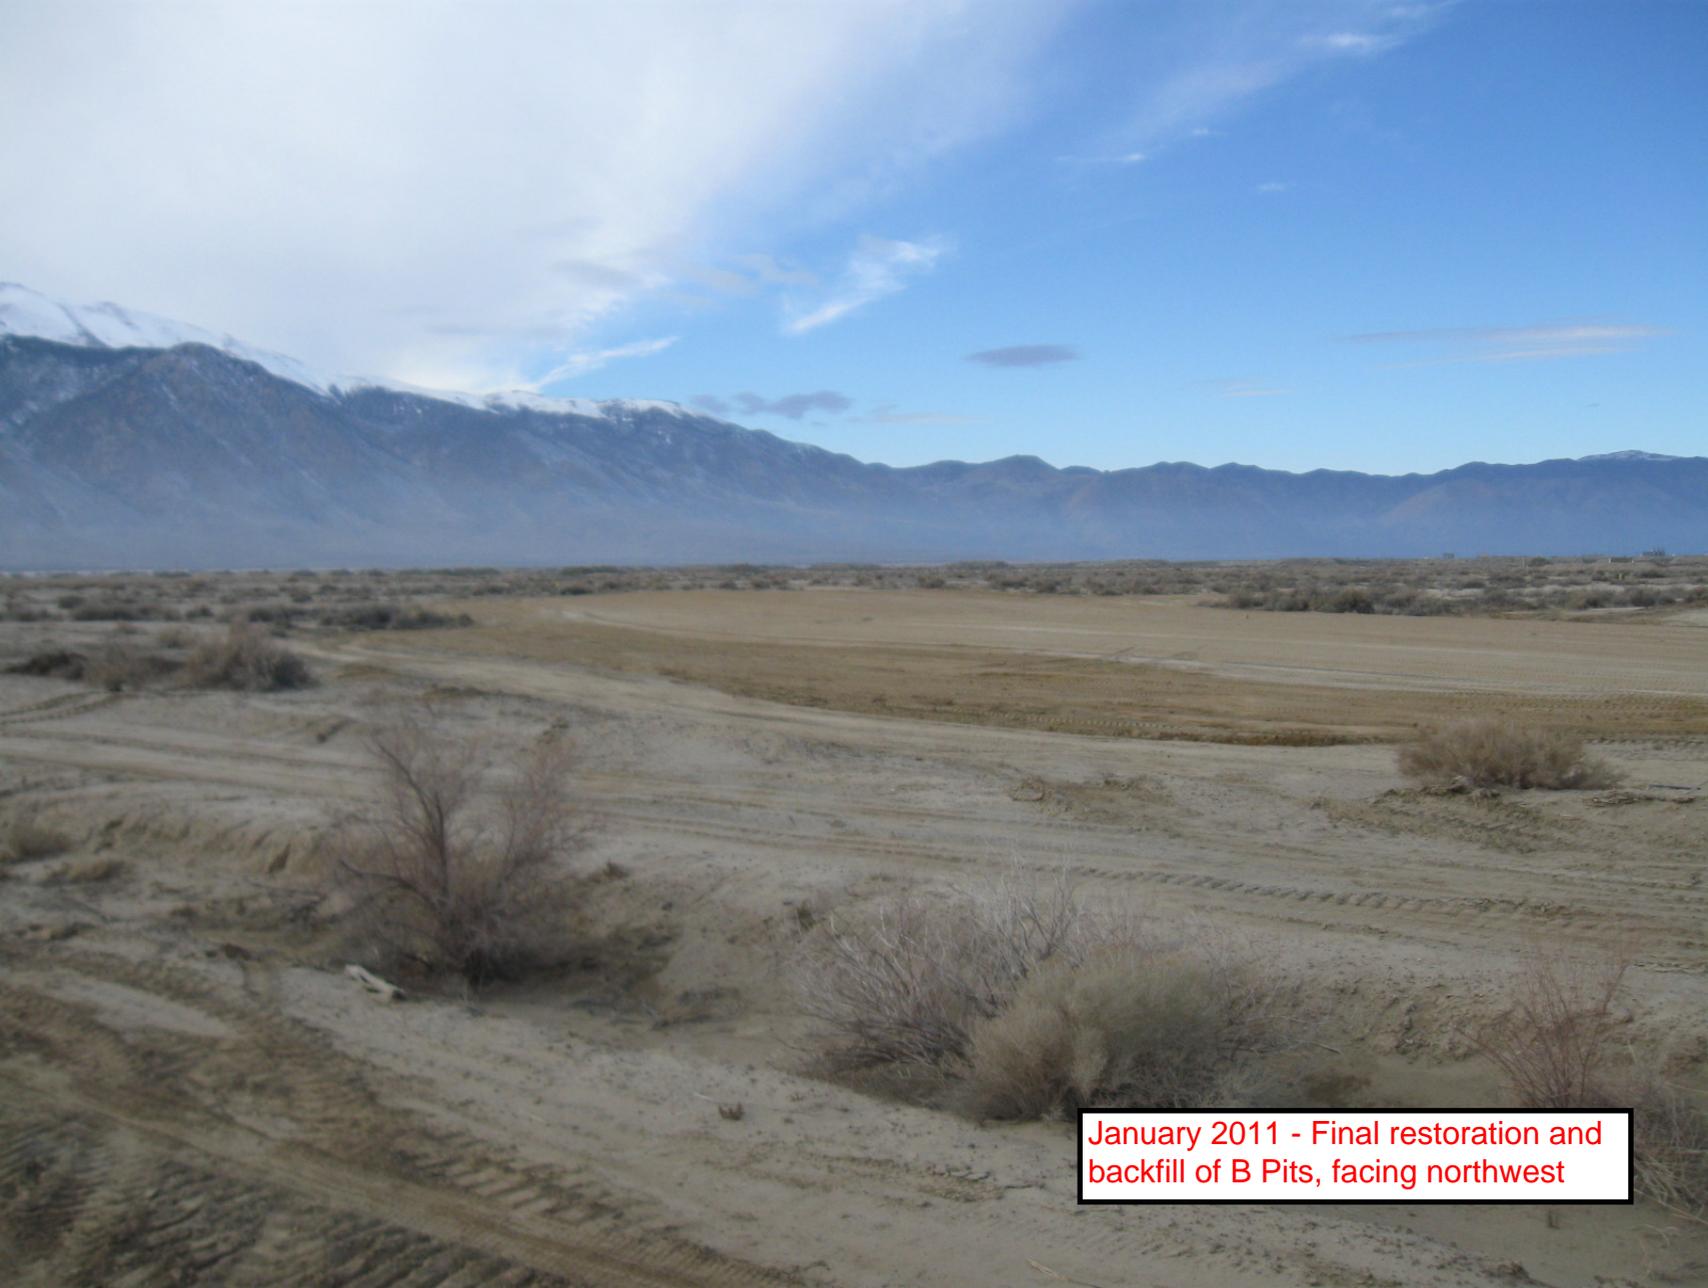
January 2011 - Final restoration and backfill of B Pits, facing northwest

Following excavation activities at SWMU B27A, confirmation samples were collected and compared to established SSTLs. Concentrations in residual soil were below the established SSTLs, and the site was backfilled in 2011.

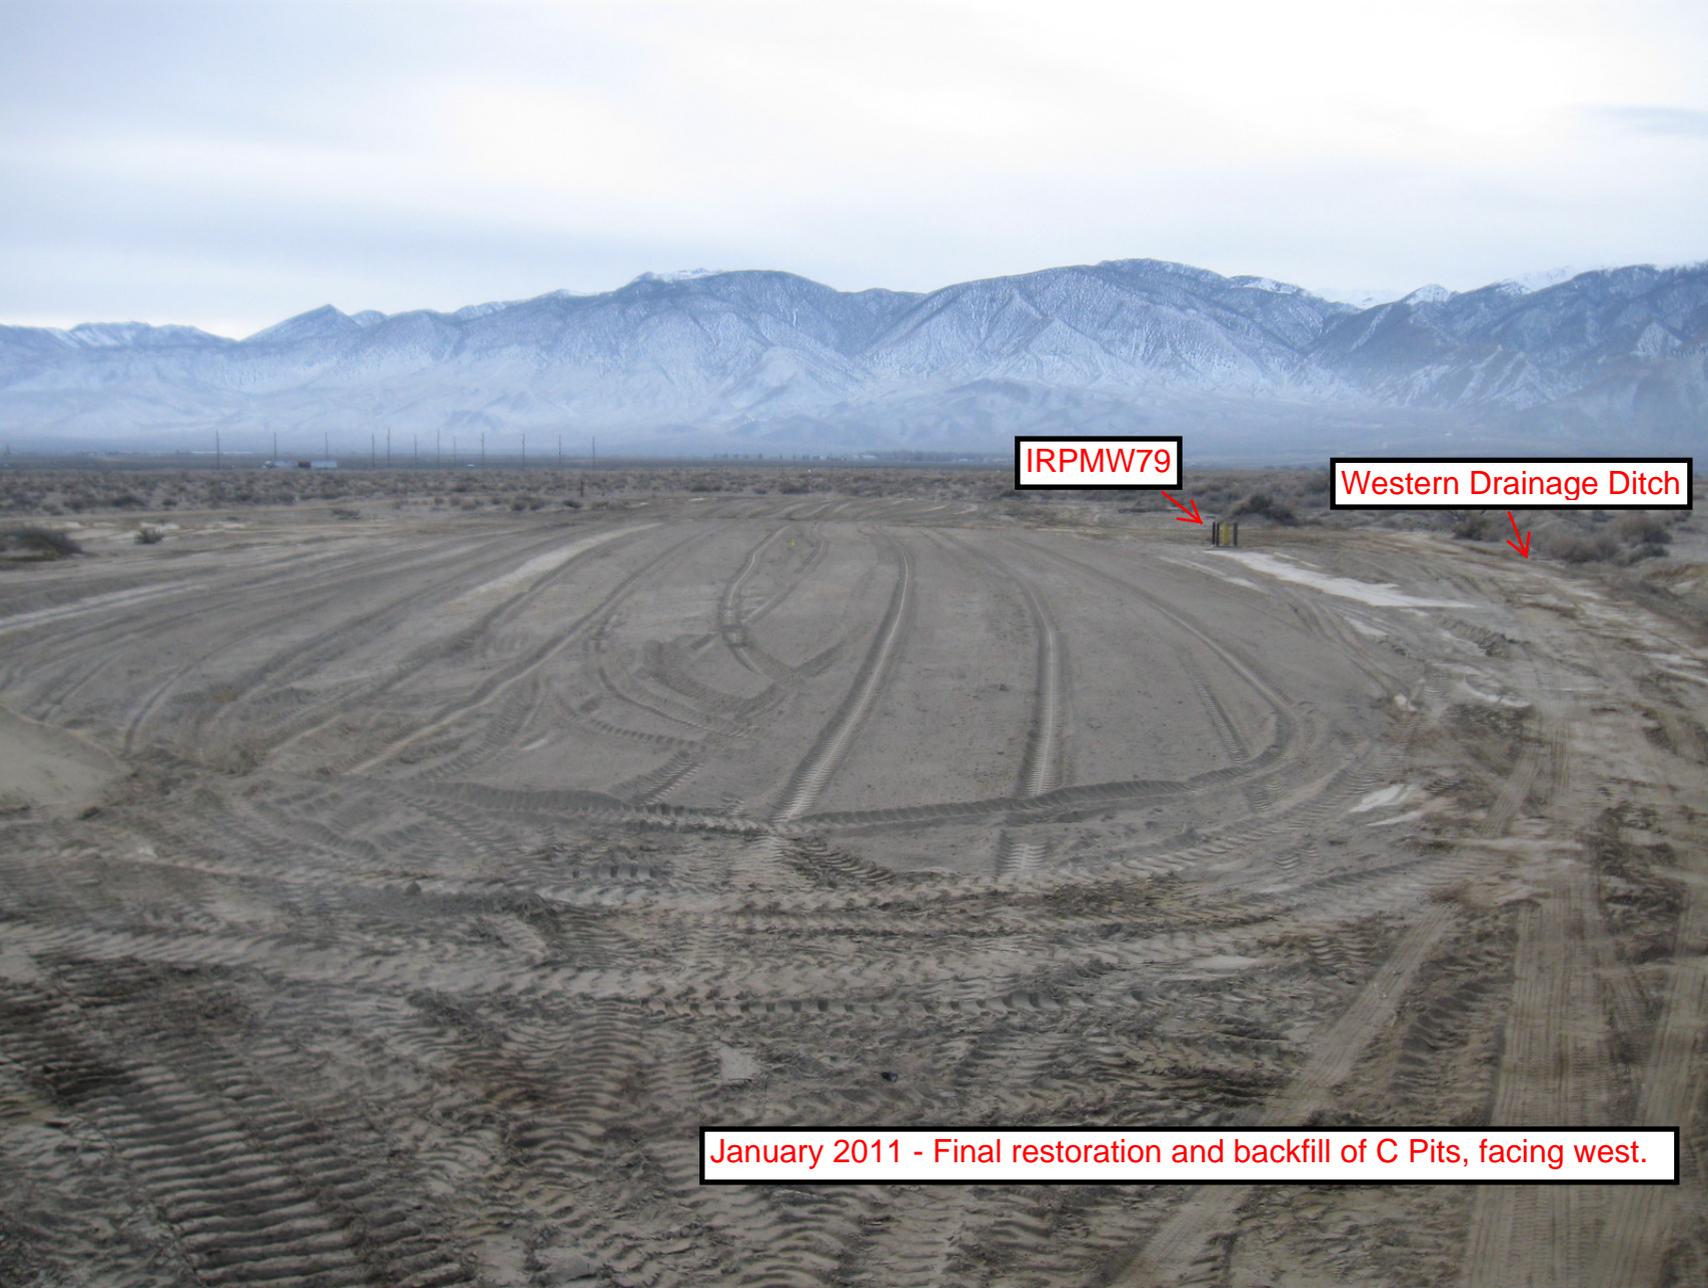
IRPMW79

Western Drainage Ditch
