COMPLIANCE EVALUATION INSPECTION REPORT

FACILITY PERMIT: Town of Gabbs – NEV70021

FACILITY DESCRIPTION: (4) Facultative Ponds

DATE OF INSPECTION: Wednesday, November 18, 2009

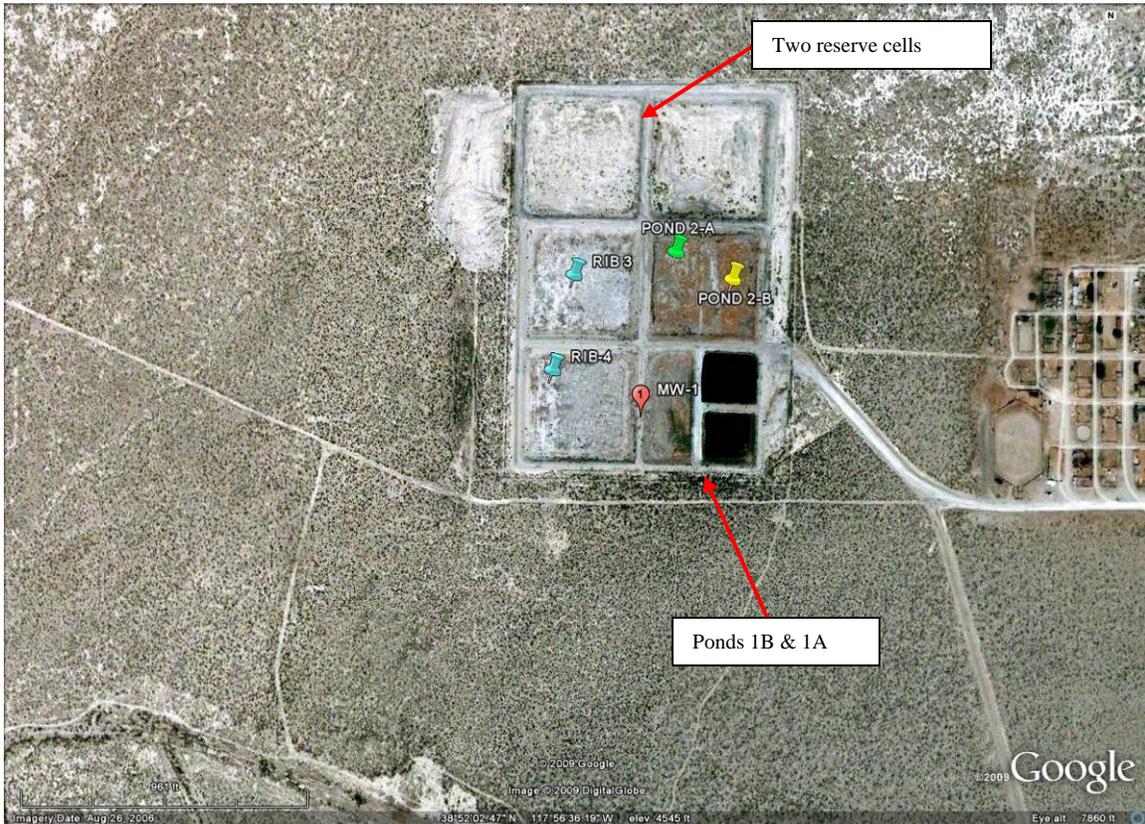
Figure 1 – Aerial Map

Today's site activity at the Gabbs WWTF consisted of Recovery Act (ARRA) and compliance evaluation (CEI) inspections by NDEP staff. This report documents the CEI. The Gabbs WWTF facility upgrade project broke ground in September 2009. The aerial photograph below was compiled in August 2006 when the facility consisted of two unlined ¼-acre treatment ponds and a 1-acre RIB.

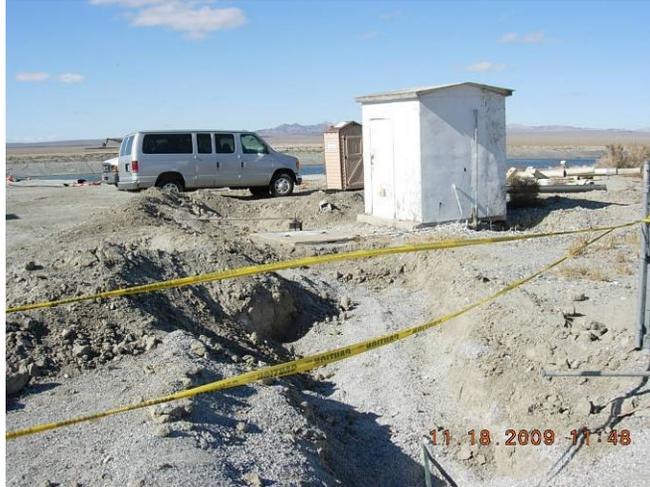
Fig. 2 – Trenching

Head Works: Just upstream of the flow meter, trenching work is underway for replacement of 400 feet of sewer main and the flow splitter. A new steel lid was fabricated for the meter vault.

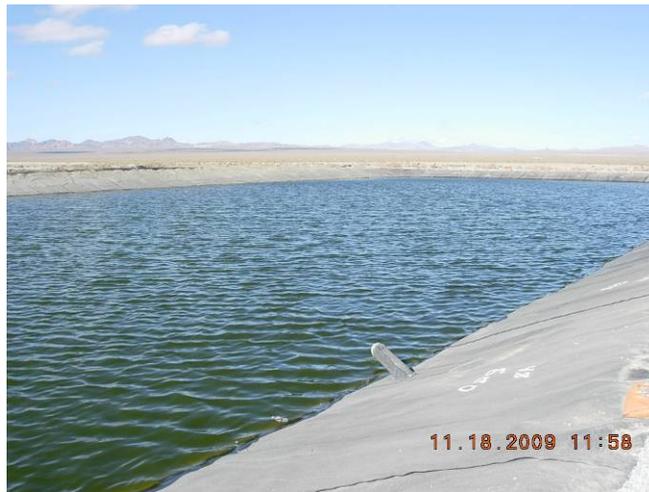
Fig. 5 – Pond 2B Inlet

Treatment Ponds: Four ponds (2A, 2B, 1A & 1B) are being lined with 60-mil HDPE (textured surface) and have equivalent dimensions of 1½ acres (surface) × 5 feet (operating depth). Ponds 2B and 2A are now complete. The flow arrangement can either be parallel (two cells) or series (four cells). The operator's preference is series flow to maintain minimum ballast in each cell of 1 feet and well water addition may be needed in the summer to offset evaporation. Since staff gages were not funded, the operator will track the operating depth using the rungs on the sidewall escape ladders (rungs spaced six inches apart). Pond 2B was filling and had not yet iced over. Its color was a light olive green with no objectionable odor. The operator pointed out the inlet where the relatively clear influent stream was representative of the light BOD loading measured at the head works.

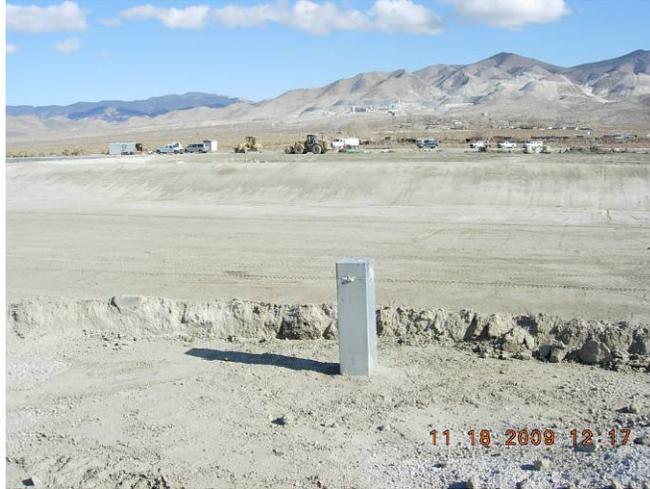
Fig. 10 – MW-1 (overlooking the Pond 1A, which is scheduled for lining)

MW-1: The monitoring well was installed in 2007 at a location down-gradient of the now decommissioned ponds. Upon pond lining, the monitoring well will be located between pond 1A and RIB 4. The groundwater gradient is to the west.

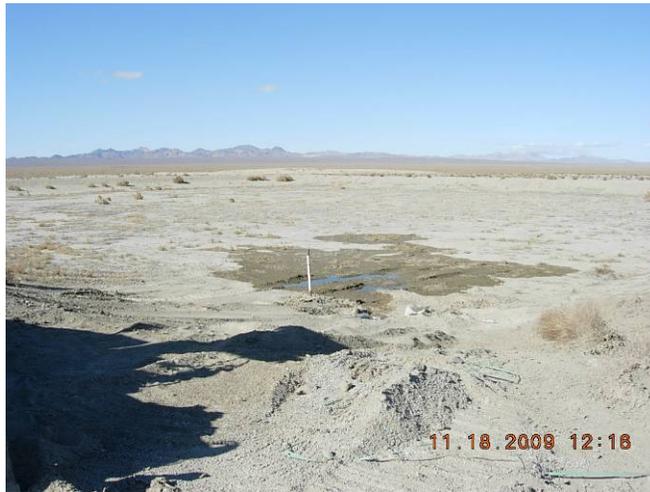
Fig. 11 – RIB 3

RIBs: The ponds will discharge to one of two percolations ponds designated as RIB 3 & RIB 4, which are unchanged from the original design. Each RIB capacity is 4¼ million gallons. Thus, disposal capacity is not an issue. When the unlined ponds were decommissioned, effluent was drained into RIB 3 where only a small puddle of water remains.

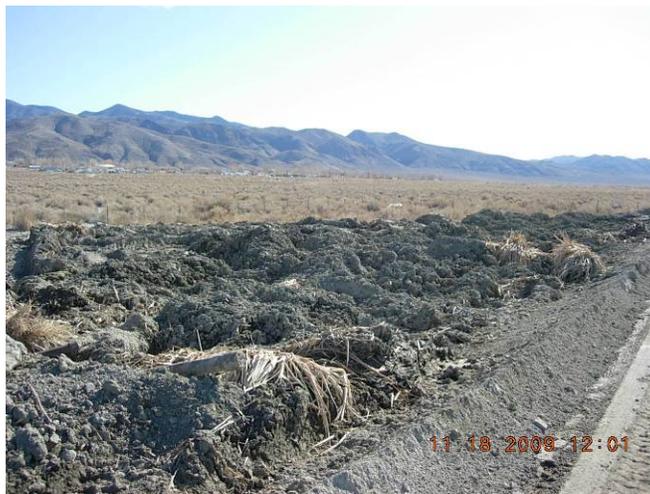
Fig. 13 – Spoil Pile alongside the East Fence Line

Biosolids: When the unlined ponds were decommissioned, the spoil pile was placed alongside the outer shoulder of the service road. After five years of these ponds' operation, the operator observed little sludge (biosolids) accumulation upon their dewatering, mentioned as being 1 to 2 inches in overall thickness prior to drying. There was also some vegetation (cattail and bulrush) removed from the sidewall embankment. The total estimated volume of spoil and sludge is 400 yd³. The contractor proposes to compact this material and seed it with native grass. This plan is forwarded for review by Permits (Janine Hartley) to determine applicability with biosolids beneficial reuse. Tech Services comments that the contractor's plan appears reasonable provided that the seeded area is periodically watered to establish plant growth (grass N uptake is estimated at 50 lbs N/acre-ton). The stabilized spoil area will be within the posted perimeter fence line and located two-thirds mile from the nearest residence. There are no nearby wells, except for MW-1.

1. Irrigation: For the first growing season, the stabilized spoil pile needs to be periodically watered by a water truck to establish the grass seed.
2. Exfiltration: During winter (assuming low outdoor water usage), the potable demand is $5 \times$ the measured influent flow rate. As funding allows, an investigation of the upstream collection system in town is recommended to determine exfiltration (leakage) or areas of solids dropout.
3. Certification: Mr. Donahue should contact the operator's certification board to have a local operator available upon Mr. Dummar's retirement.
