# Pyramid Lake Paiute Tribe

## Guanomi Mine Reclamation

# Guanomi Mine Site

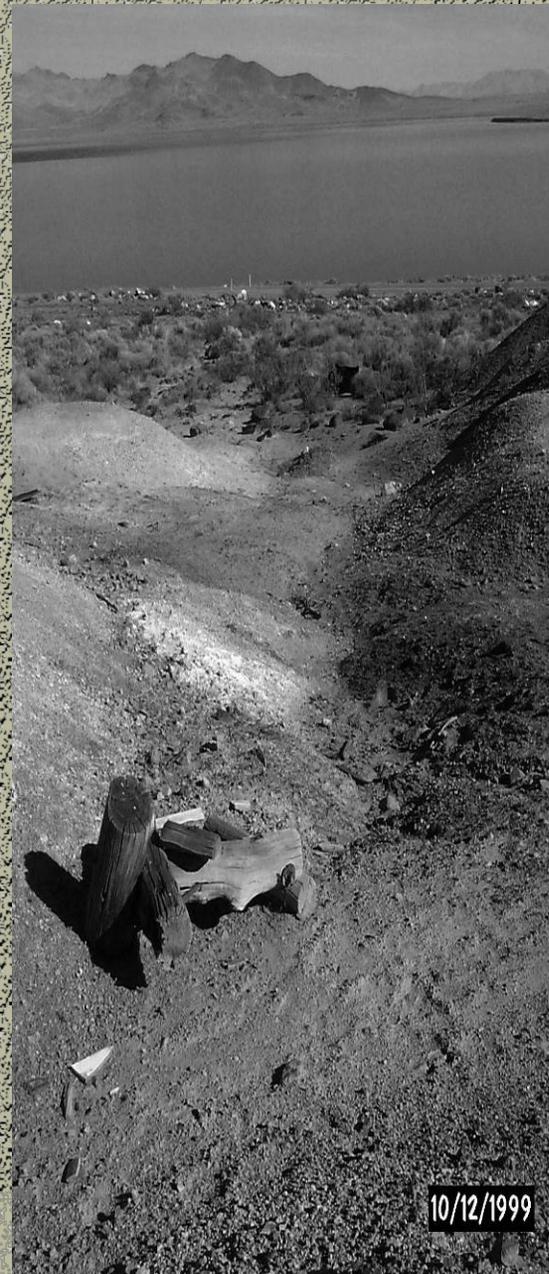
6 water features with periodic acidic discharges

2 caved adits and 2 caved shafts

1 open shaft

Tailings waste dumps with acid generating rock

1 small landfill

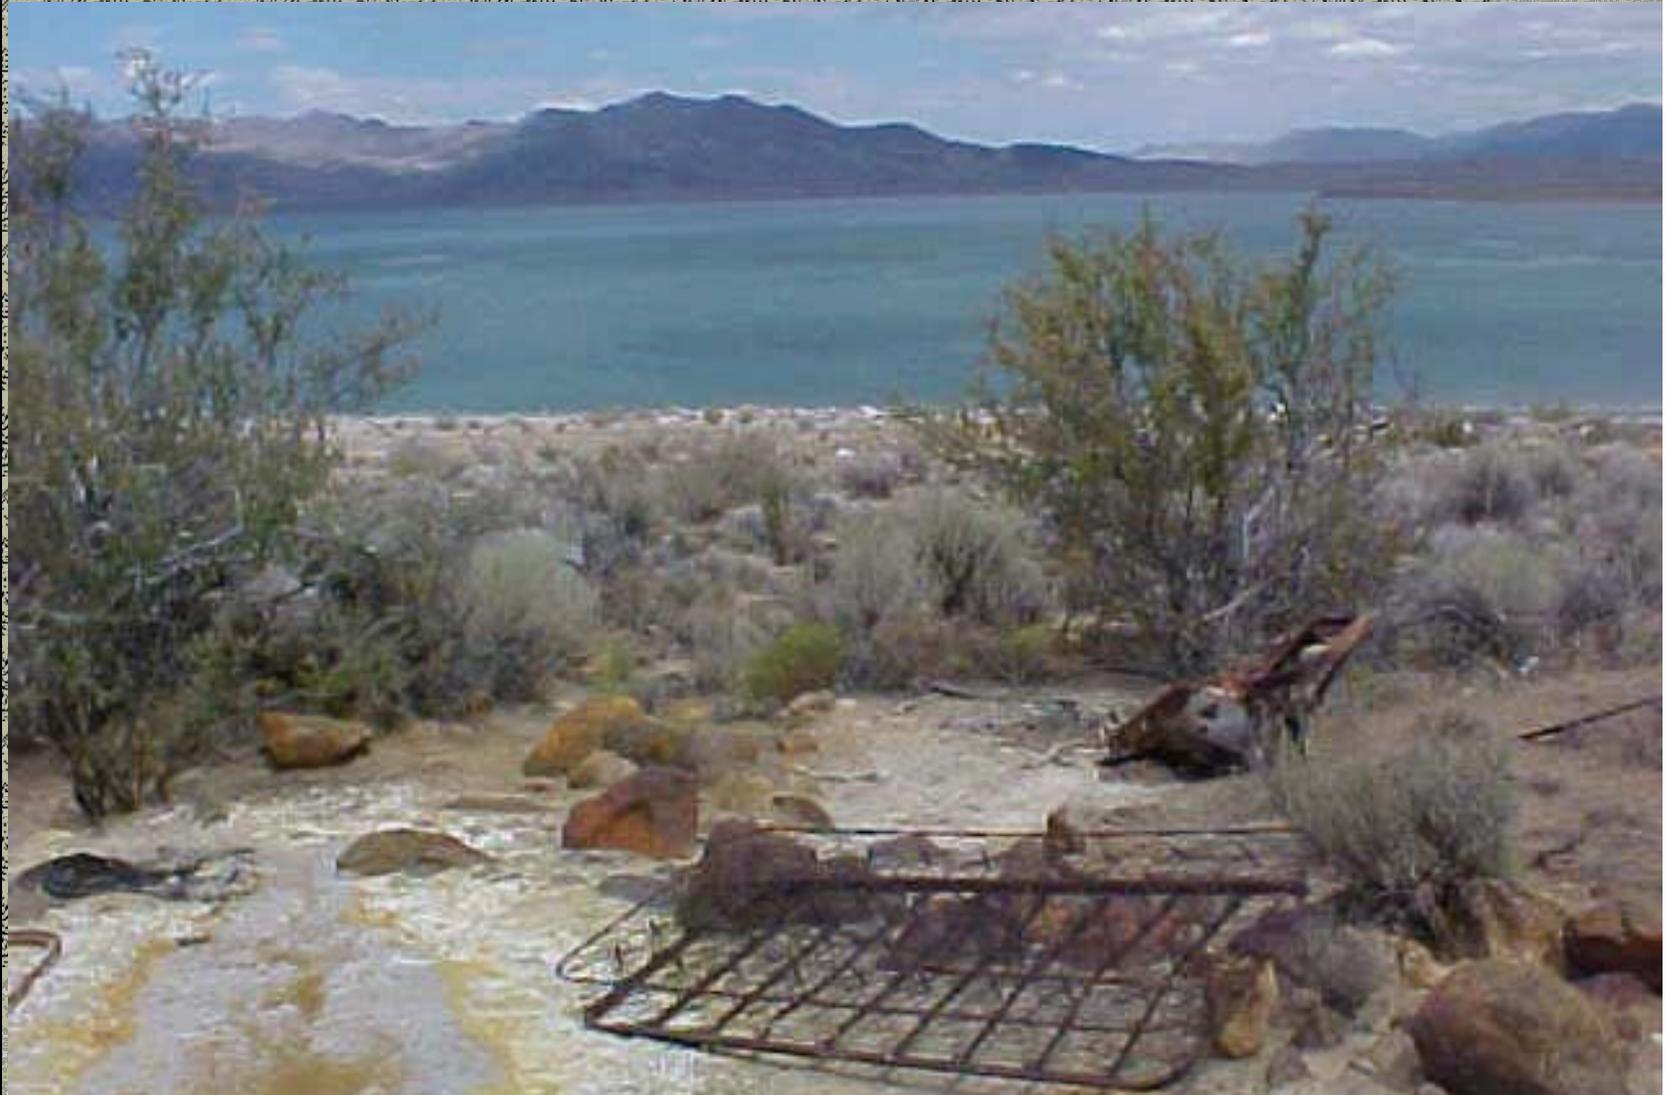
# Landfill at the Edge of the Site

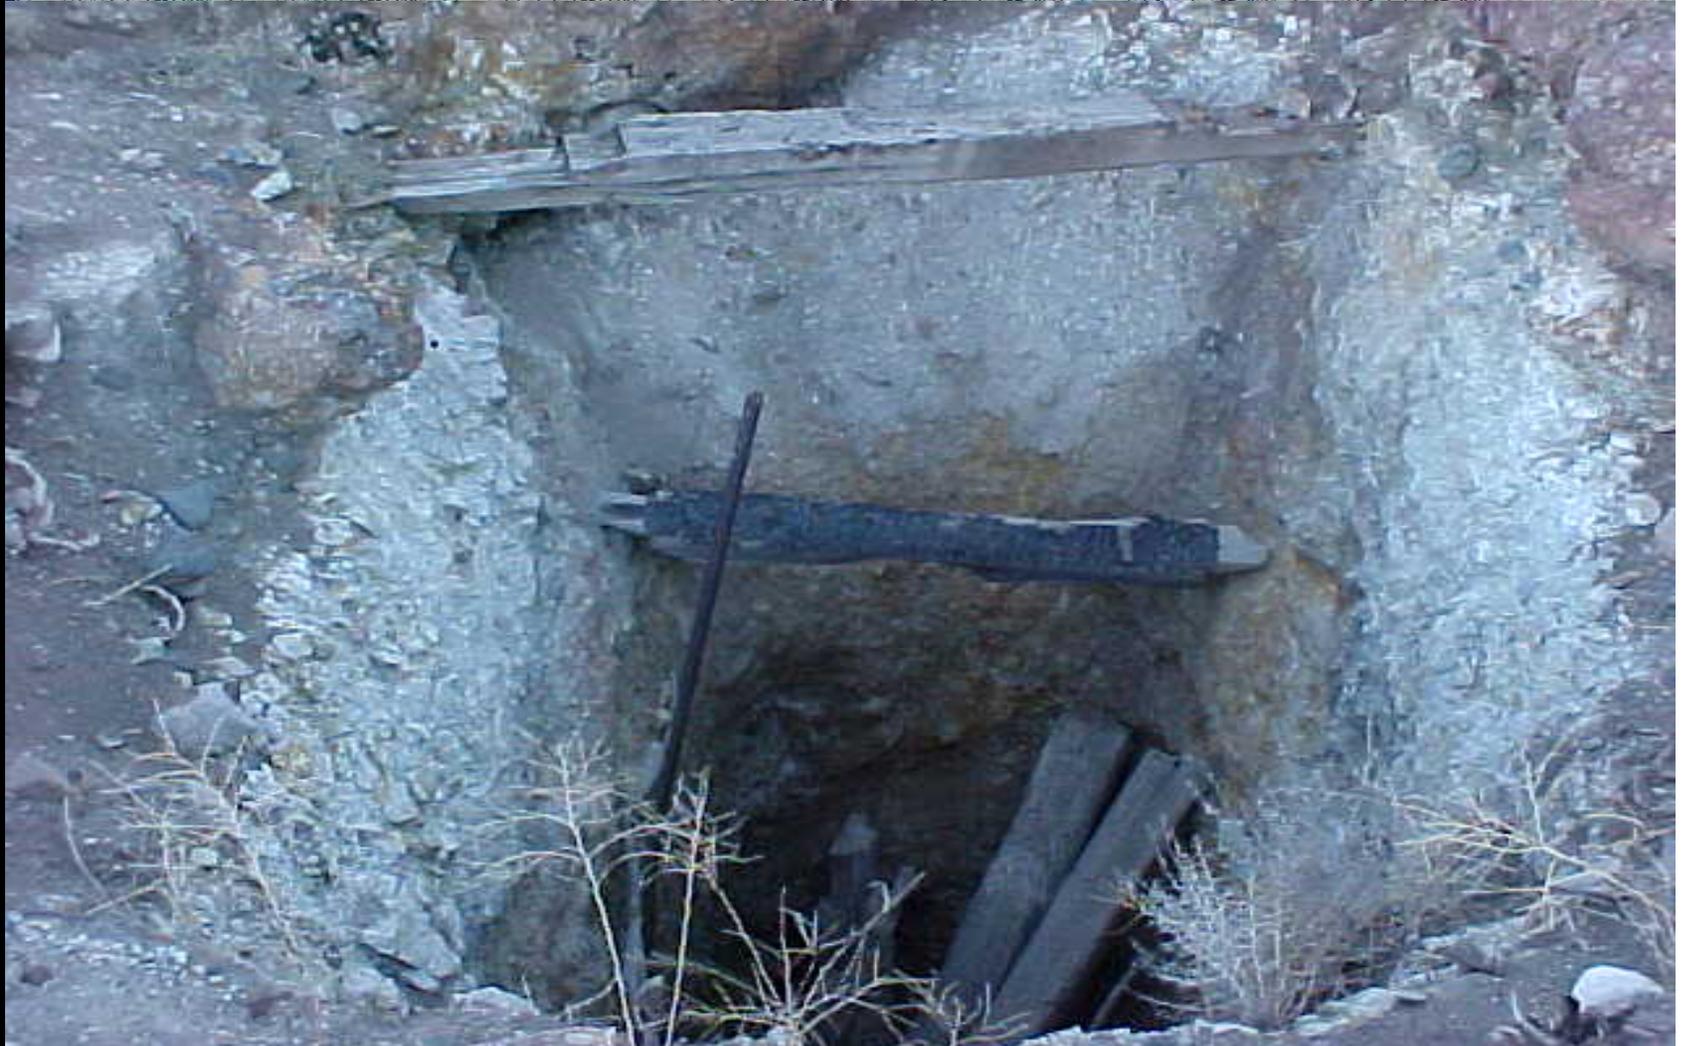
# Shaft or Pit That Is Caved

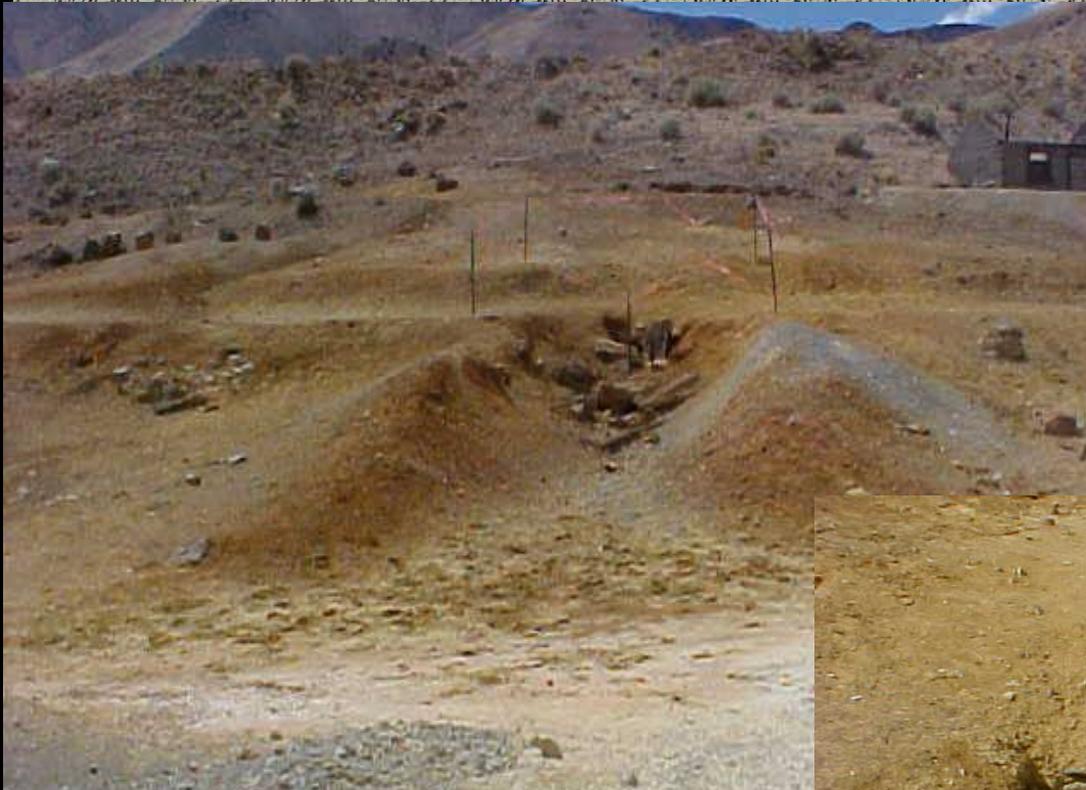
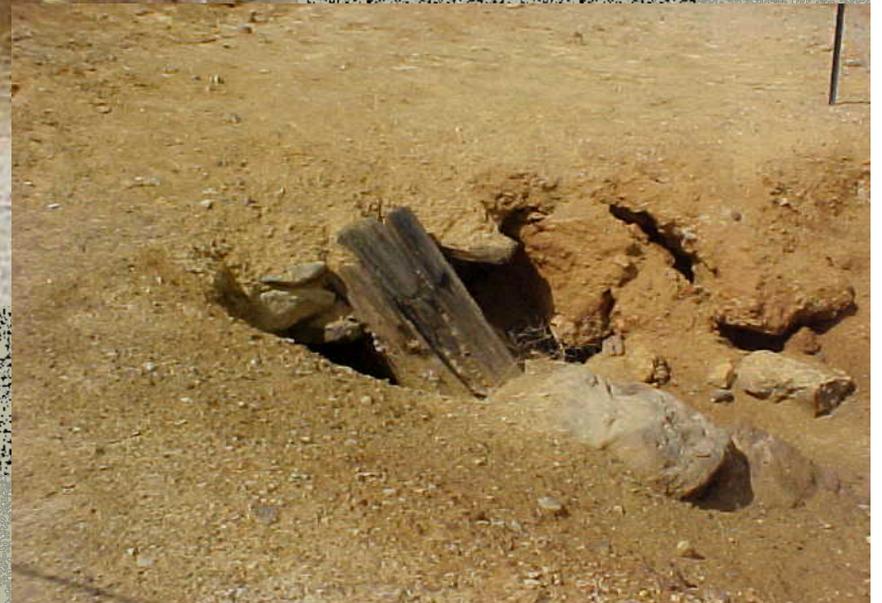
# Caved Adit with Acidic Drainage

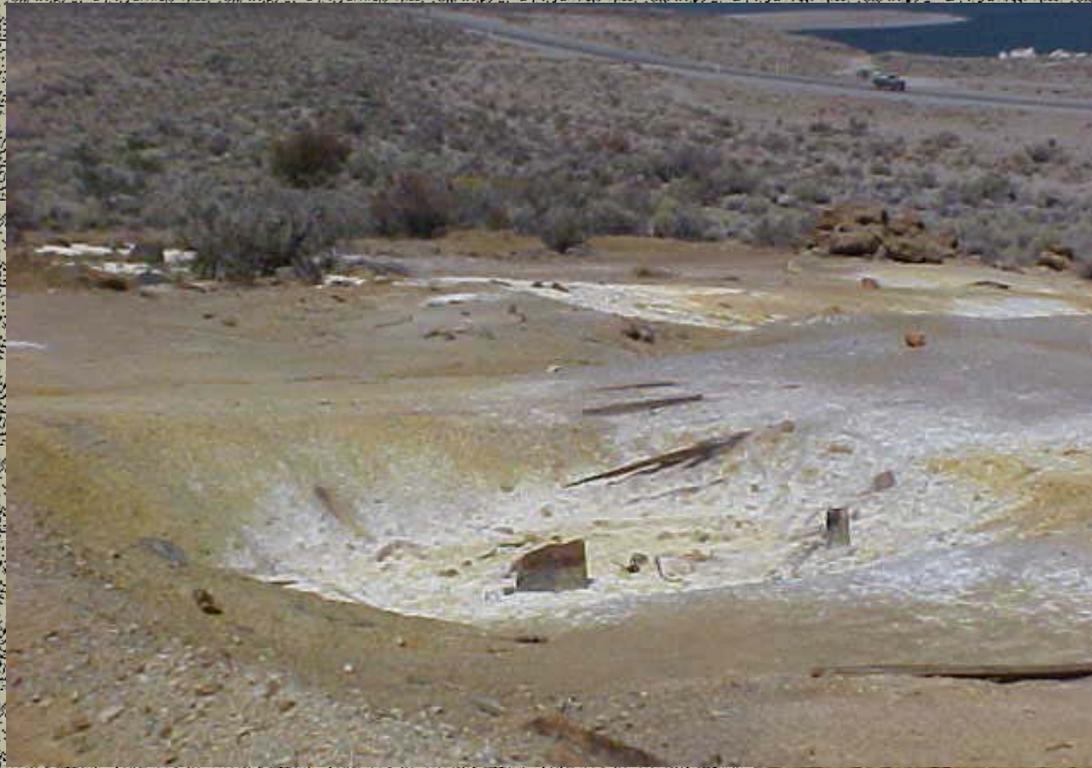
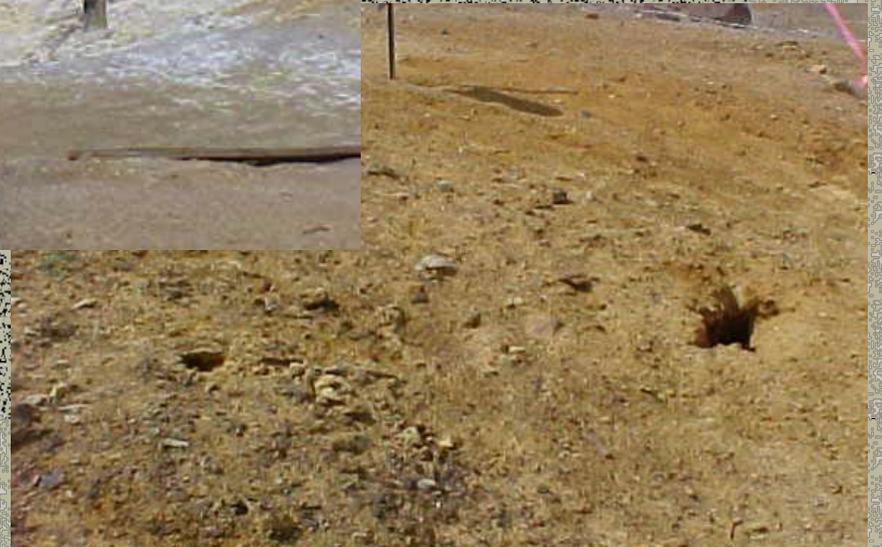
# Collapsed Adits Are Safety Concerns

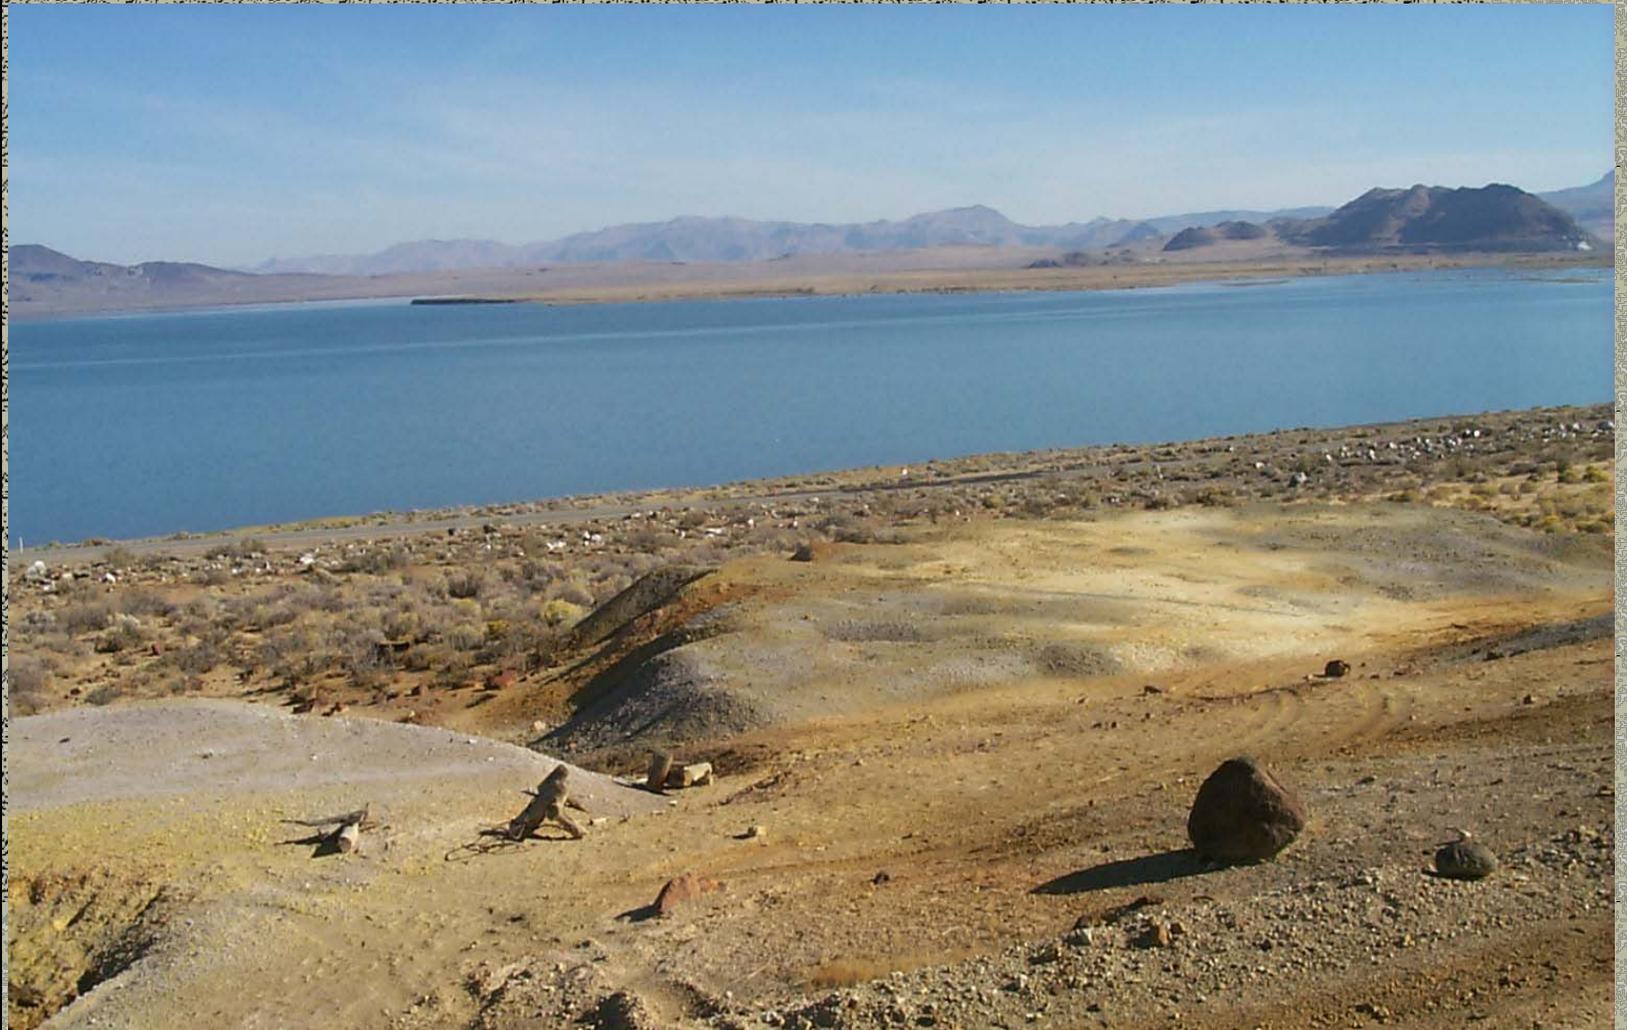
# Tailings Leach During Storm Events

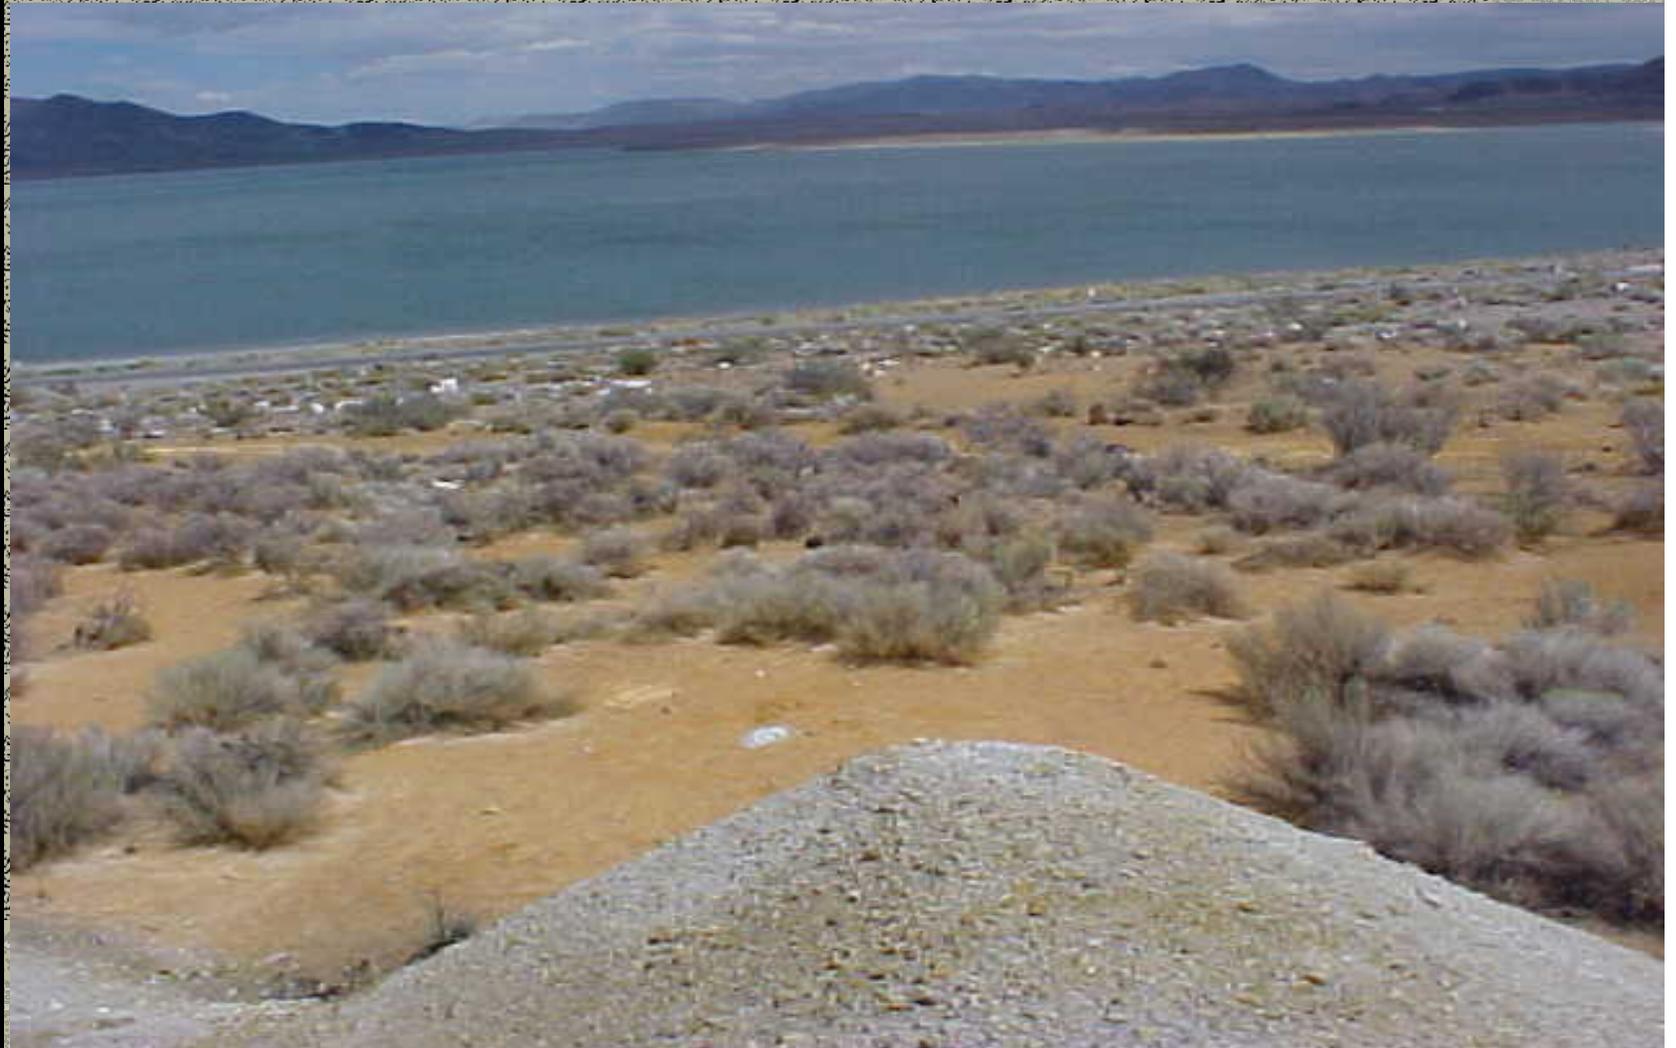
# Red Precipitate From Tailings

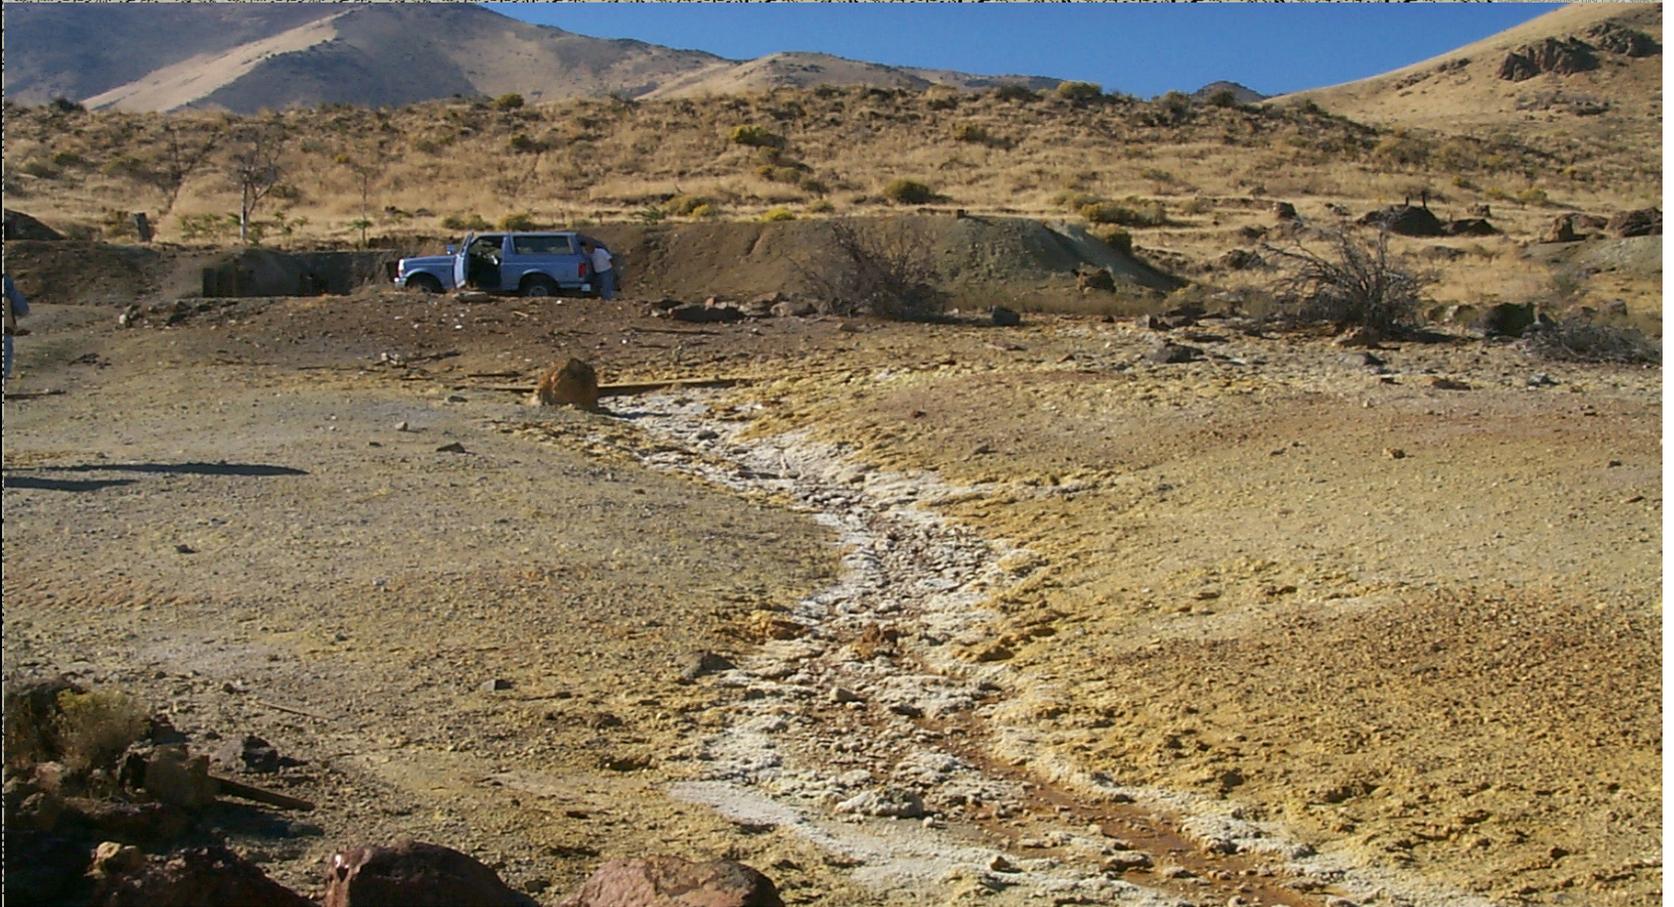
# Flowing Discharge

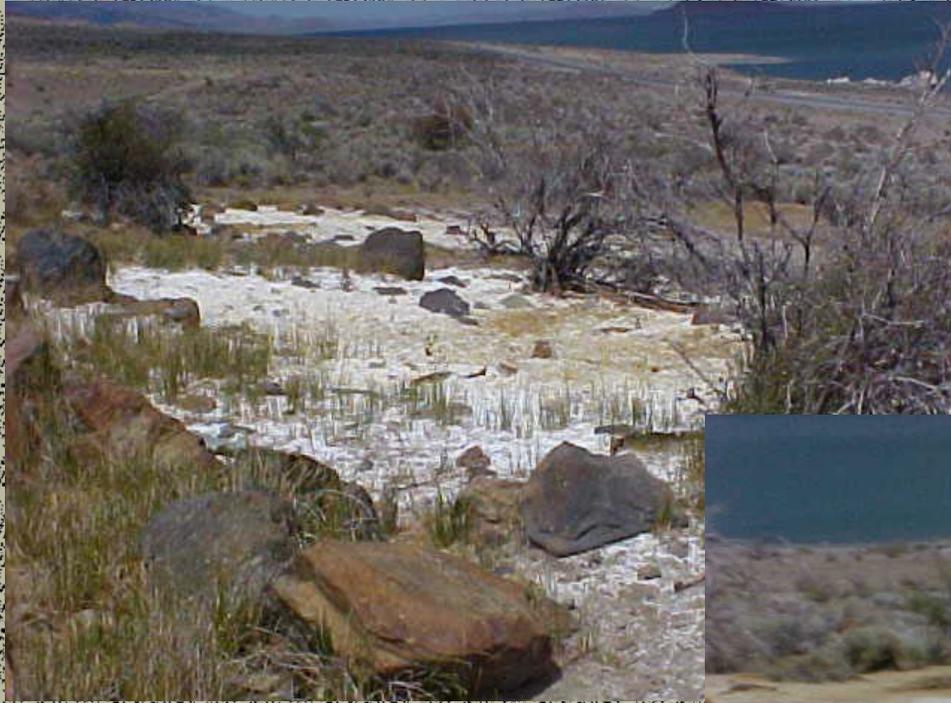
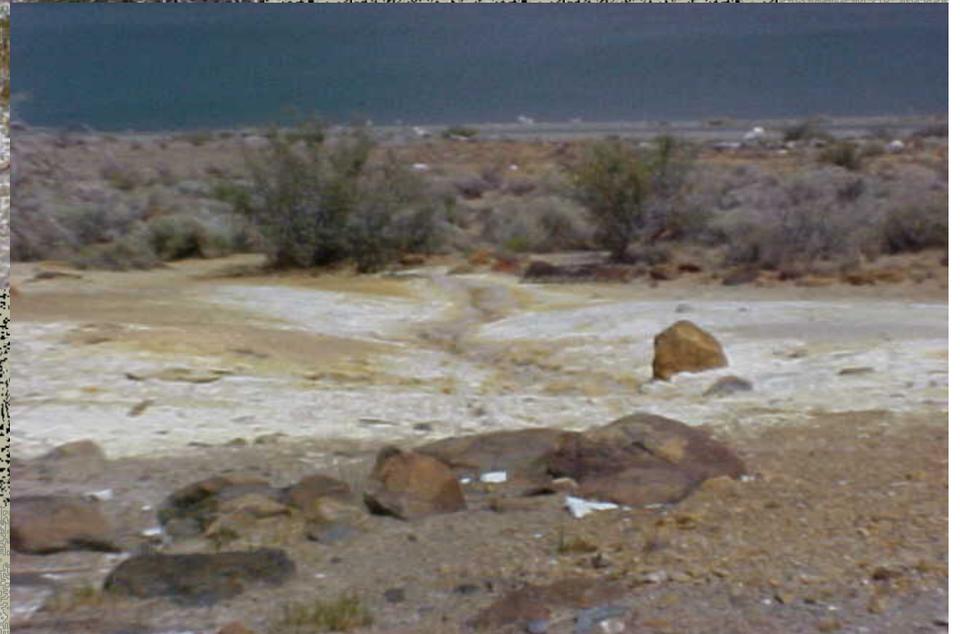
# Springs Encrusted With Precipitate

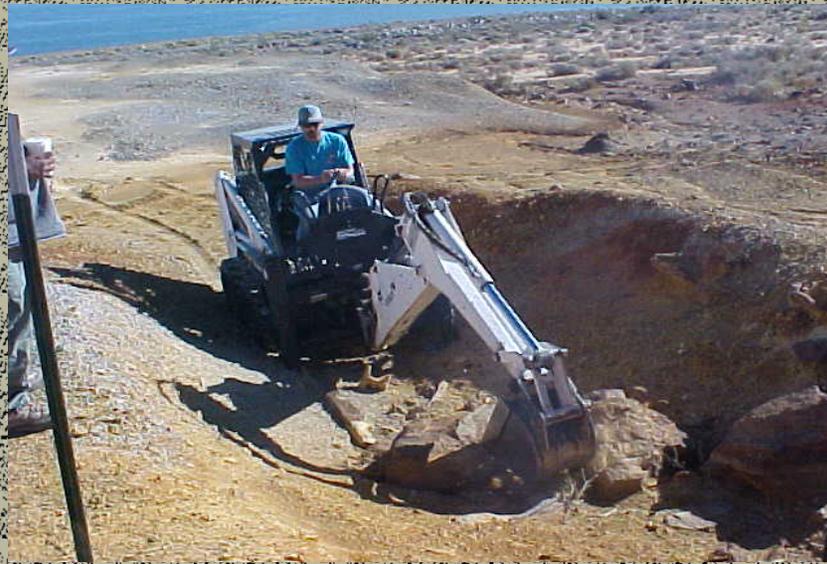
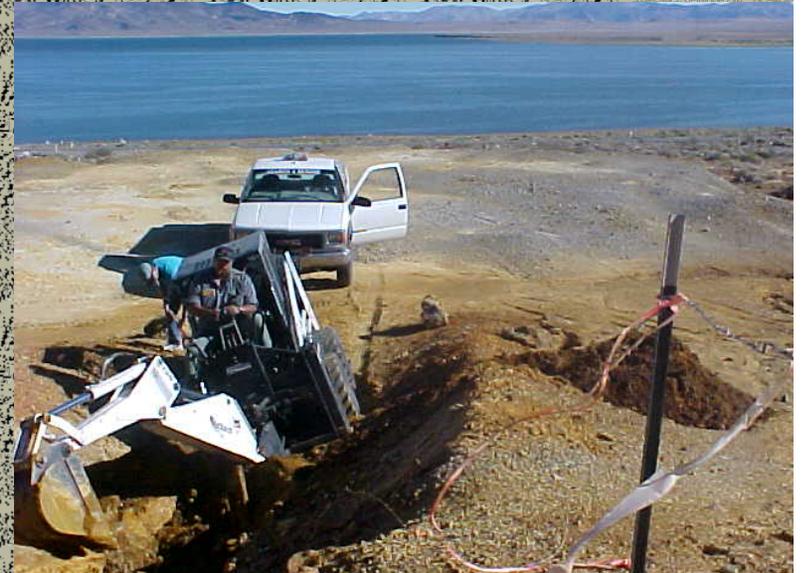
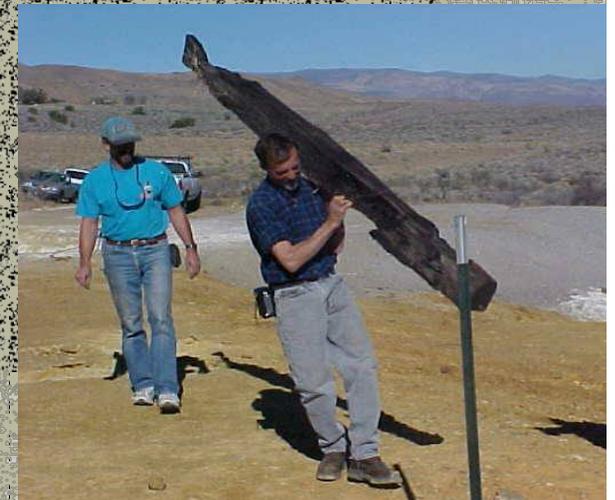
# Opening the Adit

Bobcat with a backhoe attachment used to remove debris from the entrance of the adit. Timbers were carried out.

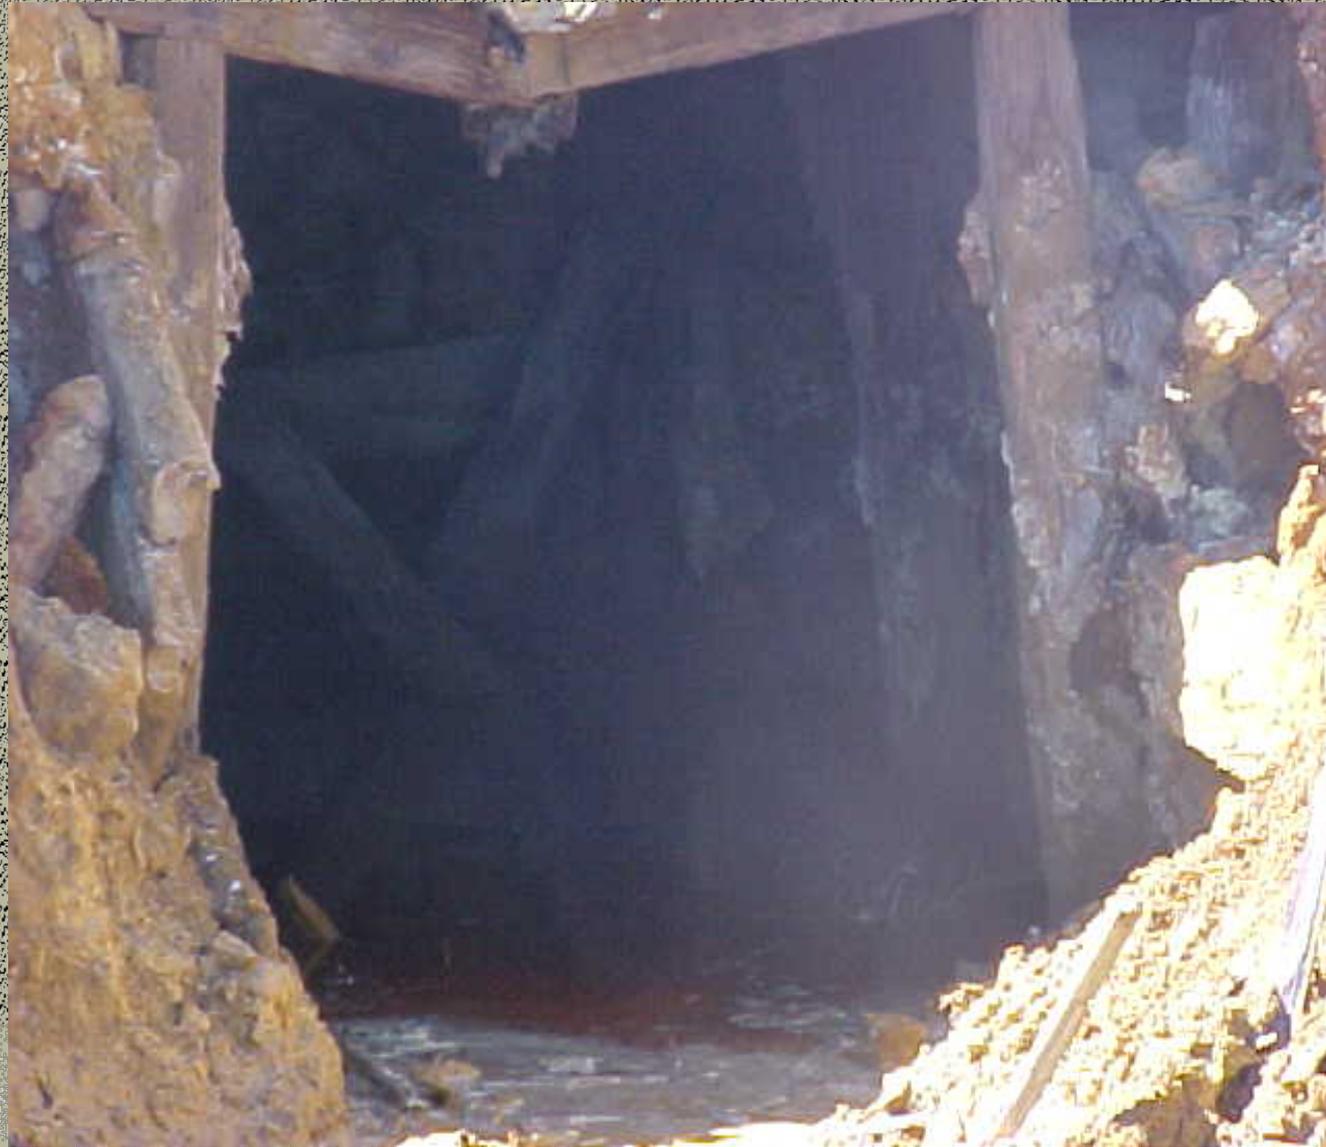
## Acidic Water in the Drainage
