# Aquatic Resources Delineation Report

for —  
**Marlette Lake Intake Structure Replacement Project**  
**Washoe County, Nevada**

**(RCI #26-142.1)**

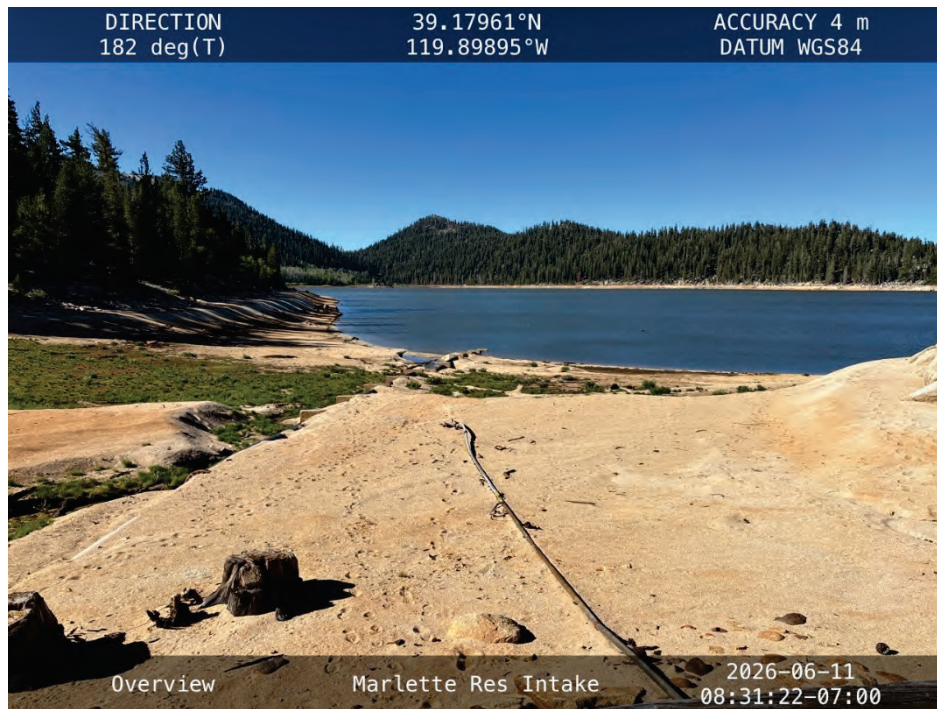
Photo 1. Photo taken from normal water edge looking south along water line extending into drained lake. Project area is approximately 200 feet lakeward below water.

This Survey Area includes the existing intake structure located on the floor of Marlette Lake. The Lake is presently drawn down to approximately 20 feet below the normal high-water line due to the separately permitted Marlette Dam rehabilitation project on the opposite shore of the Lake. When the Lake is full, the intake structure is submerged by approximately 32 feet of water and is approximately 600 feet offshore. At the time of the survey, the intake structure was presently submerged by approximately 12 feet of water due to the drawn-down lake level and is approximately 200 feet offshore.

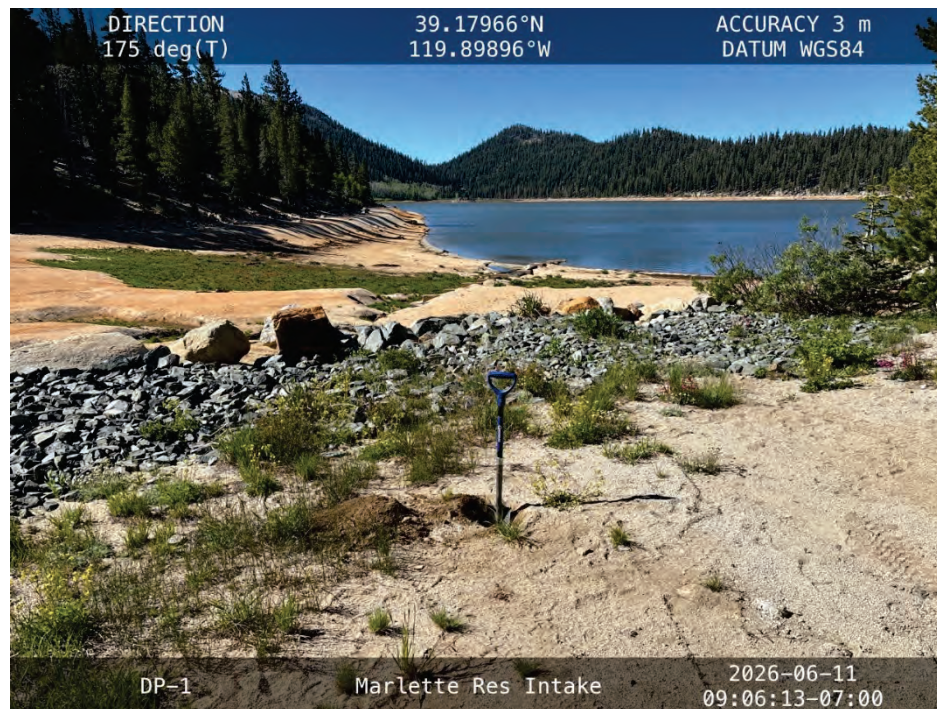
Photo 2. Data point 1 – Upland disturbed area adjacent to Marlette Lake.

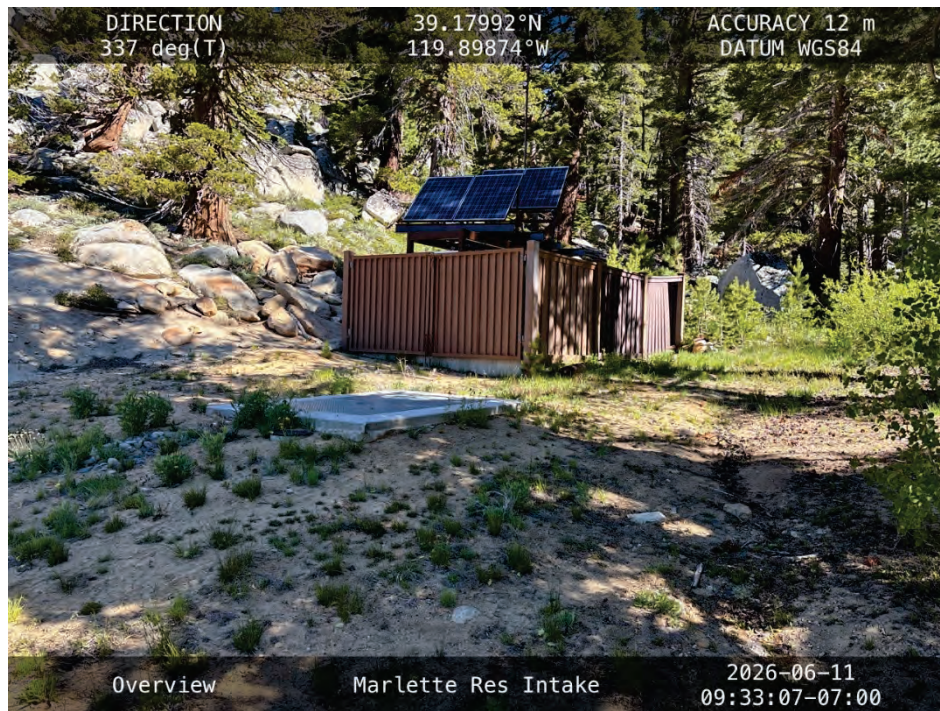
Photo 3. View of existing pump house and adjacent upland vegetation

Two access points will be utilized for staging, storage, and operations to replace the intake structure. The main location is on the east shore of the Lake, adjacent to the intake. It will be used for coordination of offshore activities and to manage spoil piles if any sand is removed. This site is currently used by MLWS to access the system pump station and for vehicular turn around. As such, vegetation is sparse and occurs only on the fringe (see Attachment C – photos 2 and 3).

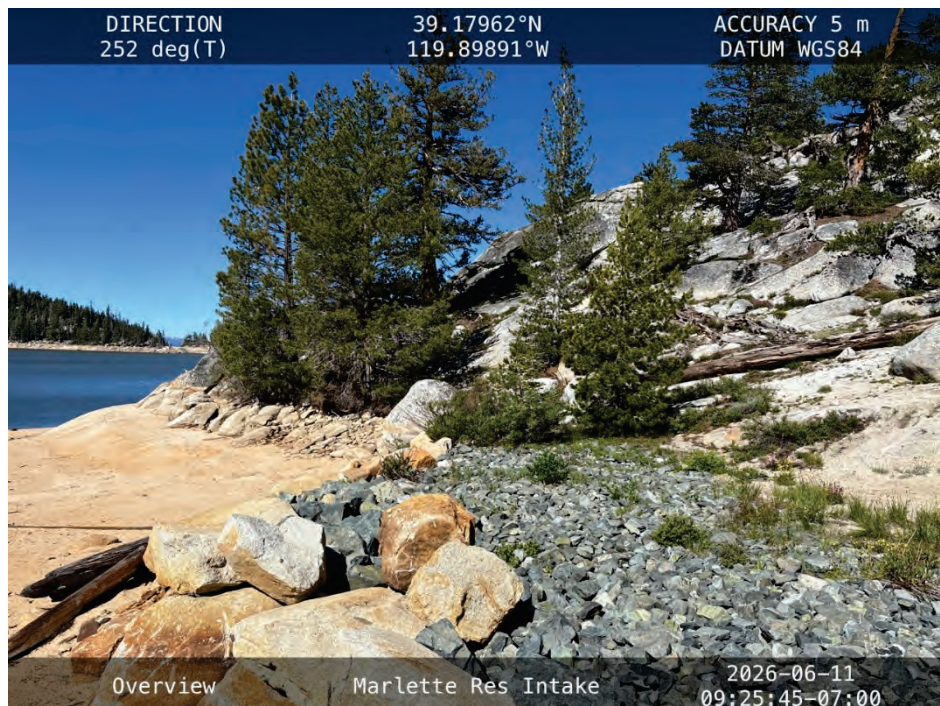
Photo 4. OHWM-1: Marlette Lake. OHWM defined in the field by distinct topo break, lack of vegetation, and change in substrate.

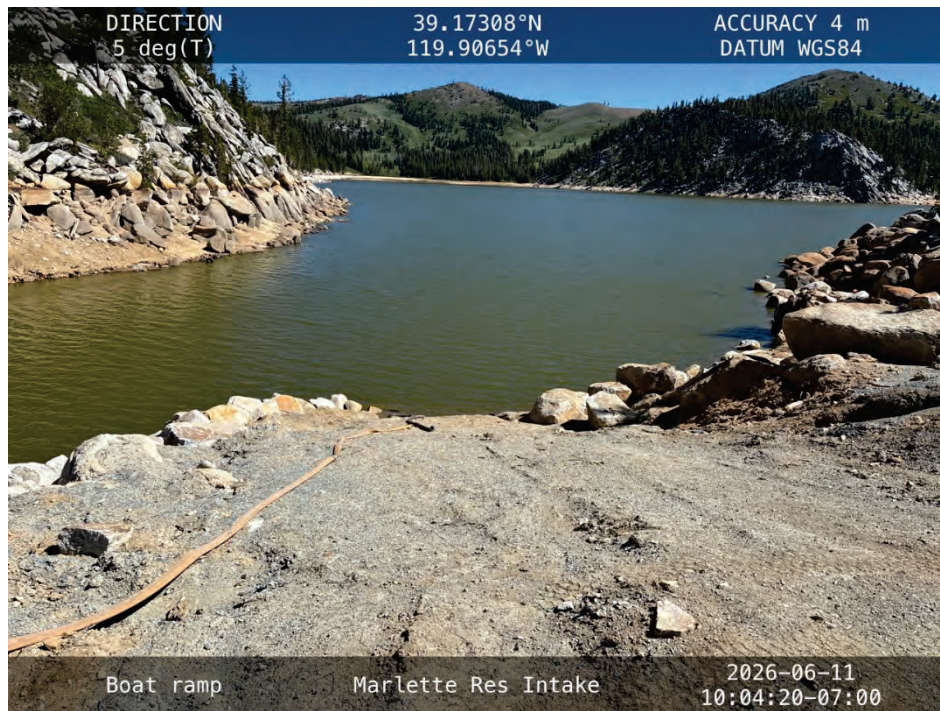
Photo 5. Existing boat ramp to be used to launch barge that is needed to hoist and raise/lower the old and new intake structure for removal/installation.

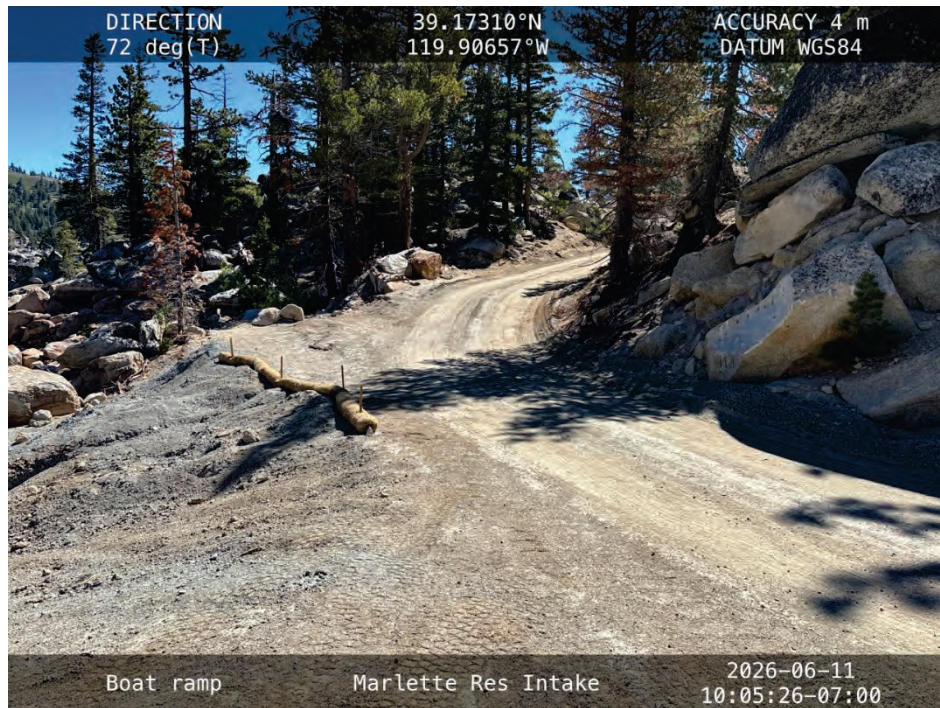
Photo 6. Existing access road to boat ramp.

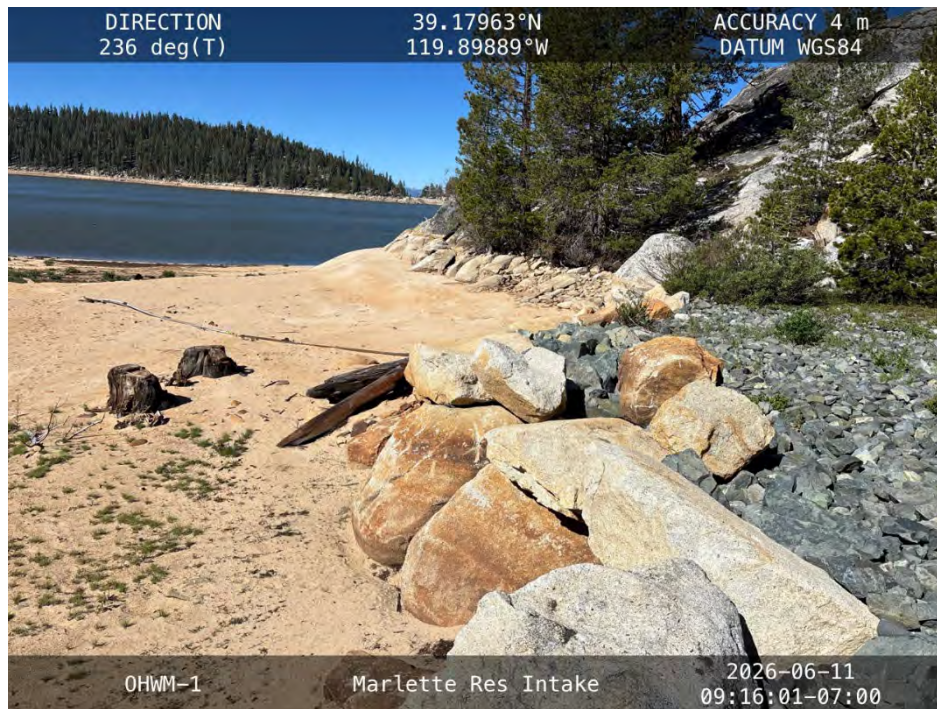
Photo 1. OHWM-1: Marlette Lake. OHWM defined in the field by distinct topo break, lack of vegetation, and change in substrate.
