Project: McFaul CK Meadow

# **McFaul Creek Stream and Meadow Restoration Project Aquatic Resource Delineation Report**

Garth Alling, Sierra Ecotone Solutions LLC  
Alison Stanton, M.S. Botanist

May 2026

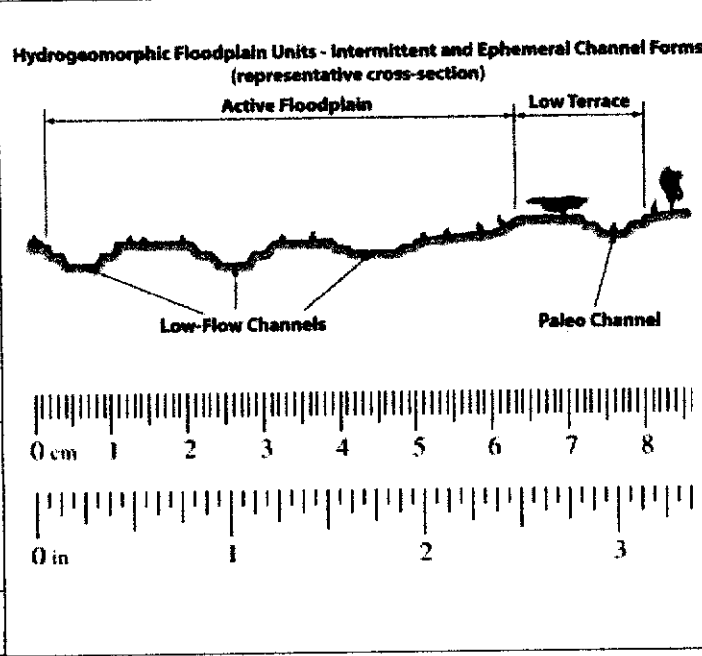
**Notes:** Historical ditch  
 CS 2

**Brief site description:**  
 Creek following edge of meadow after Bourne Med. Basins

Characteristics of the low-flow channel:  
Average sediment texture: Loam High DM  
Total veg cover: 30 % Tree: 0 % Shrub: 10 % Herb: 20 %

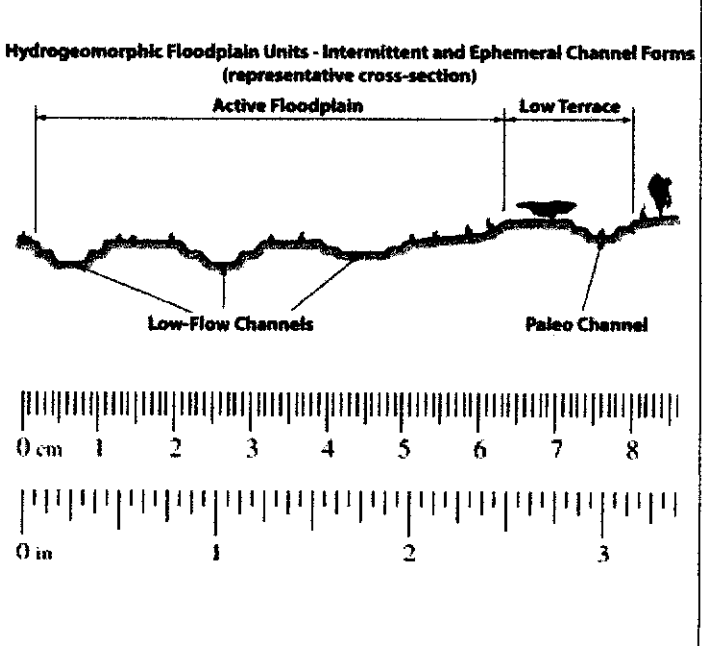
Notes: Historical ditch along edge of existing meadow & upland  
 upstream - lake nearby from  
 2011 -> channel from center of meadow to lake

Brief site description: Upstream of project area McFaulck turns into a  
 junction box (height unknown) & under Hwy.  
 Ek flows in channel/ditch along meadow edge  
 lower 1/2 contours to lake ephemeral drainage

Average sediment texture: Sandy loam

Average sediment texture: loam high % of gm

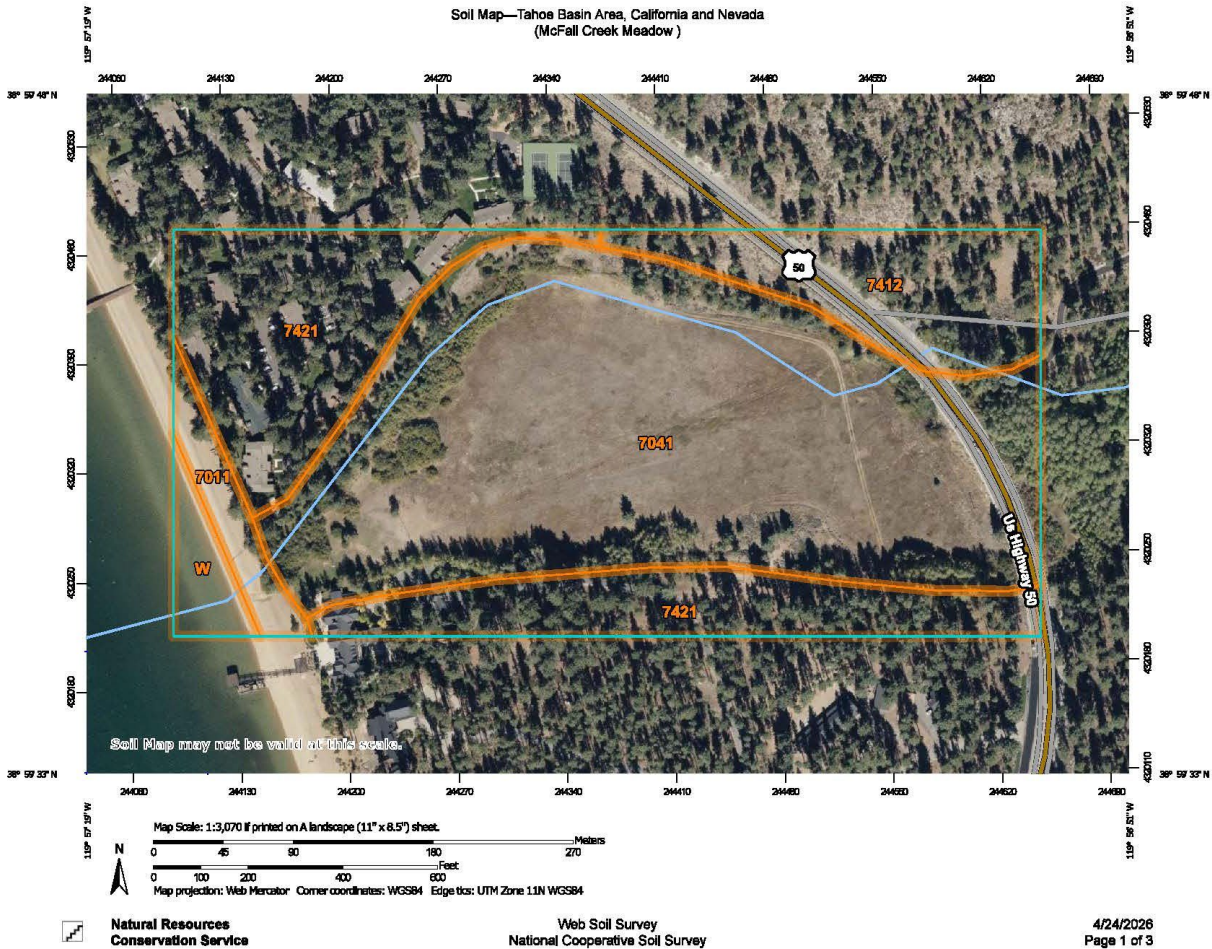
**Figure 3. Soils map**

Geology in the McFaul Creek watershed is granitic and is underlain primarily by Cretaceous-aged granodiorite with valley fill that includes both fluvial and glacial deposits characterized by non-consolidated sands, silts and some gravels (Saucedo, 2005). Within the Project area the geology is Holocene-aged matrix of unsorted, poorly consolidated granitic colluvium, decomposed granite, and supported debris flow material of sand and cobble to boulder gravel. Soils are formed by active erosion processes and are well-drained to excessively well drained. Approximately 58% of the Project area is mapped as Tahoe complex, 0-2 % slopes, 26 % as Cassenai very stony gravelly loamy coarse sand (5-15 percent slopes), and an additional 11% is mapped as extremely stony Cagwin-Rock outcrop complex (5-15 percent slope) (**Figure 3, NRCS 2025**).

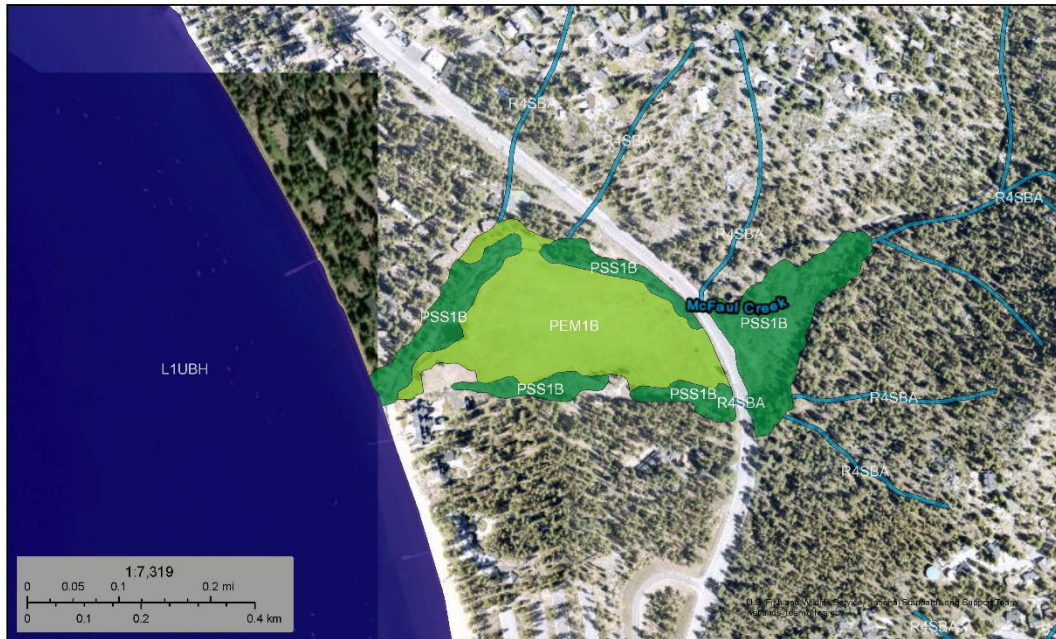
**Figure 4** shows waters and wetlands identified by the National Wetlands Inventory (NWI) (USFWS 2025). Waters mapped in the study area by the NWI include the bed and channel of McFaul Creek mapped as R4SB (Riverine, Intermittent, Streambed) that is Seasonally or Temporarily Flooded, freshwater forested wetland mapped as PSS1B (Palustrine, Scrub Shrub), and the emergent wetland mapped as PEM1B (Palustrine, Emergent).
