Biological Assessment  
Marlette Lake Dam Resilient  
Infrastructure Project

Nevada State Public Works Division

PDMC-PJ-09-NV-2018-001

*July 2023*

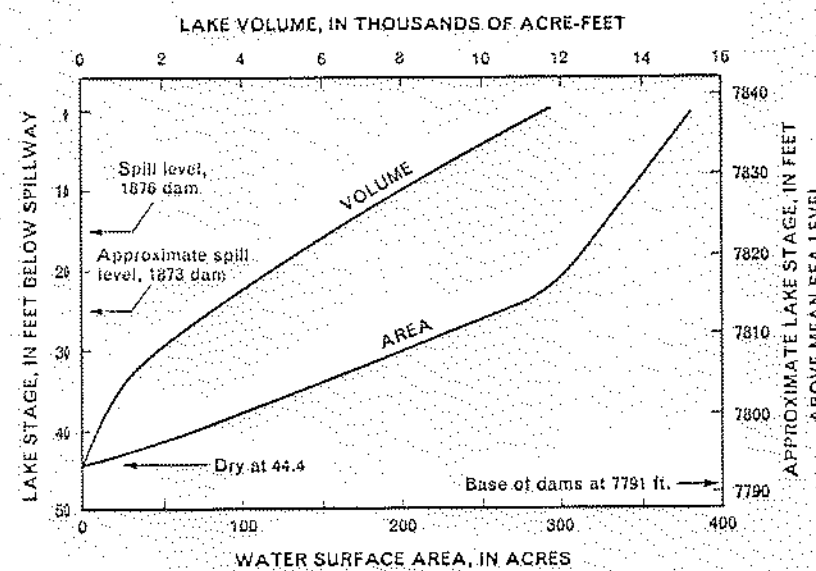
Figure 3.—Stage-area-volume relations for Marlette Lake

The bottom of Marlette Lake, or that area below a depth of 35 feet, generally can be characterized as a very gently sloping plane. The plane, dipping to the northwest, may have been formed as a horizontal playalike surface that has been tilted by faulting along the western margin of the lake. The short time since faulting has limited the modification of the surface by sedimentation or erosion.

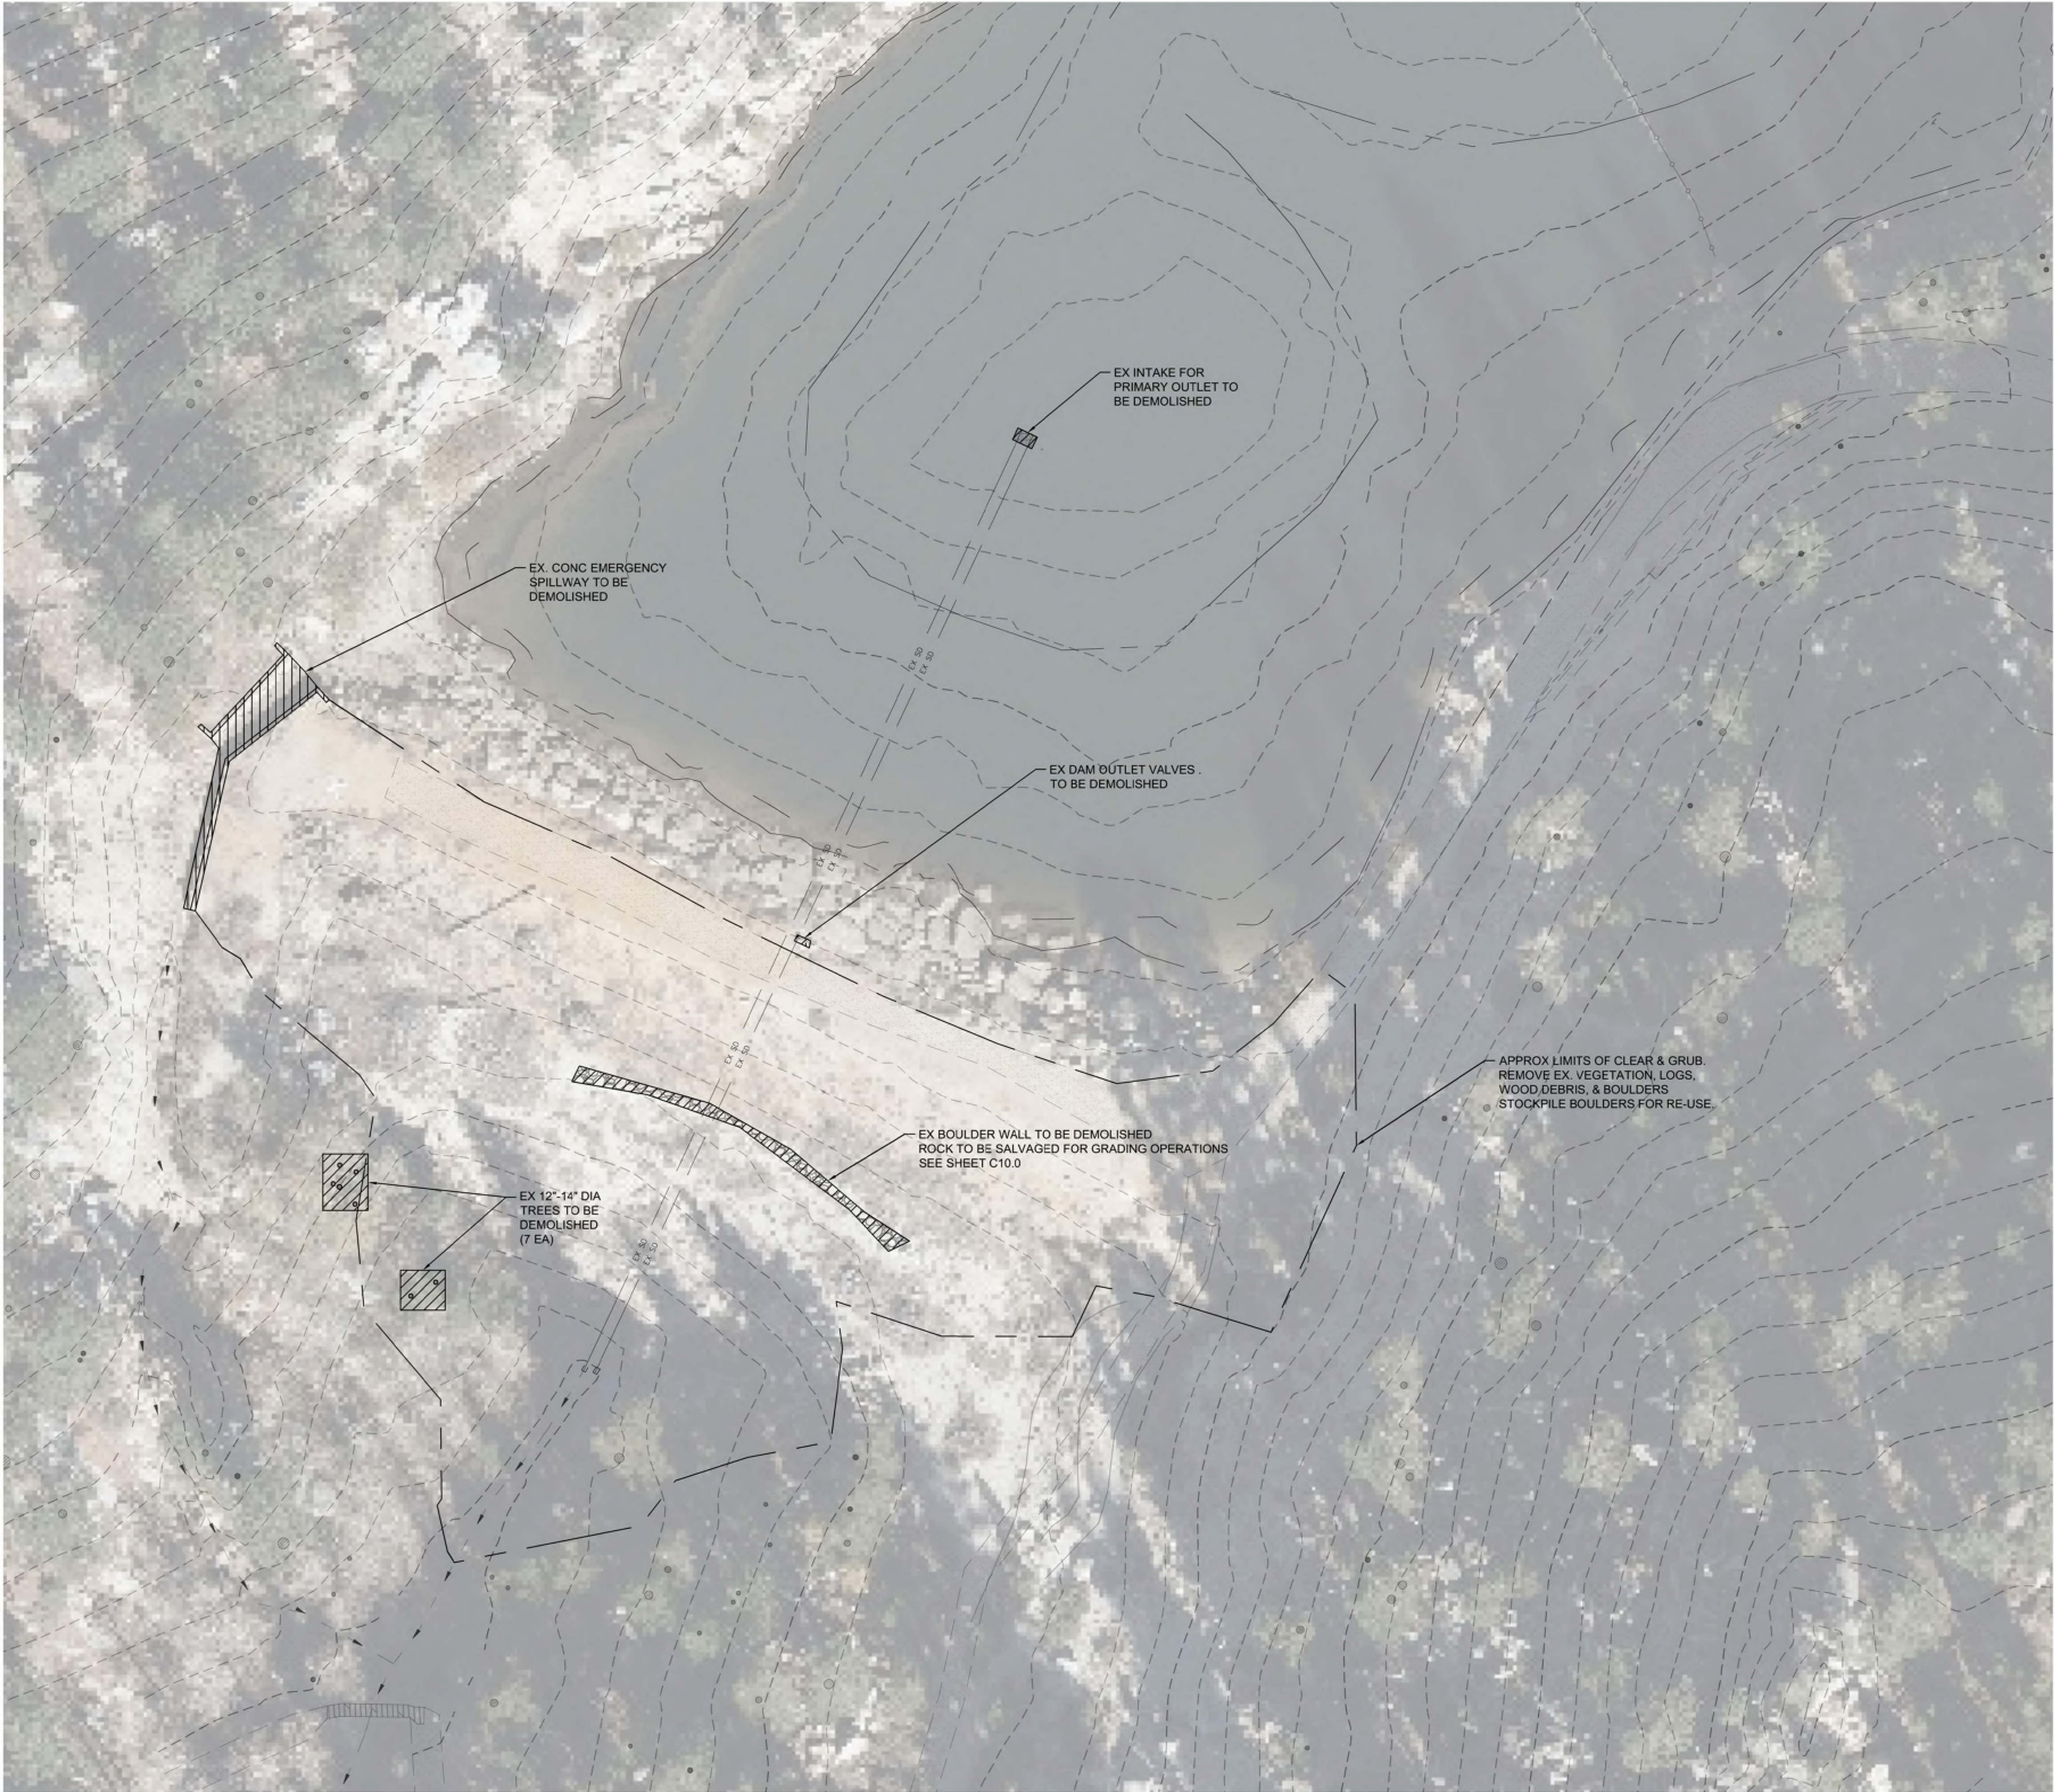
- DEMOLITION NOTES:
1. CONTRACTOR SHALL NOT EXCAVATE INTO EX. DAM WHILE PERFORMING DEMOLITION OF EX. FACILITIES.

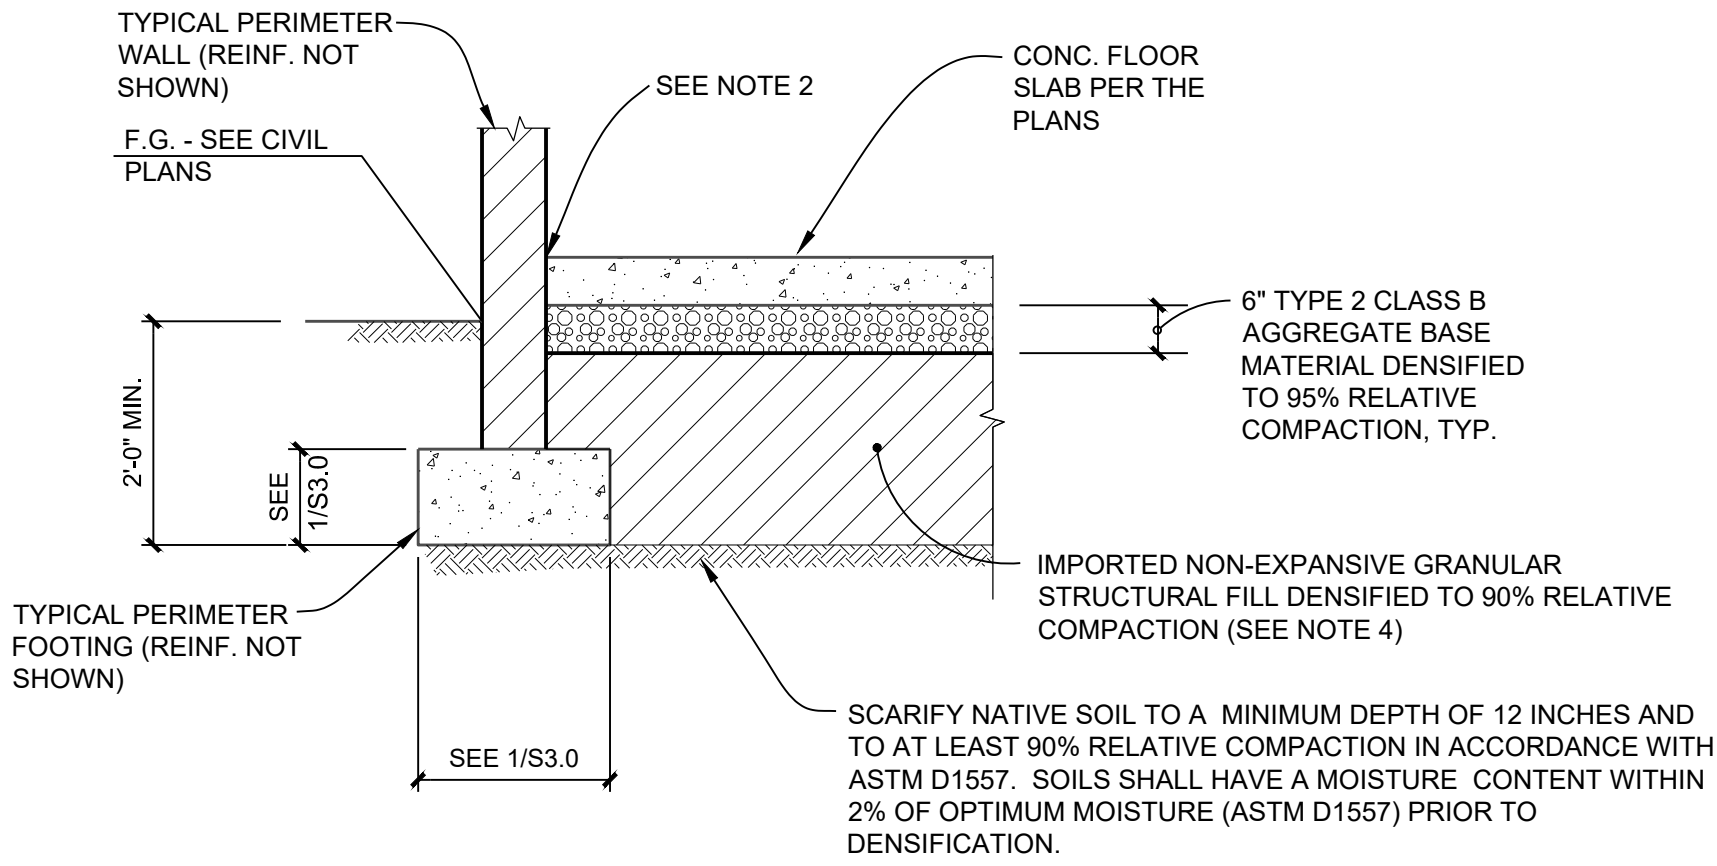
## 1 TYPICAL BUILDING FOUNDATION PREPARATION DETAIL

- NOTES: 1. SEE SHEET C2.1 FOR FINAL GRADES AND EXTERIOR IMPROVEMENTS.  
2. THE INTERIOR FLOOR SLAB - BUILDING WALL JOINT SHALL BE CAULKED WITH SIKAFLEX-2C NS OR APPROVED EQUAL. SEE THE STRUCTURAL NOTES & 6/S-8 (SIM.)  
3. ALL EXCAVATION SLOPES SHALL BE IN ACCORDANCE WITH OSHA REGULATIONS.  
4. STRUCTURAL FILL SHALL BE AS APPROVED BY THE GEOTECHNICAL ENGINEER.

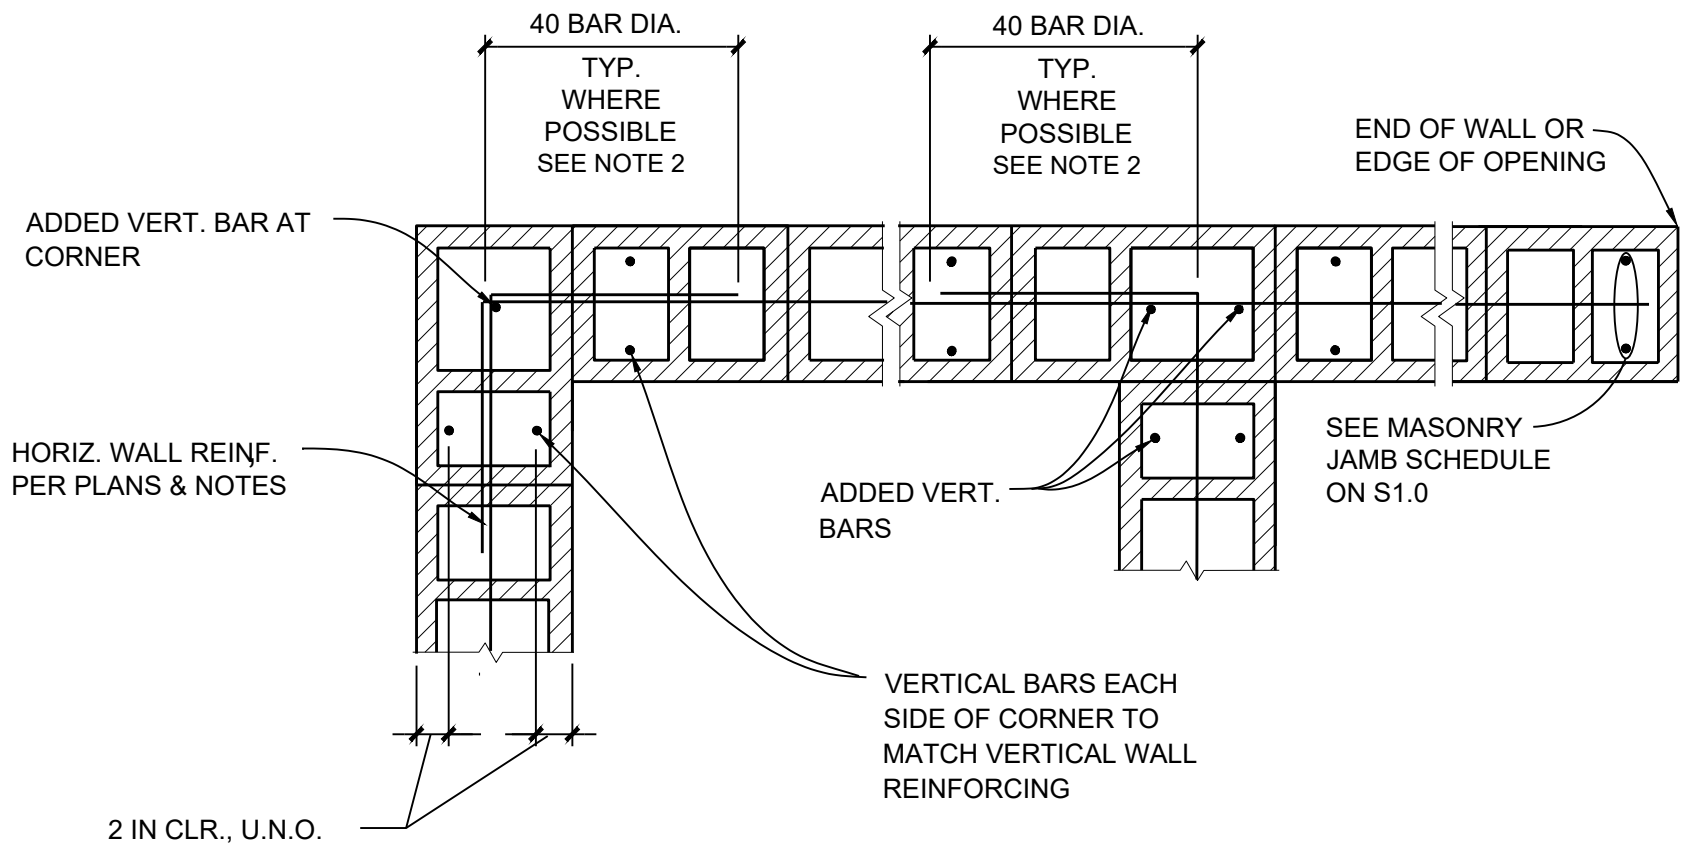
**TYPICAL MASONRY WALL REINFORCING  
PLACEMENT DOUBLE CURTAIN**

- 1  
S0.3
- N.T.S.
- NOTES: 1. ADDED VERTICAL BARS TO HAVE MATCHING DOWEL BARS.  
2. WHERE EXTENSION IS NOT POSSIBLE, EXTEND AS FAR AS POSSIBLE AND HOOK.

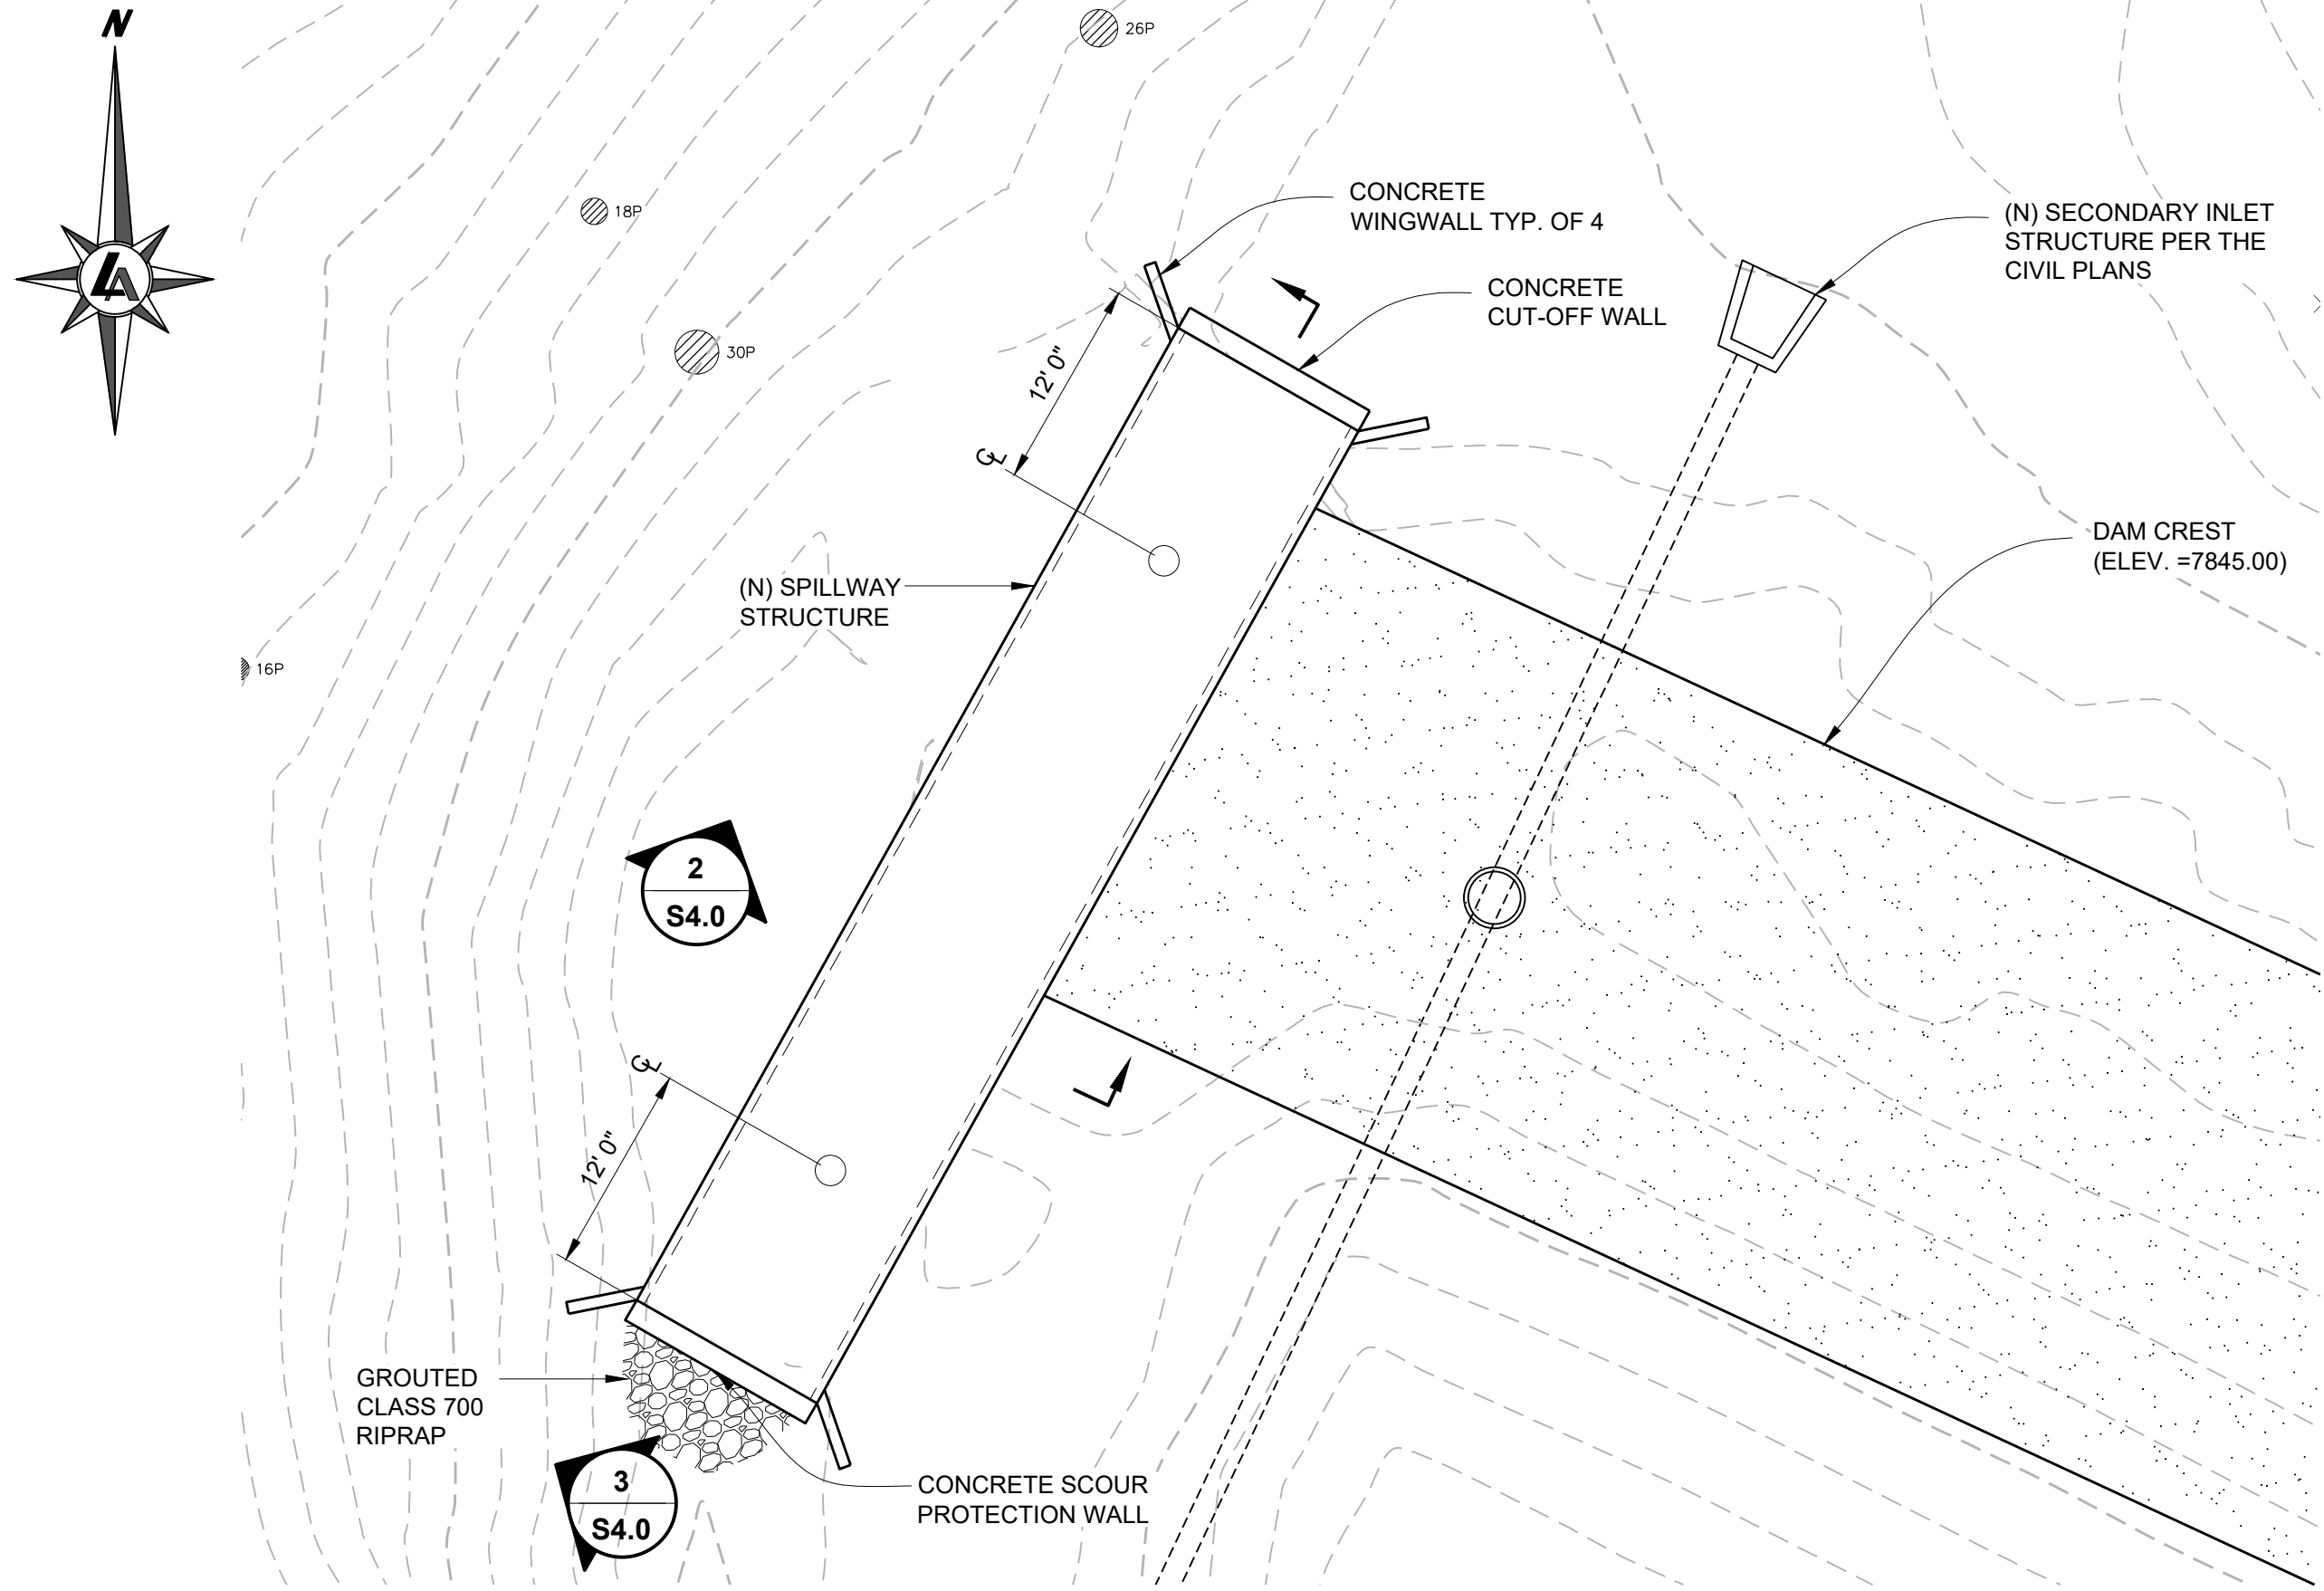
**1**  
**S4.0** **SPILLWAY PLAN**  
SCALE: 1"=10'

NOTES: 1. SEE CIVIL PLANS FOR THE SPILLWAY LOCATION.

The existing concrete spillway would be removed and replaced with a new concrete box culvert that would be 11 feet wide, 6 feet tall, and 78 feet long. The base area beneath the spillway would be excavated an additional 12 inches to accommodate a compacted aggregate base for the new box culvert. The culvert would convey excess flows during the probable maximum flood (i.e., the flood that might be expected from the most severe combination of critical meteorologic and hydrologic conditions reasonably possible in the region) and maintain the required freeboard of 4 feet below the dam crest. The invert of the new concrete box culvert would be at the same elevation as the existing spillway crest, and the reservoir capacity would remain the same as the existing capacity.

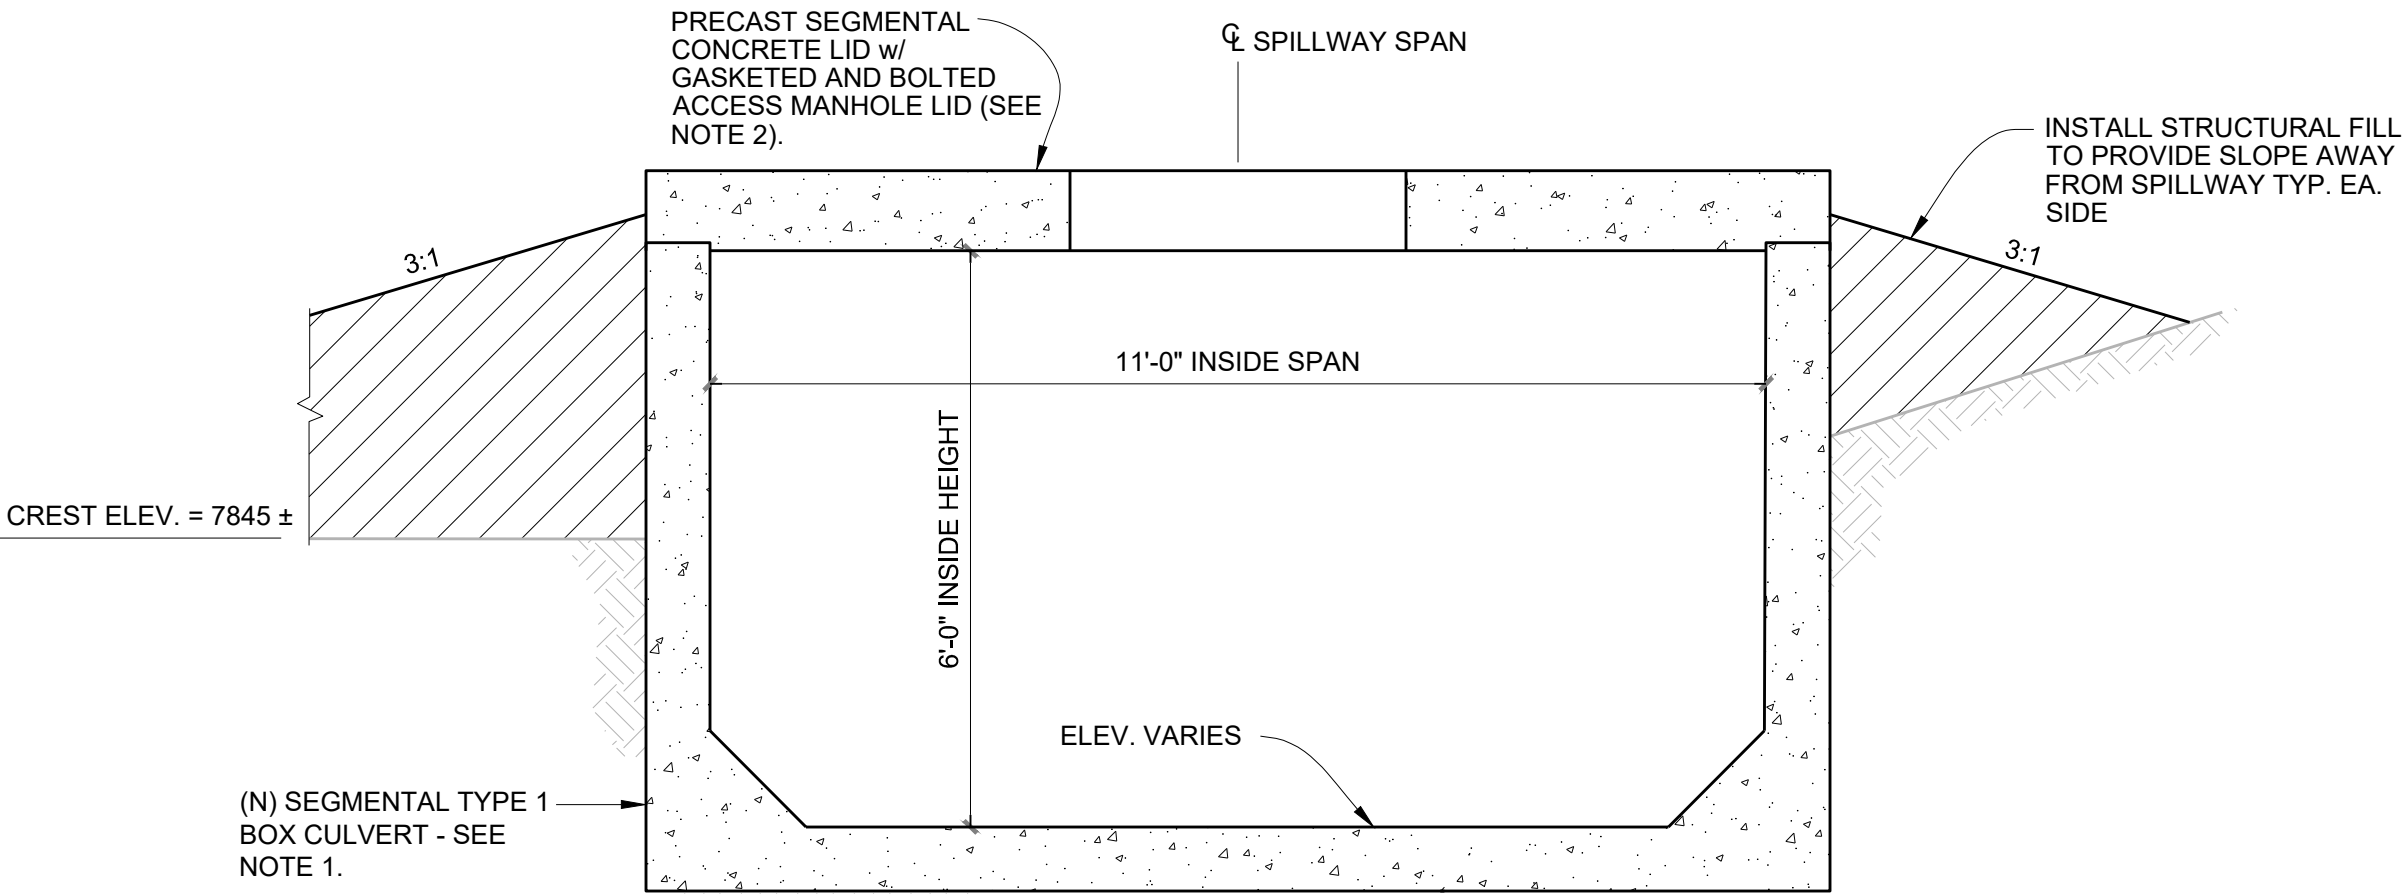
**2**  
**S4.0** **SPILLWAY TRANSVERSE SECTION**  
SCALE: 1/2"=1'-0"

NOTES: 1. THE SPILLWAY SHALL BE COMPRISED OF A PRECAST TYPE 1 SEGMENTAL BOX CULVERT.  
2. ACCESS MANHOLE LIDS SHALL BE HEAVY DUTY DUCTILE IRON OR STEEL WITH A 21 INCH (MIN.) DIAMETER. THE LIDS SHALL HAVE A GASKET TO PREVENT INCIDENTAL SURFACE WATER INFILTRATION. BOLTS SHALL BE STAINLESS STEEL.
