HAZARDOUS BUILDING MATERIALS SURVEY

Asbestos and Lead-Based Paint

**1 and 55 Sunshine Lane
Reno, Nevada
APN 012-302-14**

***Contract DEP17-026
Task Number MA30-21***

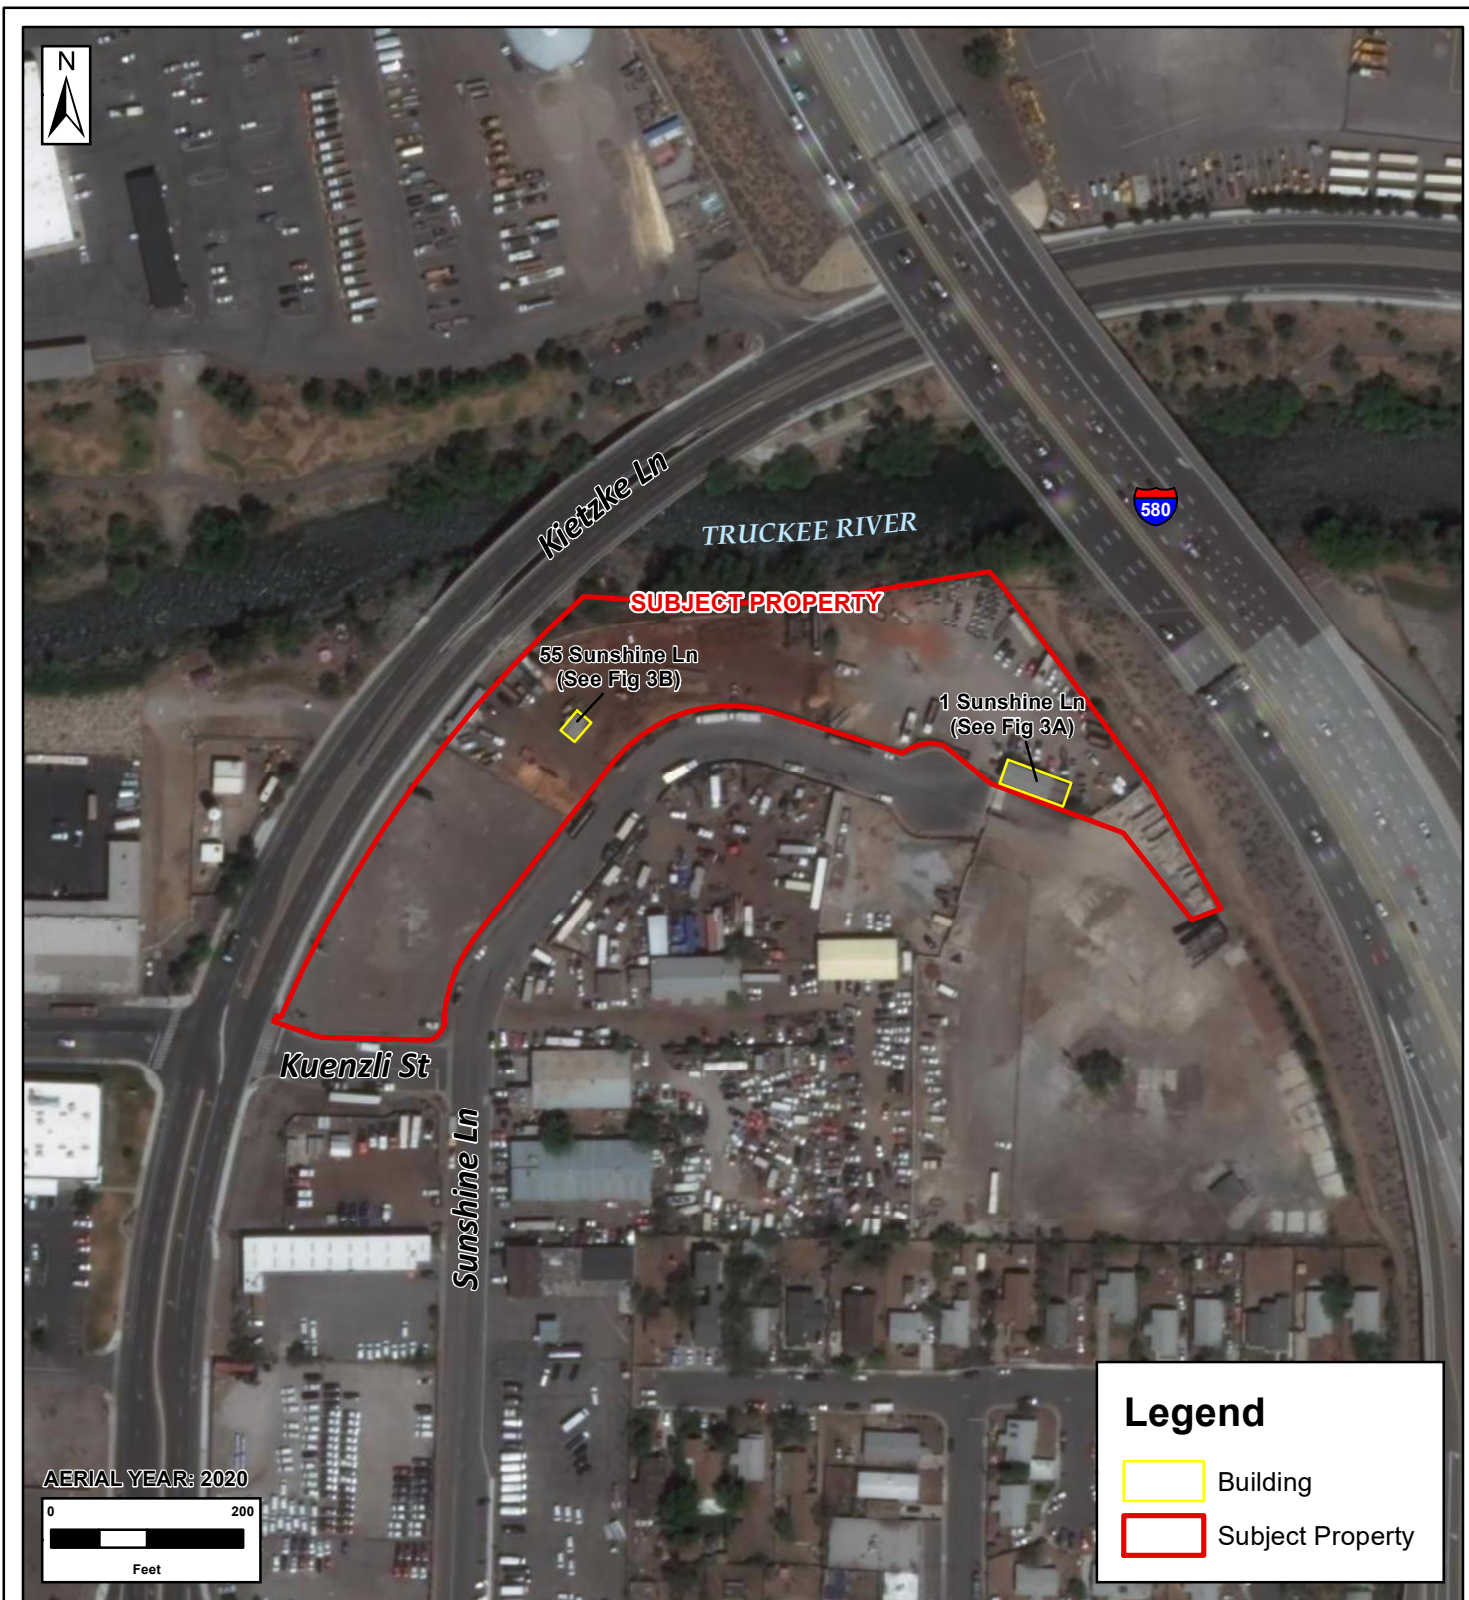
FIGURE 2

**SITE MAP
-SHOWING-
1 AND 55 SUNSHINE LN
APN: 012-302-14
RENO, WASHOE COUNTY, NV**

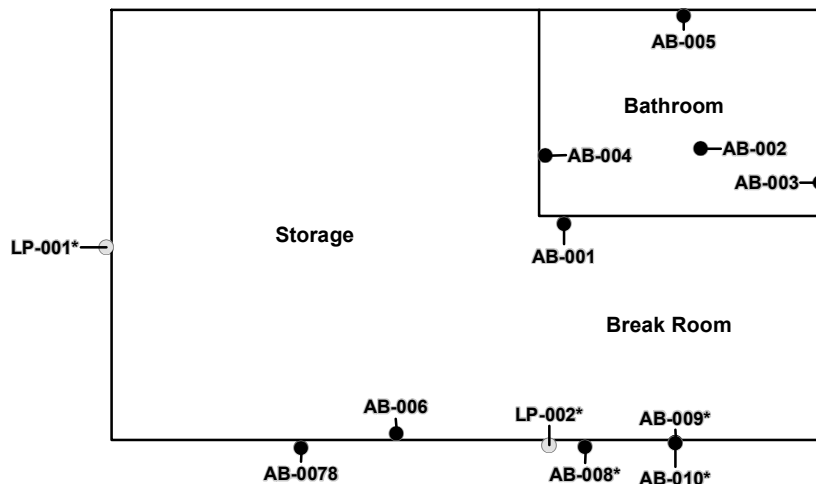
FIGURE 3B

- Negative Asbestos Sample
- Negative Lead-based Paint Sample
- * Exterior Sample

**SITE MAP
-SHOWING-
55 SUNSHINE LN
APN: 012-302-14
RENO, WASHOE COUNTY, NV**

A total of 23 bulk samples and one field duplicate sample were collected from the Subject Property. Each collected bulk sample was placed and sealed in a sample bag and assigned a unique sample identification number (*BRN071-AB-001 through BRN071-AB-024*). The field duplicate sample was provided its own distinct identification number to keep its identity blind to the laboratory. A summary of the samples collected during the survey is presented in Table 1. Sample locations are presented in Figures 3A-3B.

A total of 3 bulk paint chip samples were collected from the Subject Property. Each collected paint chip sample was placed and sealed in a sample bag and assigned a unique sample identification number (*BRN071-LP-001 through BRN071-LP-003*). A full list of paint chip sample locations and results is presented in Table 2. Sample locations are presented in Figures 3A-3B.
