# PHASE I ENVIRONMENTAL SITE ASSESSMENT

**Proposed NRHA Headquarters  
680 Hot Springs Road  
(APN 002-052-12)  
Carson City  
Nevada**

*Contract DEP17-026  
Task Number M06-18*

*On behalf of:  
Nevada Rural Housing Authority*

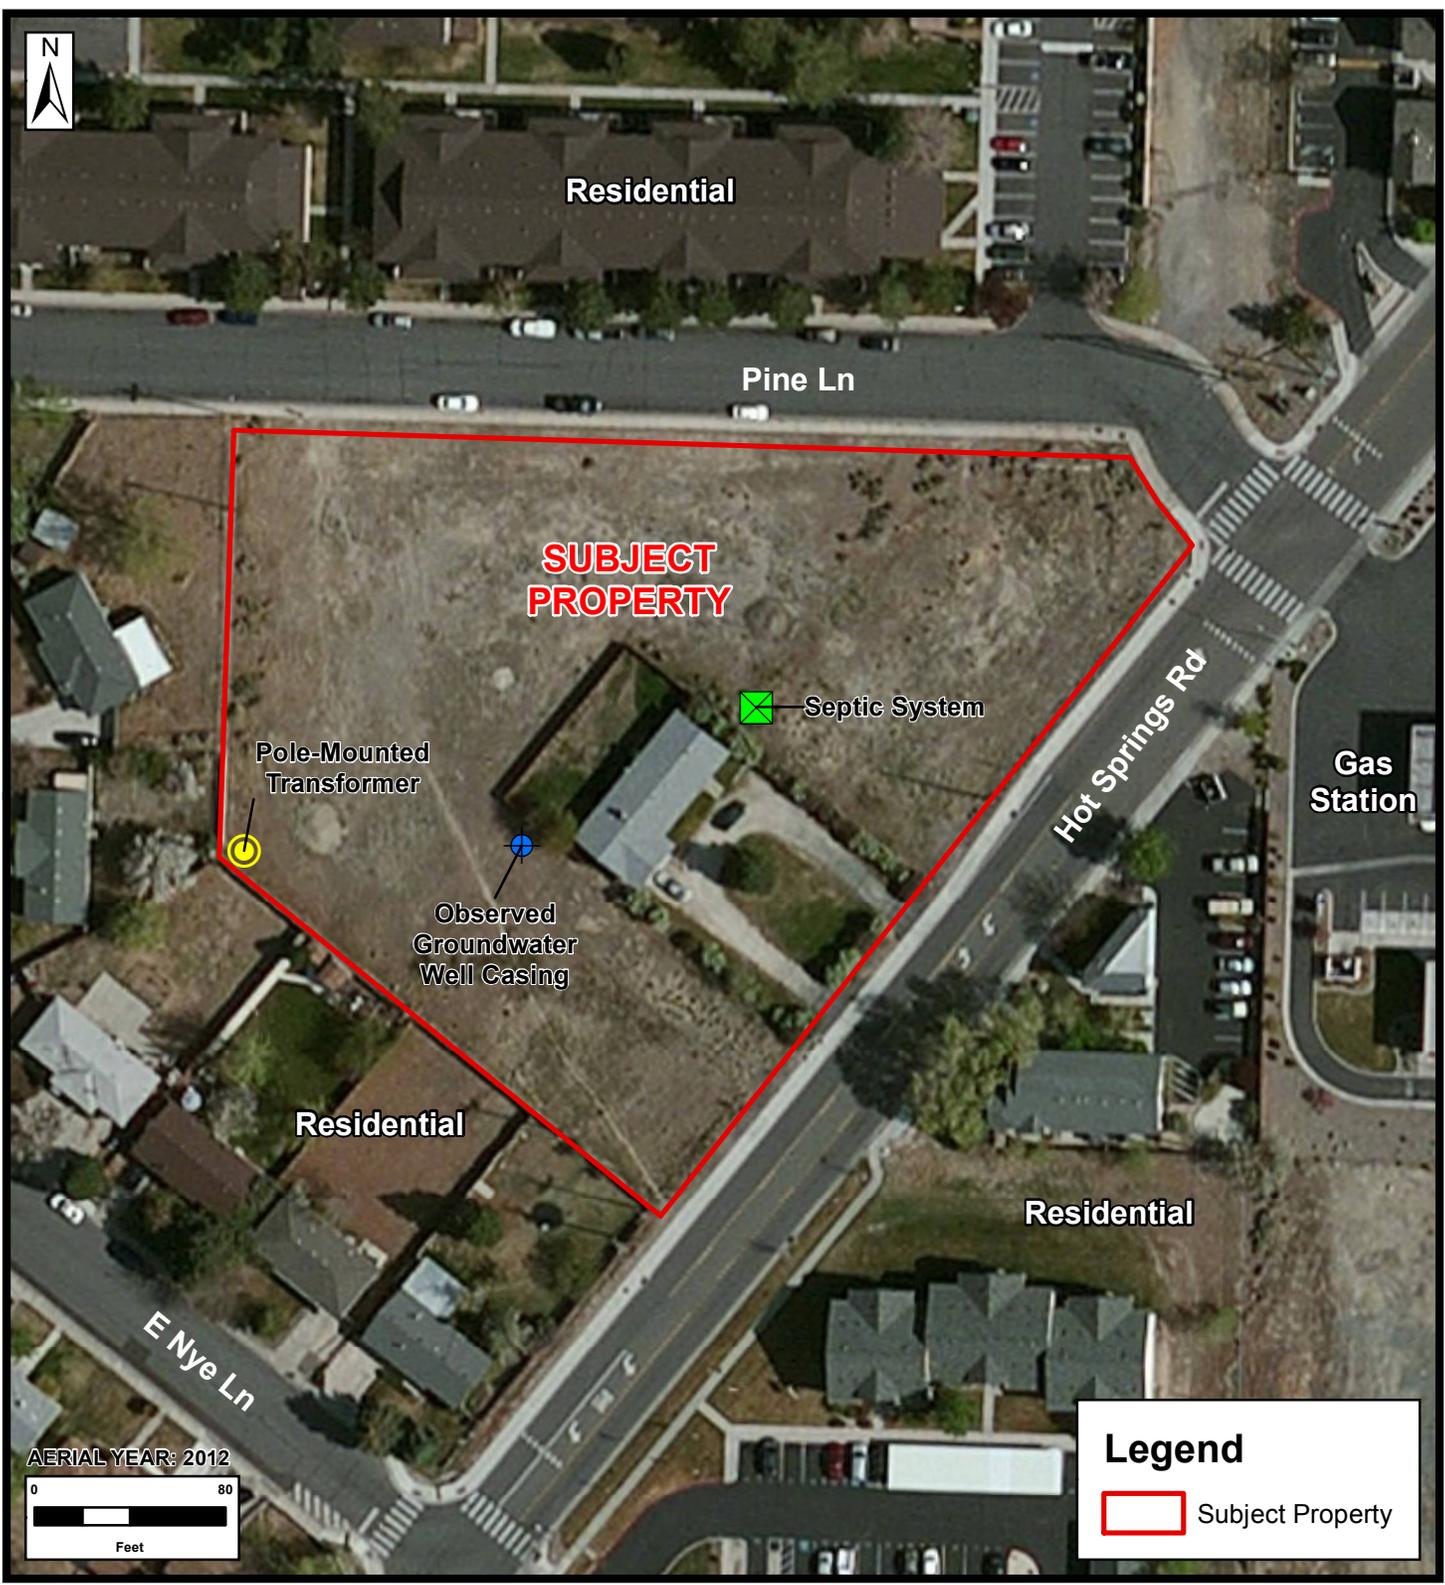
**FIGURE 2**

TITLE:  
**SITE MAP  
 -SHOWING-  
 PROPOSED NRHA  
 HEADQUARTERS  
 680 HOT SPRINGS RD  
 CARSON CITY, NV 89706**
