# PHASE I ENVIRONMENTAL SITE ASSESSMENT

**City of Henderson Site D  
Water St.  
(APNs 179-18-710-223, -224,  
-229, -230, and -240)  
Henderson  
Nevada**

***Contract DEP17-026  
Task Number MA09-18***

***July 27, 2018***

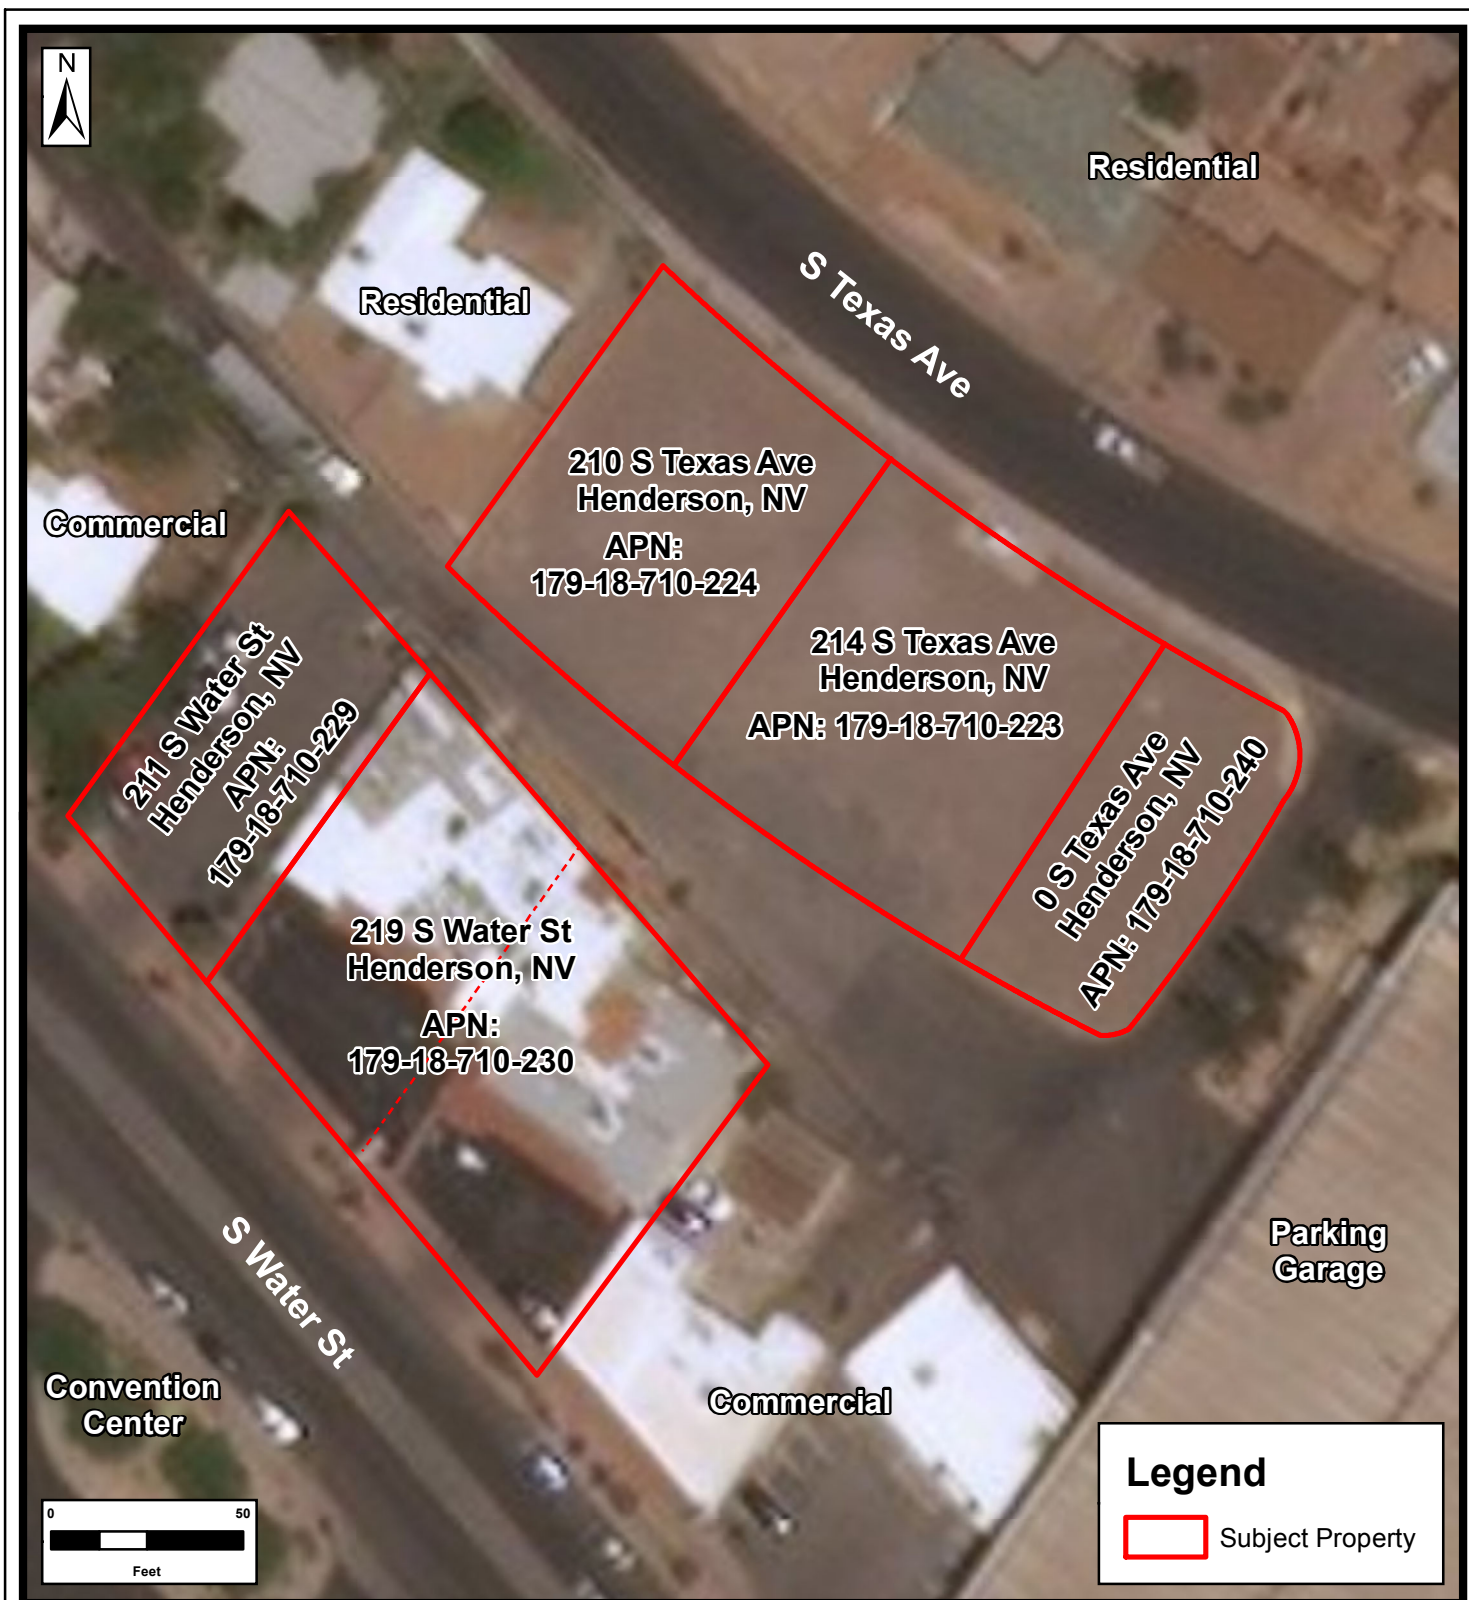
## FIGURE 2

The Subject Property is located in the N ½ of the SE ¼ of Section 18, Township 22 South, Range 63 East, of the Mount Diablo Baseline and Meridian. A parcel map from the Clark County Assessor's Office, which depicts the Subject Property parcel, is provided herein as Appendix A. The location of the site and the property boundary are displayed in Figures 1 and 2.
