Lakeview Executive Golf Course

1471 East Mount Charleston Drive Pahrump, NV 89048

BEC Project No. 018-17-001 January 26, 2018

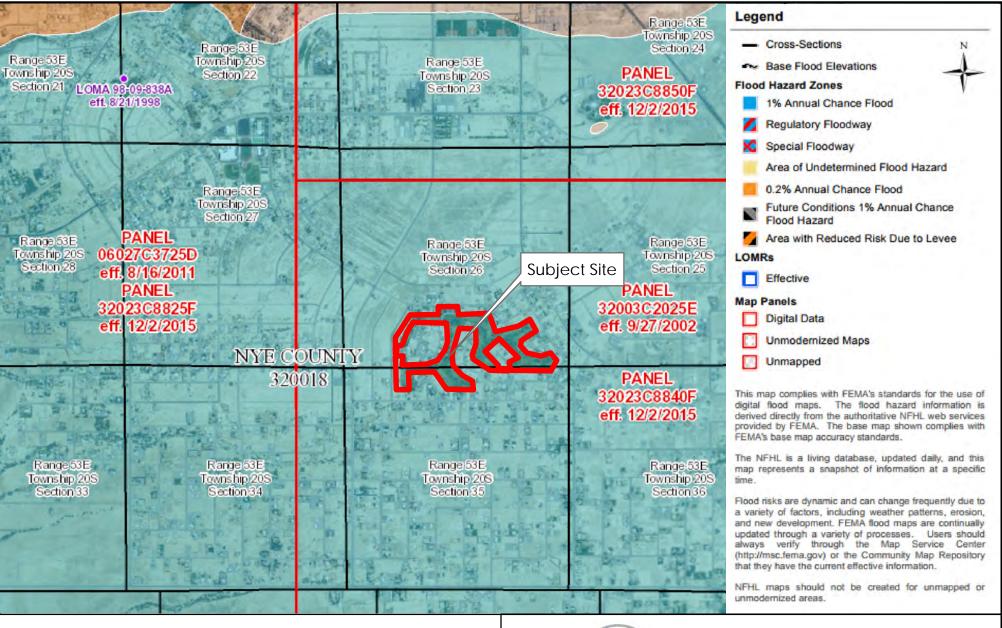
Figure 5 - FEMA Flood Zone Map

The project area is located in the Pahrump Valley Hydrographic Basin 162. There are no perennial streams or ephemeral washes within the project area, but there are seven man-made ponds, as depicted in the topographic maps of the site and observed during the site reconnaissance. The Federal Emergency Management Agency (FEMA) Flood Zone Map (**Attachment 1**, **Figure 5**) depicts the location of the subject site is located within Zone AO (1-percent shallow flooding where average depths are between one and three feet) (FEMA, 2015).
