**Memo**

**Subject** **Lambertucci-Roma Ranch Assessment, Esmeralda County, Nevada**

The following presents AMEC Earth & Environmental, Inc.'s (AMEC's) preliminary assessment of potential hazardous materials to be located at the Lambertucci-Roma Ranch (the Ranch), Esmeralda County, Nevada. This work was performed for the Nevada Division of Environmental Protection (NDEP) Brownfields Program under contract #06-015. The purpose of the assessment was to assist Esmeralda County (the County) with addressing apparent imminent health and safety issues at the site as well as providing information regarding site conditions that would assist them in deciding whether to acquire the property. This technical memorandum contains a property description, scope of work performed, historical data reviewed, site visit information, conclusions and recommendations.

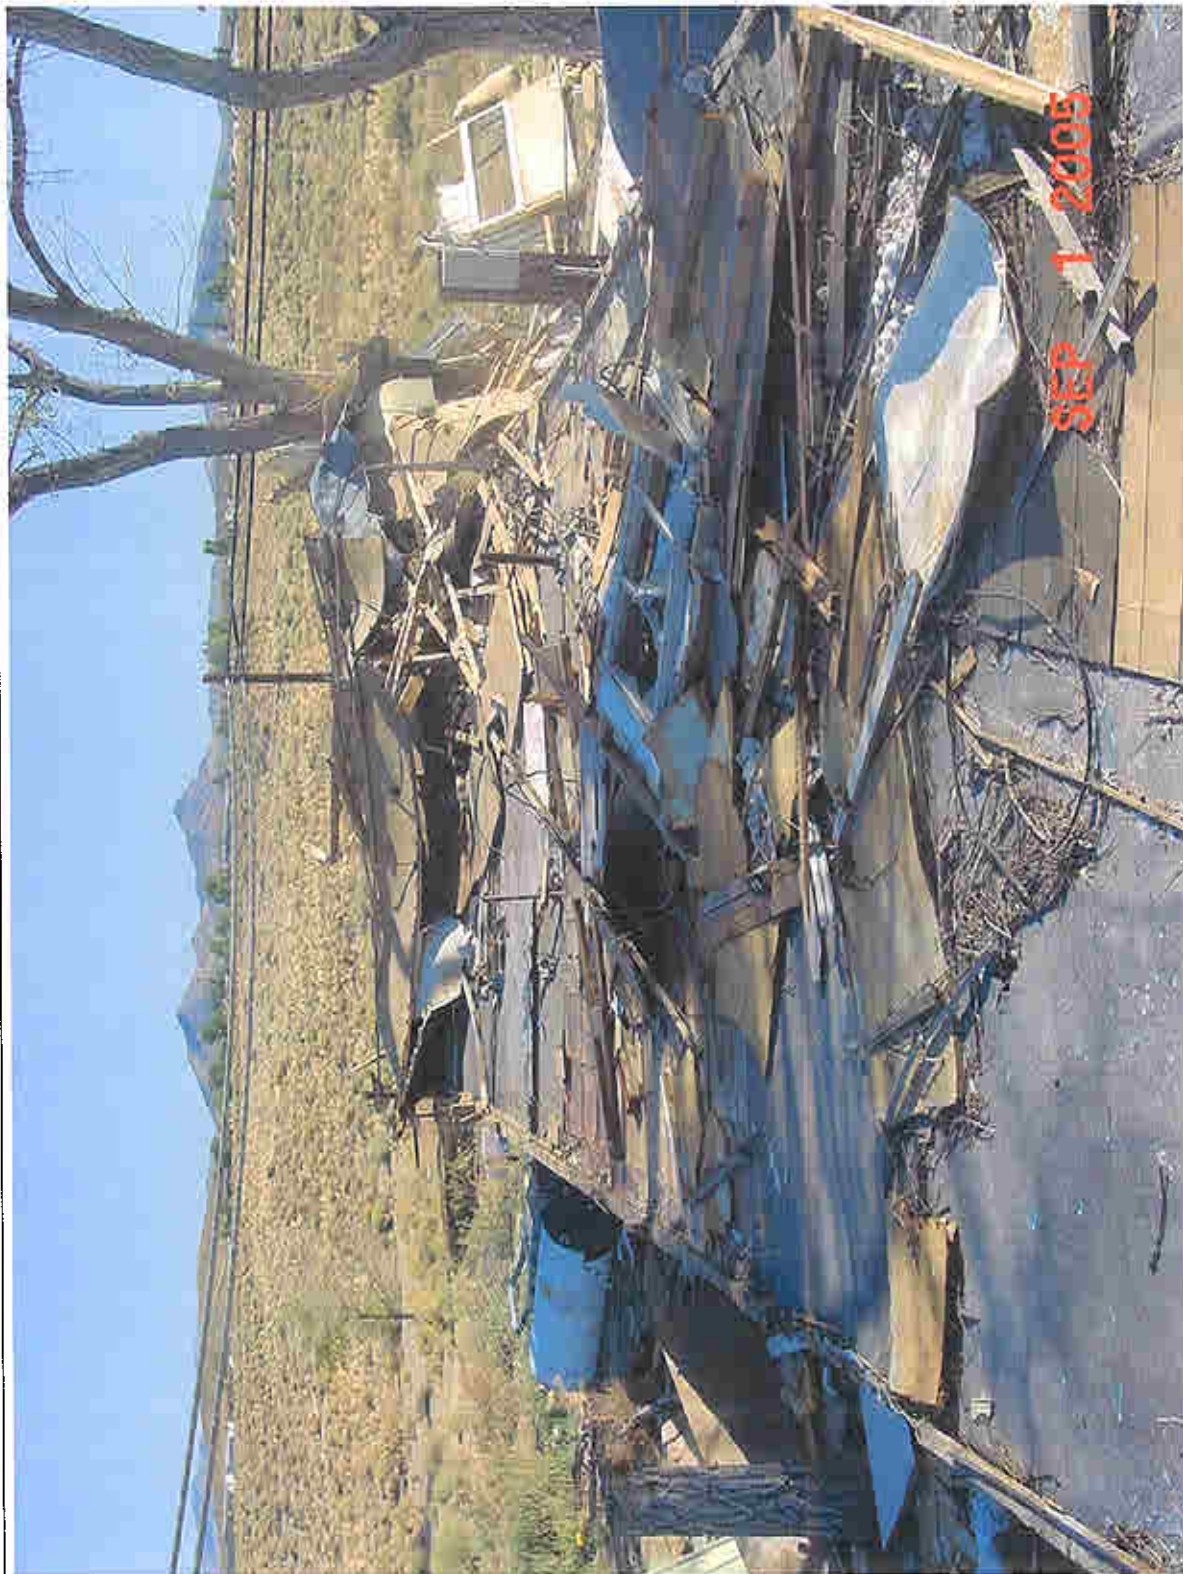
PHOTO 1  
 LAMBERTUCCI-ROMA  
 RANCH ASSESSMENT  
 ESMERALDA COUNTY, NV

located on the south side of the highway. The reason to remove these structures is the decrepit state which allows the wind to blow large pieces of material from them. This debris has ended up out on Hwy 95 and other locations offsite, making them a hazard to traffic and people. Photographs 1 through 3, 6, 9 and 10 show the condition of the various trailers at the site.

1. An asbestos survey should be performed on the trailers prior to further demolition and removal from the site. Regulated asbestos containing materials (if found) should be managed per applicable state and federal regulations prior to demolition of the trailers.

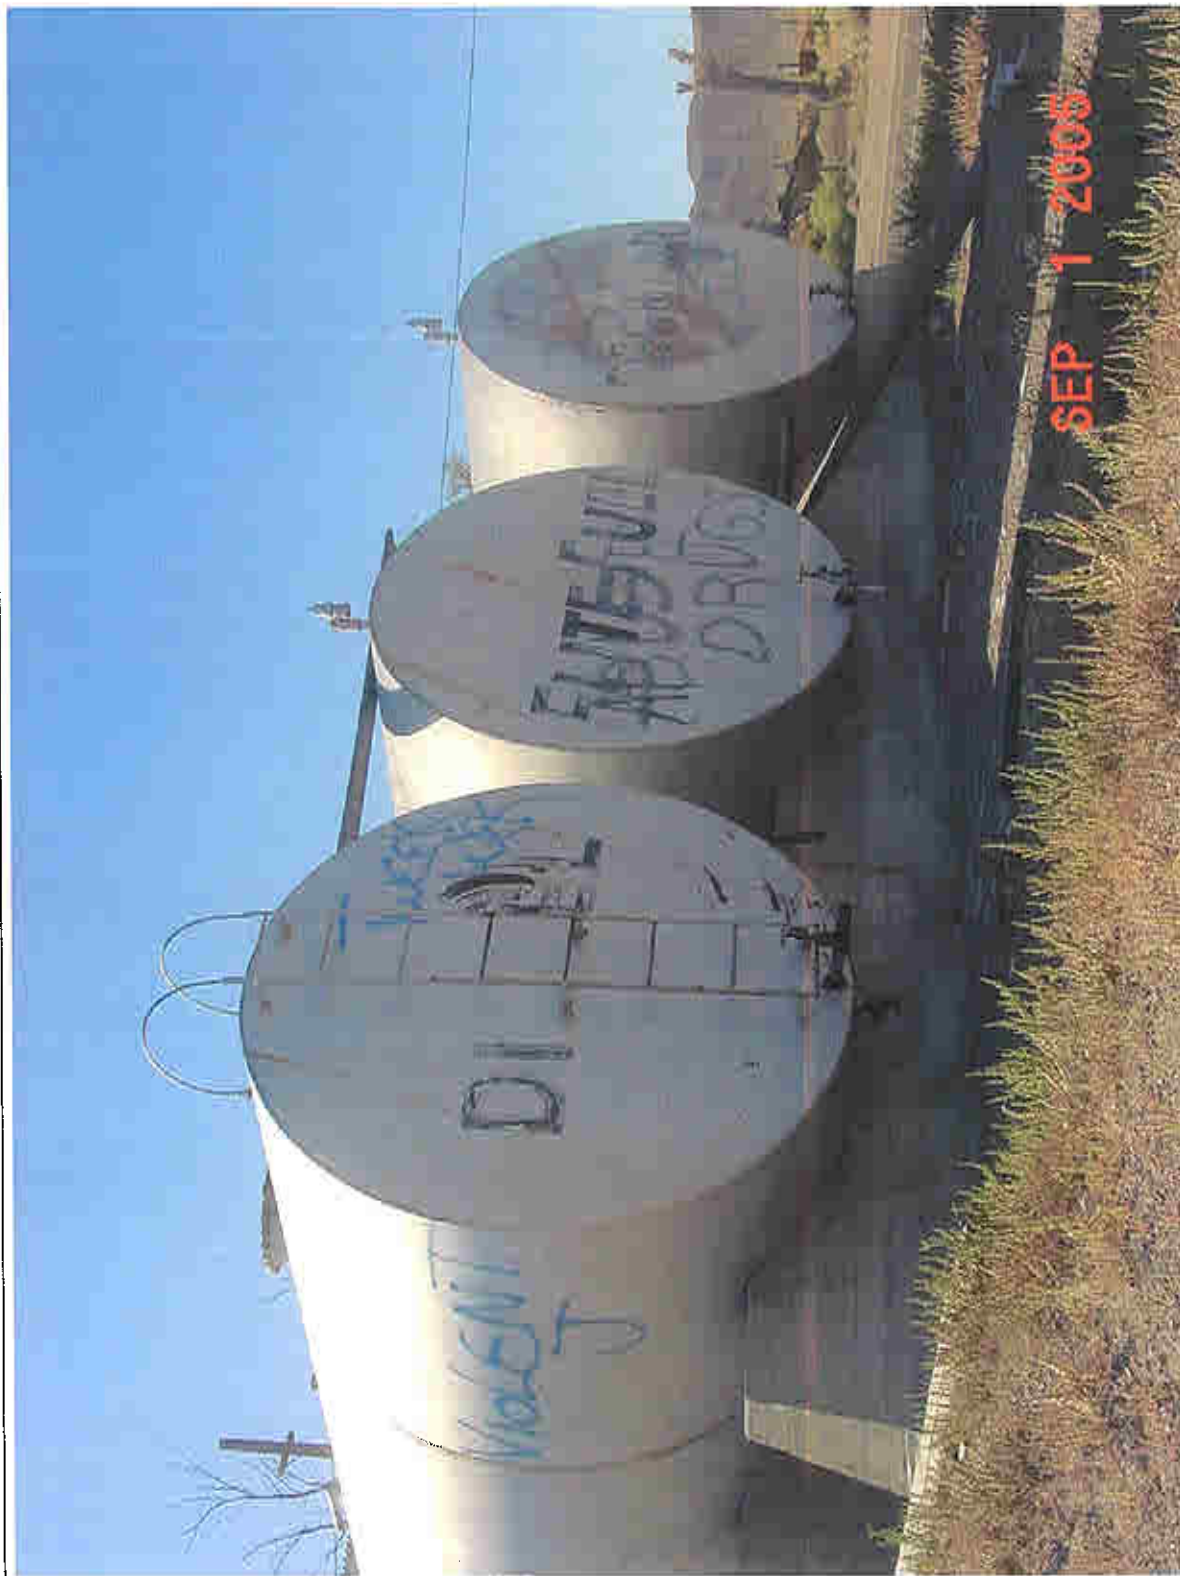
PHOTO 4  
 LAMBERTUCCI-ROMA  
 RANCH ASSESSMENT  
 EMERALDA COUNTY, NV

- Above and underground storage tanks are located onsite. Three large aboveground tanks are located on the northeastern portion of the site, along US Hwy 95, Photographs 4 and 12. There is distribution equipment scattered about the tank area. A date in the concrete cradle of November 13, 1948 gives an indication of the time of placement. Evidence of underground storage tank/s is present in front of an abandoned store/gas station, Photograph 8. Several the above ground tanks are strewn about the property, Photographs 18 and 19.

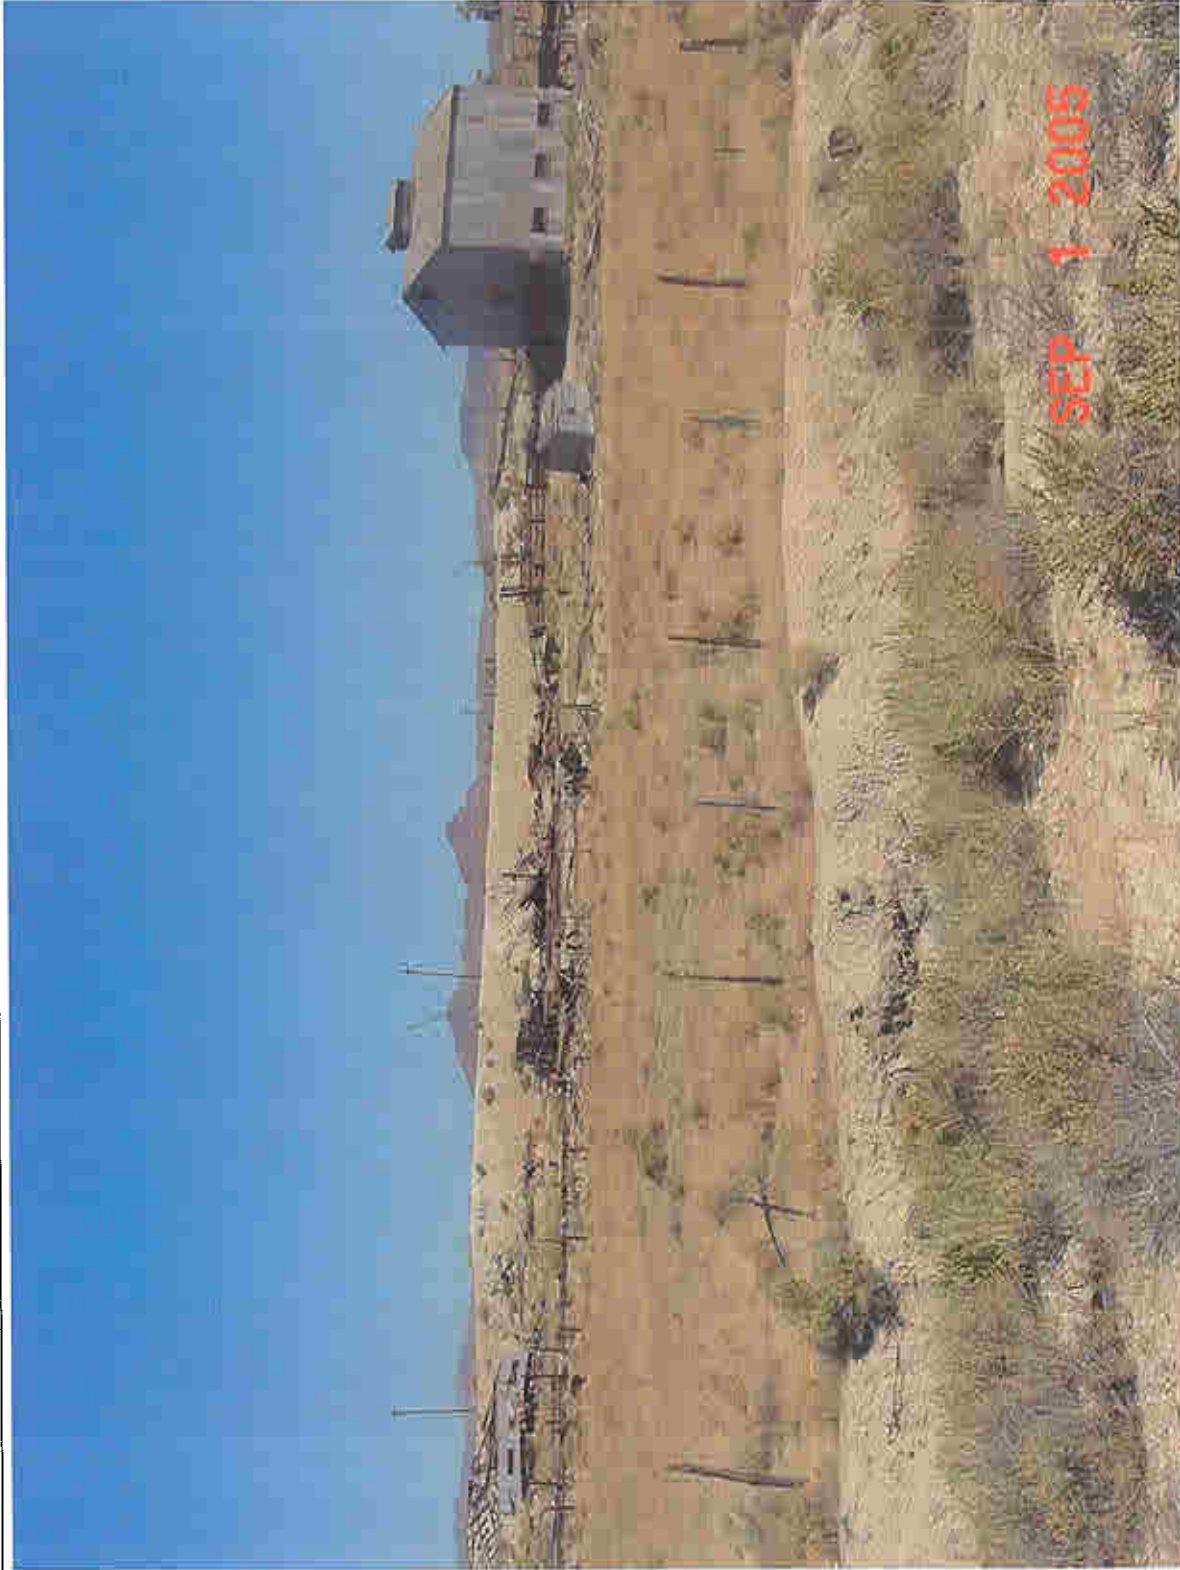
PHOTO 26  
LAMBERTUCCI-ROMA  
RANCH ASSESSMENT  
ESMERALDA COUNTY, NV

- Apparent potential asbestos debris is located west of the barn structure shown on Photograph 26, see Photograph 28. This material appeared to be a felt material that survived the apparent burning of the parent structure.

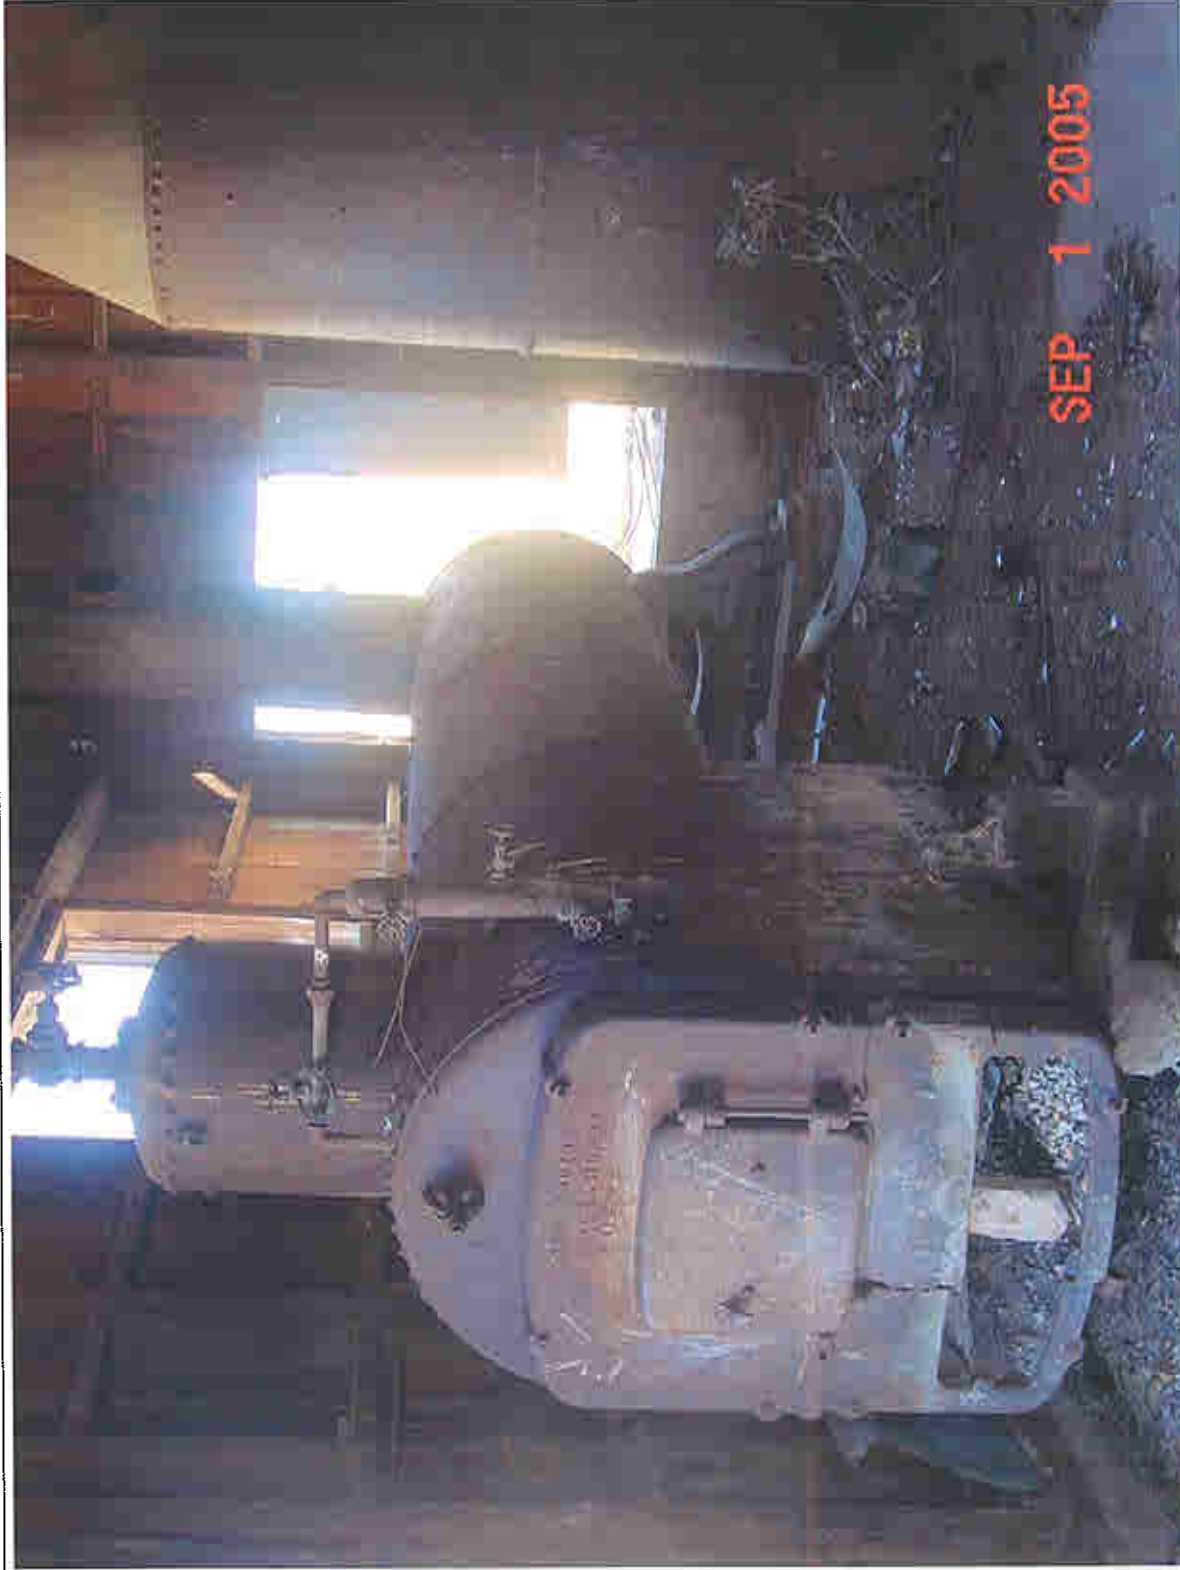
PHOTO 27  
LAMBERTUCCI-ROMA  
RANCH ASSESSMENT  
ESMERALDA COUNTY, NV

- Ore processing was most likely conducted on site. Therefore, one may expect that residual process chemicals may be present. Photograph 27 shows some of the equipment that may have been used for ore processing.
