**Subject: Phase I Environmental Site Assessment
Moapa Band of Paiutes Packing Plant
Moapa River Reservation
Portion of APN 030-36-000-006
Clark County, Nevada**

**PHASE I ENVIRONMENTAL SITE ASSESSMENT
MOAPA BAND OF PAIUTES PACKING PLANT
MOAPA RIVER RESERVATION
PORTION OF APN 030-36-000-006
CLARK COUNTY, NEVADA**

PROJECT NO. 126687.01

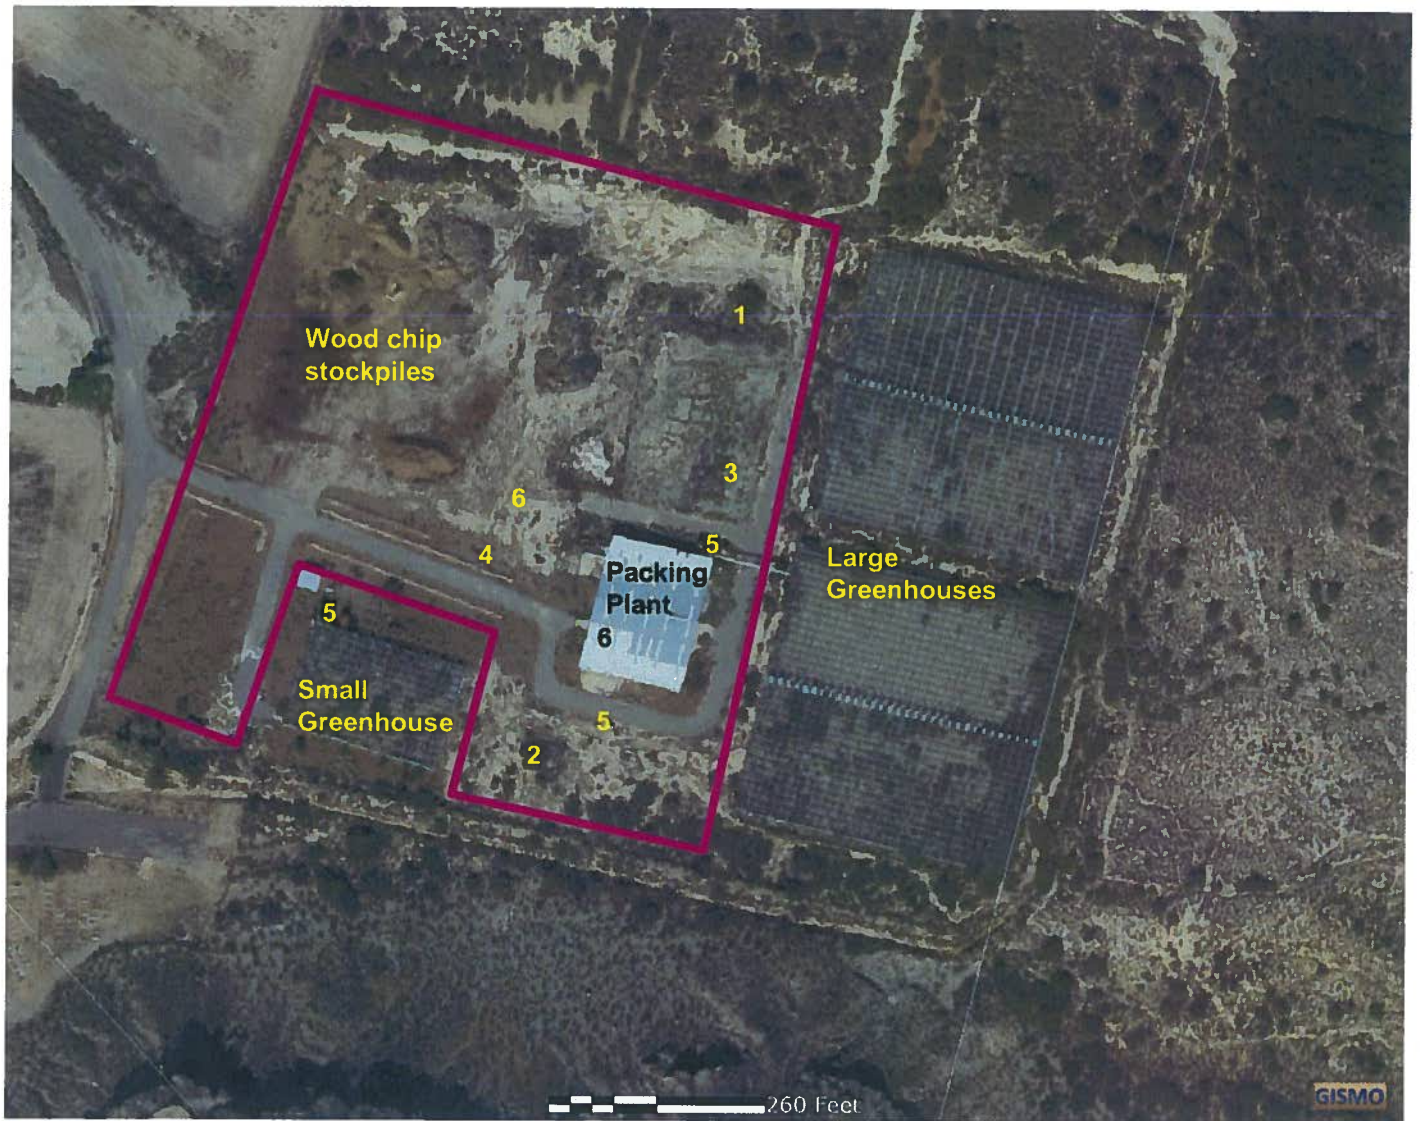
Approximate location of observations

- 1 Groundwater well
- 2 Burned Area
- 3 Drums
- 4 Shallow groundwater well
- 5 Above ground storage tanks
- 6 Native plant seedling storage

The subject property and perimeter were walked and adjacent properties were observed (as viewable from the subject property and public rights of way). Significant observations are mapped on Plate 2. At the time of our site reconnaissance, we observed the following:

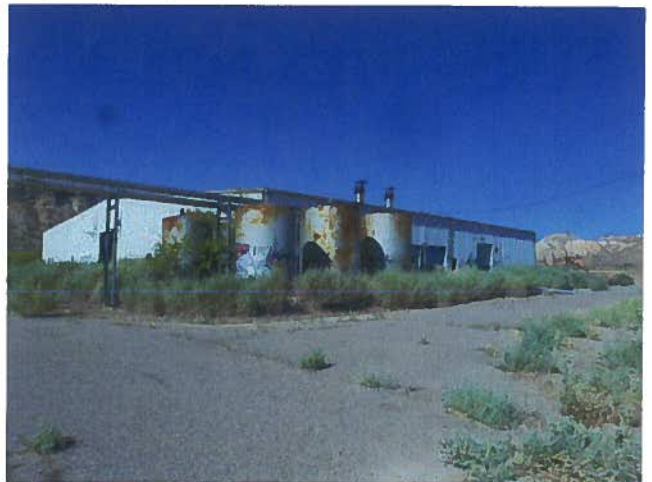
On-site ASTs, northeast corner of Packing Plant

- There were ASTs observed on the northeast corner of the Packing Plant. These appear to be for water storage for the Packing Plant's boiler system operations. However, the boilers were never brought into operations. Therefore, the ASTs and boilers are not considered to be a REC.

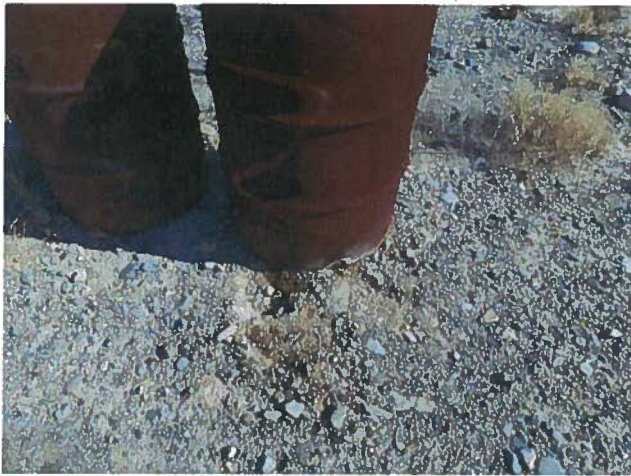
On-site drums (one punctured at base)

- Two, unlabeled 55-gallon drums were observed on the subject property, north of the Packing Plant and west of the north large greenhouse. The drums were unlabeled and aged, with visible signs of corrosion. One drum was full of an unknown substance and it could not be ascertained if it was a solid or a liquid. The other drum was empty and had a hole at the bottom of the drum. A small quantity of stained soil at the base of the drum was visible and staining appeared to be petroleum based.

Two 55-gallon drums were observed to the north of the Packing Plant, immediately west of the adjacent property's north greenhouse. These drums were unlabeled, rusted, corroded and both appeared to have some quantity of unknown content. One drum appeared to be full and the other drum had a hole at the bottom of the drum. Stained soil was observed at the base of the drum with the hole. As part of Phase II ESA activities (Kleinfelder, 2012b), a soil sample collected from beneath the penetrated drum contained a TPH-ORO concentration of 6,500 mg/kg. Although the vertical extent was not defined, based on the small surface area of stained soil, it appears that less than three cubic yards of soil were impacted.

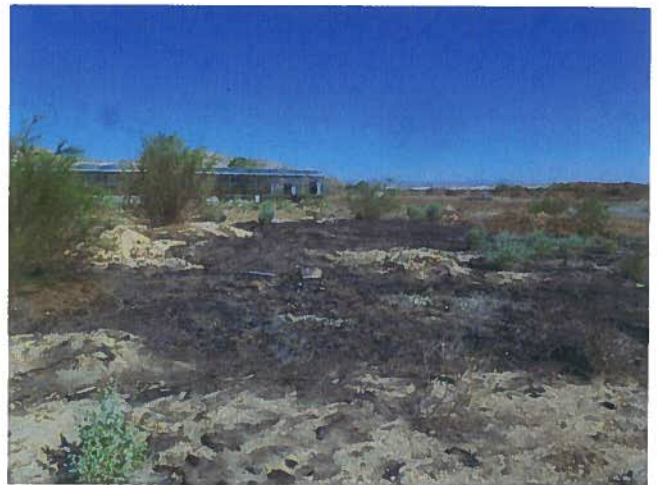
On-site burn area, south of Packing Plant

- A burn area was observed on the subject property, south of the Packing Plant and east of the small greenhouse. The approximate area of the burn was 20 square feet and consisted of vegetation, steel and glass, which appear to be building materials from the nearby greenhouses. No evidence of chemical or petroleum containers was observed.

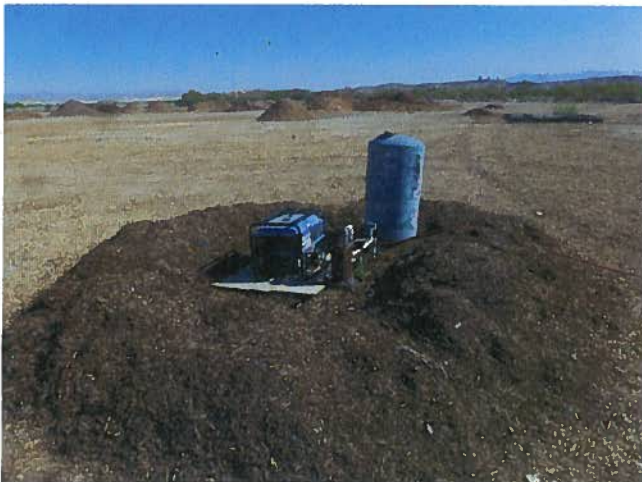
On-site groundwater well, with generator, west of Packing Plant

- A shallow irrigation well (well A) was observed on the subject property, located west of the Packing Plant. The well, powered by a small generator, was surrounded by a dirt berm. At the time this Phase I ESA was being prepared, the irrigation well was being used to water the native plant seedling being temporarily stored on the subject property. A second irrigation well (well B, currently out-of-use) is located near the northwest corner of the northernmost large greenhouse.

Well A was observed on the subject property, located west of the Packing Plant. The well, powered by a small generator, was surrounded by a dirt berm. At the time this Phase I ESA was being prepared, the well A was being used to water the native plant seedling being temporarily stored on the subject property.

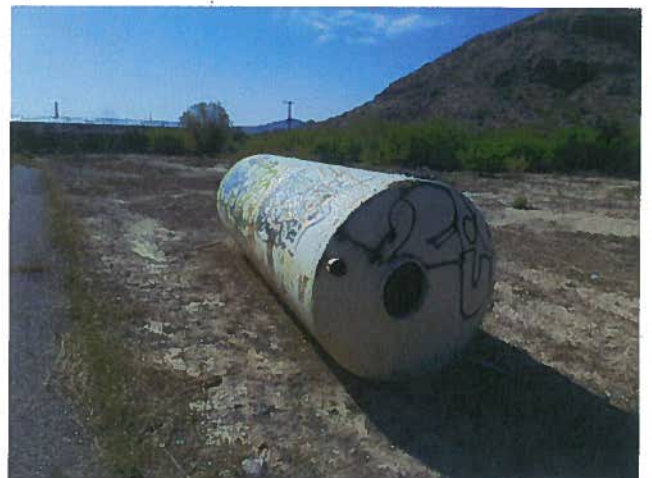
On-site AST, west of Packing Plant

- There was a single aboveground storage tank (AST) observed to be laying on its side, located south of the Packing Plant. The end of the AST was observed to have been penetrated, rendering it unusable. No soil staining was observed around the AST.

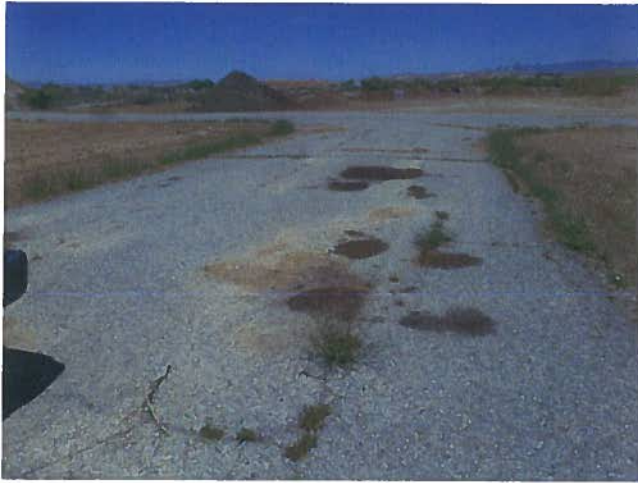
On-site pavement staining, north of small greenhouse

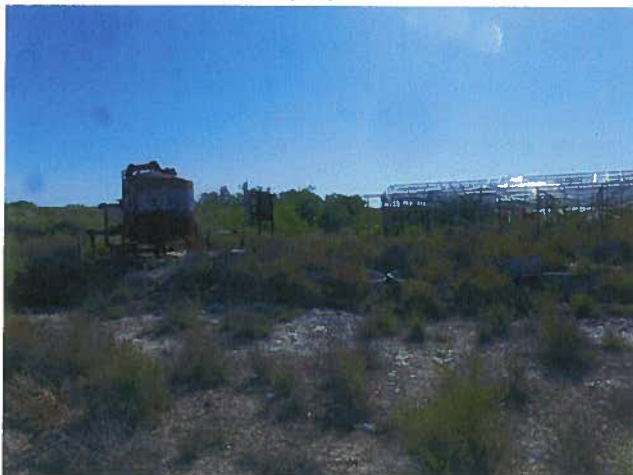
Adjacent northeast well and large greenhouse

Well B (currently out-of-use) was observed at the northeast corner of the subject property, near the northwest corner of the northernmost large greenhouse.

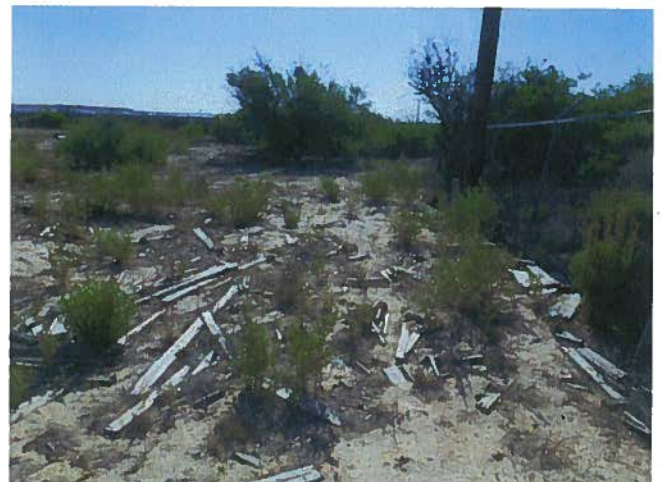
Debris on site

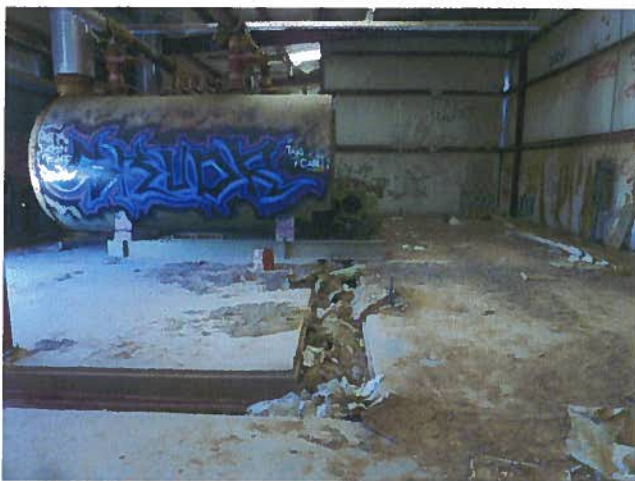
Packing Plant Boiler Room fuel tank

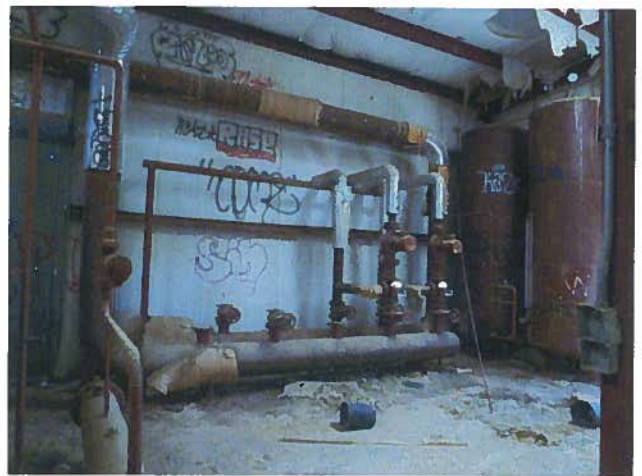
Boiler Room piping and water tanks

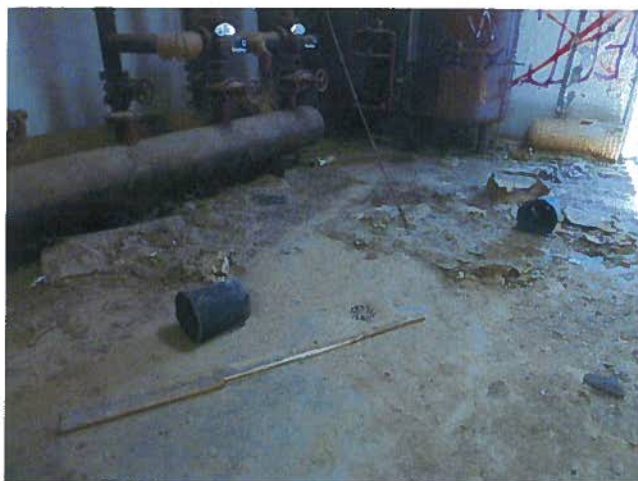
Floor drain in Boiler Room

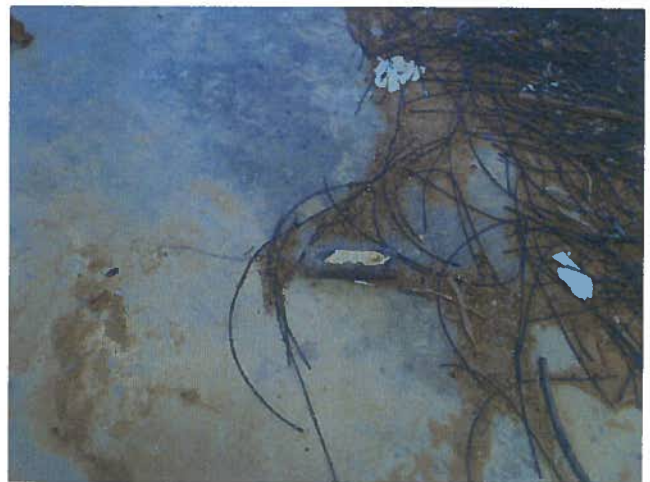
Fluorescent light ballast on floor
