June 28, 2011  
Project Number 117225.02

**Subject: Hazardous Substances Phase II Environmental Site  
Assessment  
Abandoned Water Tank near the Moapa Senior Center  
Moapa Paiutes Indian Reservation  
Moapa, Clark County, Nevada**

<b>SUBJECT SITE AND VICINITY MAP</b>	
Abandoned Water Tank Moapa Indian Reservation Moapa, Clark County, Nevada	PLATE <b>1</b>

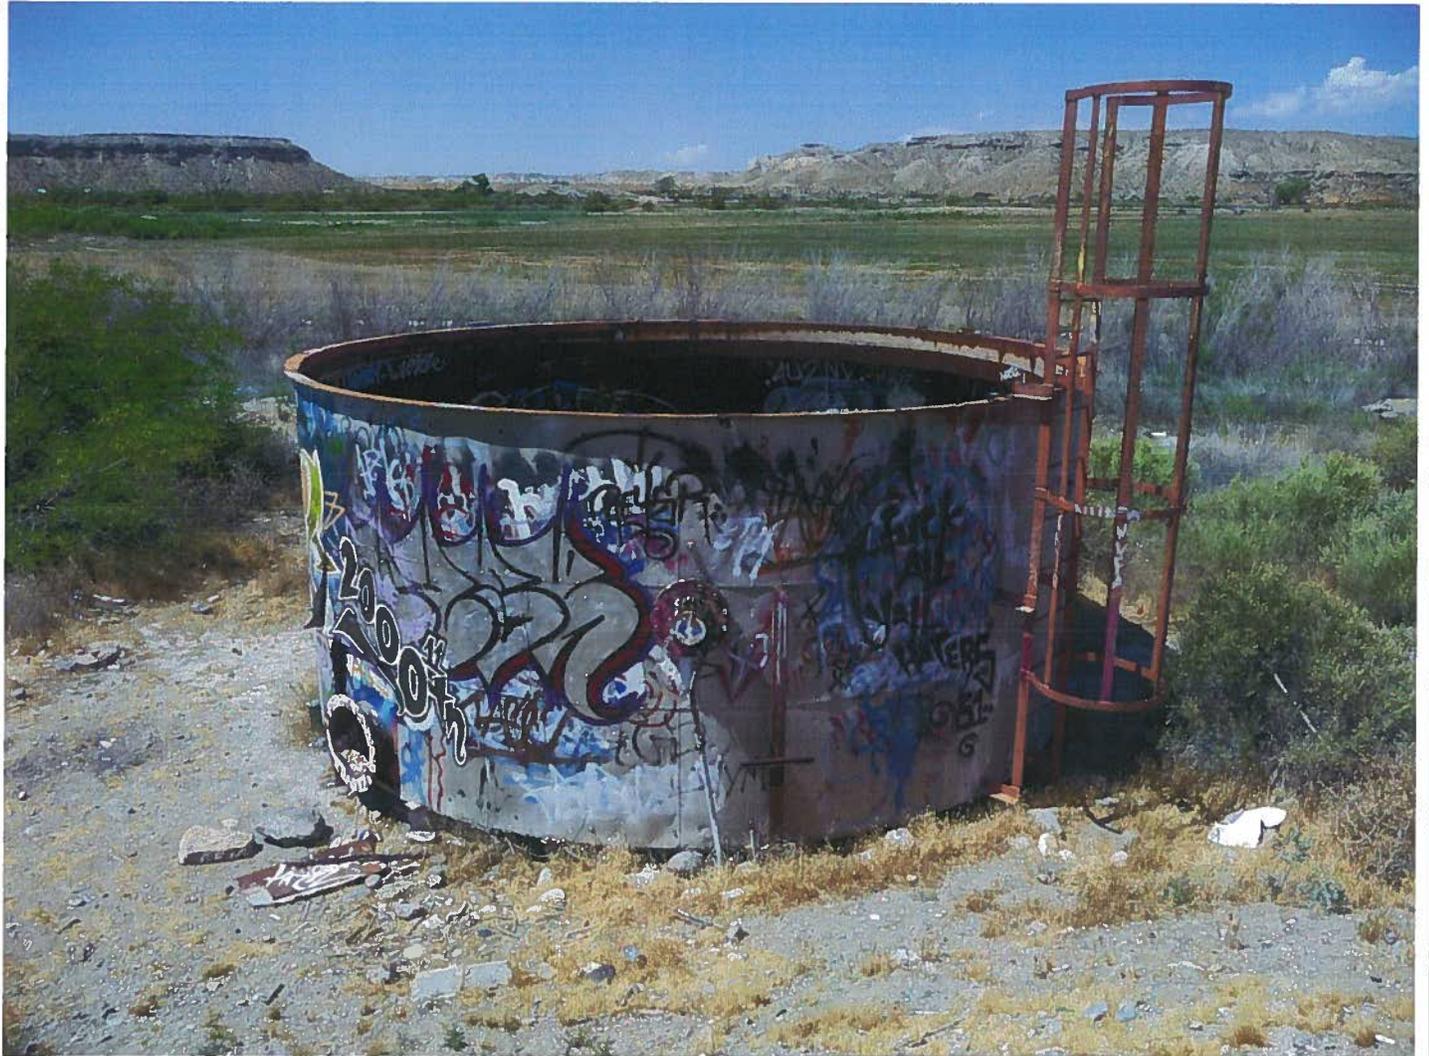
PLATE  
**2**

On June 8, 2011, three samples of exposed water tank insulation were collected by Mr. Daniel Burns, Nevada Asbestos Consultant-Inspector (I-0971).

Fiberquant reported the samples as being negative for asbestos. A copy of the laboratory analytical results is included as Appendix A. Therefore, no further action is recommended regarding the water tank and the Paiute Tribe can evaluate how they want to remove the abandoned water tank, without asbestos concerns.

**ABANDONED WATER TANK**
