**PHASE I ENVIRONMENTAL SITE ASSESSMENT
MOAPA PAIUTE FARM SMALL GREENHOUSE
MOAPA RIVER INDIAN RESERVATION
A PORTION OF APN 030-36-000-006
CLARK COUNTY, NEVADA**

PROJECT NO. 117225.01

April 5, 2011

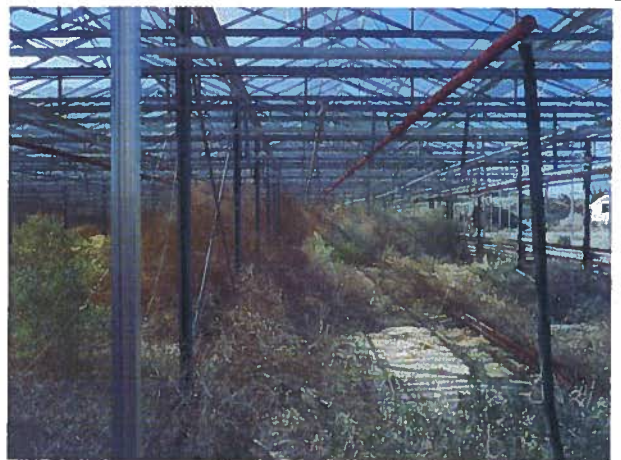
Interior of Subject Property's Greenhouse

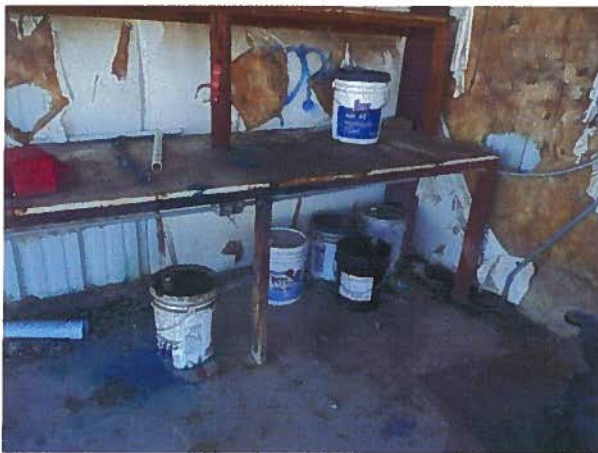
At the time of our site reconnaissance, we observed 5-gallon size containers, labeled as hydraulic oil, engine oil, and paint, located in the equipment shed on the northeast corner of the Subject Property. There is an oil fueled boiler, located in a shed between the equipment shed and the greenhouse. No separate fuel storage for the boiler was observed, so the fuel storage may be internal to the boiler system. An AST (water) is located adjacent (to the east) of the sheds.

5-gallon containers on Subject Property

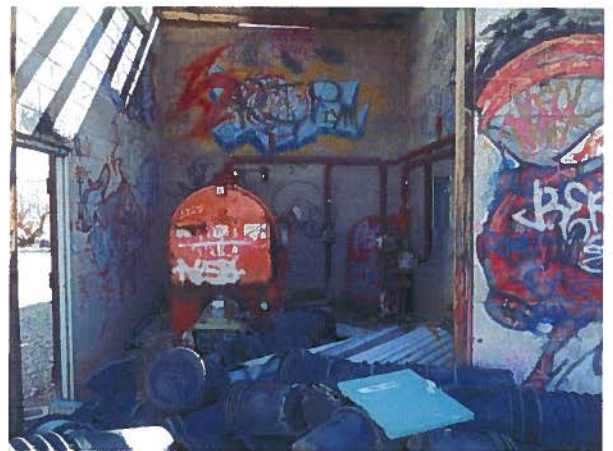
- An oil-fueled boiler assembly (generator and boiler) indicates oil was used at the site and may have been released to the ground. There was no surface staining visible where the ground was visible around the boiler assembly.

Oil fueled boiler on Subject Property

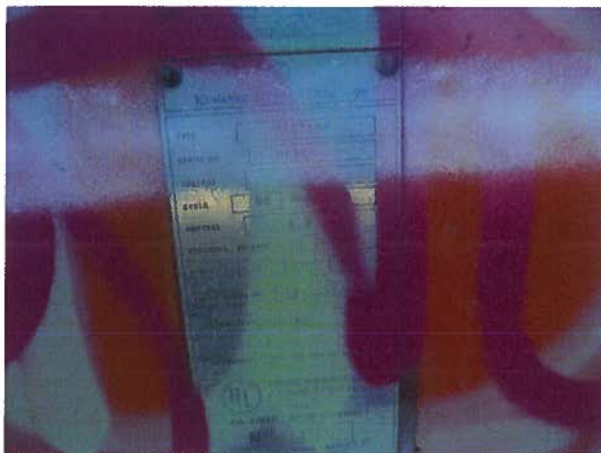
Oil Fueled Boiler Manufacturer Plate ,
designating the boiler is oil fueled

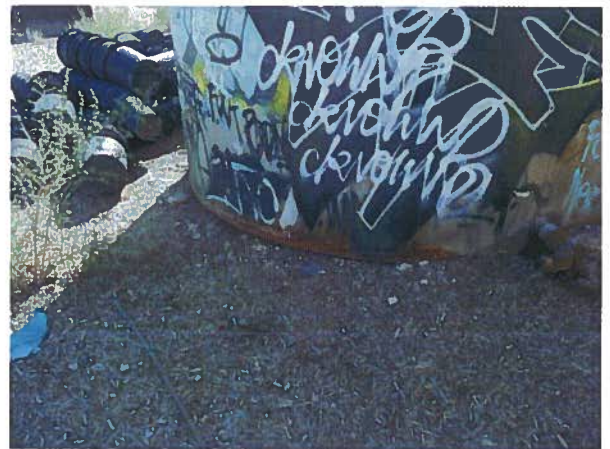
Base of Above Ground Water Tank on Subject
Property

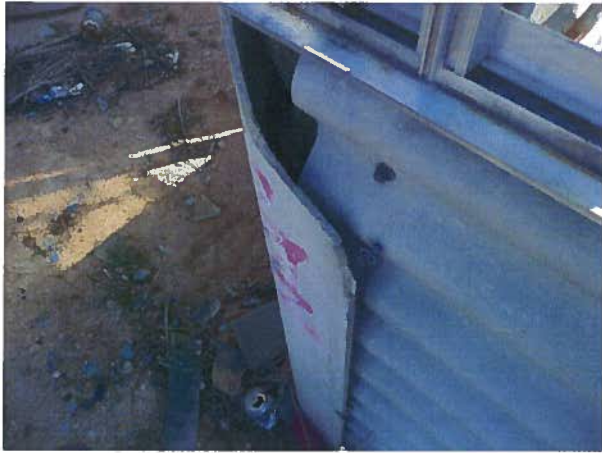
- The presence of potential asbestos containing building materials (ACBM), consisting of 3-feet high cementitious asbestos board (CAB) skirting installed around the exterior (ground level) of the greenhouse was observed. Prior to renovation and/or demolition of the greenhouse, or the other structures on the subject property, an asbestos survey should be conducted.

Suspect asbestos containing skirting along perimeter of greenhouse

- Based on the site use as a greenhouse; herbicides and pesticides may have been used at the subject property. However, no records of pesticide or herbicide use were revealed during the preparation of the Phase I ESA.
- An oil-fueled boiler assembly (generator and boiler) indicates oil was used at the site and may have been released to the ground. There was no surface staining visible where the ground was visible around the boiler assembly.
- During the site reconnaissance, the presence of ACBM, consisting of 3-feet high CAB skirting installed around the exterior (ground level) of the greenhouse was observed. Prior to renovation of this greenhouse, an asbestos survey should be conducted of the suspected CAB skirting material.

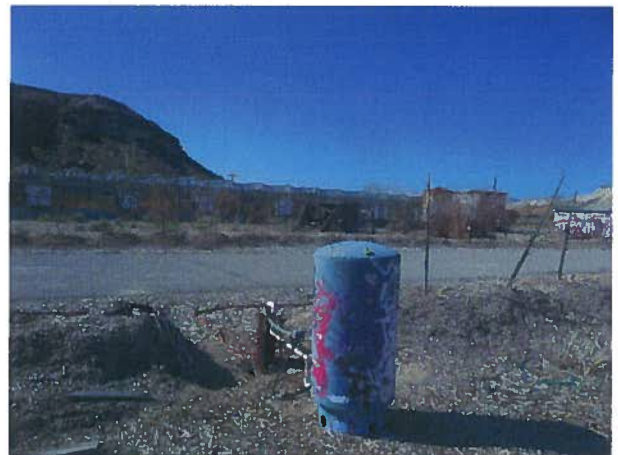
Irrigation well on north adjacent property (looking towards Subject Property)

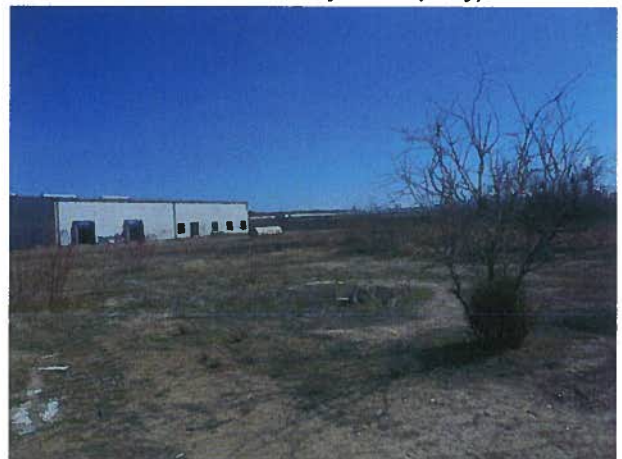
There was a single aboveground storage tank (AST) observed on the east adjacent property (near the former produce packaging plant and warehouse). The end of the AST facing the Subject Property was observed to have been penetrated, rendering the AST useless as a containing vessel in its observed condition.

The site perimeter was walked and adjacent properties observed (as viewable from the subject property and public rights of way). This consisted of an AST, whose north end (facing the Subject Property) was observed to have been penetrated.

East adjacent property, with AST in background (looking towards NE from Subject Property)

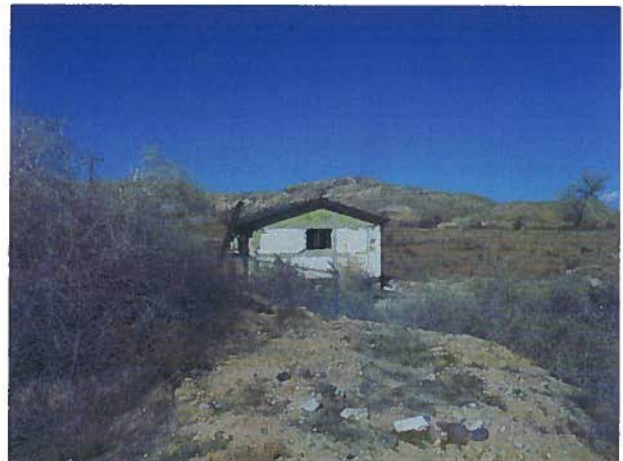
Abandoned building, located south west of the Subject property (looking west along boundary with south adjacent property).
