Phase I Environmental Site Assessment

Nye County Courthouse

1 Frankie Street
Tonopah, Nevada 89049

Date February 10, 2021

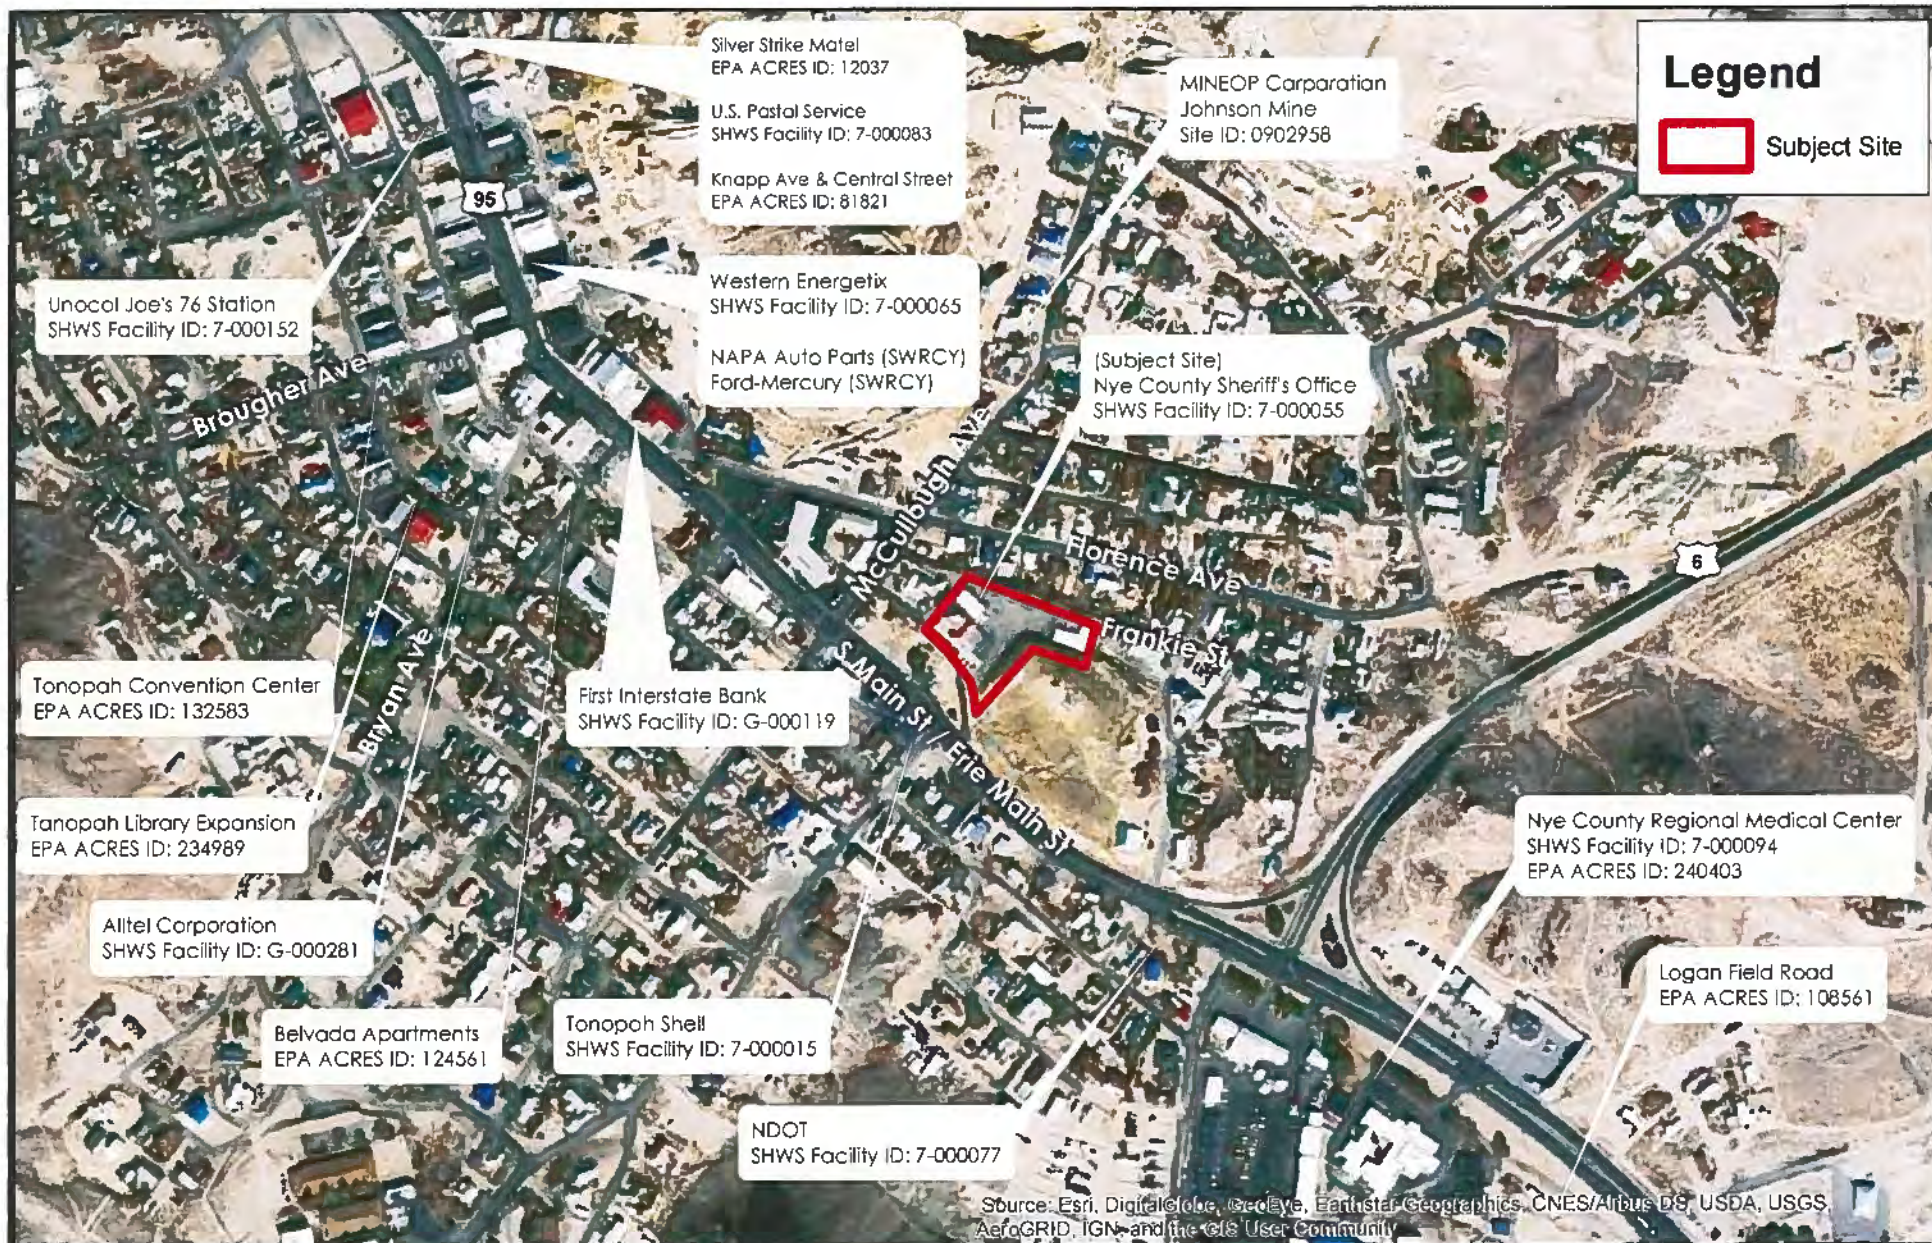
Figure 3 - Area Reconnaissance Map
Nye County Courthouse
1 Frankie Street
Tonopah, Nevada 89049

The subject site is comprised of a 2.01-acre parcel with one 22,689-ft² Courthouse building, one single-story pre-fabricated building, four sheds, and one CONEX storage container located at 1 Frankie Street, Tonopah, Nevada, APN 008-311-01. Features of adjoining and nearby properties are identified in the Area Reconnaissance Map (**Attachment 1, Figure 3**). Key observations made during the exterior portion of the site visit are depicted in the Site Reconnaissance Map (**Attachment 1, Figure 4**). The current use of adjoining properties to the north, east, south, and west, are described in **Table 2-1**.

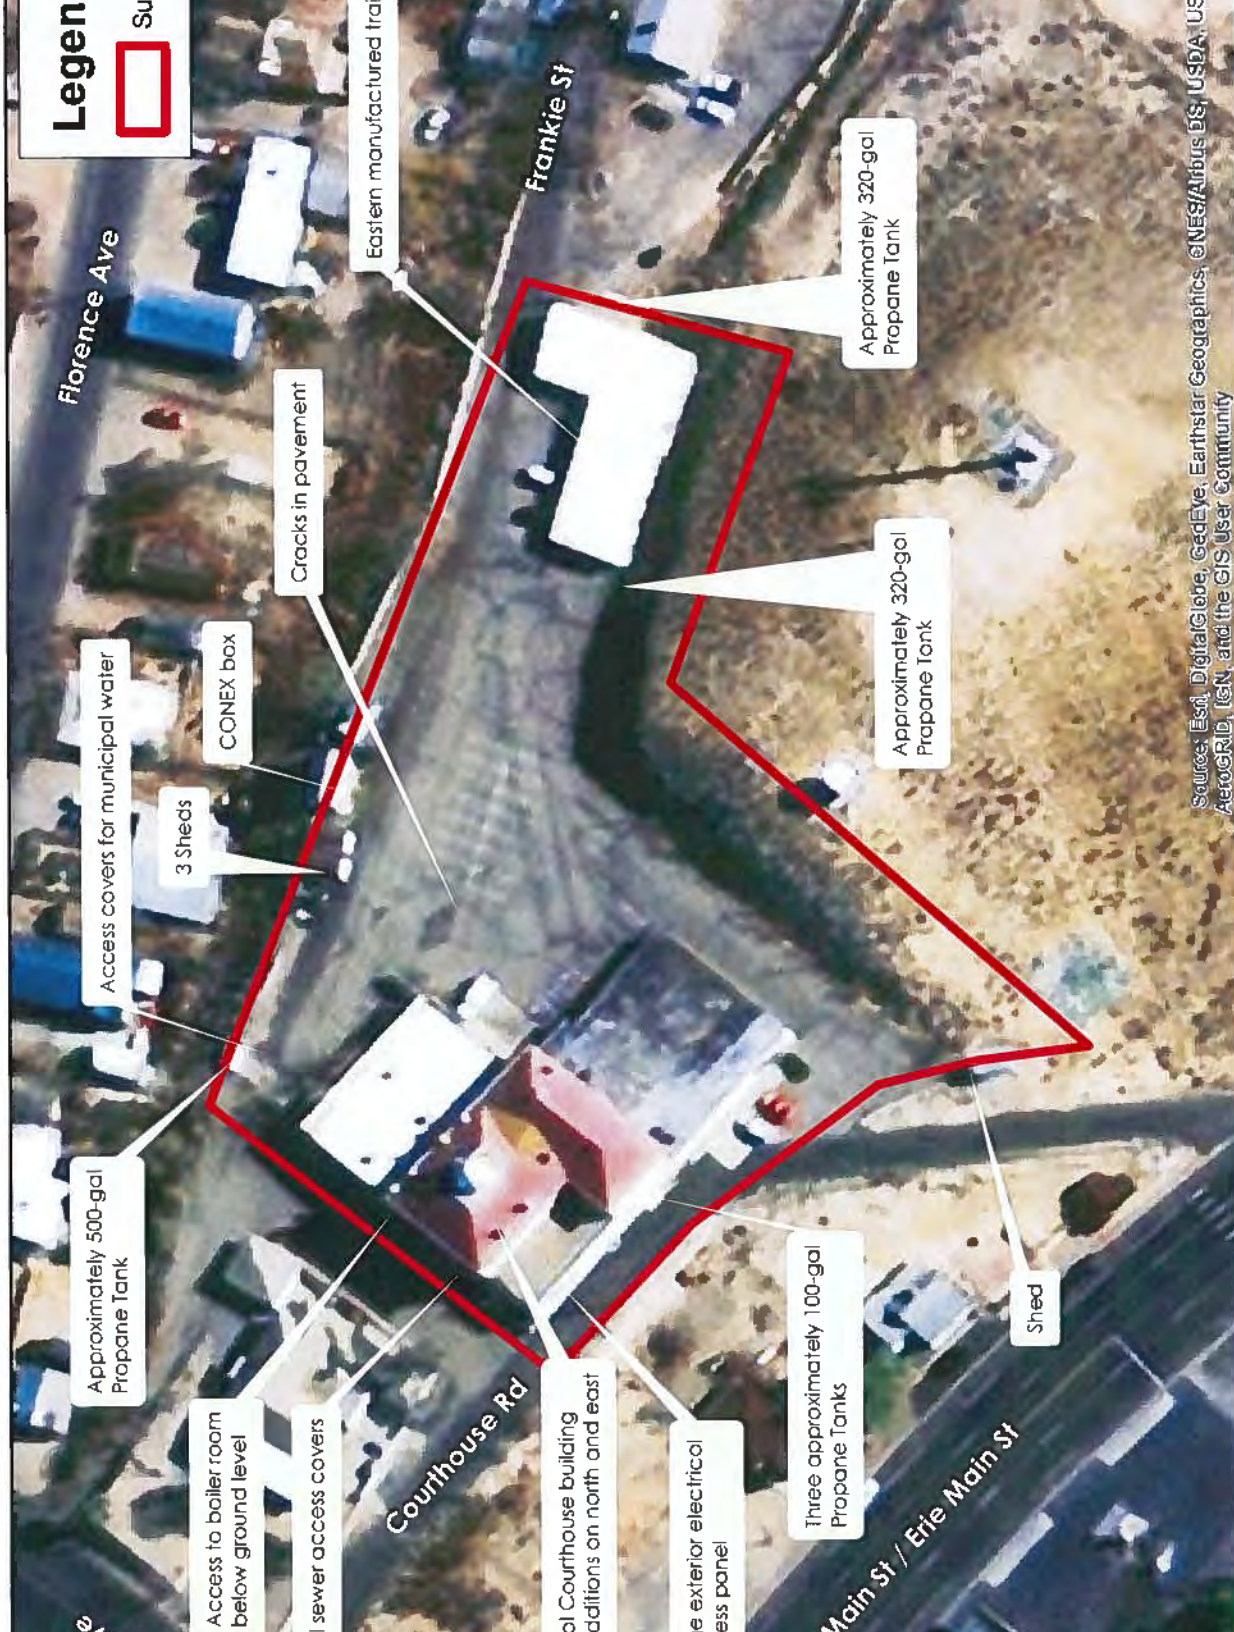
Figure 4 - Site Reconnaissance Map

BEC walked the perimeter of the subject site and noted conditions inconsistent with those expected for a mixed-use neighborhood. The site reconnaissance began in the southeastern addition of the courthouse, then in the old sheriff's office and jail, then in the original courthouse building. The perimeter of the parcel was then walked beginning at the northwest corner toward the eastern side of the parcel. The interior and exterior of the eastern manufactured trailer building was then observed. The exterior of the parcel was then walked to the southernmost point, the western corner, and back to the northwestern corner. Finally, the interior of the northern addition of the courthouse building was observed.
