# **Future Flows: Maggie Creek Watershed Enhancement Plan**

**CONTINUING COMMUNITY-DRIVEN  
RESTORATION EFFORTS IN THE MAGGIE  
CREEK BASIN**

DOCUMENTED BY TROUT UNLIMITED, IN PARTNERSHIP WITH NEVADA  
GOLD MINES LLC

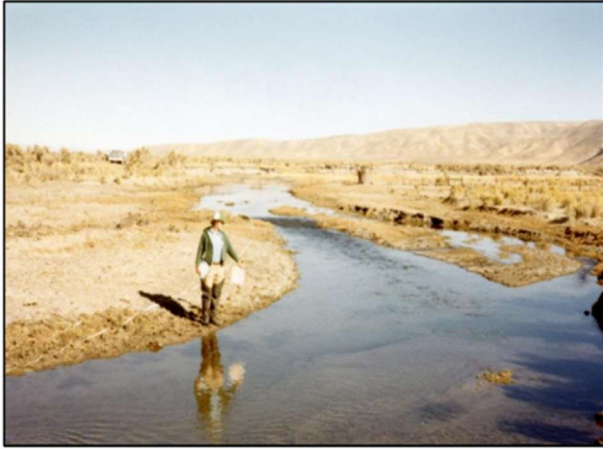
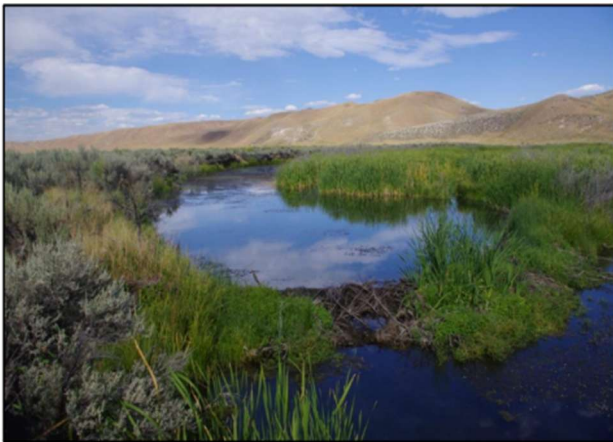
Fig 5. BLM. Photos of Maggie Creek before restoration and later in 2011 (2012).

faster signs of recovery than expected. Riparian vegetation has had a strong comeback (Fig. 5, Fig. 31), the floodplain has extended to farther reaches and is slowly rehydrating, and beavers have returned and have begun to create complexes in previously uninhabited ranges (Evans & Snyder, 2012). From 2006 to 2010, it was shown that seven stream miles had returned to Proper Functioning Condition (White Horse Associates, 2011). Overall results of the NFWF-funded Keystone Initiative, from both the genetics assessments and stream reconnections, show a 3-fold increase in population densities in focal waters, with an overall size increase of migratory fish (Neville & Barnes, 2023).

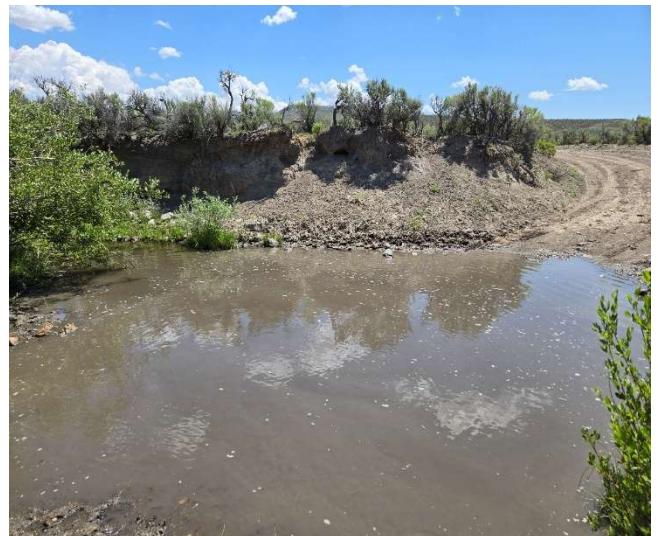
*Fig 16. TU. The degraded road crossing on mainstem Maggie Creek, near Dip Creek (June 2025).*

Stampede Ranch Road, on 25 Ranch property located at the northern stretches of Maggie Creek, is an unmaintained road that is used to access their grazing pastures in the north. Slightly South of where Dip Creek flows into Maggie Creek, a moderate-use crossing occurs on mainstem Maggie Creek (Fig. 15). Passage can be difficult, especially during the snowmelt in the Spring. This has led to a ponding at the crossing point and degraded stream bottom (Fig. 16).

An initial recommendation is to create a hardened stream crossing that would narrow up the disturbance while also allowing for fish passage. Structures such as a stream ford (i.e., an underwater hardened pathway; Barkley et al., 2015), would be a cost-effective and resourceful alternative to a culvert and would help prevent further degradation and erosion of the stream bottom. This could be done by either sourcing local boulders and rocks to form a “cobblestone” base, or by utilizing concrete slabs, making it an overall low-cost and low-effort project. After the ford is constructed, assessments will occur to confirm structure stability and if another alternative is required.

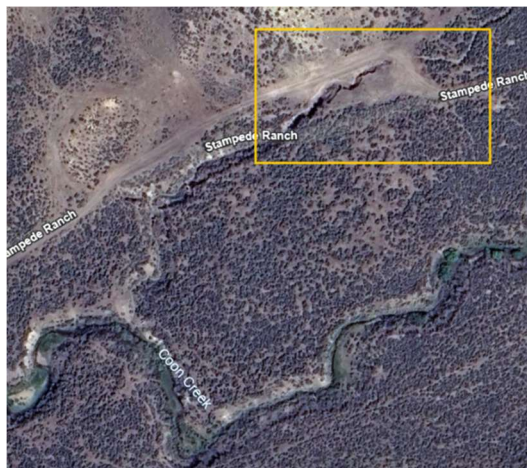
After the crossing and further upstream, into Coon Creek, other restoration opportunities are available. The most pressing being a severe head cut formation that has branched from Coon Creek (Fig. 17, Fig. 18). This head cut has formed a significant gulley and has led to high sediment loading into Coon Creek and Maggie Creek (Fig. 19). The 25 Ranch had to move Stampede Road northward multiple times due to the head cut cutting through their pathway.

*Fig 17. Google Earth. Location of the head cut and gulley on Stampede Ranch Road, by Coon Creek.*

Considering the size and impact of the head cut and newly formed gulley, the best proposed path forward is to prevent further degradation rather than repairing the entire system. This head cut does not have any direct flow; it only collects water from Coon and runoff from storm events. The ephemeral nature of this feature poses no threat to any upstream watersheds but currently it is an issue to the road infrastructure. Placing a Zeedyk structure, such as a log or rock mulch rundown with unused hay bales, is the proposed method most likely to stabilize this area (Sponholtz & Anderson, 2010). After construction, monitoring of the headcut and its stability will occur. This project will be low cost, especially if local resources can be utilized, and will only have moderate effort only due to the remoteness of the location (i.e., hauling materials or equipment to the project site).

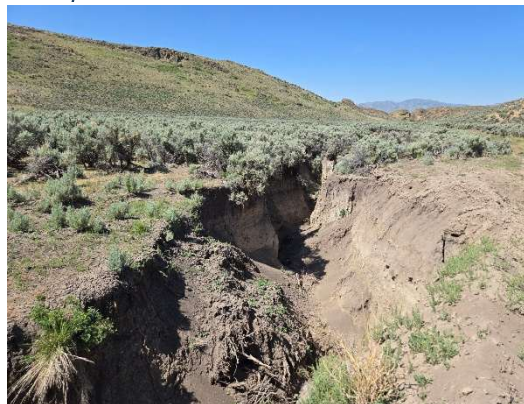
*Fig 18. TU. The head cut formation next to Stampede Ranch Road (June 2025).*

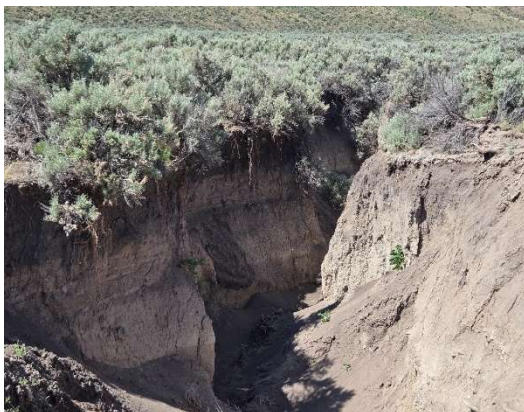
*Fig 19. TU. Down from the head cut, a large gulley formed near Stampede Ranch Road (June 2025).*

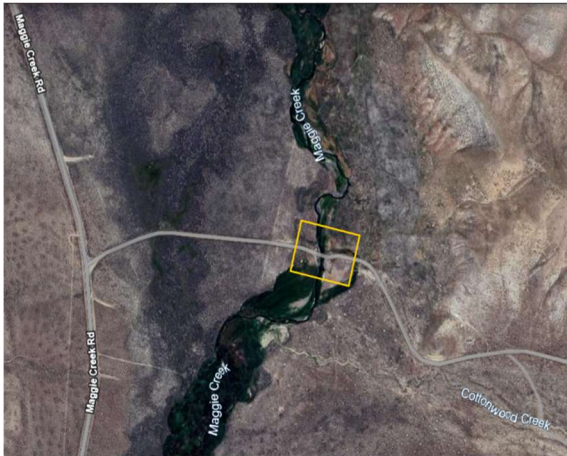
Fig 21. TU. Photo of the degraded crossing where cattle access mainstem Maggie Creek for water (June 2025).

Moving South to the mainstem Maggie Creek, on Maggie Creek Ranch property and bordering NGM property, is a road crossing (Fig. 20). The road crossing, although not destructive, is an open source for free-range cattle to access Maggie Creek (Fig. 21, Fig. 22). This access has led to degradation of the area, a concern expressed by the Maggie Creek Ranch.

*Extend riparian fencing to prevent cattle from degrading open portion of Maggie Creek.*

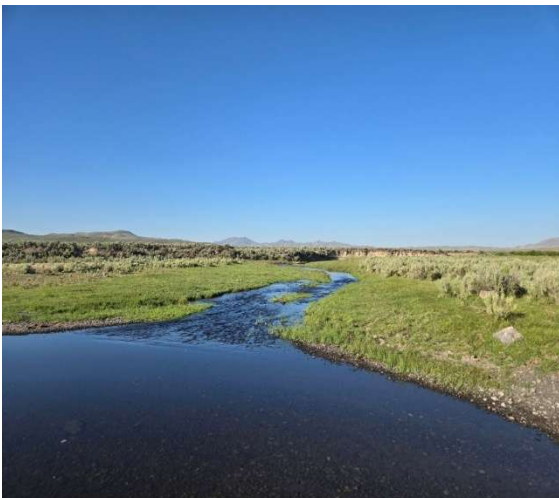
Fig 22. TU. A downstream view of the area which cattle can access on mainstem Maggie Creek (June 2025).

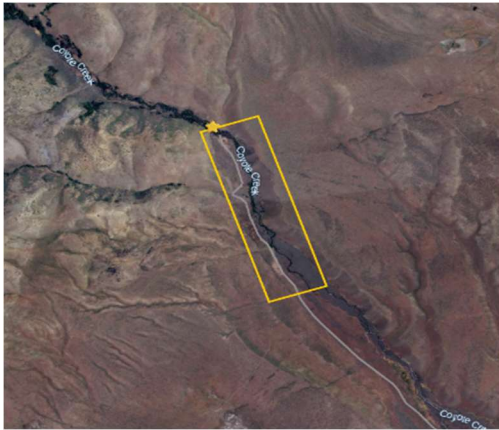
The first tributary, Coyote Creek, is the most Northern of the three. In this location, TU and NGM staff saw many LCT (*Fig. 23*, with a star at the location where fish were seen; *Fig. 24* is an LCT that was caught and released at this location). There is a strong beaver presence here; beavers were seen swimming as the TU staff were fishing, leading to deep pools where the trout were discovered. As soon as the beaver presence ends, however, Coyote Creek quickly shallows and loses much of the woody riparian vegetation found in the upstream habitat (*Fig. 25, Fig. 26*). It is proposed that 5-15 BDAs be constructed at this shallowing point, to encourage beaver activity further downstream and therefore increase water levels. If the initial BDA construction shows signs of success, more BDAs will be implemented yearly. In conjunction with BDA installations, TU would encourage the installation of willow cuttings into these degraded areas to help facilitate willow migration that could become a future food source.

*Fig 23. Google Earth. Location of proposed LTPBR work along Coyote Creek. Star icon is the site where LCT were spotted, and beavers were active.*

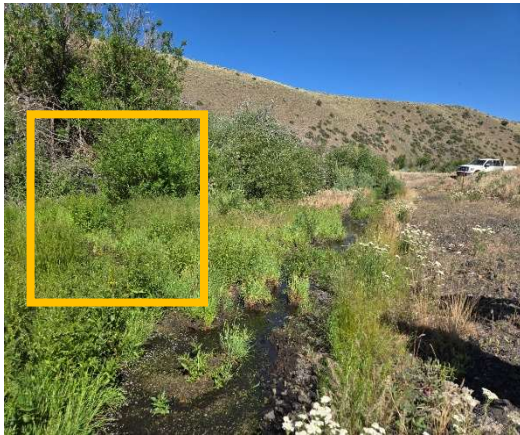
*Fig 25. TU. At the proposed LTPBR site on Coyote Creek, an NGM monitoring site is hidden in the vegetation (yellow square; June 2025).*

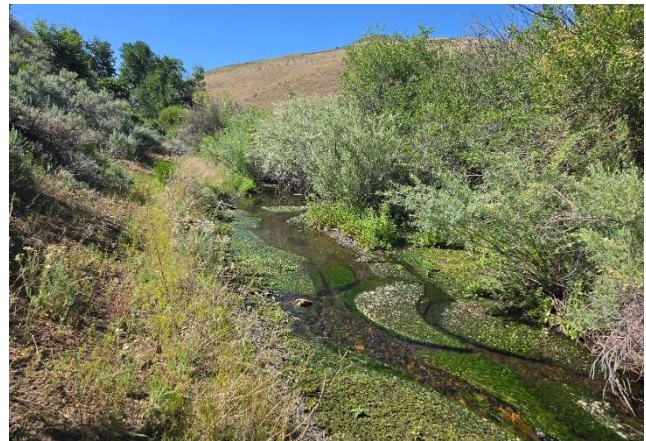
*Fig 26. TU. Proposed site for initial LTPBR, BDA construction on Coyote Creek, immediately downstream of sighted LCT and beaver activity (June 2025).*

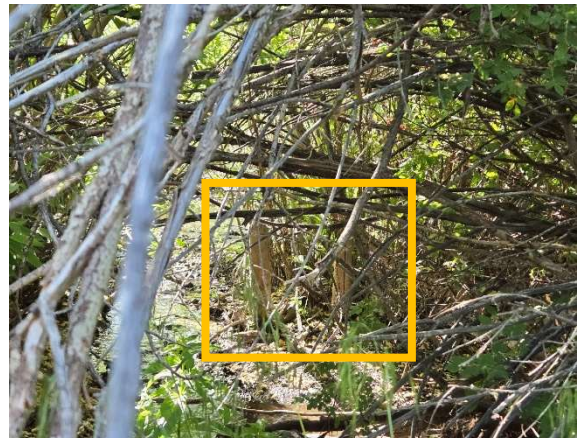
*Fig 28. TU. Previous BDA work on Little Jack Creek (yellow square) showing signs of success: strong vegetation recovery and groundwater (June 2025).*

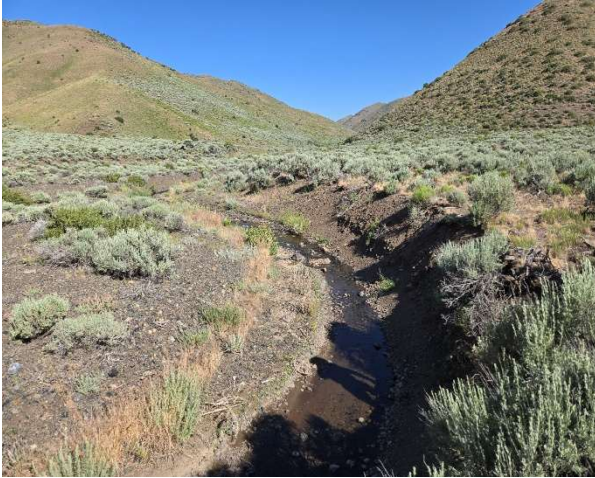
*Fig 30. TU. Riparian fencing, installed by NGM as part of the MCWRP on Little Jack Creek (June 2025).*

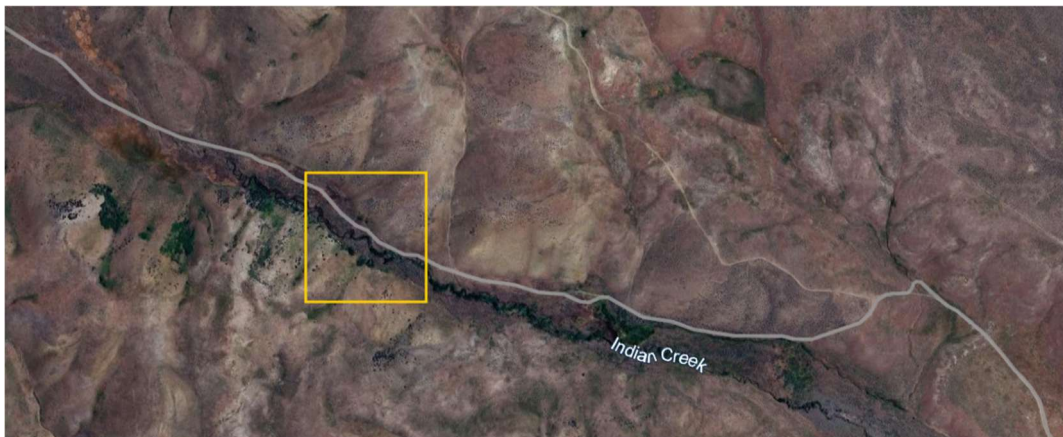
*Fig 32. TU. Large side cut on Indian Creek, where vegetation has grown in well. Encouragement of further growth is recommended (June 2025).*

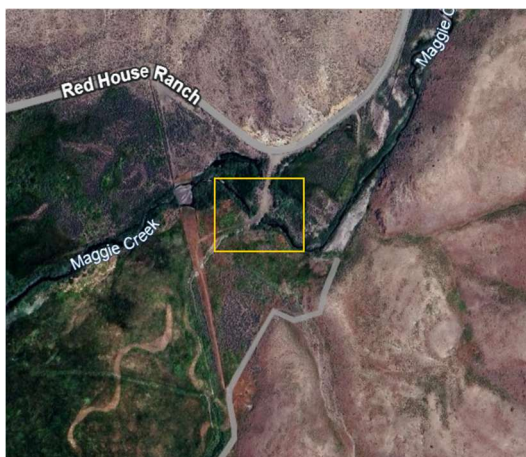
*Fig 34. Google Earth. Location of culverts needing reset on Maggie Creek.*

There is also an irrigation system connected to Maggie Creek next to these culverts. Maggie Creek Ranch management believes there is a leak in the headgate, not in the valve itself but rather the soil surrounding it, leading to uncontrollable water loss. Further investigation is required but may lead to another water conservation opportunity.

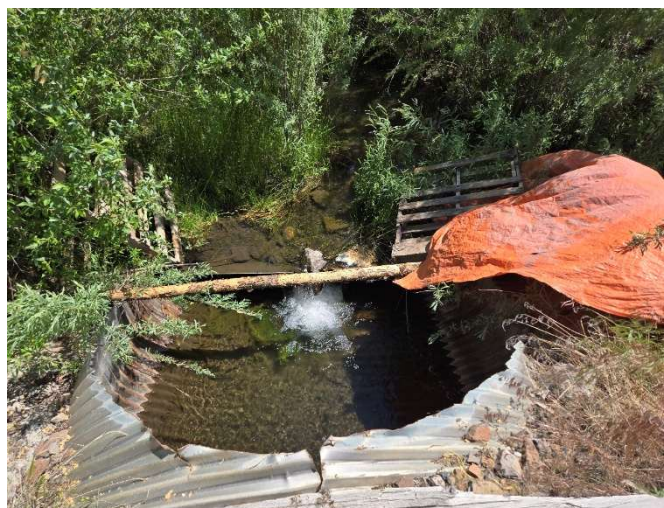
*Fig 35. TU. View of the displaced culverts on Maggie Creek, upstream. A diversion (wood and orange tarp) was built to help control water during high flow periods (June 2025).*

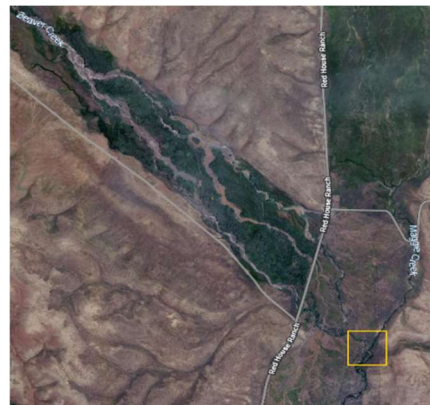
At the point where Beaver Creek confluent Maggie Creek, on Maggie Creek Ranch property, a significant side cut is present (Fig. 36). Here, a few restoration opportunities are presented:

*Fig 36. Google Earth. Location of potential LTPBR work to do at the confluence of Beaver Creek and Maggie Creek.*

Both opportunities are relatively low-cost, but the breadth of work required to stabilize Beaver Creek may require a higher level of effort than a typical Tier 2 project.

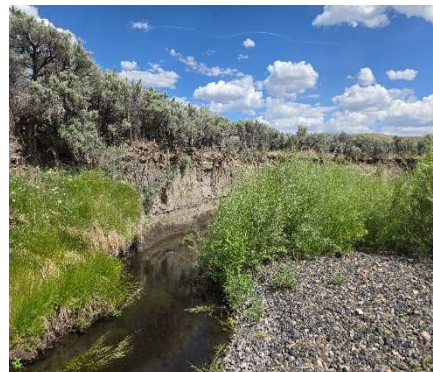
*Fig 37. TU. After Beaver Creek connects, Maggie Creek has a very large side cut (June 2025).*

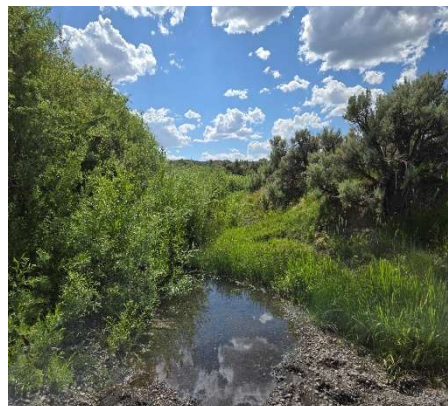
*Fig 38. TU. Before connecting to Maggie Creek, Beaver only has aboveground ponding and inconsistent flow (June 2025).*

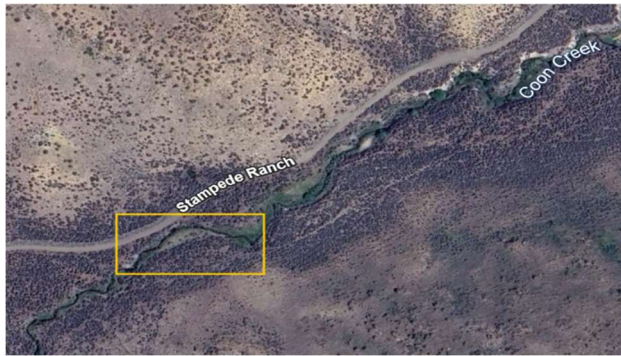
Fig 39. Google Earth. Location of the large side cut on Coon Creek, downstream of the large head cut.

A steep side cut, just downstream from the aforementioned head cut on Coon Creek on 25 Ranch (Fig. 39), poses challenges for the ranch staff. The sudden grade change from the road to the wet meadow is drastic and makes access to the creek below, where cattle can rest, difficult (Fig. 40, Fig 41).

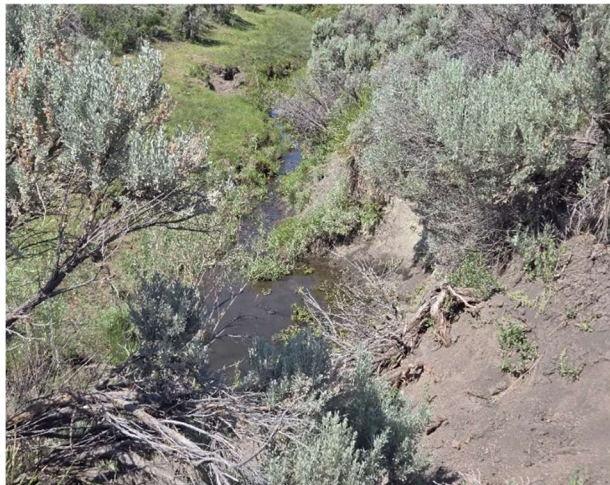
Fig 41. TU. A view of the steep side cut on Coyote Creek (June 2025).

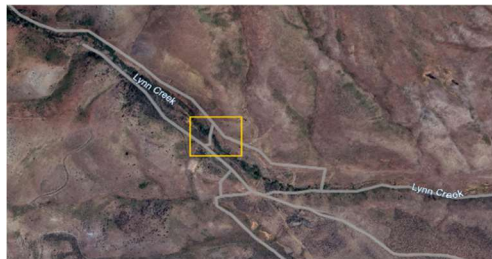
1. Culvert removal and replacement: Four culvert pipes were previously installed. At some point, likely during a high flow period, these shifted and have collapsed on one another (Fig. 43). Some culverts are broken; water is draining from their middle sections and causing soil to erode from underneath the drainages. It is recommended these culverts be removed and replaced entirely. This would be a moderate-cost and high-effort project, as full reconstruction is required and access to the site may be challenging for equipment. Significant grading and earth moving would be necessary here to tie into adjacent slopes to reduce further progression of a headcut and channel incision that has developed downstream.

*Fig 42. Google Earth. Location of the damaged culverts on Lynn Creek.*

2. Potential AML reclamation site: upstream on Lynn Creek, NGM staff mentioned that several potential abandoned mine land (AML) features exist. This poses a risk to the health of Lynn Creek and Maggie Creek during periods of high flow. At the site of the culvert, Lynn is showing a red discoloration of its waters (Fig. 44) indicating the presence of metals and pH fluctuation. Further investigation is a necessity, including an analysis of metals and potential pollutant load in Lynn Creek. If AML reclamation were to become a project, this would be a long-term Tier 4 project.

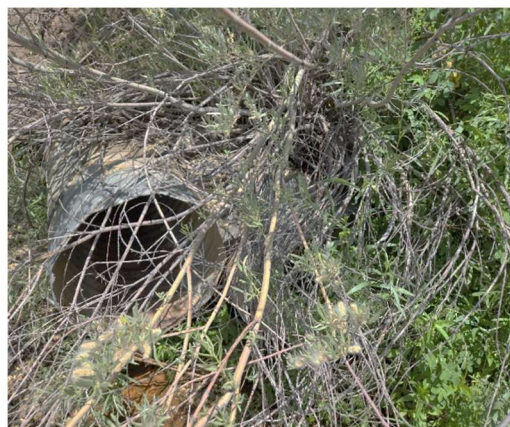
*Fig 43. TU. The damaged culverts beneath vegetation cover on Lynn Creek. While not visible, four culverts are collapsed here. (June 2025).*

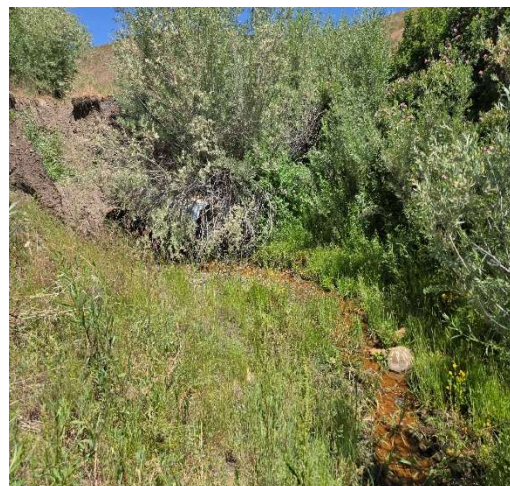
*Fig 44. TU. At the collapsed culverts on Lynn Creek, red water drains, possibly due to an upstream AML (June 2025).*

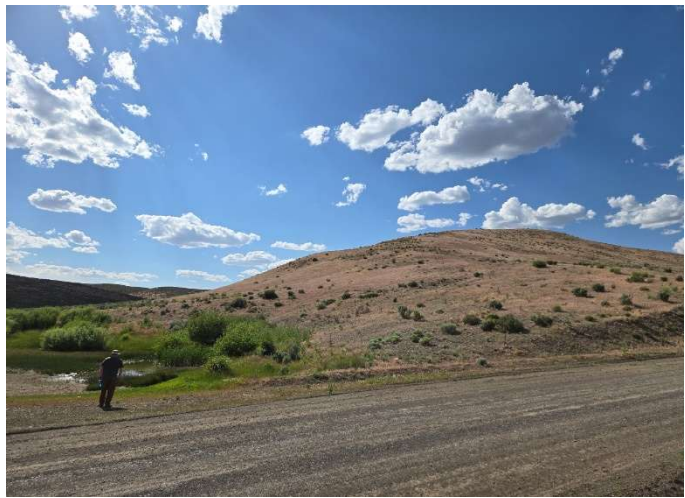
Being the driest state in the United States, with a monthly average precipitation of 0.7 inches, fire is an unfortunately common occurrence in Nevada (Nag, 2019). Management at Maggie Creek Ranch has experienced the impact of wildfire firsthand. On hills neighboring Maggie Creek (Fig. 45), fire had decimated the landscape and even overtook Maggie Creek and its associated riparian vegetation (Fig. 46).

*Fig 46. TU. The effects of the Maggie Creek fire are still present, as shown by the lack of native vegetation on the hillside (June 2025).*

This project will be a large undertaking; it is not specific to one region on Maggie Creek Ranch - fires happen sporadically - so resiliency work will need to be a broad-scale, whole-watershed effort. To start, identifying primary sites for noxious weed removal and riparian fortification will be necessary. Efforts can be targeted in those areas and then spread more broadly to the entire watershed, prioritizing regions where the USDA Forest Service's (USFS) Elko Front Landscape Project and the BLM Elko District's Fire Management Plan overlap (USDA Forest Service, 2025) (BLM Elko District Office, 2023). A lasting relationship with partners and experts in fire mitigation and invasive weed removal, such as BLM and USFS, will be vital to ensure proper management strategies are implemented.

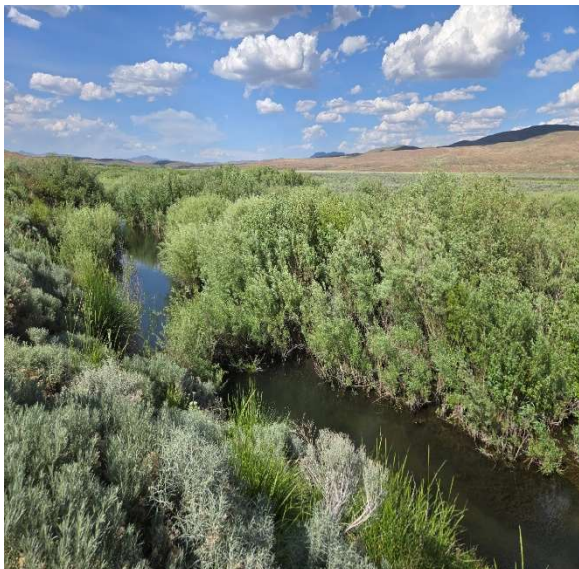
Fortunately, Maggie Creek has recovered well: vegetation has regrown, and beavers are present (Fig. 47). Maggie Creek Ranch management have a strong interest in further fortifying the watershed on their property to increase fire resiliency, protecting their grazing lands and the surrounding habitat.

*Fig 47. TU. Maggie Creek has recovered well from the wildfire, with revegetation and beaver activity seen (June 2025).*
