5. Human Interaction With the Watershed

5.1 *Historic Period Human Interaction With the Watershed*

5.2 *Geomorphic Effects of Human Disturbance on Streams*

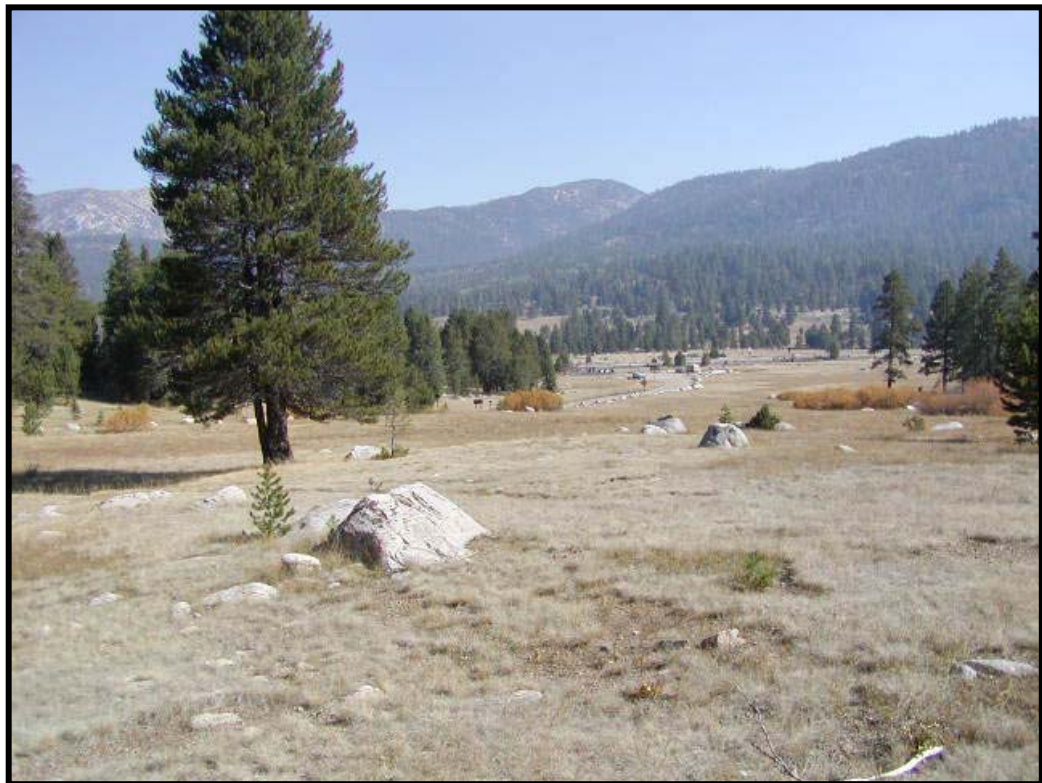
Figure 5.1 Hope Valley in 1934 and 2004.

Evidence of forest change was found in historic photo comparisons. The amount of forested area has increased in recent history. For example, in photos of Hope Valley (Figure 5.1), note the treeline on the opposite side of the valley in 1934. Then note the treeline in the current photo. Over the last seventy years, the forest has moved almost all the way to the valley bottom. Figure 5.2 provides a comparison of forest composition over time. The first photograph is of Markleeville in the late 1800s. The hills behind Markleeville are bare; the forest had been completely harvested. Note the absence of disturbance or stumps. Areas comprised of brush and small trees can be seen in the distance at the right of the photo. These data suggest that the forest may not have extended all the way to the Markleeville town site in prehistoric times. In the more recent picture, from about 1955, the forest is encroaching on the town. Figure 5.3 provides a comparison of the Silver City area in the 1860s and at present. In the 1860s photo, stumps are evident in the foreground and downed logs are present on the far right hillside. These data suggest heavy logging activity during the mining era. The few remaining trees are tall and lack limbs at the lower level. Bedrock is evident and low brush cover is present in many areas, including around the cabin in the foreground. The prevalence of brush suggests that the prehistoric forest in this area may have had a higher proportion of brush cover that is present today. The recent photo shows a dense forest of trees with limbs that extend almost to the ground. Also, the forest cover extends onto rocky slopes where brush cover was prevalent in the 1860s photo.

As noted previously, the dominant land use impact in West Fork meadows has been grazing. Figure 5.13 shows a 1866 photo of Hope Valley. It was likely taken near where a gravel pit is now located just upstream of the Highway 88 crossing. The photo looks across the West Fork, and the stream bank on the far side shows very heavy grazing pressure. Cobbles and bare dirt on the floodplain in the background also attest to heavy grazing pressure. Note also the well-developed road in the background, which was probably the immigrant trail. If the date attributed to this photograph is correct, it strongly suggests that grazing and other land uses were impacting the channel not long after initial European settlement of the area. Grazing continued until about 20 years ago in the Hope meadows and until the late 1980s in Faith Valley. Evidence of forest change was found in historic photo comparisons. In Figure 5.9, note the relative size of the trees in the historic photo and the current photo. Trees in the historic photo are much taller, with limbs absent at the bottom, indicating an open, park-like condition (if all the trees were present). Trees in the current photo are much smaller with limbs all the way to the ground, limiting the amount of grass and forbs that can grow under the forest canopy. Substantial recreational use also occurred on the meadows (see Figure 5.1).

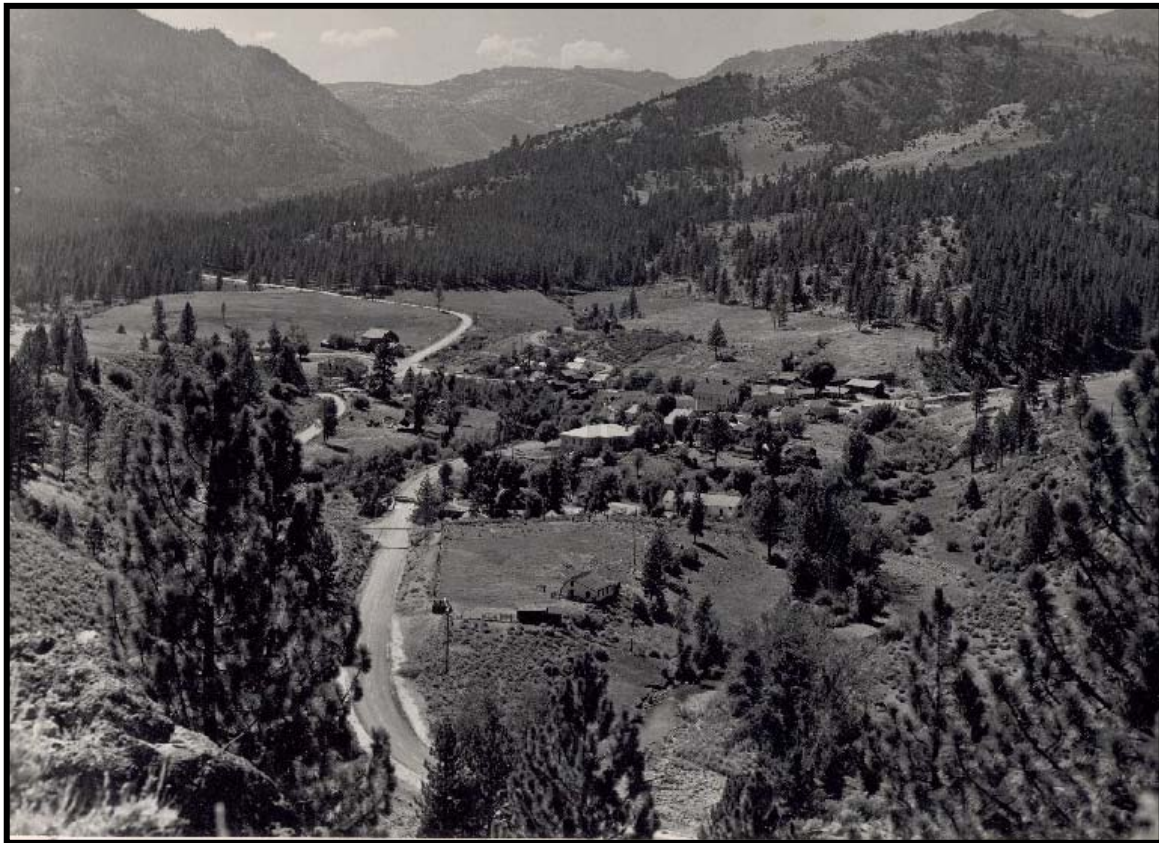
Figure 5.2 Markleeville in about the 1870s and in 1935.

As noted in section 5.1.9, forest expanse and structure has changed in the historic period. Historical photographs appear to support these general trends in forest structure. In several locations, the assessment team was able to take modern photographs from the same location as historic photos (see Figures 5.1 through 5.3). These changes in forest structure are likely to increase the intensity of future fires. Forest stands are denser, fuels are more abundant, and the multiple canopies provide ample ladder fuels (Chang 1996). Intense, stand-replacing crown fires are most likely. Erosion rates typically increase substantially after such fires, and more sediment, both coarse and fine, is supplied to channels.

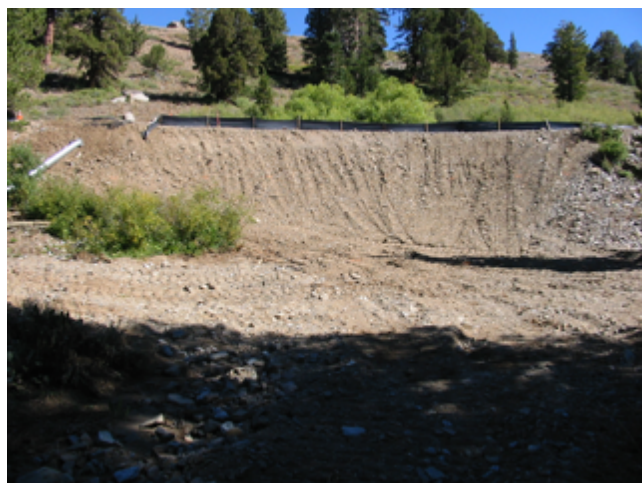
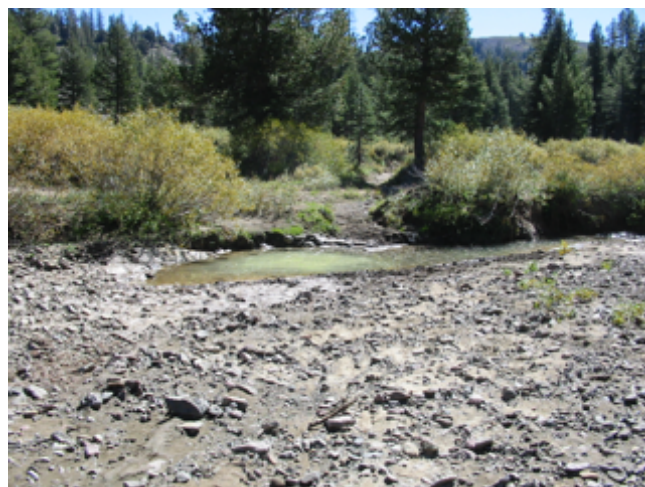
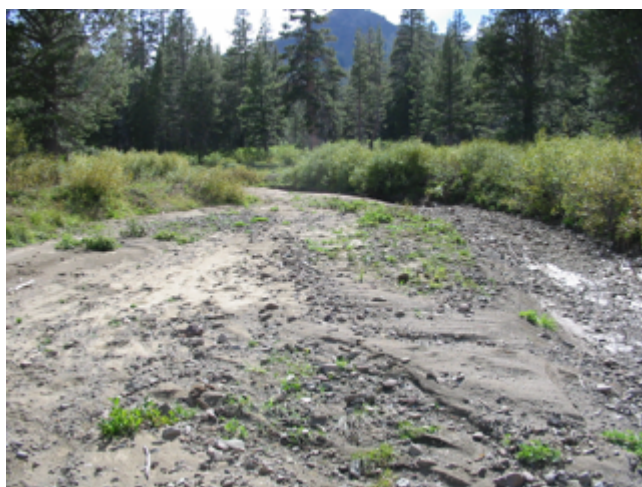
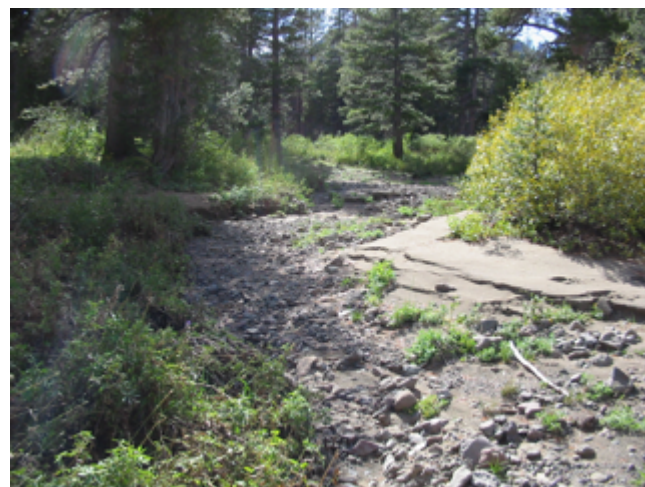
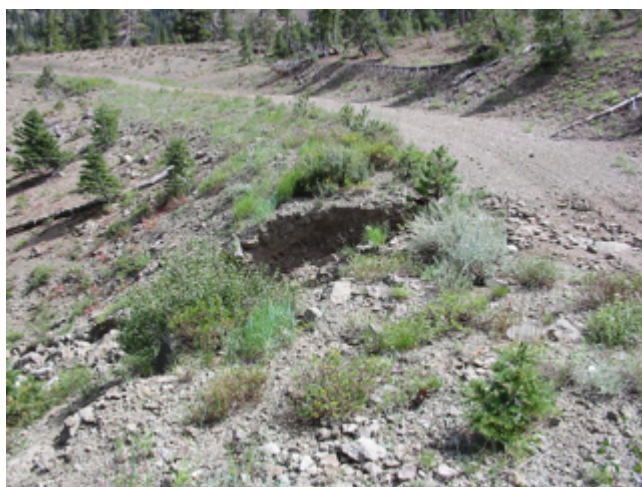
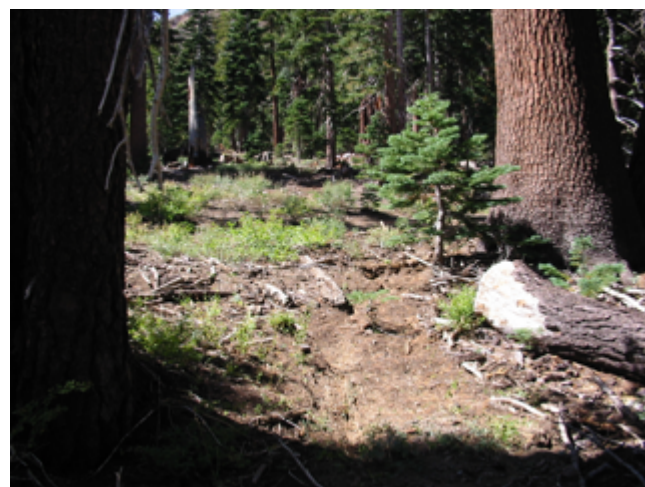
Figure 5.5. Charity Valley Creek sediment survey photos.

A tributary to the main channel is located about 500 feet upstream of where the Blue Lake Road sediment entered the channel. That tributary also transported substantial sediment during the storms (Figure 5.5, Photo CV033). The assessment team surveyed the area to determine the source of the sediment in the tributary. In a few locations, sediment supplied to the tributary exhibited a human influence. A road embankment failure near the middle of the watershed supplied fine and coarse sediment to a gully that enters the tributary (Figure 5.5, Photo CV016). This was the only site located along the tributary that contributed significant quantities of coarse sediment. Other roads or skid trails, generally small and old, had rills and gullies that likely contributed some fine sediment (Figure 5.5, Photo CV017), but no other large-scale failures could be found.

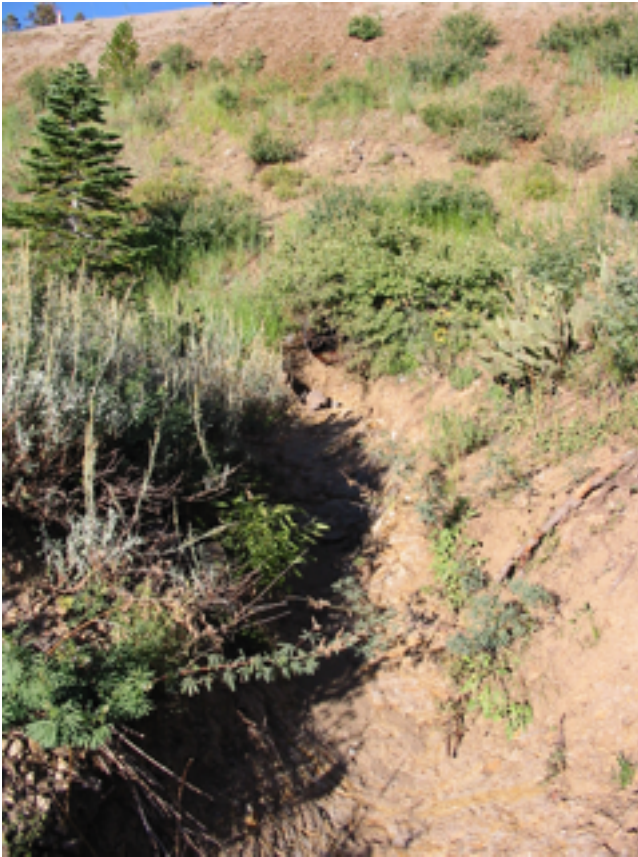
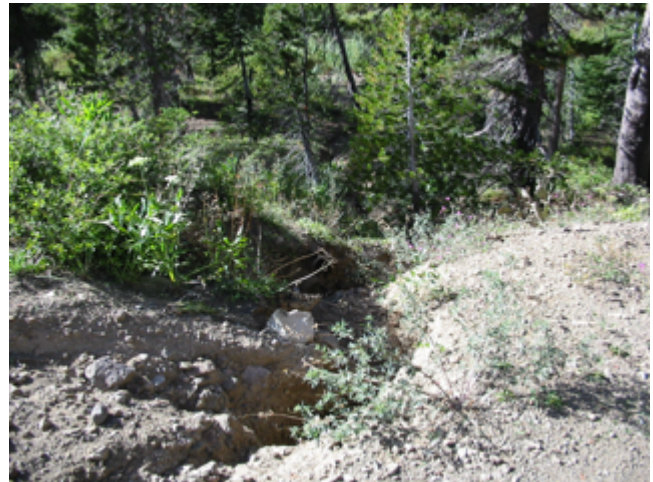
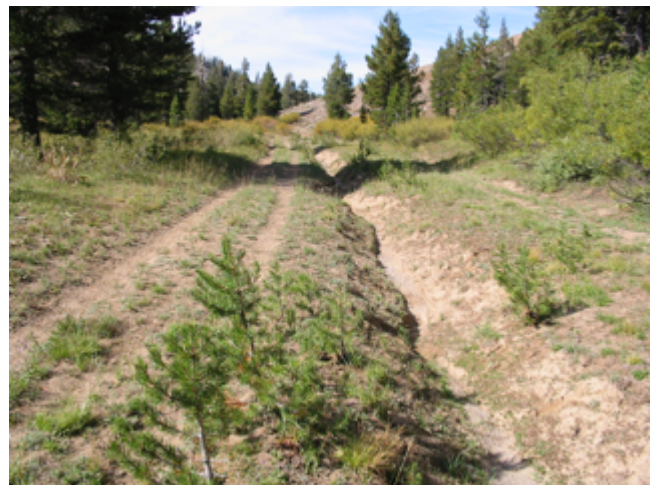
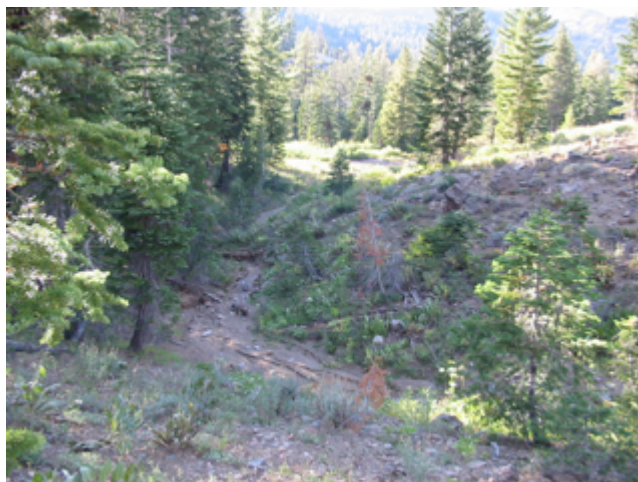
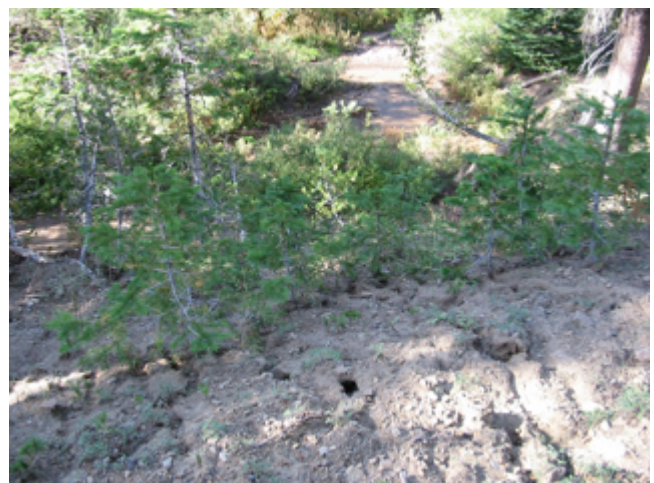
Figure 5.7. Charity Valley Creek sediment survey photos.

Several light duty dirt roads contribute sediment to stream channels in other portions of the watershed. Problems were caused by the concentration of flows. For example, a culvert under the Blue Lakes road contributed to the creation of a gully through concentration of flow on the downstream side (Figure 5.7, Photo CV051). Embankments on Forest Service roads have gullied in several locations due to concentration of flow on road surfaces (Figure 5.7, Photo CV043). The concentration of flow along roads or in ditches also has created erosion along a road in a riparian area (Figure 5.7, Photo CV031). Less substantial rills and gullies are common on both fill and cut slopes throughout the watershed (Figure 5.7, Photo CV042), though similar rills and gullies were observed on many undisturbed slopes.

Road crossings over existing drainages can also be sources of sediment. The gully below the Blue Lakes road culvert (Figure 5.7, Photo CV051) crosses a Forest Service road further down slope (Figure 5.7, Photo CV052). High sediment transport to the crossing from upstream has filled the culvert. As a result, the road itself is susceptible to failure during future flood events.

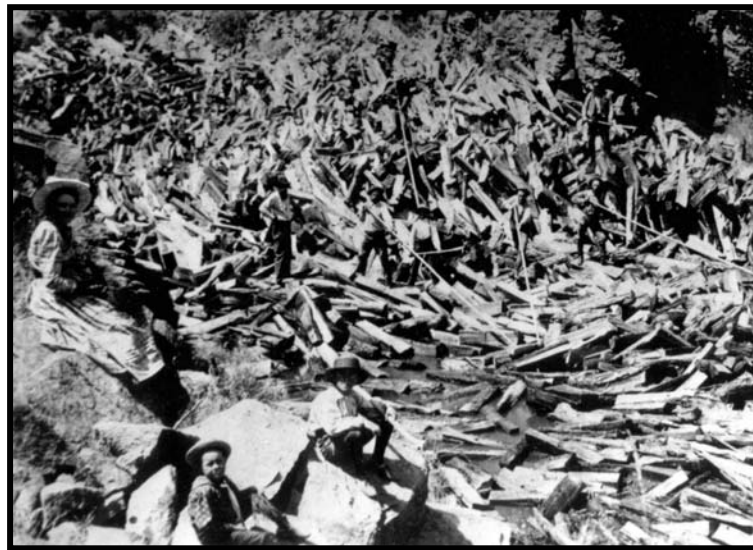
Figure 5.8 Log jam along the East Fork of the Carson River, late 1800s.

Logs from timbering operations higher up in the watershed were rafted through a portion of the lower Carson in the latter part of the 19th century. Although the team could find no direct evidence regarding where these drives took place, they may have occurred in the lower portion of the assessment area. These drives took place during high water in the late winter and spring. The scale of the drives may have been quite large (Figure 5.8), and there is evidence that log jams from the drives impacted flooding (California DWR 1991).

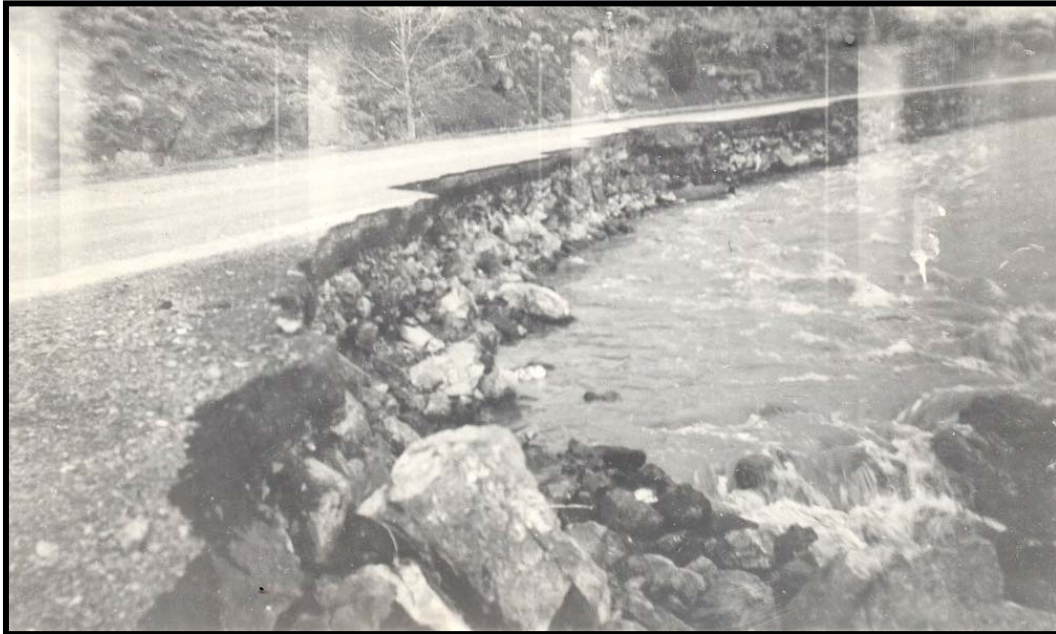
Figure 5.12 Highway 89 flood photo pairs, 1937 and 1955.
