DIXIE AND HANKS CREEKS TEMPERATURE TMDLS

OCTOBER 2010

Prepared by:
Randy Pahl
Nevada Division of Environmental Protection
Bureau of Water Quality Planning

Dixie and Hanks Creeks Temperature TMDLs

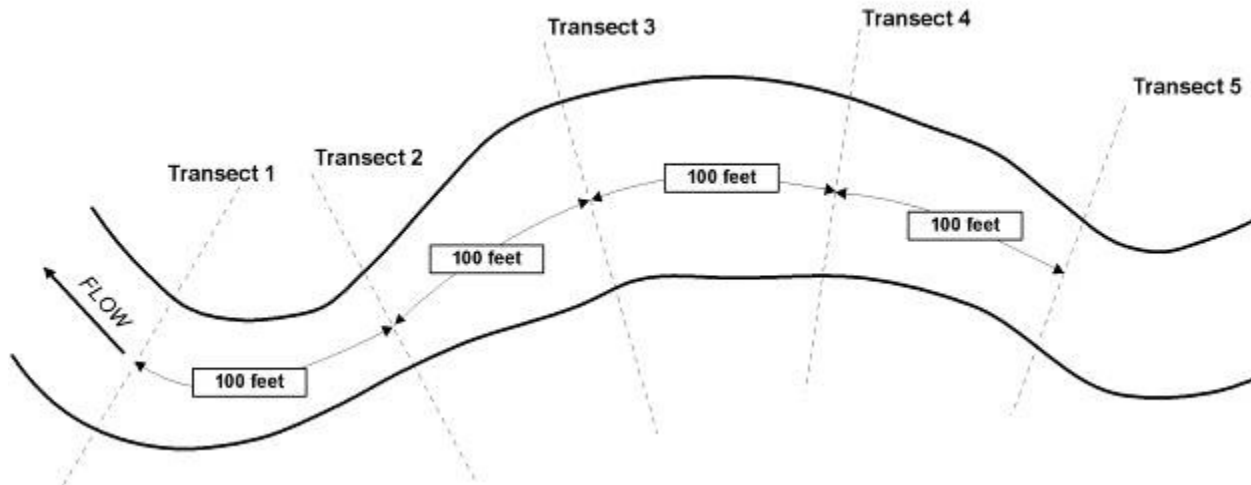
At each survey site, five cross-sectional transects (T1 – T5) are placed 100 feet apart with T1 at the downstream point (Figure 3). At each transect, a bank cover rating and a bank stability rating are estimated for both the left bank and the right bank extending 50 feet above and below the transect. Ratings vary from 0.5 to 2.0 as shown in Tables 2 and 3. The overall bank cover rating for the site is equal to the sum of the 10 subreach cover ratings, and the overall bank stability rating is equal to the sum of the 10 subreach stability ratings. A maximum rating of 20 can be achieved if all subreaches have a rating of 2.0. From the bank cover and bank stability ratings, BLM calculates a riparian condition rating by adding the bank cover and bank stability ratings and dividing by the total number of points. The resulting riparian condition calculation can vary from 25% to 100% of optimum. See Appendix A for

example photographs for each rating.

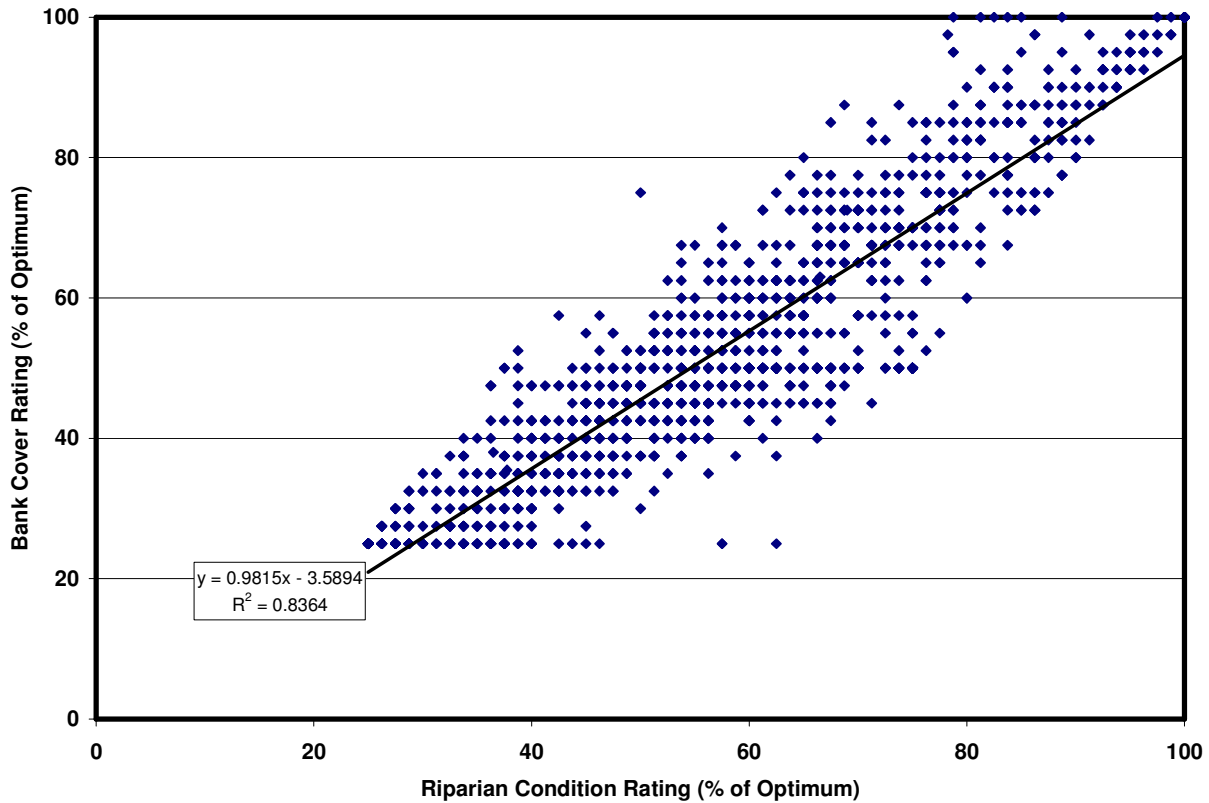
Figure 5. Bank Cover Rating vs. Riparian Condition Rating

As discussed earlier, BLM's riparian condition rating incorporates both the bank cover rating and the bank stability rating. However, it was determined that bank stability conditions could not be readily estimated from the NAIP imagery, but bank cover conditions could. Therefore, the bank cover rating has been selected as the surrogate for the riparian condition rating. An evaluation of the nearly 30,000 datapoints in the BLM database indicated a good correlation between riparian condition rating and the bank cover rating (see Figure 5). This is not surprising as the bank cover scores make up ½ of the riparian condition ratings. Also, channel health is needed to facilitate vegetation health so one would expect a reasonable relationship.

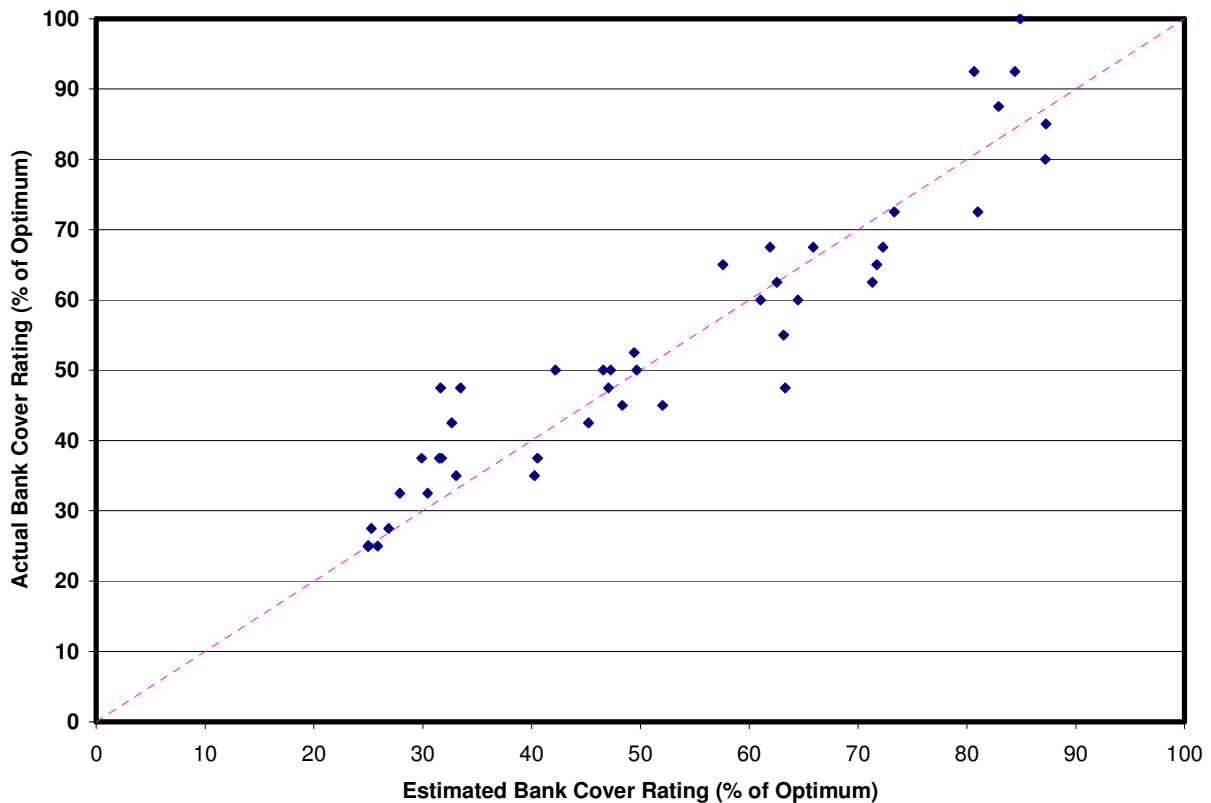
Figure 10. Predicted Bank Cover Rating vs. Actual Bank Cover Ratings

When applied to the 46 selected sites, this relationship provided very reasonable estimates of the actual bank cover ratings for those sites (Figure 10). This relationship was deemed to be more than adequate for estimating bank cover conditions throughout Hanks and Dixie creeks.

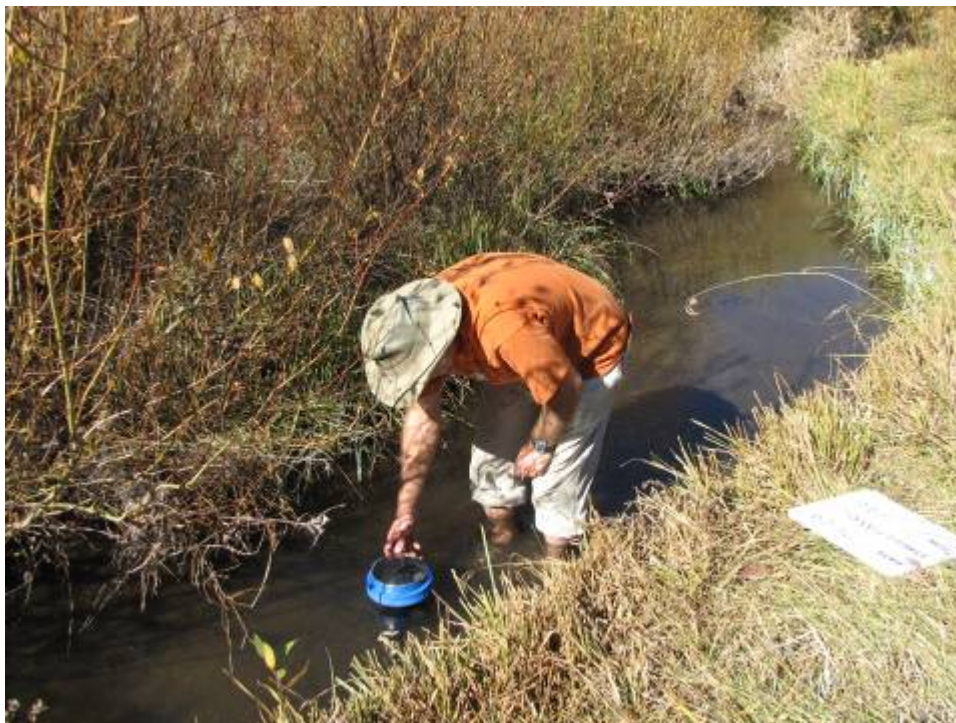
Figure 12. Setting Up the Solar Pathfinder

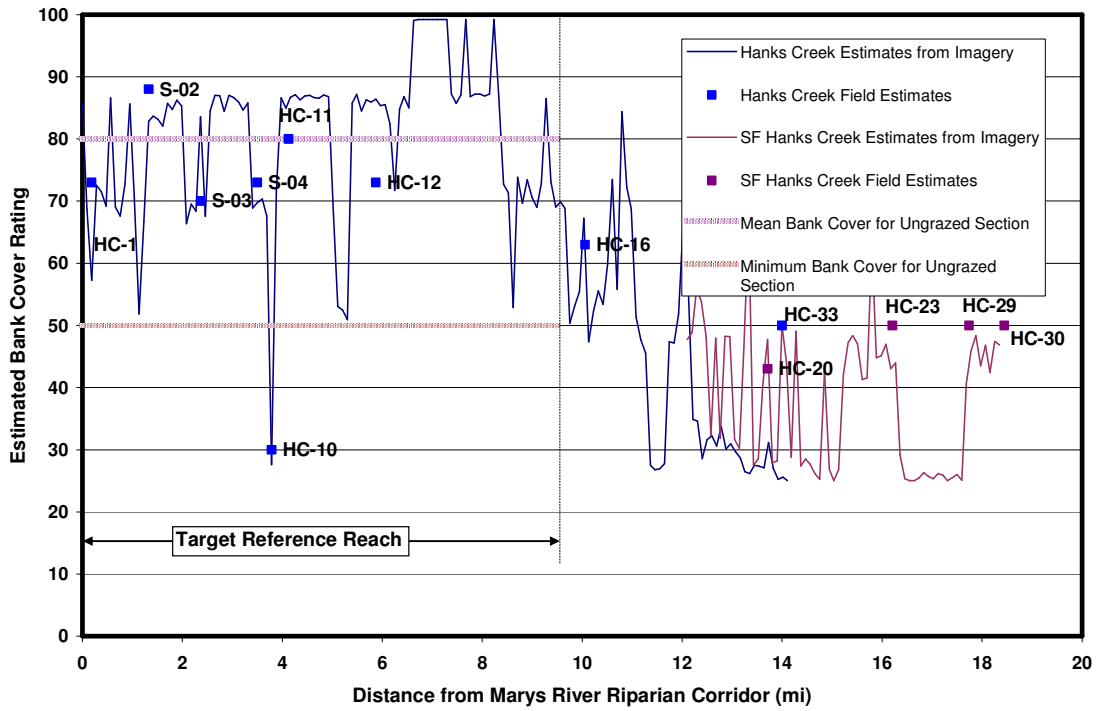
Figure 13. Estimated Bank Cover for the Target Reference Portion of Hanks Creek

Using Equation 1 and 2006 NAIP imagery (collected prior to recent wildfires), bank cover conditions were estimated for Hanks Creek and SF Hanks Creek (Figure 13). Field estimates were also performed during the summer of 2009 at selected sites (Figure 14). For the lower 9.5 miles, bank cover conditions ranged from about 30 to nearly 100. However the low value at HC-10 is due to the existence of a water gap where livestock are allowed access to the stream for drinking water. The other locations with low bank cover values (0.2, 1.1, 5.3 and 8.6 miles) are thought to be part of the natural variability of the system. Excluding the HC-10 location, the bank cover for the lower 9.5 mile portion of Hanks Creek has an average value of 80 and a minimum value of 50. These values will be used as the target for these TMDLs.

There is considerable uncertainty associated with the individual bank cover estimates (approximately ± 15) depicted on Figure 13. For any given location along the creek, there is a 95% certainty that the actual bank cover value falls within the range represented by the Prediction Interval lines on Figure 15. If the uncertainty associated with individual predictions using Equation 1 were considered, the actual range of bank cover conditions (excluding the HC10 section) could vary from 37 to 100.

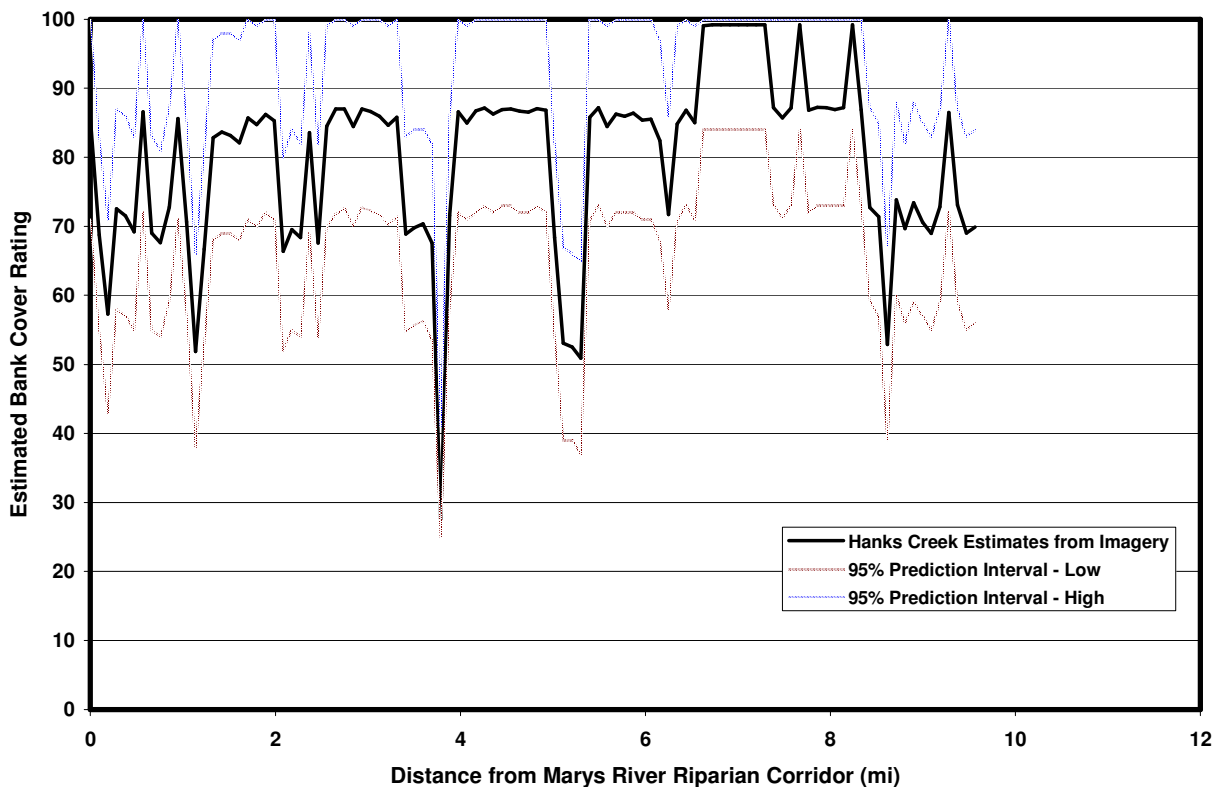
Figure 15. 95% Prediction Interval for Bank Cover Estimates on Lower Hanks Creek

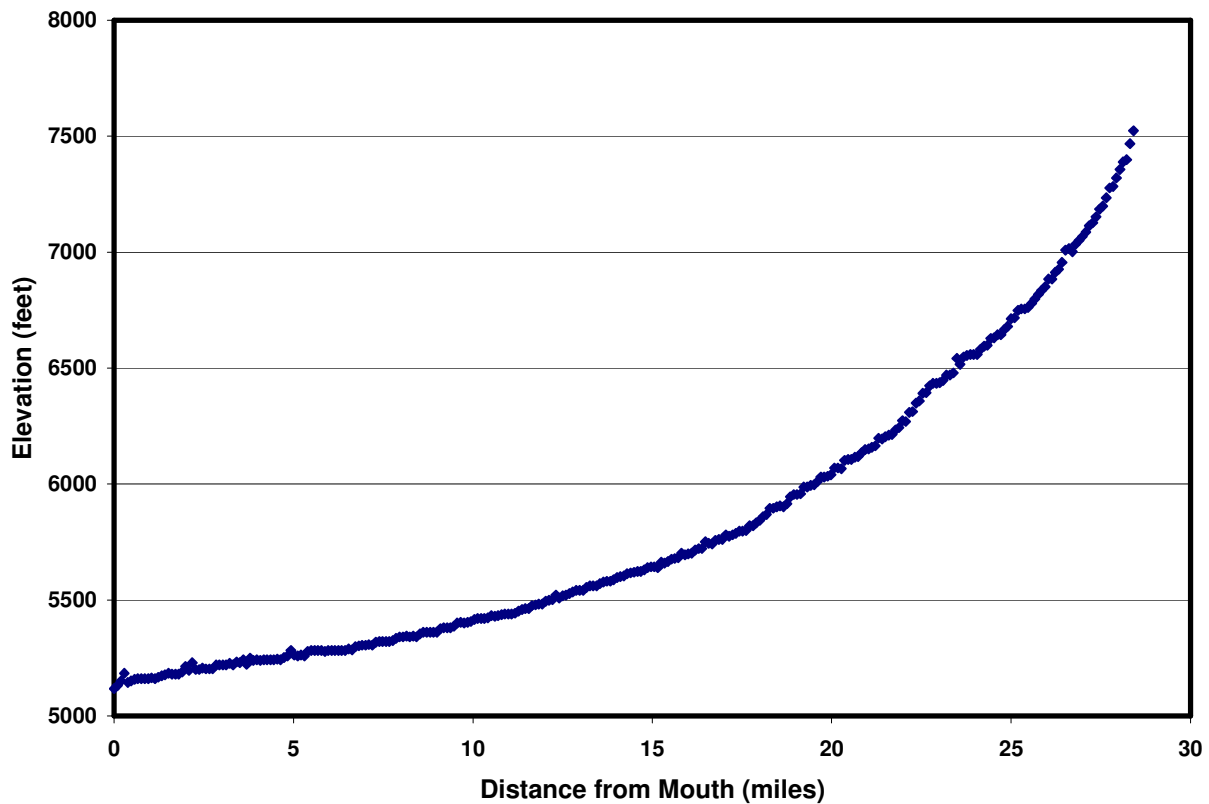
Figure 22. Dixie Creek Stream Profile

Dixie Creek is a small stream with widths typically less than 6 feet (Schroeter, 2001), and a typical parabolic shape to the stream profile (Figure 22). Slopes range from about 5% in the upper reaches to about 0.05% in the lower 10 miles of the creek. Much of lower 21 miles of Dixie Creek is incised to some degree, with depths as high as ~15 feet in some areas (Figure 23). However, new floodplains have been developed in many reaches providing areas for riparian vegetation establishment.

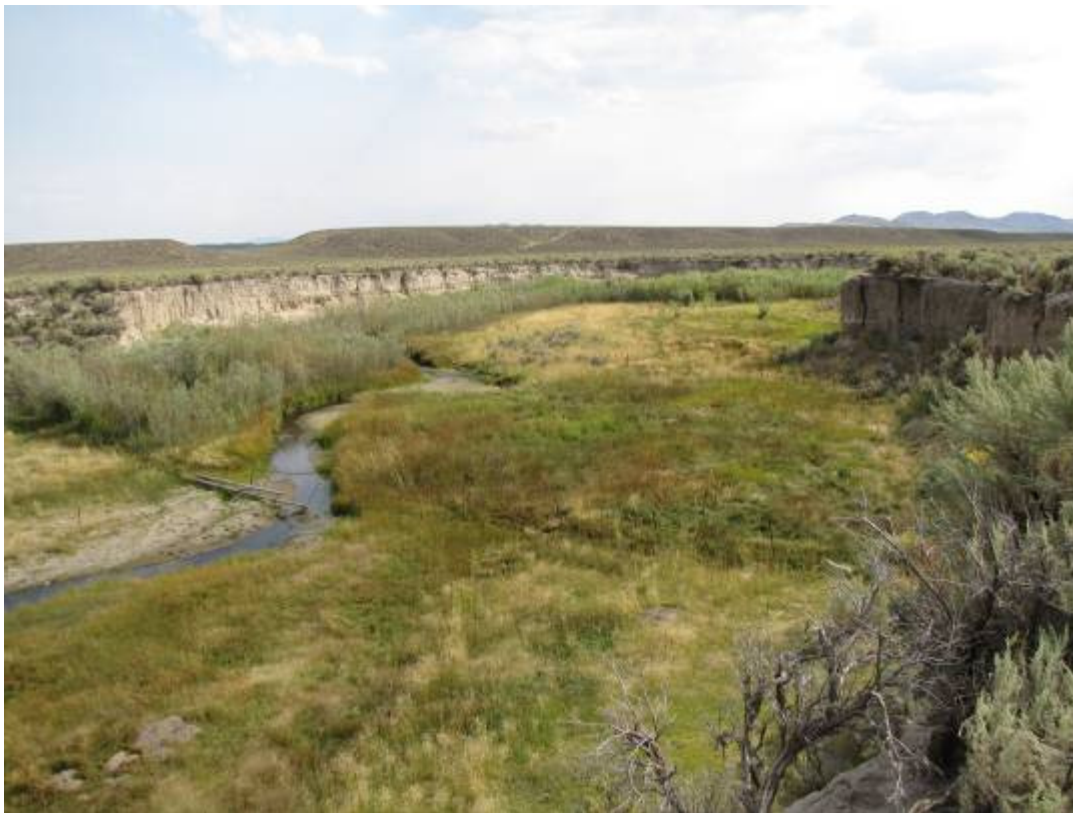
Figure 23. Deep Incisement in Dixie Creek about 6.5 Miles from Mouth

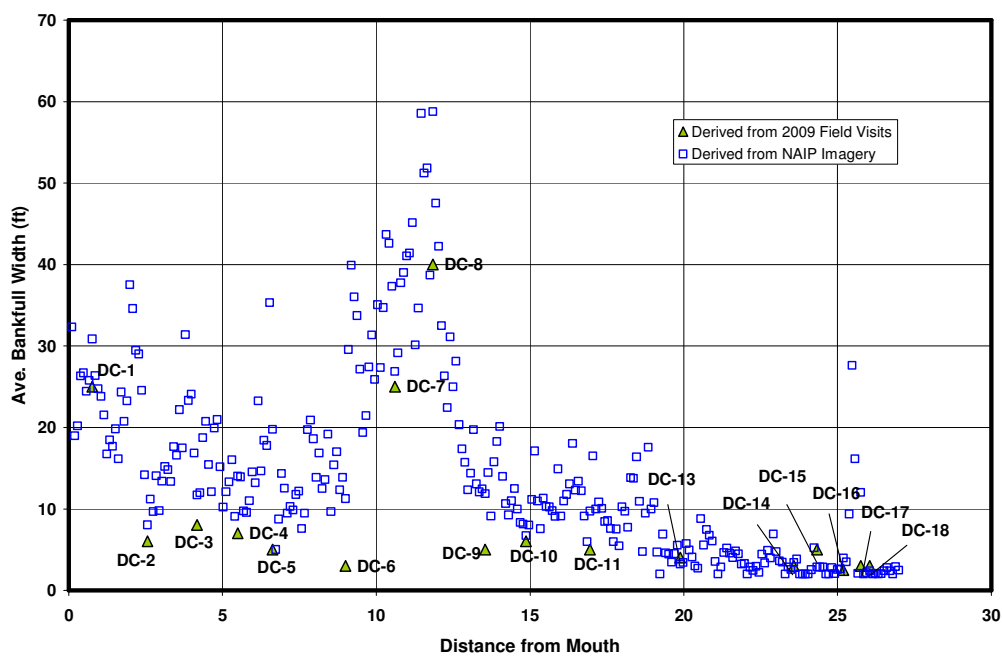
Figure 24. Dixie Creek Existing Bankfull Widths

Bankfull widths vary from about 1-2 feet in the headwaters to 40 feet and higher in the mid-section of the stream (Figure 24). The higher widths tend to occur in those areas with limited perennial flow.

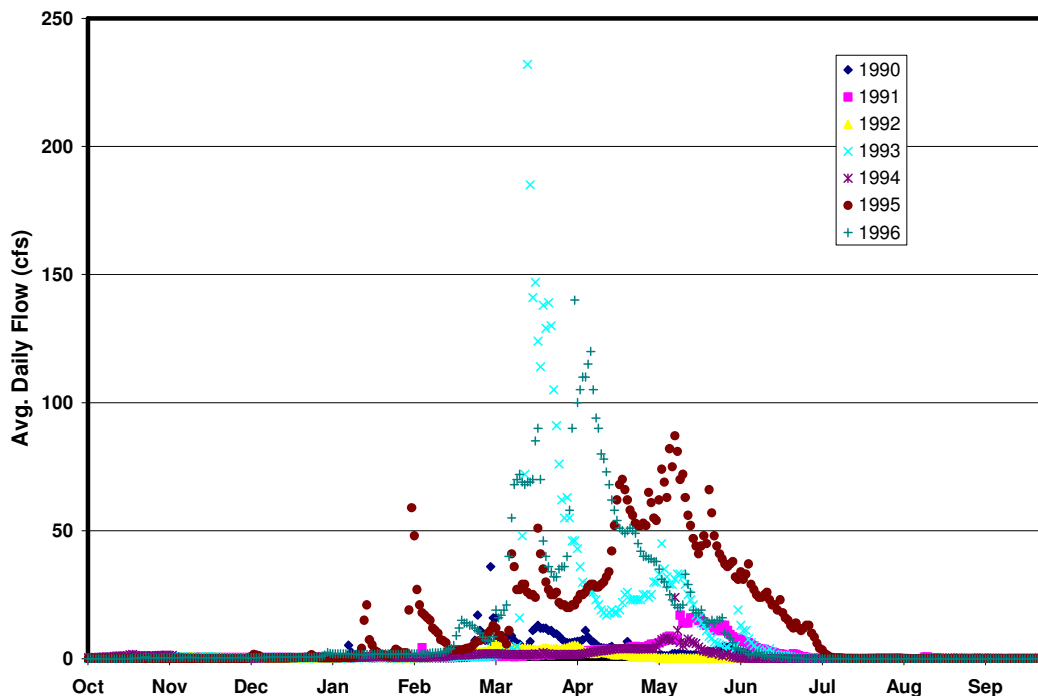
Figure 25. Average Daily Flows at 10320100 – Dixie Creek above South Fork Humboldt River near Elko, NV.

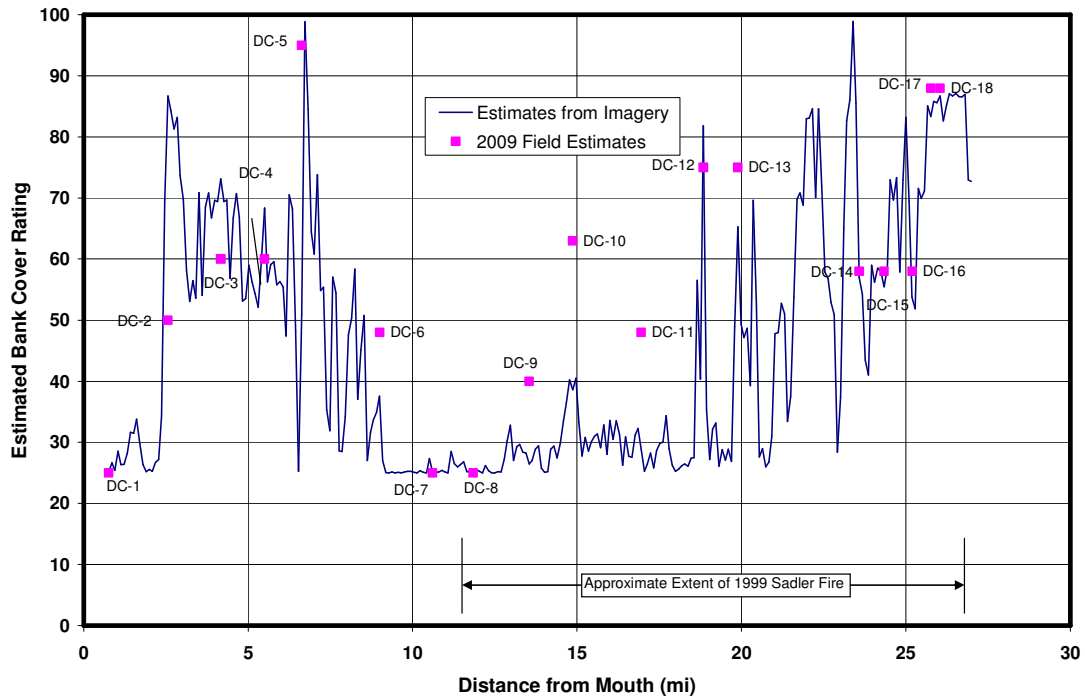
Figure 30. Dixie Creek – Existing Bank Cover Rating

For the reach from Mile 11.4 to origin, Dixie Creek fell within the limits of the 1999 Sadler Fire (Figure 30). As a result, several important riparian areas were burned or experienced delayed mortality. This no doubt affected the conditions depicted on the 2006 imagery and observed during the 2009 field work. However, Nevada Department of Wildlife reports indicated that the condition of the riparian vegetation was already in poor to fair conditions prior to the 1999 fire (Schroeter, 2001). It is uncertain what factors led to these poor/fair conditions observed by NDOW. Grazing does occur in parts of this reach, however the impacts to the riparian vegetation are uncertain. Other factors such as beaver activity, channel conditions and soils may play a role in shaping the extent of the riparian conditions.

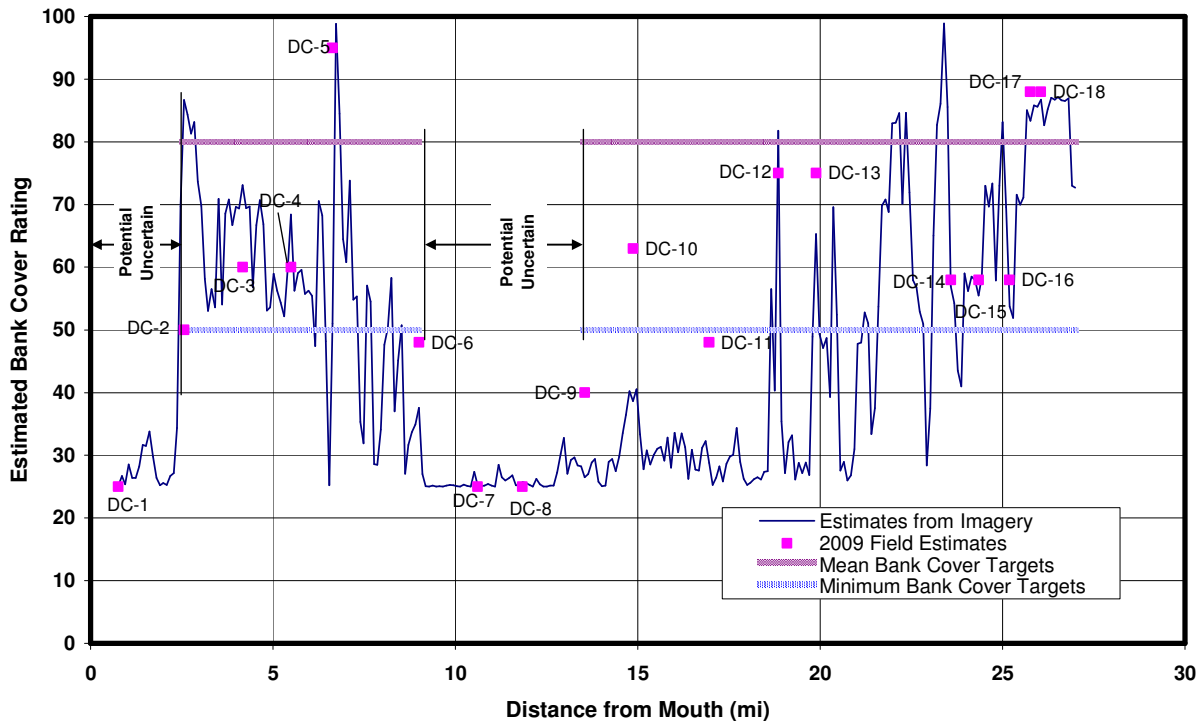
Figure 31. Dixie Creek – Existing and Target Bank Cover Rating

Figure 31 presents bank cover conditions as estimated using the 2006 NAIP imagery and bank cover targets for Dixie Creek. Of the approximately 20 miles with assigned targets, only about 14% of Dixie Creek exceeds the mean bank cover target of 80, with about 54% exceeding the minimum bank cover target of 50. The actual percentages are expected to be somewhat higher as conditions between DC-9 and DC-12 have improved since the 2006 NAIP imagery was collected.

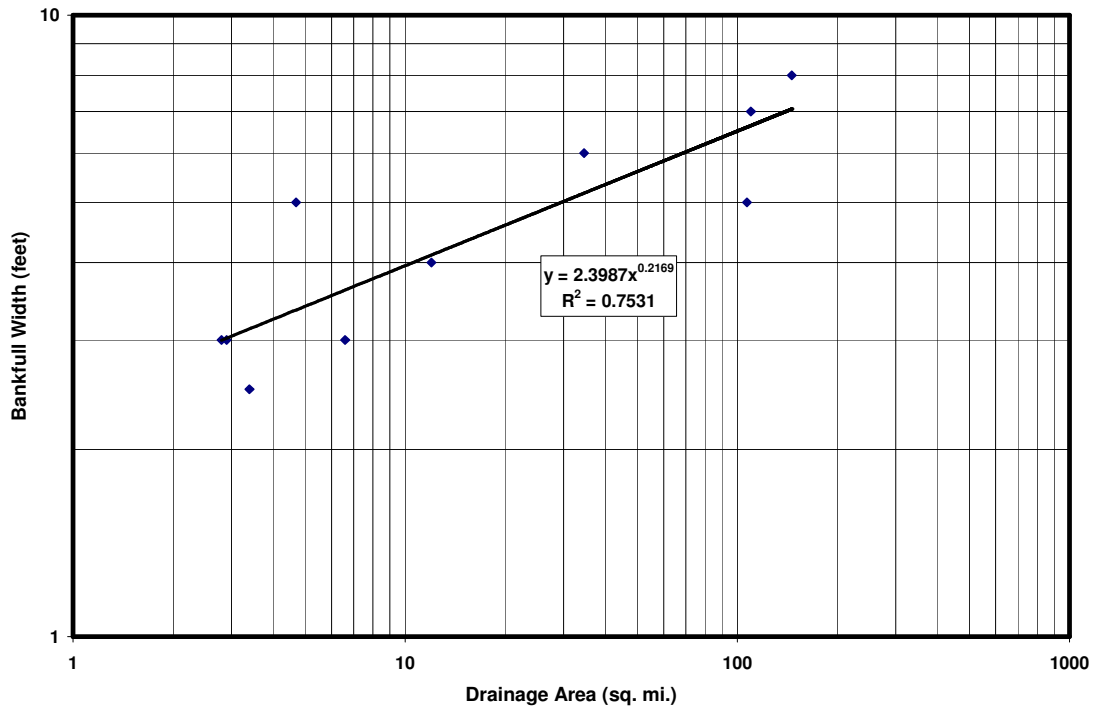
Figure 32. Drainage Area vs. Bankfull Width – Dixie Creek Stations Near or exceeding Bankfull Targets

Target Loads: Target loads were calculated using the same model inputs as the existing loads, except for stream width and vegetation density. The target bankfull widths were assigned based upon the widths for the healthier locations within Dixie Creek. Using data for selected 2009 field survey sites with bank cover conditions near or above the bank cover targets, a relationship between bankfull widths and drainage area was developed and was used to develop target bankfull widths (Figure 32).

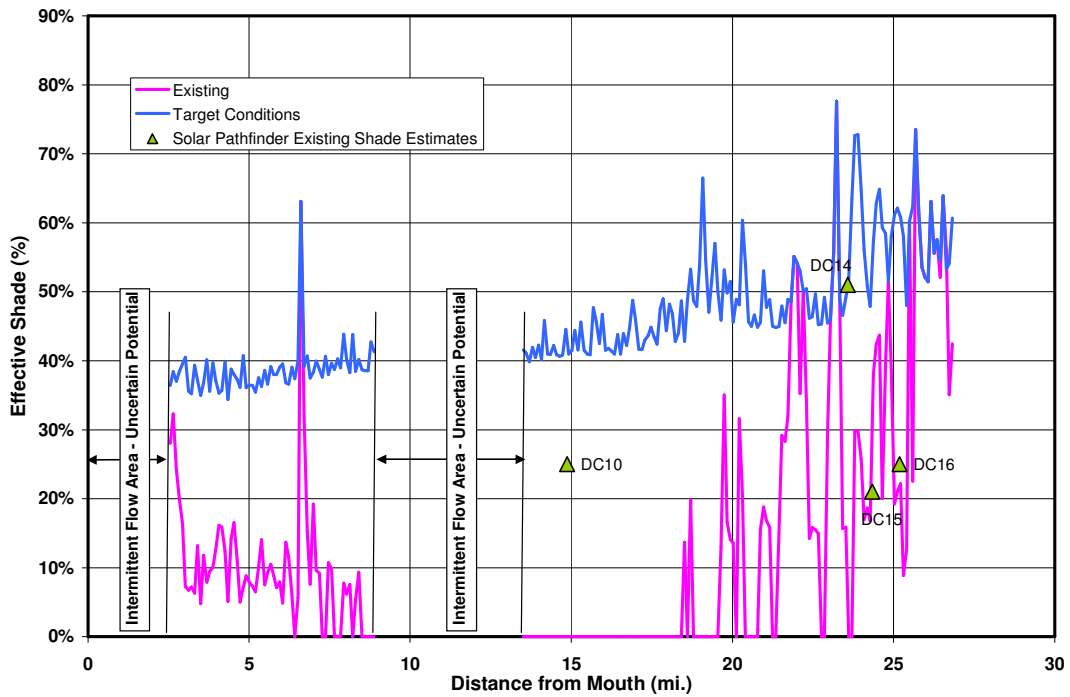
Figure 33. Dixie Creek – Effective Shade – Existing and Target Conditions

Allocations and Load Reductions: The existing and target shade and solar radiation loads as estimated using the Heat Source Model are shown in Figures 33 and 34. Shade estimates from the Solar Pathfinder were close to those estimated using the Heat Source Model, with the exception of DC-10 which has experienced improved riparian conditions since the 2006 NAIP imagery was generated.

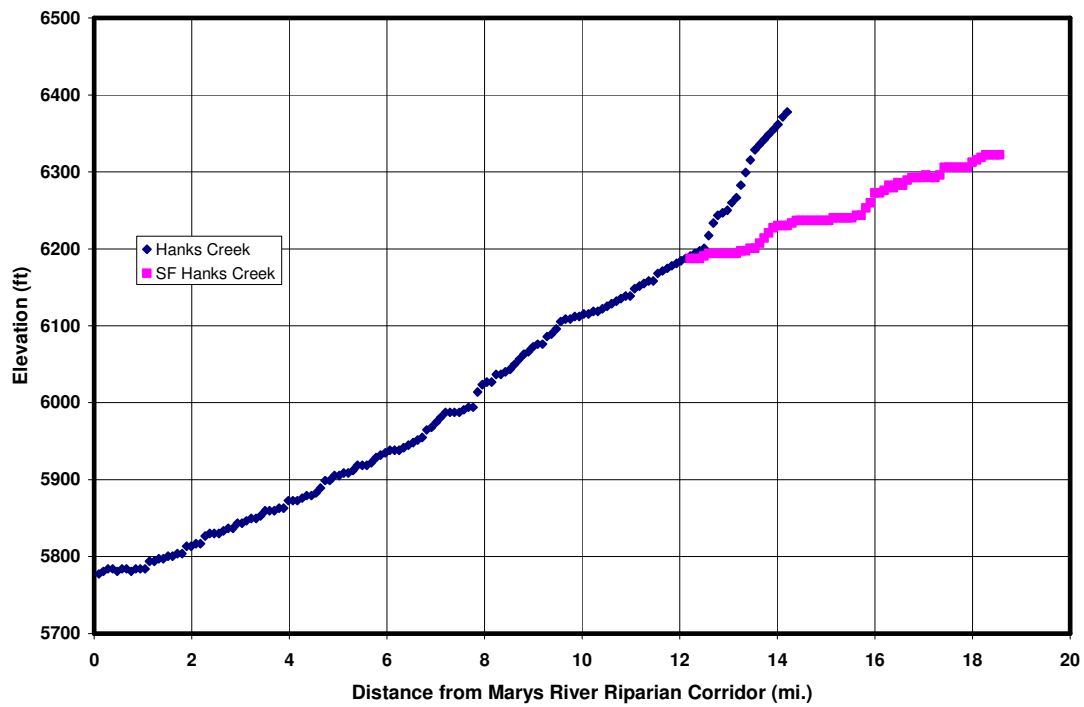
Figure 40. Hanks Creek and SF Hanks Creek Stream Profiles

Hanks Creek and its main tributary, SF Hanks Creek, are small streams with widths typically less than 6 to 8 feet as derived from field visits and the 2006 NAIP imagery (Figure 39). Slopes are not as variable as in Dixie Creek, with gradients ranging from about 2% in upper Hanks Creek to 0.5% in lower Hanks Creek (Figure 40).

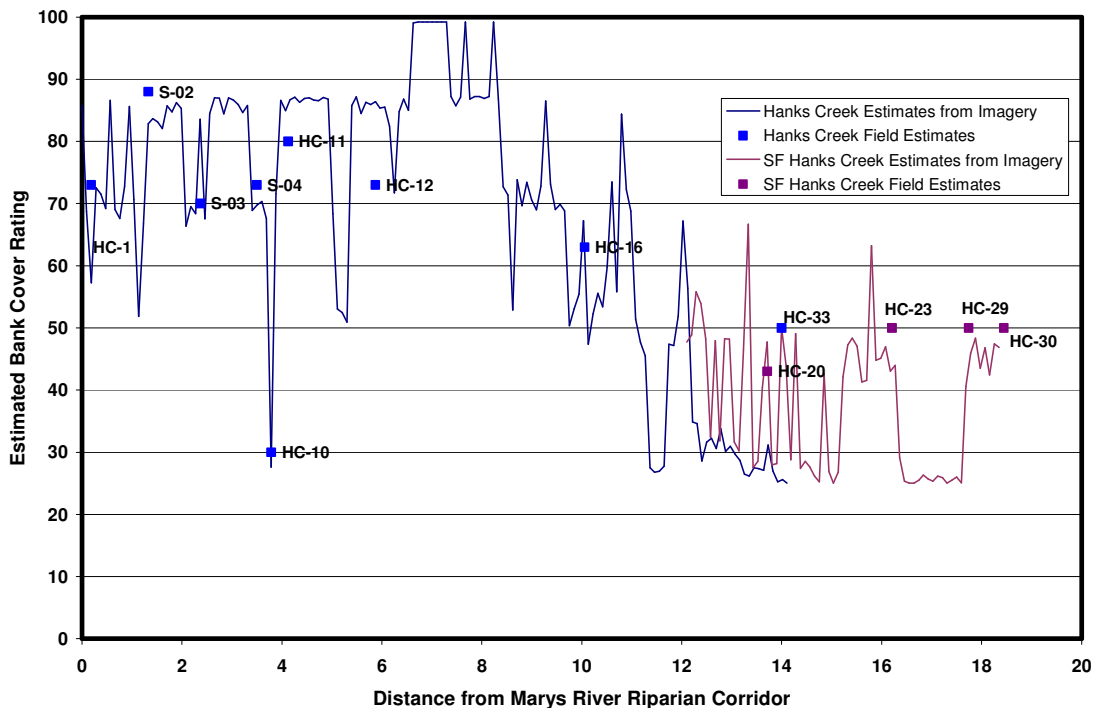
Figure 45. Hanks Creek and SF Hanks Creek – Existing Bank Cover Rating

Based upon the 2006 NAIP imagery, SF Hanks Creek has bank cover ratings ranging from 25 to around 60. The source of the inadequate riparian vegetation along SF Hanks Creek is uncertain. BLM records show no evidence of any fires in this reach for the last several decades. The available information suggests that flows are not a limiting factor. Possible causes for the reduced riparian vegetation could be grazing and/or natural conditions such as channel conditions, soils, etc. Nevertheless, BLM staff believe the bank cover targets are achievable in this reach.

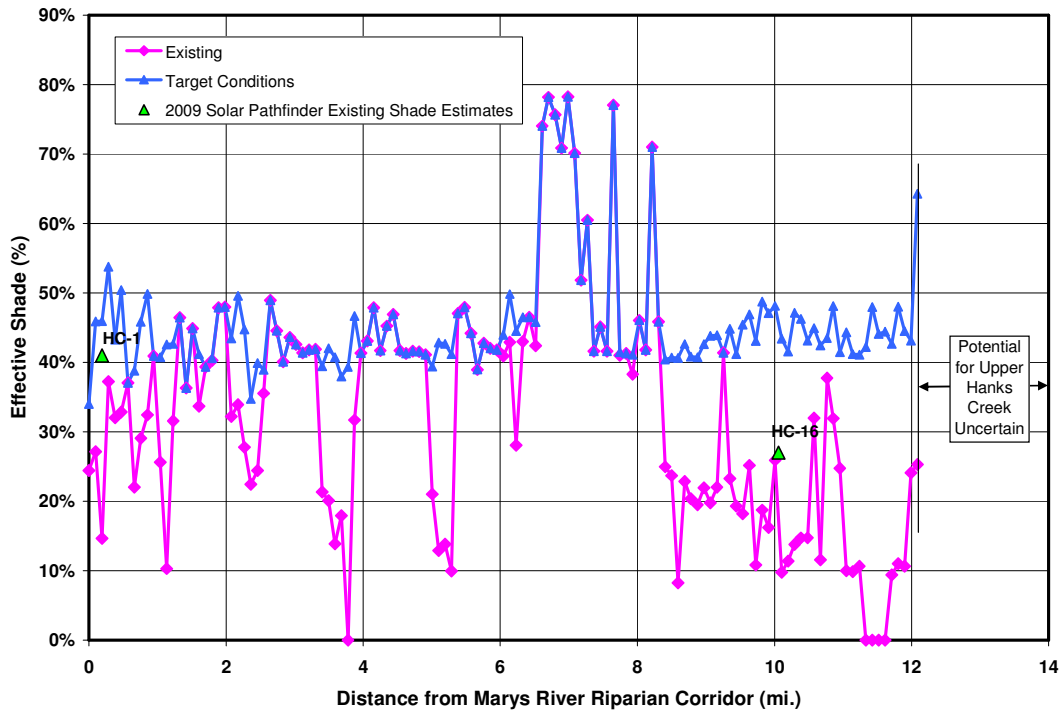
Figure 48. Hanks Creek – Effective Shade – Existing and Target Conditions

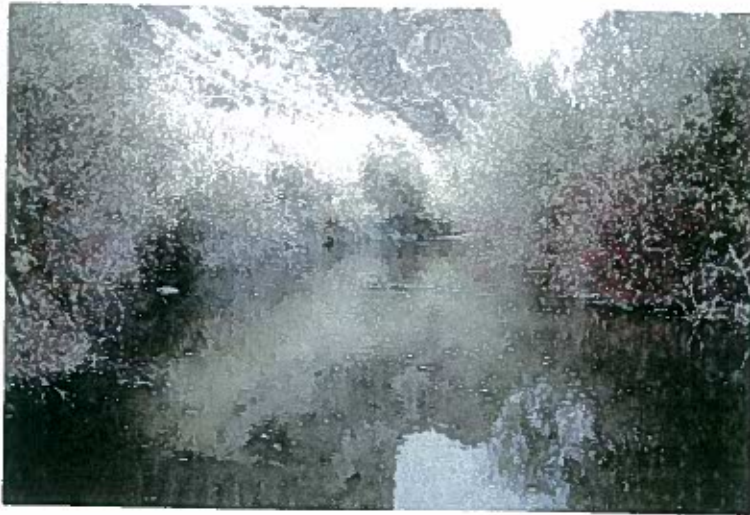
2.0 Cover

Height, density and proximity of the willow/dogwood riparian community give this site a rating of 2.0.

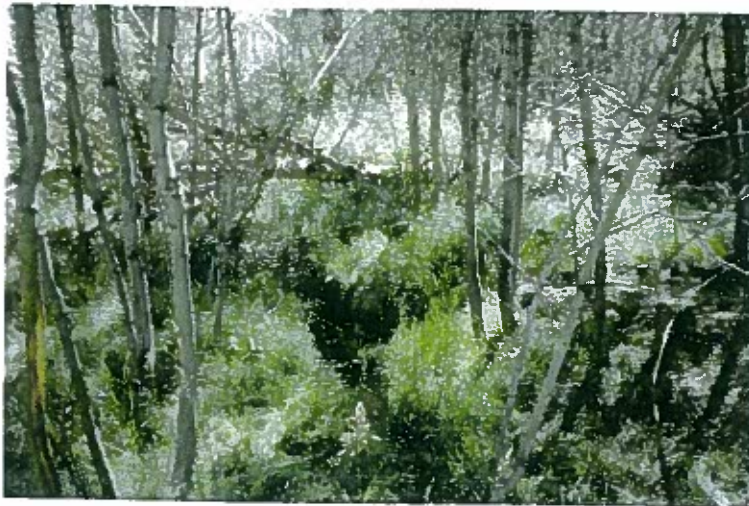
2.0 Cover

Height and spacing of aspen saplings form the basis of this 2.0 cover rating. Openings between aspen do not exceed ten feet.

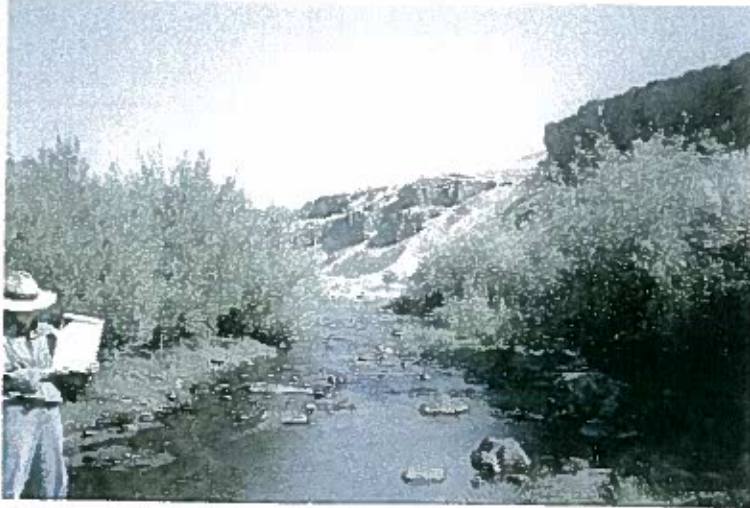
1.5 Cover

Although a small grassy floodplain exists between the willow corridor and the base-flow stream channel, the willows are within half their height of the water's edge and are therefore included in the evaluation of streambank cover. The height of the willows, as well as the presence of two or more ten-foot openings, gives this site a rating of 1.5. This example represents the upper end of the 1.5 cover category.

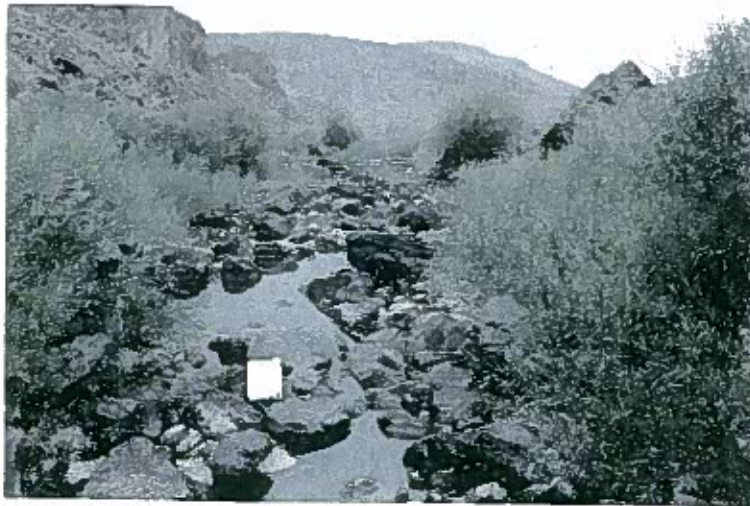
1.5 Cover

Willow height and density are the basis for a rating of 1.5 at this site. Willows here are more scattered than in the previous example, but they are sufficiently dense to warrant a rating of 1.5.

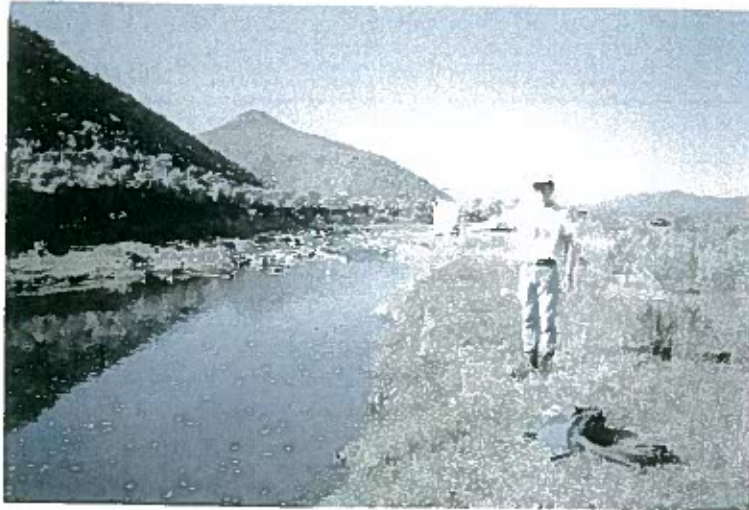
1.0 Cover

Although grazed, herbaceous riparian cover remains medium to heavy, resulting in a rating of 1.0.

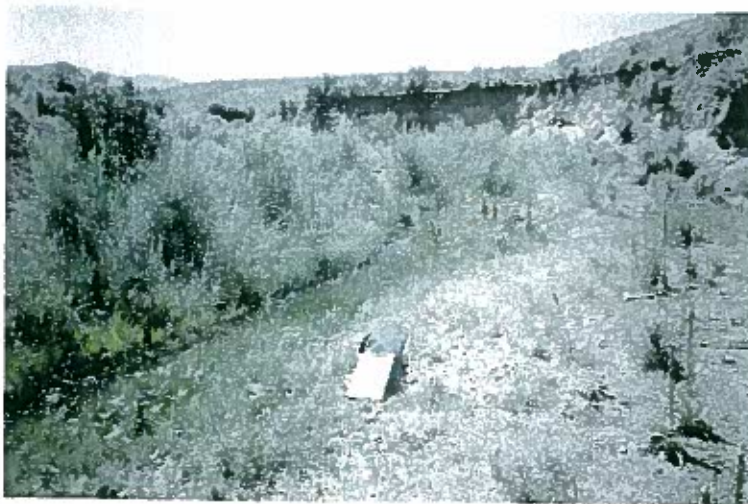
1.0 Cover

At this site, both streambanks support combinations of medium to heavy cover of low to medium shrubs (in this case, willows), riparian grasses, and forbs. This example represents the upper end of the 1.0 cover class.

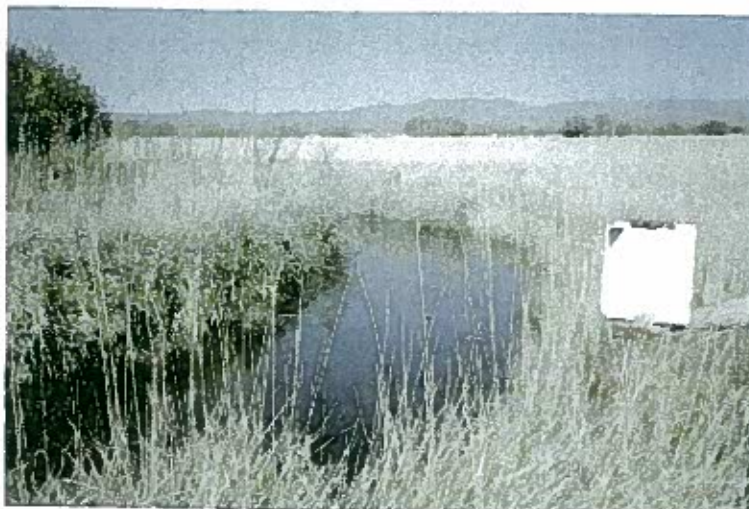
1.0 Cover

Streambanks are heavily covered with a combination of riparian forbs, grasses and grass-like species. Although not specifically identified in the cover description, it is important to include riparian grass-like species such as sedges and rushes in the assessment of streambank cover.

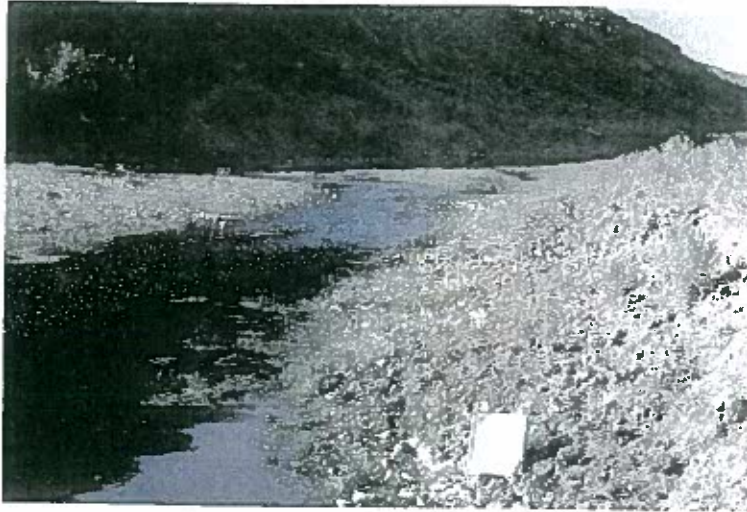
0.5 Cover

This example represents the lower end of the cover class description. The few riparian forbs and grass species are present are widely scattered and the streambanks are exposed.

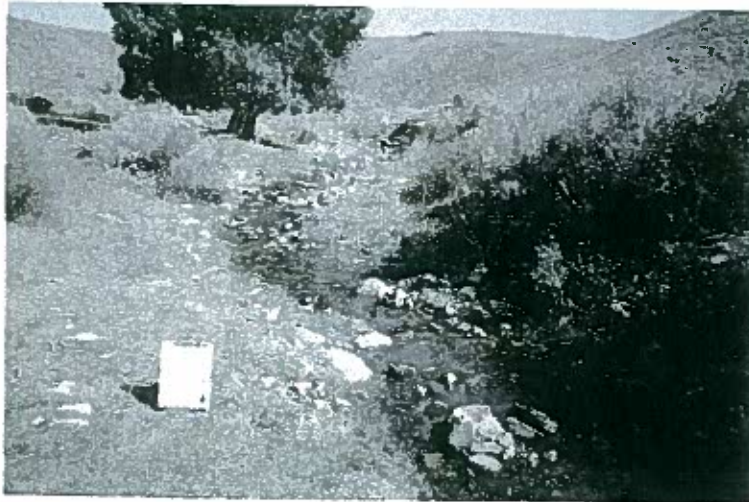
0.5 Cover

Although there are riparian grasses and forbs present, the amount of bare ground precludes the site from being characterized as supporting medium to heavy cover. Note that the presence of a few large trees does not change the overall cover rating of 0.5.

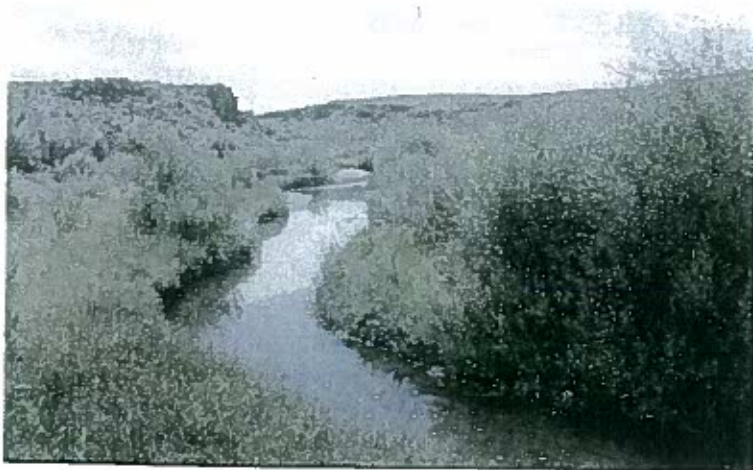
2.0 Stability

Near complete cover of herbaceous and woody riparian species and their associated root masses make these streambanks very stable. The occasional downstream point bars are within the bankfull channel and should not be evaluated in the context of streambank stability.

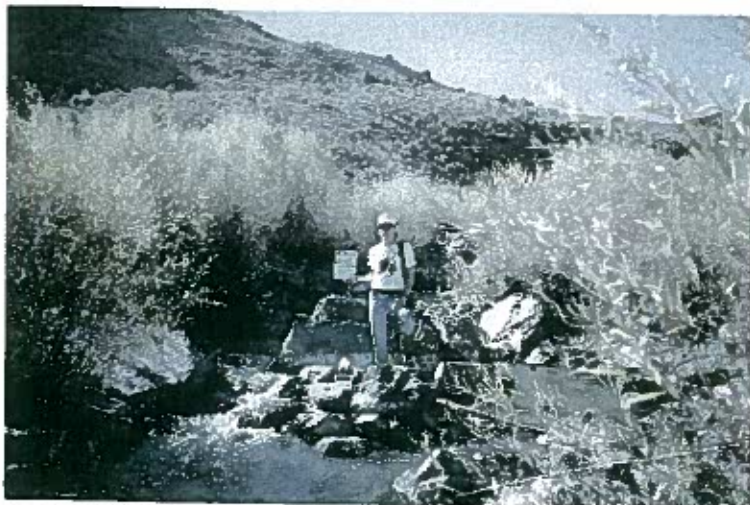
2.0 Stability

A combination of boulders and vigorous willow growth make these streambanks extremely stable.

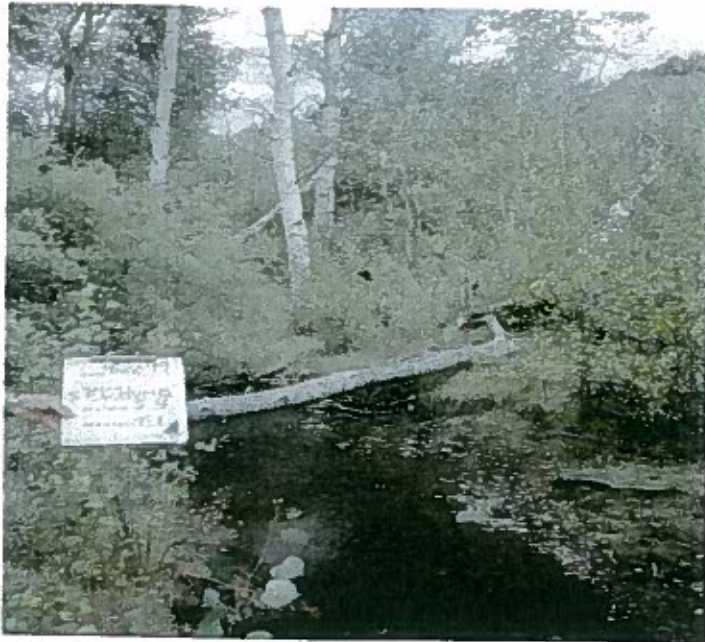
1.5 Stability

Although the streambanks are quite stable, the 1.5 rating is based on the limited presence of exposed or sloughing banks.

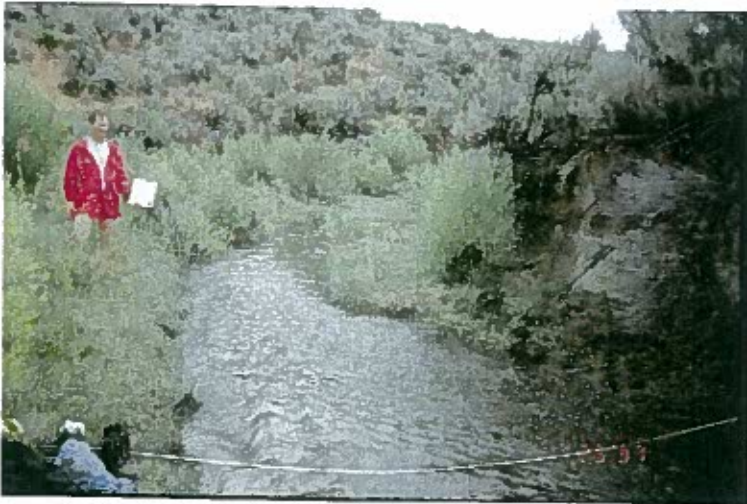
1.5 Stability

Streambanks exhibit stability where the stream is functioning within a floodplain; however, sloughing is still occurring where the stream is cutting into a terrace. Minor amounts of streambank erosion are also evident within the floodplain.

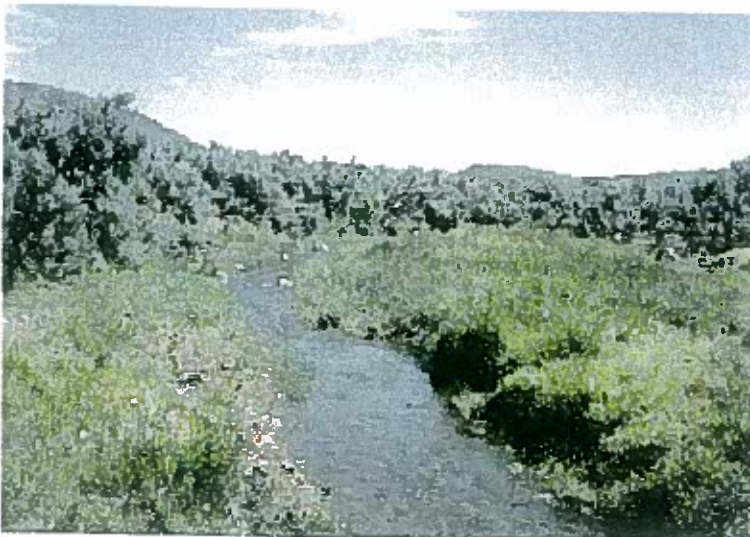
1.5 Stability

Although the herbaceous cover is scattered, the bank's moderate to high rock content provides for additional streambank stability resulting in a rating of 1.5.

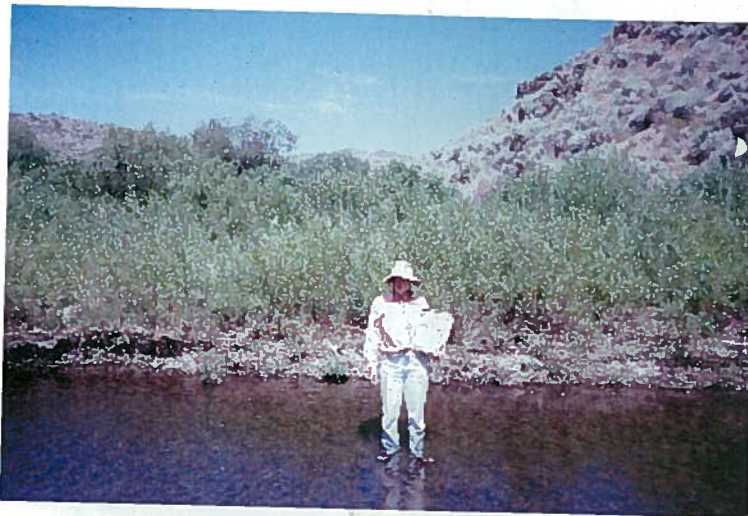
1.0 Stability

The roots associated with these young willows will provide some anchoring for the unconsolidated alluvial material comprising this streambank. Normally, unconsolidated alluvium, particularly if composed of fine materials, would be considered unstable.
