DIXIE AND HANKS CREEKS TEMPERATURE TMDLS

OCTOBER 2010

Prepared by:
Randy Pahl
Nevada Division of Environmental Protection
Bureau of Water Quality Planning

Dixie and Hanks Creeks Temperature TMDLs

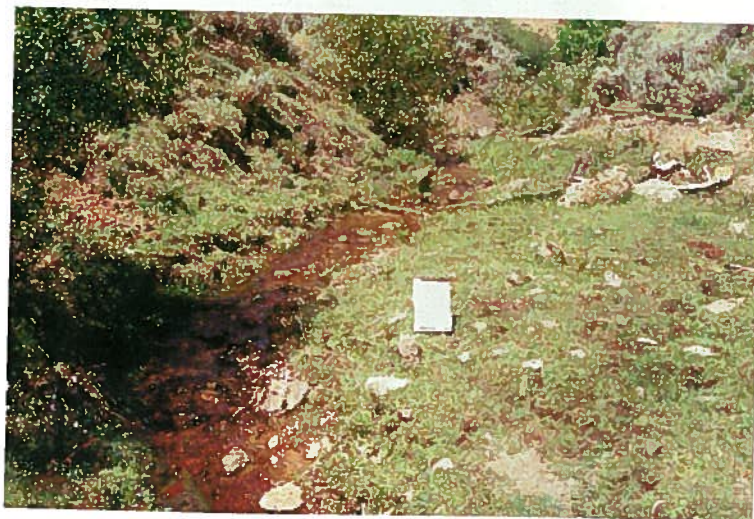
1.0 Stability

Though rock and herbaceous cover provide some stability, the high level of bank shearing and trampling, as well as a lack of deep rooted riparian species, makes these banks vulnerable to erosion. This example represents the upper end of the 1.0 stability rating.

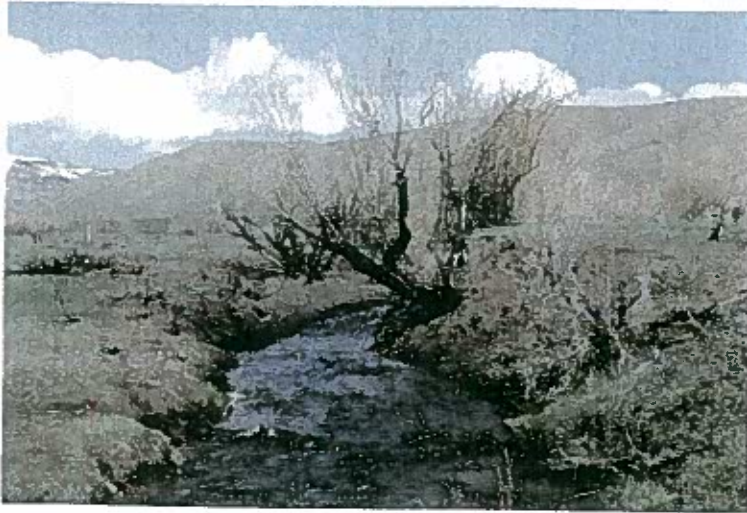
0.5 Stability

The minimal herbaceous riparian cover present is insufficient to provide any stability to these incised streambanks. Although some willow cover is present, it does not appear to have survived severe scorching by wildfire.

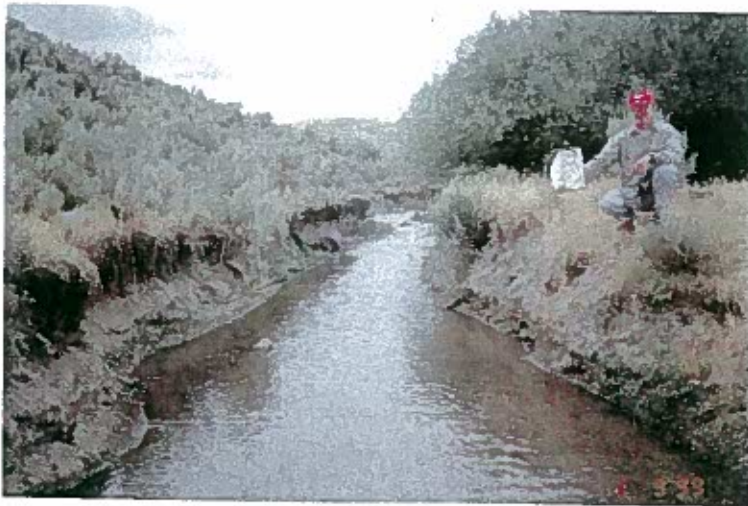
0.5 Stability

This channel is deeply incised and totally unstable, representing the lower end of the 0.5 stability rating.

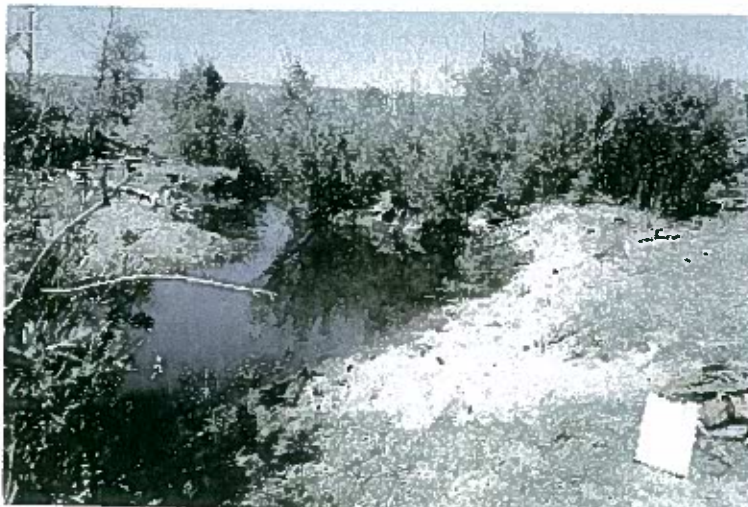
0.5 Stability

Although these streambanks have some willow cover, they are almost entirely comprised of fine erosive materials and are therefore essentially unstable.

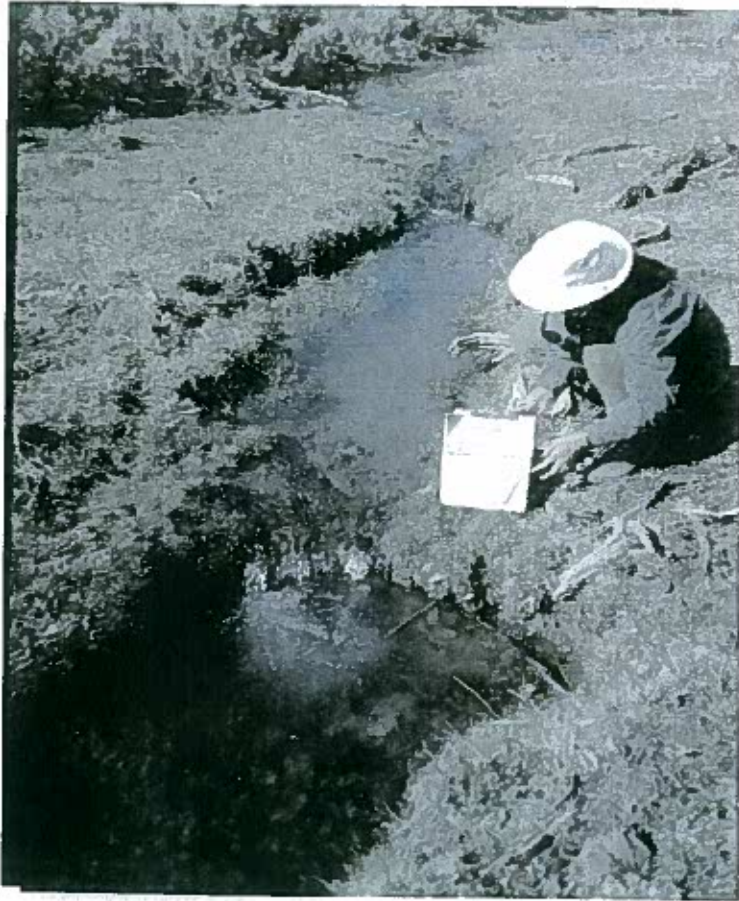
Stability: Special Considerations

It could be argued that the streambanks immediately upstream from the lower head-cut should receive a stability rating of 1.0. However, a rating of 0.5 is probably more accurate given the evidence of active and progressive channel down-cutting. Note the second head-cut forming in the upper part of the photo.

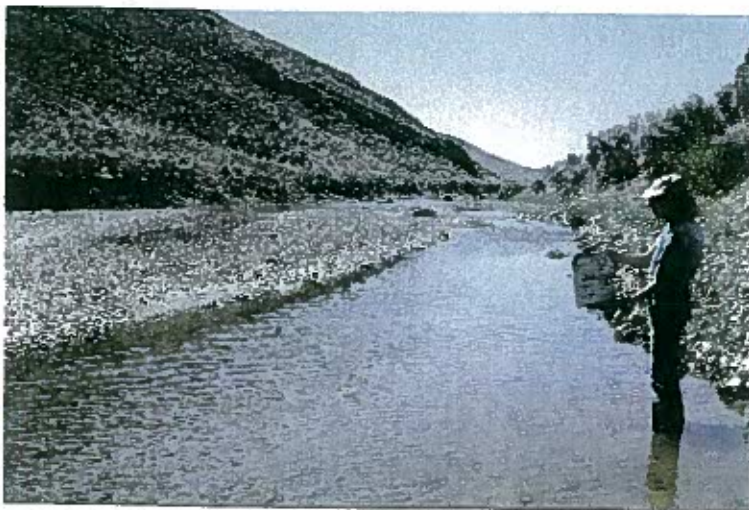
Stability: Special Considerations

This gravel bar, which is located within the active bankfull channel, should not be evaluated for streambank stability. Instead, it is the steep, exposed streambanks located beyond the bankfull channel that should be rated 0.5 for stability.
