3. Preliminary Field Study Results

3.1 *Methods and Data*

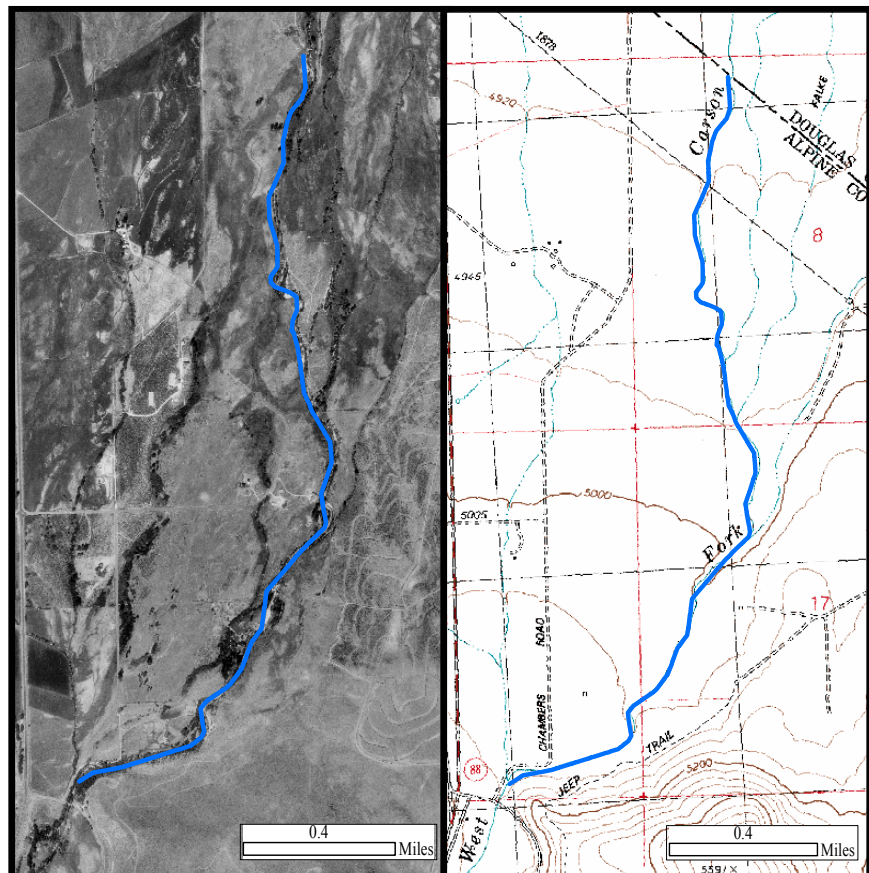
Land uses include water diversions that deliver irrigation water to pasture lands. Some pastures are irrigated with treated effluent supplied by the South Tahoe Public Utility District (STPUD). Rural residential development is replacing pasturelands across portions of the fan surface. Because the current channel is entrenched into the fan surface, the risk of flooding to those residential properties is relatively low. Potential concerns for aquatic ecosystem health in this reach include water diversion and groundwater contamination from septic systems.

Riparian vegetation is fairly continuous along this reach. Black cottonwood (*Populus balsamifera* ssp. *trichocarpa*) and Pacific tree willow (*Salix lucida* ssp. *caudata*) are relegated to the top of bank. Among the black cottonwood, young age classes (seedlings, saplings) are present in a narrow band along the main channel. Assorted willow species occur along the bank slope. Willow species seem healthy and some younger age classes are present.

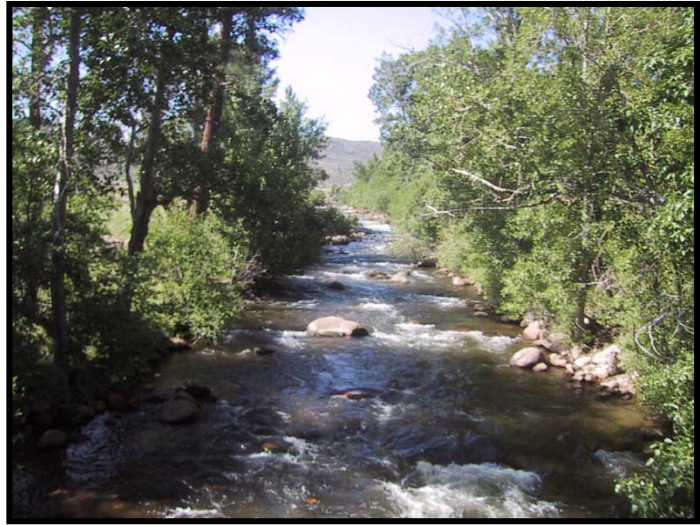
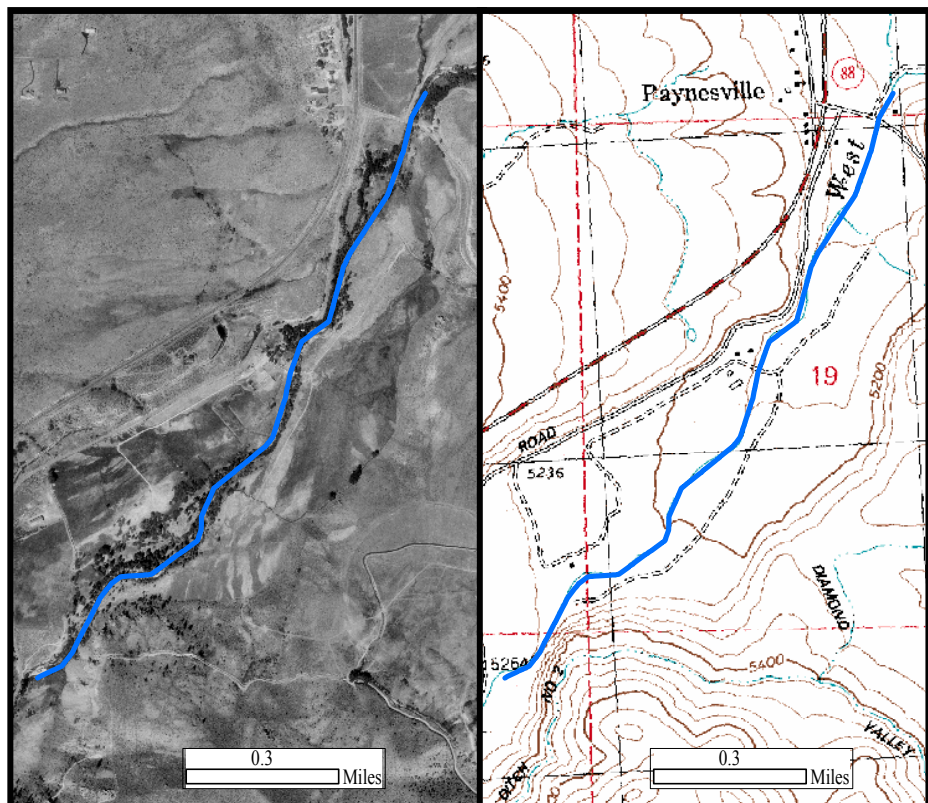
3.2.1.2 Reach WF2

Reach WF2 starts at the Paynesville Bridge and ends at the upstream end of Carson Valley. This reach was separated from Reach WF1 since it has a steeper gradient, generally coarser substrate, and is not located on an alluvial fan. The channel along Reach WF2 is still relatively confined (Rosgen B-type). Boulders are found throughout the banks and streambed, and the channel is resistant to erosion.

Irrigated pastureland is the primary land use along the reach, with a few scattered ranch buildings. Dewatering for irrigation and the use of treated effluent as irrigation water are the primary potential impacts to the stream and aquatic habitat.

Vegetation along the reach is similar to WF1. This is due to the confined nature of the channel and floodplain along both reaches. Riparian vegetation is fairly continuous with black cottonwood and Pacific tree willow relegated to the top of bank. Some stinging nettle (*Urtica dioica*) and horsetail (*Equisetum* sp.) are present as components of the herbaceous understory. A few young age classes (seedlings, saplings) of black cottonwood are present in an adjacent pasture located on the west side of the river. Willow species appear healthy. Young saplings are evident among the sediment in-filled bank boulder cover.

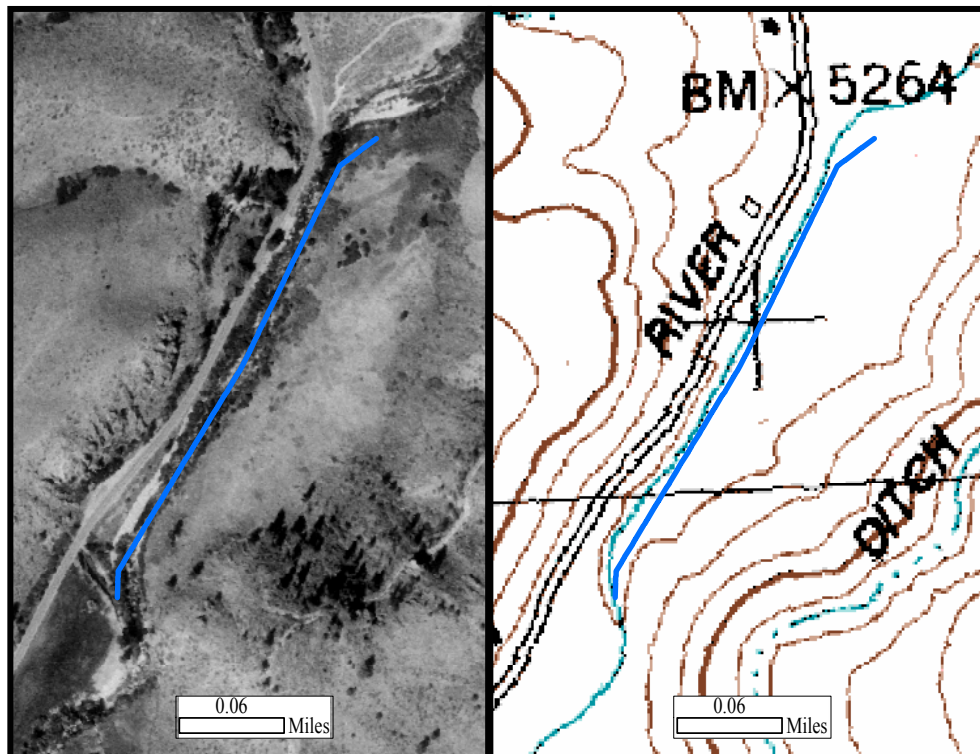
3.2.1.3 Reach WF3

A paved rural road constricts the channel in a few locations. Some areas of bank erosion appear to have occurred during the 1997 flood. Bank protection, consisting of placed and grouted rock, has been constructed in these areas. Some undercutting of the bank protection has occurred, and the grout limits riparian regeneration.

Riparian vegetation is not contiguous along this reach. The tree layer (black cottonwood and Pacific tree willow) observed in downstream reaches is no longer present. Where present, two shrubby species of willows provide the dominant riparian cover.

Sparse grasses or forbes form the limited understory. Surrounding uplands are vegetated with heavy shrub cover consisting primarily of mountain big sagebrush (*Artemisia tridentata* ssp. *vaseyana*) and antelope bitterbrush (*Purshia tridentata*).

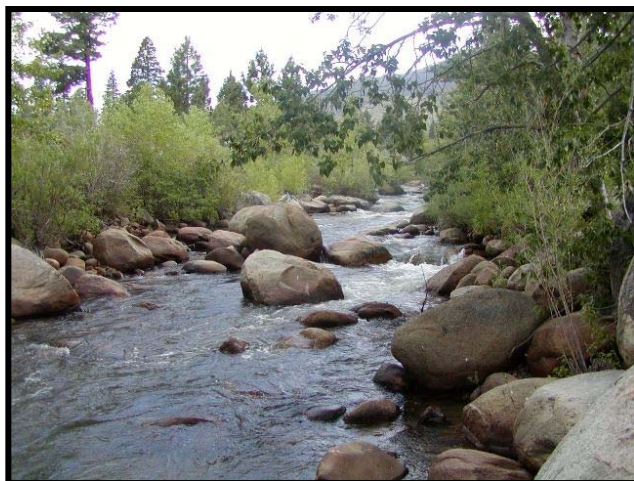
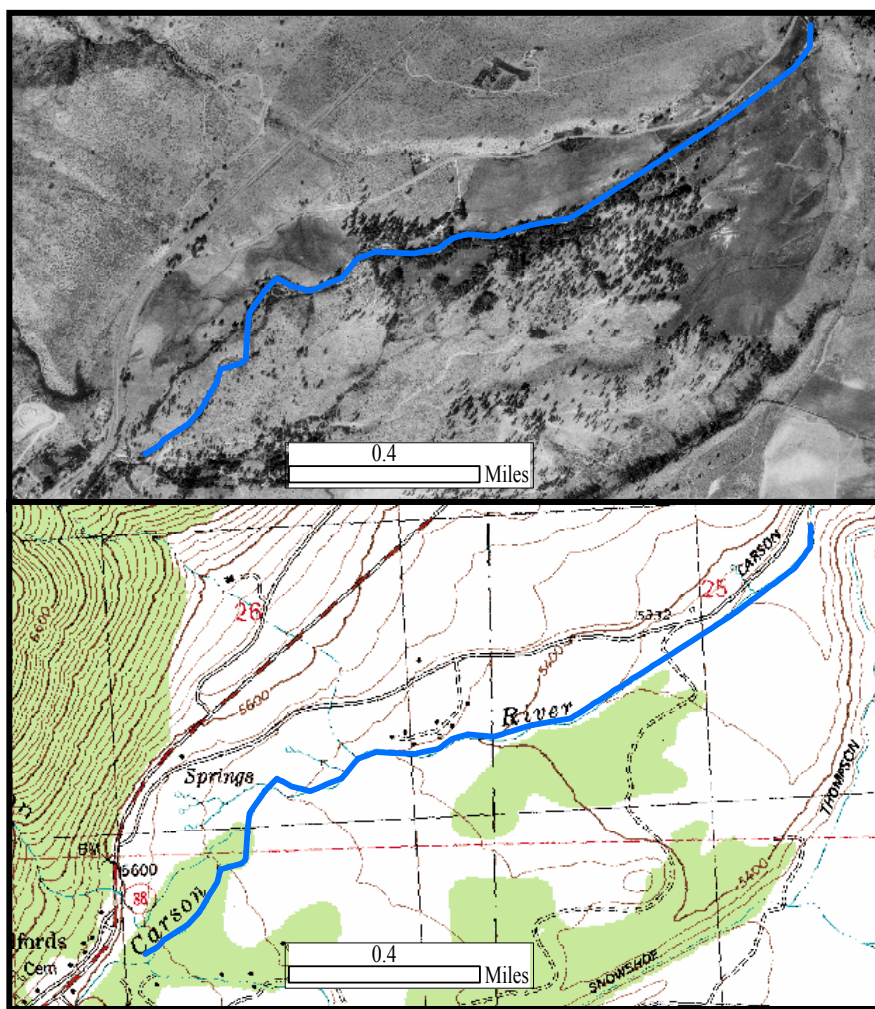
3.2.1.4 Reach WF4

Reach WF4 flows northwest of Diamond Valley to Woodfords. The valley consists of a restricted fan surface that is much steeper than the fan surface present in Reach WF1. Reach WF4 is located at the mouth of the West Fork gorge where extensive debris flow and glacial outwash deposits have accumulated. The channel is incised into these deposits. Bed and stream banks consist of boulders and cobbles, and are generally stable.

Pastureland is the dominant land use through this reach. This channel type is resistant to long-term effects due to the dominance of coarse substrate material and its resistance to bank erosion. Any impacts are likely to be short term in nature.

Riparian vegetation along Reach WF4 consists of fairly continuous shrubby willow species located near the ordinary high water elevation and along the lower bank slopes. Intermittent black cottonwood and Pacific tree willow represent overstory components at the top of bank. In pasture areas, where access to the elevated stream terrace occurs during high flow events, the tree layer tends to expand.

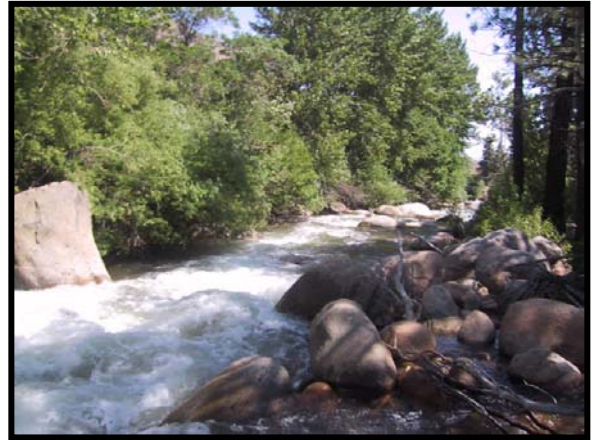
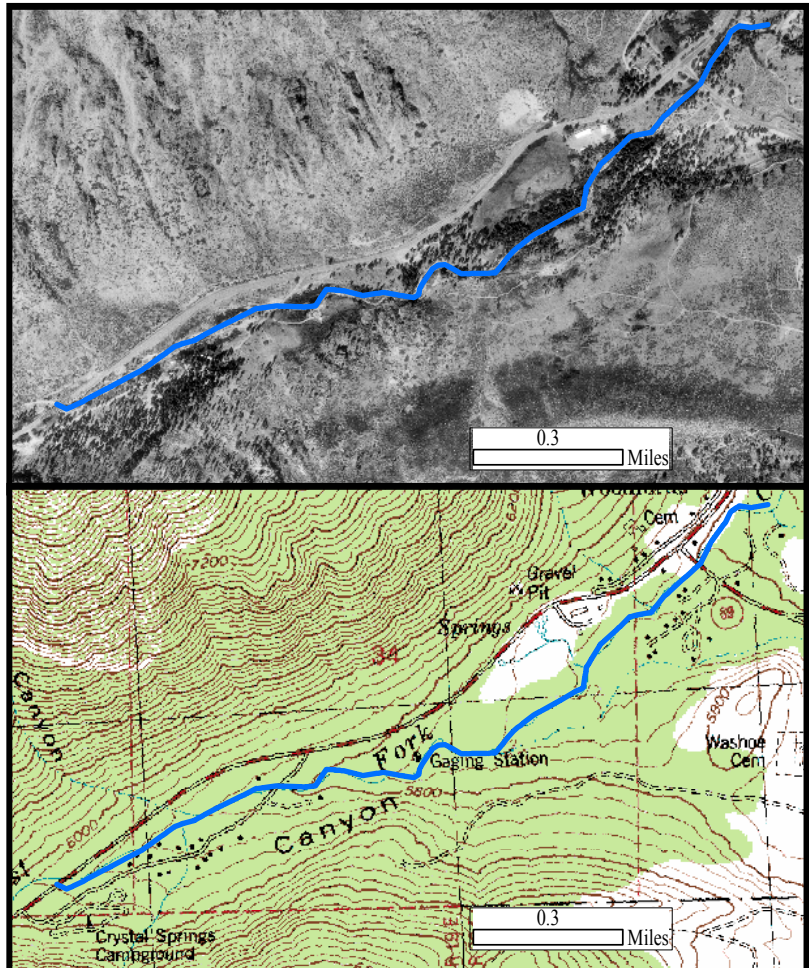
3.2.1.5 Reach WF5

Reach WF 5 is similar to Reach WF4. The channel is entrenched in debris flow and outwash deposits. Canyon walls restrict the channel more than in Reach WF4, but less than in Reach WF6. The channel gradient is relatively steep, and the bed is composed primarily of boulders and cobble (Rosgen B-type).

The highway is located on terraces and hill slopes well away from the channel, except at a crossing near the upstream end of the reach. Although the bed and banks are generally resistant to erosion, substantial bank erosion occurred downstream of the crossing during the 1997 flood. The bridge may have contributed to erosion by concentrating flows. The Snowshoe Thompson ditch was damaged and may be damaged again during similar large floods.

The riparian canopy provides fairly continuous woody cover throughout Reach WF5. This canopy is restricted to a narrow band where the road limits expansion of the riparian zone. Mountain alder (*Alnus incana* ssp. *tenuifolia*) and Pacific tree willow are the dominant forms of shrub cover, and two willow species are located along the bank slopes and at the ordinary high water mark. Black cottonwood is located intermittently at the top of bank. Creeping wildrye (*Leymus triticoides*) is a common understory grass. Surrounding upland vegetation varies between open coniferous forest dominated by Jeffrey pine (*Pinus jeffreyi*) and white fir (*Abies concolor*), clusters of incense cedar (*Calocedrus decurrens*) on moister sites, and shrub dominated slopes (mountain big sagebrush, antelope bitterbrush, and manzanita [*Arctostaphylos patula*]).

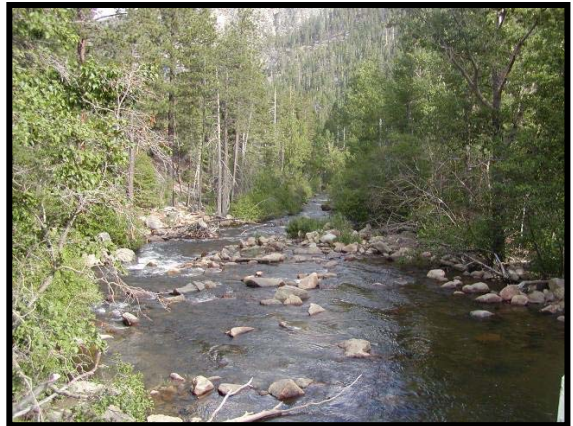
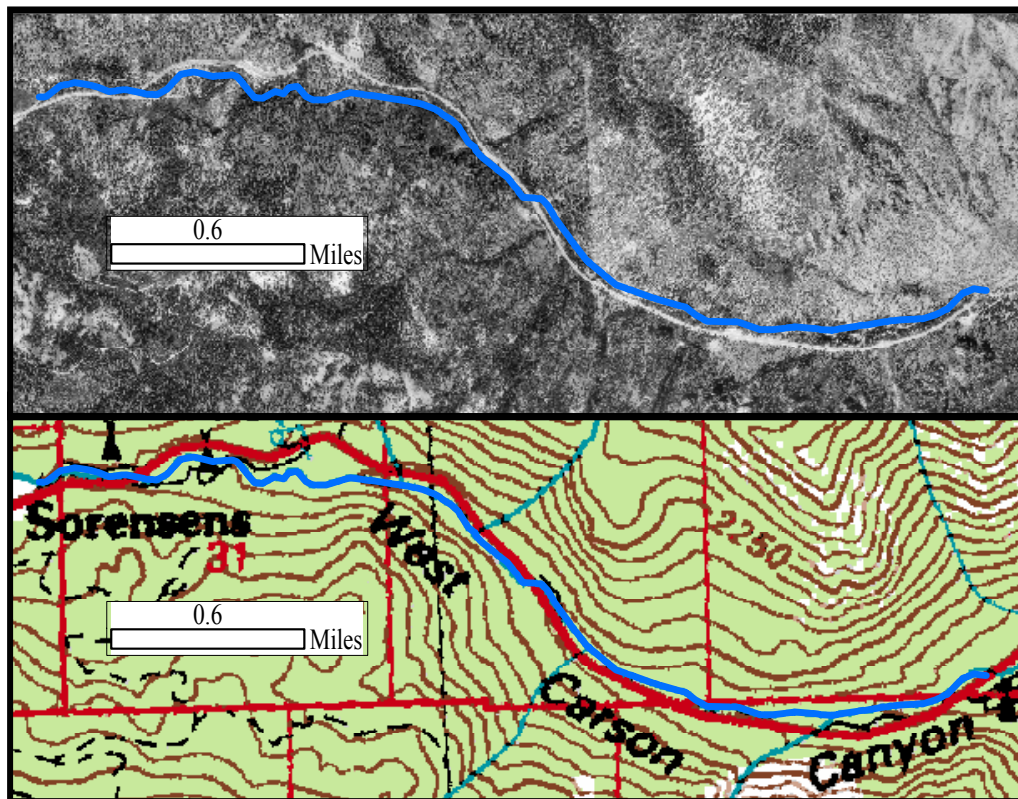
3.2.1.6 Reach WF6

Canyon walls restrict the channel and floodplain to a very narrow area along Reach WF6, whose upstream end is located near Sorenson's Resort. Debris flow chutes are found on both sides of the canyon wall. They likely deliver sediment directly to the channel during rain-on-snow events. The channel is steep (Rosgen A-type in locations) and is composed of very large boulders. The bed and banks are highly resistant to erosion.

Because the valley floor is so narrow, the highway is close to the channel throughout the reach. However, because the channel is so resistant to erosion, the road has had limited influence on the stream. A potential impact of the road is sand delivered to the stream during winter maintenance operations. Some light recreation occurs in this reach at developed campgrounds, but these activities have only a minor impact due to the stable nature of the channel.

Similar to Reach WF5, the riparian canopy provides fairly continuous woody cover throughout Reach WF6. The road restricts this canopy to a narrow band, which expands where flooding of adjacent elevated stream terraces occur. Mountain alder and Pacific tree willow are the dominant forms of shrub cover, and two willow species are located along the bank slopes and at the ordinary high water mark. Black cottonwood cover increases in backwater channels. Under story and upland vegetation is similar to that observed along Reach WF5.

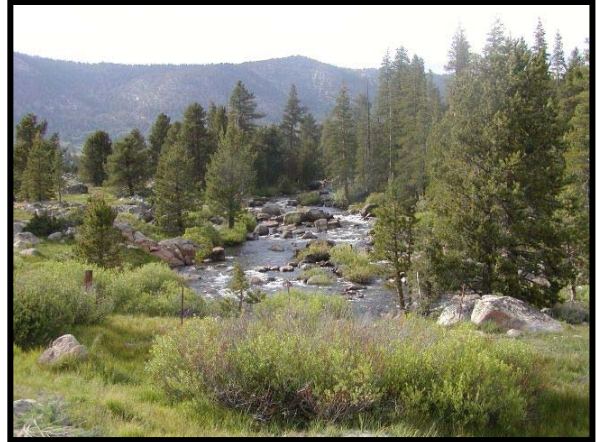
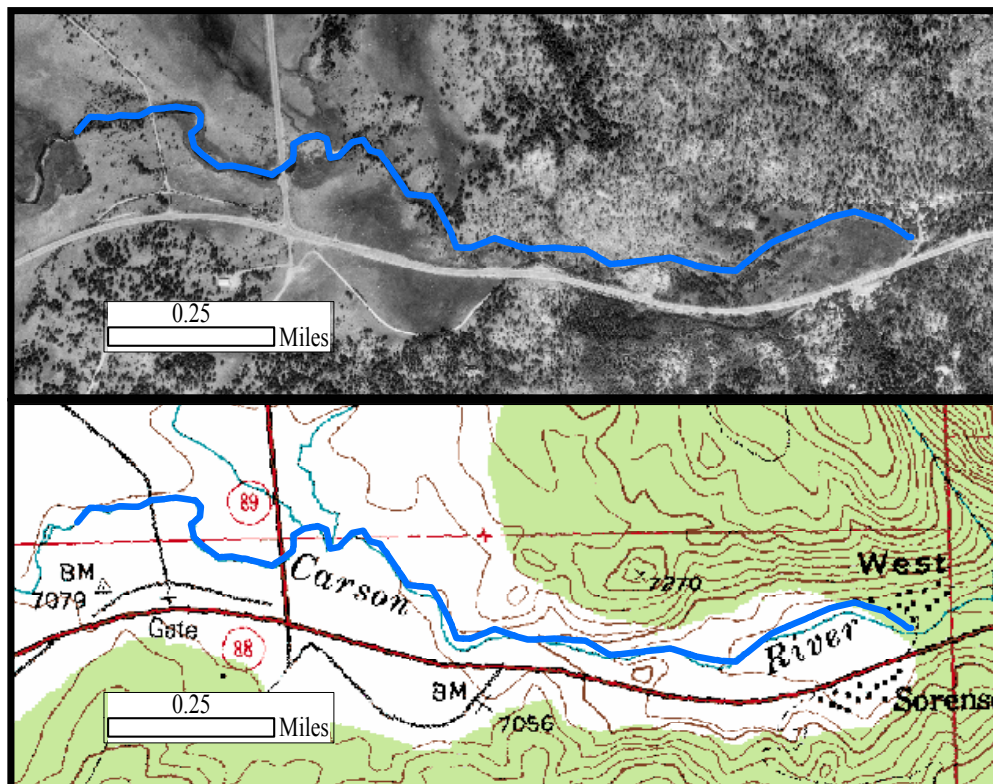
3.2.1.7 Reach WF7

Reach WF7 is transitional between Hope Valley meadow reaches (upstream) and West Fork gorge reaches (downstream). The reach starts at the Hope Valley Resort and ends at a terminal moraine located just upstream of the Hwy 89 Bridge. The upper portion is entrenched in terminal moraine deposits (a Rosgen B-channel). The lower end is composed of coarse material typical of areas influenced by rain-on-snow events and debris flow deposits. Floodplain development has occurred in some areas and the channel trends toward a Rosgen C-type.

Grazing occurred on meadows around this reach between the 1850s and the 1980s. Today, the dominant land use is recreation, particularly fishing and winter activities, mostly skiing. Several stream banks in this reach are unstable. Factors that could contribute to this instability include highway construction, historic grazing activities, or other watershed characteristics.

Within Reach WF7, willow cover is present intermittently at ordinary high water elevations and along bank slopes adjacent to the river. Graminoid dominated meadow vegetation is predominant on the surrounding river terraces. Remnant channels support stands of dense willow cover, particularly evident in the floodplain across from the Hope Valley Resort. Black cottonwood is present in the overstory near the downstream portion of the reach. Terminal moraine debris supports upland vegetation consisting of occasional lodgepole pine (*Pinus contorta*) and sagebrush.

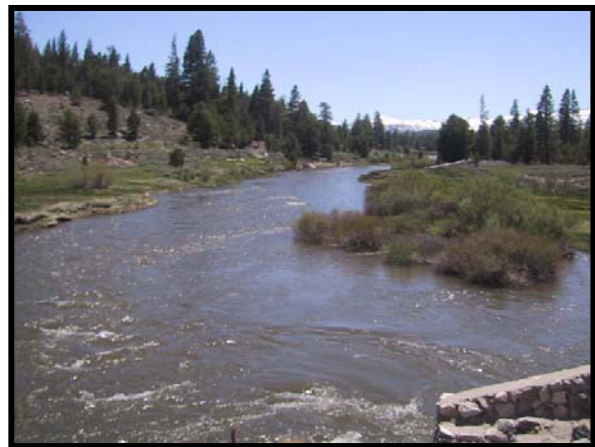
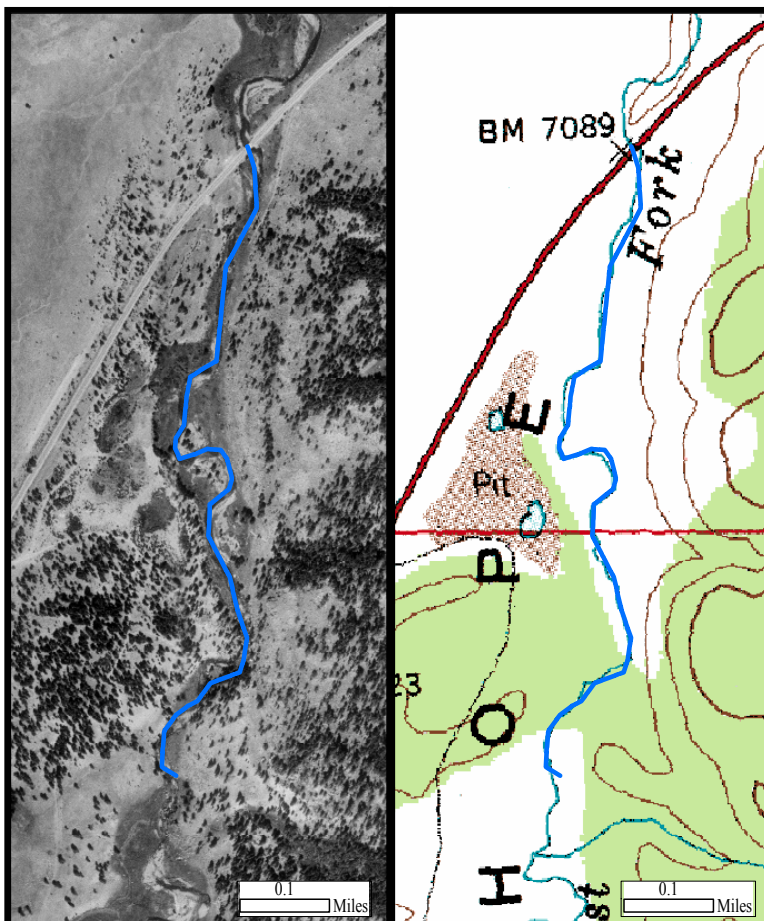
3.2.1.9 Reach WF9

Reach WF9 consists of a relatively confined, low gradient channel that has incised through a large terminal moraine separating structural meadows found in reaches WF8 and WF10. The confinement and entrenchment through the moraine has resulted in a channel with coarser bed material (due to erosion of the moraine deposits), less sinuosity, and higher bank stability and resiliency (Rosgen B-type). Stream banks are relatively stable in Reach WF9, and there is no evidence of the incision apparent in upstream and downstream meadows.

It is likely that the relatively stable nature of the streambed and banks made this portion of the stream less responsive to conditions that caused incision in other areas. Also, the rocky terrain of the moraine probably limited the extent of the historic land use that may have occurred in Reaches WF8 and WF10. Land use today is predominantly recreation.

Observations regarding vegetation along Reach WF9 are made based on the examination of a single location and on the interpretation of aerial photographs. These data indicate that bank slopes and bars along this reach support an intermittent riparian canopy; sapling and mature willows are present.

Similar to WF7, remnant channels support dense stands of willow. Graminoid dominated meadows are found adjacent to the river.

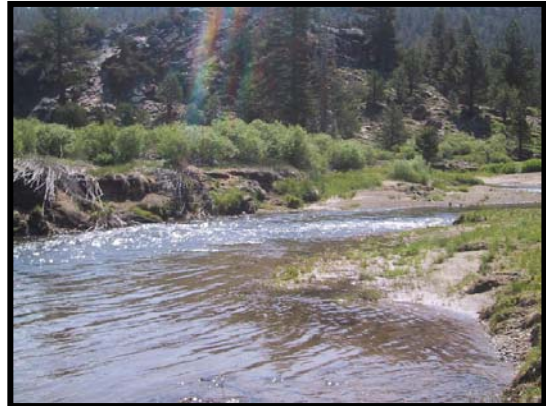
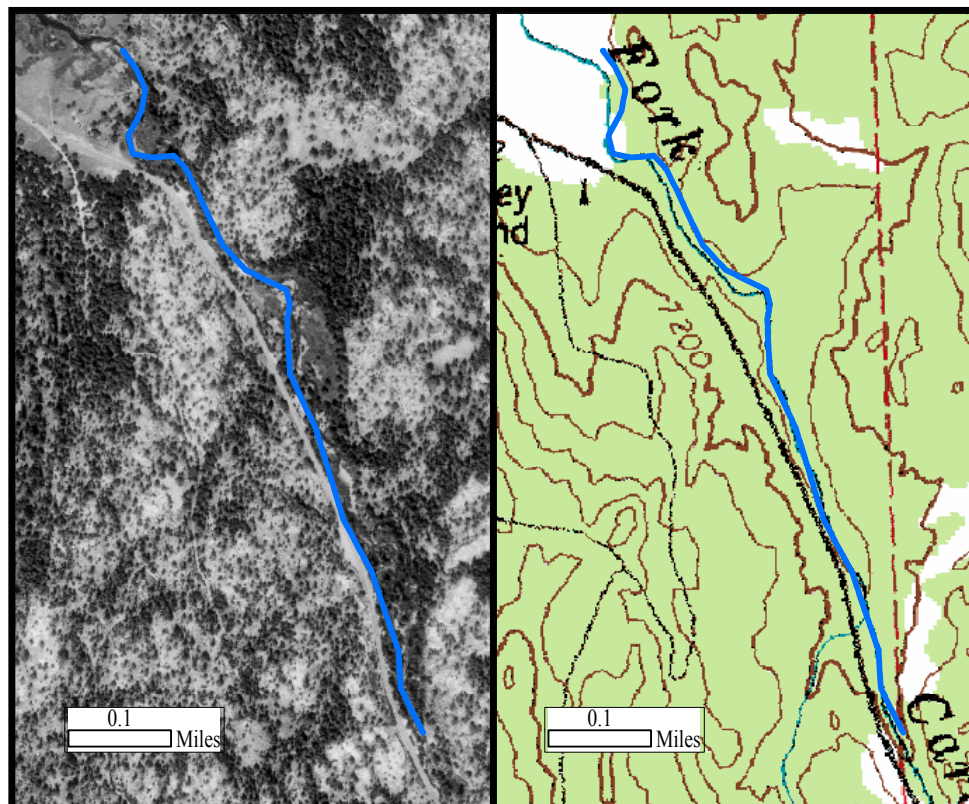
3.2.1.10 Reach WF11

Reach WF11 consists of a short, low gradient segment of channel characterized by several small structural meadows, interspersed by morainal deposits. This reach was split out from Reach WF10 because it is more functional in terms of channel-floodplain interactions and is more confined (the meadows are significantly smaller). In the meadow areas, the channel is meandering and has a gravel bed (Rosgen C-type), while the channel is straighter and bed substrate is larger in the short segments flowing through moraines (Rosgen B-type). Stream banks are relatively stable throughout this reach.

The canyon is narrow along this reach and as a result the Blue Lakes Road is near the channel in many locations. While the road had little direct effect on the channel, it does affect riparian and meadow vegetation in some locations. Dispersed camping is common, and some campsites have affected riparian vegetation along stream banks.

The riparian canopy is fairly continuous along Reach WF11 with willow species and some mountain alder present on shallow bank slopes and at the ordinary high water mark. A dense layer of wet meadow graminoids and forbs are also present in the understory. Black cottonwood is evident in the adjacent floodplain meadows, and all age classes of willows and cottonwood are represented.

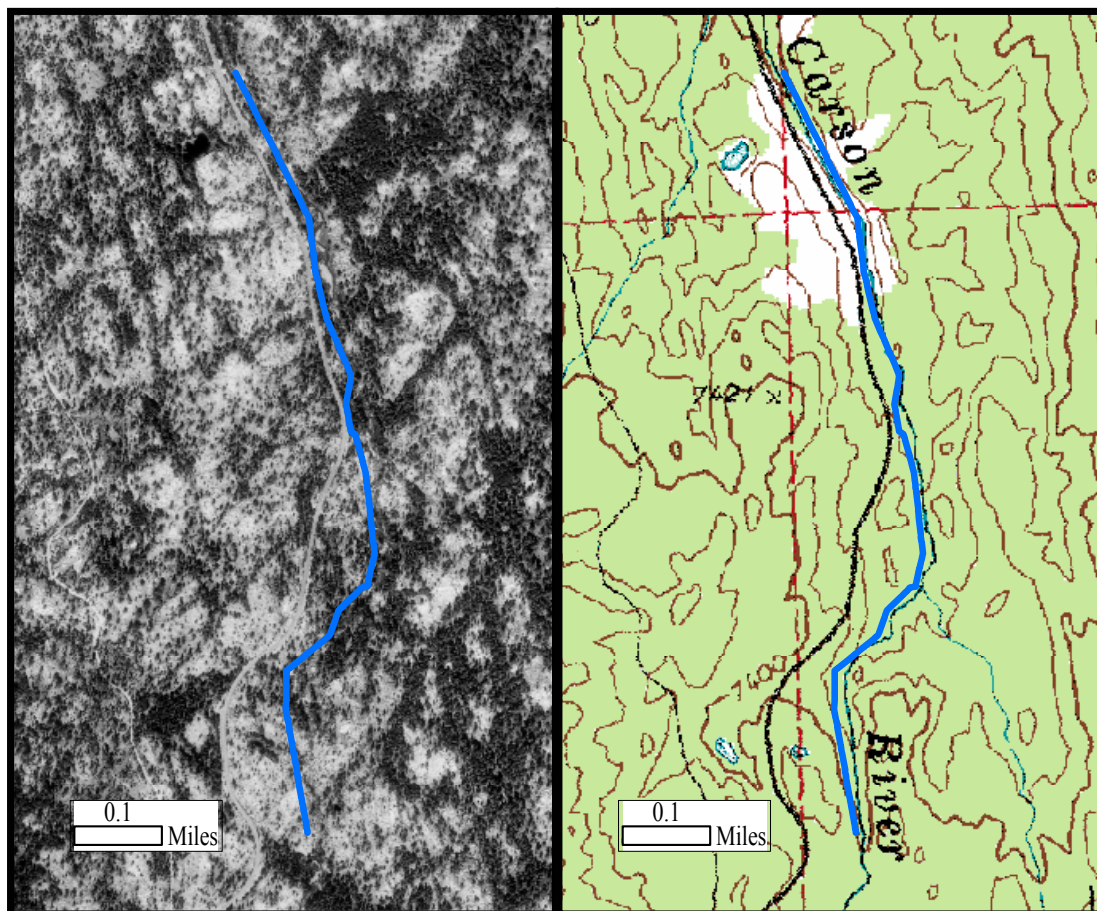
3.2.1.11 Reach WF12

Reach WF12 consists of a steeper, more confined, bedrock dominated valley. Boulder and cobble dominate the streambed and banks. The channel is straight and relatively entrenched (Rosgen B-type). Stream banks are stable throughout this reach.

Because the valley is narrow, the Blue Lakes Road is often directly adjacent to the channel. In some locations, bank protection measures have been employed to maintain the road. Because this channel type is inherently stable, road modifications have had little effect on riparian or channel function. The steep, rocky terrain limits dispersed camping.

Woody riparian plants similar to those observed along Reach WF11 are present along Reach WF12, but are confined to a fairly continuous, narrow band along bank slopes. The herbaceous component of graminoids and forbs is sparse due to lack of soil needed for plant establishment.

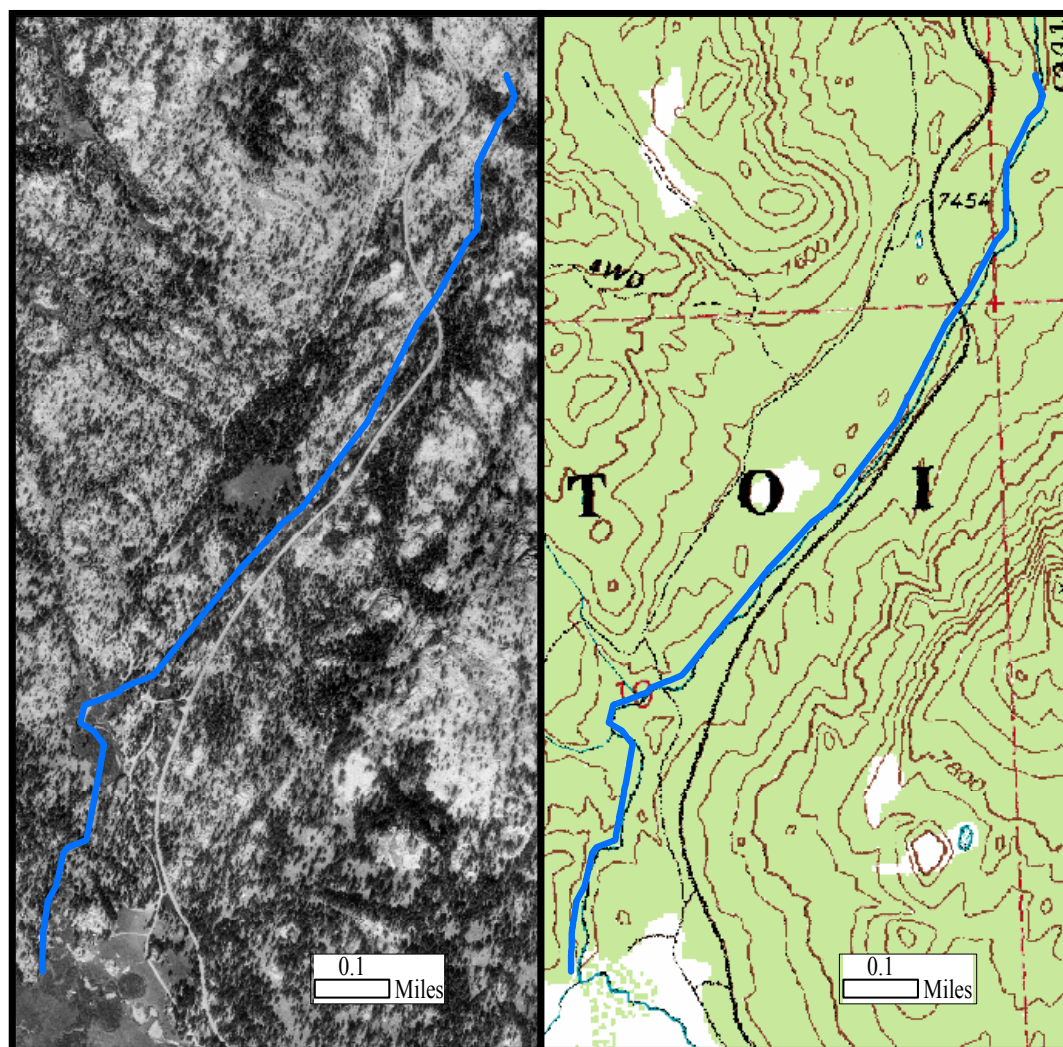
3.2.1.12 Reach WF13

The channel flattens out considerably through Reach WF13 when compared to Reach WF12, though the channel form and function appear to be similar due to the confining nature of the underlying bedrock. Reach WF13 is slightly more meandering, as this reach contains more alluvium on the valley floor. The Blue Lakes Road is not as constricting through this reach, though several road crossings are present. A large amount of woody material is present through this reach, providing a considerable amount of structure for pool formation.

Land use impacts appear to be minimal due to the resiliency of the bedrock-boulder dominated channel and banks. The upstream end point for this reach is the Faith Valley meadow system.

Reach WF13 is similar to WF11 in that where channel confinement occurs, the riparian canopy is relegated to fairly continuous willow shrub cover along both bank slopes. In meadow areas adjacent to the river, wet meadow graminoids are dominant. Dense stands of shrub willows occur in topographic lows.

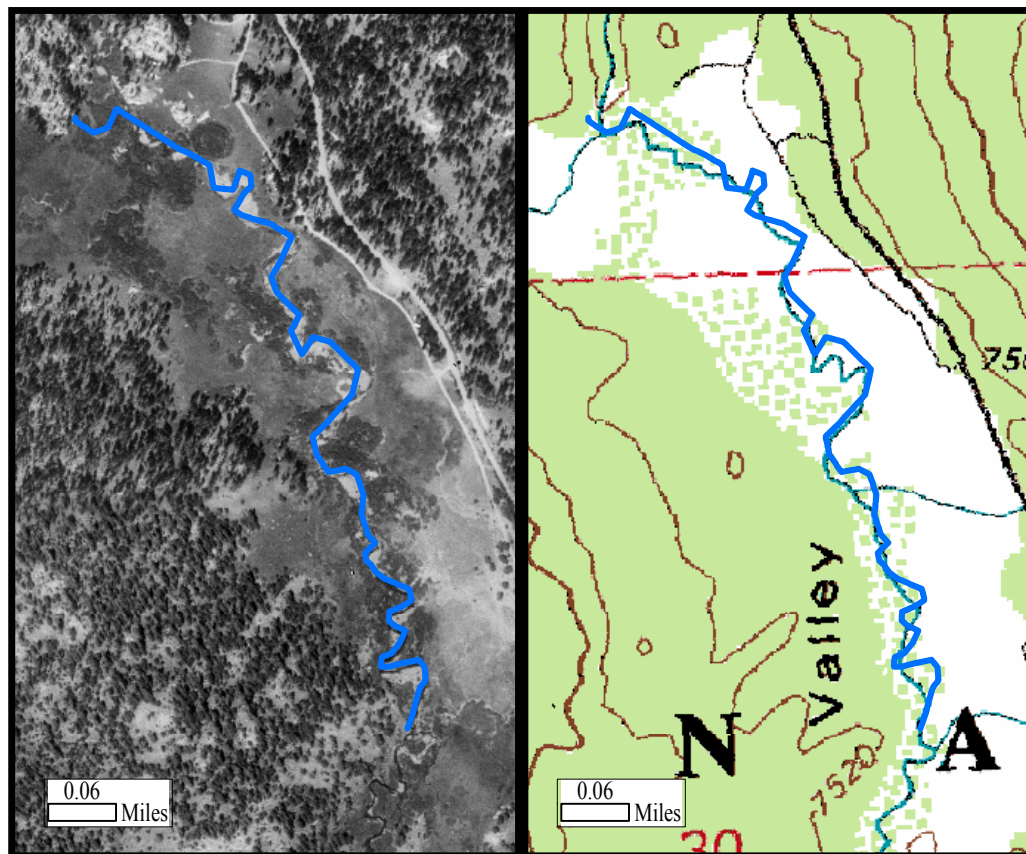
Reach 14

The meadow system was split into two reaches based on field observations and aerial photo analysis. These data suggest significant differences in channel conditions downstream (WF14) of a large tributary entering from the East, as compared to upstream (WF15). The tributary appears to be delivering a large amount of coarse bed load, resulting in unstable stream banks in the downstream reach. During the 1997 flood, the culvert carrying the tributary under the Blue Lakes road apparently clogged and portions of the road may have washed out.

Morphology of the tributary upstream of the culvert suggests that channel modifications have occurred. These modifications may have been attempts to stabilize the road crossing in the face of high upstream sediment loads. Alternately, the modifications themselves may be at least partly responsible for high bed load transport at the culvert. Dispersed recreation is common in this area, and some impacts to riparian vegetation are evident.

In terms of riparian canopy cover, well-established continuous stands of Lemmon's willow (*Salix lemmonii*) are present along the stream banks. Young willow recruits are present on bars in Reach WF14. This canopy becomes discontinuous along the channel upstream in reach WF15 where the saturated sedge meadow becomes the dominant vegetation feature. However, willow stands are still evident in less saturated areas of the meadow providing a mosaic effect. Adjacent uplands support stands of lodgepole pine with an understory varying from shrub dominated to grasses and forb dominated.

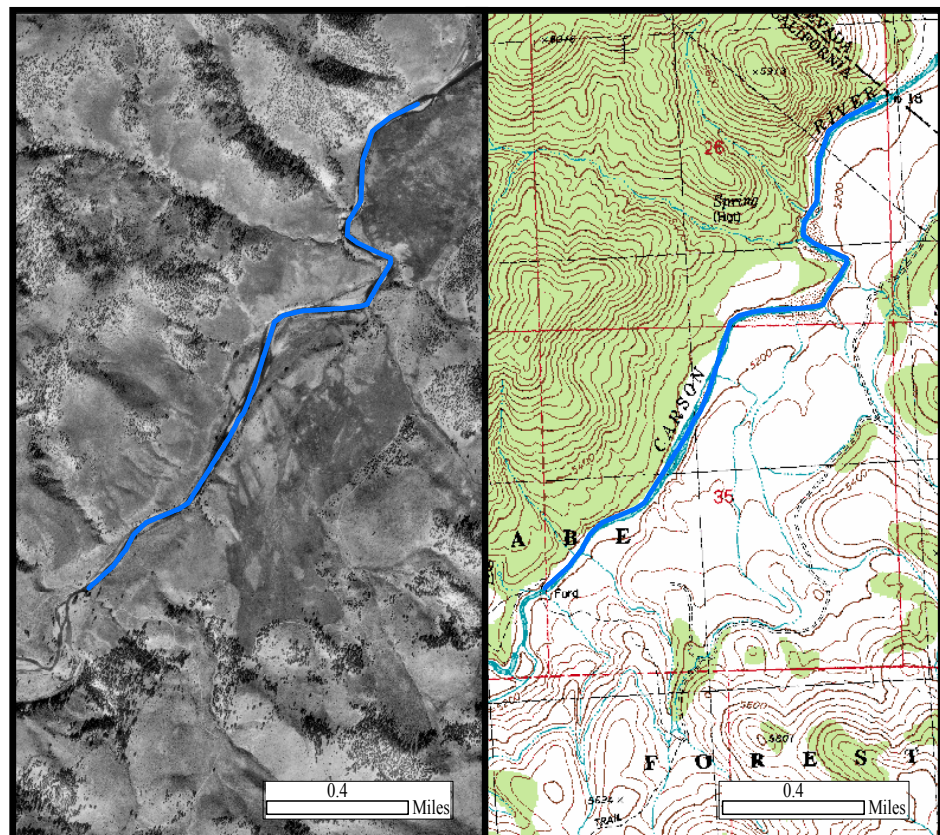
East Fork 1

The East Fork of the Carson River in the lower portions of the assessment area flows through a deep, inaccessible canyon. Reach breaks are based on the relative confinement of the valley as evidenced by the presence of a braided channel and bar and floodplain development. Aerial photos suggest that Reaches EF1 and EF3 are narrow and straight. Reach EF2 has more developed floodplain surfaces and bar features, at least partly due to less confinement by the valley walls. Throughout these reaches, the stream is likely either a Rosgen B- or C-type channel.

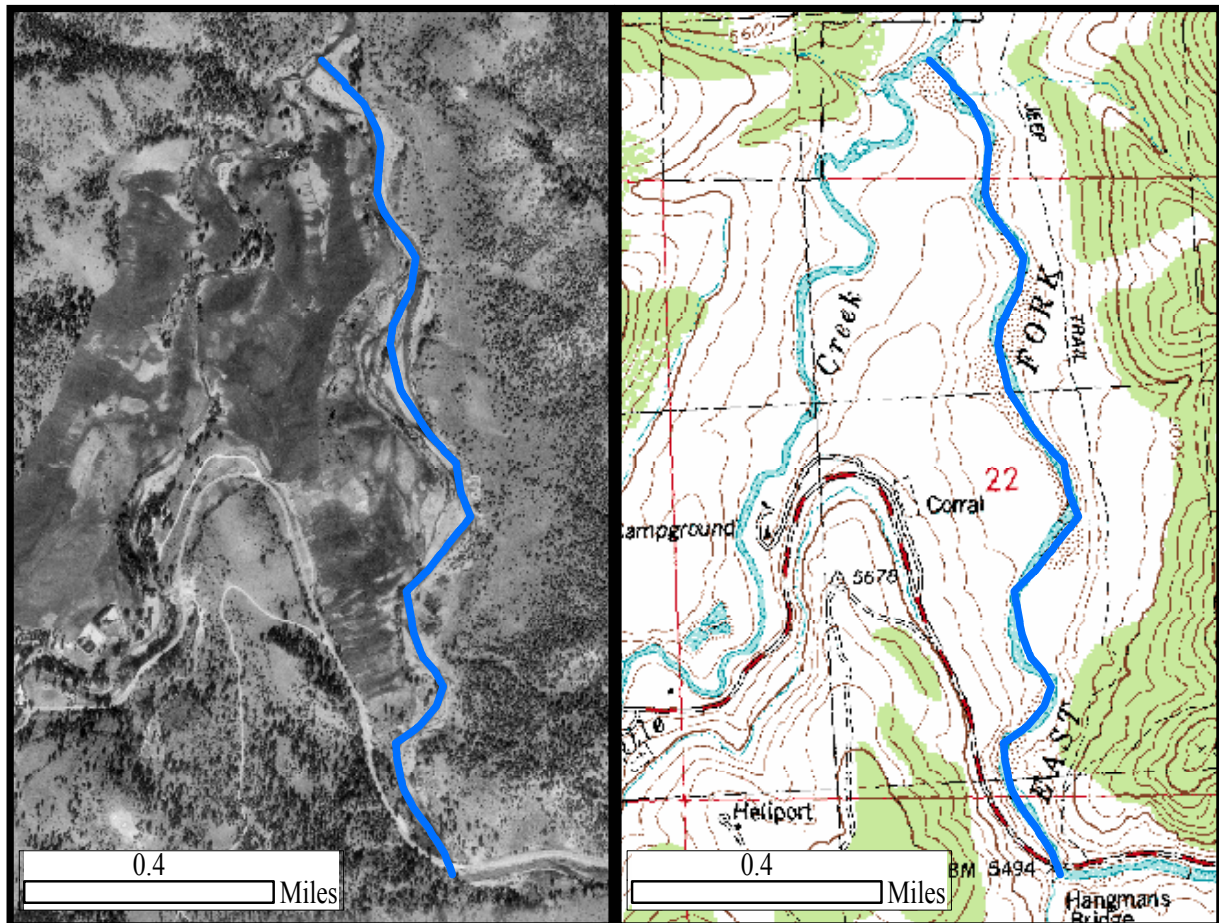
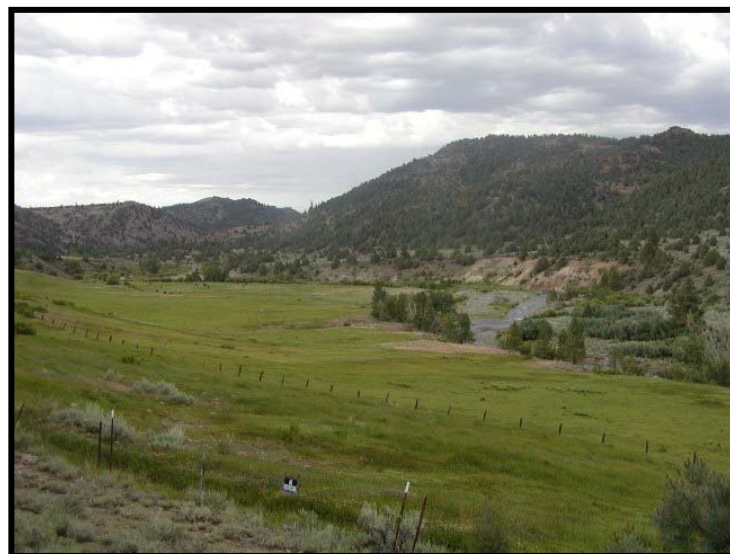
East Fork 4

Bar formation is especially evident in Reach EF4. The west side of the reach is not confined by steep valley walls. It is also immediately downstream from Hangman's Bridge and the long, confined canyon upstream from this point. Because the canyon is so narrow upstream of this location, much of the sediment produced by the watershed upstream of Hangman's Bridge is likely transported to Reach EF4. Here, where the canyon broadens somewhat, deposition of the bed load occurs, resulting in an actively mobile channel, somewhat braided, with extensive bars.

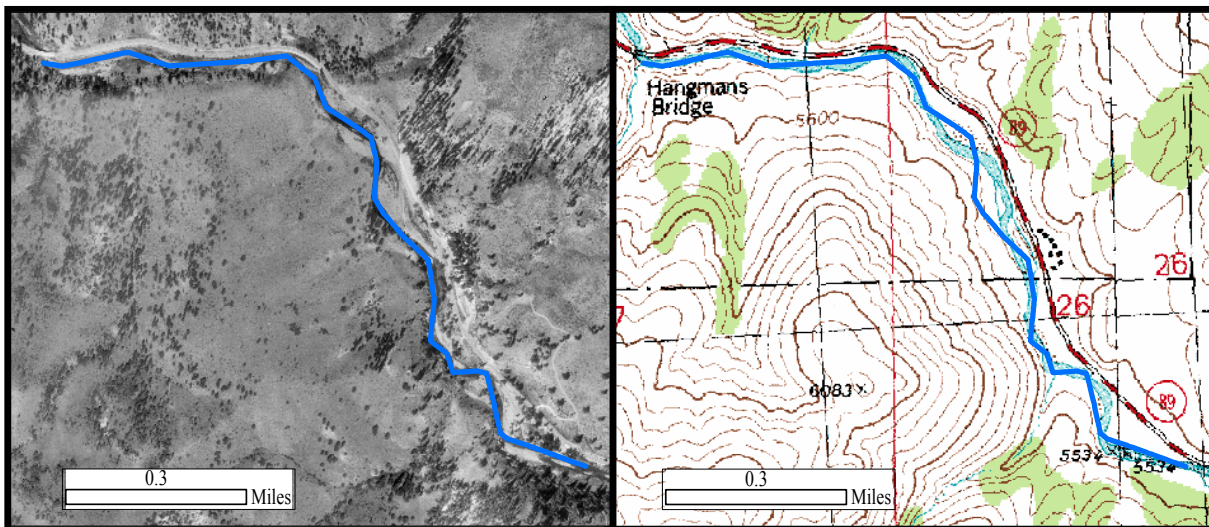
East Fork 5

These reaches were split out from Reaches EF6, EF8, and EF10 based on the influence of the adjacent highway, which has a substantial impact on channel form and function. In Reaches EF5, EF7, and EF9, the highway is present within the floodplain. Some natural meanders were cut off during highway construction. Throughout these reaches, substantial portions of the historic floodplain have been taken over by the highway, reducing floodplain area (especially during larger floods), eliminating riparian vegetation, and requiring levees, groins, and revetments to protect the road from undercutting or over wash. Additionally, along Reach EF5, recreational facilities (camping, some structures) have been built in the historic floodplain.

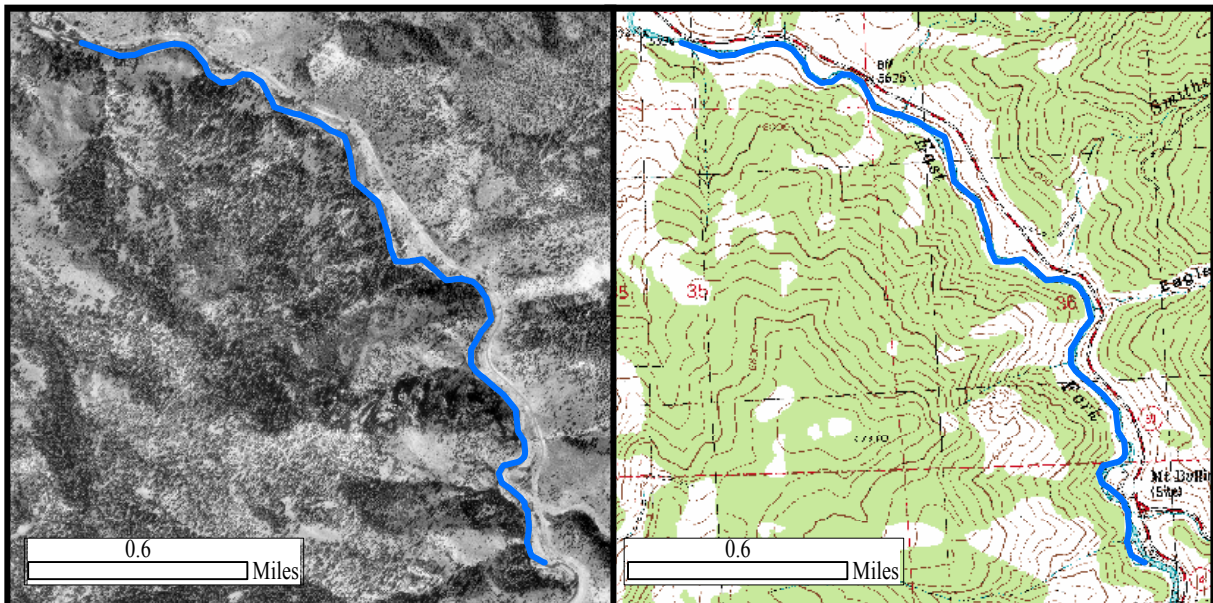
East Fork 6

Although reaches EF6, EF8 and EF10 are similar geomorphically to reaches EF5, EF7, and EF9, the road was constructed on adjacent hill slopes and as a result does not affect the floodplain. These reaches could provide reference conditions for the comparison of geomorphic and vegetation conditions with reaches where road-related impacts are apparent.

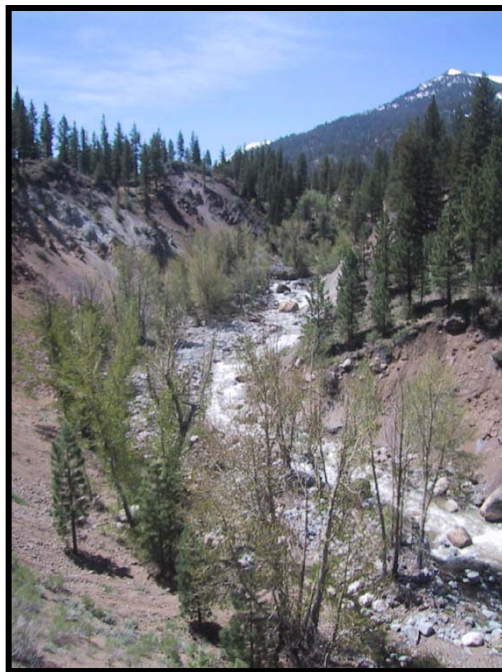
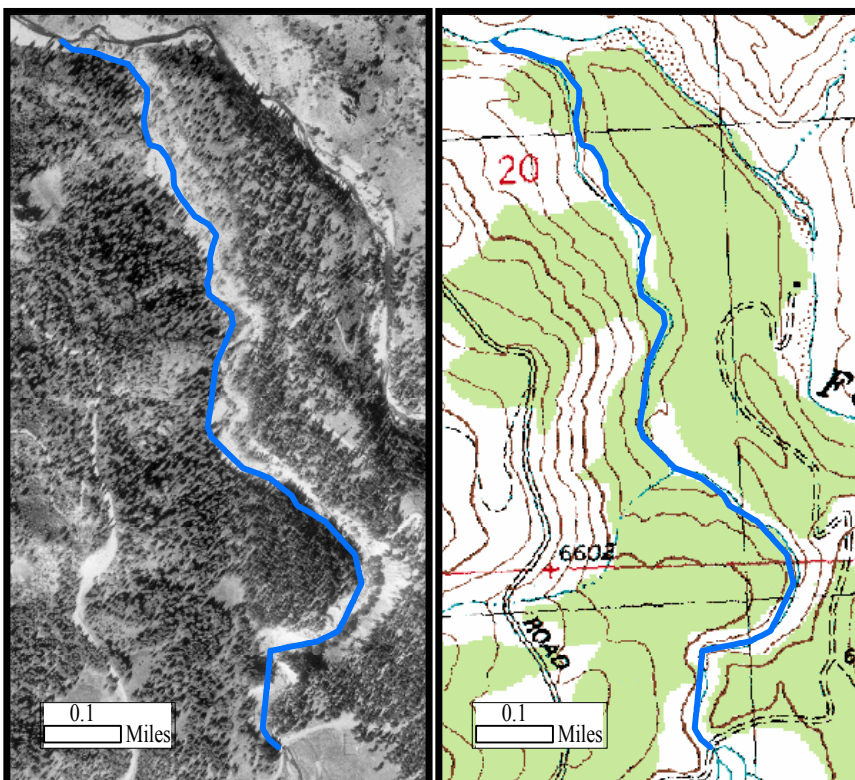
Erosion in this canyon is predominantly the result of natural geomorphic processes. The East Fork is a much larger watershed, and has carved a deeper canyon both through fluvial and glacial processes. This steep reach represents a discontinuity between the relative rates of valley erosion in the East Fork and Wolf Creek. A gravel road near the canyon has little influence over erosion in this area.

The gradient at the upstream boundary of Reach WC1 is fairly gradual and the riparian canopy consists of dense willows located adjacent to the stream. The gradient steepens abruptly as one moves down the reach. Only one observation point provided an overview of this steeper portion of the reach. The riparian canopy is intermittent and sparse. Willow species are located on bank slopes adjacent to the creek and

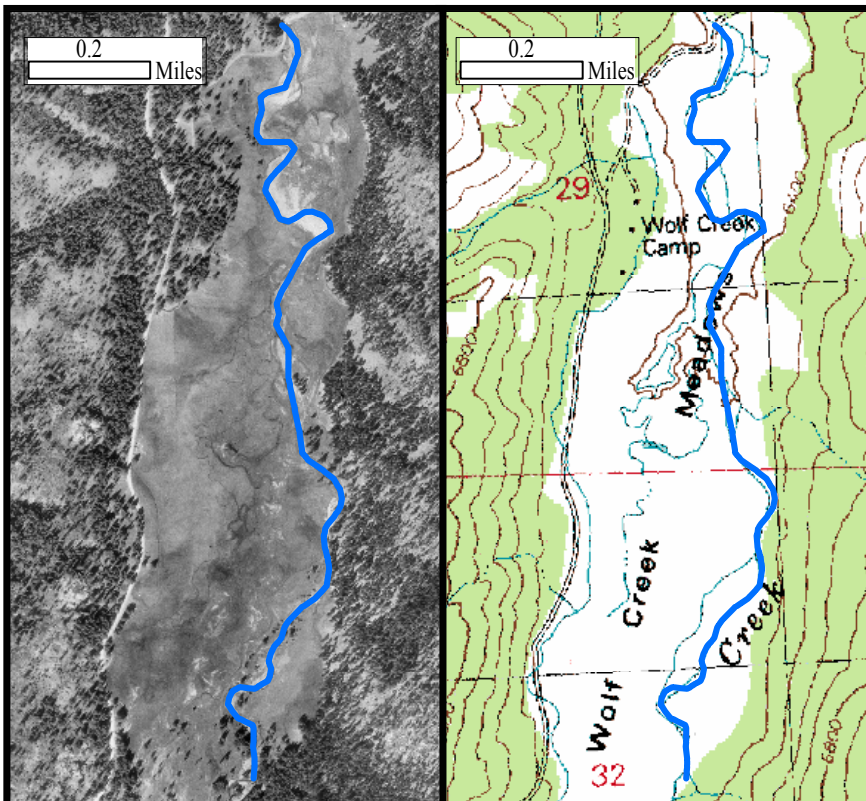
Dominant land use in the area is grazing. Although grazing and irrigation may have contributed to incision, effects of large floods and bed load transport from upstream are also important factors.

The riparian canopy along WC2 is sparse and discontinuous. Where present, willows appear to be fairly young, perhaps having become established as a result of the 1997 flood event. Vegetation on elevated stream terraces adjacent to the channel consists of wet meadow dominated by graminoids.
