3. Preliminary Field Study Results

3.1 *Methods and Data*

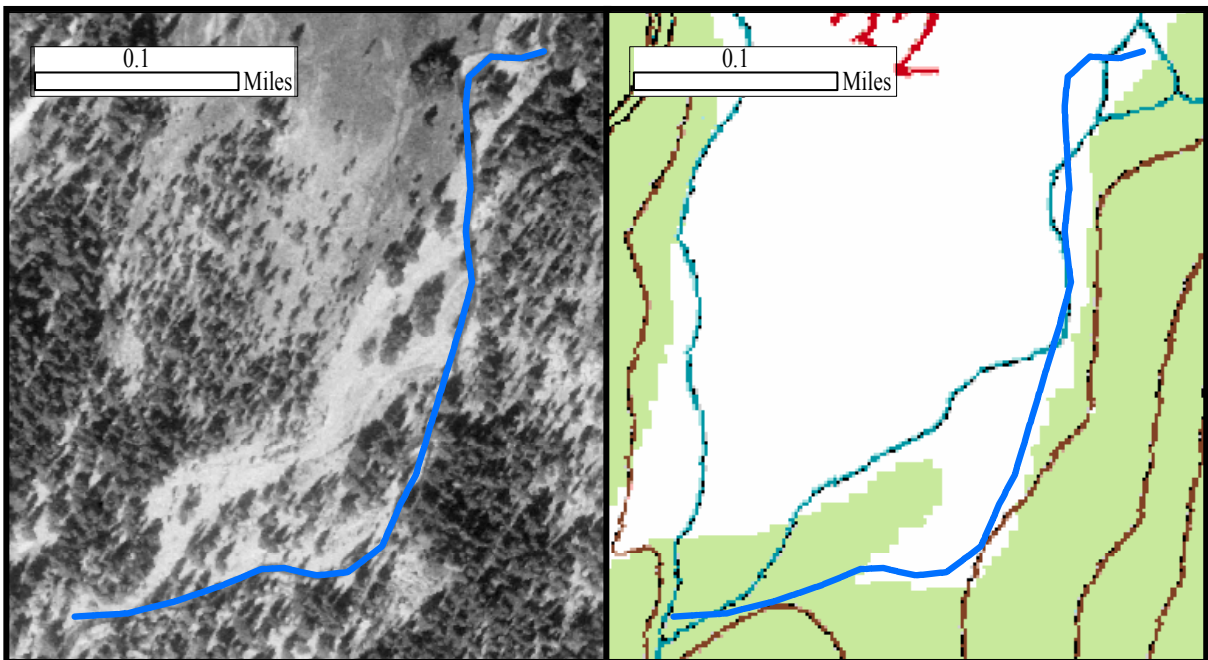
Although the 1997 flood caused extensive changes to the channel in this area, there is evidence that similar events have occurred in the past. For example, the floodplain is hummocky and uneven, suggesting that splays of gravel are an important part of floodplain formation. Large rain-on-snow floods occur fairly regularly in the area, and may often result in channel changes like those seen in 1997. Area land uses, predominantly grazing and irrigation, may also play a role.

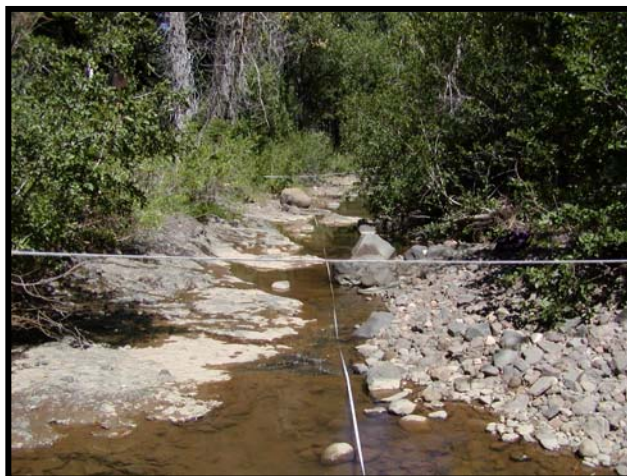
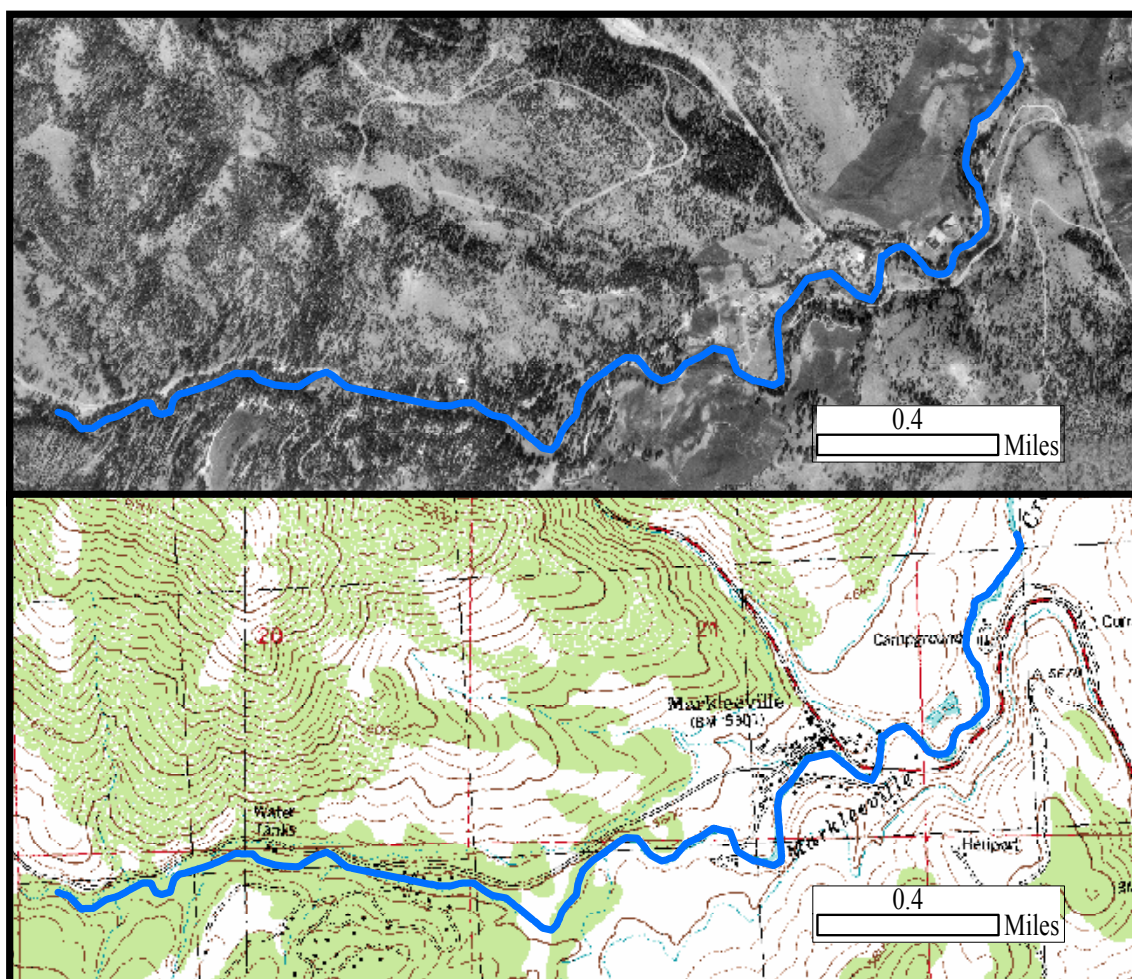
Reach MC2 consists of an alternating pattern of short, steep, confined, bedrock sections interspersed with wider, flatter, alluvial reaches where debris flow material transported through the narrow reaches is deposited and reworked during later floods. The short, steep segments may be areas where geologic (bedrock) confinement increases, or could in some cases be the toe of side canyon debris flow deposits. Wider segments are areas where valley wall confinement is reduced, and deposition tends to occur. There is evidence throughout this reach that sediment loads are relatively high. Fill terraces present throughout the wider, alluvial segments are evidence of high rates of sediment transport, which may be driven by periodic fire and subsequent intense rain-on-snow events.

Stream banks along fill terraces are relatively unstable. Depending on their location, erosion of the fill terraces may have either natural or human causes. In such areas, some adjustment of gradient and pattern would be expected after large sediment transport events. However, land use activities have also affected the river and watershed. Logging and road-building have occurred throughout the area. The river has been modified in some locations to facilitate irrigation diversion, and there has been some modification of the floodplain for residential development.

Highway 89 crosses the creek within this reach. This bridge may be undersized (see the hydraulic analysis in Section 4.3.3 of this report). Just downstream of the bridge, the USFS Guard Station occupies floodplain on the left bank. A flood wall has been constructed to protect the station, substantially reducing the floodplain area. Downstream of the station, the left bank eroded significantly in the 1997 flood, requiring bank stabilization to protect a sewer line.

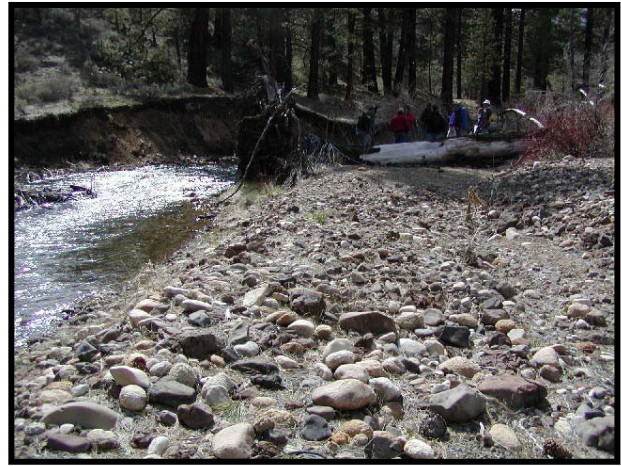
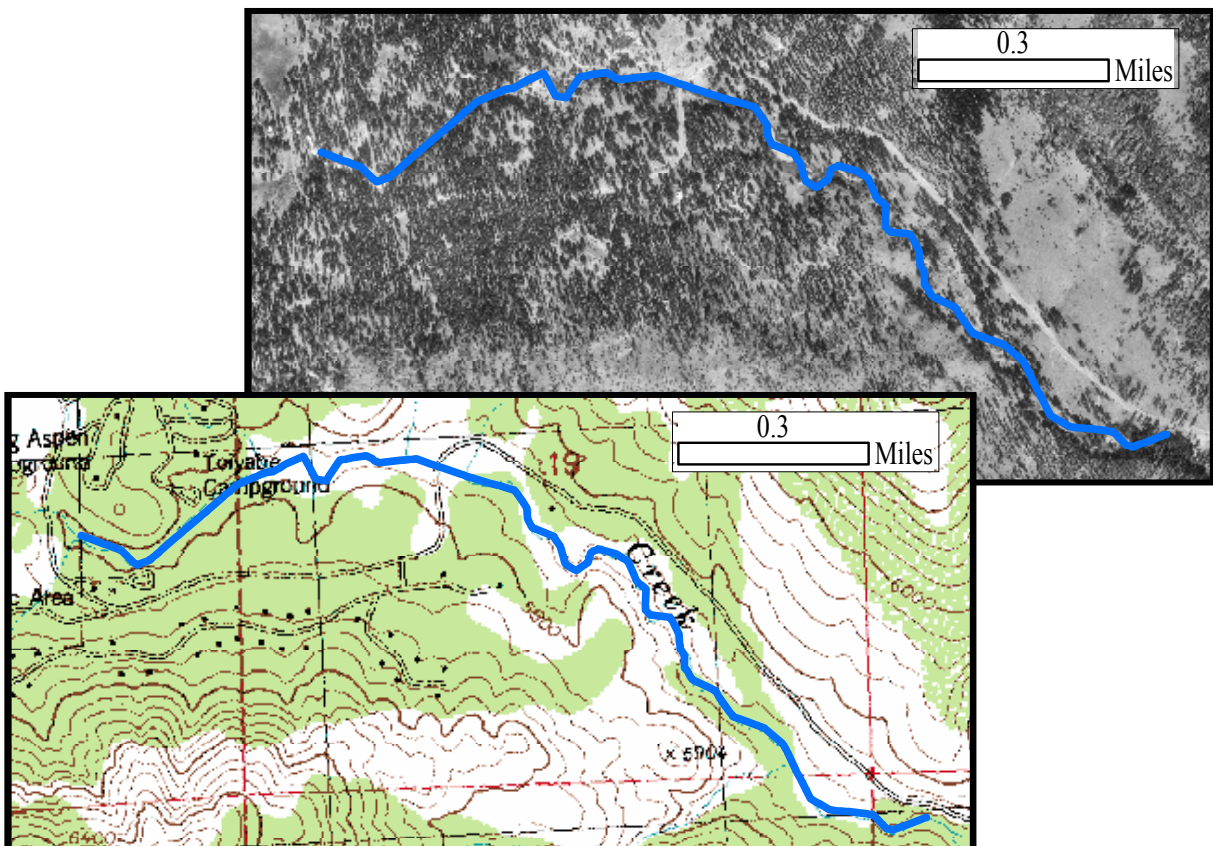
Reach MC3 is somewhat more confined by canyon walls, and may have a lower gradient than Reach MC2. However, it has a similar morphology, with straighter, more confined segments interspersed with wider areas dominated by fill terraces. It appears to be transitional between morphologic conditions described in Reach MC2 and the meadow type stream channel present in Reach MC4. Stream banks in wider portions of Reach MC3 appear to be actively eroding, especially after the 1997 flood.

There is some encroachment from residential development. A fairly dense network of dirt roads parallels the channel with several crossings.

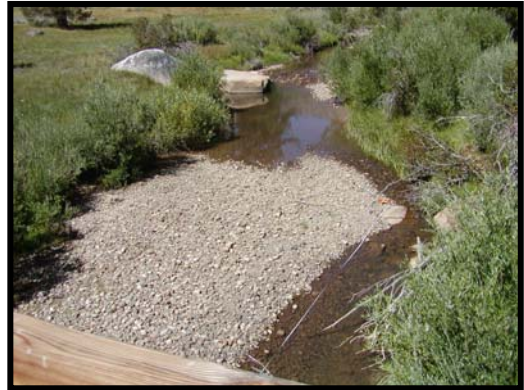
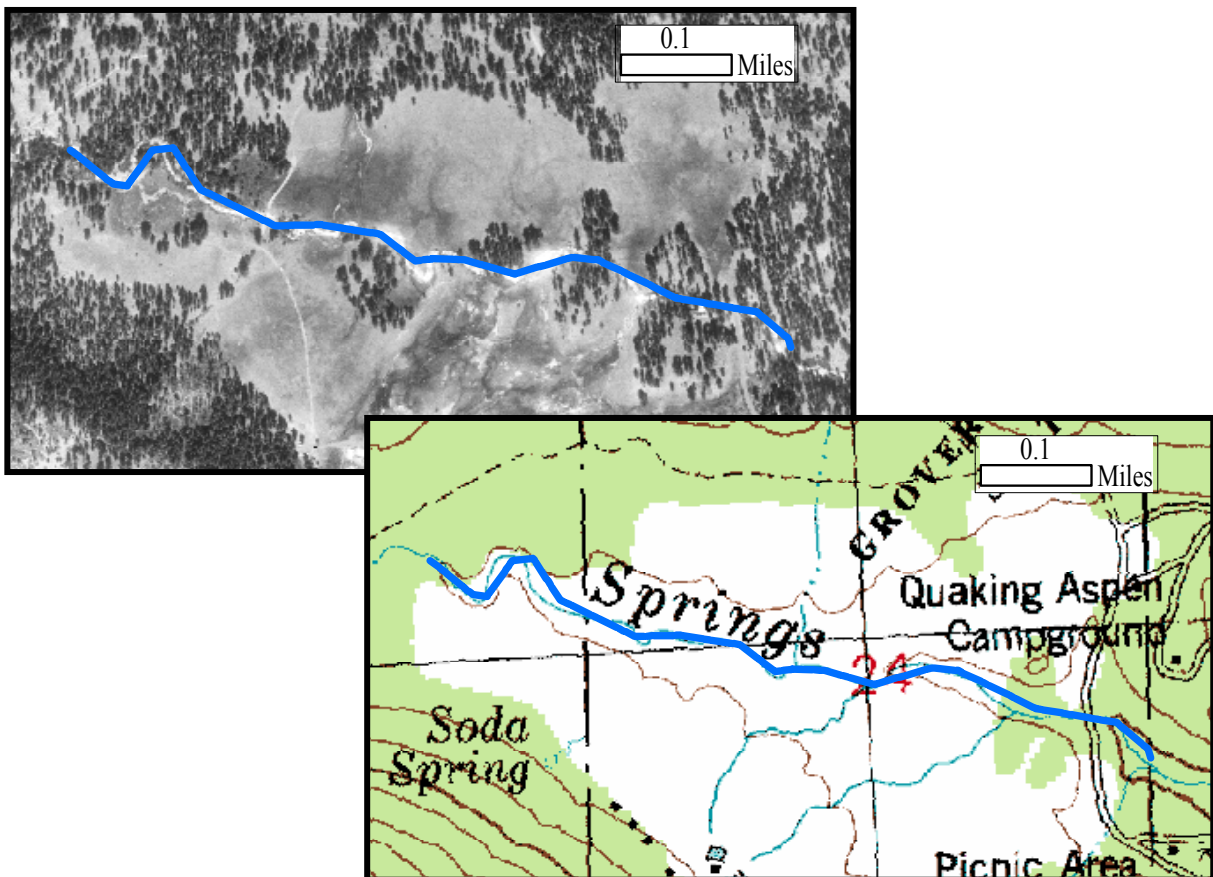
Reach MC4 flows through the meadow area adjacent to Grover Hot Springs and consists of a meandering channel incised within the meadow. The channel is meandering and has a relatively low slope. Woody material and other large roughness elements such as boulders play an important role in development of habitat such as pools and undercut banks. The dominant substrate within this reach is gravel. Stream banks are relatively high, and many show signs of recent erosion. The 1997 flood appears to have substantially increased erosion in this reach.

Historic land use includes grazing and recreation. The channel is somewhat incised, which could result from past land use impacts, naturally high sediment yield from the watershed, or both.
