4.2.8 Reach MC2

4.2.9 Reach MC4

4.3 Hydraulic Analyses

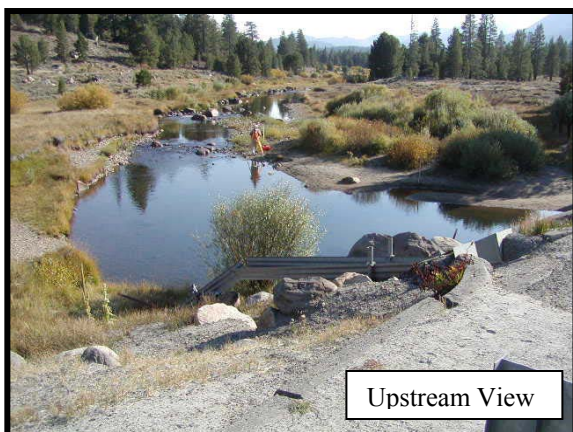
The Hope Valley Bridge appears to have adequate capacity to convey the 100-year event without overtopping the roadway. The water surface profile (Model data, Figure H3) through the bridge reveals an average freeboard (distance from the bottom of the bridge deck to the water surface) of approximately 1.9 feet for the 100-year flow.

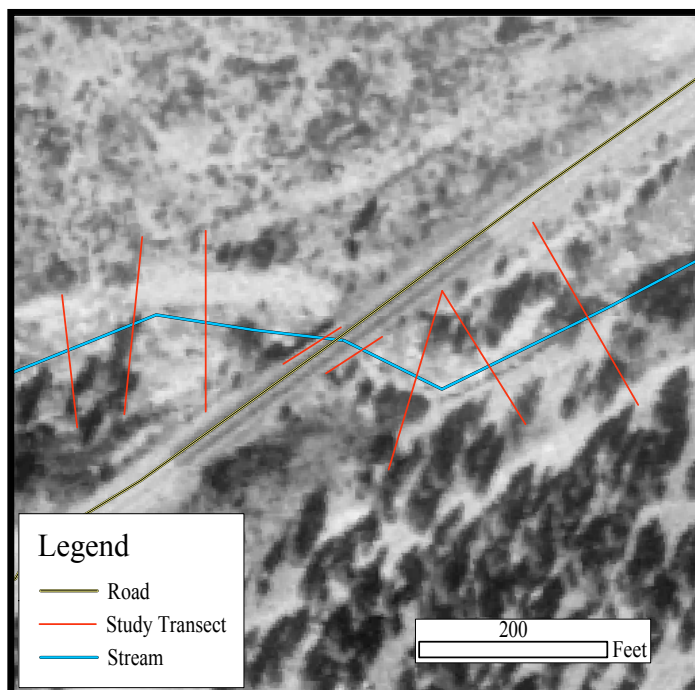
The Highway 88 Bridge at Woodfords is located on the West Fork of the Carson River. The bridge carries two lanes of traffic, and is at an approximate 20 degree skew to the river streamlines, however the abutments are not skewed. Field observations indicate that the streambed material is large, consisting primarily of angular and rounded boulders approximately between 8- to 24-inches in diameter, with several boulders outside of this range as well. This reach is relatively steep at a slope of nearly 5 percent.

The Highway 88 Bridge appears to have adequate capacity to convey the 100-year event without overtopping the roadway. The water surface profile (Model data, Figure W3) through the bridge reveals an average freeboard of approximately 10.7 feet at the 100-year flow rate.

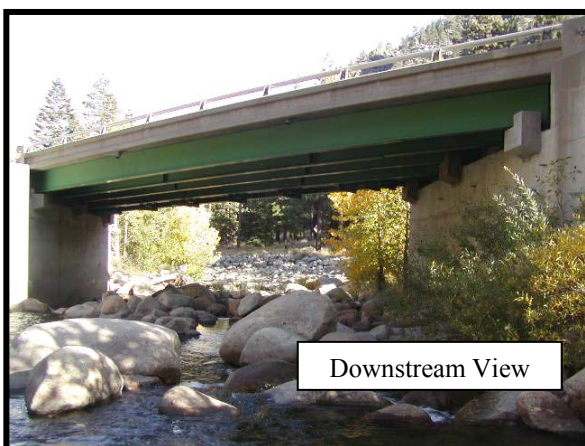
As shown in Figure W1 (Model data), the Highway 88 Bridge does not appear to narrow the available flow path when compared to cross sections measured just upstream (main channel distance 305 feet) and downstream (main channel distance 260 feet) of the bridge, for evaluated flows (2-year through 100-year).

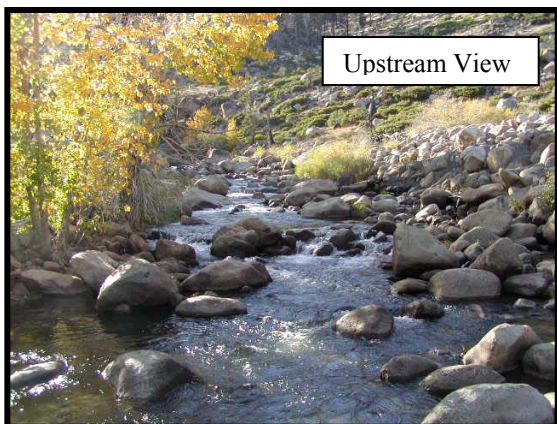
The stream power, however, spikes significantly at the upstream end of the bridge for the 25-year and higher flows, but drops at the downstream end of the bridge (see Figure W2, Model data). It is important to note that the stream power also spikes significantly a few hundred feet upstream of the bridge and about 100 feet downstream of the bridge as well. The spikes and drops in stream power indicate that this portion of the river is highly dynamic, whether or not the bridge is present. The bridge does not appear to significantly affect hydraulic characteristics of the stream anymore than the existing natural channel geometry. As can be seen in the stream profile

(Figure W3, Model data), the spike in stream power at the upstream end of the bridge does not appear to have resulted in any consequential degradation of the streambed at this location.

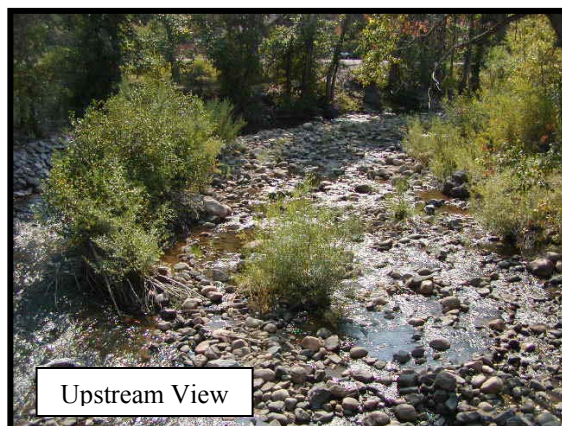
The Markleeville Bridge and the downstream rockery walls erected on the banks of the stream represent a narrowed flow path for the passage of Markleeville Creek (see Figure M1 in Model data). The bridge starts at main channel distance 427 feet. The constriction caused by the bridge and the rockery walls continues downstream for approximately 200 feet before the stream is no longer confined (one wall continues further downstream than the other).

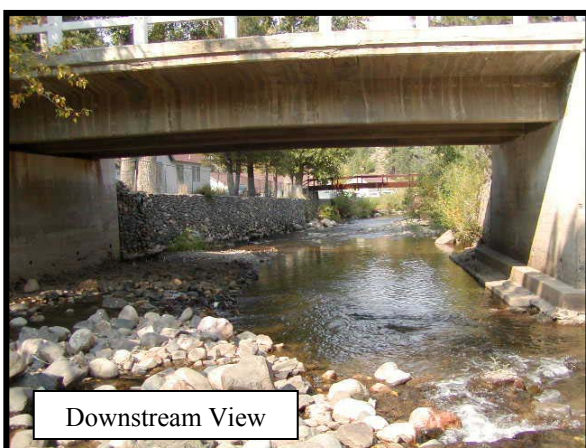
The channel constriction is most likely responsible for the increase in stream power at the bridge, for flows equal to and exceeding the 25-year recurrence interval (Figure M2, Model data). The constriction and subsequent increase in stream power contribute to the channel incision, as can be seen on the stream profile in Figure M3 (Model data). The channel bottom drops significantly at the bridge.

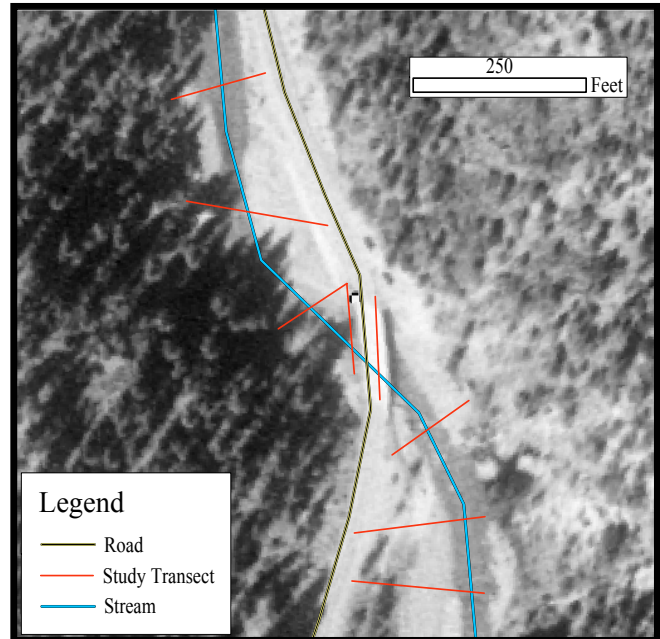
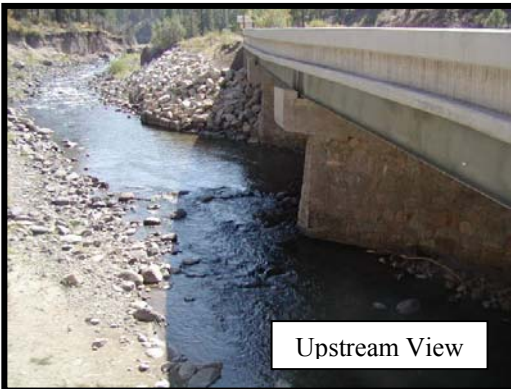
The Centerville Flat Bridge appears to have adequate capacity to convey the 100-year event without overtopping the roadway. The water surface profile (Figure C3, Model data) through the bridge reveals an average freeboard of approximately 1.4 feet at the 100-year flow rate.

The flow path available at the Centerville Flat Bridge does not vary significantly with respect to flow path widths evident upstream (main channel distance 454 feet) or downstream (main channel distance 410 feet) of the bridge (see Figure C1 in Model data). In fact, one cross section measured approximately 150 feet upstream of the bridge is significantly narrower than the cross section through the bridge. The stream power spikes at a few locations within the channel, but neither of these locations are at the bridge (see Figure C2 in Model data). The Centerville Flat Bridge does not appear to be significantly impinging upon the natural hydraulic characteristics of the channel.
