Post Asbestos Abatement Inspection Report Silver Peak Community Center Silver Peak, Nevada

Project No. 22-01-194-201

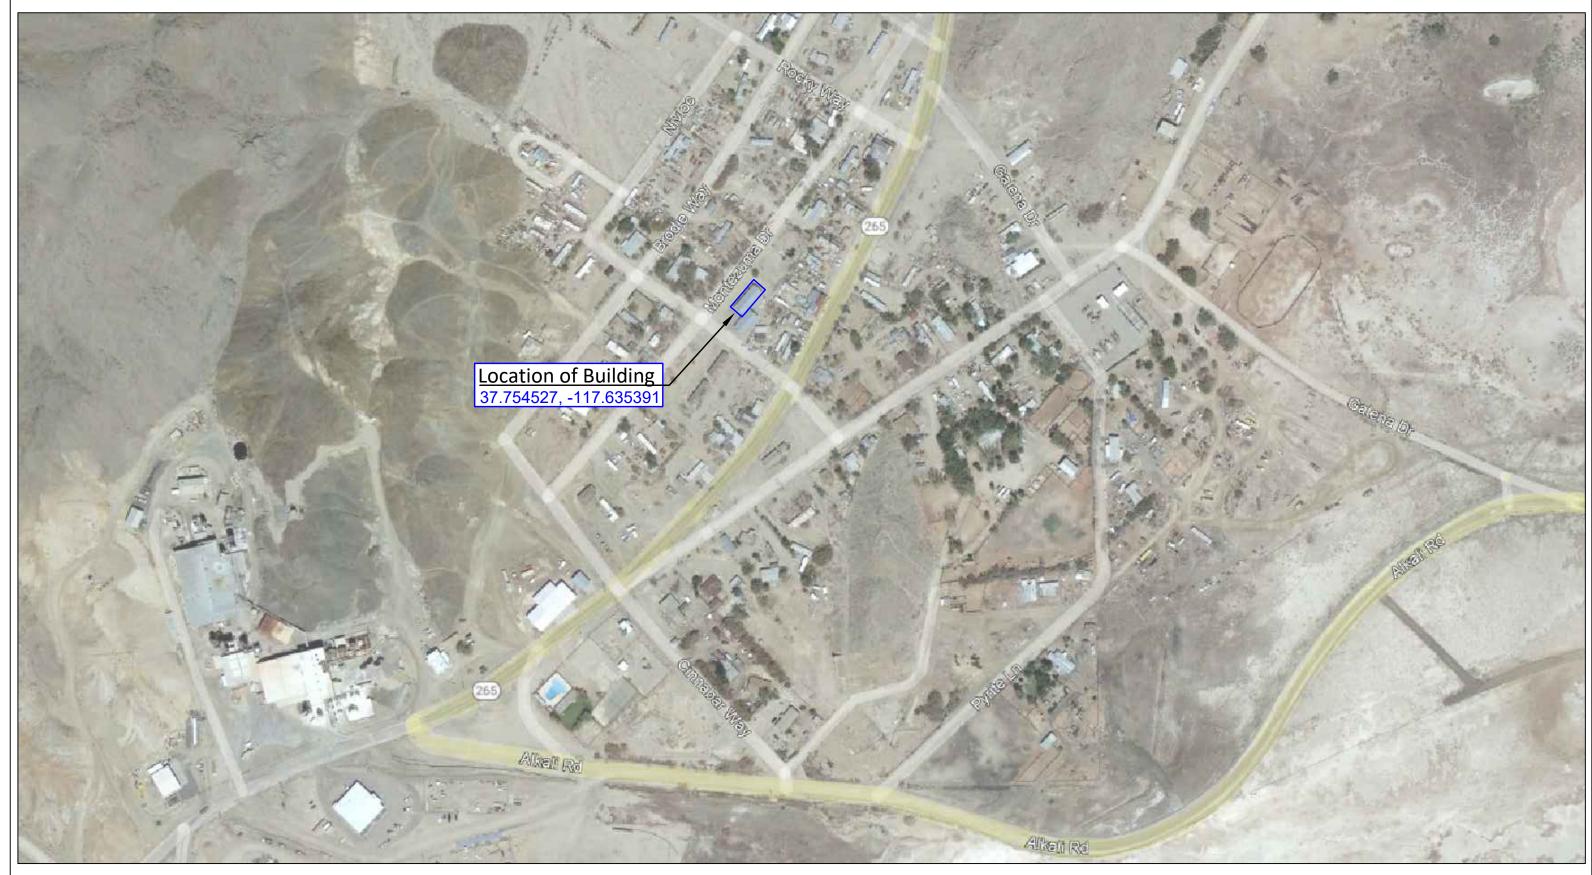
Figure No. 1
Site Location Figure

37.754527, -117.635391 GPS Coordinates of Building

Silver Peak Community Center 10 Montezuma Drive Silver Peak, Nevada

Asbestos abatement activities were performed at the Silver Peak Community Center (Center) located in Silver Peak, Nevada (Property). The abatement activities were performed to remove asbestos containing materials (ACM) in preparation for renovations to the Center. Broadbent and Associates, Inc. (Broadbent) was contracted by Castillo Construction to provide inspection activities subsequent to completing the abatement of ACM at the Center. Work was executed in accordance with a Broadbent proposal dated May 10, 2023. This report serves to document visual observations and air sampling data obtained during the performance of the post asbestos abatement inspection activities at the Property. Figure 1 depicts the location of the Property.
