HAZARDOUS BUILDING MATERIALS SURVEY

Asbestos and Lead-Based Paint

50 Kietzke Lane Reno, Nevada APN 012-304-01

May 4, 2021

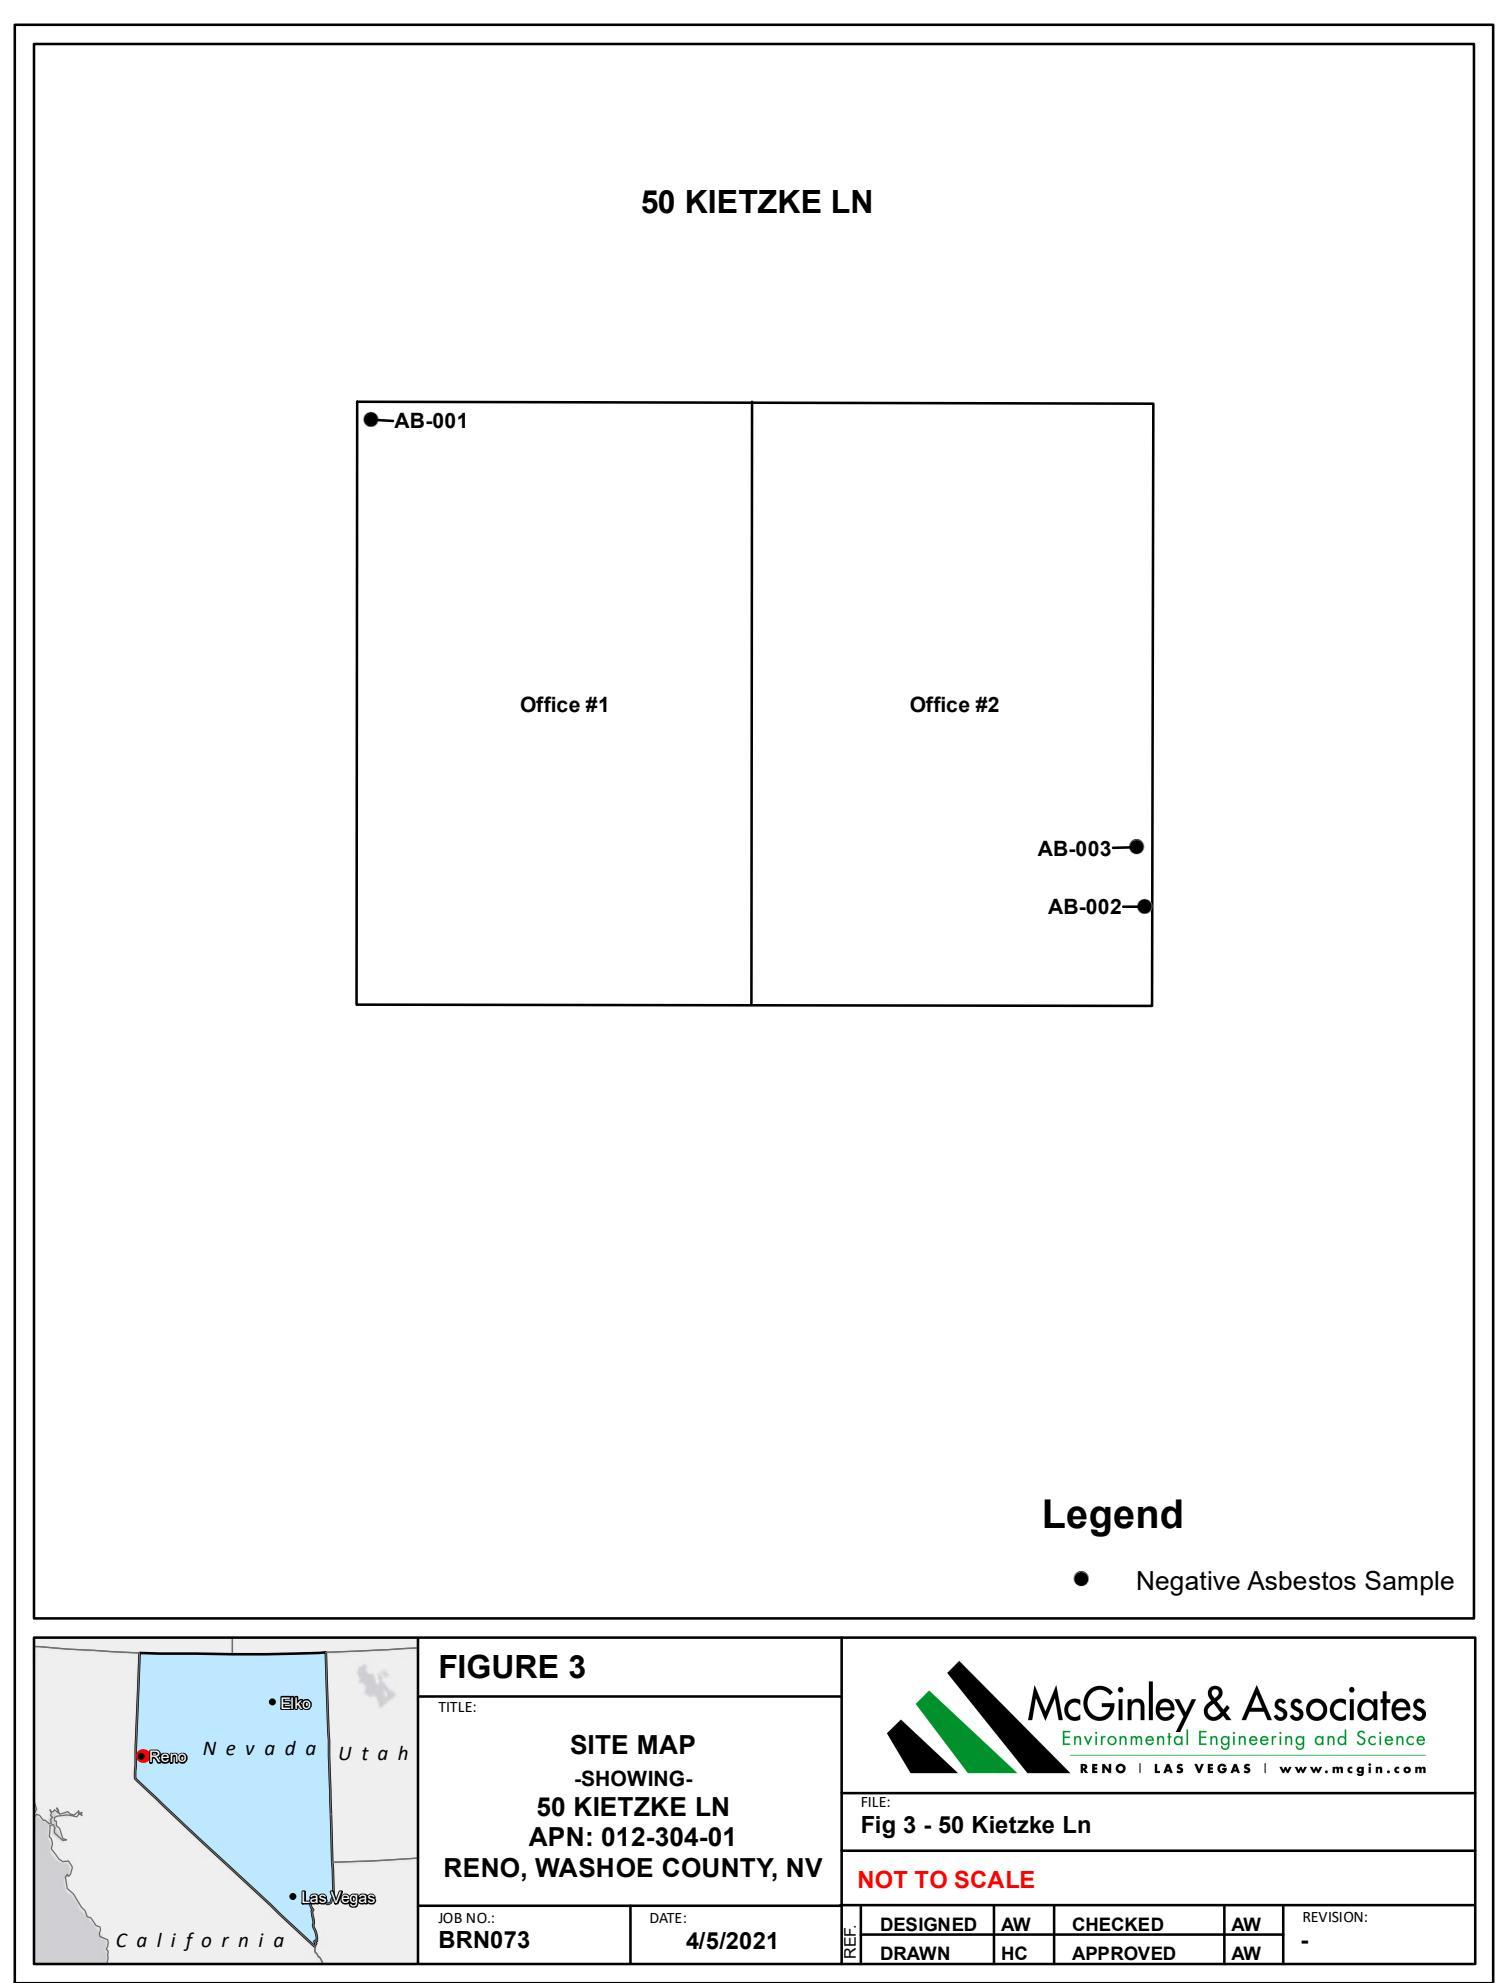
R:\Projects\GIS Data\BRN\073\Fig 3 - 50 Kietzke Ln.mxd

A total of 3 bulk samples were collected from the Subject Property. Each collected bulk sample was placed and sealed in a sample bag and assigned a unique sample identification number (*BRN073-AB-001 through BRN073-AB-003*). Based on the number of samples collected, a field duplicate sample was not collected for this survey. A summary of the samples collected during the survey is presented in Table 1. Sample locations are presented in Figure 3.
