What is a Tailings Impoundment?

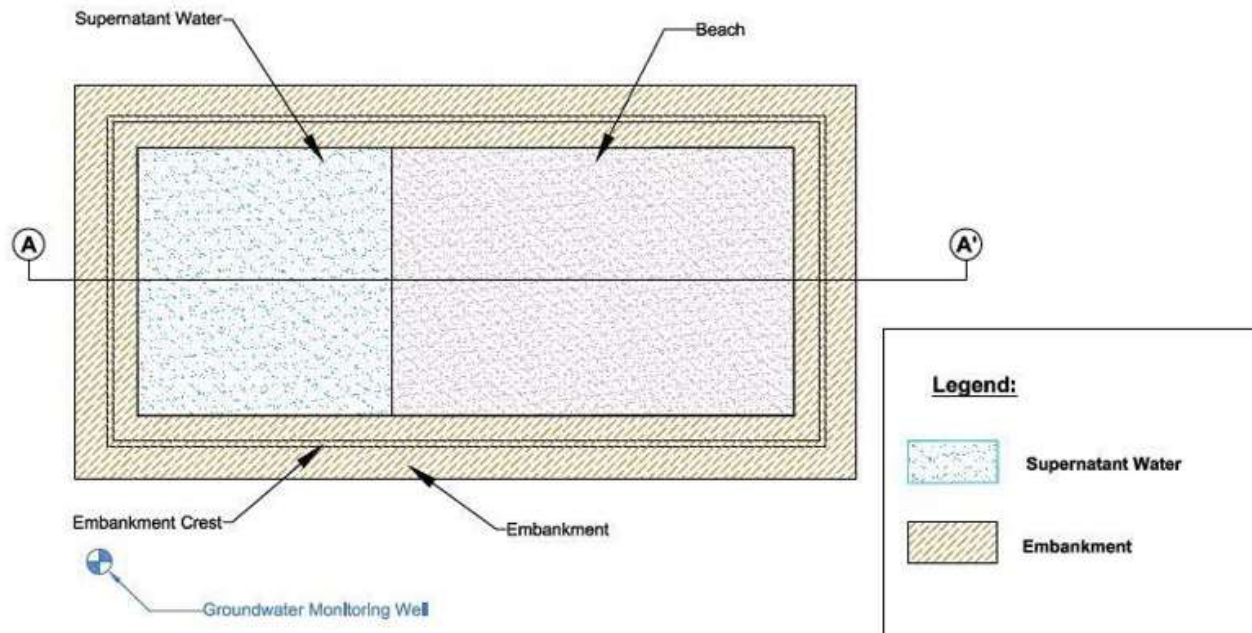
Figure 1: An idealized tailings impoundment consisting of a liner system, a “beach” of dewatered solids and a pond.

A pond on the surface of the tailings impoundment is called the “supernatant pool”; an underdrain system reclaims this water so it can be pumped back to the mill for re-use. A “beach” of dried slurry forms in the impoundment as solids settle out of the water. See Figures 1 and 2.

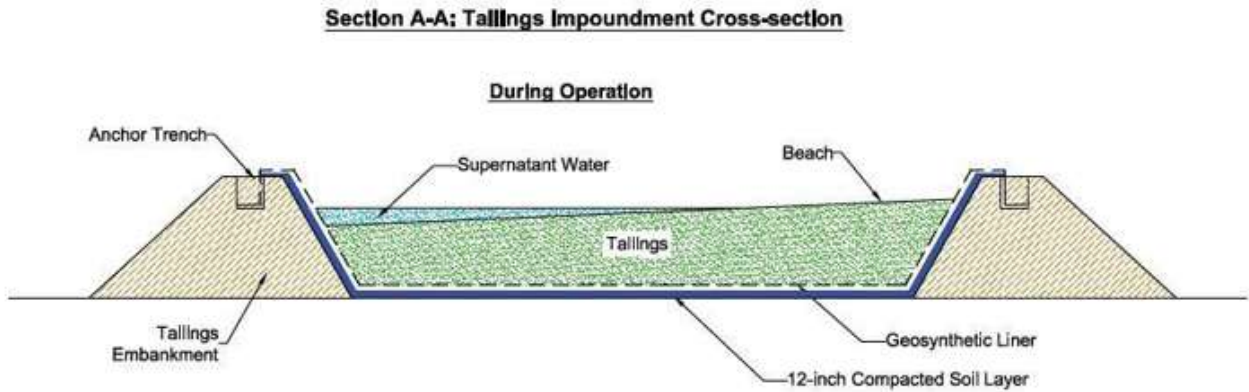
Figure 2: Side view of an idealized tailings impoundment showing the liner system.
